**PRELIMINARY SITE ASSESSMENT
APPROXIMATELY 4.29 ACRES ALONG
NORFOLK SOUTHERN RAILROAD
MECKLENBURG COUNTY, NORTH CAROLINA
STATE PROJECT NO. 9.9081000 (P-3800)**

**Prepared for:
NCDOT Geotechnical Unit
1589 Mail Service Center
Raleigh, North Carolina 27699-1589**

**Prepared by:
Solutions Industrial & Environmental Services, Inc.
3722 Benson Drive
Raleigh, North Carolina 27609**

December 6, 2001

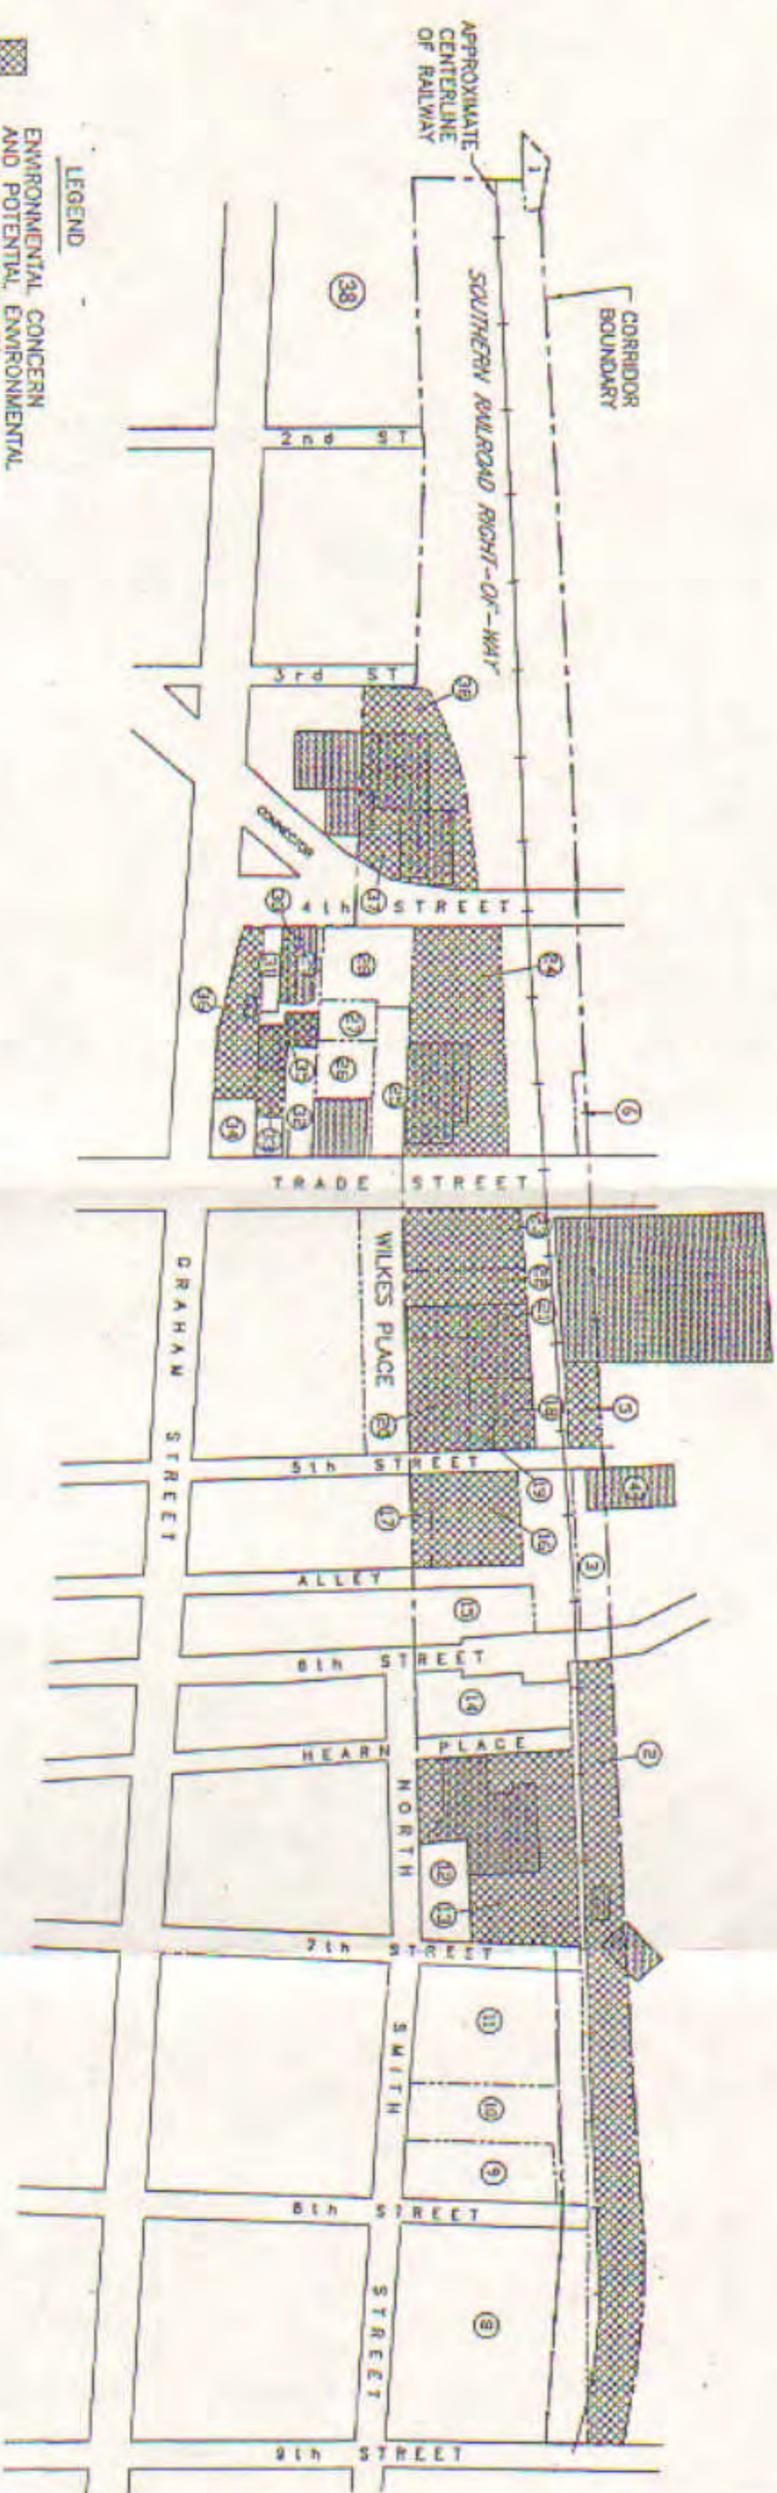
POTENTIAL ENVIRONMENTAL LIABILITY AREAS
NORFOLK SOUTHERN RAILROAD
SOURCE (AGWA, 2000)
STATE PROJECT NO. 9.9081000 (P-3800)

Arcadis Geraghty & Miller (AGM, 2000) prepared a Limited Phase I Environmental Site Assessment Report (PESAR) for many of the properties surrounding the NS right-of-way in the project area. Figure 3 shows the property locations that were investigated during the PESAR. The cross-hatched and numbered properties shown on Figure 3 were highlighted as presenting possible environmental concern and/or posing possible environmental liability. The properties of noted concern that are adjacent to the four parcels being assessed for this PSA report are briefly described below:

Parcel 2 is located near a former polychlorinated biphenyl (PCB) disposal facility that was stabilized with cement and redeveloped as practice fields for the Carolina Panthers football team. The former disposal site is not shown in Figure 3. It was located west of (across the right-of-way) Parcel 2 and is not expected to have affected environmental conditions on Parcel 2. A Duke Power substation (not numbered) is

located adjacent to the south half of Parcel 2, but most likely has not affected environmental conditions (AGM, 2000). Image Plus, a custom color printing operation (shown as 38) is located on the city block between 3rd and 4th Streets. The PESAR (AGM, 2000) does not cite instances of chemical releases, but has listed it as a potential environmental liability area because of its historical property use for automobile servicing and painting. The Charlotte Florist (number 37) is also listed as a potential environmental site because of historical property use for automobile servicing and painting.

The Greyhound Lines, Inc., bus terminal (number 24) may represent the greatest potential for environmental liability adjacent to the study area. Parcel 4 is located along the northwest side of the terminal building. The Greyhound Lines, Inc. facility has three active diesel pumps fed by a 15,000-gallon UST. According to the PESAR, the facility had a 10,000-gallon diesel leaking UST (LUST) that was removed in 1996. The LUST was located along the northern portion of the property, approximately 25 feet from the terminal building. However, the PESAR did not include a map identifying the exact location of the former LUST.

Parcel 5 is located adjacent to several businesses. The Witzens Art Gallery (number 18) may represent some environmental risk because of historical property use as a machine shop. The Daily Double Sports Bar and Business Records Storage, Inc. (numbers 20 and 21) were also noted because of their historical use including coal storage, a machine shop and automotive repair shop. Paid Parking owns two gravel/asphalt parking lots (numbers 22 and 23) located adjacent to the southeast half of Parcel 5. They were noted to represent some environmental risk because of their historical use including coal storage, a machine shop, oil house, and gasoline station with three USTs. The PESAR did not list any incidences of

Parcel 7 is located next to an active construction site, Carolina Rim & Wheel, and a cleared gravel parking lot and grassy field. The active construction site is located between 5th and 6th Streets, and was previously described as being occupied in the past by a bakery, a single-story building, and more recently, a gravel parking lot. Carolina Rim & Wheel (number 13) is an automotive parts store and was regarded by AGM as potential environmental liability area because of the possibility of petroleum hydrocarbon releases from current/past automotive servicing. The gravel parking lot between West 6th Street and West 7th Street, and the field between West 7th Street and West 8th Street (Numbers 8 through 12 on Figure 3 were not specifically studied in the PESAR).

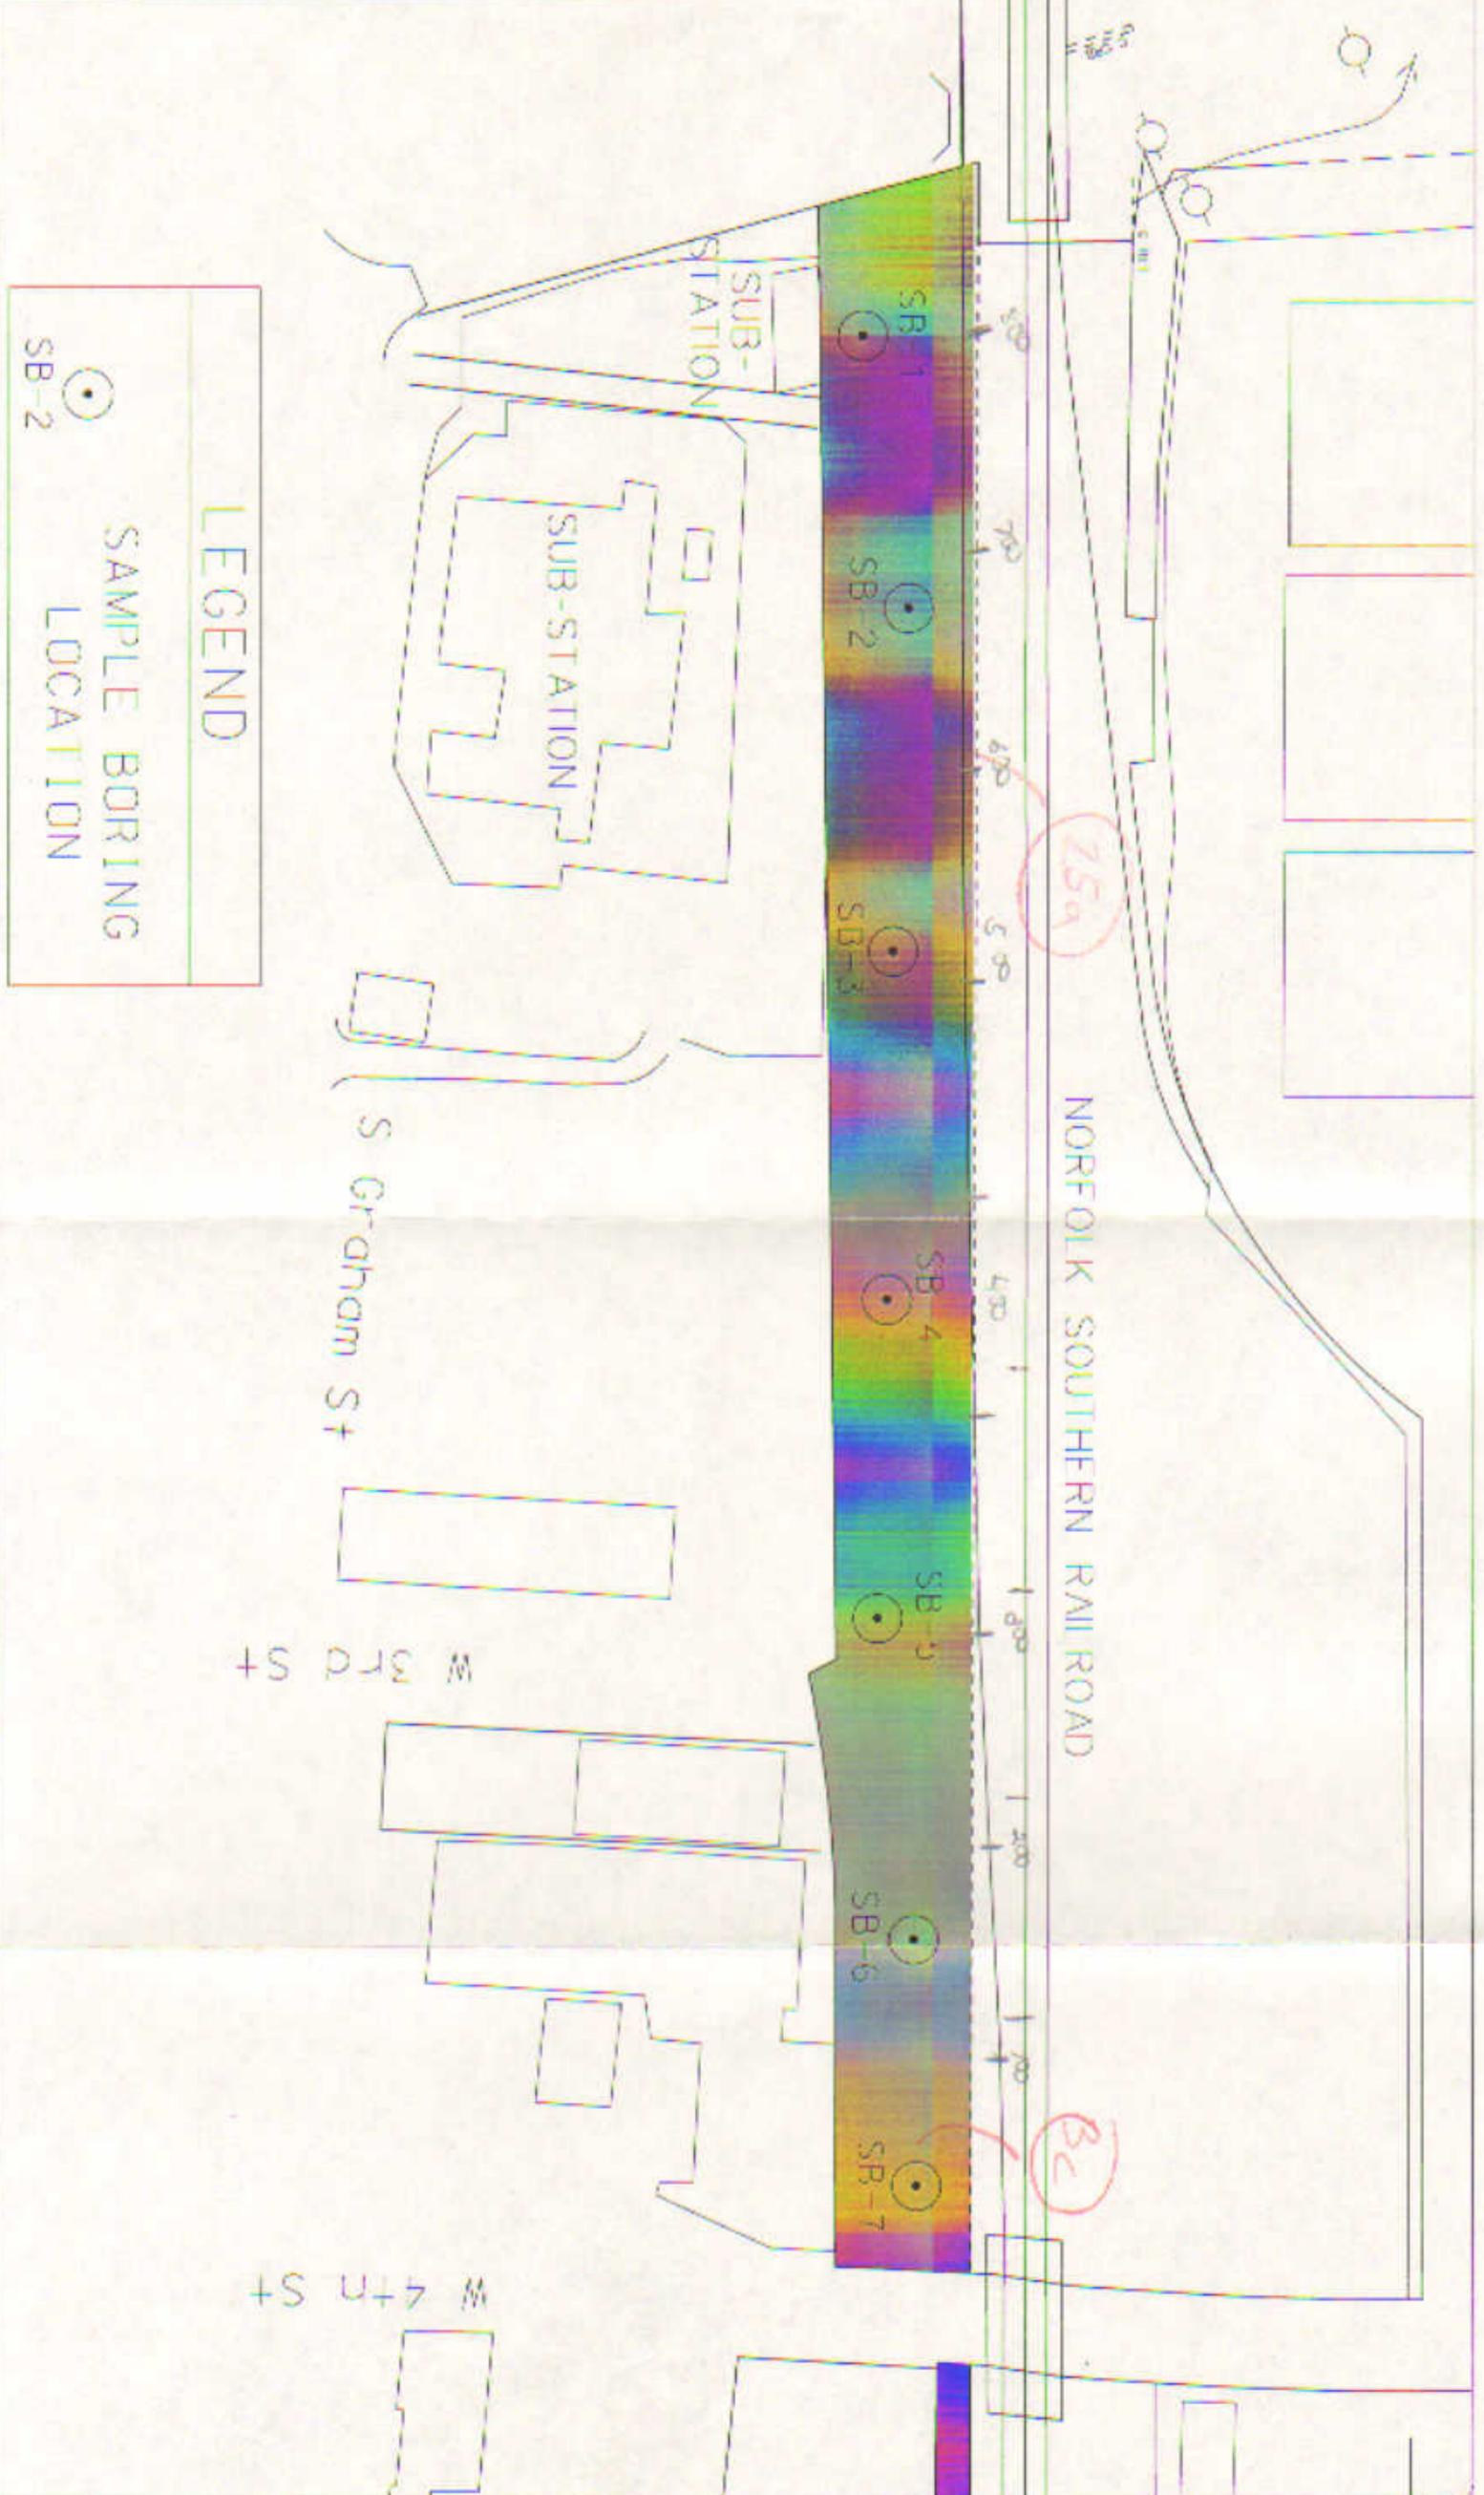
SITE AND BORING LOCATION MAP
 PARCEL 7
 NORFOLK SOUTHERN RAILROAD
 STATE PROJECT NO. 9.9081000 (P-38001)

Solutions-IES opened borings at 25 locations within Parcels 2, 4, 5 and 7. Soil samples were collected using either a Geoprobe[®], or in cases where vehicle access was impossible, we entered the area on foot and used a hand auger to collect the samples. The SB-1 boring location on Parcel 2 was in a ditch adjacent to the off-site electric power sub-station. Several hand auger borings were attempted at this location but refusal was encountered approximately 1 to 2 feet below ground surface (bgs) because of gravel and cobbles. The other borings opened in Parcel 2 were opened with the Geoprobe[®]. In Parcel 4, all of the borings were performed using a hand auger because of access restrictions. Those in the south end of Parcel 4 (SB-8 and SB-9) and Parcel 5 (SB-14) were terminated at relatively shallow depth on gravel and cobbles. In Parcel 7 all of the borings except SB-19 were opened with the Geoprobe. The boring locations for each of the four parcels are shown in Figures 4 through 7.

The results of TPH analyses performed on the five soil samples submitted to the laboratory are summarized in Table 2. Three of the samples were collected in the top 2 feet of the near-surface soils; the other two samples were collected at a depth of 6 to 8 feet bgs. No gasoline range petroleum hydrocarbons were detected in any of the five samples. Detectable concentrations of diesel range hydrocarbons were reported in the samples collected from Parcels 2 at SB-5 and Parcel 7 at SB-20 and SB-25.

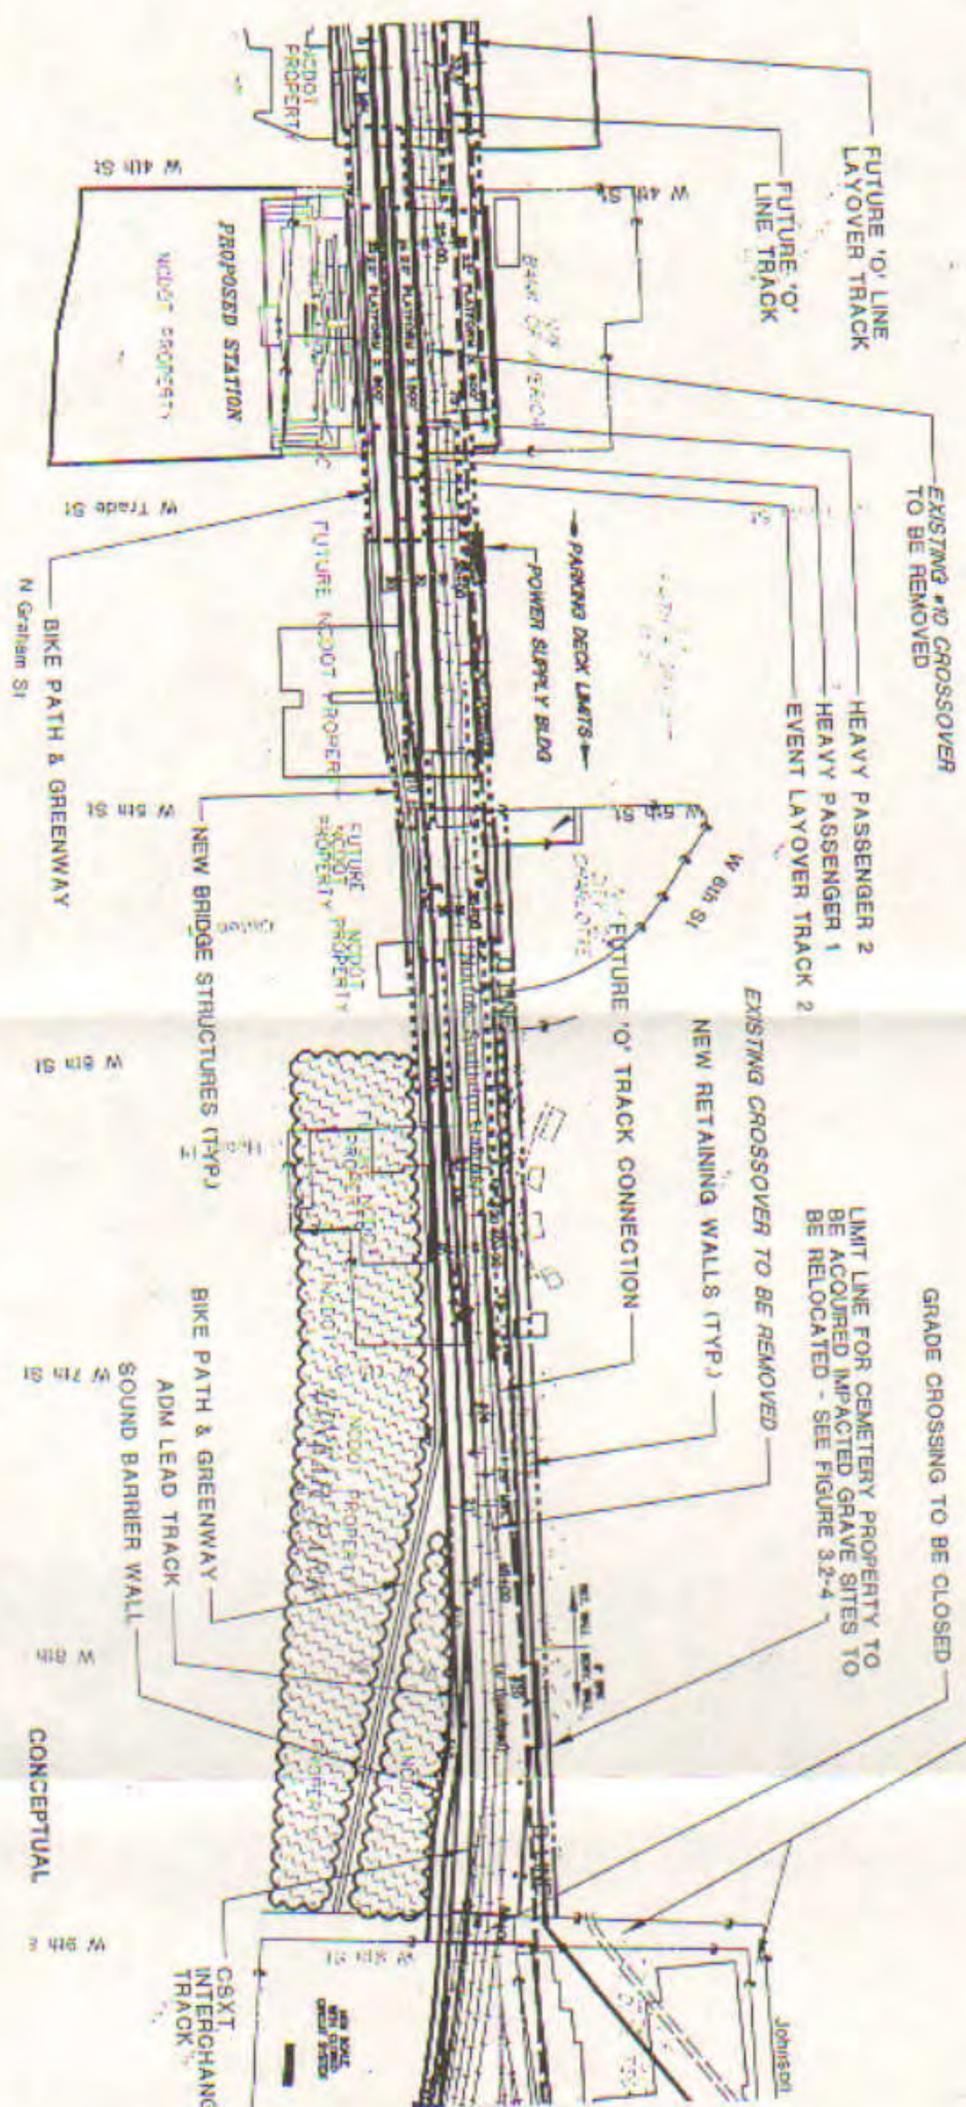
FUTURE CONSTRUCTION
PROPOSED MULTI-MODAL STATION
SOURCE (GANNETT FLEMING, 2001)
STATE PROJECT NO. 9.9081000 (P-36001)

Figure 8 shows the outline of the proposed Multi-Modal Station that will occupy Parcel 4 and the current Greyhound bus terminal property. The figure also shows portions of the track improvements that will occupy the north half of Parcel 2, Parcels 5, and Parcel 7. According to the Draft Feasibility Study, the existing NS main line tracks will remain aligned horizontally and vertically near their present position (Gannett Fleming, et al. 2001). Additional rails, noted as "Heavy Passenger 1", "Heavy Passenger 2" and "Event Layover No.2" will be constructed along with passenger sidings on the east side of the main line rails. A single rail designated as the "Future O Line Track" will be constructed on the west side of the main line rails. In the Station area, the new rails will be aligned vertically close to the main line rails. This will require the placement of extensive new fill embankments throughout the four parcels studied. The cross streets, West 6th Street through West 9th Street will be closed and a portion of Parcel 7 will be used to construct a natural area (Linear Park). A soil berm with retaining wall extending through the park will be used to create a sound and visual buffer. Because of the extensive new fill that will be required, the project will require additional off-site soil to construct the new embankments.

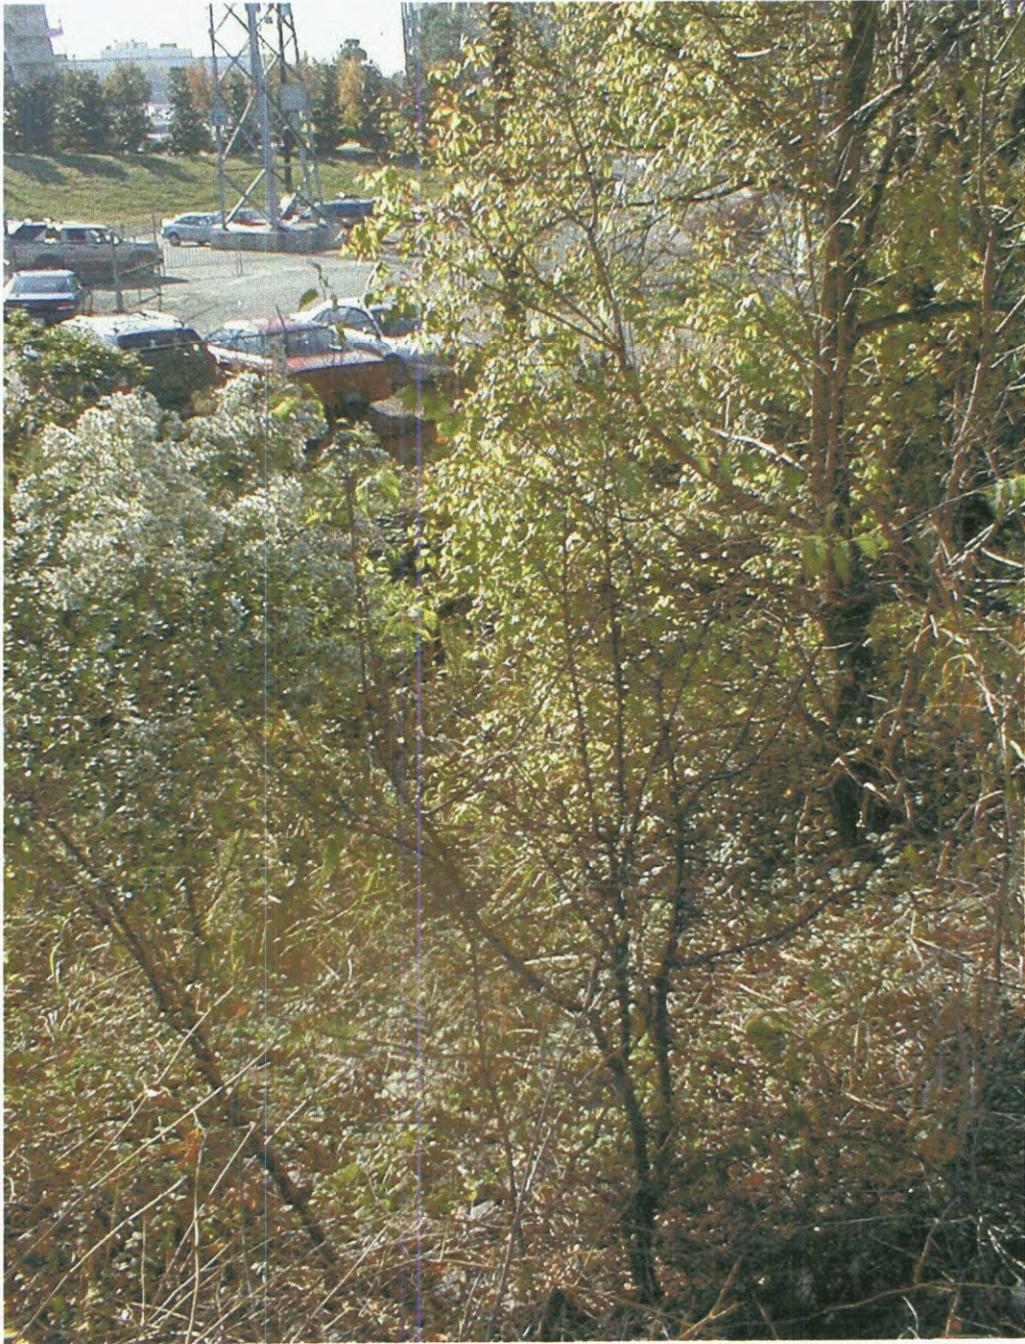
Photograph 1 Approximate location of SB-1

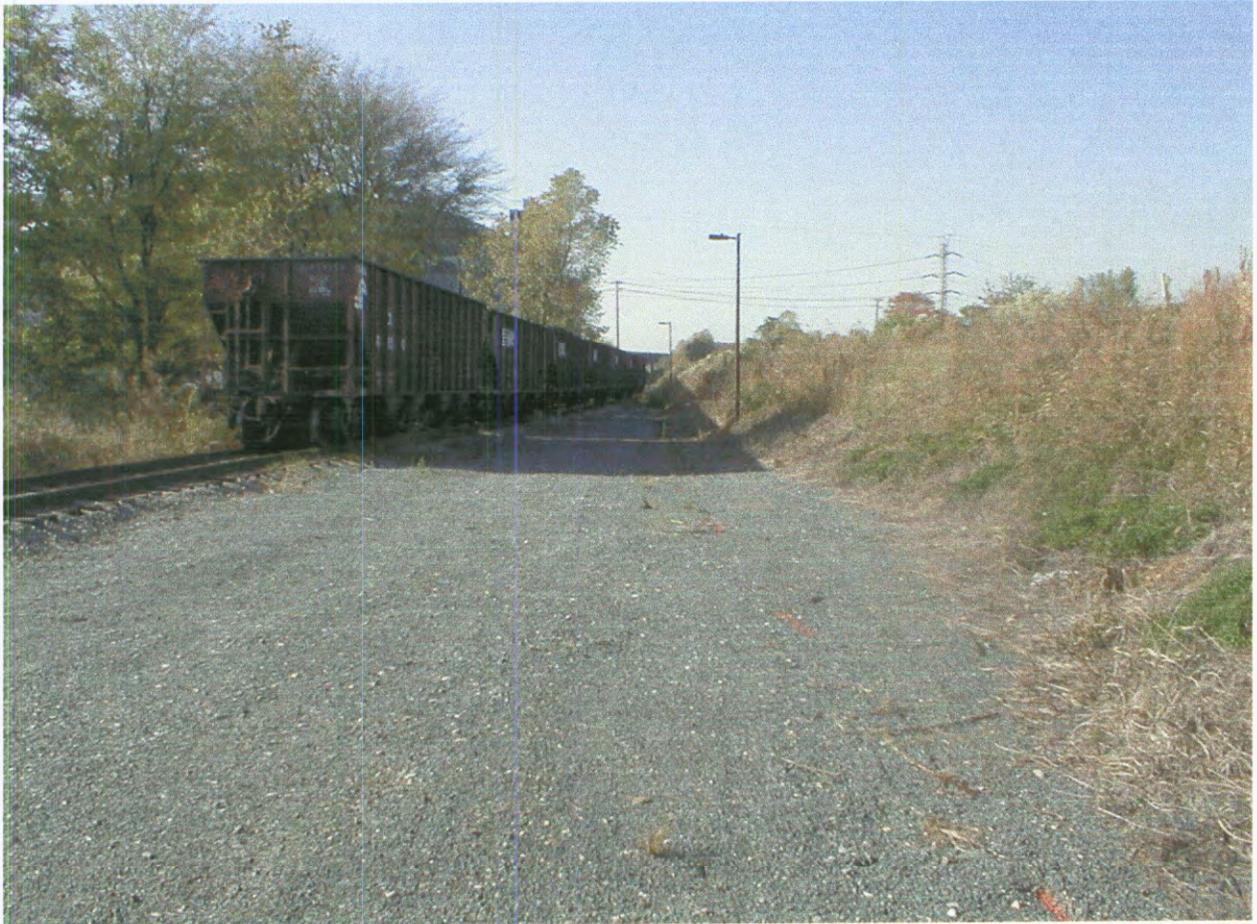
Photograph 2 Parcel #2 facing southwest. Active railroad lines are on right.

Within Parcel 2, the main line tracks are elevated on embankment fill. The fill slopes are vegetated and the portion of the property located east of the embankment slope is at street grade (10 to 15 feet below the mainline rail elevation (Photograph 1) and covered with gravel. There is an existing spur line, identified in the Feasibility Study as the "Old Team Track", extending through the parcel. Judging from the rusty rails, the spur line appears to be rarely used (Photographs 2 and 3). Parcel 2 is the largest of the four properties evaluated and encompasses approximately 3 acres. Parcel 2 was found to contain several underground utilities, including high voltage electric, cable television, and fiber optic telephone lines.

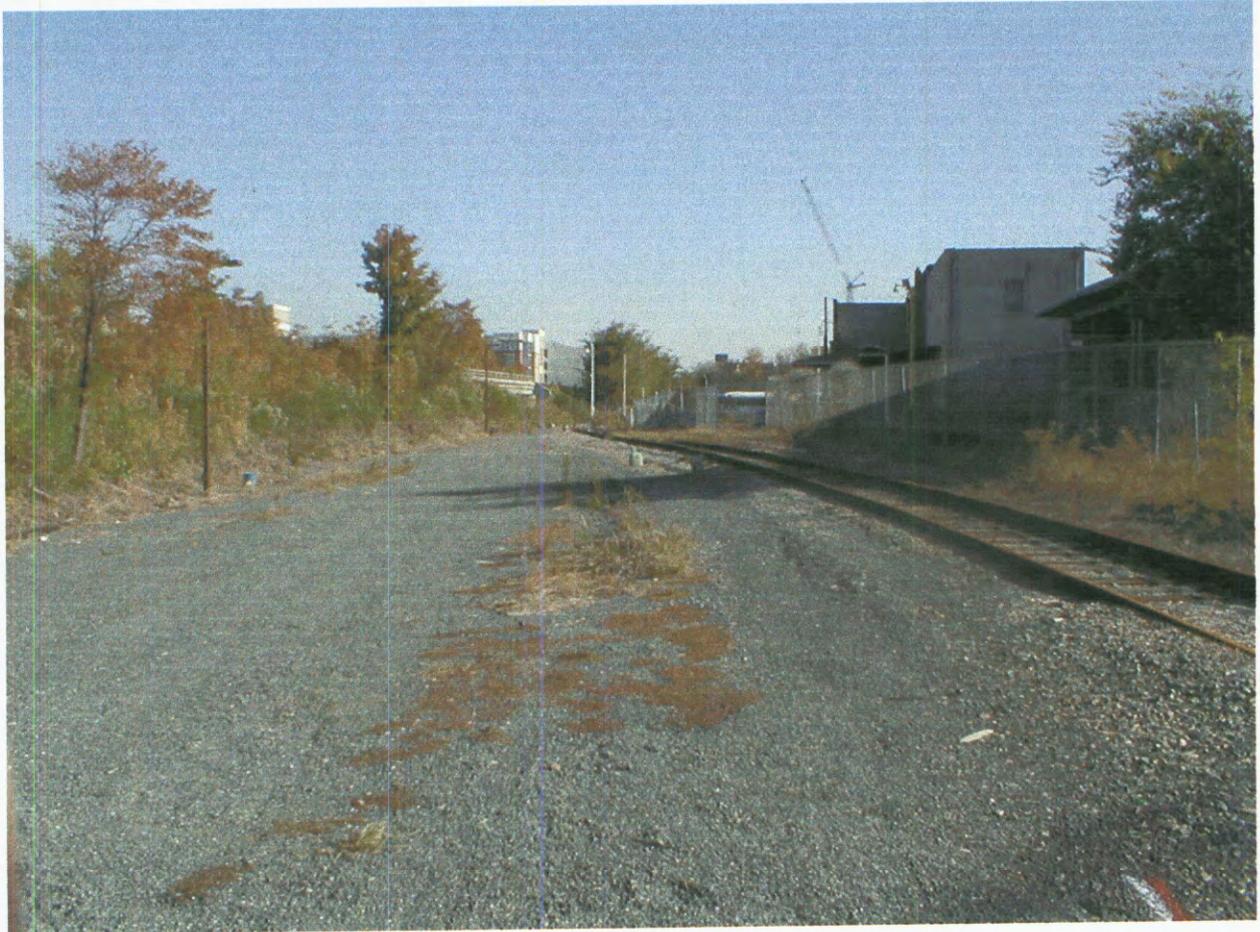
Photograph 3 Parcel #2 facing northeast.

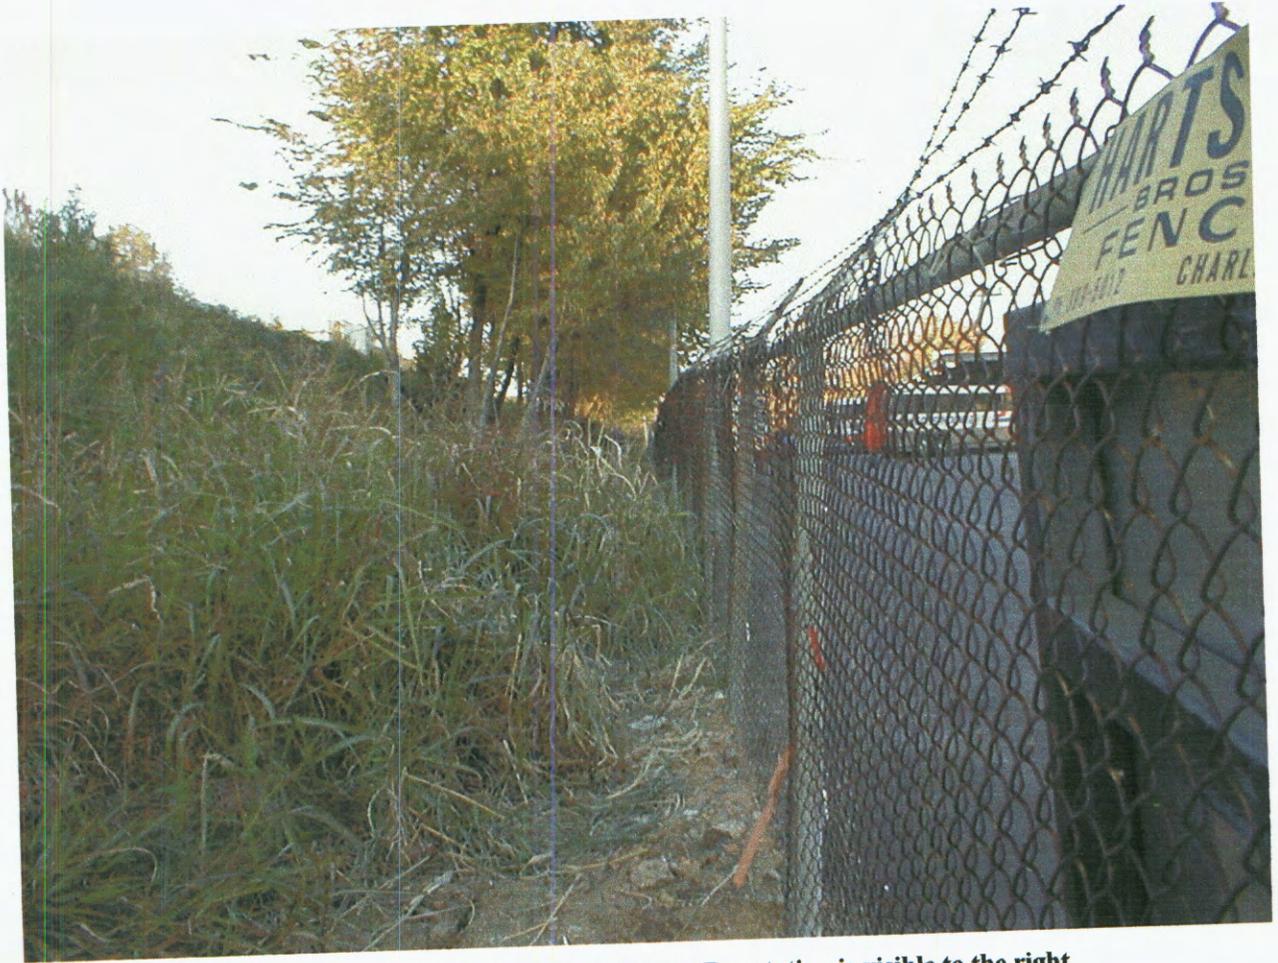
Photograph 4 Parcel #4 facing northeast. Bus station is visible to the right.

Parcel 4 encompasses approximately 0.21 acre, extending from West 4th Street and West Trade Street. The area near the perimeter fence is at street grade. The land slopes upward along the embankment slope to the main line tracks and is covered in overgrown scrub vegetation. The Greyhound bus station is located (southeast) of the perimeter fence (Photographs 4 and 5). We noted during our reconnaissance that the existing bus station has three diesel pumps and three vehicle-washing stations located on the

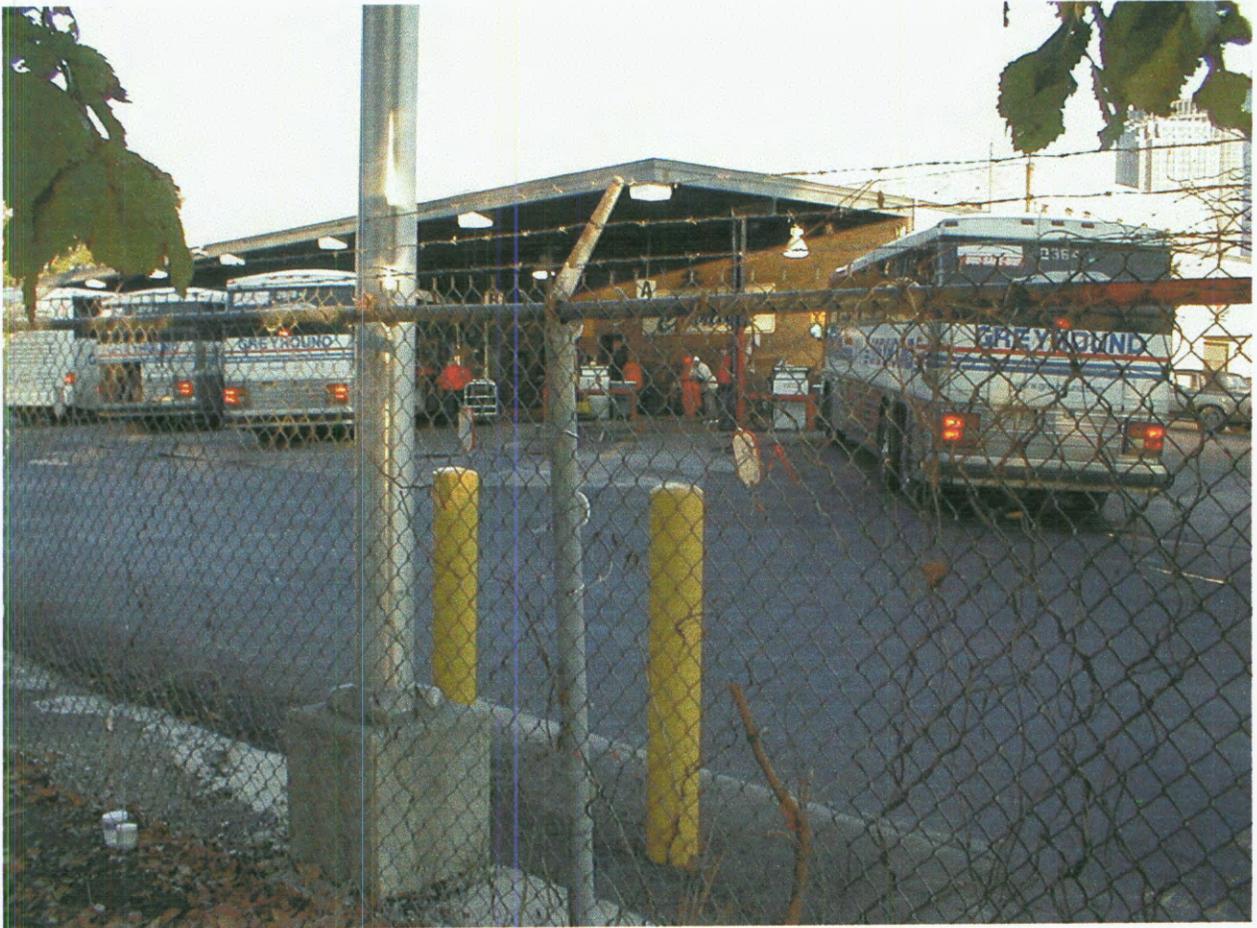
Photograph 5 Greyhound bus station viewed from Parcel #4. Diesel pumps are visible in background.

northwest side of the building (closest to Parcel 4). An existing 15,000-gallon underground storage tank (UST) is currently used for fueling busses.

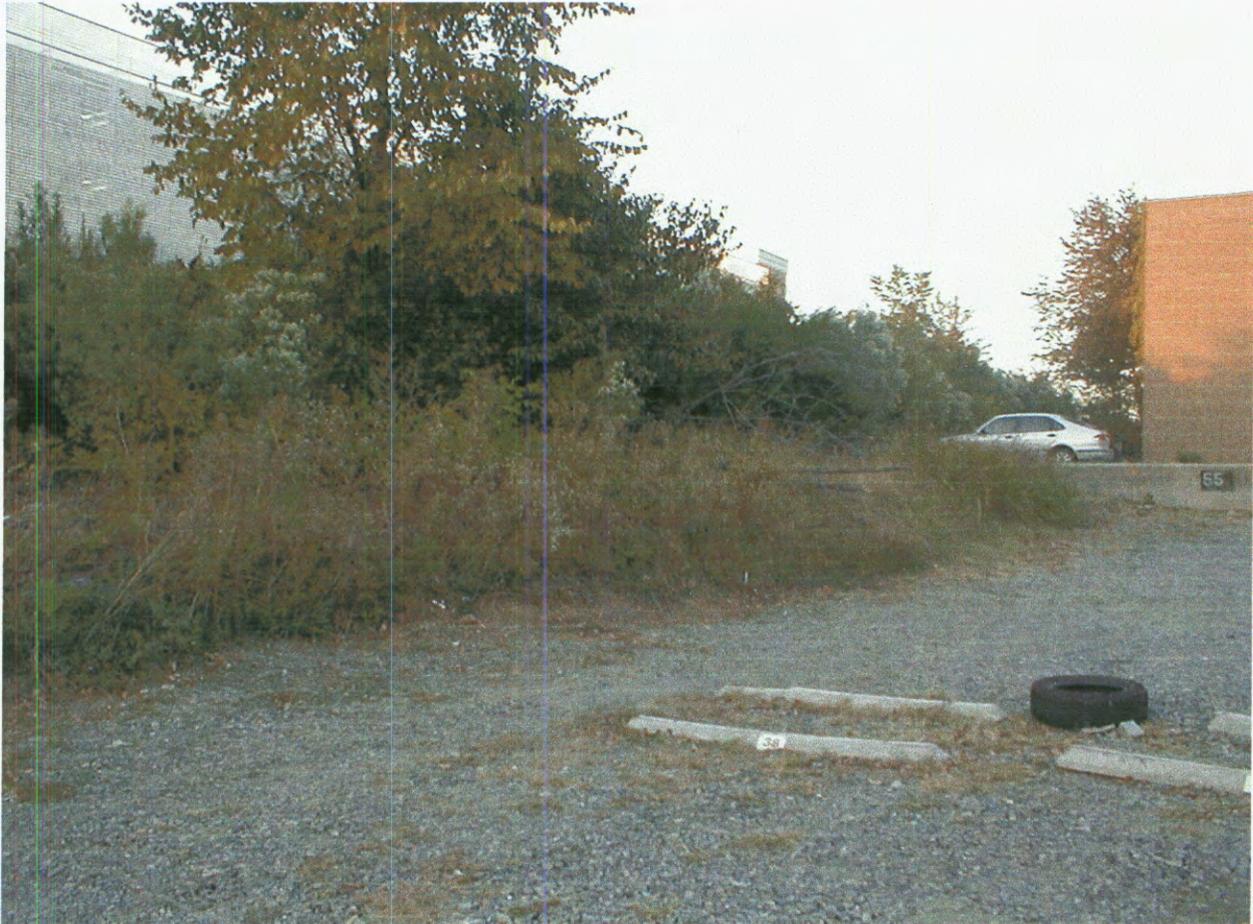
**Photograph 6 Gravel parking lots adjacent to Parcel #5.
Business Storage Inc. warehouse is visible in background.**

Parcel 5 comprises approximately 0.28 acres and extends along the east side of the main line rails from West Trade Street to West 5th Street. Most of the area east of the embankment fill is paved and is used as an alley way (Photograph 6) for the adjacent properties which include Witzens Art Gallery, Business Records Storage, Inc. warehouses, and two gravel parking lots. A solid waste container (dumpster) was observed in the alley behind the Business Records Storage, Inc. property (Photograph 7). Old, partially buried railroad tracks were observed in the alley.

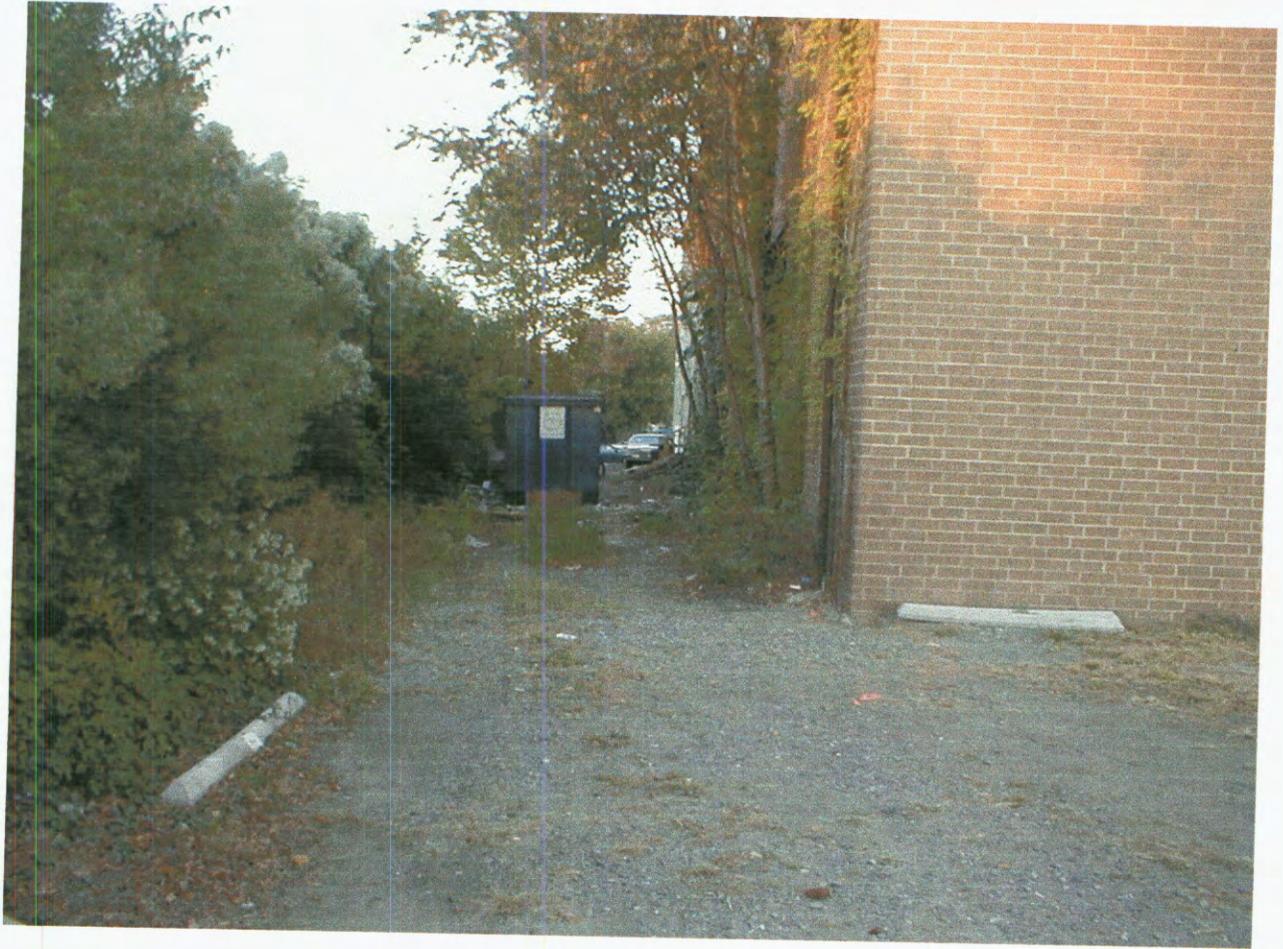
Photograph 7 Parcel #5.

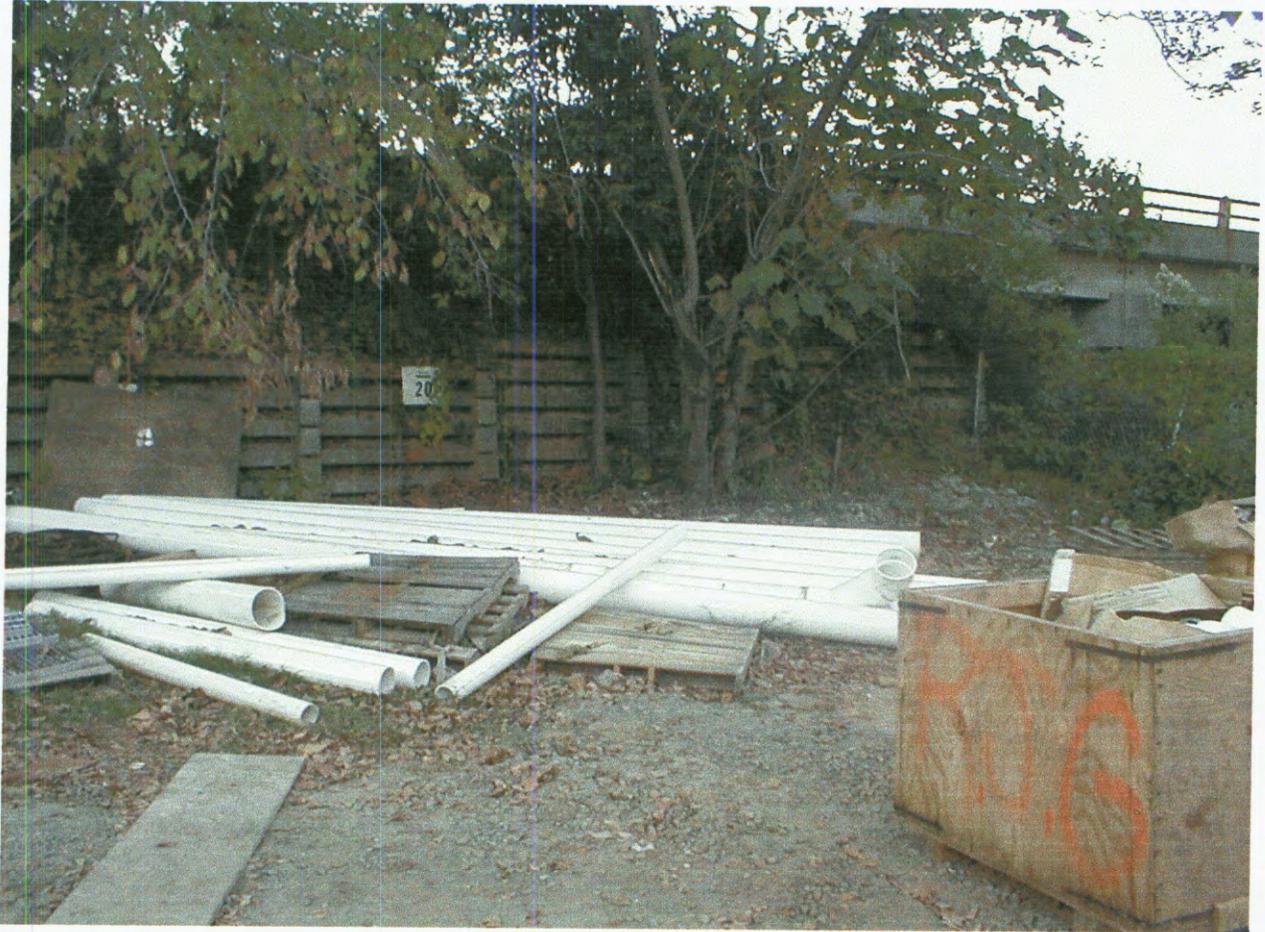
Photograph 8 Location of SB-19.

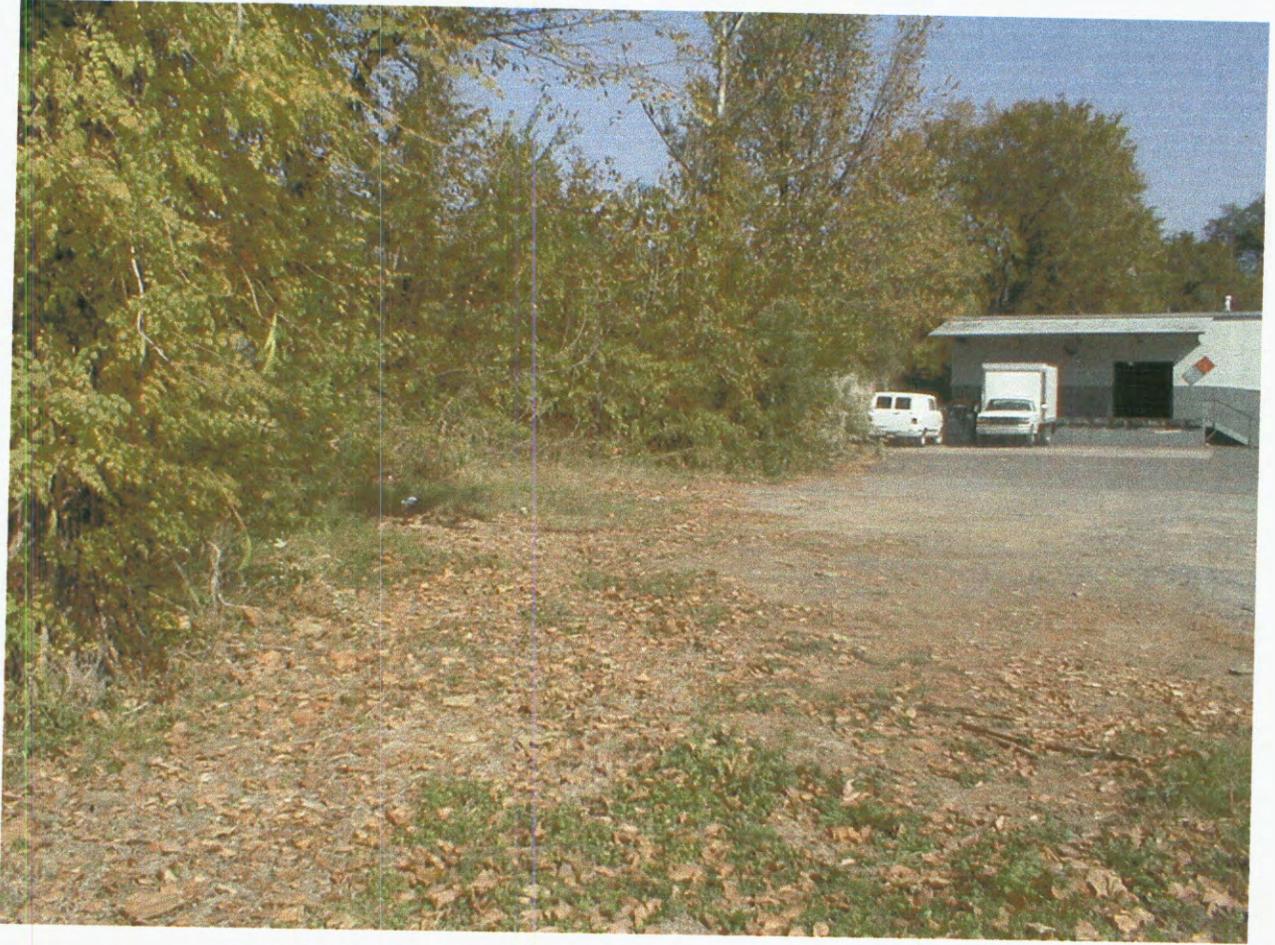
Photograph 9 Parcel #7, Carolina Rim and Wheel property.

Parcel 7 (0.8 acres) is located along the southeast side of the main line rails between 5th and 9th Streets. Most of the city block adjacent to this parcel between 5th and 6th Streets has been cleared and is currently undergoing construction. Photograph 8, taken near the south end of Parcel 7 shows some construction material stored in the NS right-of-way. The railroad embankment, visible in the photograph, is partially retained by concrete cribbing. The city block between 6th and 7th street is occupied by Carolina Rim & Wheel, an auto supply store (Photographs 9 and 10). A gravel parking lot is present between 7th and 8th Streets, and a grass field is located between 8th and 9th Streets where the NS main line rail alignment drops downward to street level (Photograph 11).

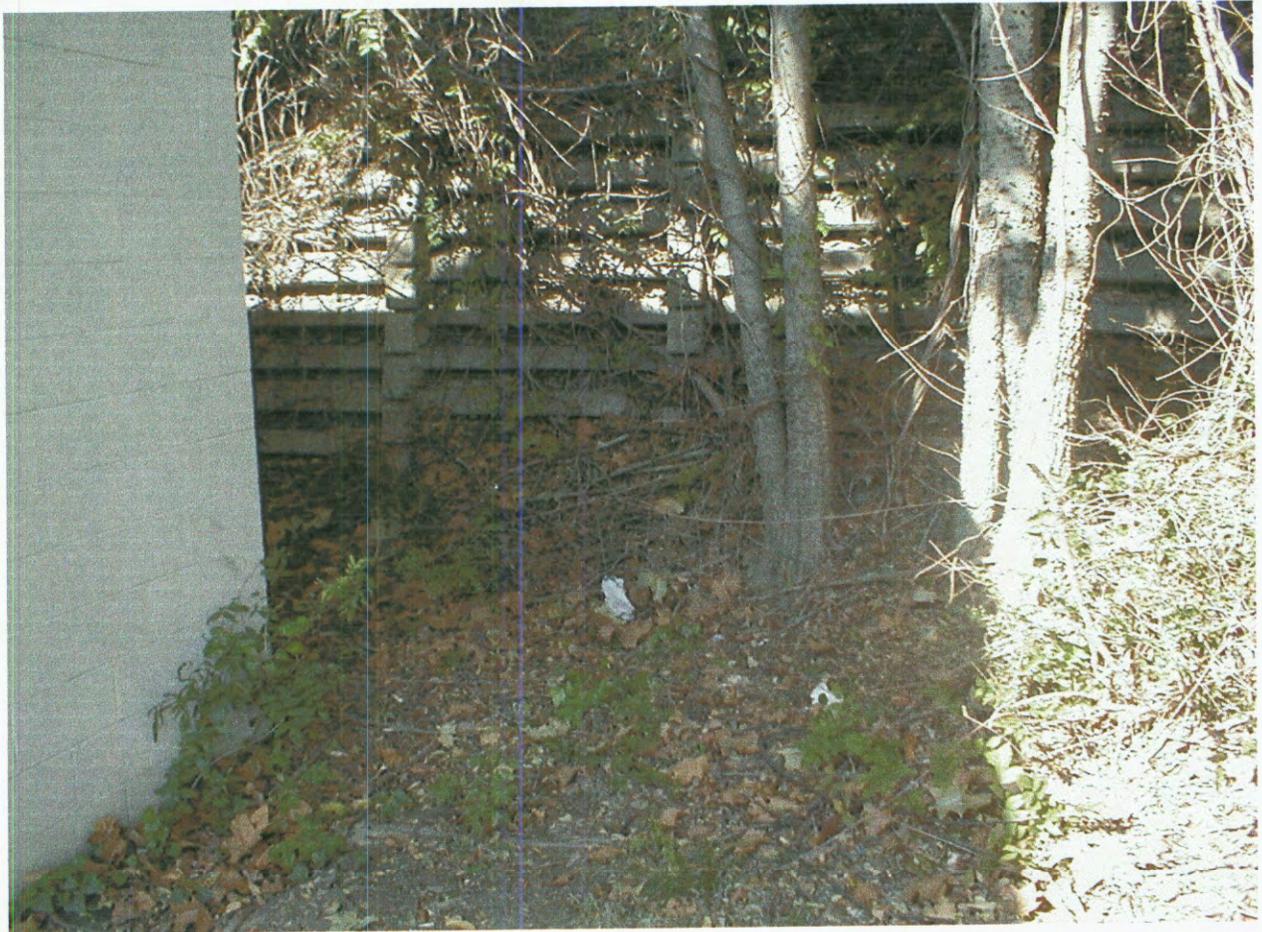
Photograph 10 Location of SB-21, located on northeastern corner of Carolina Rim and Wheel building.
