**PRELIMINARY SITE ASSESSMENT
APPROXIMATELY 4.29 ACRES ALONG
NORFOLK SOUTHERN RAILROAD
MECKLENBURG COUNTY, NORTH CAROLINA
STATE PROJECT NO. 9.9081000 (P-3800)**

**Prepared for:
NCDOT Geotechnical Unit
1589 Mail Service Center
Raleigh, North Carolina 27699-1589**

**Prepared by:
Solutions Industrial & Environmental Services, Inc.
3722 Benson Drive
Raleigh, North Carolina 27609**

December 6, 2001

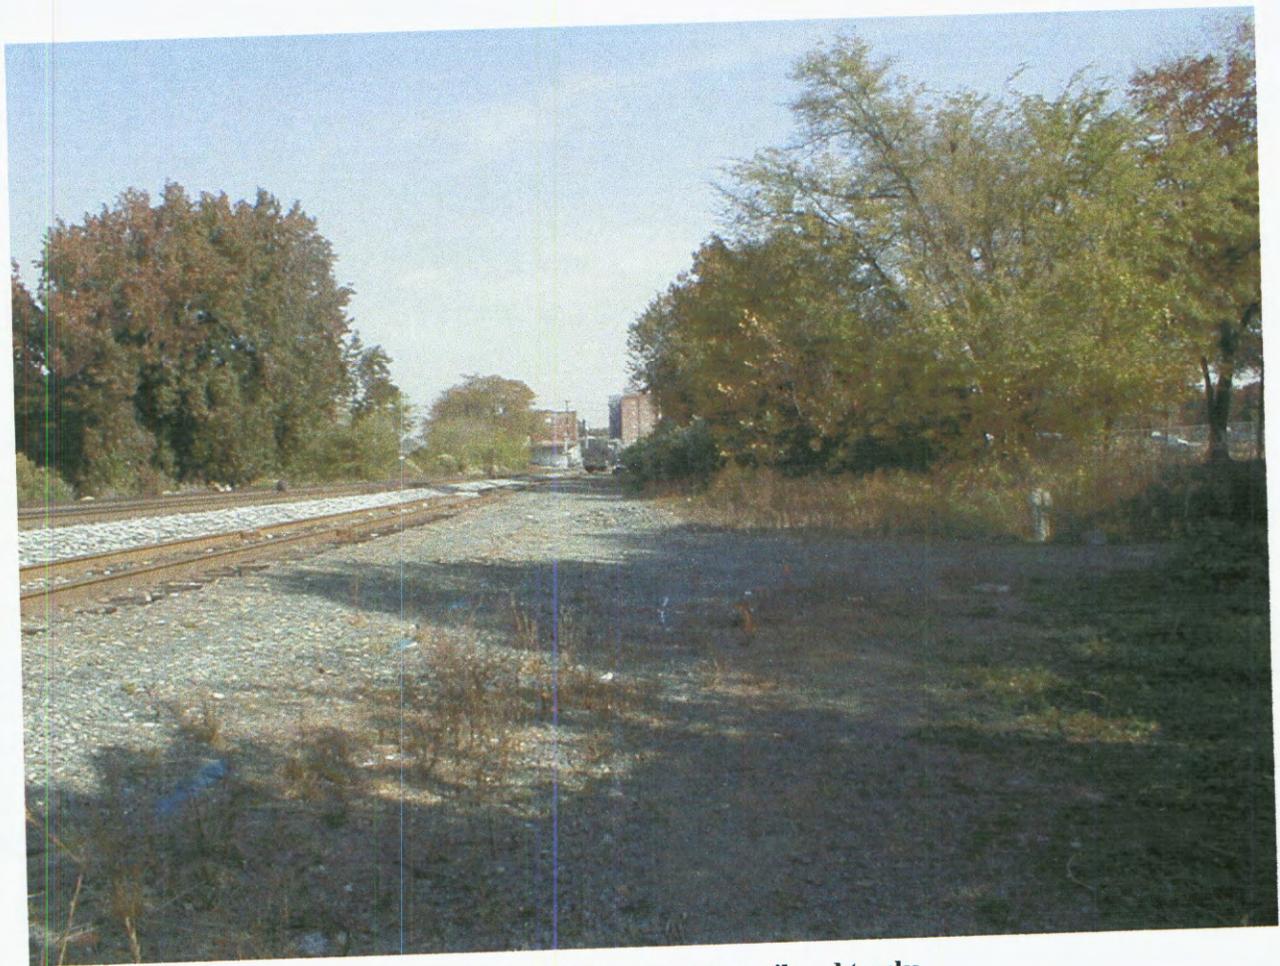
Photograph 11 Parcel #7, along railroad tracks.

Parcel 7 (0.8 acres) is located along the southeast side of the main line rails between 5th and 9th Streets. Most of the city block adjacent to this parcel between 5th and 6th Streets has been cleared and is currently undergoing construction. Photograph 8, taken near the south end of Parcel 7 shows some construction material stored in the NS right-of-way. The railroad embankment, visible in the photograph, is partially retained by concrete cribbing. The city block between 6th and 7th street is occupied by Carolina Rim & Wheel, an auto supply store (Photographs 9 and 10). A gravel parking lot is present between 7th and 8th Streets, and a grass field is located between 8th and 9th Streets where the NS main line rail alignment drops downward to street level (Photograph 11).
