LIMITED PHASE I ENVIRONMENTAL SITE ASSESSMENT REPORT

State Project No. 9.9080178
(AMTRAK)
Proposed AMTRAK Rail Station
Downtown Charlotte
Charlotte, North Carolina

September 2000

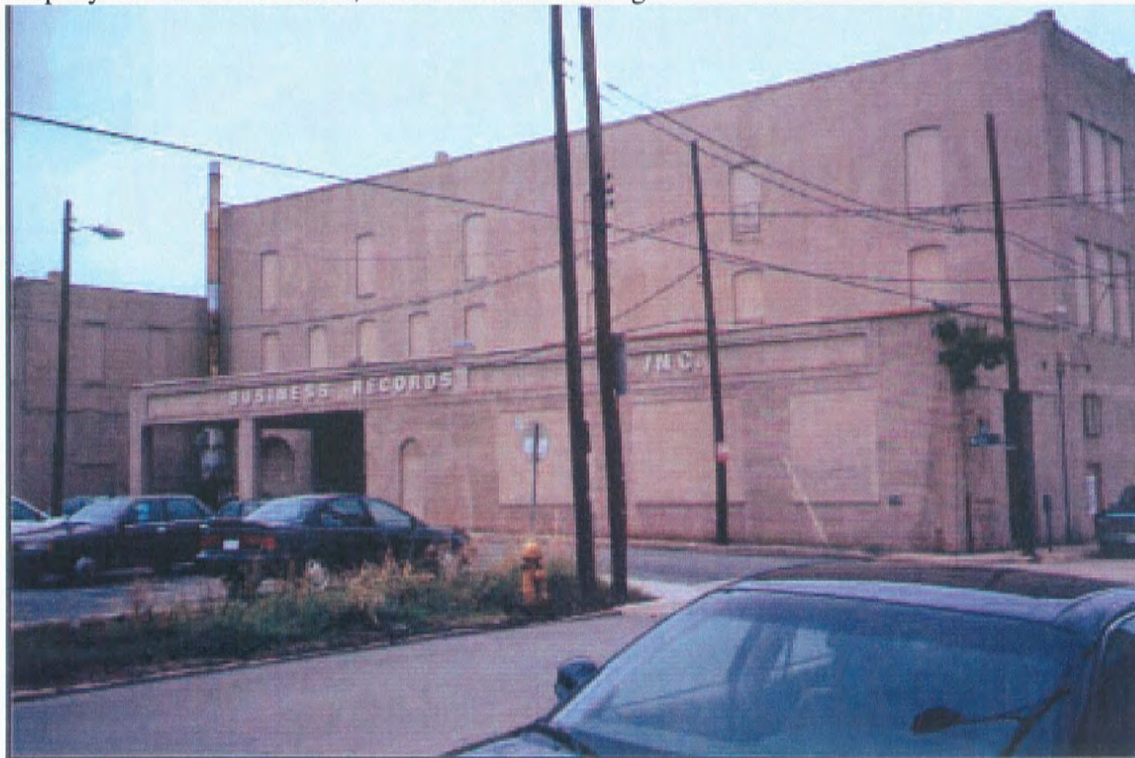
Mecklenburg County Tax Assessor's office also described the building occupied by Business Records Storage Inc., as constructed in 1952 and containing approximately 39,000 square feet of space. A stack was observed on the southeastern side of the building presumably for an incinerator associated with clearing out old, stored files. Stormwater roof gutters from the building empty directly onto West 5th Street.

Property #20. 601 W 5th Street, Business Records Storage.

- Property #20, Business Records Storage, due to potentially impacted media related historical property use (e.g., coal storage facility, machine shops, and an auto repair shop);

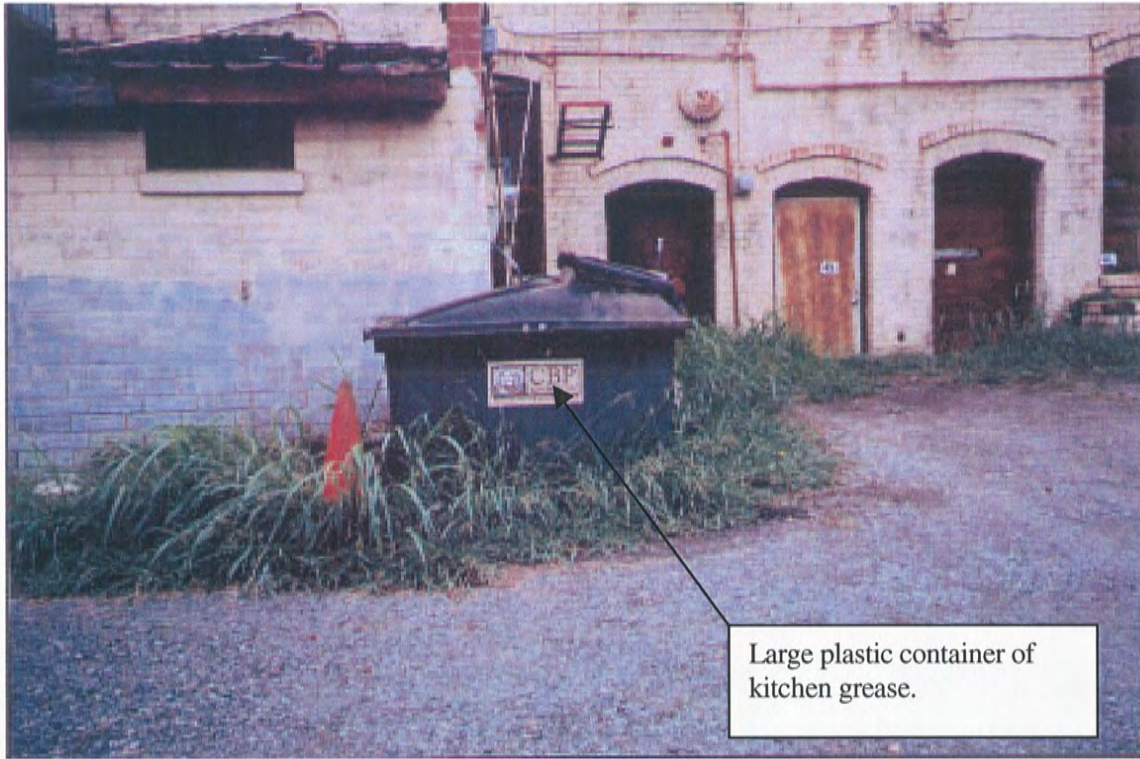
Property #26. 525 West Trades Street, Travelers Hotel and Presto Grill, back side of building.

Large plastic container of kitchen grease.

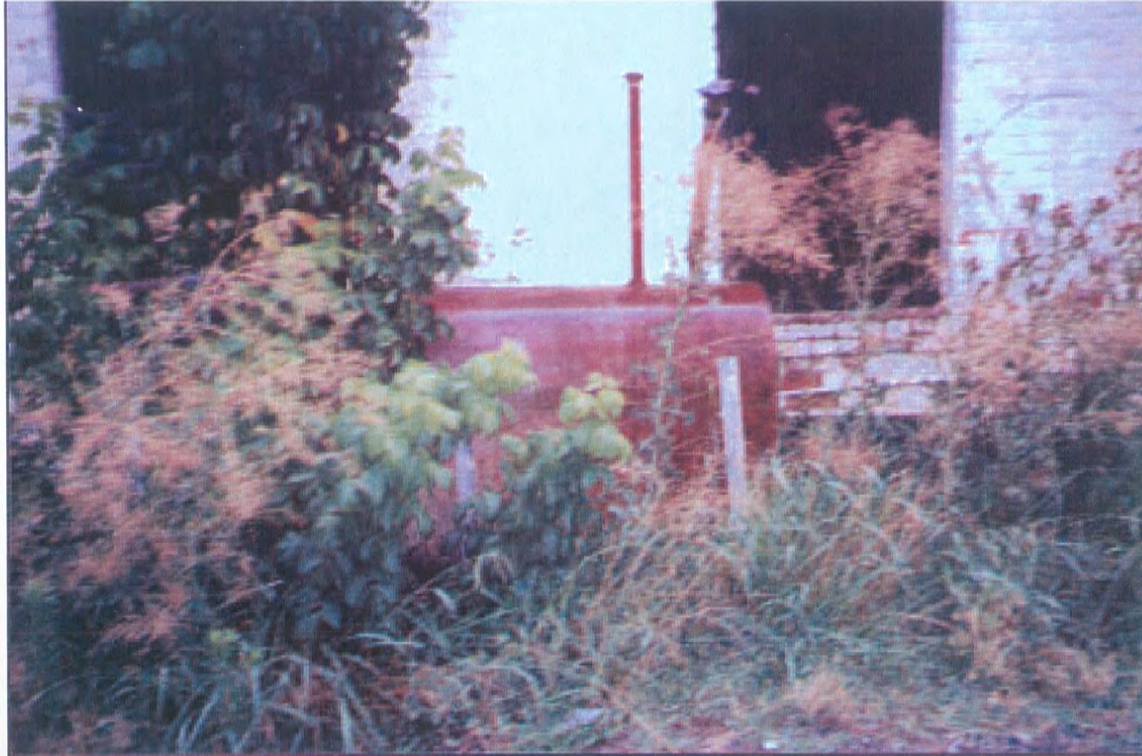
Property #30. 510 West 4th Street, Former Heritage Printers (AST behind building).

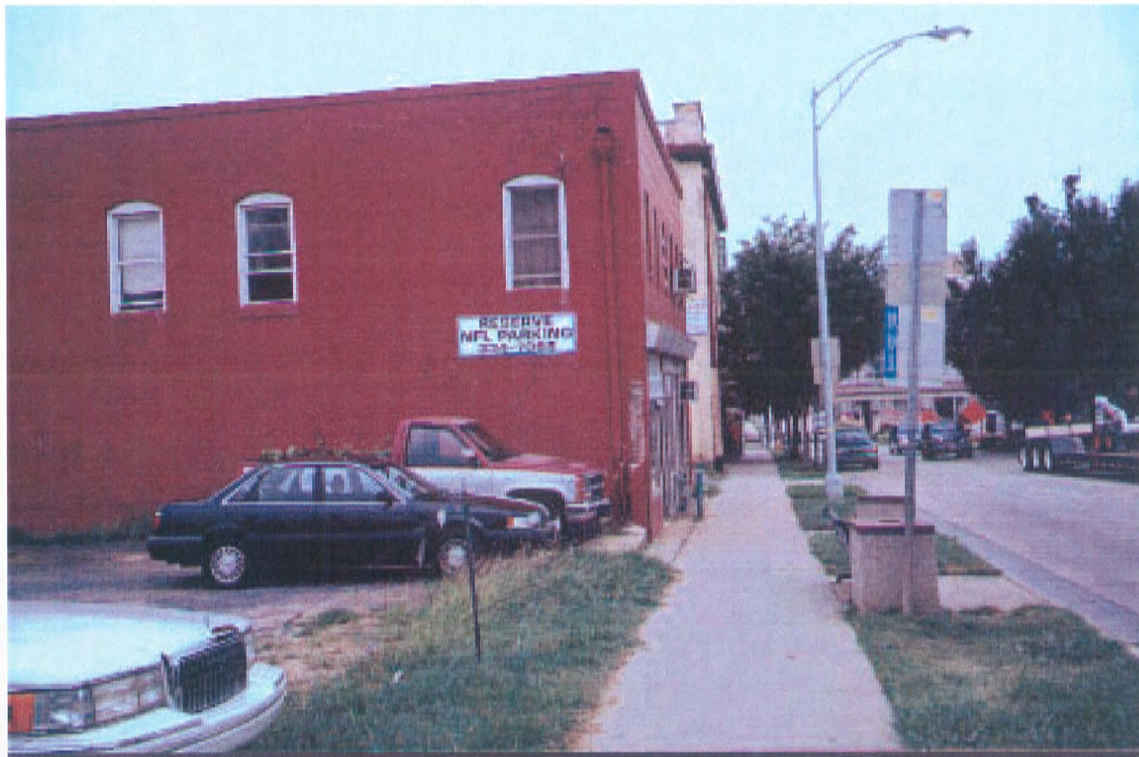
Property #33. 511 West Trade Street. Former Dirty Laundry Cleaners.

- Property #33, Former Dirty Laundry Cleaners, due to potential historic operation as a dry cleaner;
- Property #35, unknown manufacturing building, due to potential use of hazardous chemicals on the property, as indicated by NFPA placards on outside of building;

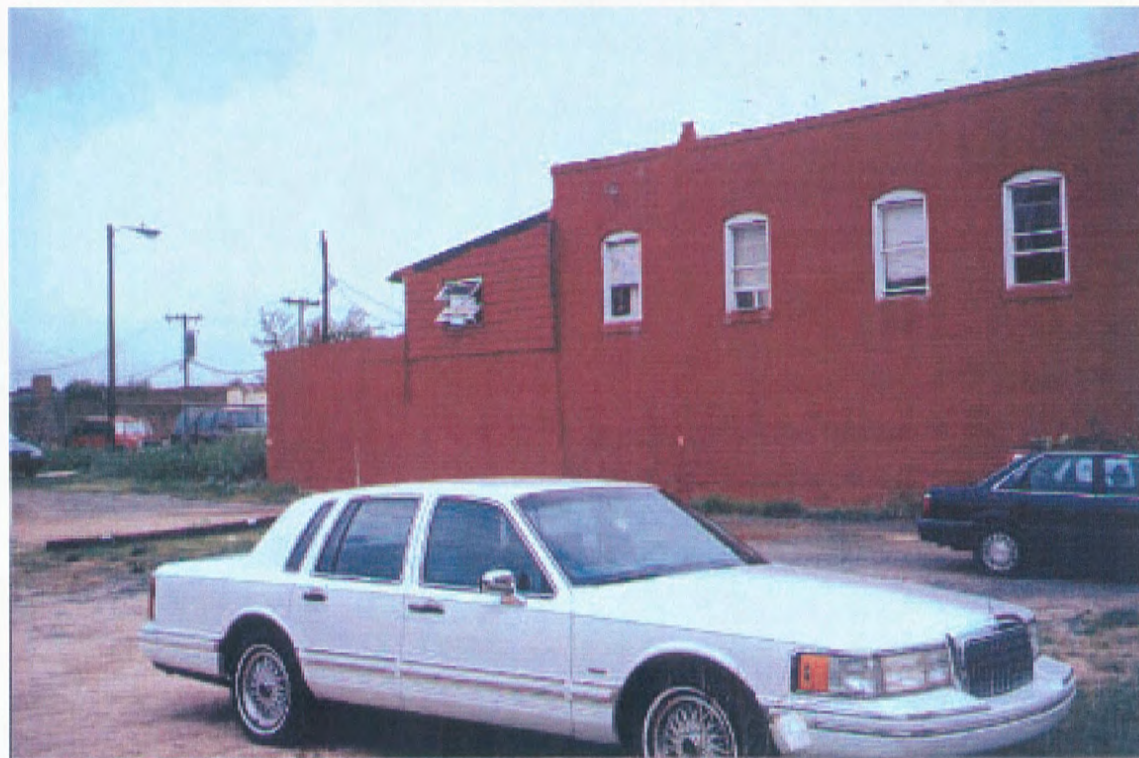
Property #33. 511 West Trade Street. Former Dirty Laundry Cleaners.

- Property #33, Former Dirty Laundry Cleaners, due to potential historic operation as a dry cleaner;
- Property #35, unknown manufacturing building, due to potential use of hazardous chemicals on the property, as indicated by NFPA placards on outside of building;

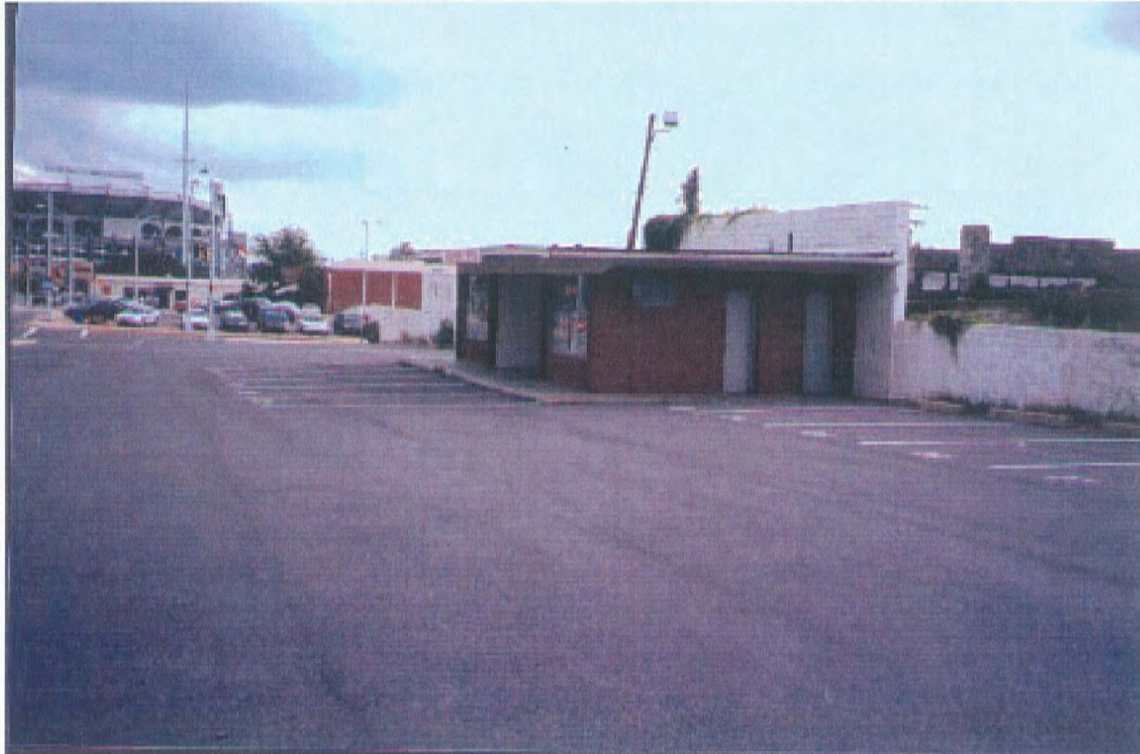
Property #35. 508 West 4th Street, Unknown Former Manufacturing.

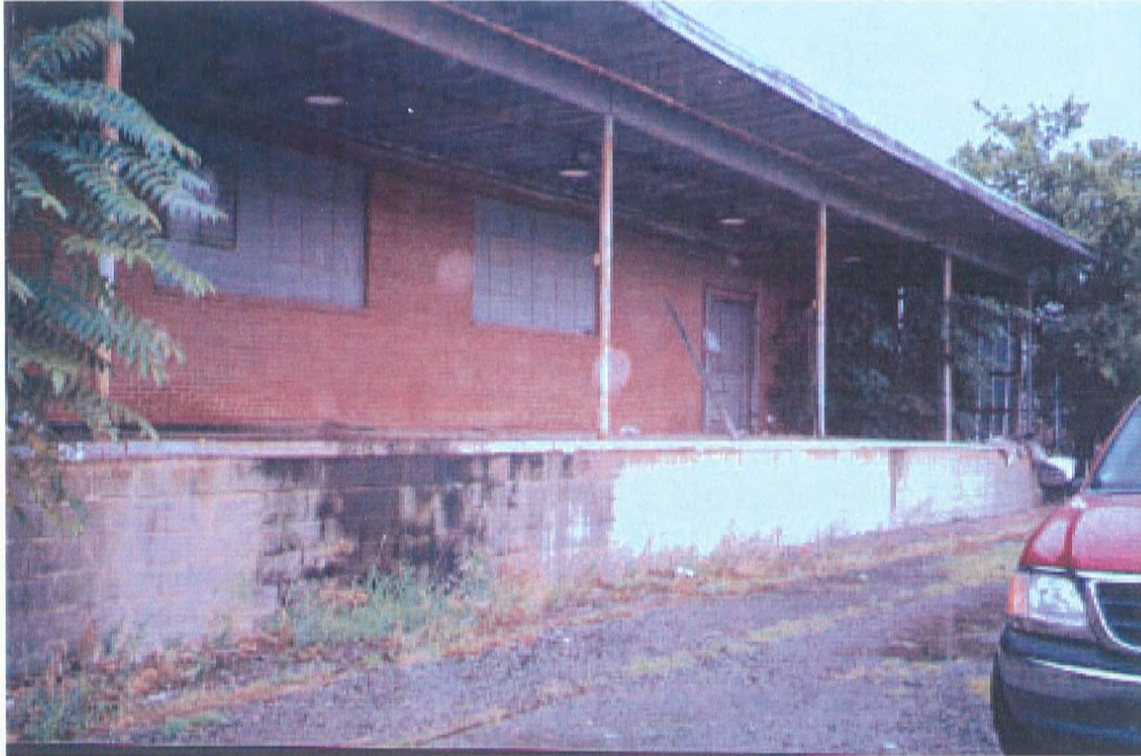
Property #37. 531 West 4th Street, Charlotte Florist Supply Company Warehouse

37	073-161-07	Hargett Zeb E & Betsy H	531 W. 4th Street				Charlotte Florist Supply Company warehouse, split level one two story, appeared vacant of used for storage.	Review of 1900 Sanborn maps revealed an engine room on Property #37; Review of 1929 Sanborn maps revealed an auto repair and painting facility on Properties #3; Review of the 1934 City Directory revealed an iron-works facility on Property #37.	Yes, potential for impacted media related to automobile servicing and painting.	Yes, potential for release of petroleum hydrocarbons.
38	073-161-01	Alexander Rick L & Doris D.	536 W. 3rd Street				Image Plus, Inc. located on property 38, performs ink processes and custom color printing for slides.	Review of 1911 Sanborn maps revealed a machine shop on Property #38; Review of 1929 Sanborn maps revealed an auto repair and painting facility on Properties #38.	Yes, potential for impacted media related to automobile servicing and painting.	Yes.
