Reference: **Preliminary Site Assessment  
Oland Little Property (Parcel #154)  
5512 Raeford Road  
Fayetteville, Cumberland County, North Carolina  
State Project: U-4405  
WBS Element 39049.1.1  
SIES Project No. 2016.0054.NDOT**

## METALLIC UST INVESTIGATION: PARCEL 154 – OLAND B. LITTLE NCDOT PROJECT U-4405

**GEOPHYSICAL INVESTIGATION REPORT**  
**Parcel 154 – 5512 Raeford Road**  
**Fayetteville, Cumberland County, North Carolina**

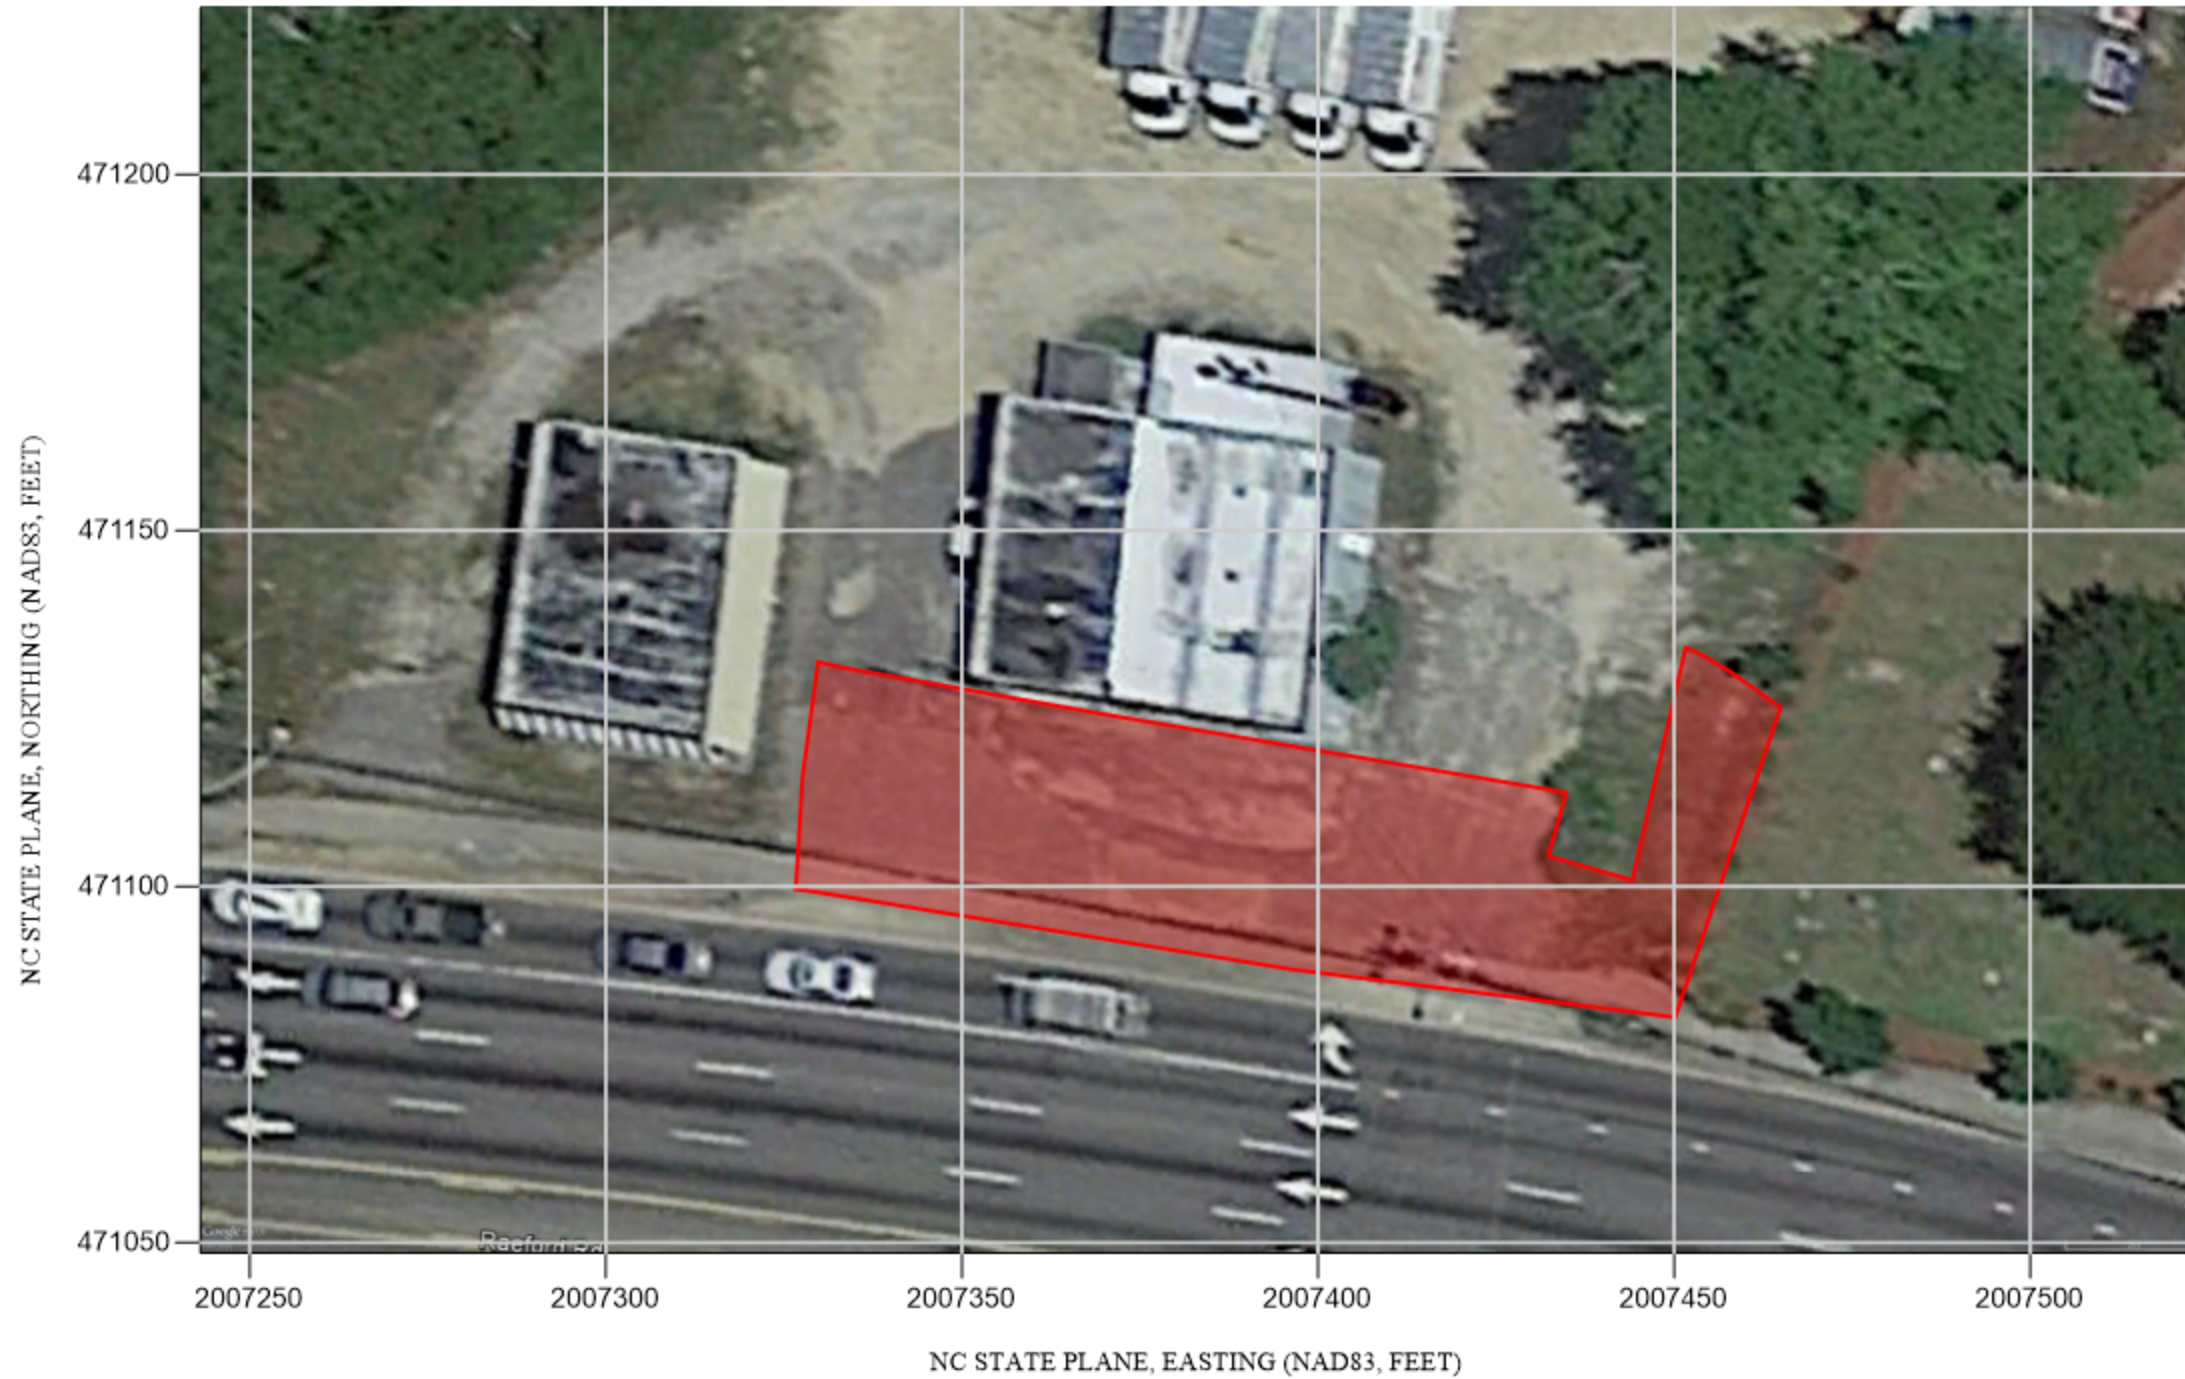
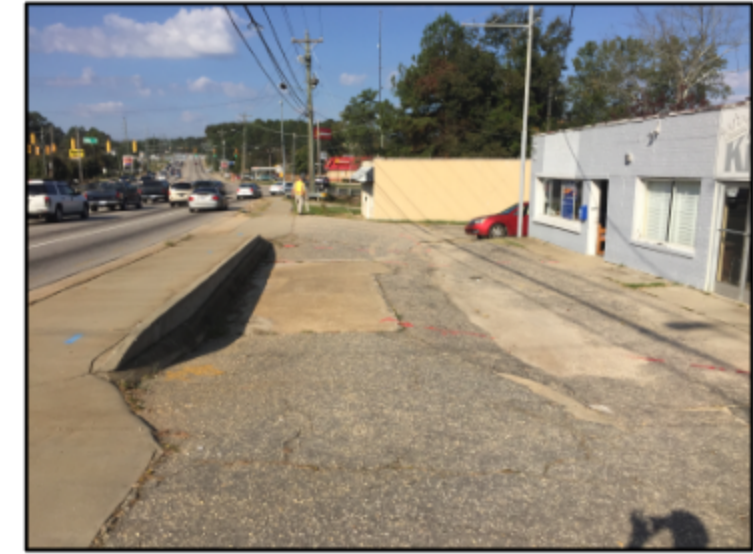
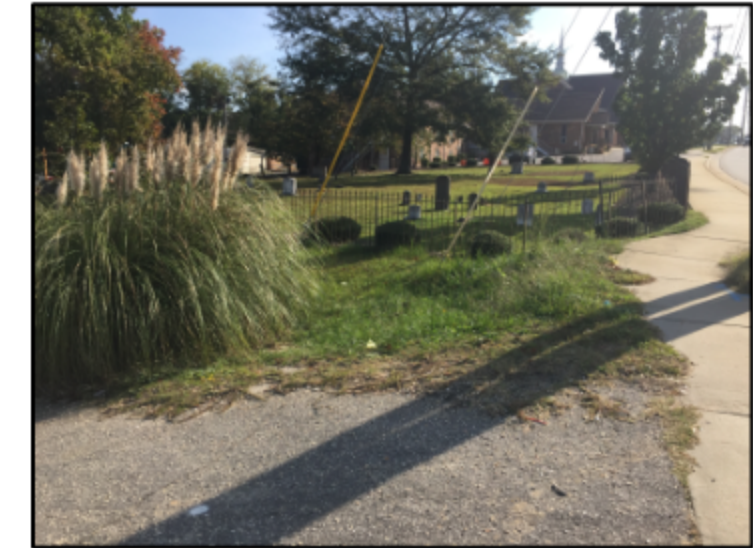
503 INDUSTRIAL AVENUE GREENSBORO, NC 27460 (336) 335-3174 (p) (336) 691-0648 (f) License # C1251 Eng. / License # C257 Geology	
DATE	10/31/16	CLIENT	SOLUTIONS, IES
PYRAMID PROJECT #:	2016-265	<b>FIGURE 1</b>

The site included a commercial building surrounded by concrete parking space, gravel drives and grassy medians. Aerial photographs showing the survey area boundaries and ground-level photographs are shown in **Figure 1**.

APPROXIMATE BOUNDARIES OF GEOPHYSICAL SURVEY AREA

View of Survey Area  
(Facing Approximately West)

View of Survey Area  
(Facing Approximately East)

TITLE		PARCEL 154 - GEOPHYSICAL SURVEY BOUNDARIES AND SITE PHOTOGRAPHS	
PROJECT		5512 RAEFORD ROAD FAYETTEVILLE, NORTH CAROLINA NCDOT PROJECT U-4405

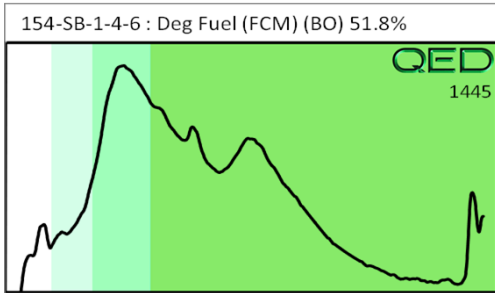
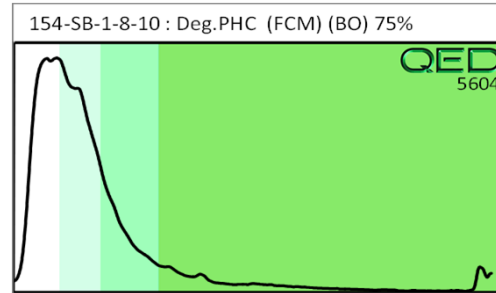
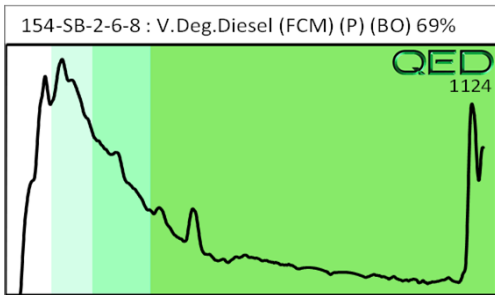
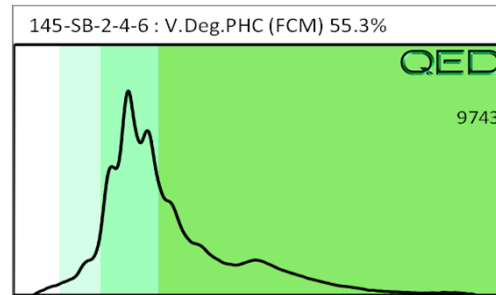
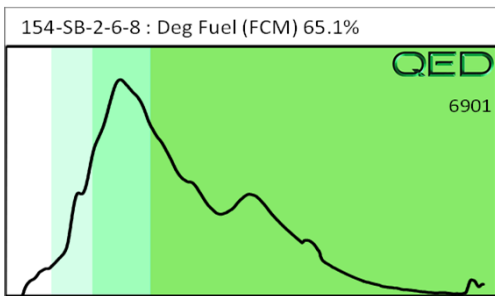
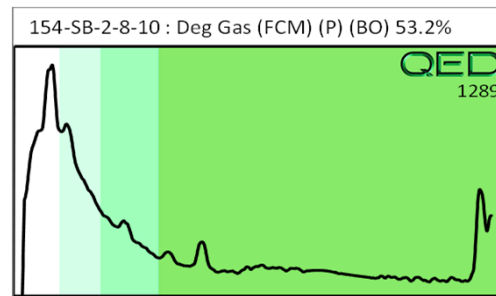
QED Hydrocarbon Fingerprints
