**North Carolina Department of Transportation  
Preliminary Site Assessment  
State Project: U-5114  
WBS Element: 42376.1.FR1  
PIN: 01710109  
Mecklenburg County**

**QAS II Inc. Property (Valvoline)  
14114 Statesville Rd  
Huntersville, NC 28078  
October 7, 2014**

**AMEC Environment and Infrastructure, Inc.  
AMEC Project: 153055114**

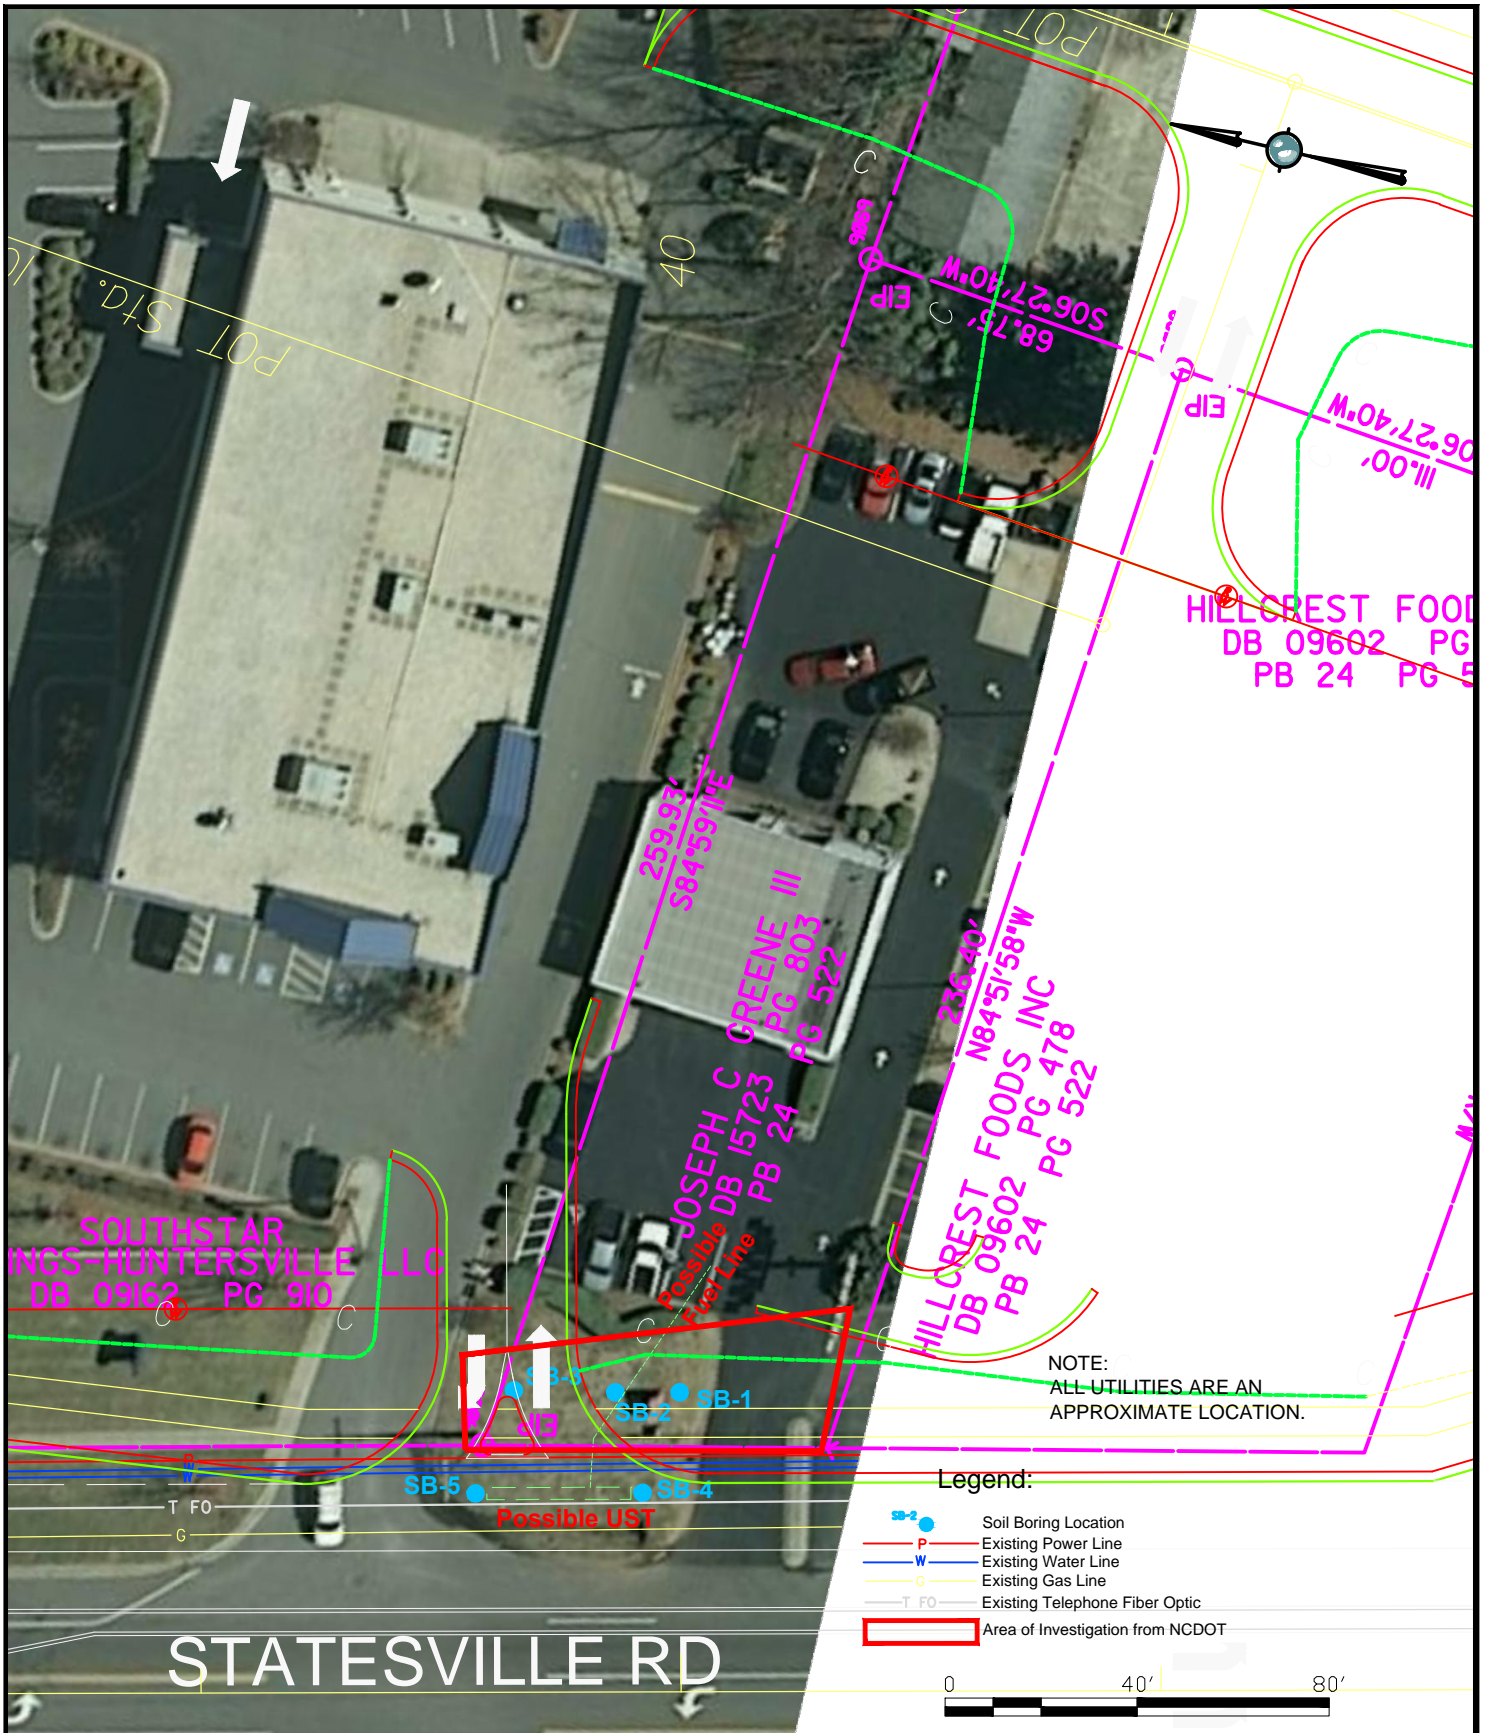
PREPARED BY: LDD/TLH	DATE: 10/1/2014	CHECKED BY: HPC	DATE: 10/1/2014	JOB NUMBER: 153055114.0003	FIGURE: 2
----------------------	-----------------	-----------------	-----------------	----------------------------	-----------

Site geology was observed through the drilling and sampling of 5 shallow direct push probe soil borings (SB) onsite. **Figure 2** presents the boring locations within the area of investigation selected by NCDOT. Borings did not exceed a total depth of ten feet below ground surface (BGS). Fill material consisting predominantly of red clayey silt to reddish-brown clayey silt was observed in each of the five borings. Boring logs are presented in **Appendix B**.

AMEC conducted drilling activities at the site on August 27th, 2014. AMEC's drilling subcontractor Geologic Exploration Inc. advanced five direct push soil borings within the proposed expanded NCDOT ROW. Soil boring locations were focused in the area of the identified geophysical anomaly and within the area of investigation. Boring locations were strategically placed on the northern and southern ends of the possible UST. Utilities which run parallel to the possible UST did not allow borings to be placed on the western side of the possible UST. The remaining three borings were placed parallel to Statesville Road on the eastern side of the possible UST and within the area of investigation. Figure 2 presents the Site Map with boring locations and identifications.

SITE MAP WITH BORING LOCATIONS  
QAS II Inc. (Valvoline Oil)  
14114 Statesville Rd. Huntersville, NC 28078

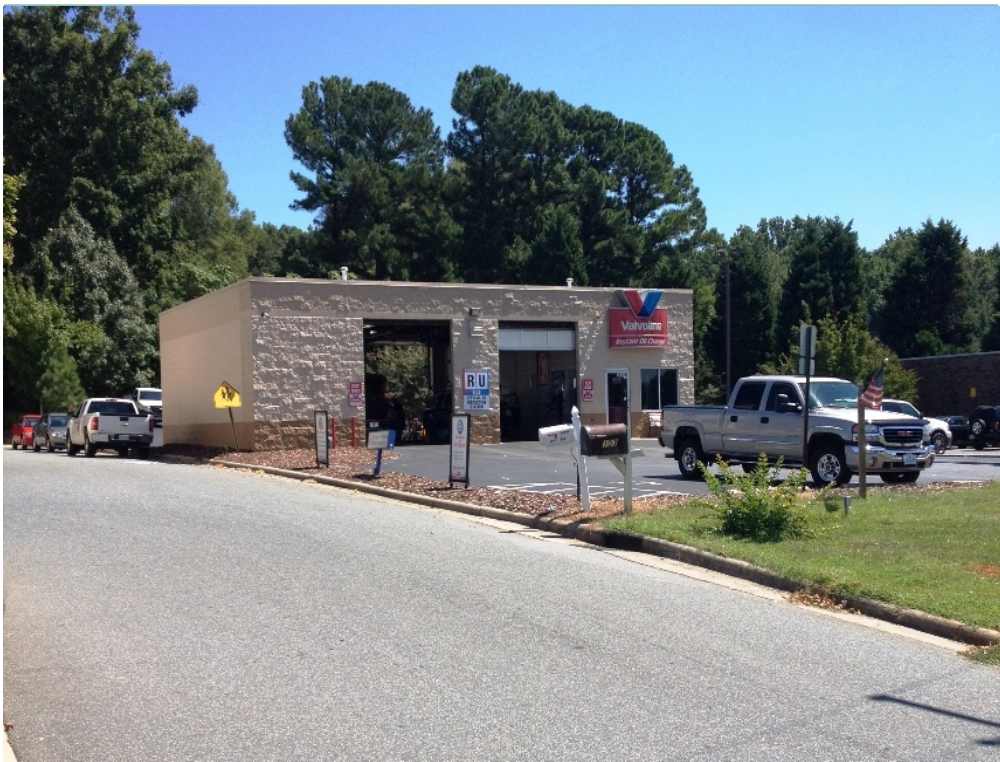
**Photo 1**

Site prior to PSA activities .

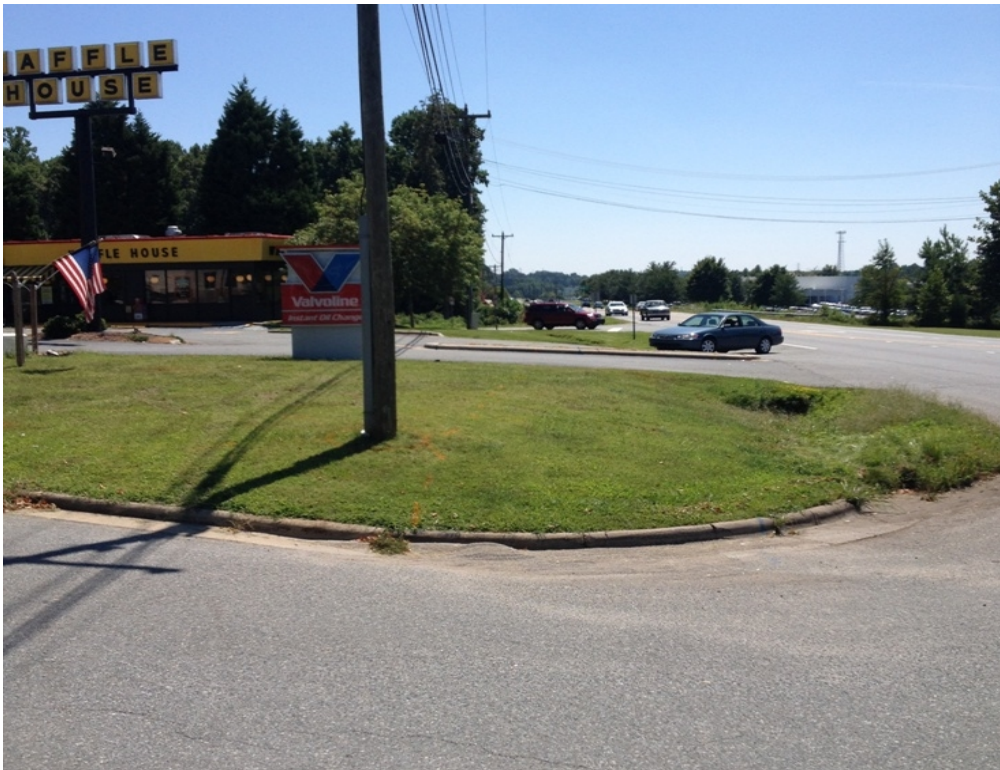
**Photo 2**

Area of investigation.

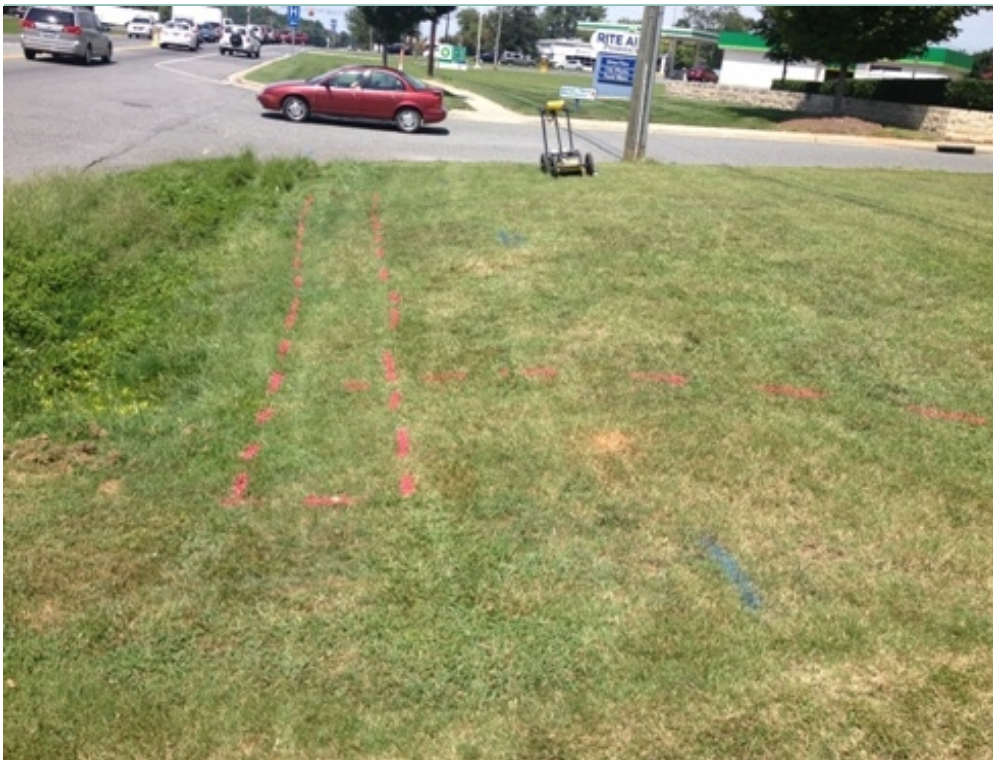
**Photo 3**

Possible UST as marked by Geophysical Survey.

Our review of the geophysical data collected for this project indicates the presence of a possible UST(s) within the geophysical study areas. The possible UST(s) is about 20 feet long, about 2.5 feet in diameter, and is buried about 5 feet below the ground surface. These dimensions correspond to a tank volume of about 700 gallons or possibly two 350-gallon tanks.

Based on these PSA results, AMEC does not recommend further assessment or soil sampling in the area of investigation. Once design information is available, specifically the depth of construction for roadway improvements, the possible UST may need to be investigated and closed by removal.

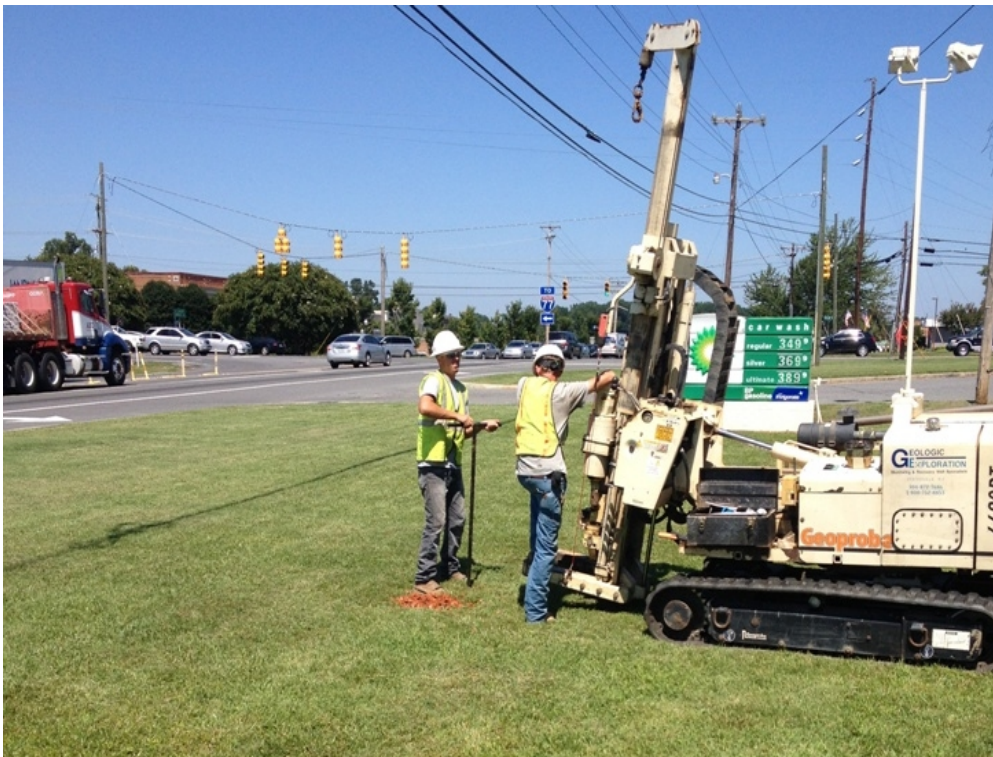
**Photo 4**

Geologic Exploration using a hand auger for the upper 5 feet prior to using the direct push drill rig.

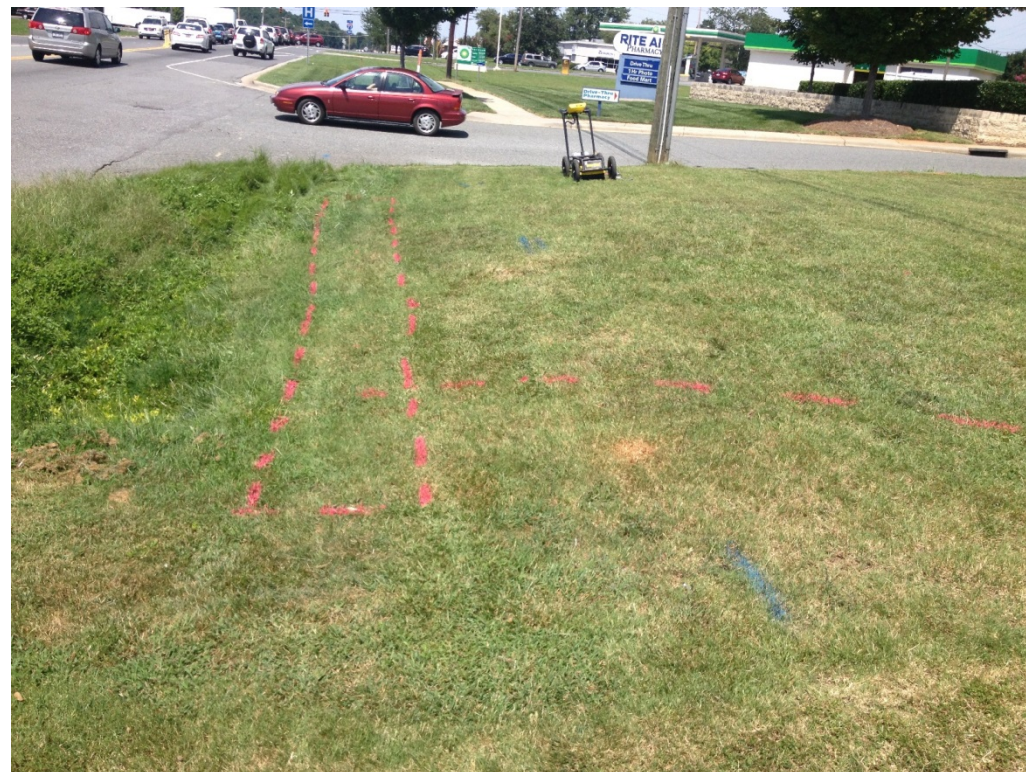
spacing of one to two feet in the vicinity of an EM61 anomaly in the drainage ditch on the west side of the property (Figure 1.C). The remaining EM61 anomalies on the property were attributed to surface objects and buried utilities.

C. Photo of Possible UST marked on Valvoline site, looking north.

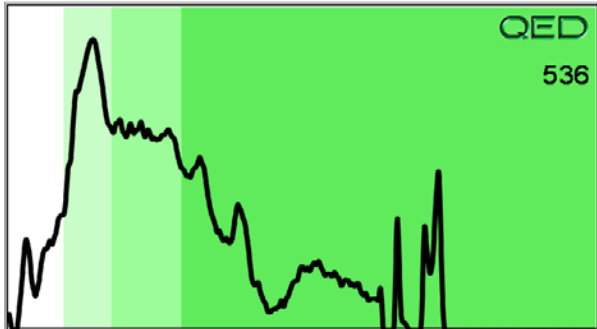
Elevated GRO or DRO values, above the NCDENR Action Limit of 10 mg/kg, were not detected in any of the five soil borings drilled at the site. Low level TPH or PAH concentrations were measured in four of the ten soil samples with identified fingerprint matches of waste oil or degraded petroleum hydrocarbons. Maximum concentrations were observed in V-SB-2 at the 5 to 6 feet BGS sample with 4.09 mg/kg TPH-DRO and 1.26 mg/kg PAHs. This boring is east of the possible UST and north of the possible fuel line.

Waste Oil Waste Oil (FCM) 58.1% V-SB-2 (5-6)

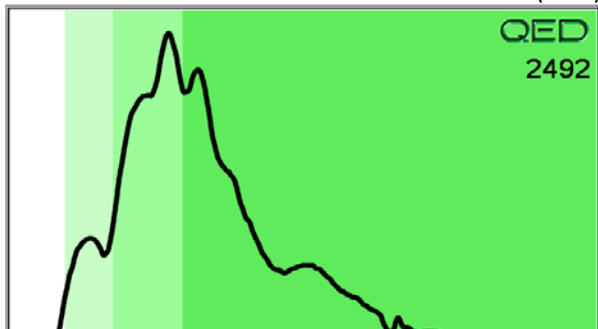
Coal Tar 92.1% V-SB--3 (9-10)
