Reference: **Preliminary Site Assessment**
Joseph Molgora Property (Parcel #140)
6002 Raeford Road
Fayetteville, Cumberland County, North Carolina
State Project: U-4405
WBS Element 39049.1.1
SIES Project No. 2016.0054.NDOT

UNDERGROUND STORAGE TANK CLOSURE REPORT

Reference: **SOIL AND GROUNDWATER SAMPLING SERVICES**
6002 Raeford Road
Fayetteville, North Carolina
Job No. 1034-04-049

METALLIC UST INVESTIGATION: PARCEL 140 – JOSEPH E. MOLGORA NCDOT PROJECT U-4405

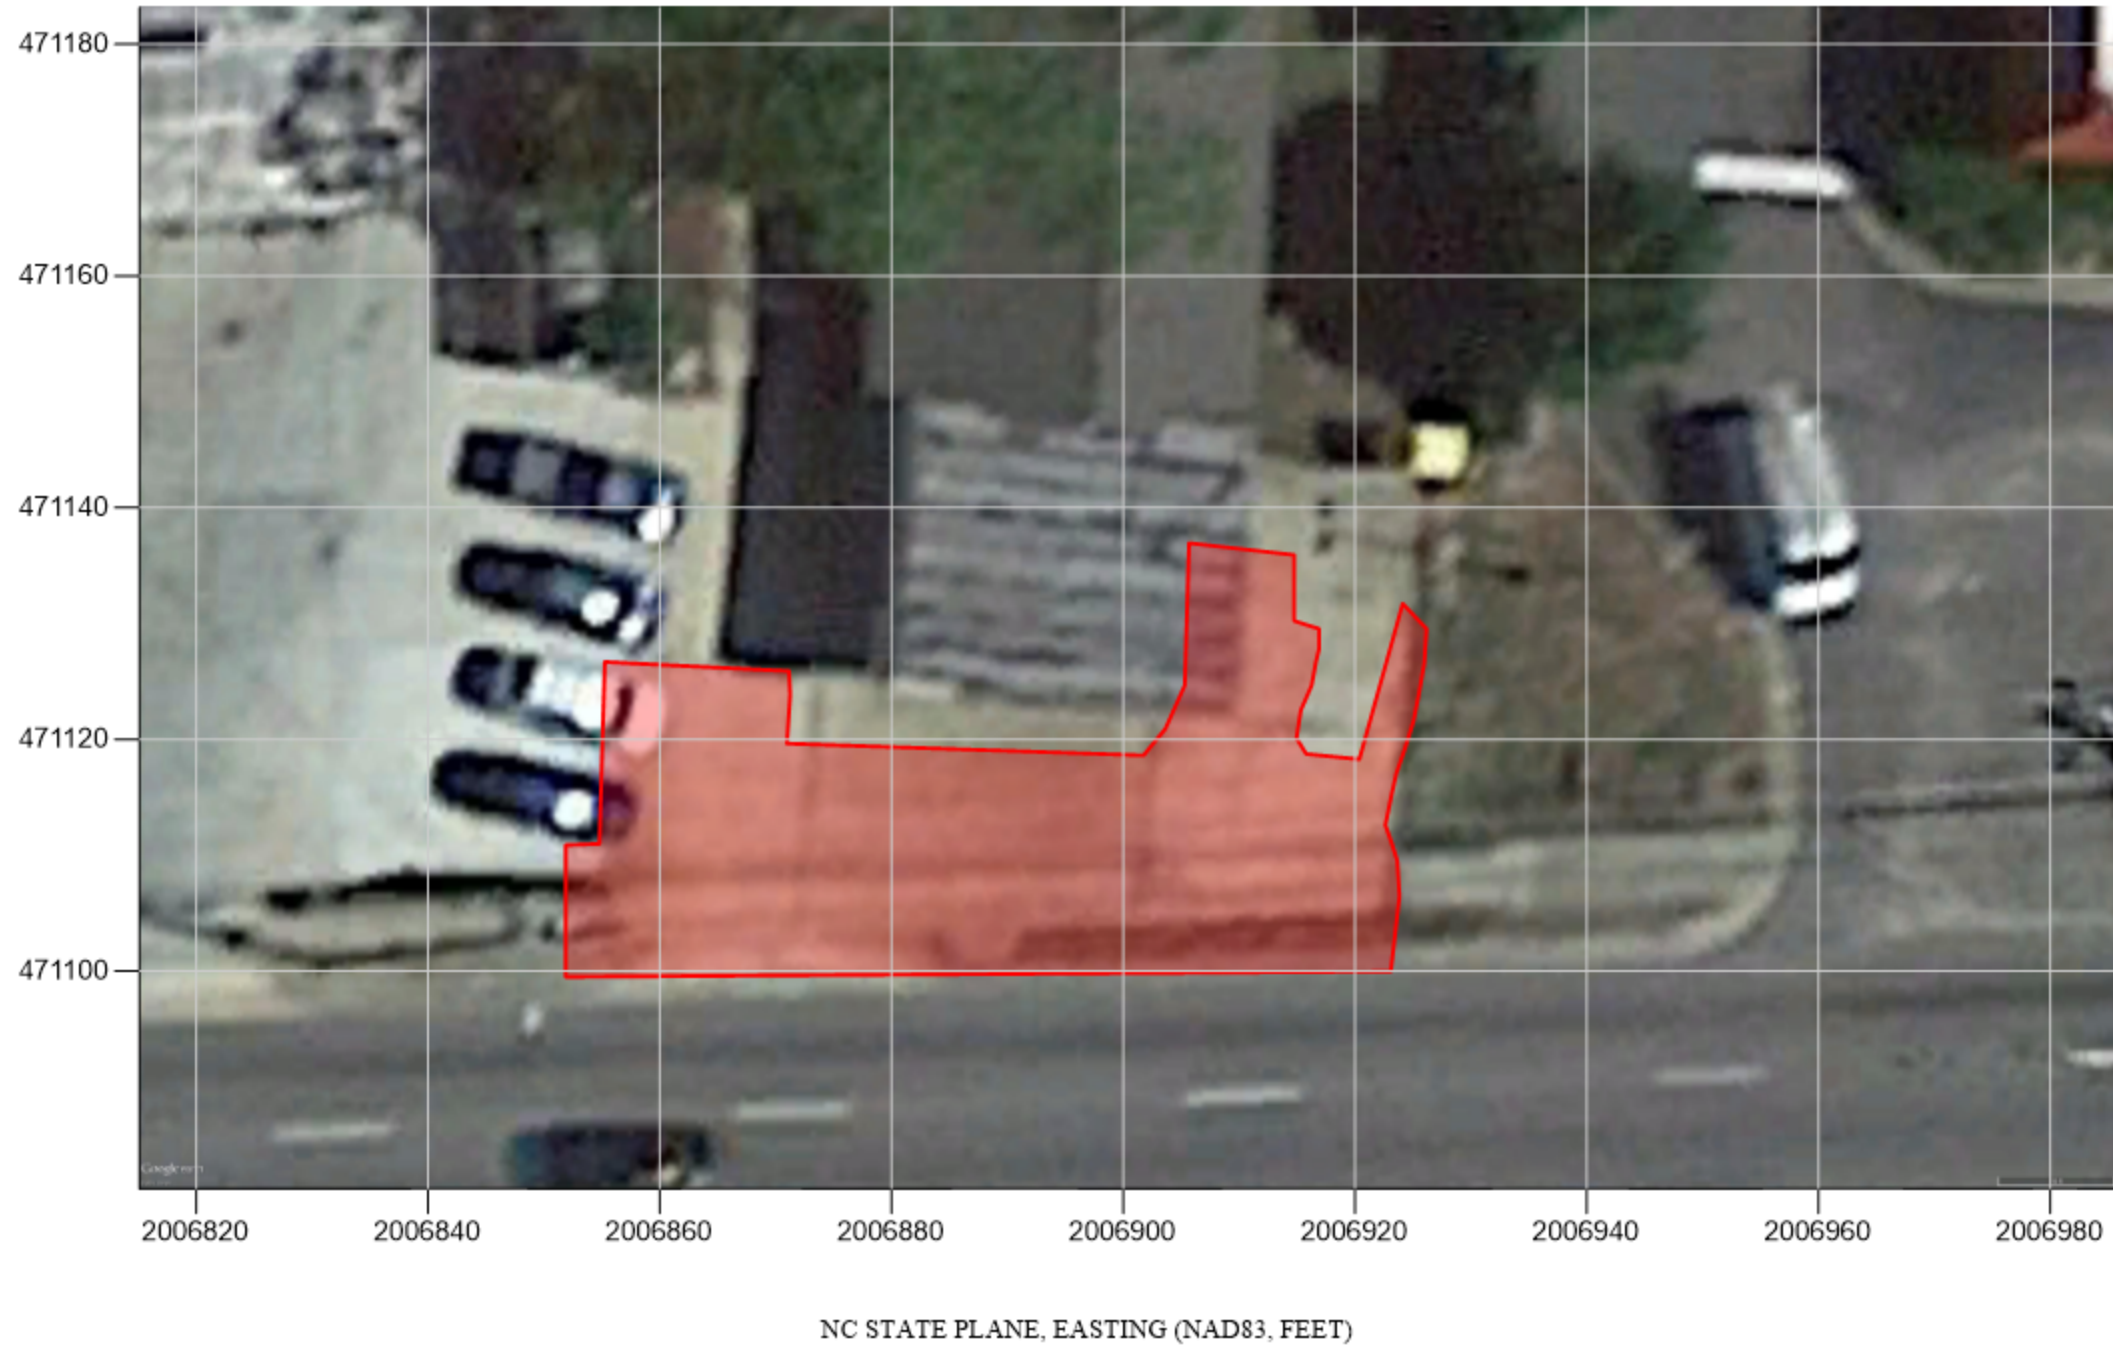
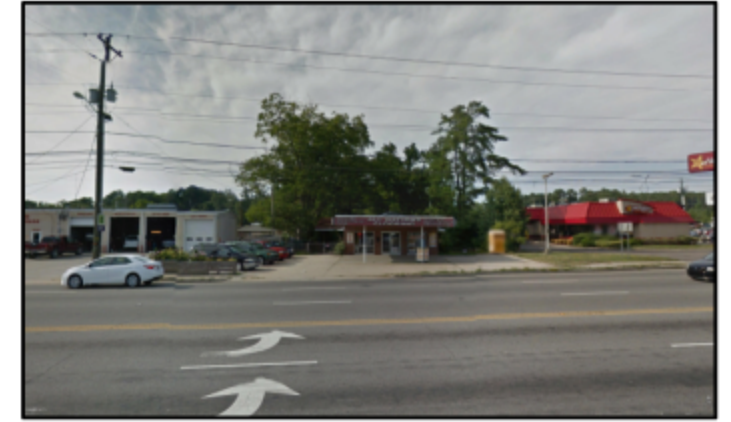
The site included a commercial building with a canopy surrounded by concrete parking space. Two possible fill ports were observed in the concrete at the east edge of the canopy. Aerial photographs showing the survey area boundaries and a ground-level photograph are shown in **Figure 1**.

View of Survey Area
(Facing Approximately North.
Additional Photos Not Available
Due to Lack of Access)

TITLE		PARCEL 140 - GEOPHYSICAL SURVEY BOUNDARIES AND SITE PHOTOGRAPHS	
PROJECT		6002 RAEFORD ROAD FAYETTEVILLE, NORTH CAROLINA NCDOT PROJECT U-4405
