TIP NO: EB-4707 WBS: 38664.1.1

DESCRIPTION: Widening Old Durham Rd (SR 1838)/Chapel Hill Rd (SR 2220)

SUBJECT: Geotechnical Pre-Scoping Report

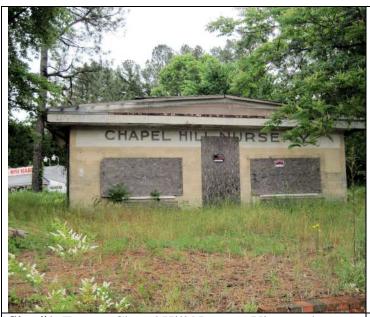
This closed business formerly operated as Chapel Hill Nursery. It is located in the southeastern quadrant of Scarlett Drive and Old Durham Road. The structure is approximately 50 feet south of the Old Durham Road centerline. No information could be found in the UST registry for this facility. Furthermore, no evidence of any UST system was observed in the field. However, the design of the building suggests it may have been a gas station at one time. **This site is anticipated to present low geoenvironmental impacts to the project.**

Site #1: Former Chapel Hill Nursery. View to the east.

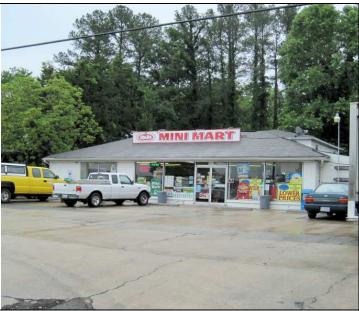
This facility currently operates as a convenience store. It is located on the south side of Old Durham Road and approximately 200 feet east of Scarlett Drive. Although no information was found in the UST Registry, evidence of an old pump island was noted during the filed reconnaissance. The former pump island is located approximately 55 feet south of the Old Durham Road median. GWI # 15985 has been assigned to this facility. **This site is anticipated to present low geoenvironmental impacts to the project.**

Site # 2: R & H Mini Mart. View to the southeast

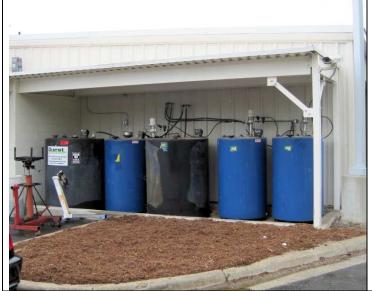
This facility currently operates as an Automotive Dealership. The property is located between US 15/501 and Old Durham Road. The paint shop and several BMW service bays with waste oil storage are located on the back side of the property. The oil storage is located 80 feet north of the Old Durham Road median. The UST registry shows that four tanks were removed between 1991 and 2002. GWI #'s 8462 and 16492 have been assigned to this facility. **This site is anticipated to present low geoenvironmental impacts to the project.**

Site # 3: Performance BMW waste oil storage. View to the northeast.

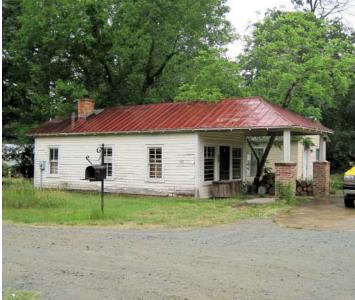
This facility is currently being used for private storage. It is located in the northeastern quadrant of N. White Oak Drive and Old Chapel Hill Road. Although no information was found in the UST registry for this facility, evidence of an old pump island was noted during the field reconnaissance. The building canopy is approximately 30 feet north of the Old Chapel Hill Road centerline. **This site is anticipated to present low geoenvironmental impacts to the project.**

Site # 4: Former Gas Station. View to the northeast.
