Preliminary Site Assessment Report

September 3, 2018
WBS Element: 32574.1.FD7
State Project: A-0011C
Clay County

SRP 2014 – 2 Funding Trust Property
Parcel I.D.: #015
3399 Highway 69, Hayesville, NC 28904
PIN #: 545802588281
Facility ID No.: 00-0-0000012476
Groundwater Incident No.: None

Seramur & Associates, PC
165 Knoll Drive
Boone, NC 28607

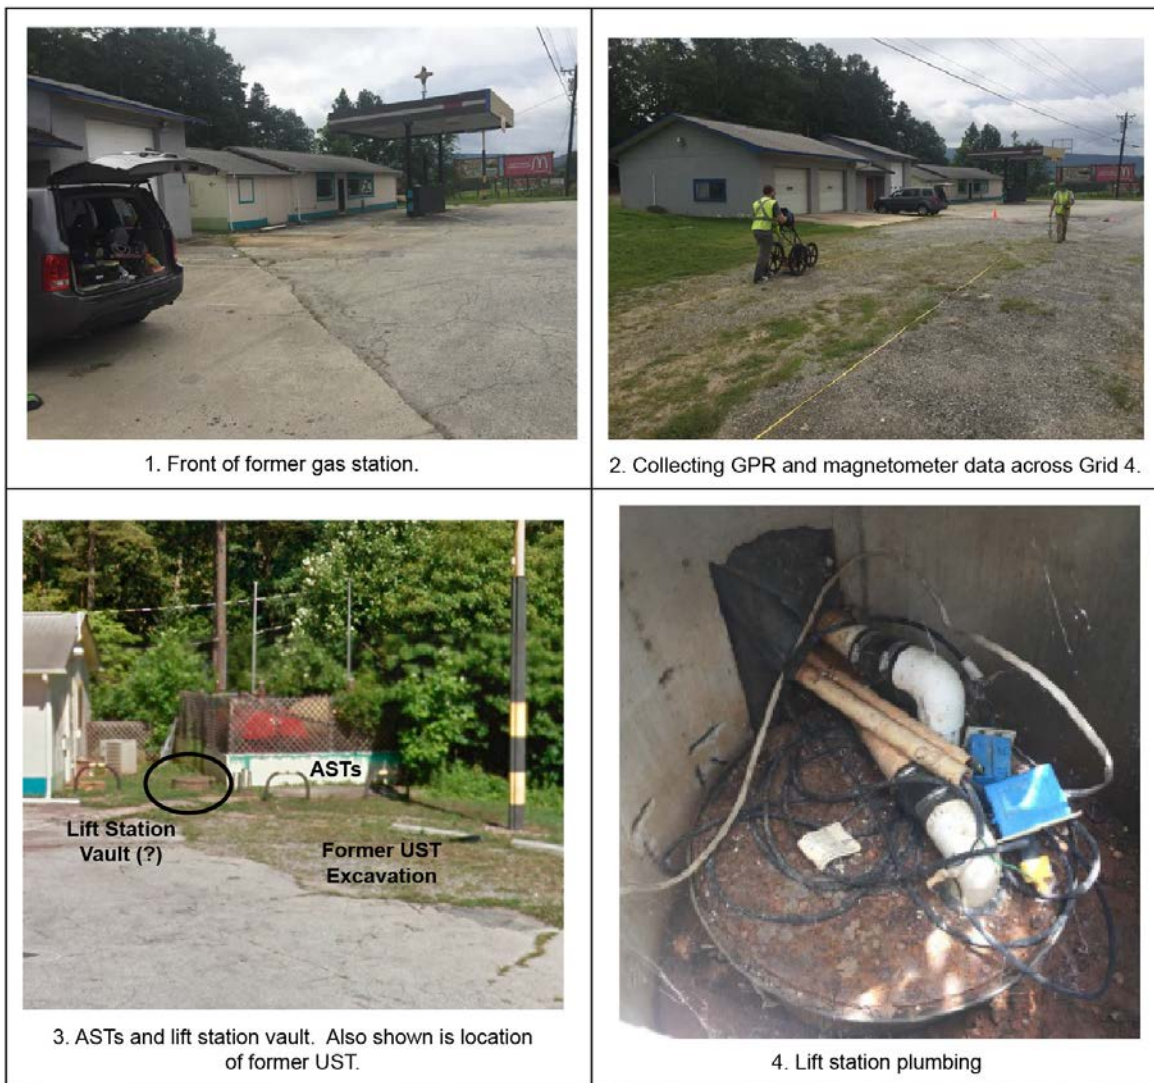
Plate 1.

A concrete vault is located next to the ASTs (Plate 1, Photo 3). Inside the vault is what appears to be the electrical and plumbing for a sewage lift station (Plate 1, Photo 3). A septic tank lid was observed on the east side of the former store (Plate 2, Photo 7). This tank is at an elevation that is higher than the storefront. A septic tank is also located on the north side of the auto repair shop (Plate 1, Photo 5). A stand for a former heating oil AST was observed on the east side of the auto repair shop. Oil-stained concrete was also observed on the east side of the auto repair shop (Plate 2, Photo 6). A propane AST is located behind (east of) the ASTs (Plate 2, Photo 7).

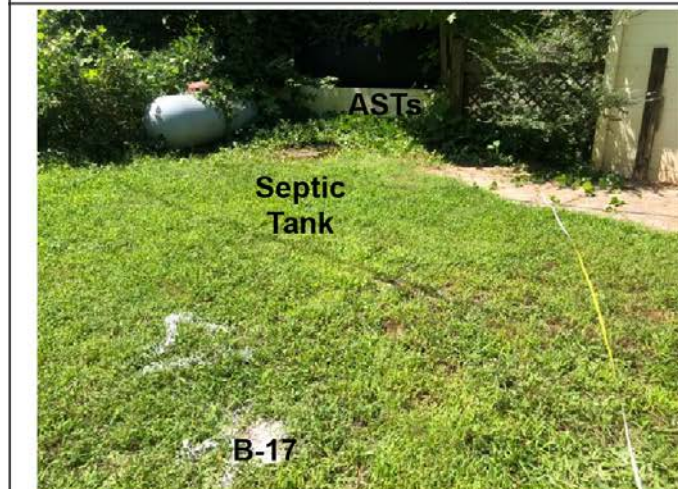
7. Back of AST containment wall and septic tank cover. Also shown is location of Boring B-17.

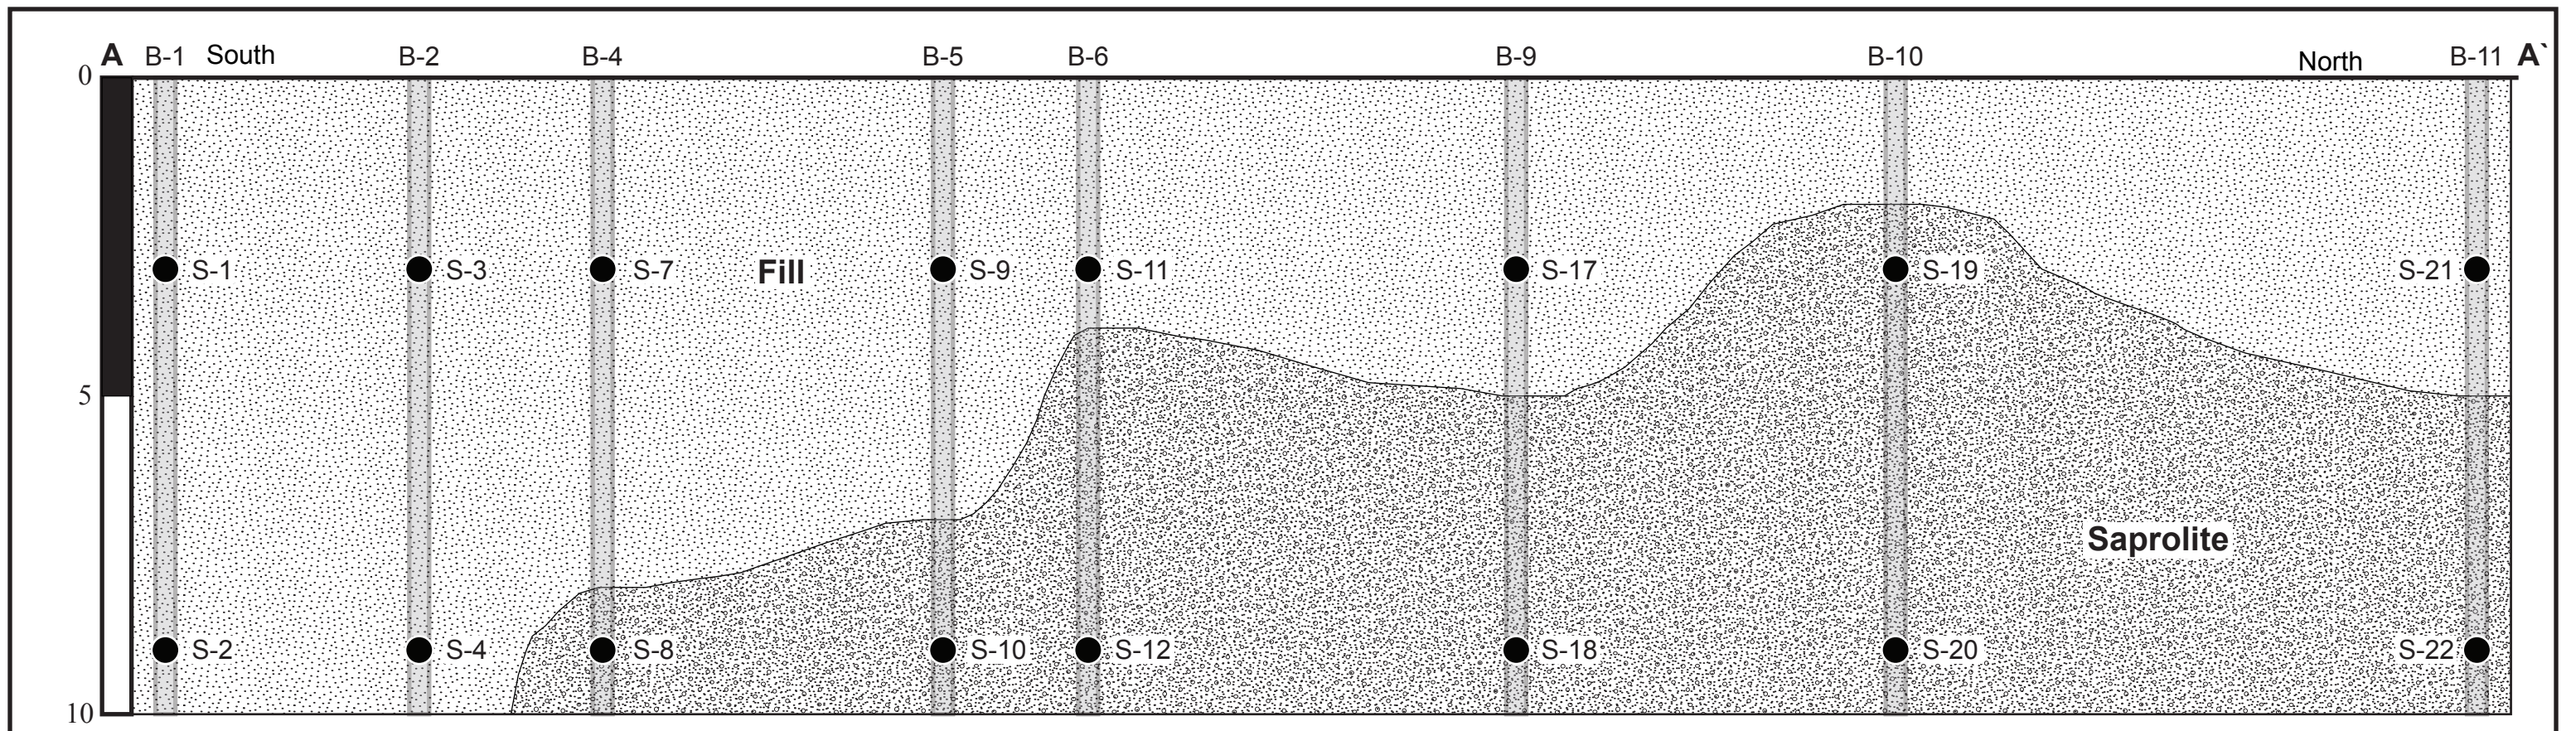
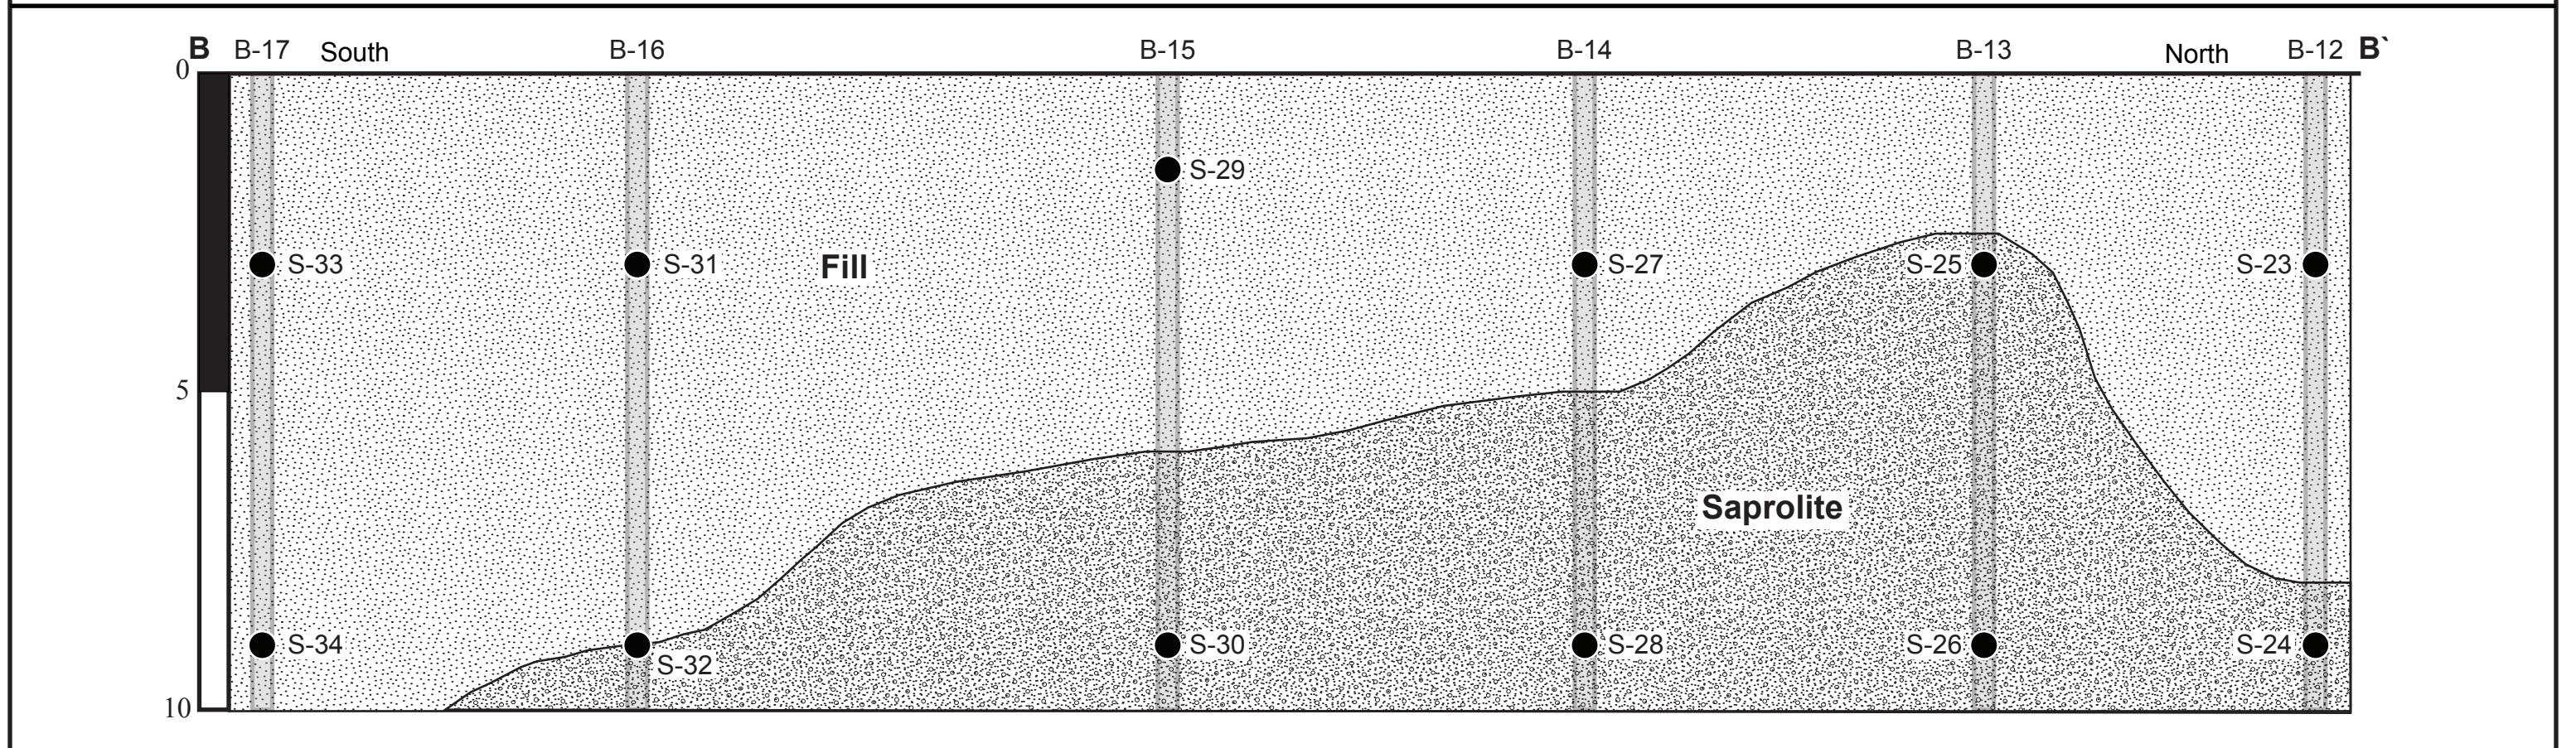
Figure 11
Cross Sections
A-A' and B-B'

The soil types at Parcel #015 consisted of a sandy silt fill material and a silty sand saprolite (Table 1). Groundwater was not encountered in any of the soil borings.

● - Location of Soil Sample
Within Geoprobe Boring

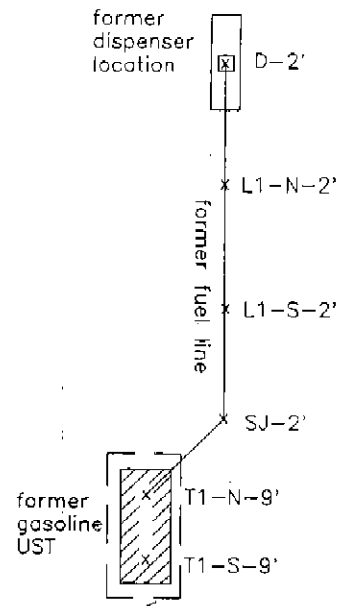
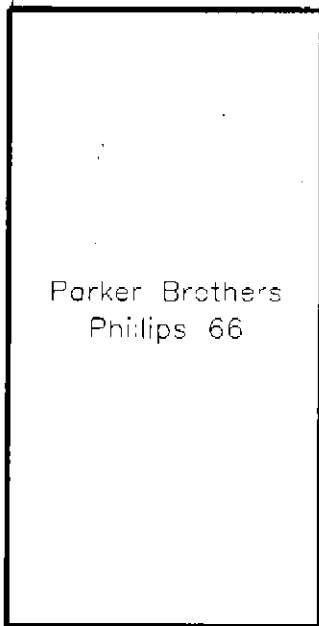
1. Describe excavation procedures noting the condition of the soils and the dimensions of the excavation in relation to the tanks, piping and/or pumps:
According to the tank owner, soil was removed directly beneath the tank to a maximum depth of 7 ft during tank removal; this soil appeared to be clean and was placed back into the excavation following tank removal. Approximate excavation dimensions are indicated on Figure 2 of Appendix A.

approximate excavation limits; pit depth reportedly 7 ft deep
