## Preliminary Site Assessment Report

Wee Are The World Child Care Property  
Parcel # 50  
2206 N. William Street  
Goldsboro, Wayne County, North Carolina  
US 117 Alternate from US 70 Bypass to Belfast  
TIP Number: U-2714  
WBS Element: 38979.1.2

**August 30, 2017**

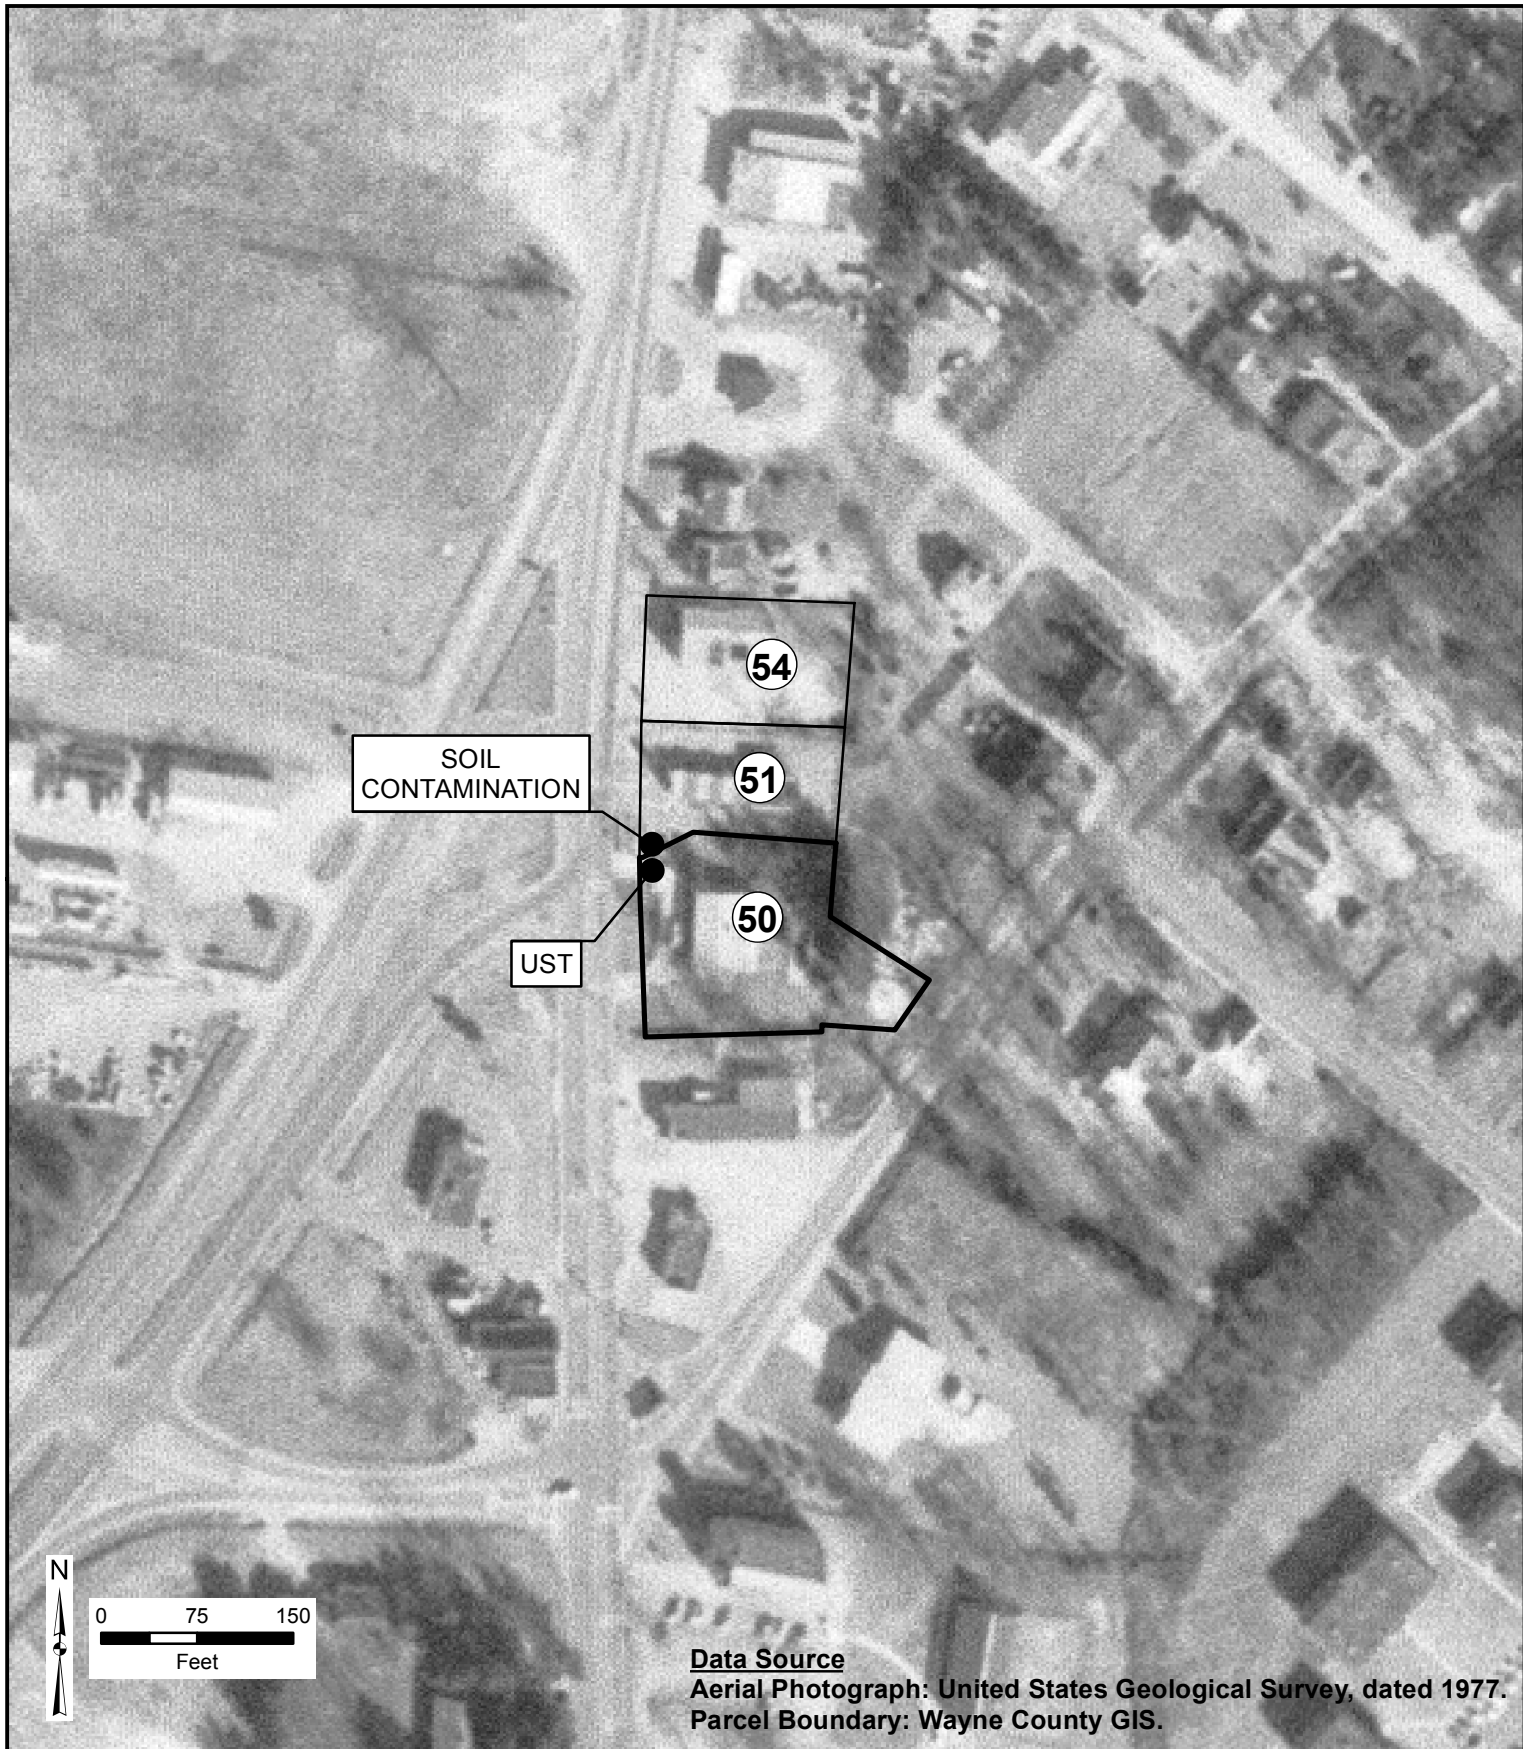
1977 AERIAL PHOTOGRAPH

Apex reviewed historical aerial photographs of the site to determine if dispensers may have been present on the adjacent parcel which were related to the UST located on Parcel 50. A historical aerial photograph from 1977 is shown in **Figure 5**. The aerial photo data was either inconclusive or did not indicate the presence of dispensers. Therefore, Apex did not identify any conclusive analytical or historical data to show that the impacted soils present on the adjacent parcel are related to the UST on Parcel 50.

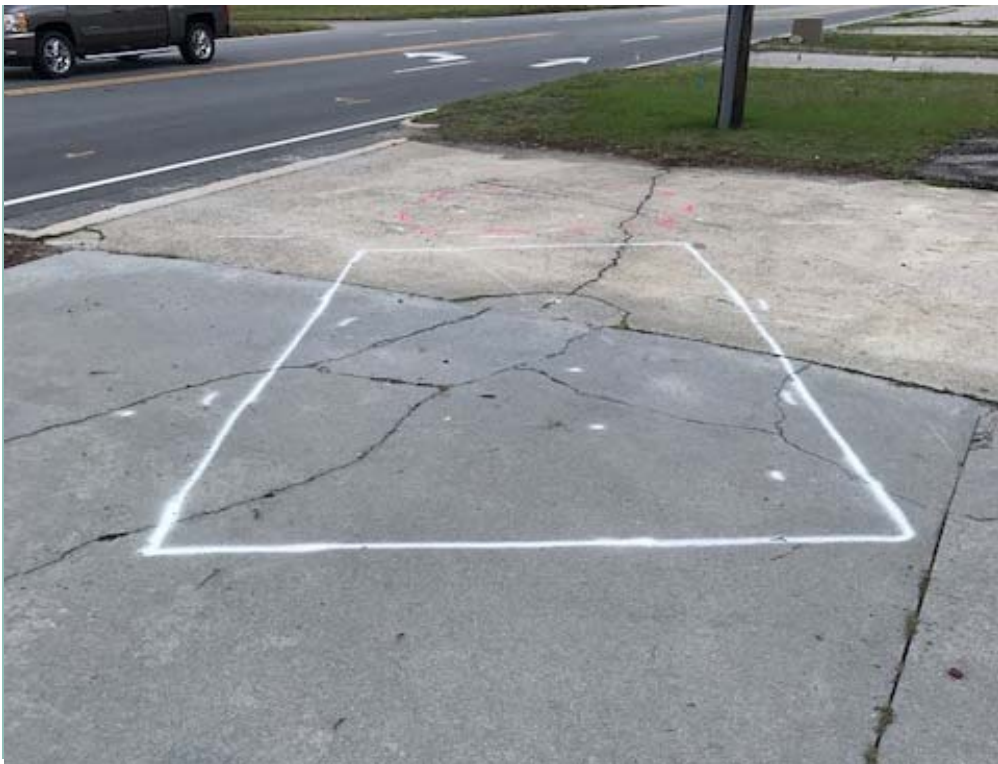
**Photo 2**

View of one possible UST in northwest corner of the site.

Based on these PSA results, there is no soil or groundwater impact which will require additional assessment or removal. A UST is present within the construction area which will likely require removal. The UST is located on the northern end of the parcel and is approximately 12 feet long and six feet wide. Apex recommends that the UST be removed in accordance with NCDEQ

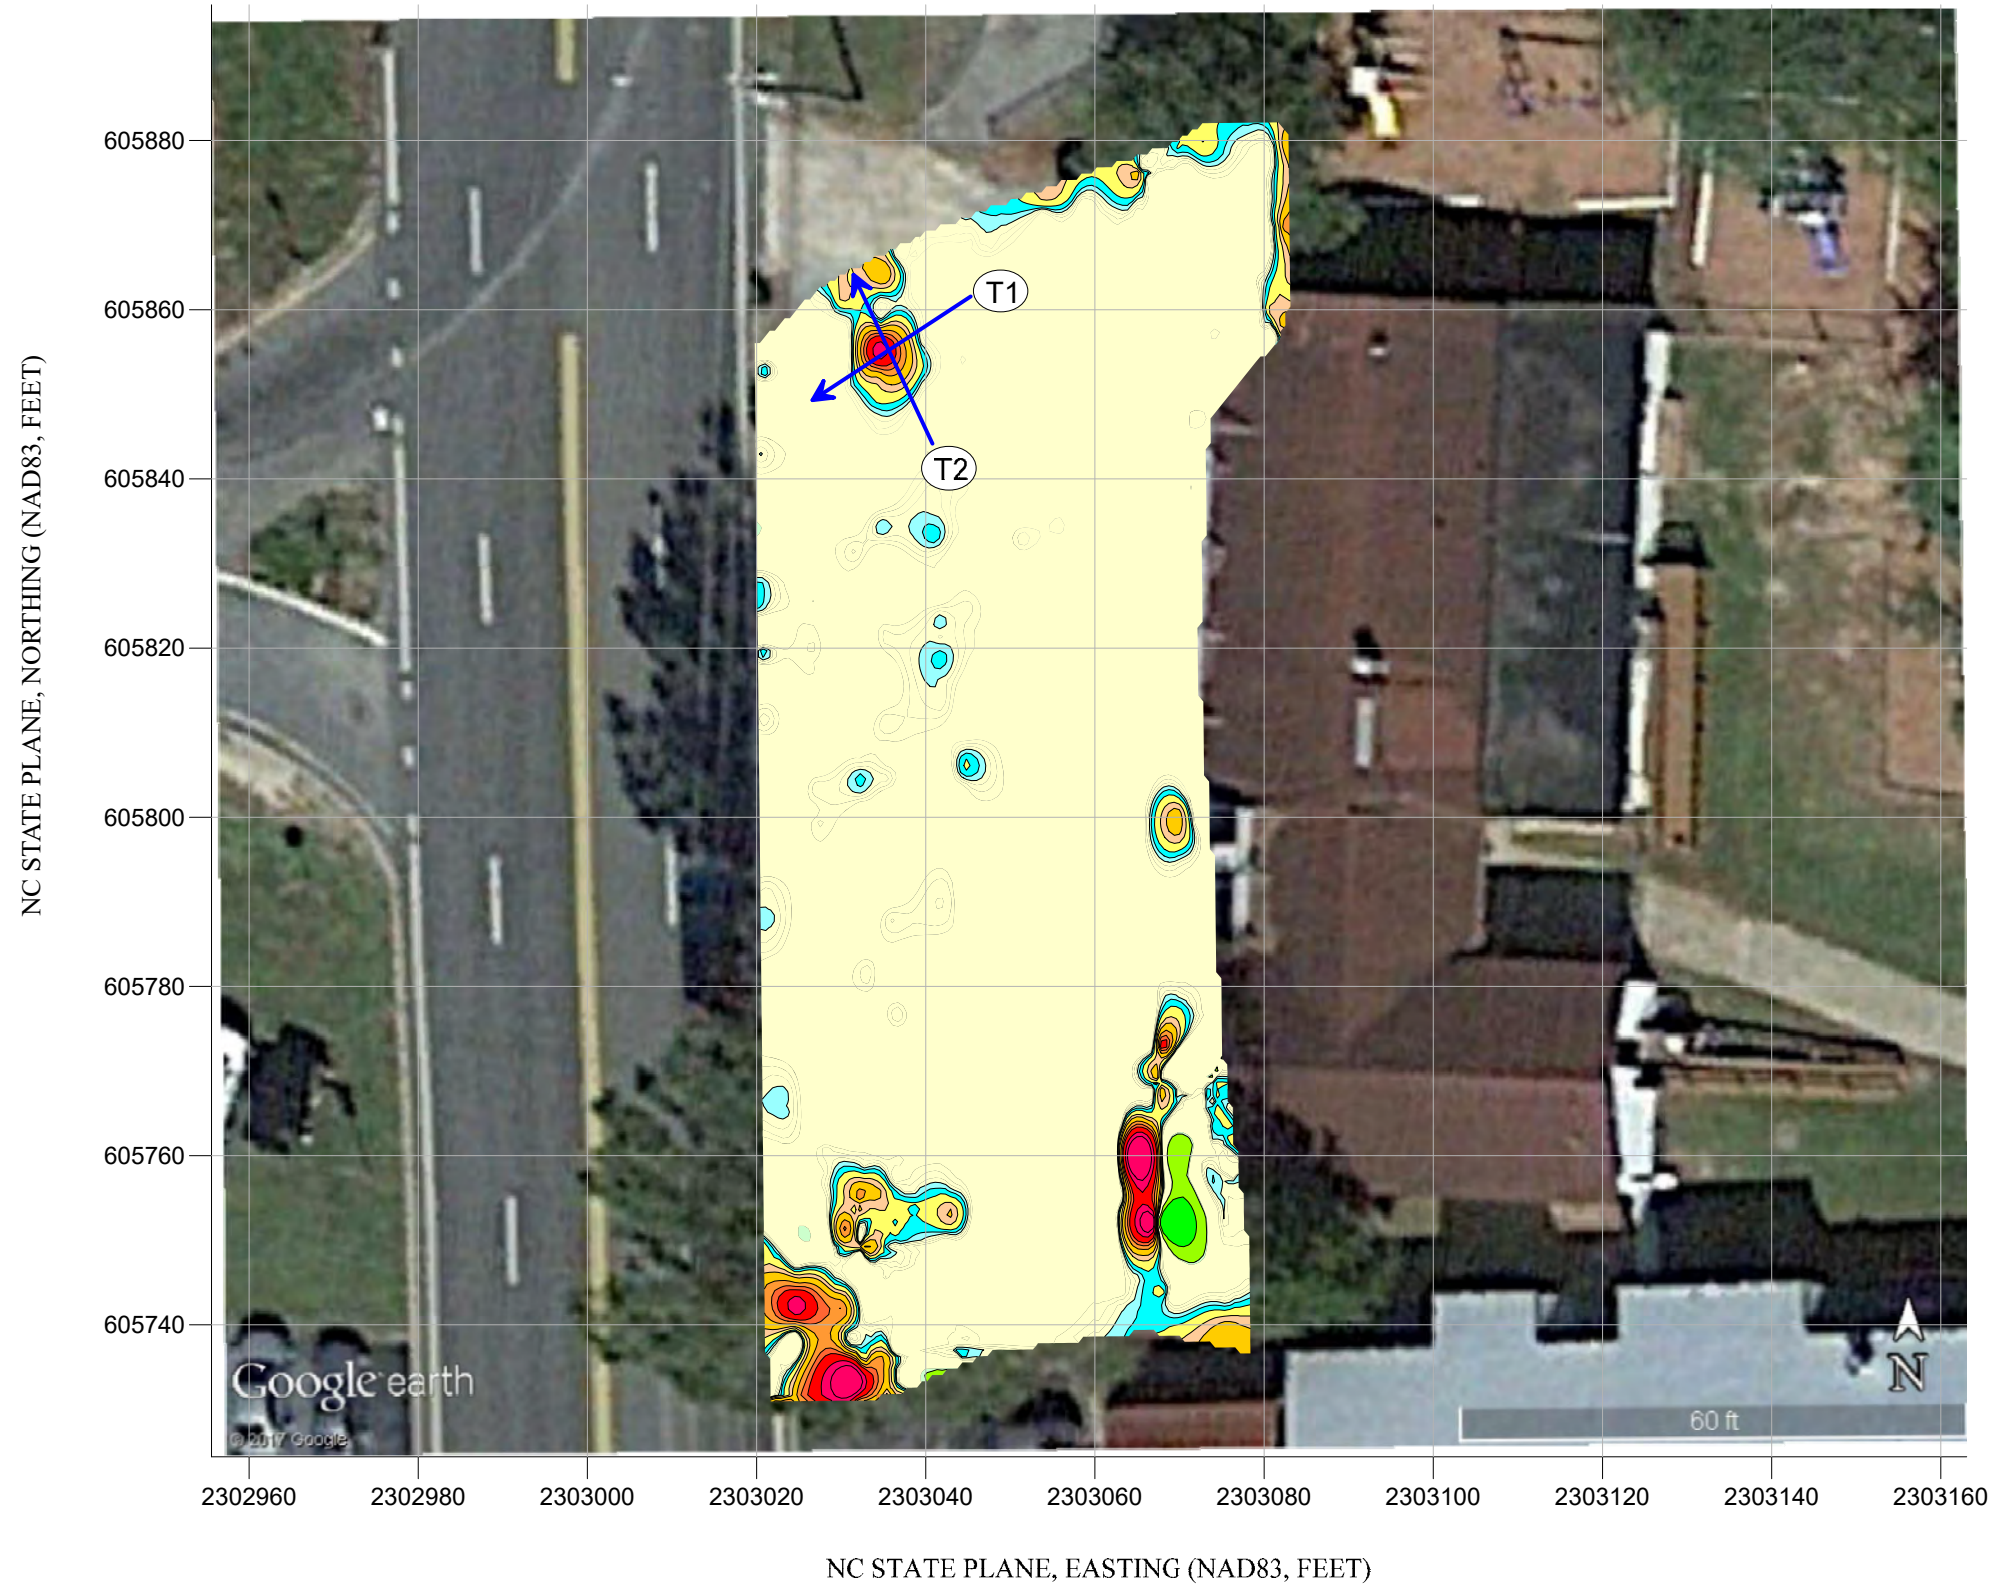
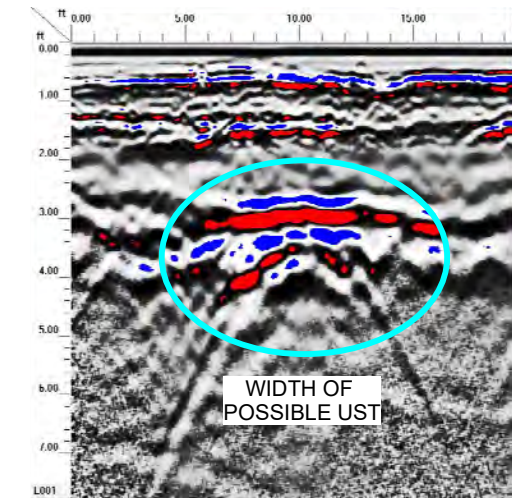
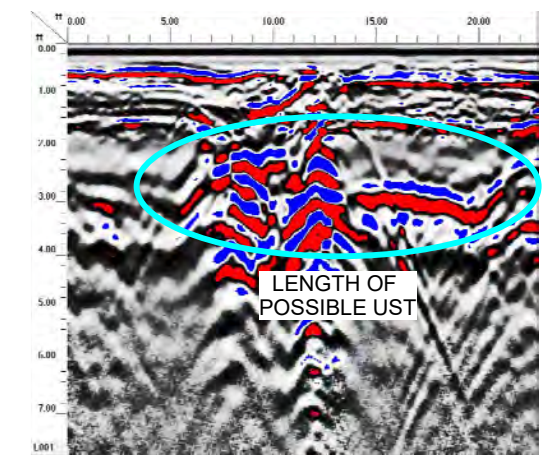
LOCATIONS OF GPR TRANSECTS

GPR TRANSECT 1 (T1)

GPR TRANSECT 2 (T2)

**Geophysical Results:** The majority of the EM anomalies were directly attributed to visible cultural features at the ground surface. EM anomalies were observed in the northern portion of the survey area that were associated with unknown buried metal, and were investigated further by GPR. A total of 2 GPR transects identified the following:

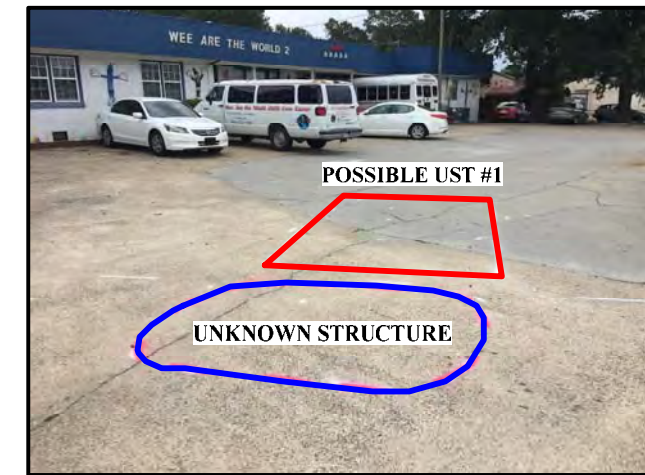
**LOCATION OF POSSIBLE UST**

POSSIBLE UST #1 AND UNKNOWN ASSOCIATED STRUCTURE FACING APPROXIMATELY SOUTH

As discussed above, an EM anomaly was also observed directly north of the possible UST. This feature was predominantly located on Parcel 51 to the north, and was examined with

GPR as part of the investigation of that parcel. The GPR indicated the presence of an anomalous structure; however, its size and shape were not consistent with a UST. It is possible this is a structure associated with the possible UST observed at Parcel 50.

Collectively, the geophysical data recorded evidence of one possible metallic UST at Parcel 050. **Figure 4** shows the location and size of the possible UST identified by the survey, as well as the location of the unknown structure to the north (not classified as a UST). **Figure 5** provides an overlay of the geophysical survey area onto the NCDOT MicroStation engineering plans (proposed ROW and easements) for reference.
