Preliminary Site Assessment Report

Kornegay Properties & Investments Property
Parcel # 9
1516 N. William Street
Goldsboro, Wayne County, North Carolina
US 117 Alternate from US 70 Bypass to Belfast
TIP Number: U-2714
WBS Element: 38979.1.2

July 14, 2017

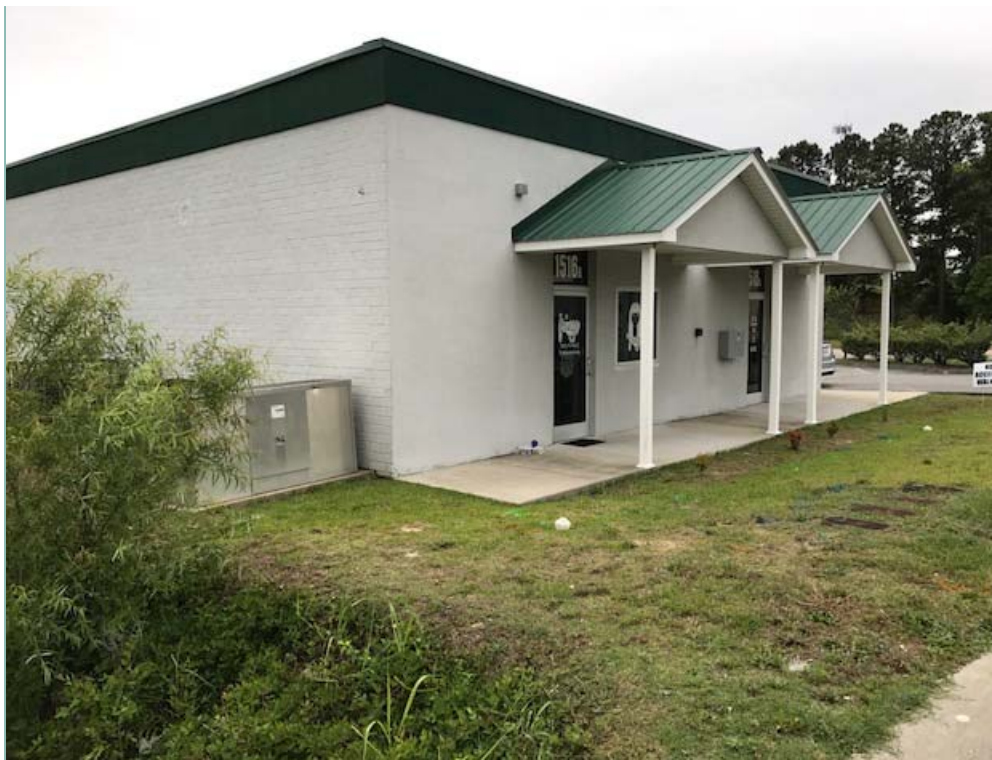
Photo 1

Overview of site prior to preliminary site assessment activities.

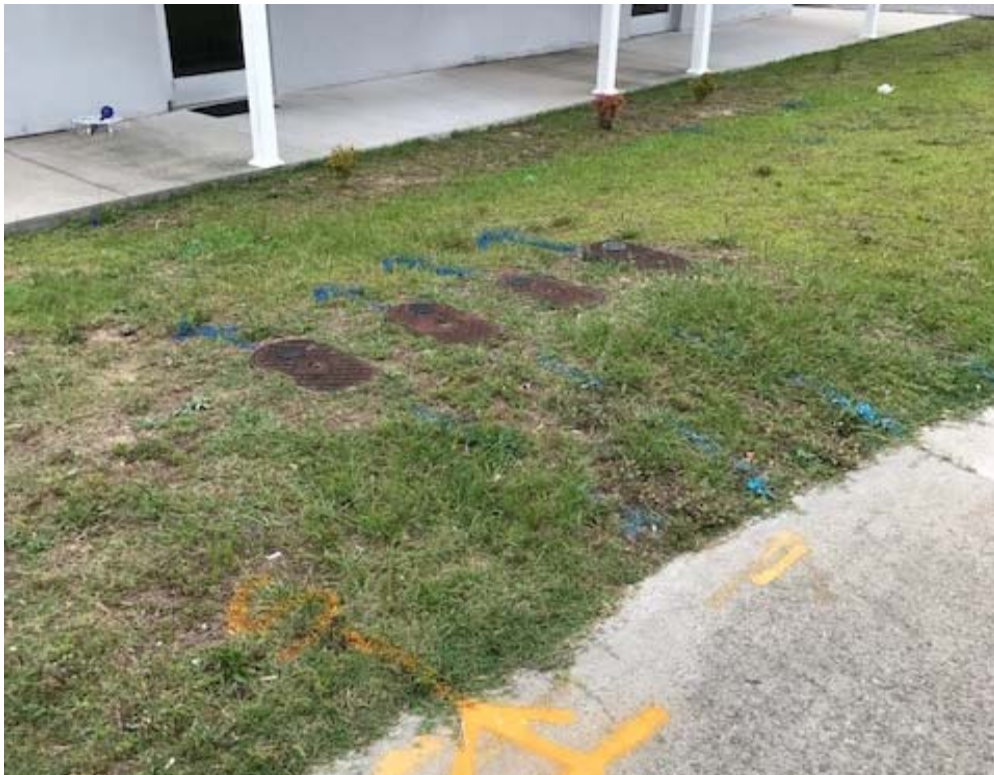
Photo 3

View of utility mark outs prior to investigation activities.
