Phase II Site Assessment Report

October 17, 2019
WBS Element: 45778.1.1
State Project: B-5825
Forsyth County

At
Donnaha Mart LLC Property
Parcel #008
9995 Reynolda Road, Tobaccoville, NC 27050
PIN #: 5970-80-2552.00
Facility ID No.: 00-0-0000015037
Groundwater Incident No.: N/A

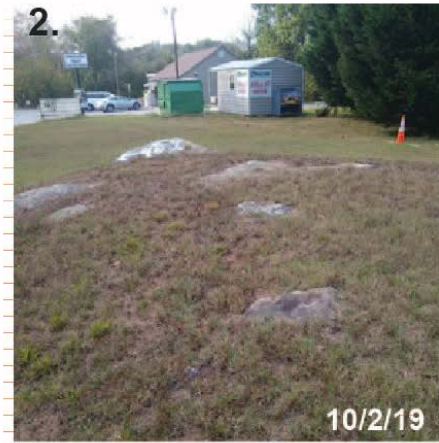
Bedrock outcrop was observed in front of the store and along the eastern side of Parcel #008.

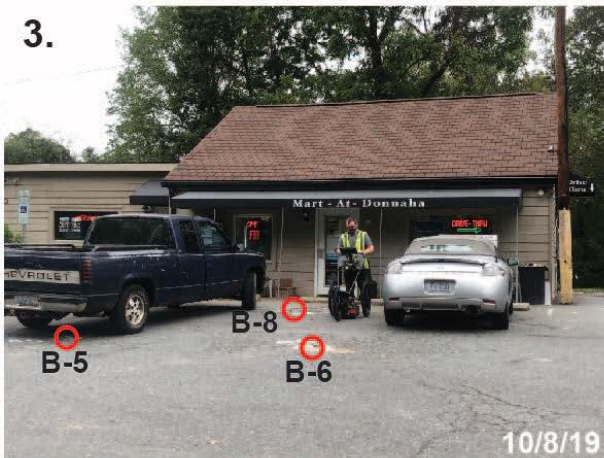
Collecting GPR data at Parcel #008. Red circles show location of soil borings B-5, B-6 and B-8 where contaminated soil was documented.

Borings B-4 through B-8 and B-17 through B-19 were drilled in the pavement south of the convenience store. Borings B-5, B-6 and B-8 were drilled immediately in front of the building in the suspected location of the former UST system. Petroleum constituents were detected in all of the samples collected from these borings. The highest petroleum concentrations were detected in Boring B-6. The shallow and deep samples had petroleum constituent concentrations of 1,753 ppm and 7,358 ppm, respectively. Boring B-5 contained GRO concentrations in the deep sample at 3,397 ppm. Boring B-8 contained GRO and DRO concentrations between 150 ppm and 800 ppm in both samples (Table B-3 and Figure 12). Borings B-4, B-7, B-17, B-18 and B-19 delineate the extent of contaminated soil (Figure 12). Boring B-18 contained elevated concentrations of DRO in both samples, although they were not above the NCDEQ Action Levels.

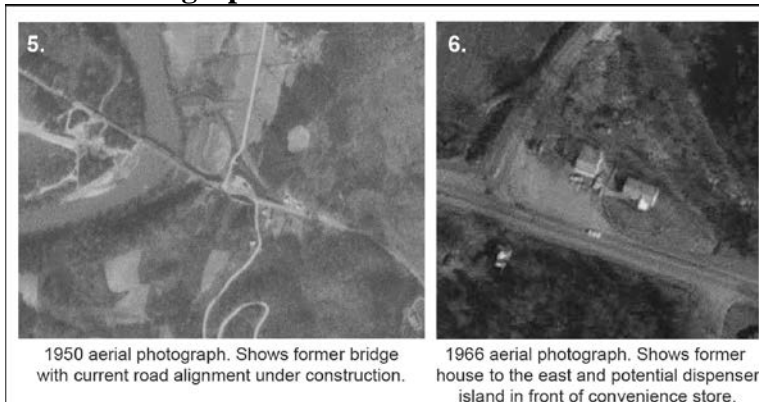
Plate 2 – Historic Aerial Photographs

1950 aerial photograph. Shows former bridge with current road alignment under construction.

1966 aerial photograph. Shows former house to the east and potential dispenser island in front of convenience store.

Historic aerial photographs indicate that the property was developed later than 1940. A 1948 aerial photograph appears to show the property undeveloped and covered with trees. There is a different bridge with an aligned further to the north across Donnaha Park Road on the west side of the river. The 1949 aerial photograph is blurry, but it appears that the former house to the east of the convenience store building is present and the rest of the property has been graded. In

1950, work had begun on realigning the road and installing the current bridge (Plate 2). The building does not appear to be present in this photograph. The next available aerial photograph is from 1962 and it shows the former house with the bridge and Reynolda Road in their current alignment. The convenience store does not appear to be present in this photograph. The aerial photograph from 1966 shows the eastern half of the building only. The dispenser island appears to be in front of the building in this 1966 photograph (Plate 2). The NCDEQ UST Database indicates that the tanks were installed in 1971, but it is not unusual to see incorrect dates listed for these older UST systems. It is likely that the tanks were installed when the building was built sometime between 1962 and 1966.

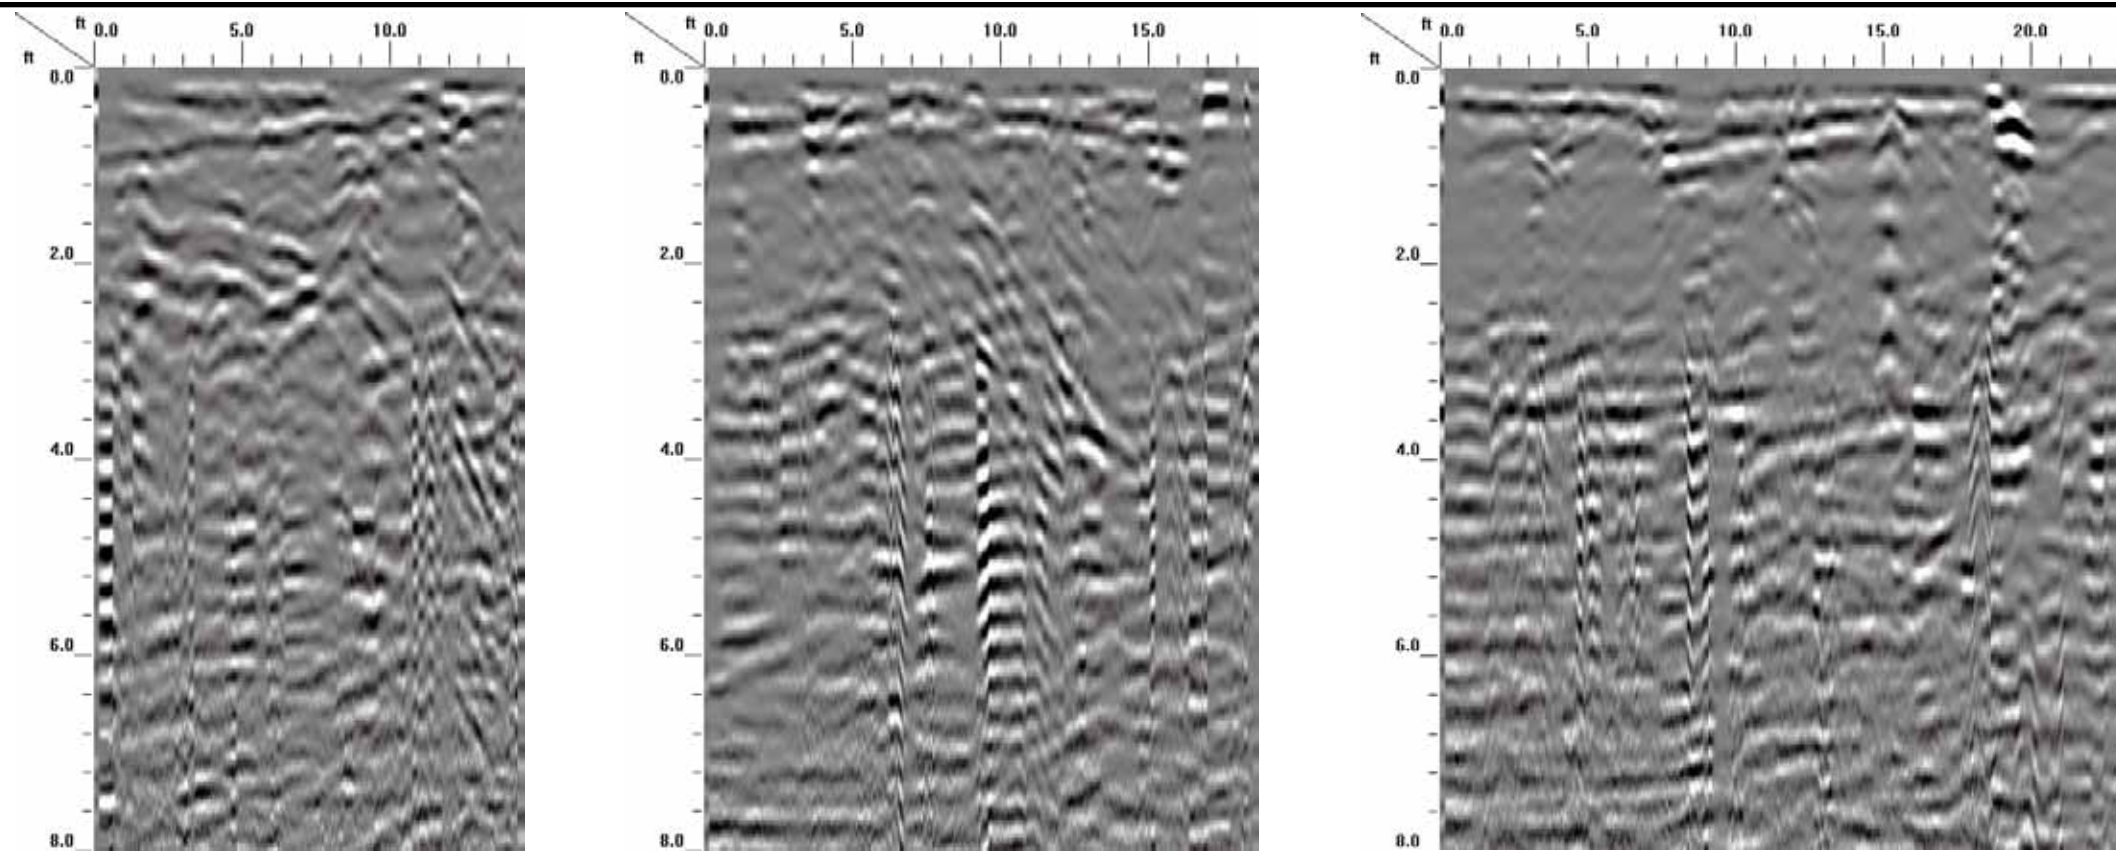
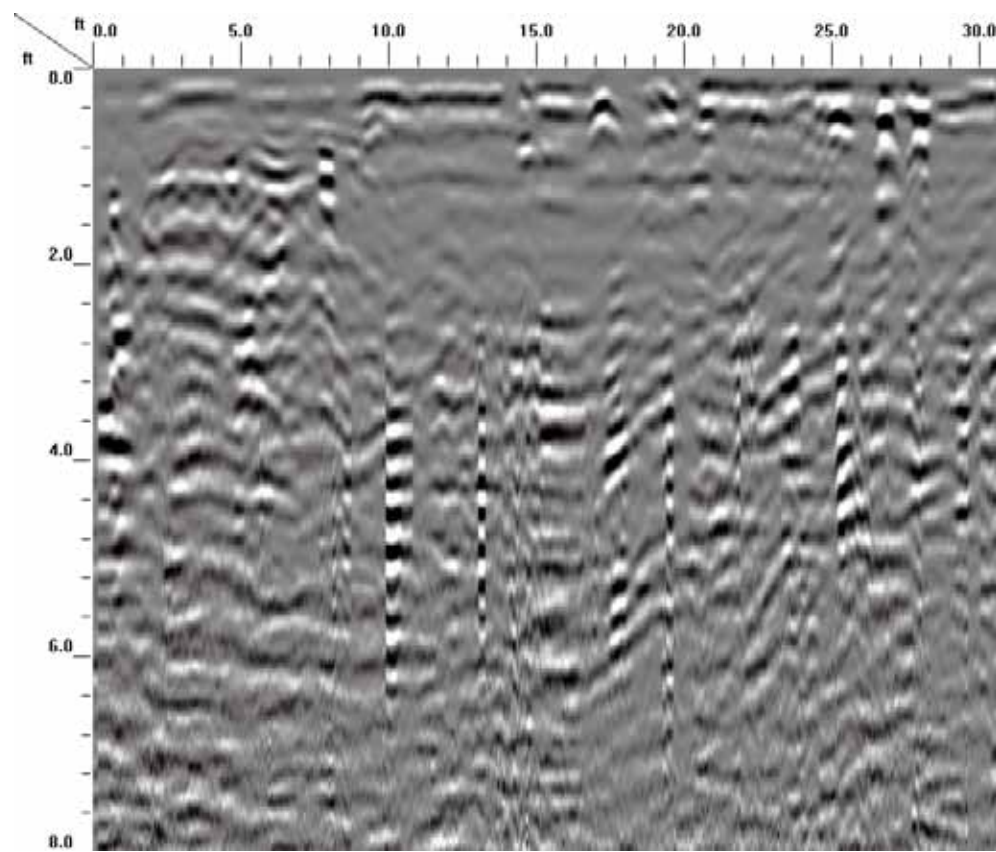
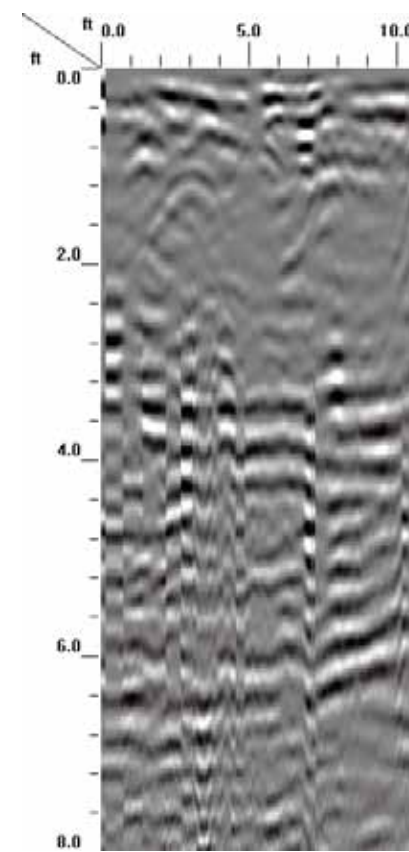
Figure 11a
GPR Transects
1 through 5

Thirteen transects of GPR data were collected outside of the five grids (Figures 11a, 11b and 11c). These profiles did not show evidence of the former UST system. Three hyperbolae at a depth of about 2 feet on profile 9 are spaced 5 to 7 feet apart as one would expect to see buried USTs (Figure 11b). These reflections are relatively low amplitude. USTs would be represented by distinct high amplitude reflections. These reflections are limited to profile 9 and do not show up on adjacent profiles 10 and 11. Further investigation with the GPR and magnetometer determined that the hyperbola do not represent buried USTs.
