PROJECT NO. 15BPR.20
HENDERSON COUNTY
 STATION: 35+30.22 -L-

REHABILITATION

STRUCTURAL STEEL
 REPAIRS

PACK RUST REPAIRS
 FOR REPRESENTATION ONLY

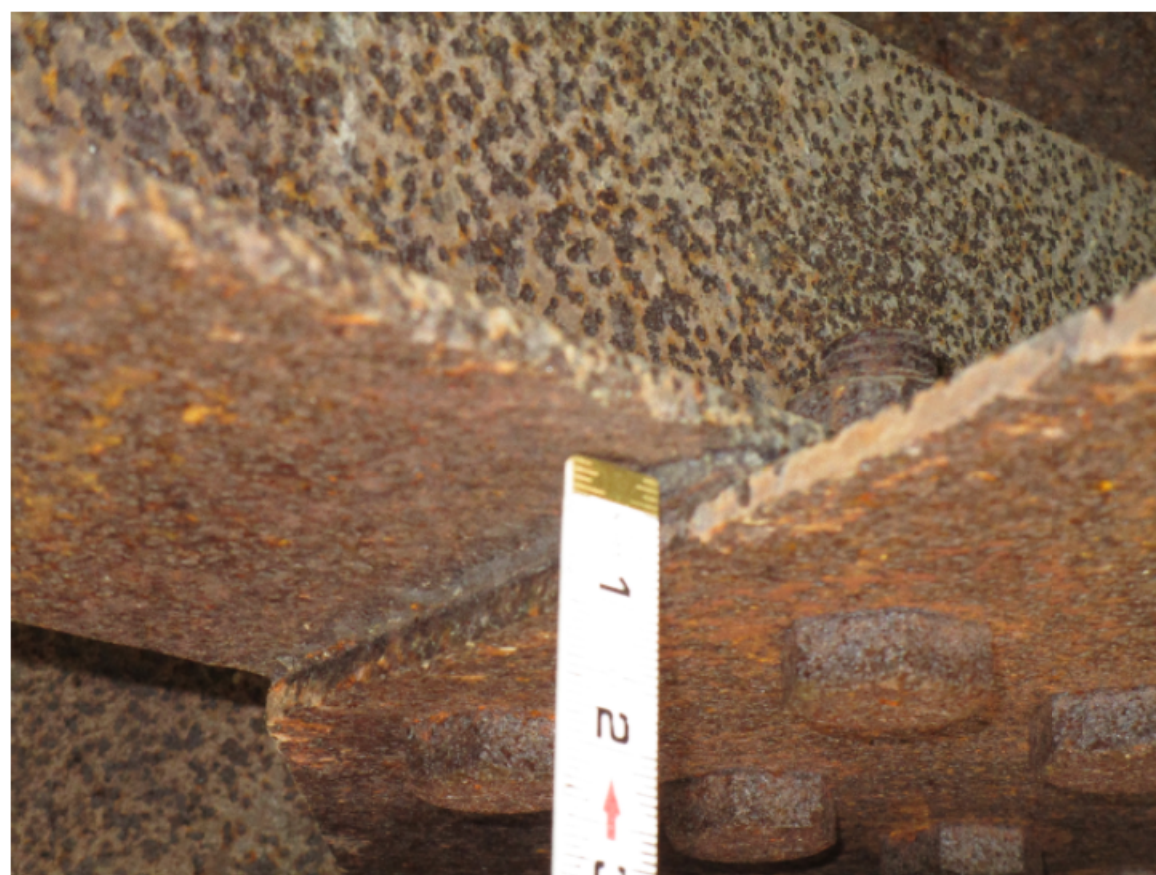
- PR-I-13 GIRDER 3, PANEL POINT 23, AT BOTTOM CROSSFRAME CONNECTION: PACK RUST BETWEEN GUSSET PLATE AND CROSSFRAME BOTTOM CHORD.
- PR-I-14 GIRDER 3, PANEL POINT 29, AT BOTTOM CROSSFRAME CONNECTION: PACK RUST BETWEEN GUSSET PLATE AND CROSSFRAME BOTTOM CHORD AND LATERAL BRACING MEMBERS.

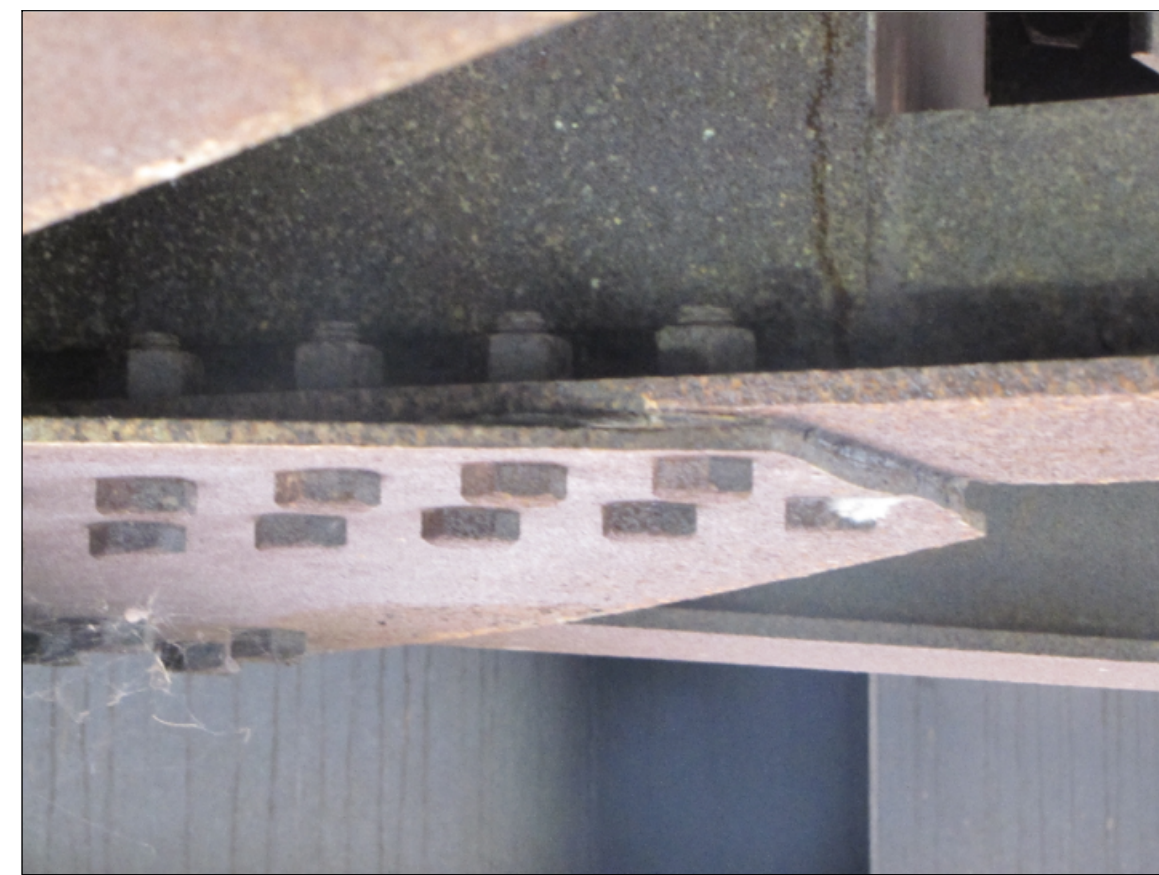
- PR-I-1 GIRDER 1, PANEL POINT 26, AT BOTTOM CROSSFRAME CONNECTION: PACK RUST BETWEEN GUSSET PLATE AND CROSSFRAME BOTTOM CHORD AND LATERAL BRACING MEMBERS.

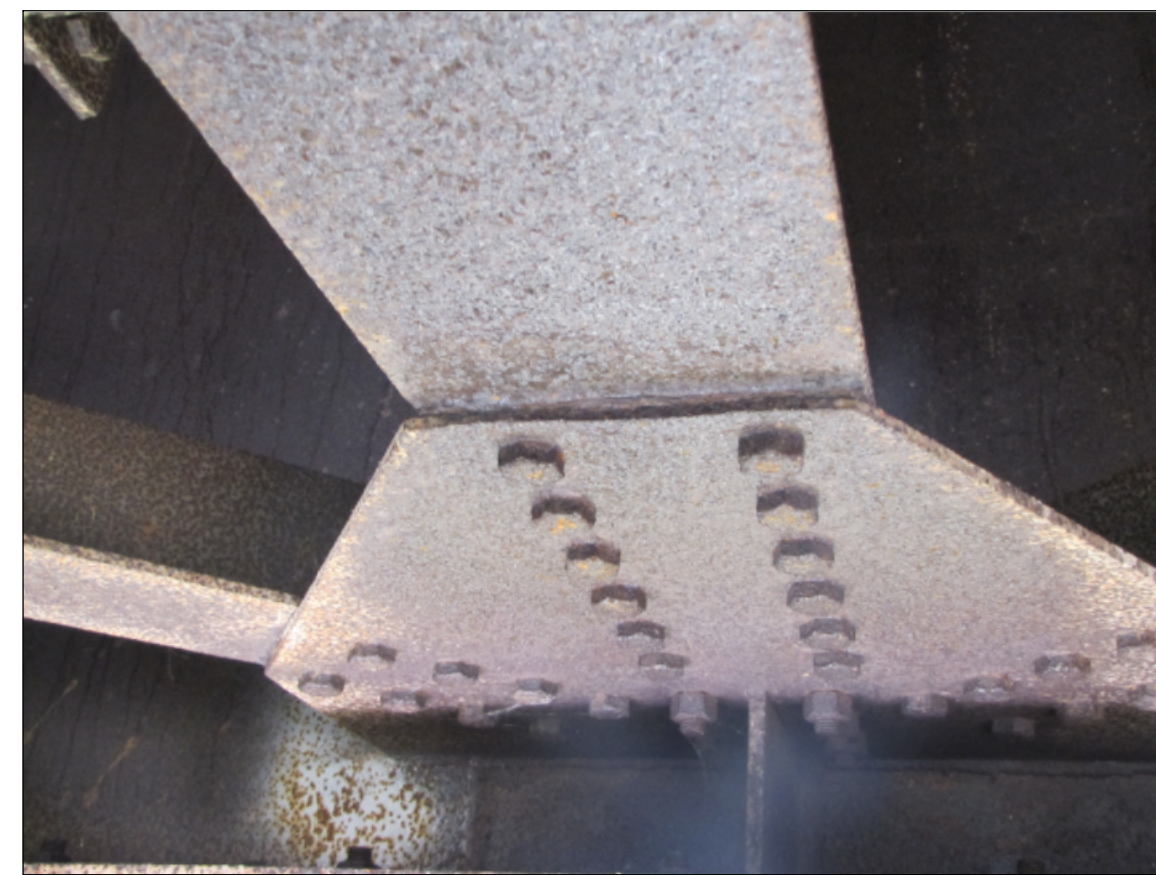
- PR-I-4 GIRDER 1, PANEL POINT 15, AT BOTTOM CROSSFRAME CONNECTION: PACK RUST BETWEEN GUSSET PLATE AND LATERAL BRACING MEMBERS.
- PR-I-5 GIRDER 1, PANEL POINT 15, AT BOTTOM CROSSFRAME CONNECTION: PACK RUST BETWEEN GUSSET PLATE AND CROSSFRAME BOTTOM CHORD.

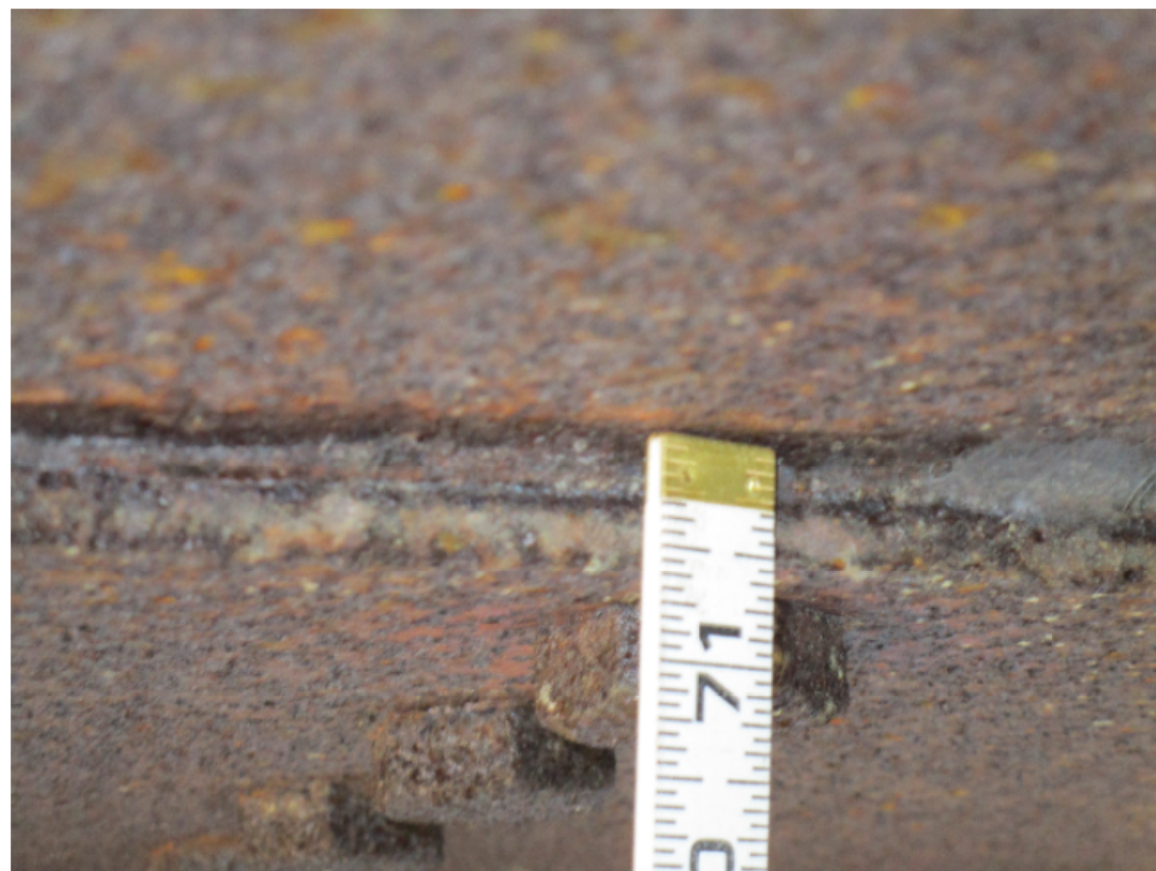
- PR-I-15 GIRDER 4, PANEL POINT 6, AT BOTTOM CROSSFRAME CONNECTION: PACK RUST BETWEEN GUSSET PLATE AND CROSSFRAME BOTTOM CHORD AND LATERAL BRACING MEMBERS.

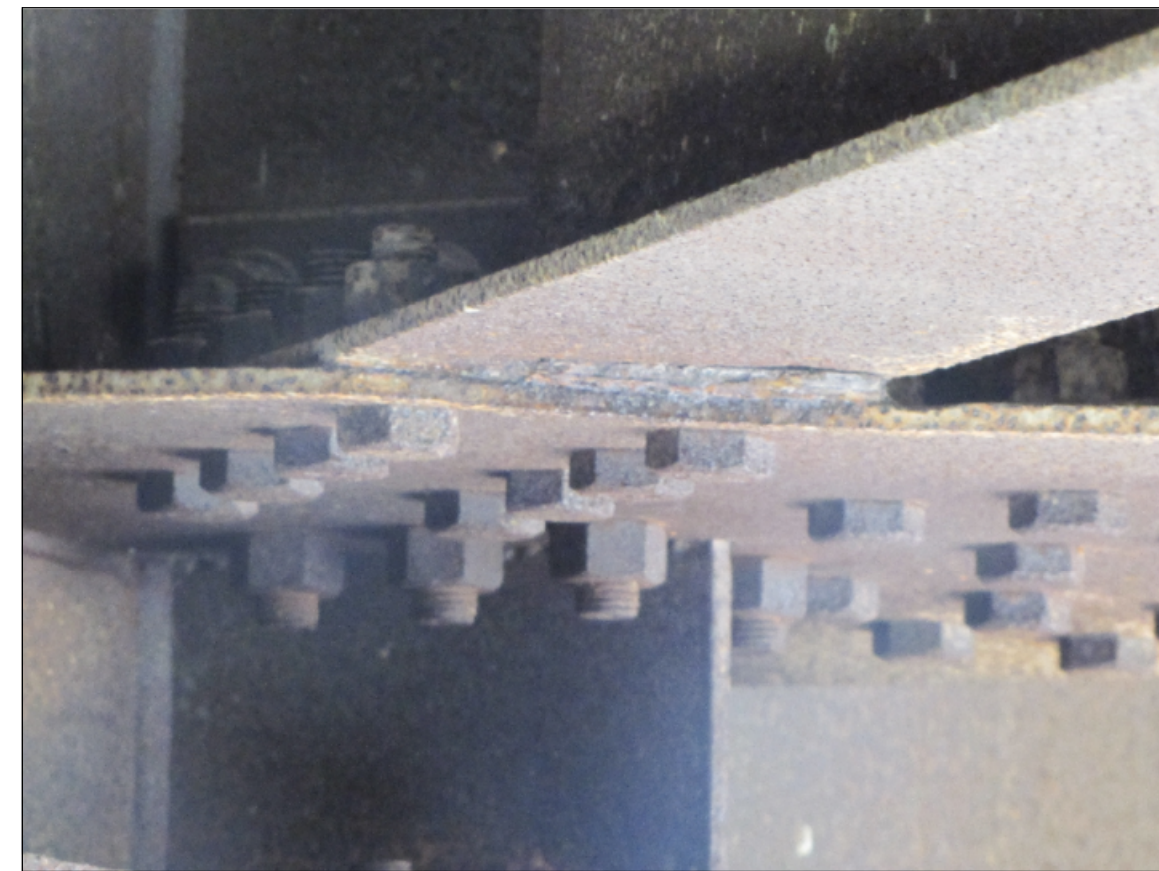
- PR-I-2 GIRDER 1, PANEL POINT 20, AT BOTTOM CROSSFRAME CONNECTION: PACK RUST BETWEEN GUSSET PLATE AND LATERAL BRACING MEMBERS.
- PR-I-3 GIRDER 1, PANEL POINT 18, AT BOTTOM CROSSFRAME CONNECTION: PACK RUST BETWEEN GUSSET PLATE AND LATERAL BRACING MEMBERS.

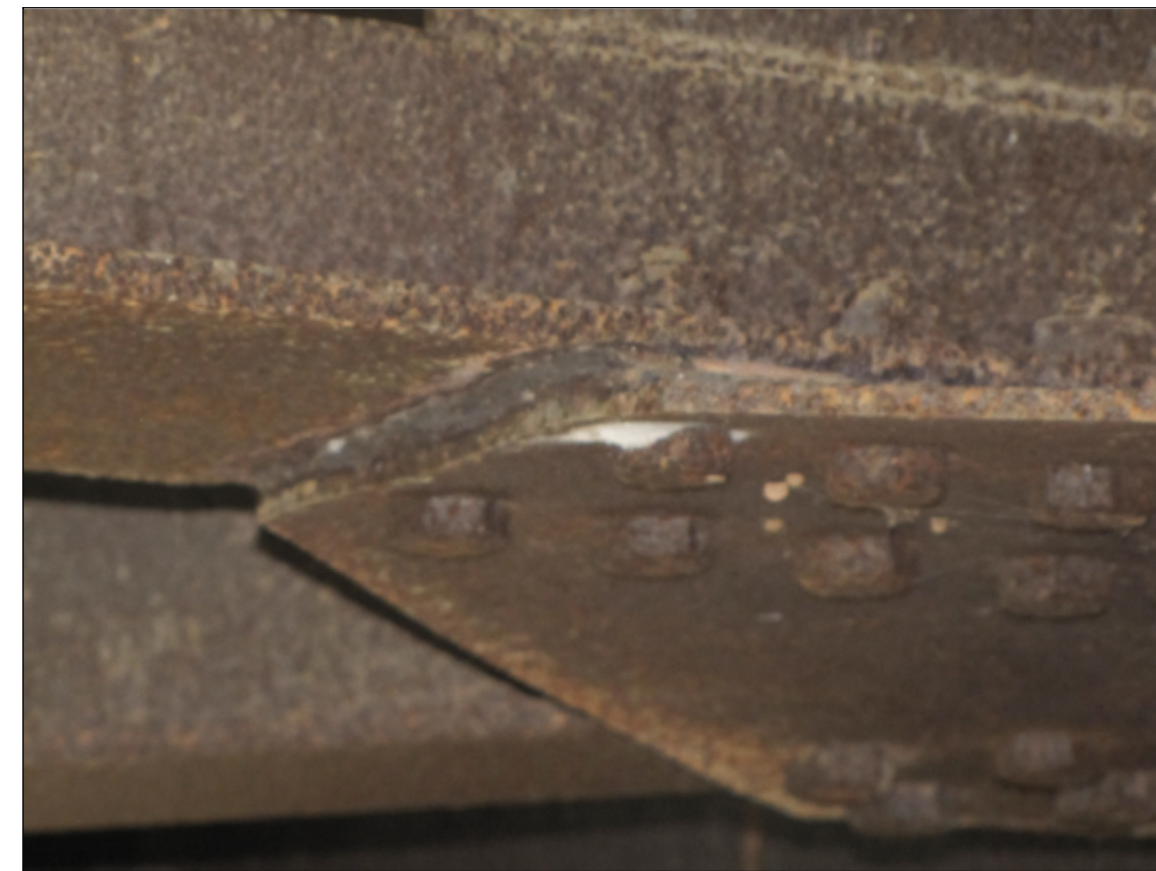
- PR-I-6 GIRDER 2, PANEL POINT 15, AT BOTTOM CROSSFRAME CONNECTION: PACK RUST BETWEEN GUSSET PLATE AND CROSSFRAME BOTTOM CHORD.
- PR-I-7 GIRDER 3, PANEL POINT 12, AT BOTTOM CROSSFRAME CONNECTION: PACK RUST BETWEEN GUSSET PLATE AND CROSSFRAME BOTTOM CHORD AND LATERAL BRACING MEMBERS.

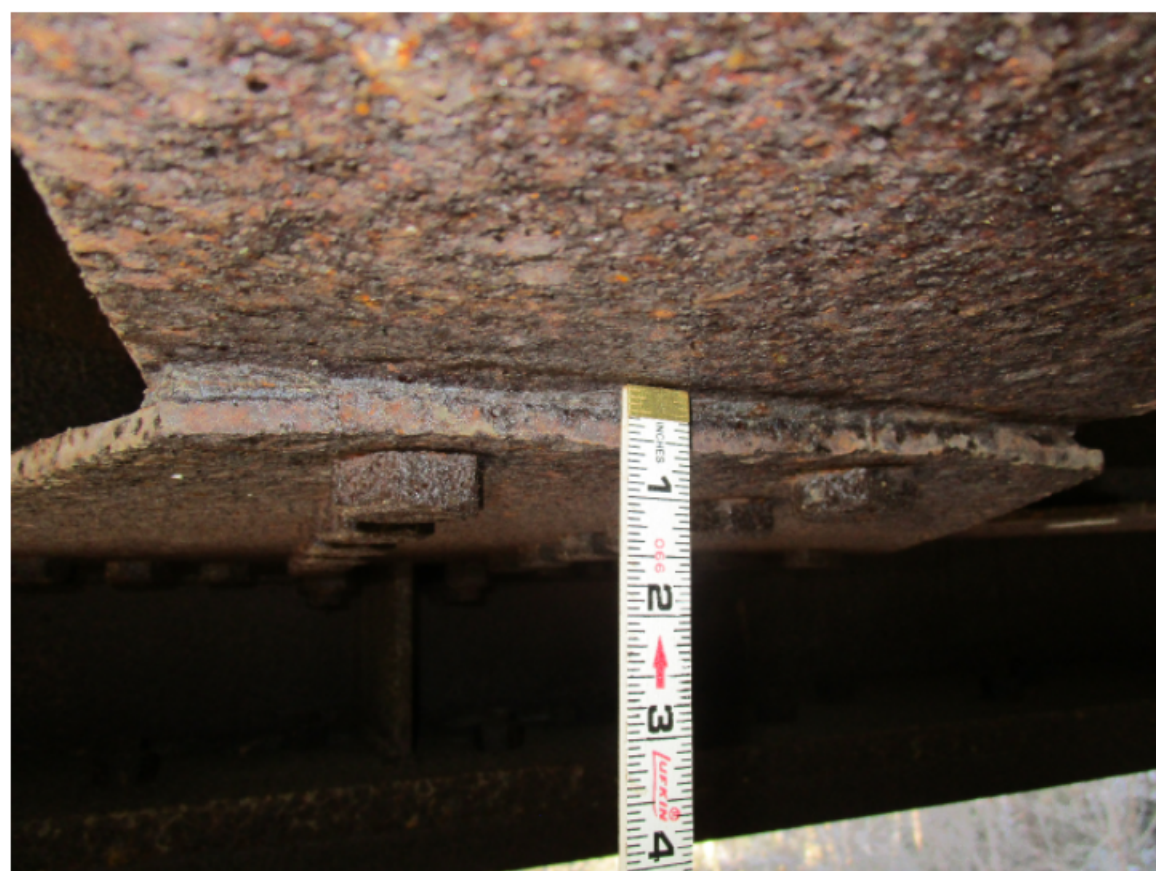
- PR-I-16 GIRDER 4, PANEL POINT 9, AT BOTTOM CROSSFRAME CONNECTION: PACK RUST BETWEEN GUSSET PLATE AND CROSSFRAME BOTTOM CHORD AND LATERAL BRACING MEMBERS.

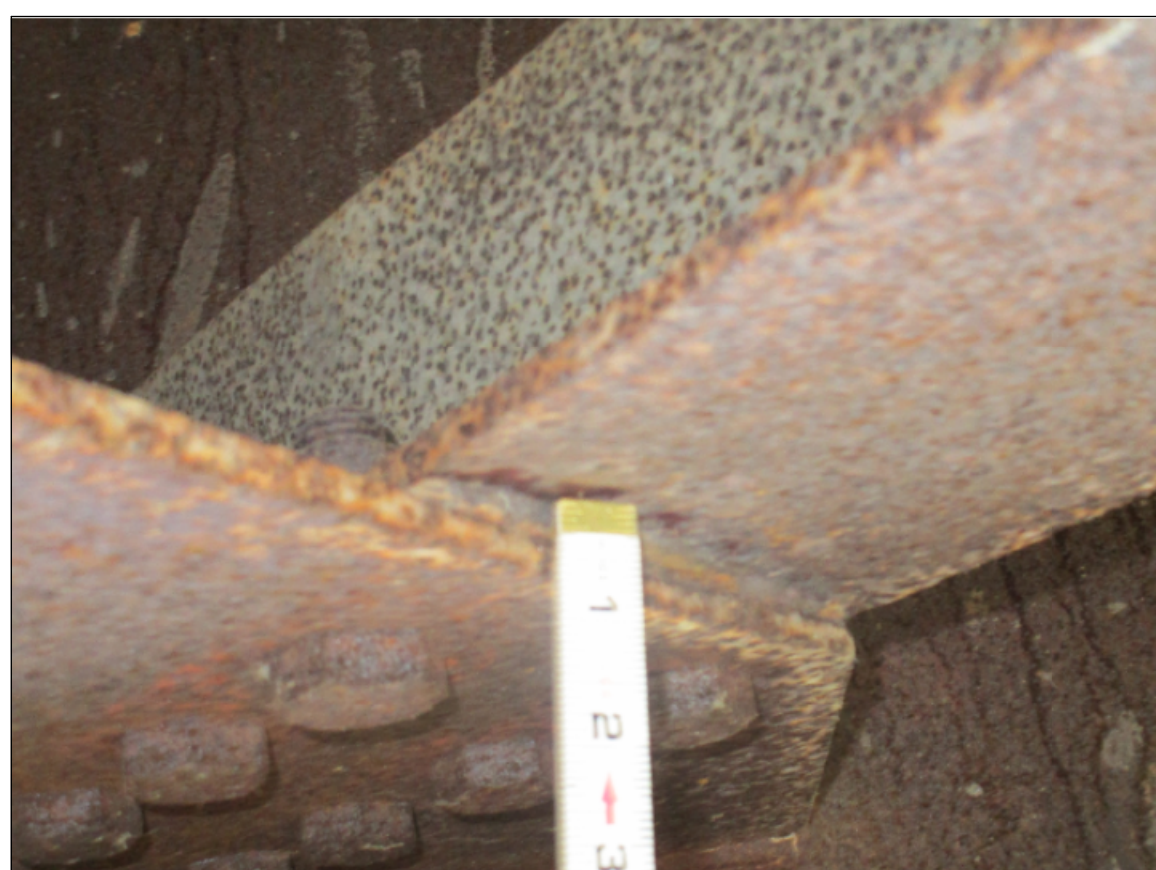
- PR-I-17 GIRDER 4, PANEL POINT 35, AT BOTTOM CROSSFRAME CONNECTION: PACK RUST BETWEEN GUSSET PLATE AND CROSSFRAME BOTTOM CHORD AND LATERAL BRACING MEMBERS.
