# Preliminary Site Assessment Report

Sibbett Properties, Inc. Property

Parcel # 19

US 701 Bypass (Madisson St-Powell Blvd) from SR 1437 (Virgil Ave) to US 74/76

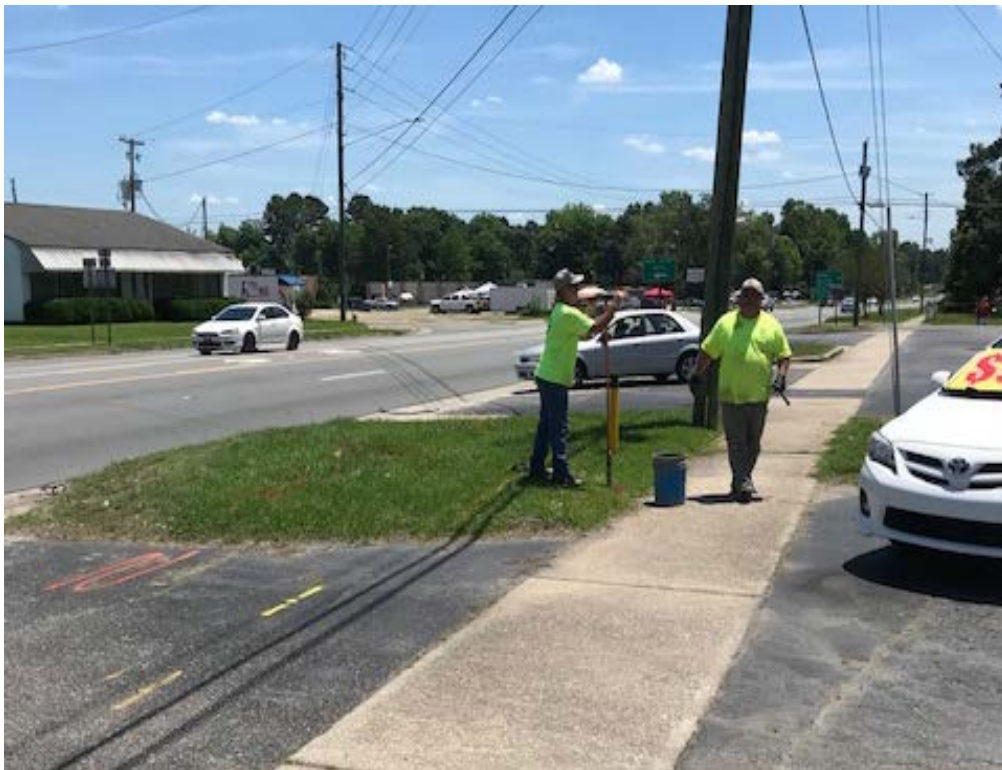
**Photo 2**

View of CSI hand augering to 5 feet prior to operating direct push rig.

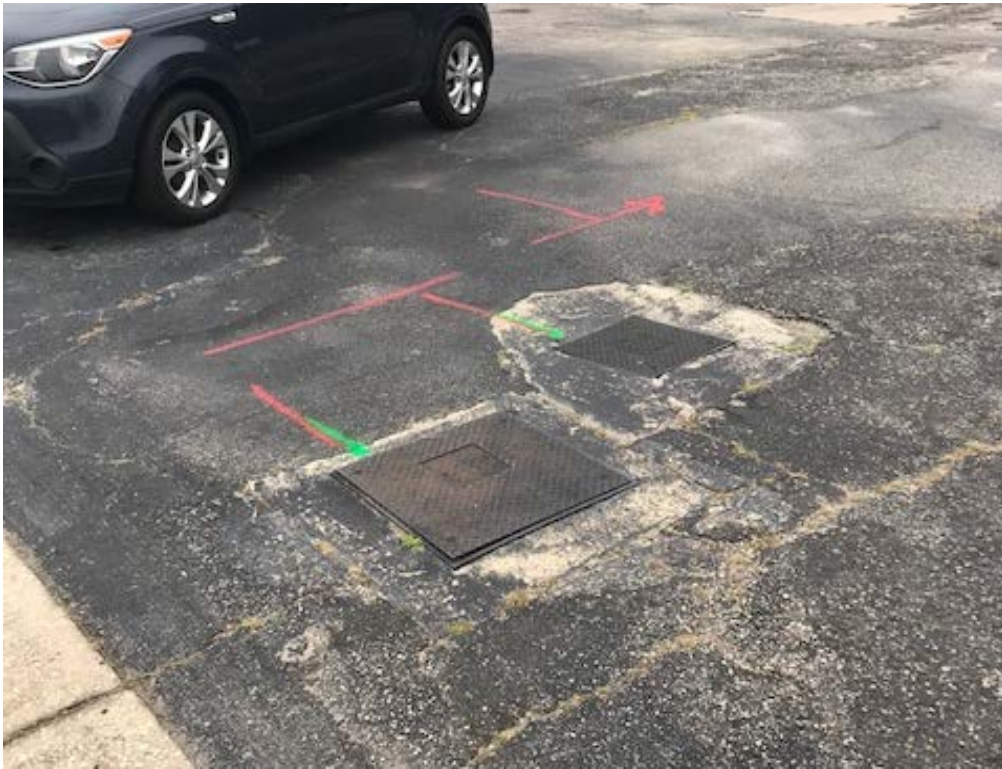
**Photo 1**

View of remediation vaults located within the proposed right of way.

Based on these PSA results, Apex does not recommend further assessment or soil sampling in the area of investigation. A remediation system composed of a series of interconnected vaults is on site. The remediation trailer is not within the design area however many of the vaults and interconnecting PVC piping are. This system and associated monitoring wells will need to be abandoned and removed prior to construction activities. Groundwater impacted with low levels of petroleum related compounds may be encountered and generated during construction activities. This groundwater will need to be managed in accordance with applicable requirements.

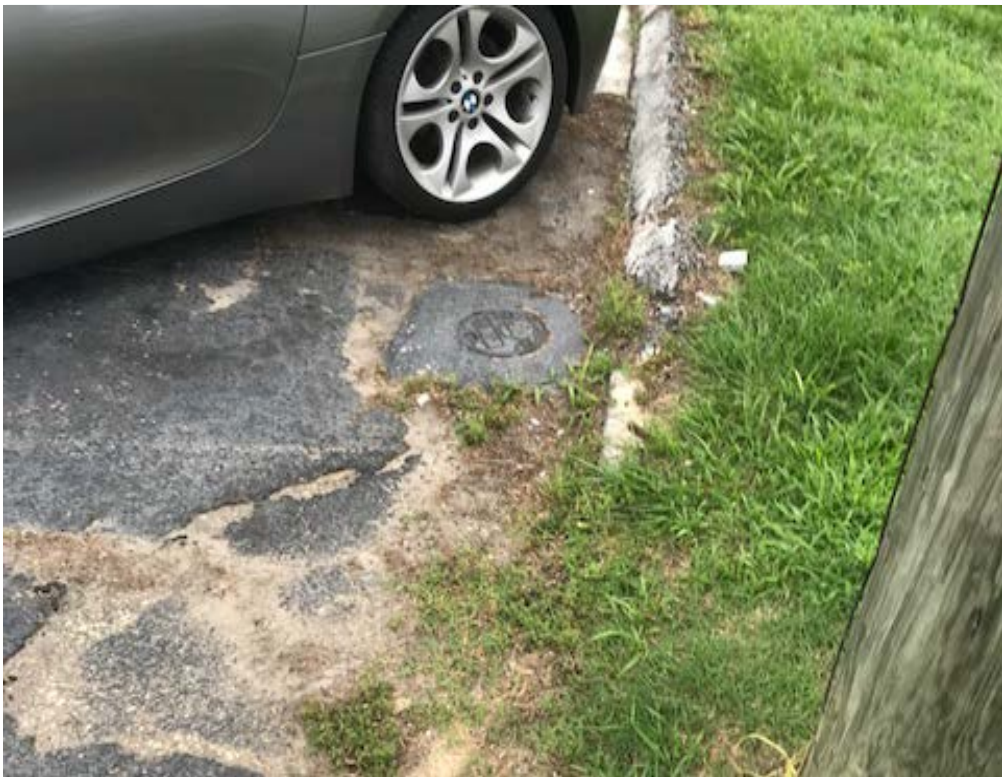
**Photo 2**

View of monitoring wells located within the proposed right of way.

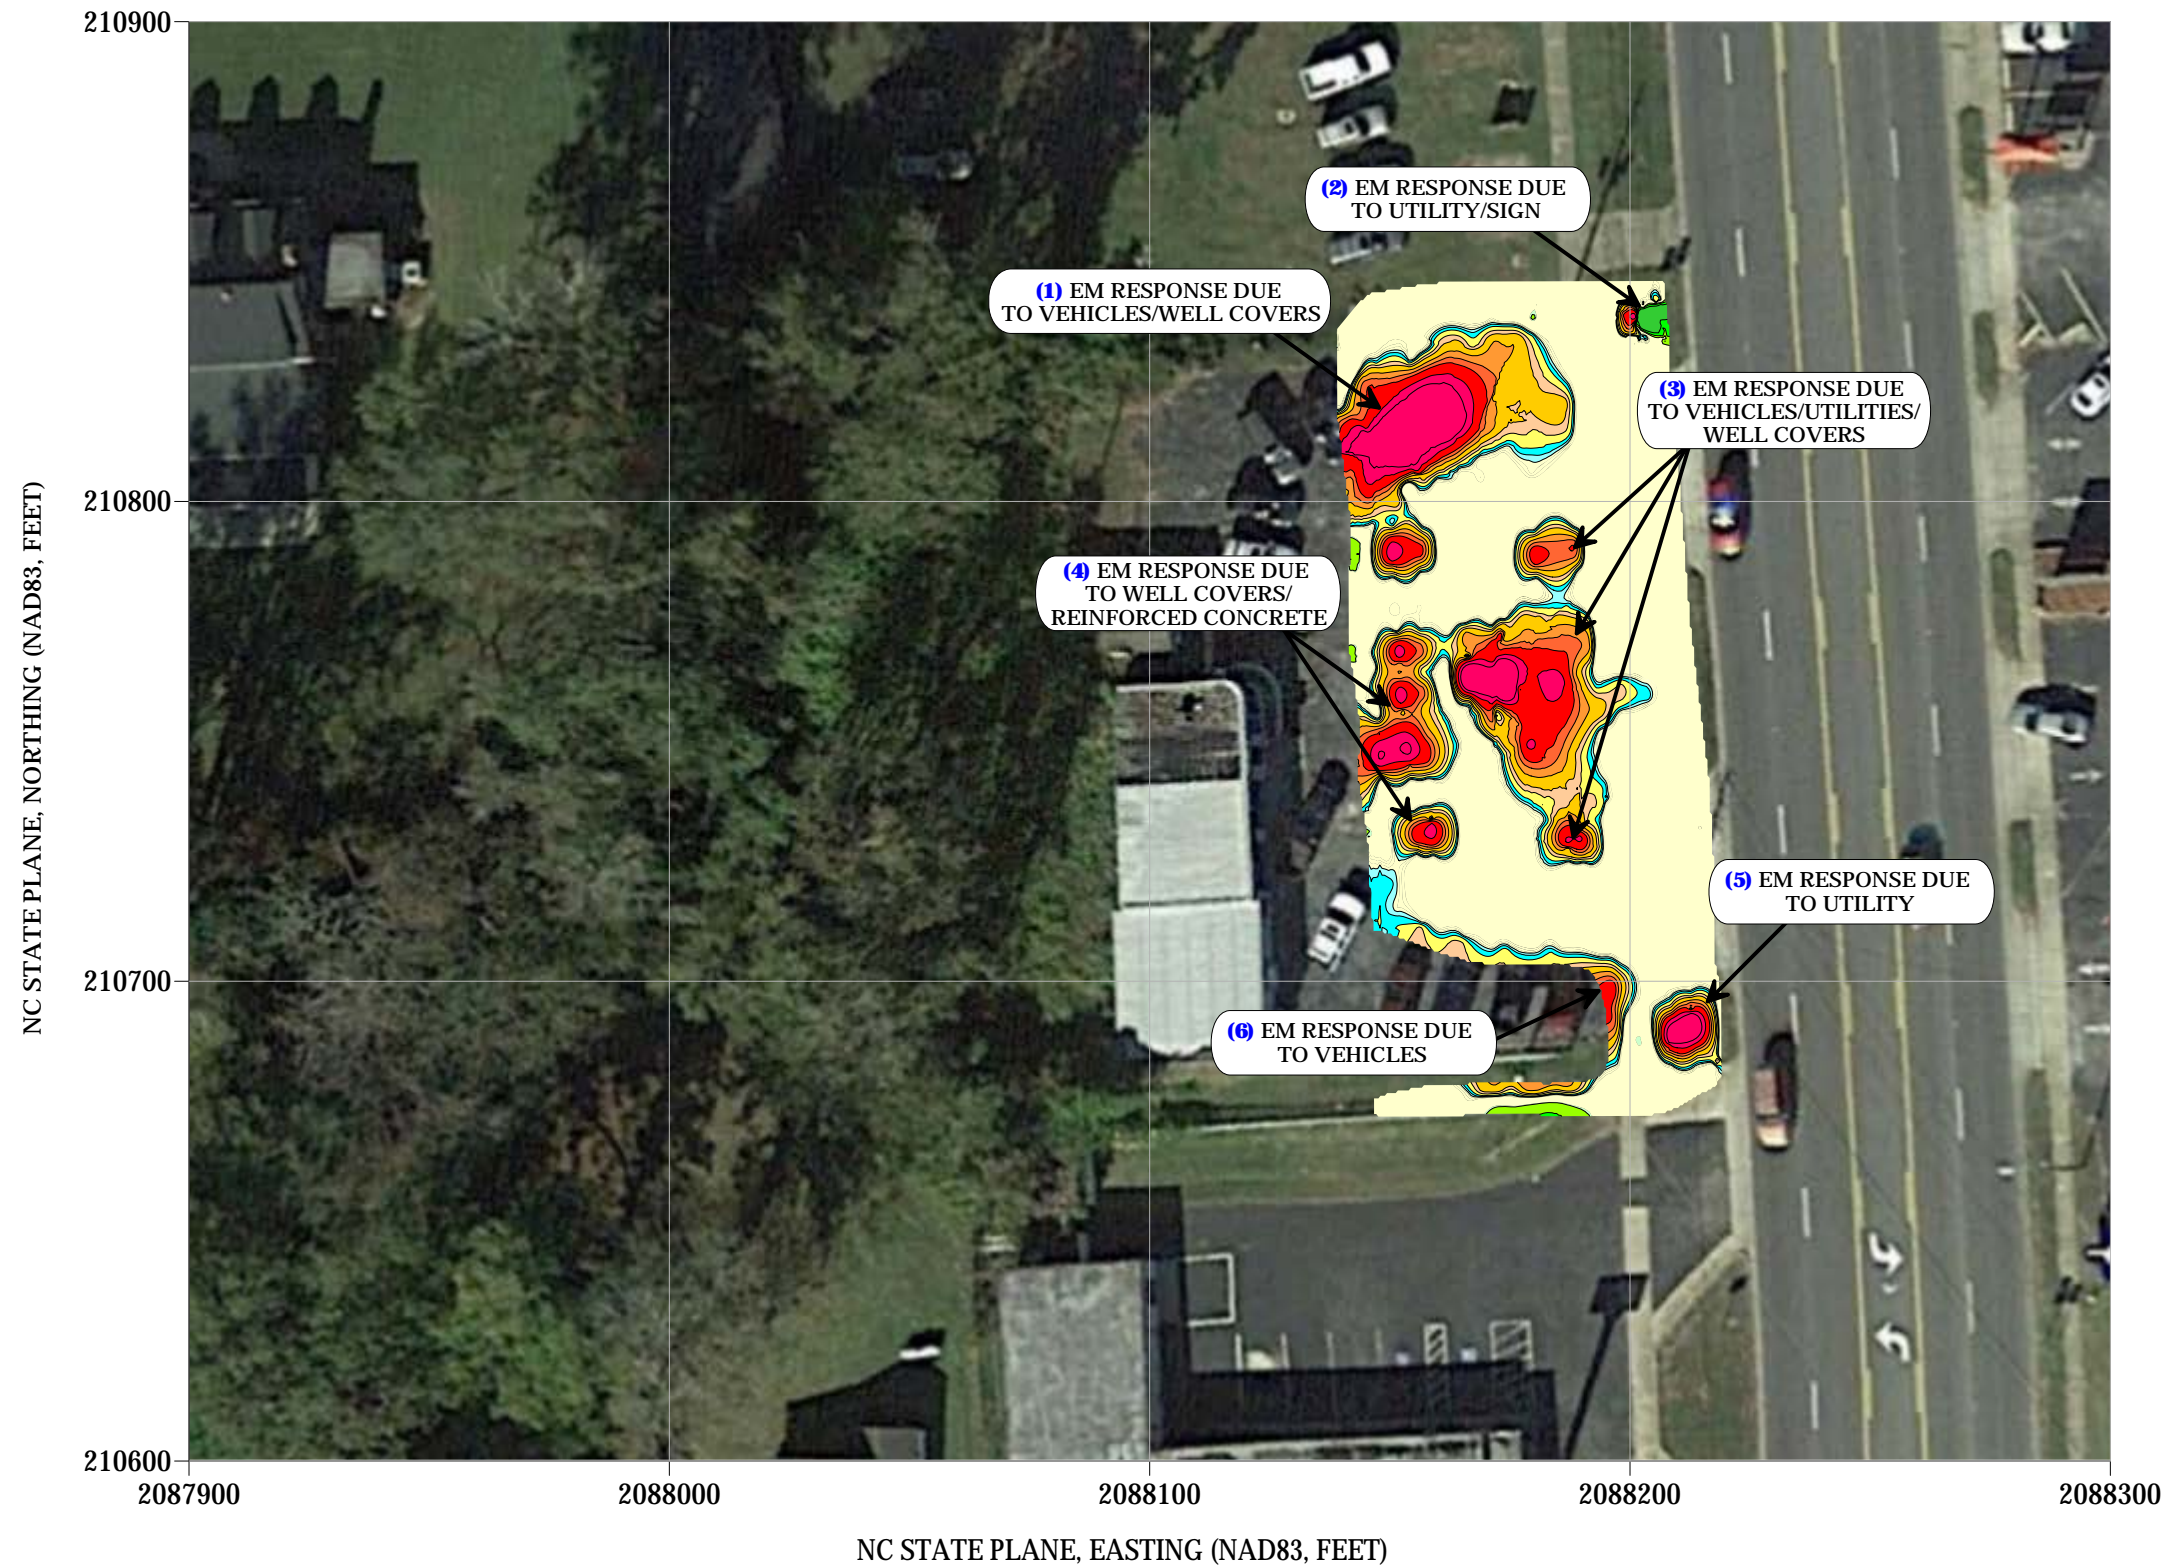
**FIGURE 1**

A contour plot of the EM61 results obtained across the survey area at the property is presented in **Figure 2**. Each EM anomaly is numbered for reference in the figure. The following table presents the list of EM anomalies and the cause of the metallic response, if known:

<b>Metallic Anomaly #</b>	<b>Cause of Anomaly</b>	<b>Investigated with GPR</b>
1	Vehicles/Well Covers	☑
2	Utility/Sign	
3	Vehicles/Utilities/Well Covers	☑
4	Well Covers/Reinforced Concrete	☑
5	Utility	
6	Vehicles	☑

The majority of the EM anomalies were directly attributed to visible cultural features at the ground surface, including vehicles, well covers for the remediation system, utilities and a sign. Anomalies 1, 3, 4, and 6 were investigated with GPR due to the EM interference caused by the vehicles parked throughout the site, well covers, and potential utilities to verify that no larger substructures were obscured by the interference. Additionally, the series of well covers suggested that a potential groundwater remediation system was in operation at the property, and GPR was used to verify its presence.

### NO EVIDENCE OF UNKNOWN METALLIC USTs OBSERVED.

The contour plot shows the differential results of the EM61 instrument in millivolts (mV). The differential results focus on larger metallic objects such as USTs and drums. The EM61 data were collected on May 30, 2018, using a Geonics EM61 instrument. Verification GPR data were collected using a GSSI UtilityScan DF instrument with a dual frequency 300/800 MHz antenna on June 4, 2018.

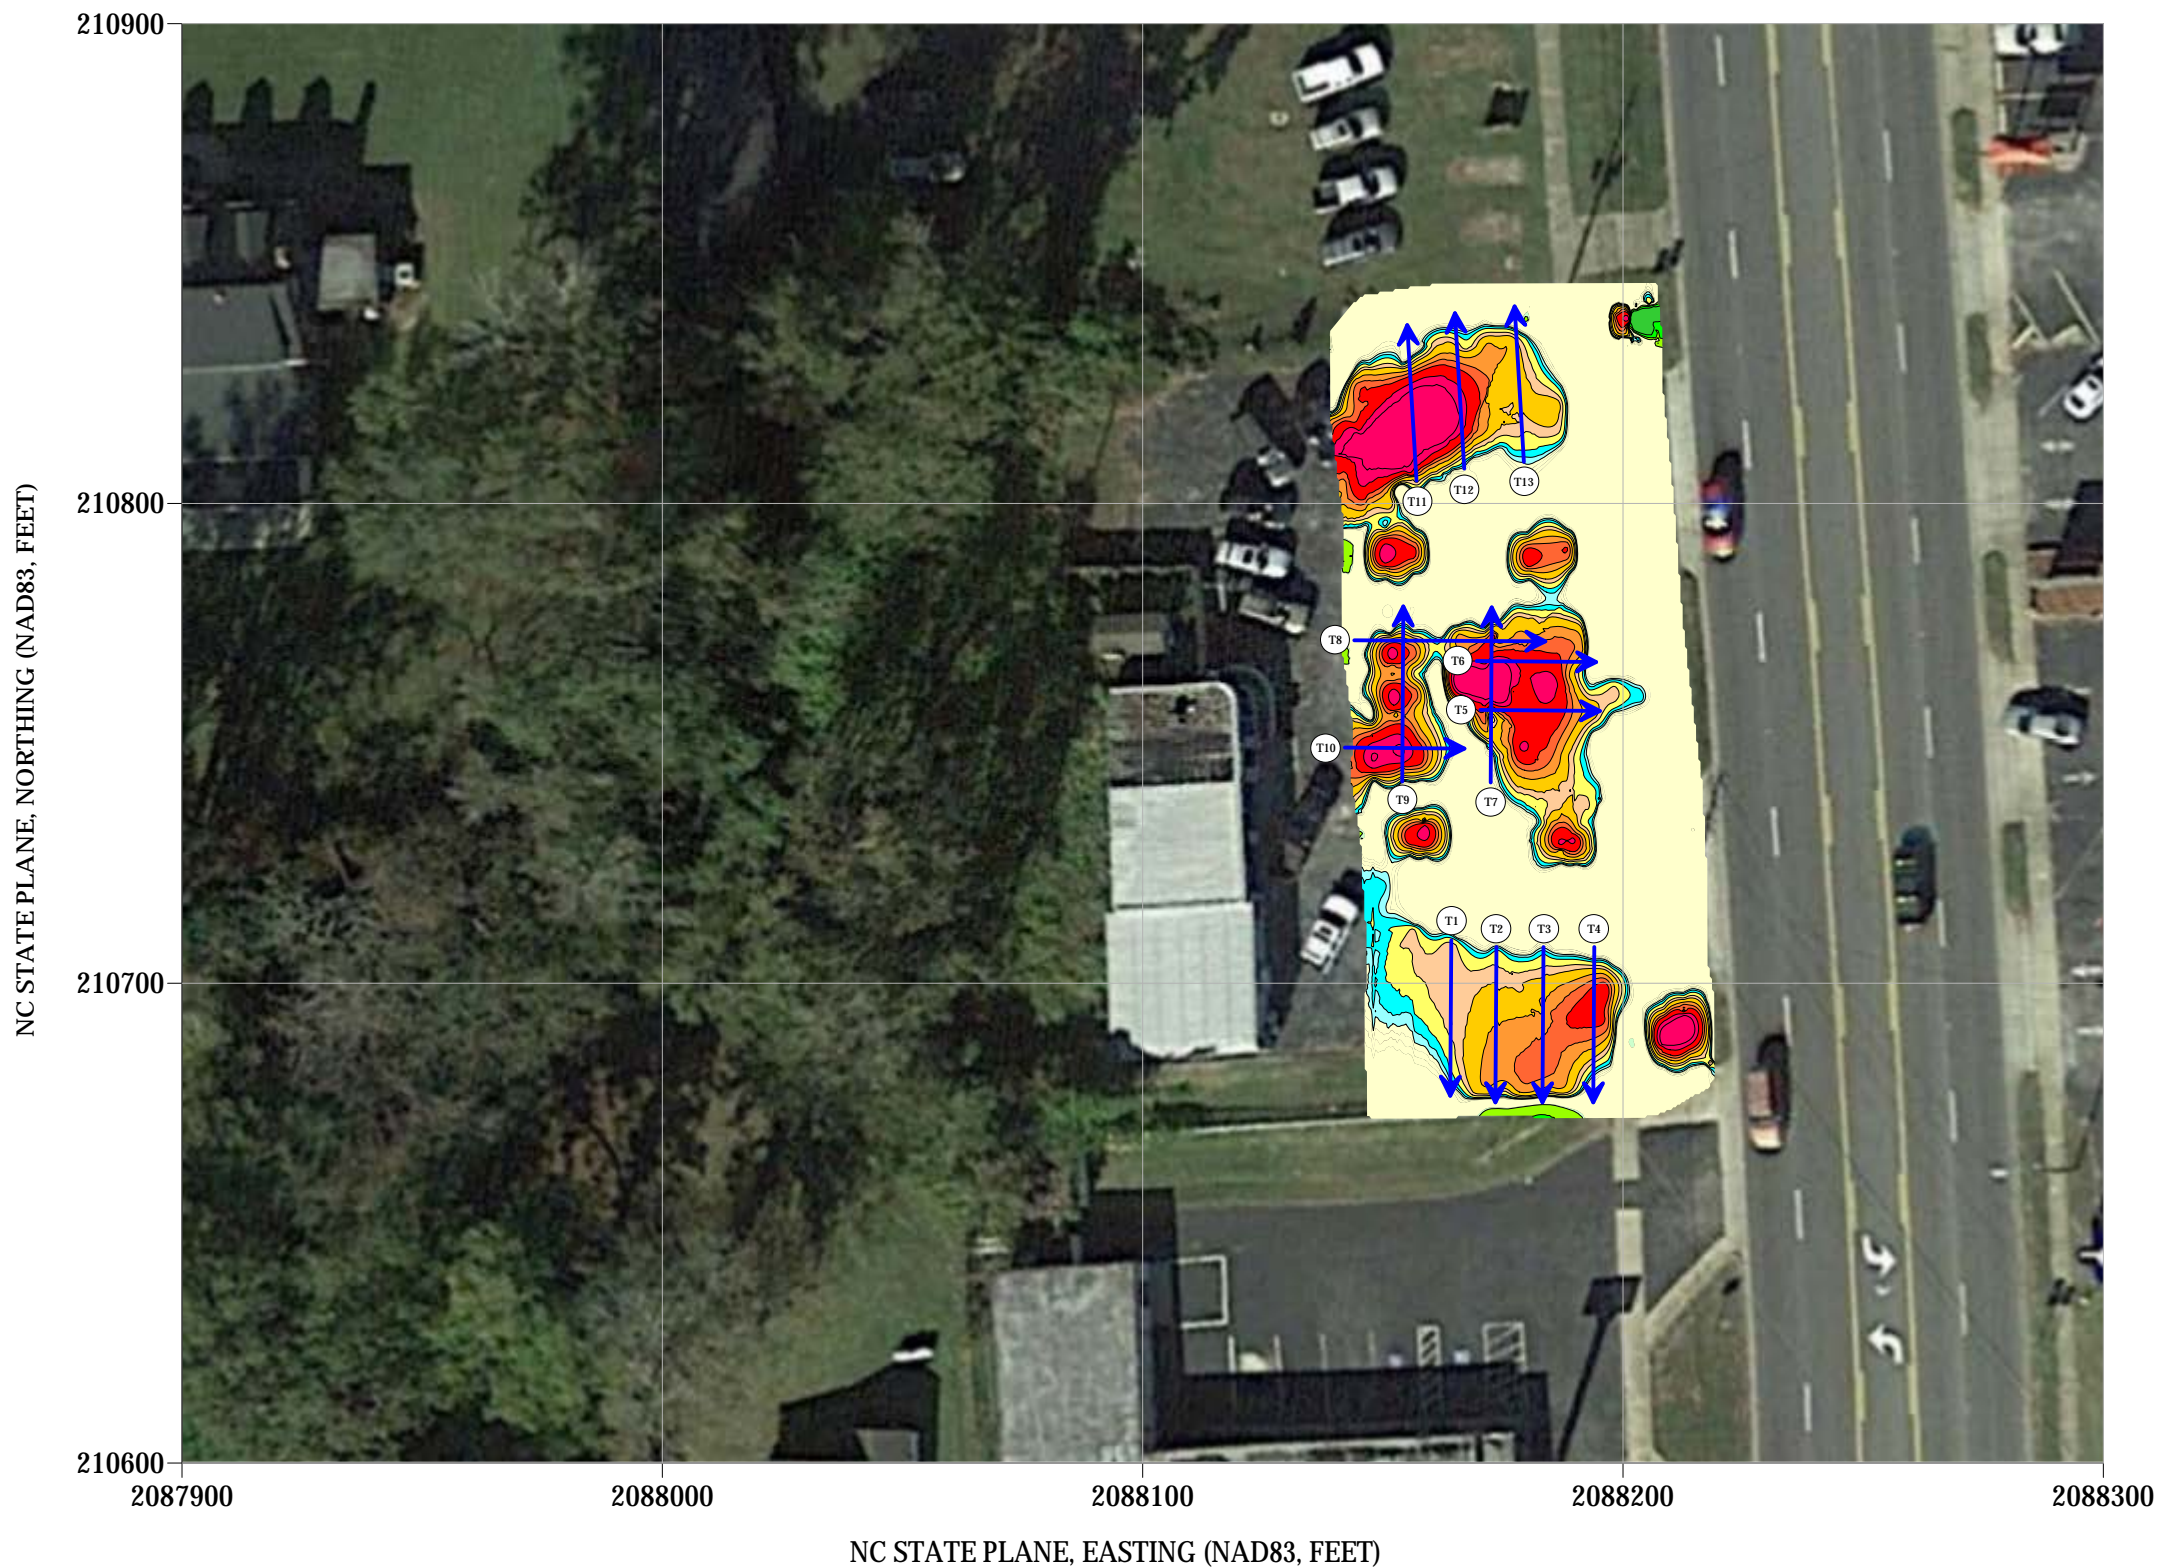
**FIGURE 2**

**Figure 3** presents the locations of the formal GPR transects performed at the property, as well as select transect images. A total of thirteen GPR transects were performed at the site. All of the transect images are included in **Appendix A**. GPR Transects 1 – 7 and 11 – 13 were performed across EM Anomalies 1, 3, and 6. These transects recorded evidence of isolated hyperbolic reflectors associated with the remediation system and/or utilities. No evidence of a larger structure such as a UST was observed in this area.

GPR Transects 8-10 were performed across the reinforced concrete (Anomaly 4). These transects verified the presence of metal reinforcement in the concrete and the presence of the remediation system. No evidence of larger structures such as USTs was observed.
