## Preliminary Site Assessment Report

Campbell Rentals LLC  
Parcel # 71  
306 W. Oliver Street  
Whiteville, Columbus County, North Carolina  
US 701 Bypass (Madisson St-Powell Blvd) from SR 1437 (Virgil Ave) to US 74/76  
TIP Number: R-5020B  
WBS Element: 41499.1.3

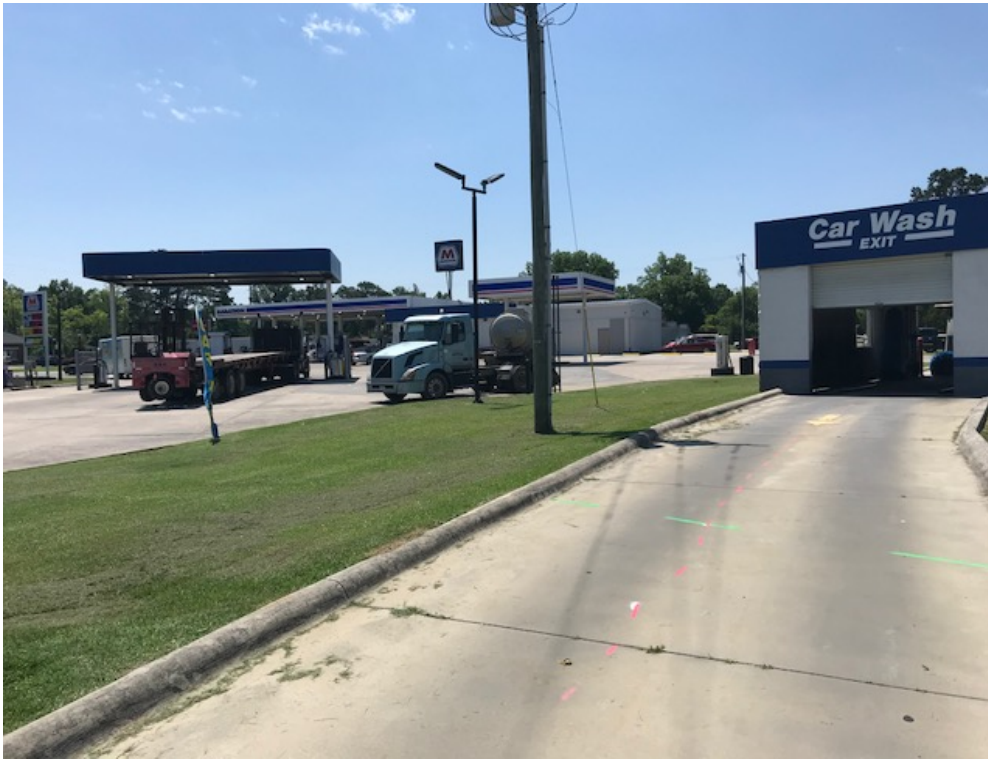
**Photo 1**

Overview of site prior to preliminary site assessment activities.

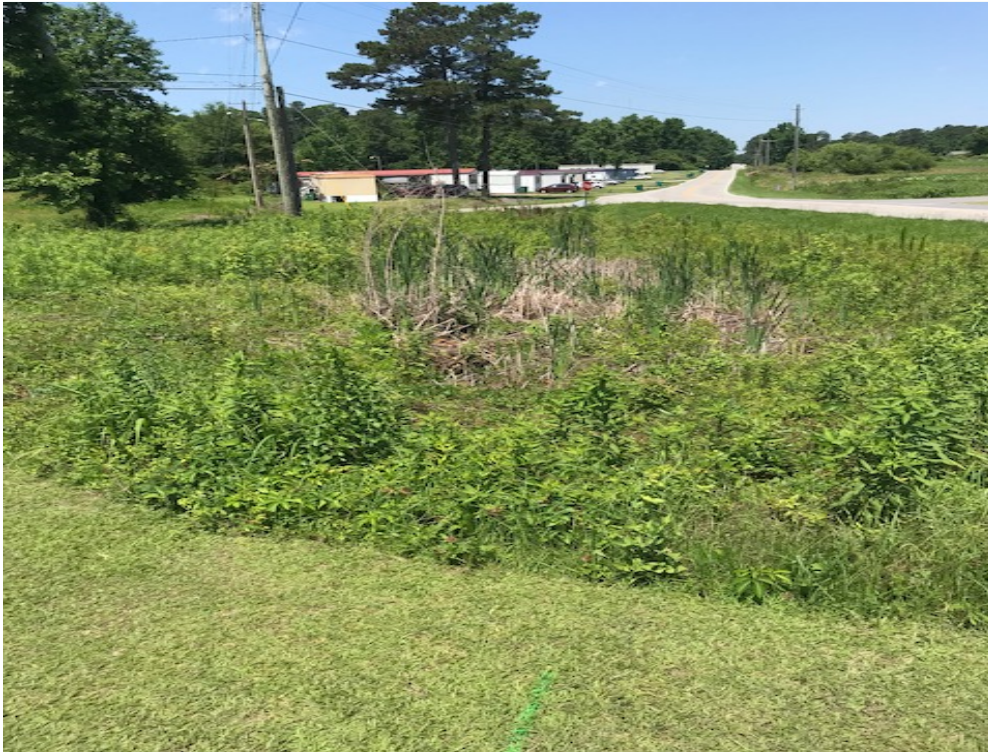
**Photo 2**

View of drainage feature located at the north-west corner of the property boundary along North Smyrna Road.

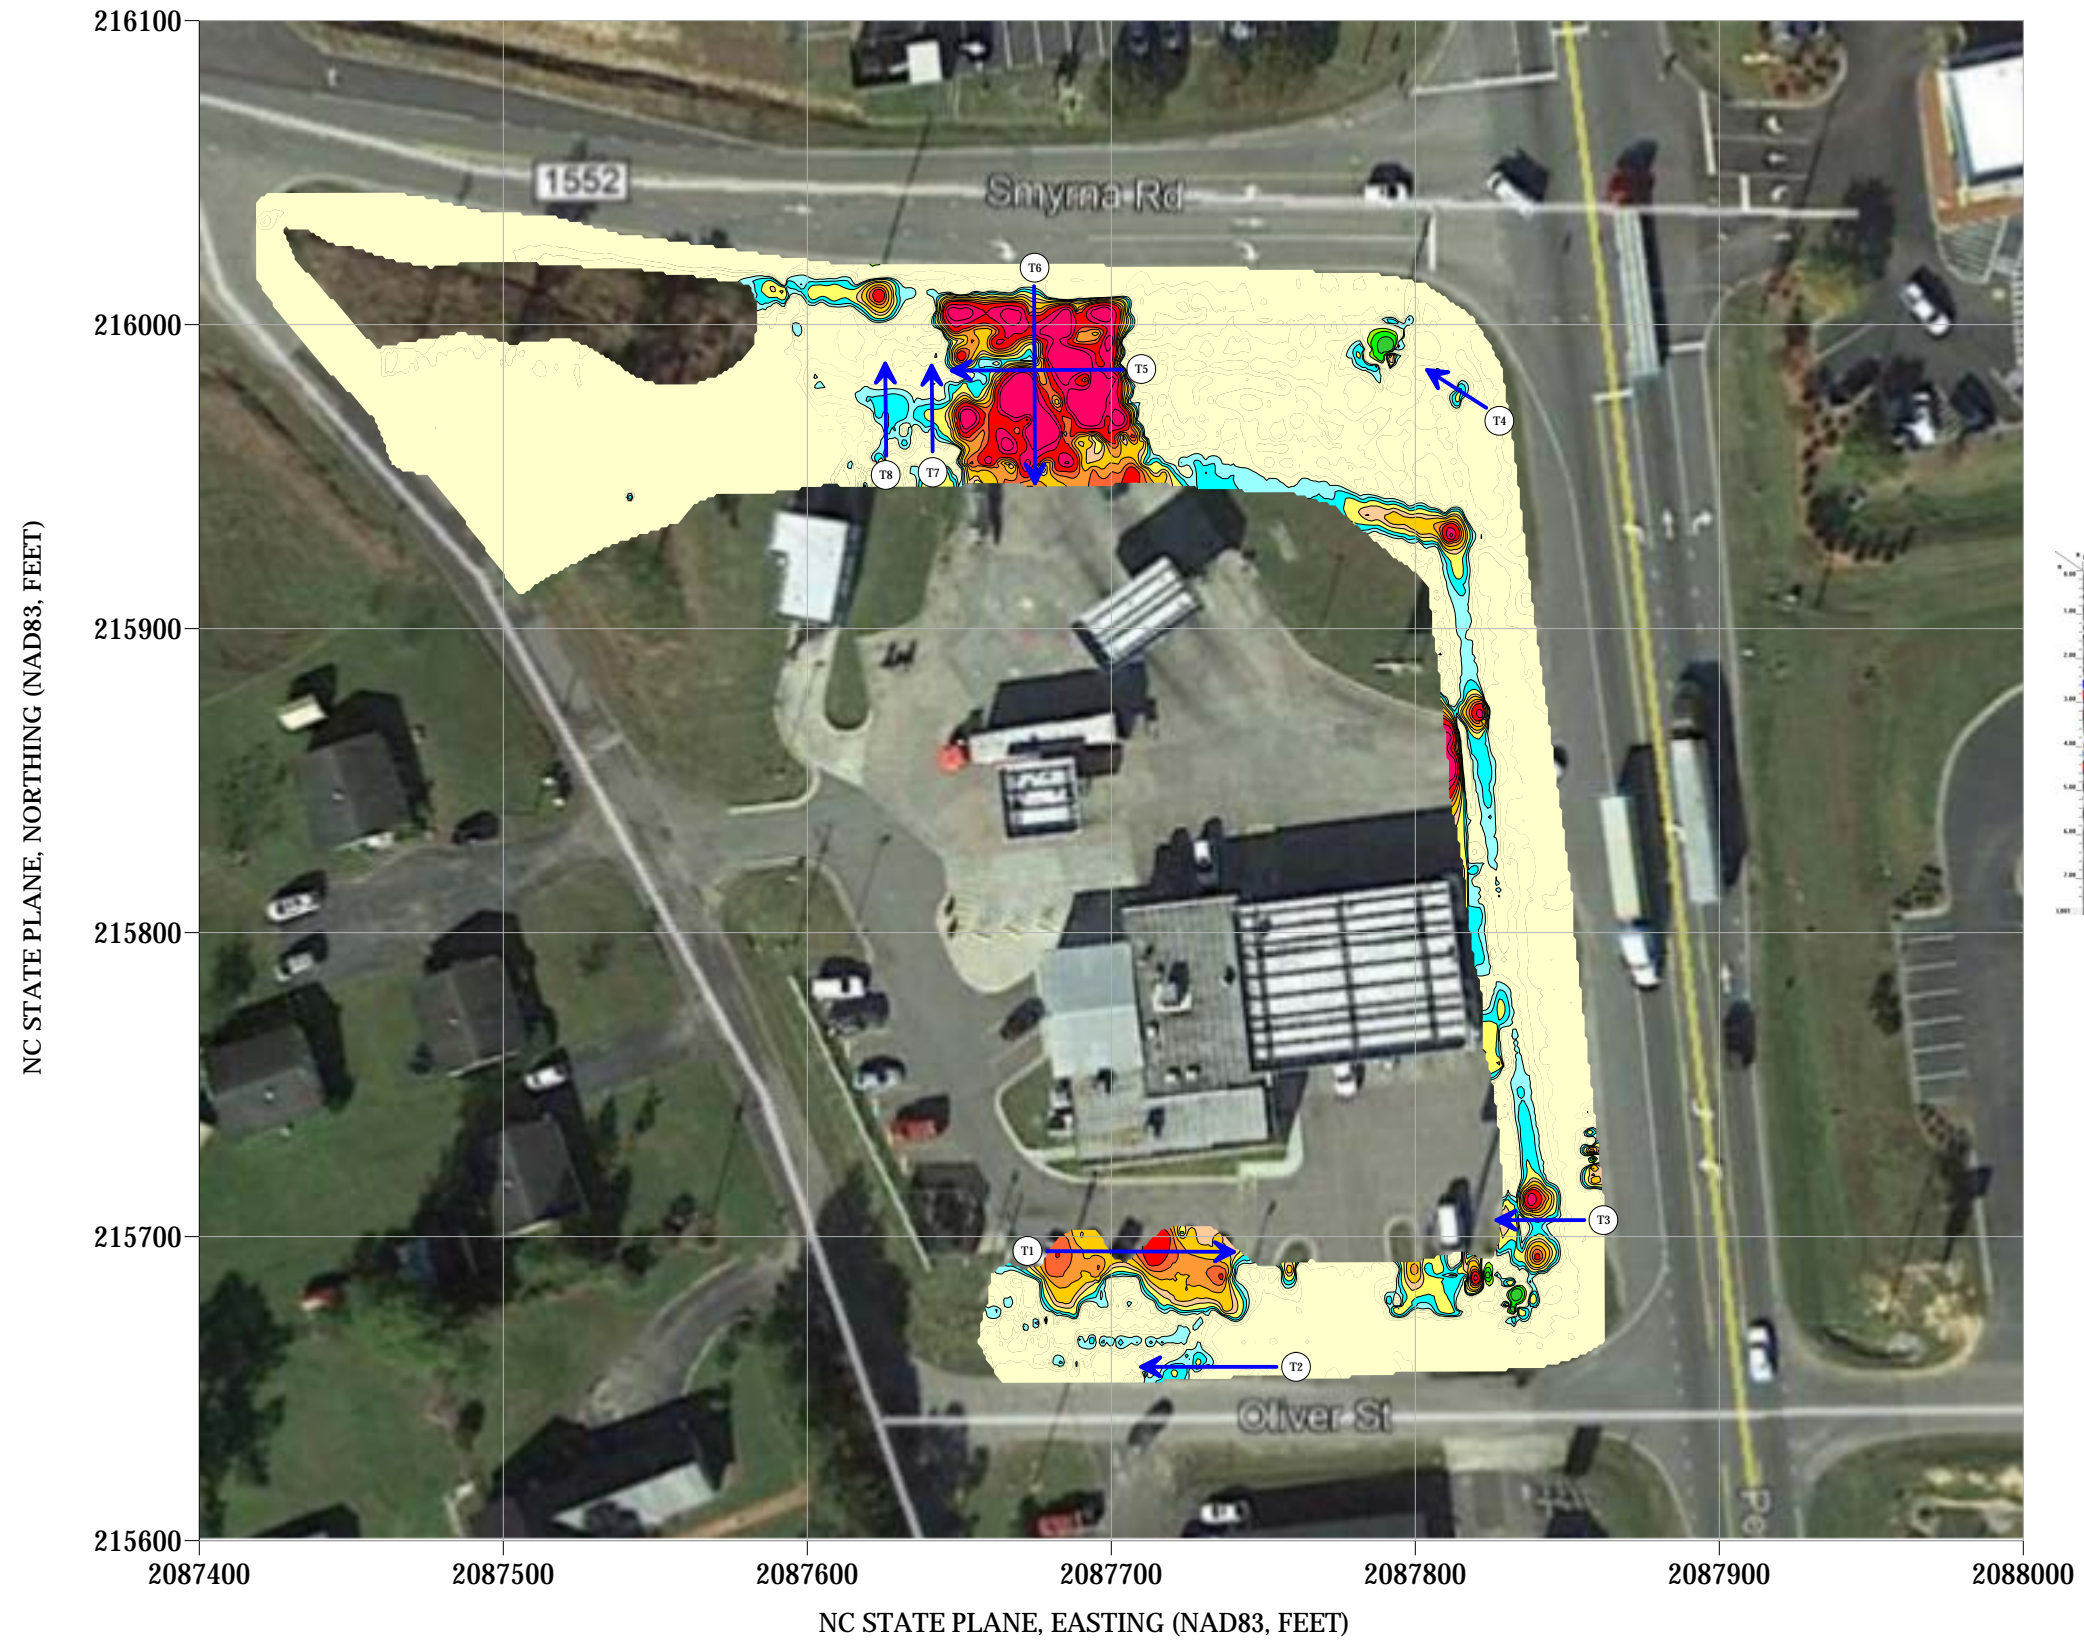
## LOCATIONS OF GPR TRANSECTS

**Figure 3** presents the locations of the formal GPR transects performed at the property, as well as select transect images. A total of eight GPR transects were performed at the site. All of the transect images are included in **Appendix A**. GPR Transect 1 was performed across Anomaly 15, where vehicles caused EM interference at the time of the survey. No evidence of larger structures, such as USTs, was observed.

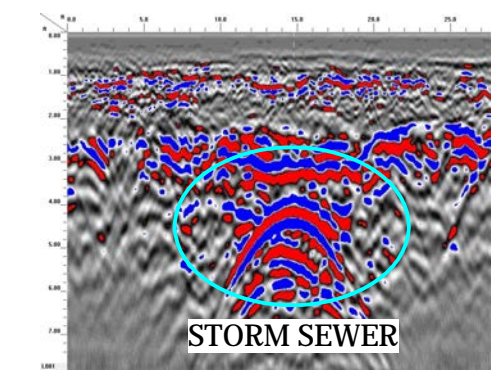
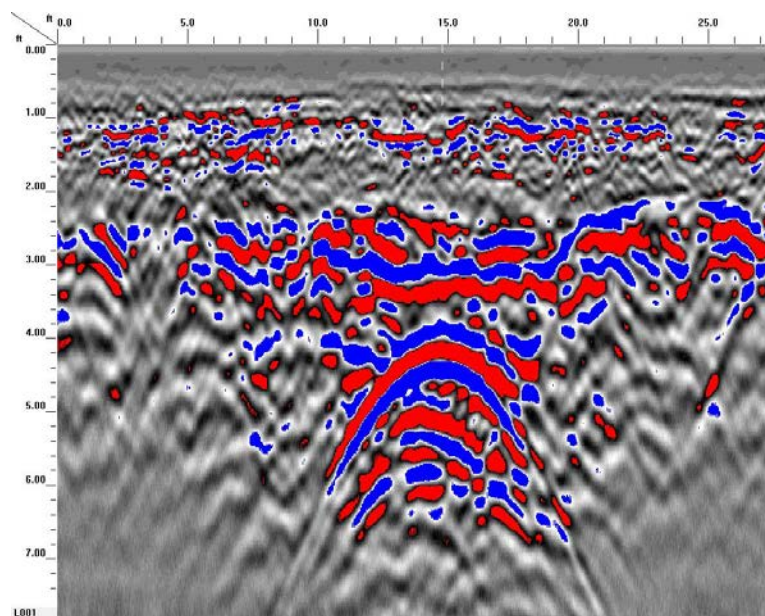
GPR TRANSECT 8 (T8)

GPR Transects 7 and 8 showed evidence of a buried manhole/storm sewer at Anomaly 6. No evidence of a larger structure, such as a UST, was observed in this area.
