BRIDGE #250025

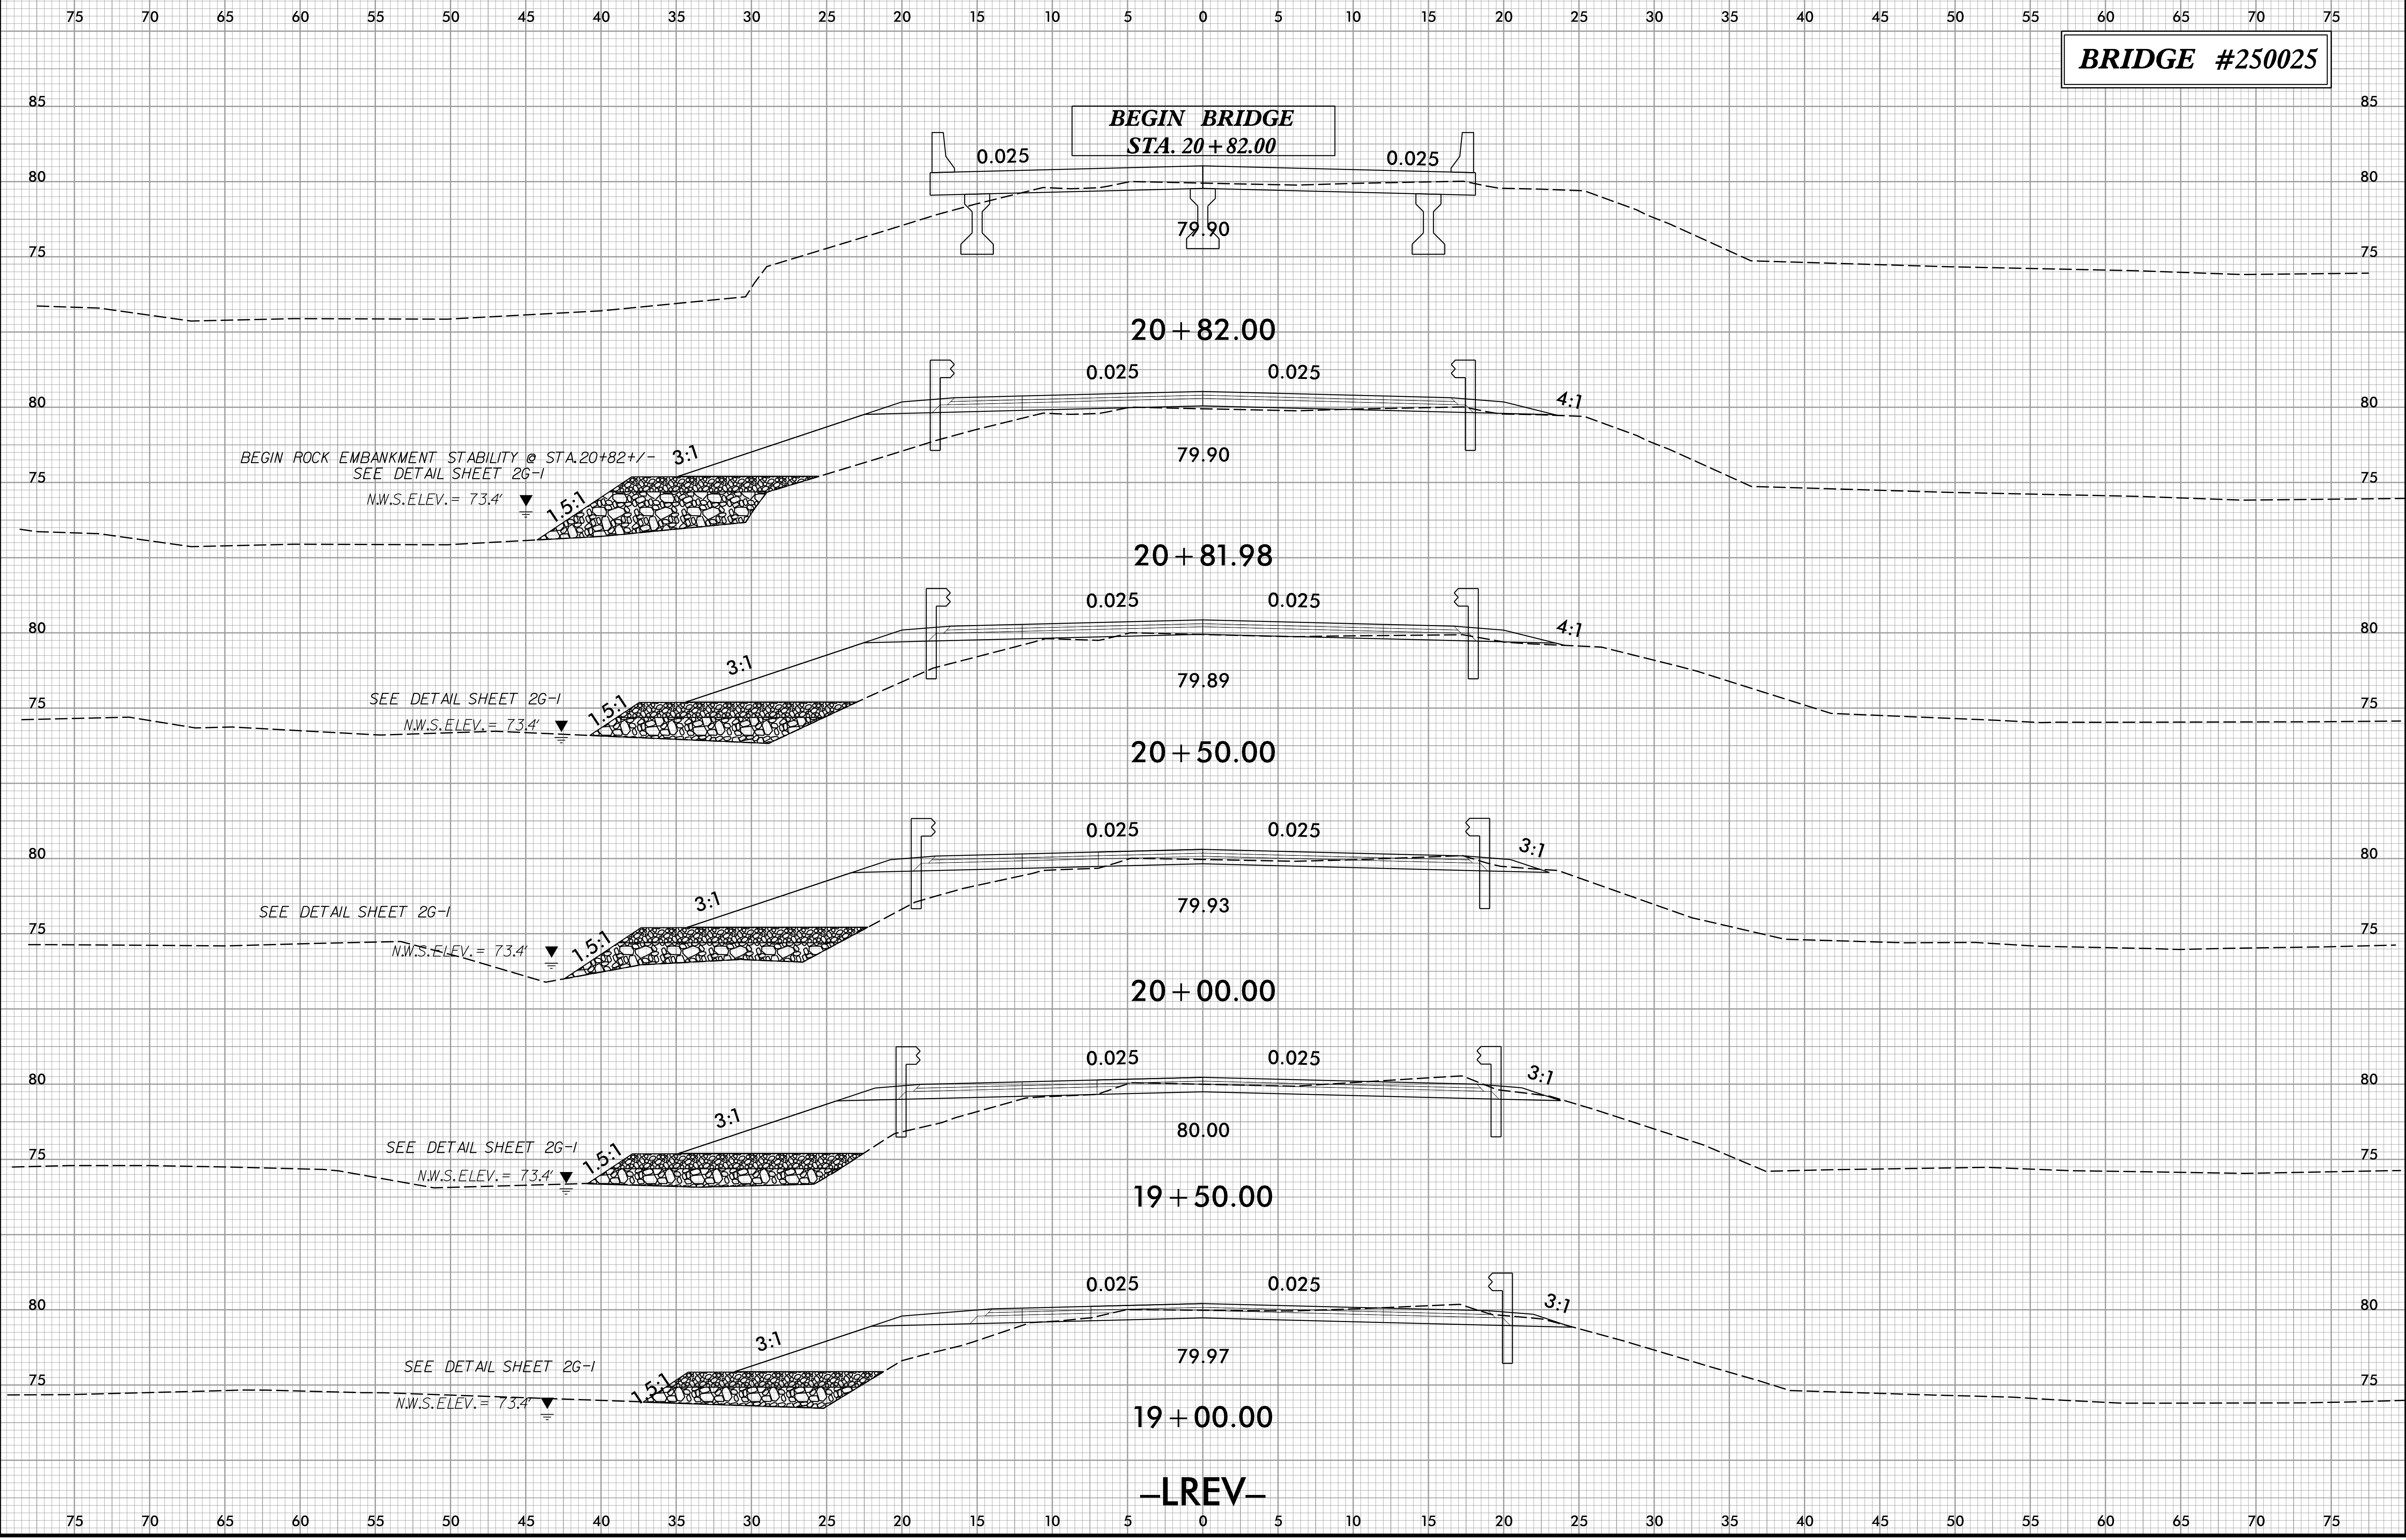
BEGIN ROCK EMBANKMENT STABILITY @ STA. 20+82+/- 3:1
SEE DETAIL SHEET 26-1
N.W.S. ELEV. = 73.4'
