Re: Phase II Investigation

Phase II Investigation Proctor and Gamble Property

NC DOT Parcel 12 Browns Summit, Guilford County North Carolina

H&H Job No. ROW-603 State Project R-4707 WBS Element #36599.1.2 September 24, 2019

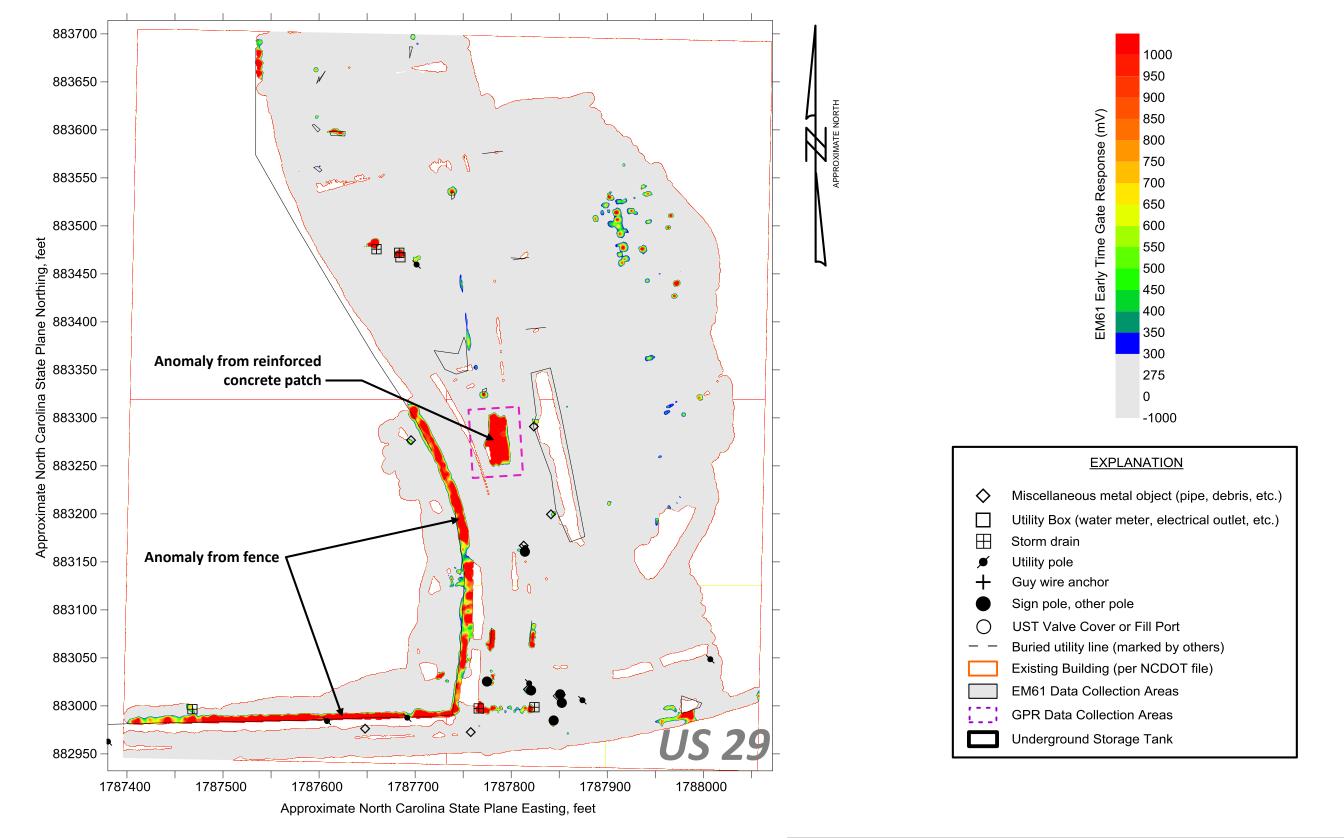
PROJECT NO. HO12.300	FIGURE 2 – PARCEL 12, PROCTOR & GAMBLE
AS SHOWN	EM61 EARLY TIME GATE DATA
7/12/19	NCDOT PROJECT R-2511, US 17 NORTH OF NC 171 TO MULTI-LANES SOUTH OF WILLIAMSTON
SBM/EDB	BEAUFORT AND MARTIN COUNTIES. NORTH CAROLINA

The EM61 data were gridded and contoured in Surfer to produce plan view contour maps of the early time gate response (Figure 2) and the differential response (Figure 3). The differential response is calculated by subtracting the response of the bottom coil from the response of the top coil of the EM61. Typically, the differential response diminishes the response from smaller, near-surface metallic objects, thus emphasizing the response from deeper and larger metallic objects, such as metallic USTs. The DGPS locations of observed site features were superimposed on the EM61 contour maps so that anomalies caused by site features such as metal objects on the ground surface could be recognized. Figures 2 and 3 show the EM61 data and the site features that we observed and mapped in the field with DGPS; these figures do not necessarily show all existing site features.

The EM61 early time gate response and differential response were exported from Surfer as georeferenced images and attached to the NCDOT plan sheet in MicroStation (Figures 5 and 6). The legend for the NCDOT line types and symbols is shown on Figure 7.

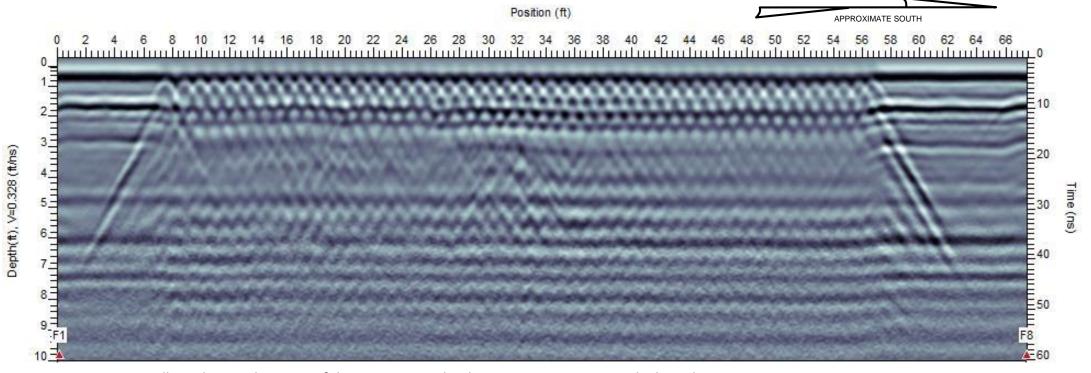
A. GPR image collected across long axis of the EM61 anomaly. This area is a concrete patch along the roadway that has been reinforced with rebar.

The GPR data we collected over the one EM61 anomaly within the asphalt drive indicated that the anomaly was caused by steel reinforcement (rebar) (Figure 4). The GPR data were reviewed in the field and it was determined that the data did not indicate the presence of abandoned metallic USTs.

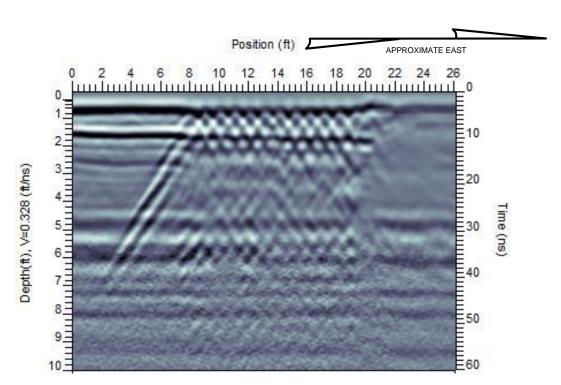
B. GPR image collected across short axis of the EM61 anomaly. This area is a concrete patch along the roadway that has been reinforced with rebar.

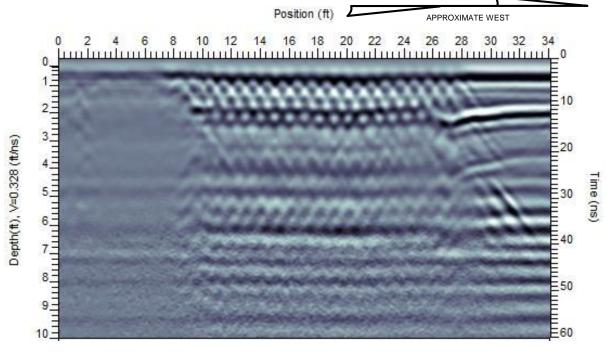
C. GPR image collected across short axis of the EM61 anomaly. This area is a concrete patch along the roadway that has been reinforced with rebar.
