Reference: **Preliminary Site Assessment Report**
NCDOT Project I-5986B, WBS Element 47532.1.3
Parcel 28-I-95 Tire and Service
918 Long Branch Road
Dunn, Harnett County, North Carolina
S&ME Project 4305-18-175

S&ME, Inc. (S&ME) is submitting this Preliminary Site Assessment (PSA) Report to the North Carolina Department of Transportation (NCDOT). This report presents the background/project information, field activities, findings, conclusions, and recommendations. These services were performed in general accordance with S&ME Proposal No. 43-1800583 REV-02 dated August 16, 2018, and Contract Number 7000018853 dated April 12, 2018 between NCDOT and S&ME, Inc., authorized by NCDOT in its August 20, 2018 Notice to Proceed Letter.

Preliminary Site Assessment Report
NCDOT Project I-5986B, WBS Element 47532.1.3
Parcel 28-I-95 Tire and Service
Dunn, Harnett County, North Carolina
S&ME Project No. 4305-18-175

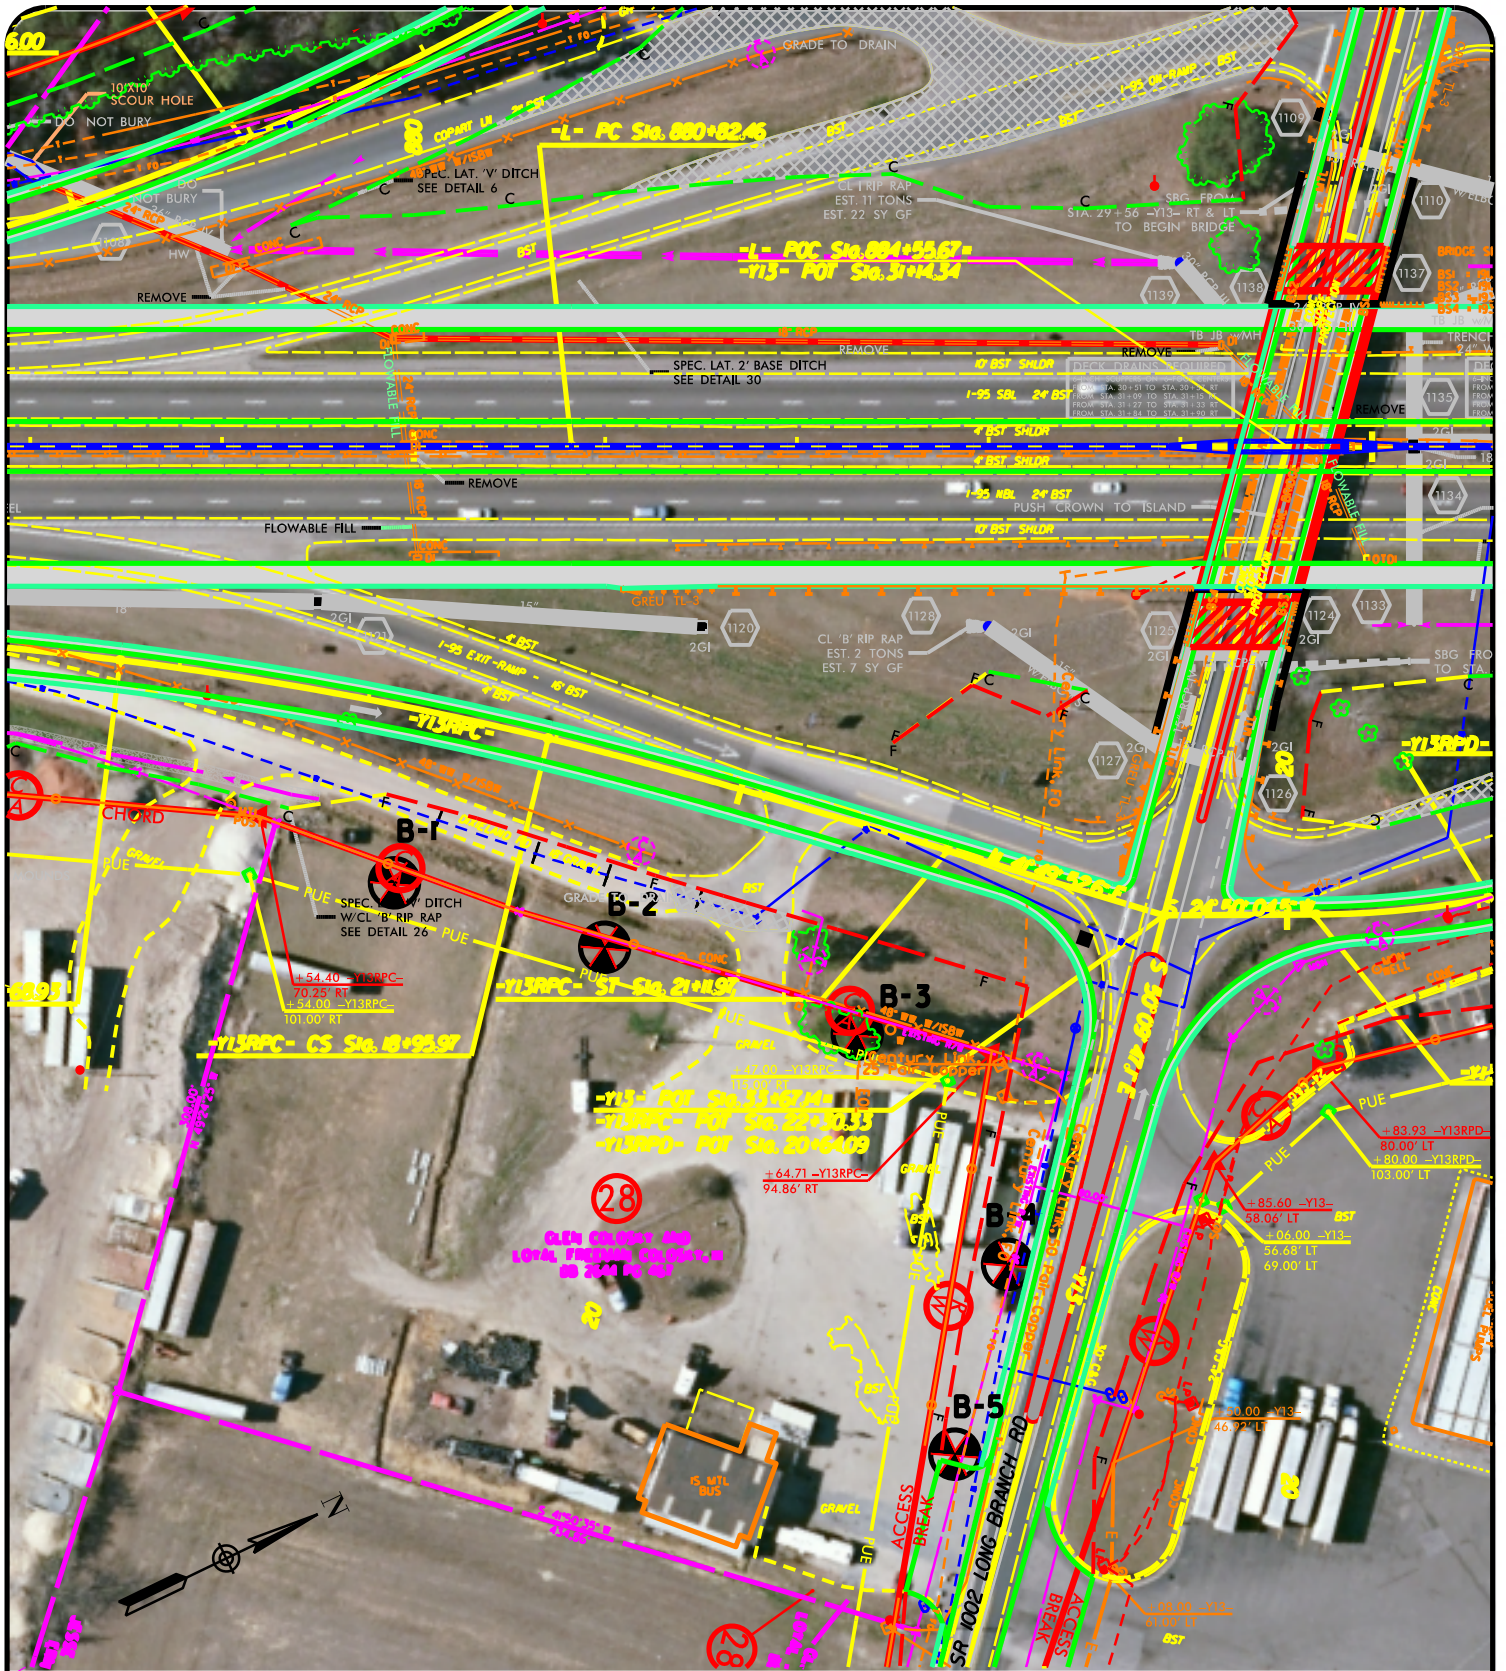
SITE MAP

On October 1, 2018, S&ME's drill crew utilized a track mounted Geoprobe[®] rig to advance five soil borings (B-1 through B-5) and to collect soil samples within accessible areas of the proposed ROW/easement at Parcel 28. The approximate location of the soil borings are shown in **Figure 2**. A photographic log is included in **Appendix I**. S&ME's drill crew advanced the Geoprobe[®] borings to a depth of approximately 10 ft.-bgs. During the advancement of the soil borings, groundwater was not encountered. Soil samples were continuously collected in four-foot long disposable acetate-plastic sleeves that line the hollow stainless-steel sample probes. Soil recovered from the sleeves was classified on-site by S&ME personnel and screened with a Photoionization Detector (PID) at approximately two foot depth intervals to measure relative headspace concentrations of volatile organic compounds (VOCs).

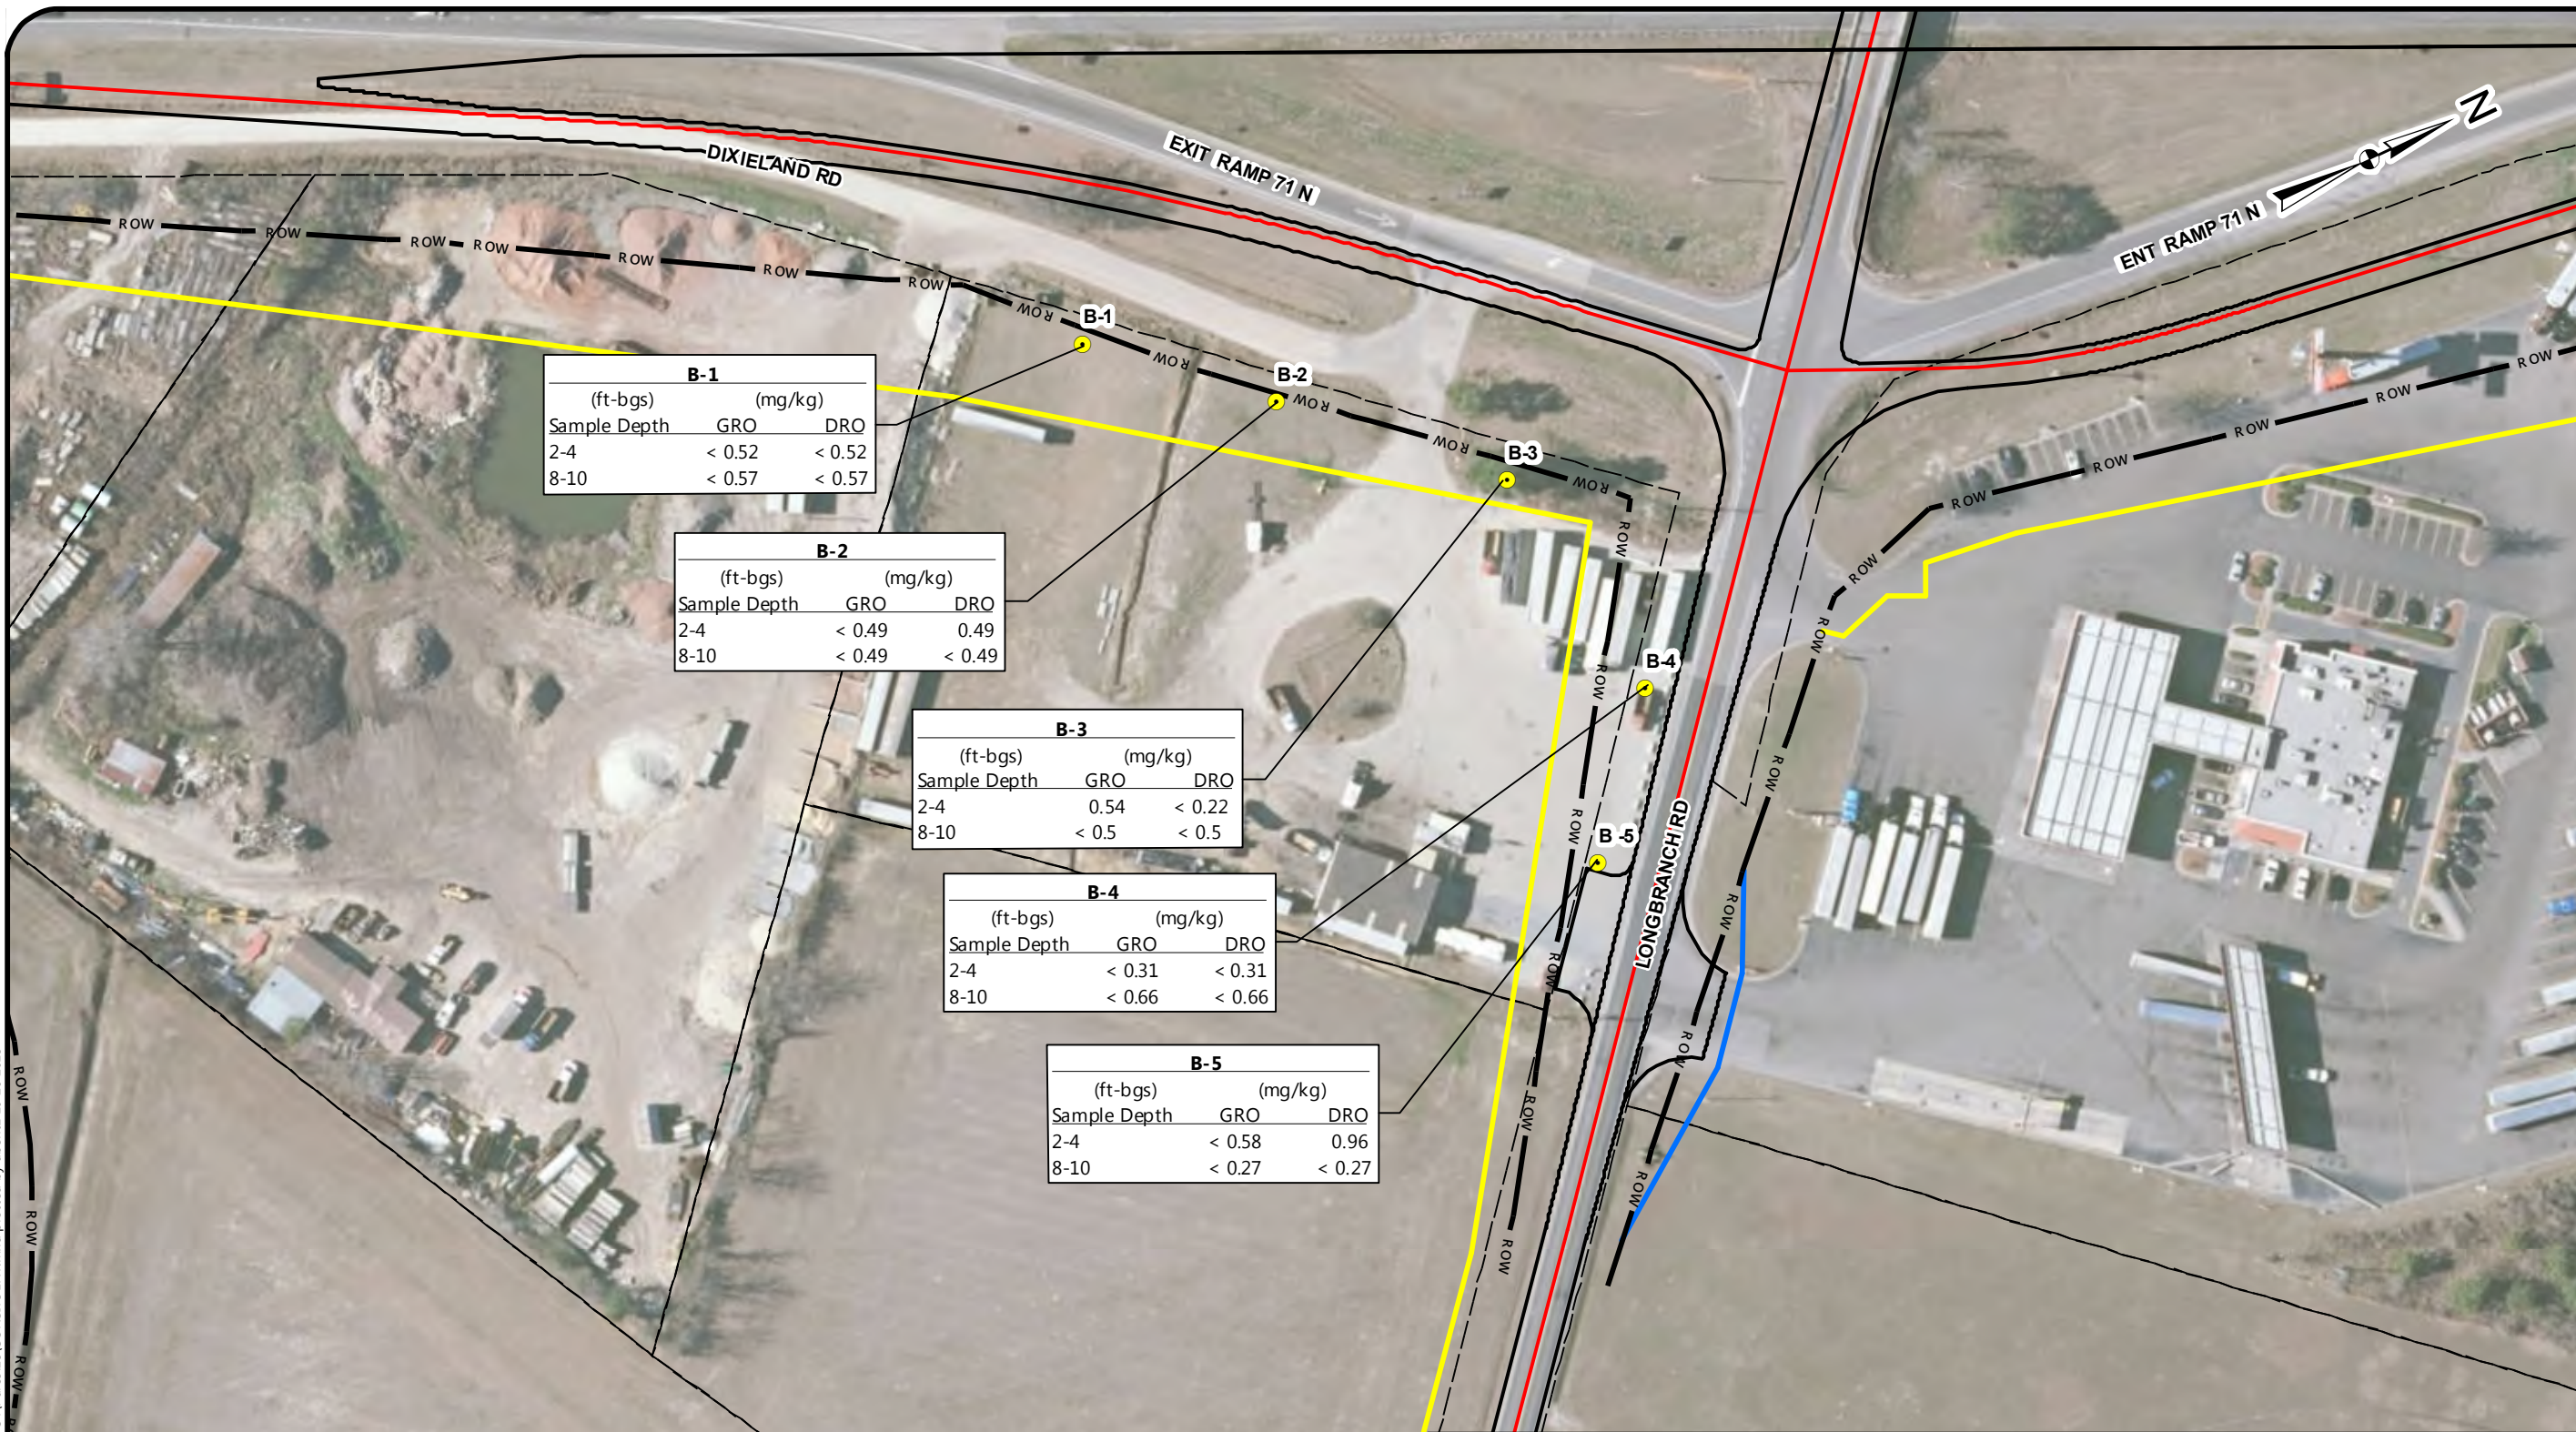
SOIL CONSTITUENT MAP

its North Carolina TPH Action Level of 50 mg/kg. TPH-GRO and TPH-DRO were not reported at concentrations exceeding the laboratory method reporting limits for the remaining soil samples. A summary of the soil analytical results is presented in **Table 1** and shown on **Figure 3**. A copy of the laboratory analytical report provided by RED Lab is presented in **Appendix III**.

B-1		
(ft-bgs)	(mg/kg)	
Sample Depth	GRO	DRO
2-4	< 0.52	< 0.52
8-10	< 0.57	< 0.57

B-2		
(ft-bgs)	(mg/kg)	
Sample Depth	GRO	DRO
2-4	< 0.49	0.49
8-10	< 0.49	< 0.49

B-3		
(ft-bgs)	(mg/kg)	
Sample Depth	GRO	DRO
2-4	0.54	< 0.22
8-10	< 0.5	< 0.5

B-4		
(ft-bgs)	(mg/kg)	
Sample Depth	GRO	DRO
2-4	< 0.31	< 0.31
8-10	< 0.66	< 0.66

B-5		
(ft-bgs)	(mg/kg)	
Sample Depth	GRO	DRO
2-4	< 0.58	0.96
8-10	< 0.27	< 0.27

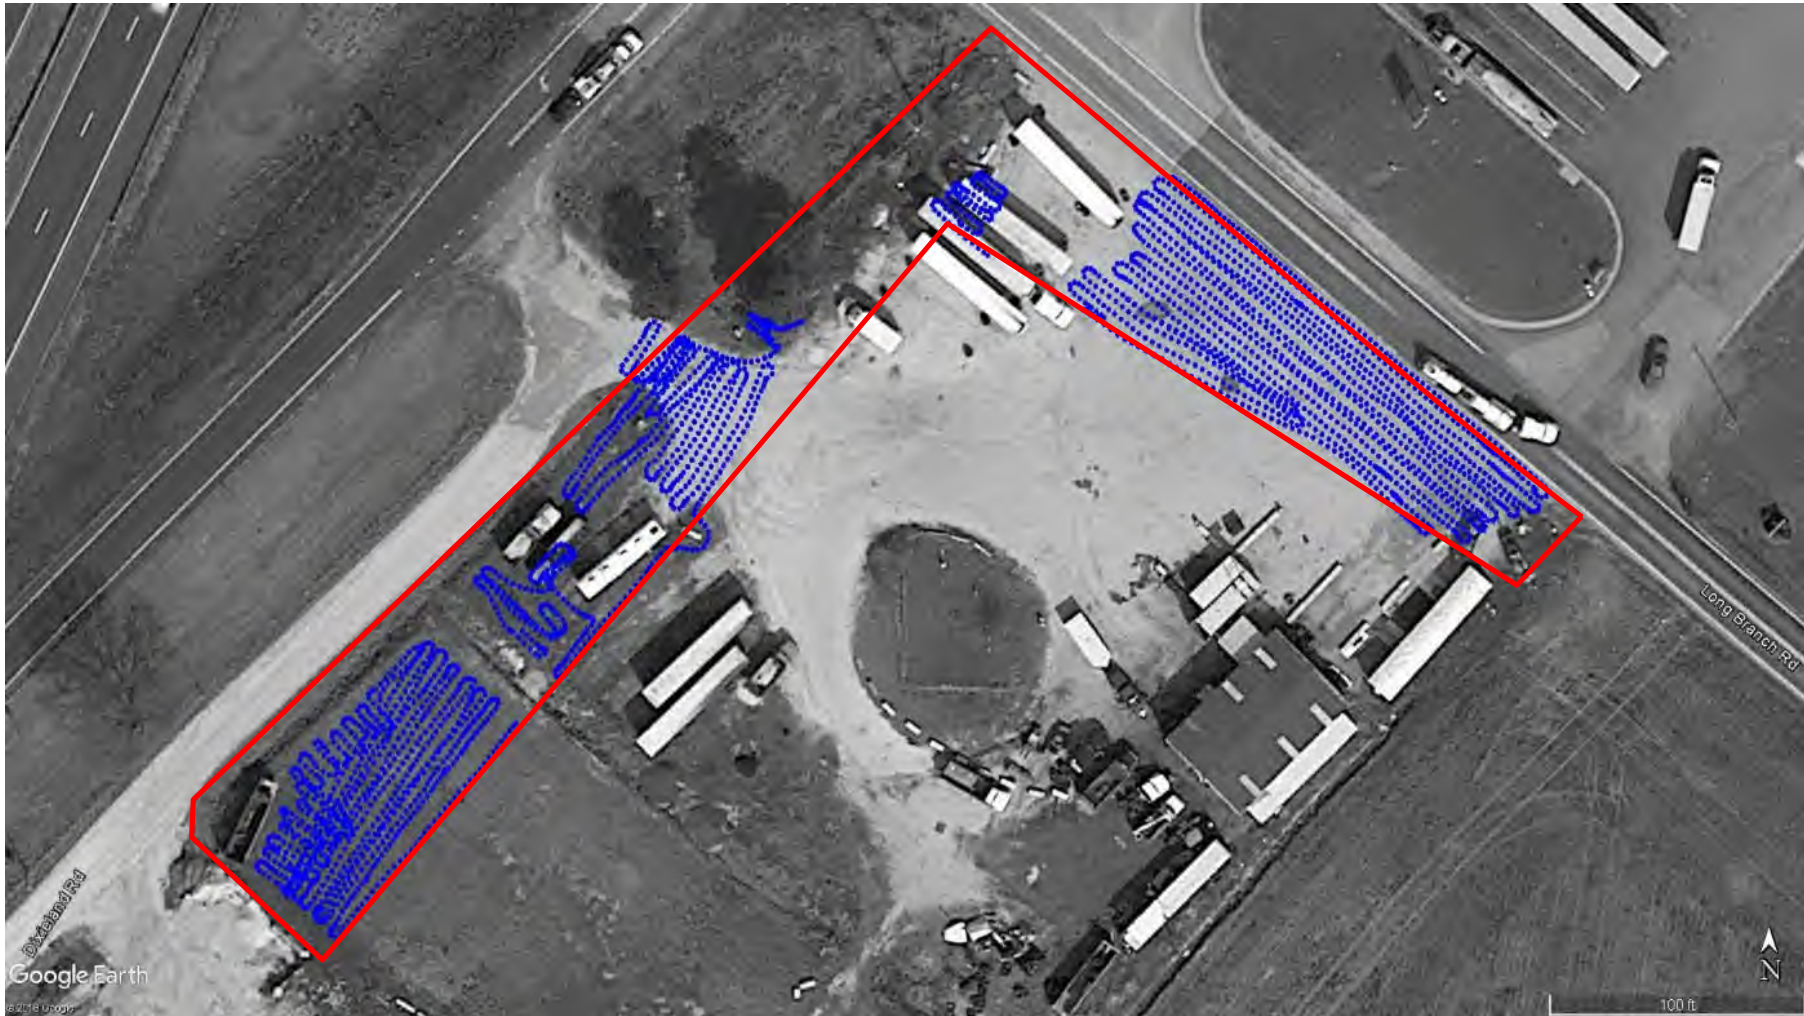
TDEM PATH LOCATION PLAN

We used a Geonics Limited EM-61 MK2 TDEM system in general accordance with ASTM D6820-02 (2007) "Standard Guide for Use of the Time Domain Electromagnetic Method for Subsurface Investigation." Data was collected along lines spaced at approximately five feet using a Juniper® Systems Geode™ sub-meter GPS as positioning support. The presence of vehicles, ditches, and other surficial obstructions within the requested survey area however prevented TDEM data collection in several locations. The approximate TDEM data collection paths are presented in **Figure 4**. Golden Software's Surfer® program was used to grid and plot the data (**Figures 5 and 6**). The TDEM data has been presented as Plots A and B in order to provide both opaque and transparent views, respectively.

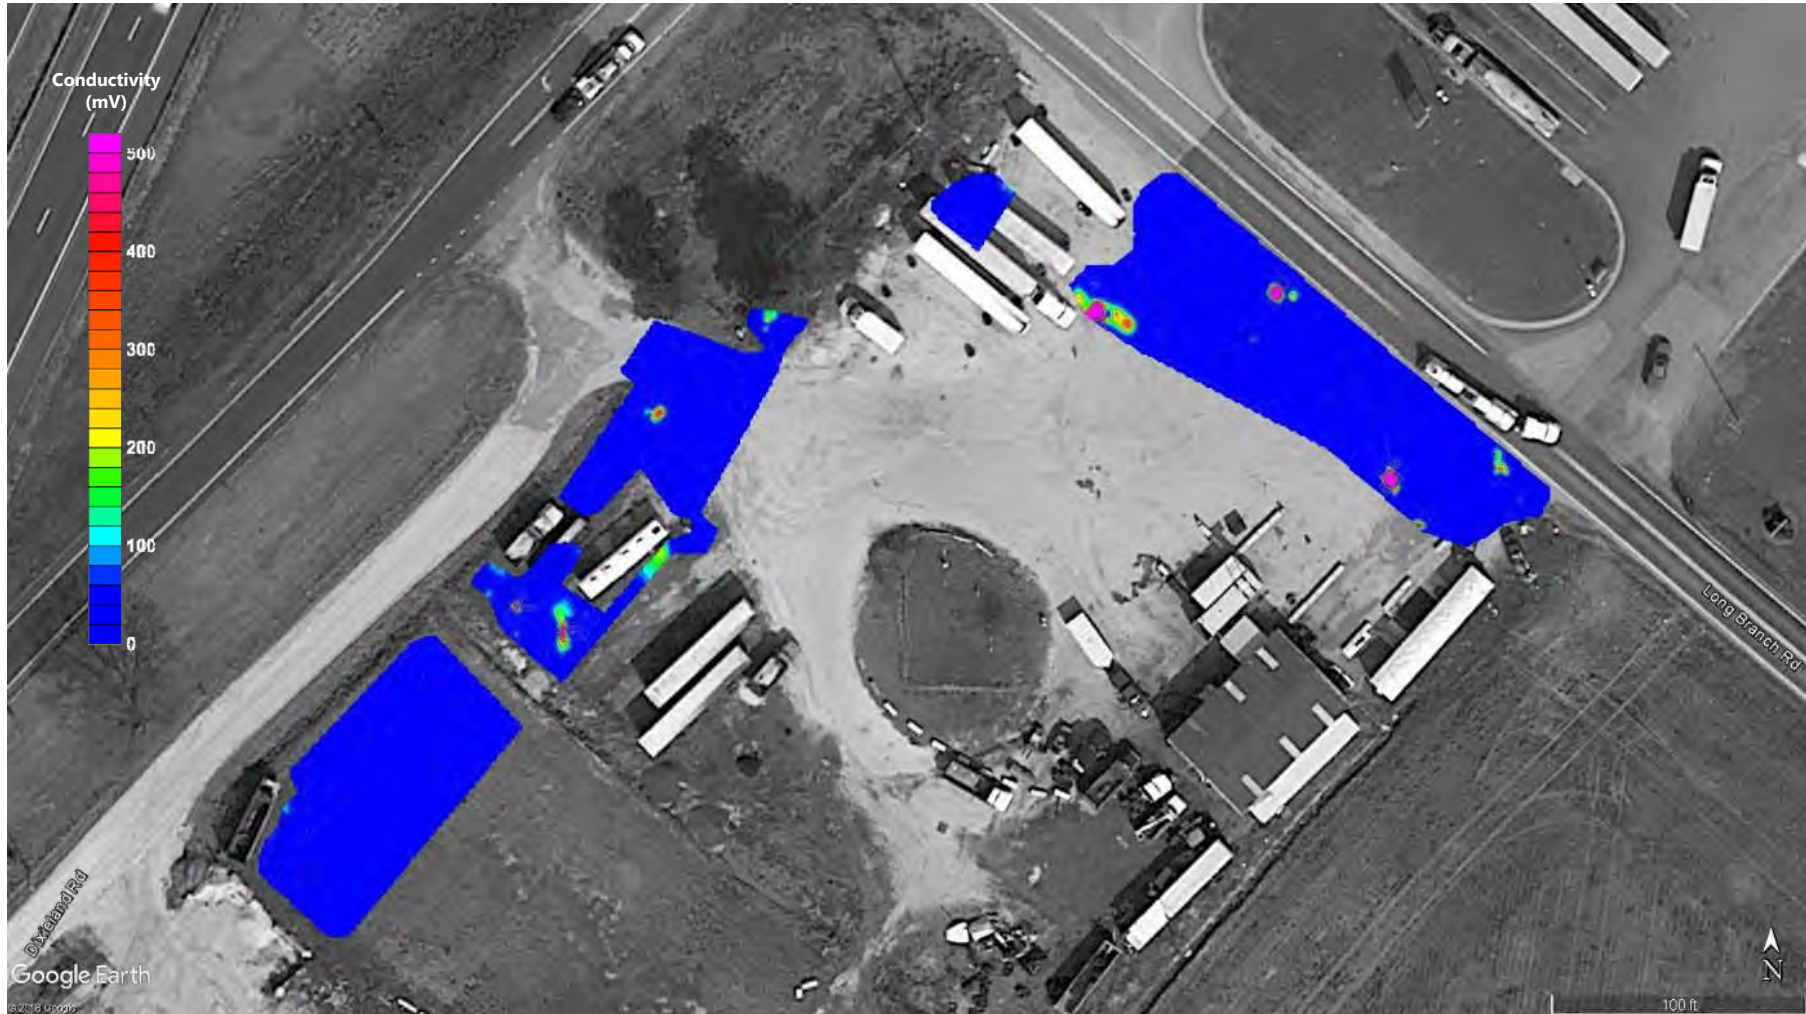
TDEM DATA PLOT A

Responses indicative of a potential UST were not identified in the geophysical data sets collected at the site. However, two anomalous features (Anomaly A and B) were identified in both the TDEM and GPR data sets (**Figures 5 through 7**). Anomaly A is characterized by relatively high TDEM values (greater than about 500 mV) and high amplitude GPR responses located within the upper one foot. Anomaly A is likely related to a buried isolated metallic target. Anomaly B is characterized by relatively high TDEM values (greater than about 500 mV) and high amplitude GPR responses located at about one ft.-bgs. Anomaly B is about four feet by four feet in size and likely related to a buried isolated metallic target. Anomalies were also marked in the field using white spray paint. Example GPR profiles are presented in **Figures 8 and 9**.

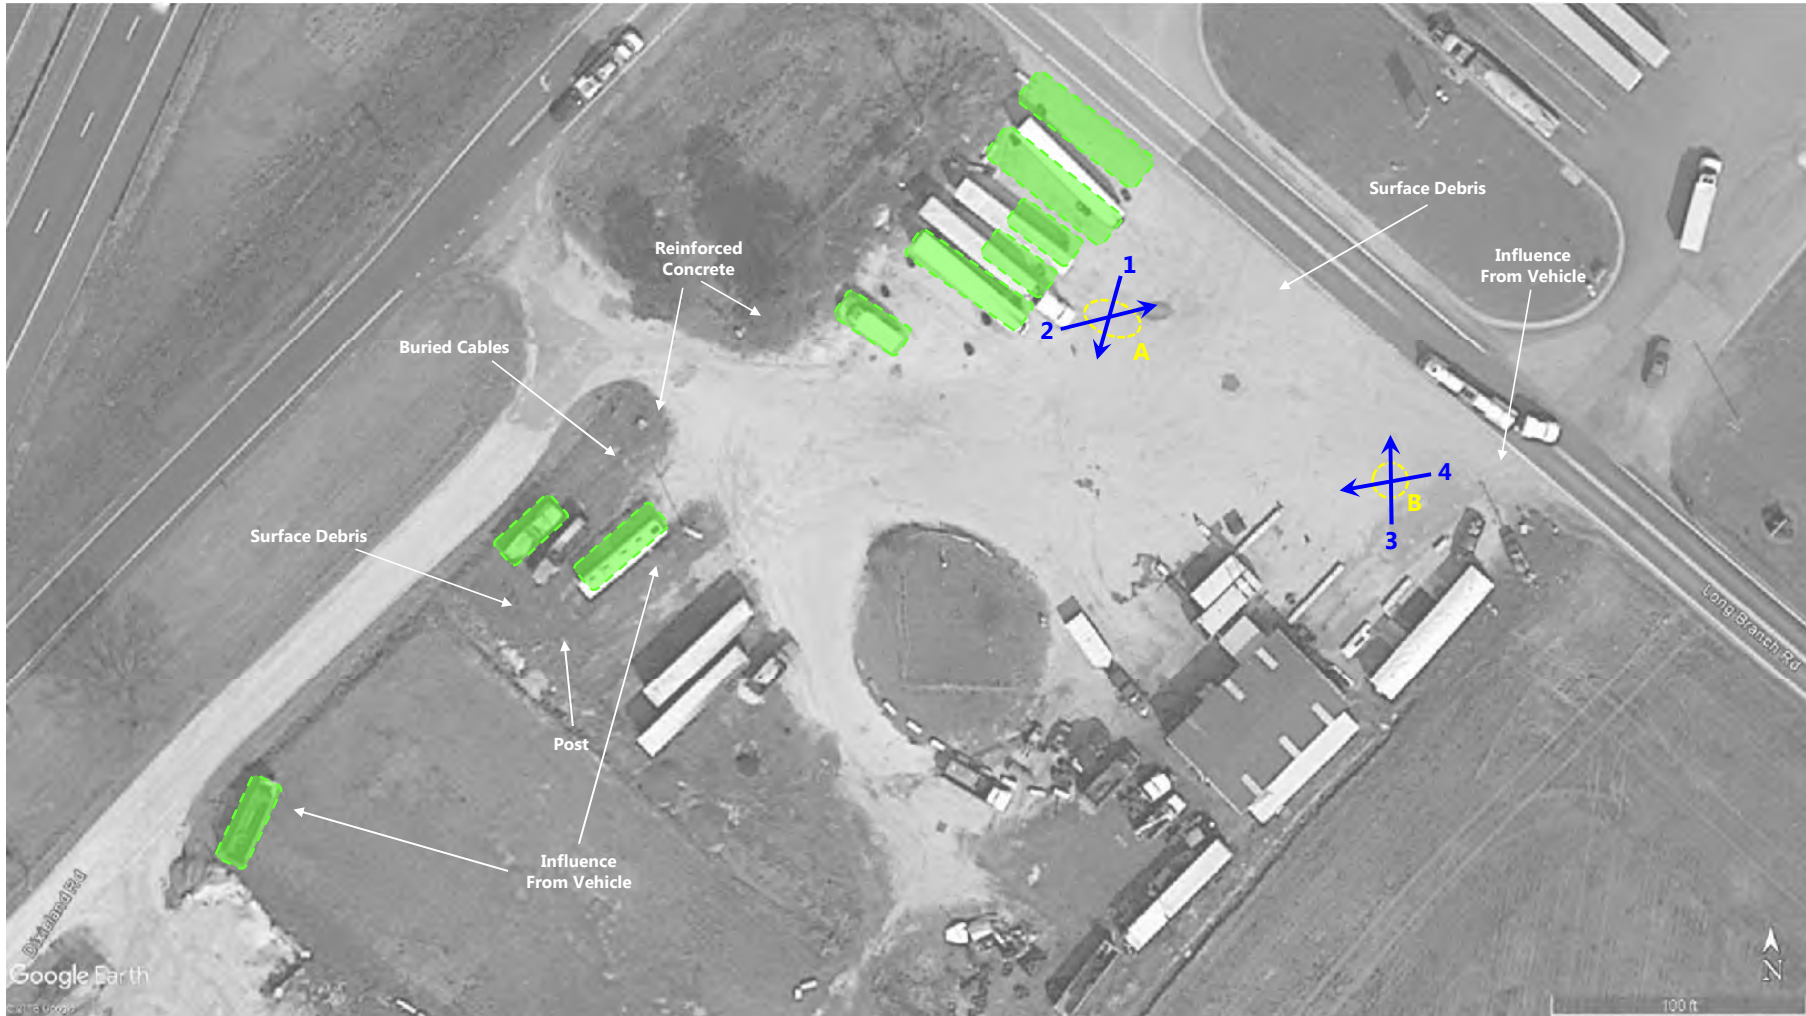
GEOPHYSICAL ANOMALY LOCATION PLAN

A total of four (4) GPR profiles (Lines 1 through 4) were collected for documentation (**Figure 7**). The data was post-processed using the GSSI Radan[®] 7 GPR software program for additional analysis.

The geophysical survey identified two anomalous features (Anomaly A and B) which are likely related to two buried isolated metallic targets. Anomaly B appears to be approximately four feet by four feet in size. Responses indicative of a potential UST were not identified in the geophysical data sets collected at the site.

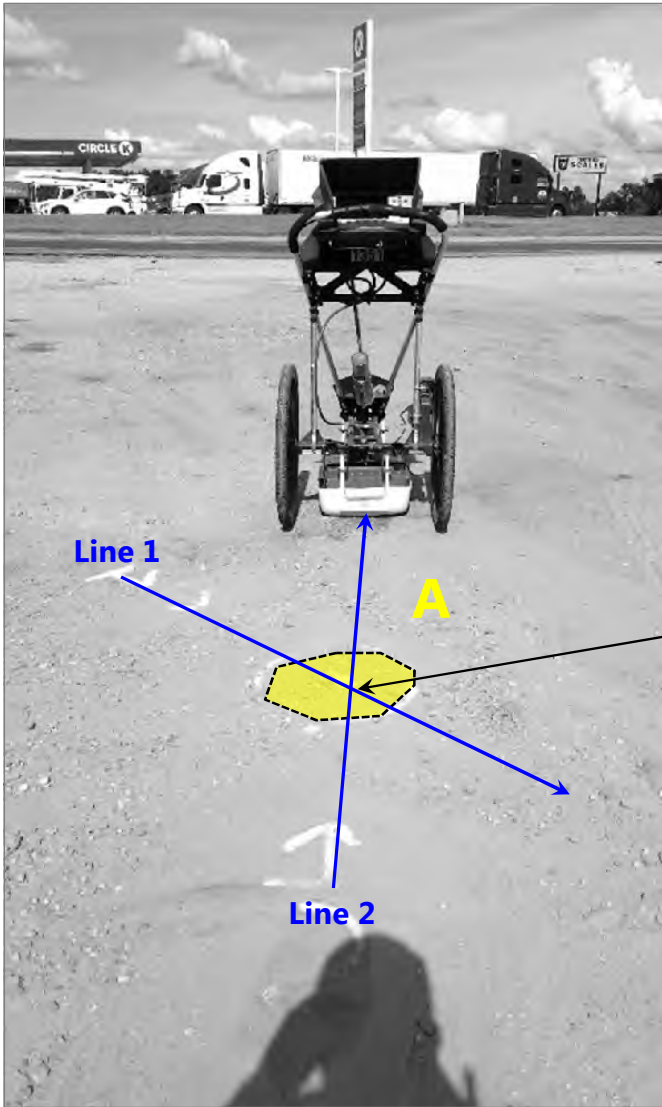
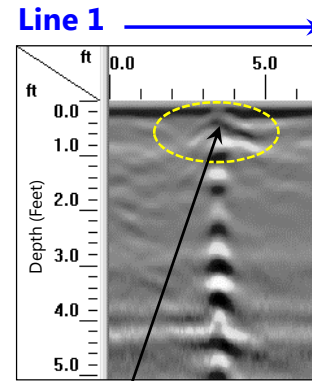
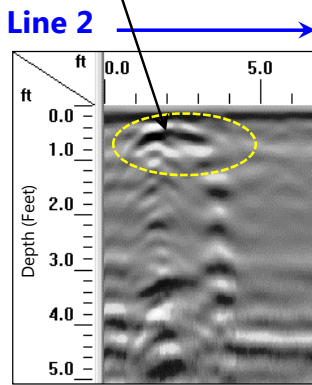
EXAMPLE GPR DATA – LINES 1 AND 2

Anomaly A

Note: Presented GPR profile depths are based on an assumed average dielectric and should be considered approximate

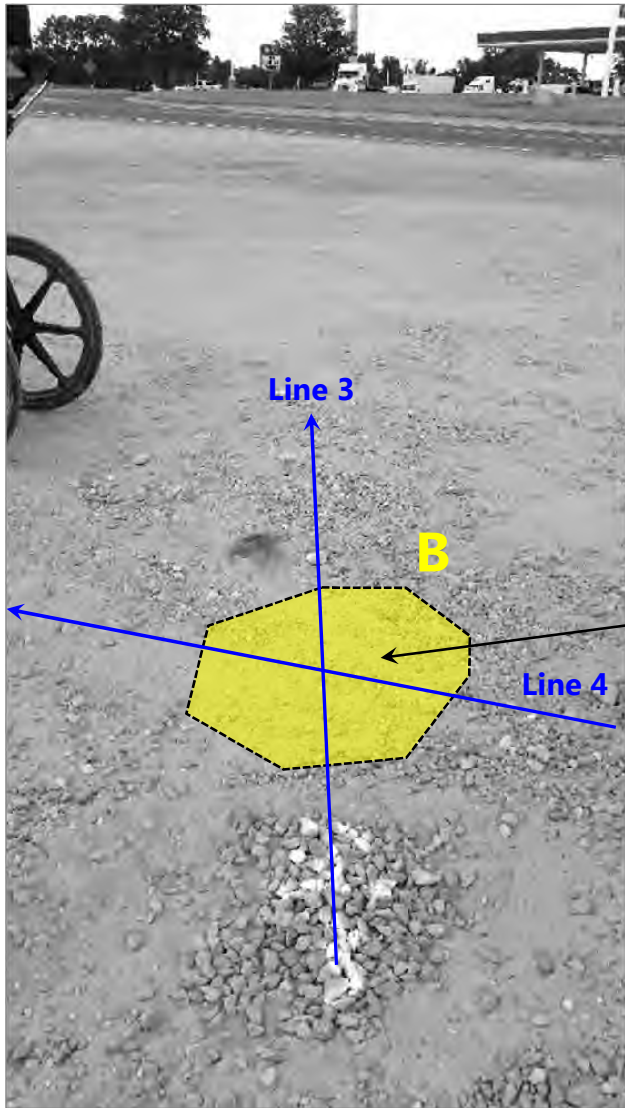
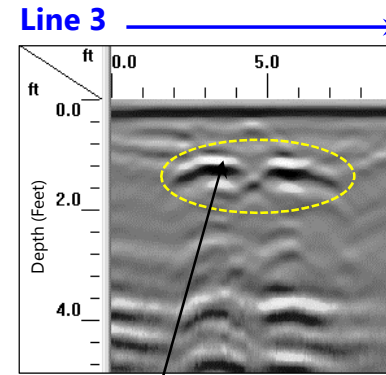
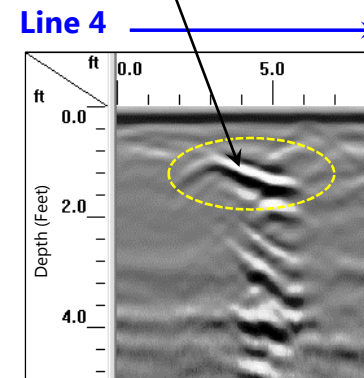
EXAMPLE GPR DATA – LINES 3 AND 4

Anomaly B

Note: Presented GPR profile depths are based on an assumed average dielectric and should be considered approximate
