Reference: **Preliminary Site Assessment Report**
NCDOT Project I-5986B, WBS Element 47532.1.3
Parcel 29-Circle K/Hardees Truck Stop
873 Long Branch Road
Dunn, Harnett County, North Carolina
S&ME Project 4305-18-175

**Preliminary Site Assessment Report
NCDOT Project I-5986B, WBS Element 47532.1.3
Parcel 29-Circle K/Hardees Truck Stop
Dunn, Harnett County, North Carolina
S&ME Project No. 4305-18-175**

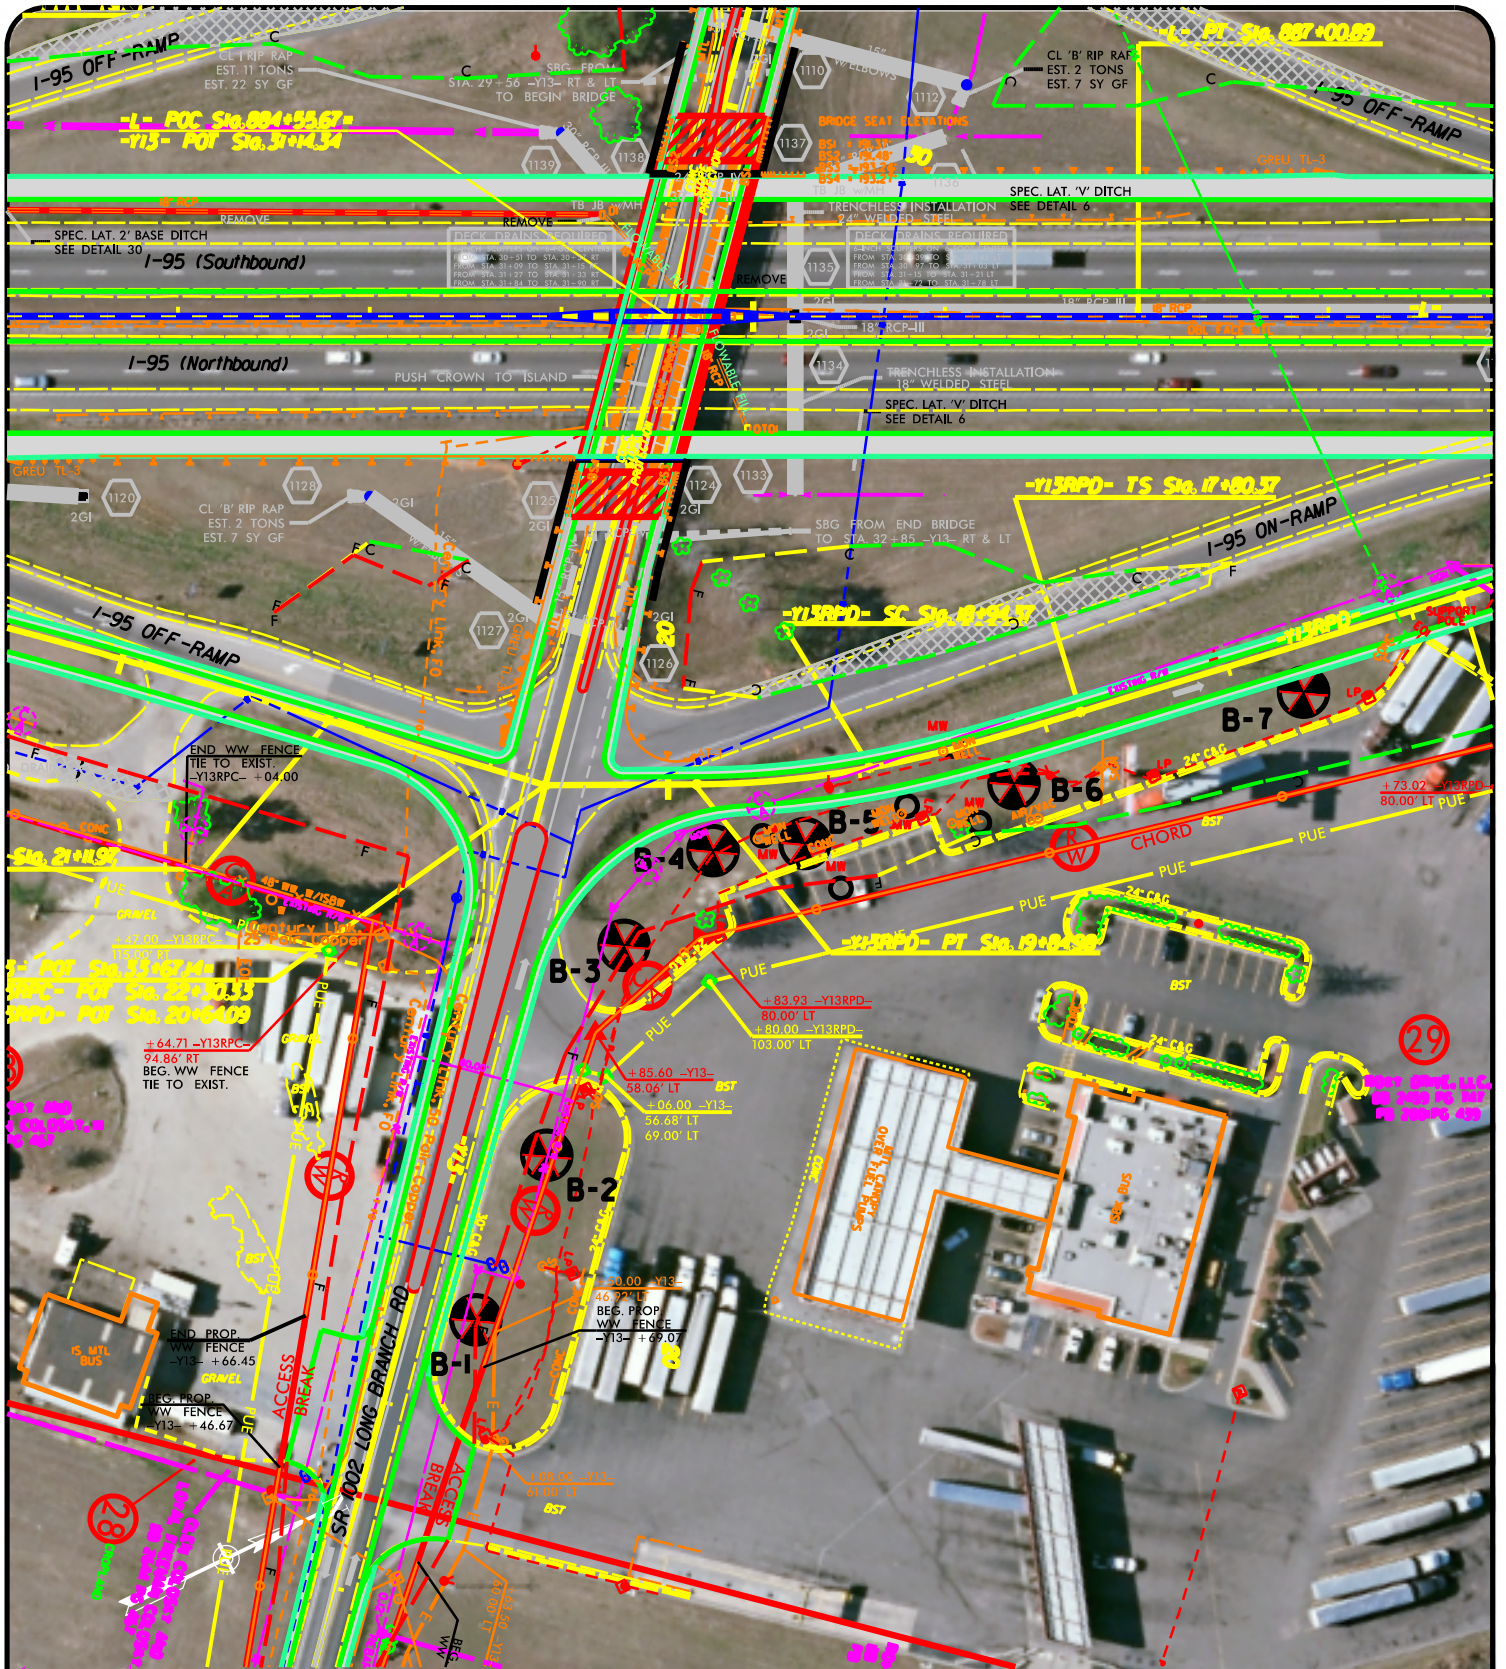
SCALE:	FIGURE NO.
1" = 100'	2
DATE:	
PROJECT NUMBER	
4305-18-175

On October 1, 2018, S&ME's drill crew utilized a track mounted Geoprobe® rig to advance seven soil borings (B-1 through B-7) and to collect soil samples within accessible areas of the proposed ROW/easement at Parcel 29. The approximate location of the soil borings are shown in **Figure 2**. A photographic log is included in **Appendix I**. During our field activities, five groundwater monitoring wells, which appear to have been abandoned (filled with grout) were observed within the proposed ROW/easement. The approximate locations of the wells are presented in **Figure 2**. S&ME's drill crew advanced the Geoprobe® borings to a depth of approximately 10 ft.-bgs. During the advancement of the soil borings, groundwater was not encountered. Soil samples were continuously collected in four-foot long disposable acetate-plastic sleeves that line the hollow stainless-steel sample probes. Soil recovered from the sleeves was classified on-site by S&ME personnel and screened with a Photoionization Detector (PID) at approximately two foot depth intervals to measure relative headspace concentrations of volatile organic compounds (VOCs).

SITE MAP

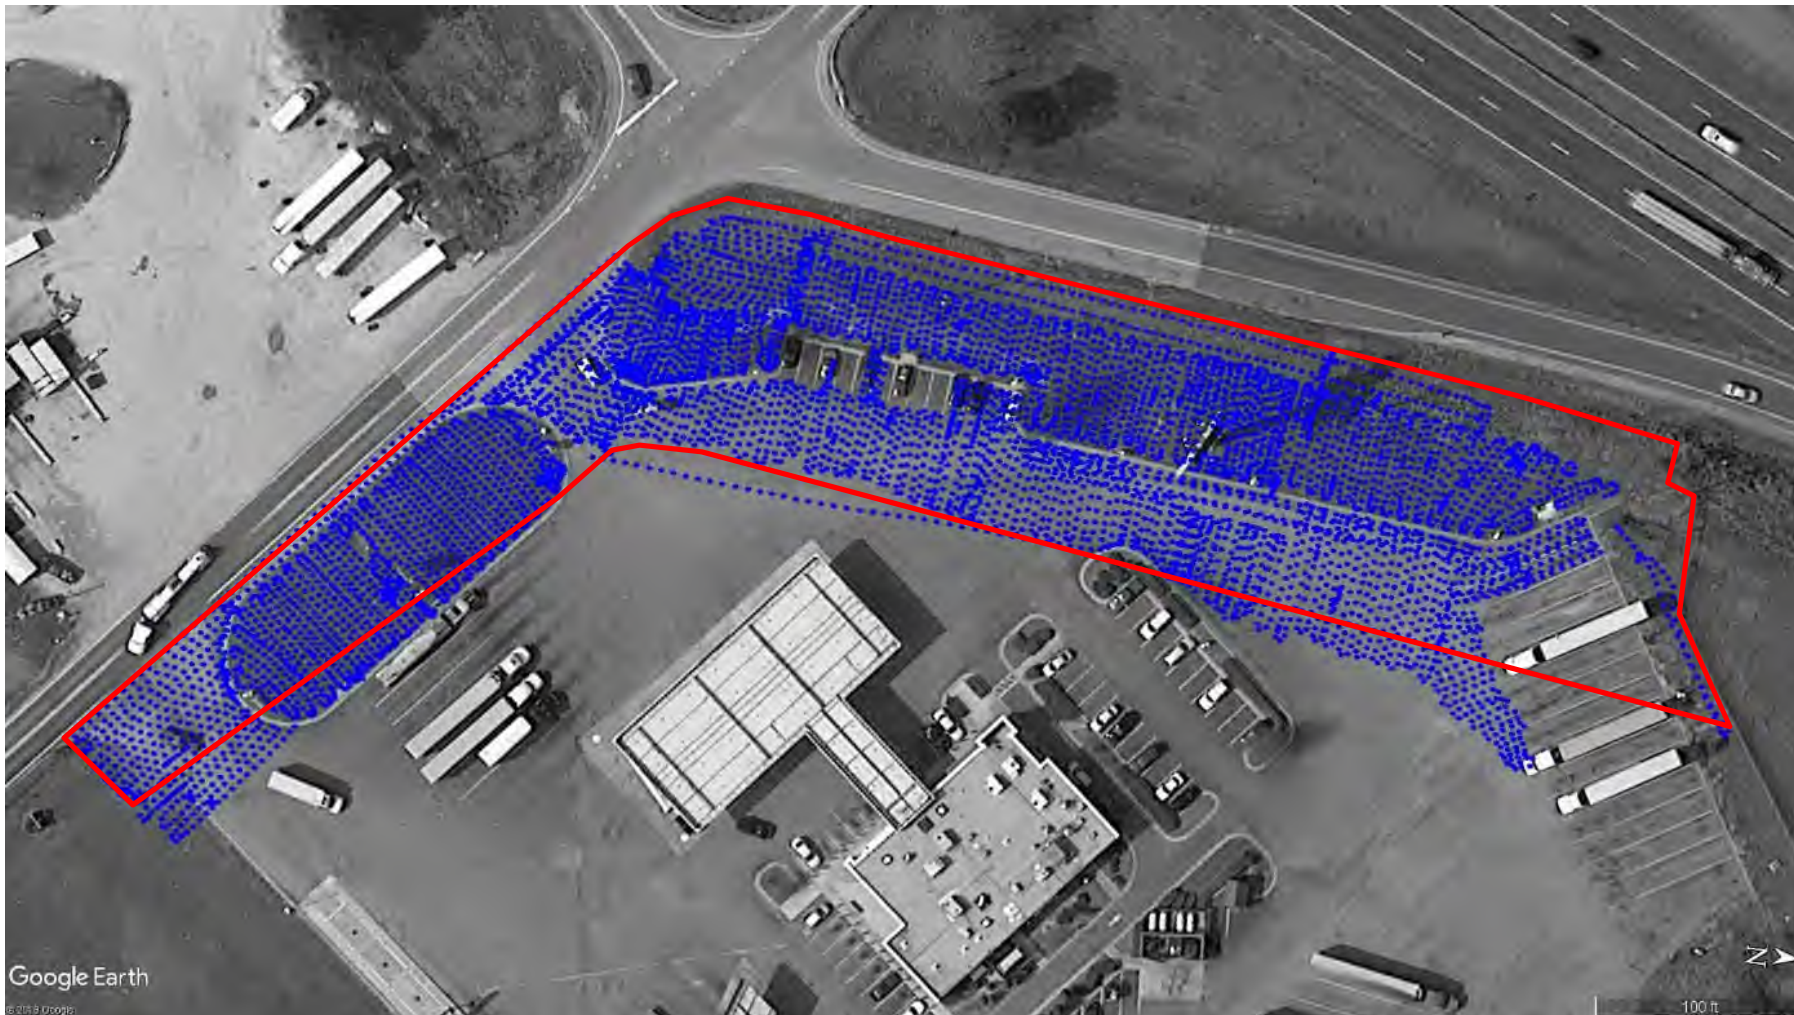
FIGURE NO.

We used a Geonics Limited EM-61 MK2 TDEM system in general accordance with ASTM D6820-02 (2007) "Standard Guide for Use of the Time Domain Electromagnetic Method for Subsurface Investigation." Data was collected along lines spaced at approximately five feet using a Juniper® Systems Geode™ sub-meter GPS as positioning support. The presence of vehicles, heavy vegetation, and other surficial obstructions within the requested survey area however prevented TDEM data collection in several locations. The approximate TDEM data collection paths are presented in **Figure 4**. Golden Software's Surfer® program was used to grid and plot the data (**Figures 5 and 6**). The TDEM data has been presented as Plots A and B in order to provide both opaque and transparent views, respectively.

TDEM PATH LOCATION PLAN

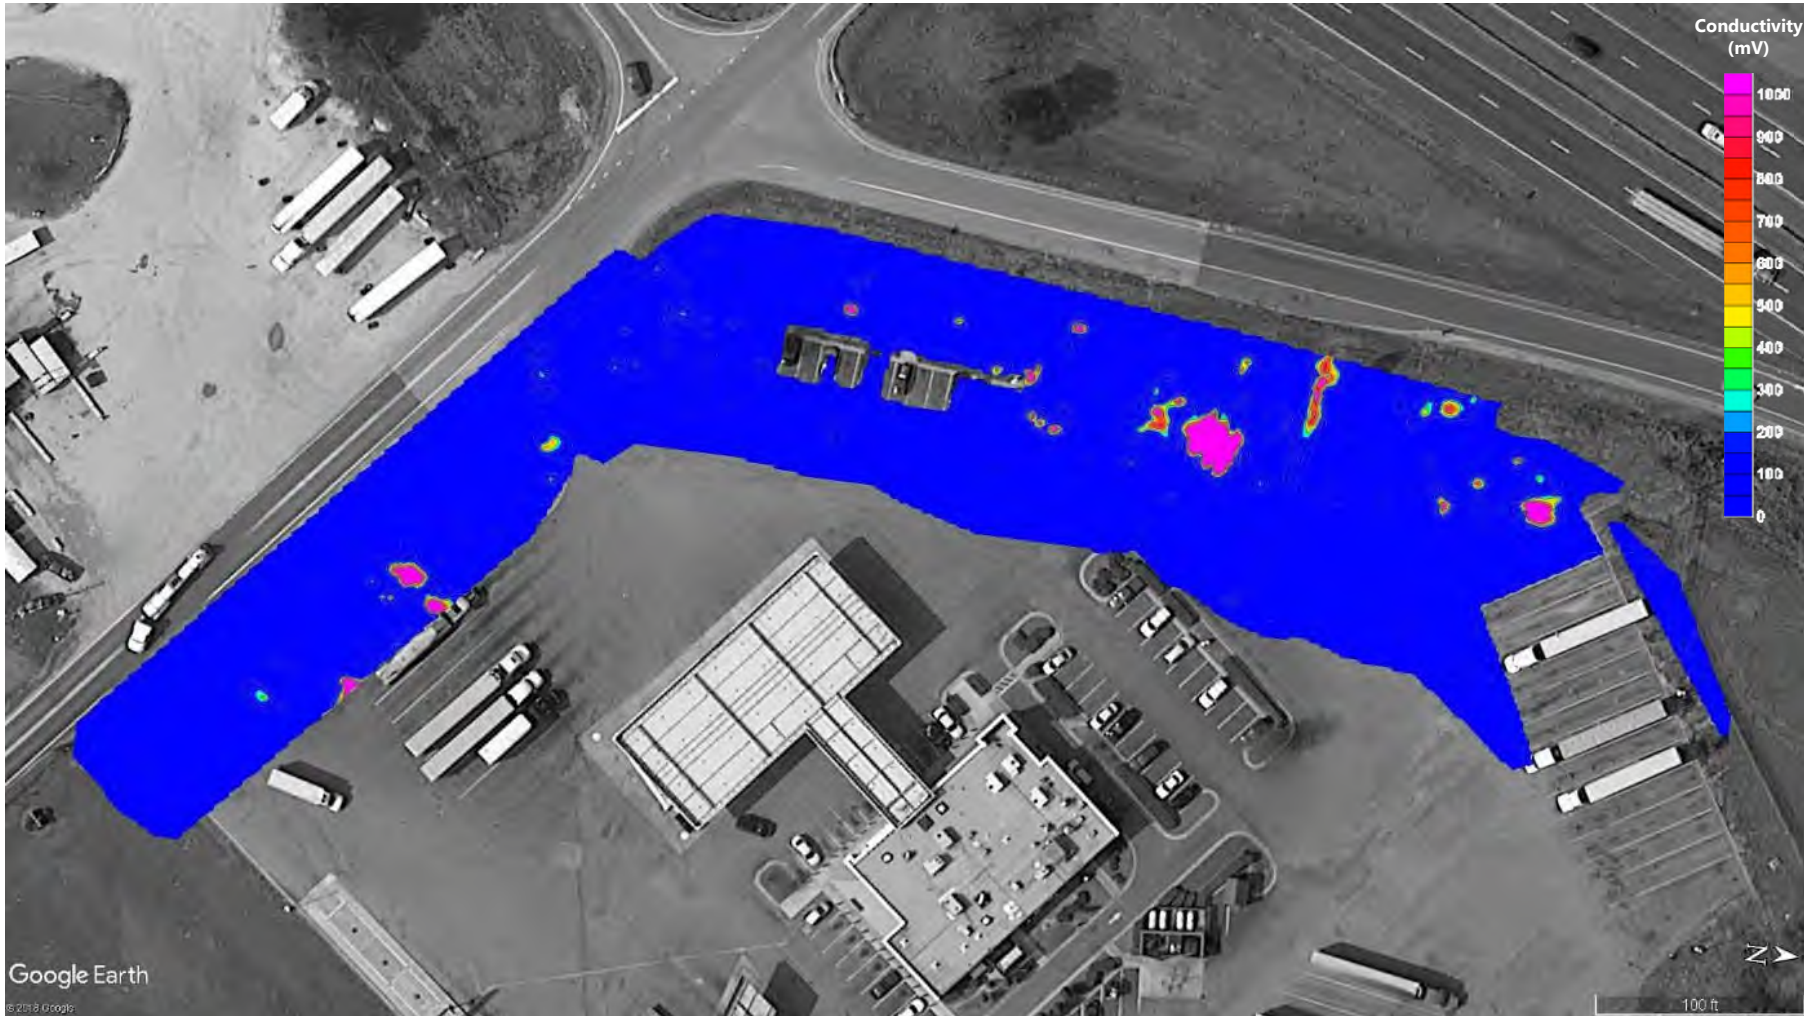
FIGURE NO.

Responses indicative of a potential UST were not identified in the geophysical data sets collected at the site. However, five anomalous features were identified in the geophysical data sets (**Figures 5 through 7**). Anomaly A is an approximate 10 foot linear feature characterized by high amplitude GPR responses at about three ft.-bgs. TDEM responses were not identified over Anomaly A which indicates it may be a buried non-metallic feature possibly related to the nearby water utility. Anomalies B through E are characterized by relatively high TDEM values (greater than about 500 mV) and high amplitude GPR responses located within the upper two feet. The anomalies range from about one to three feet in size and likely related to buried isolated metallic targets/debris. Anomalies were also marked in the field using white spray paint. Example GPR profiles are presented in **Figures 9 through 12**

TDEM DATA PLOT A

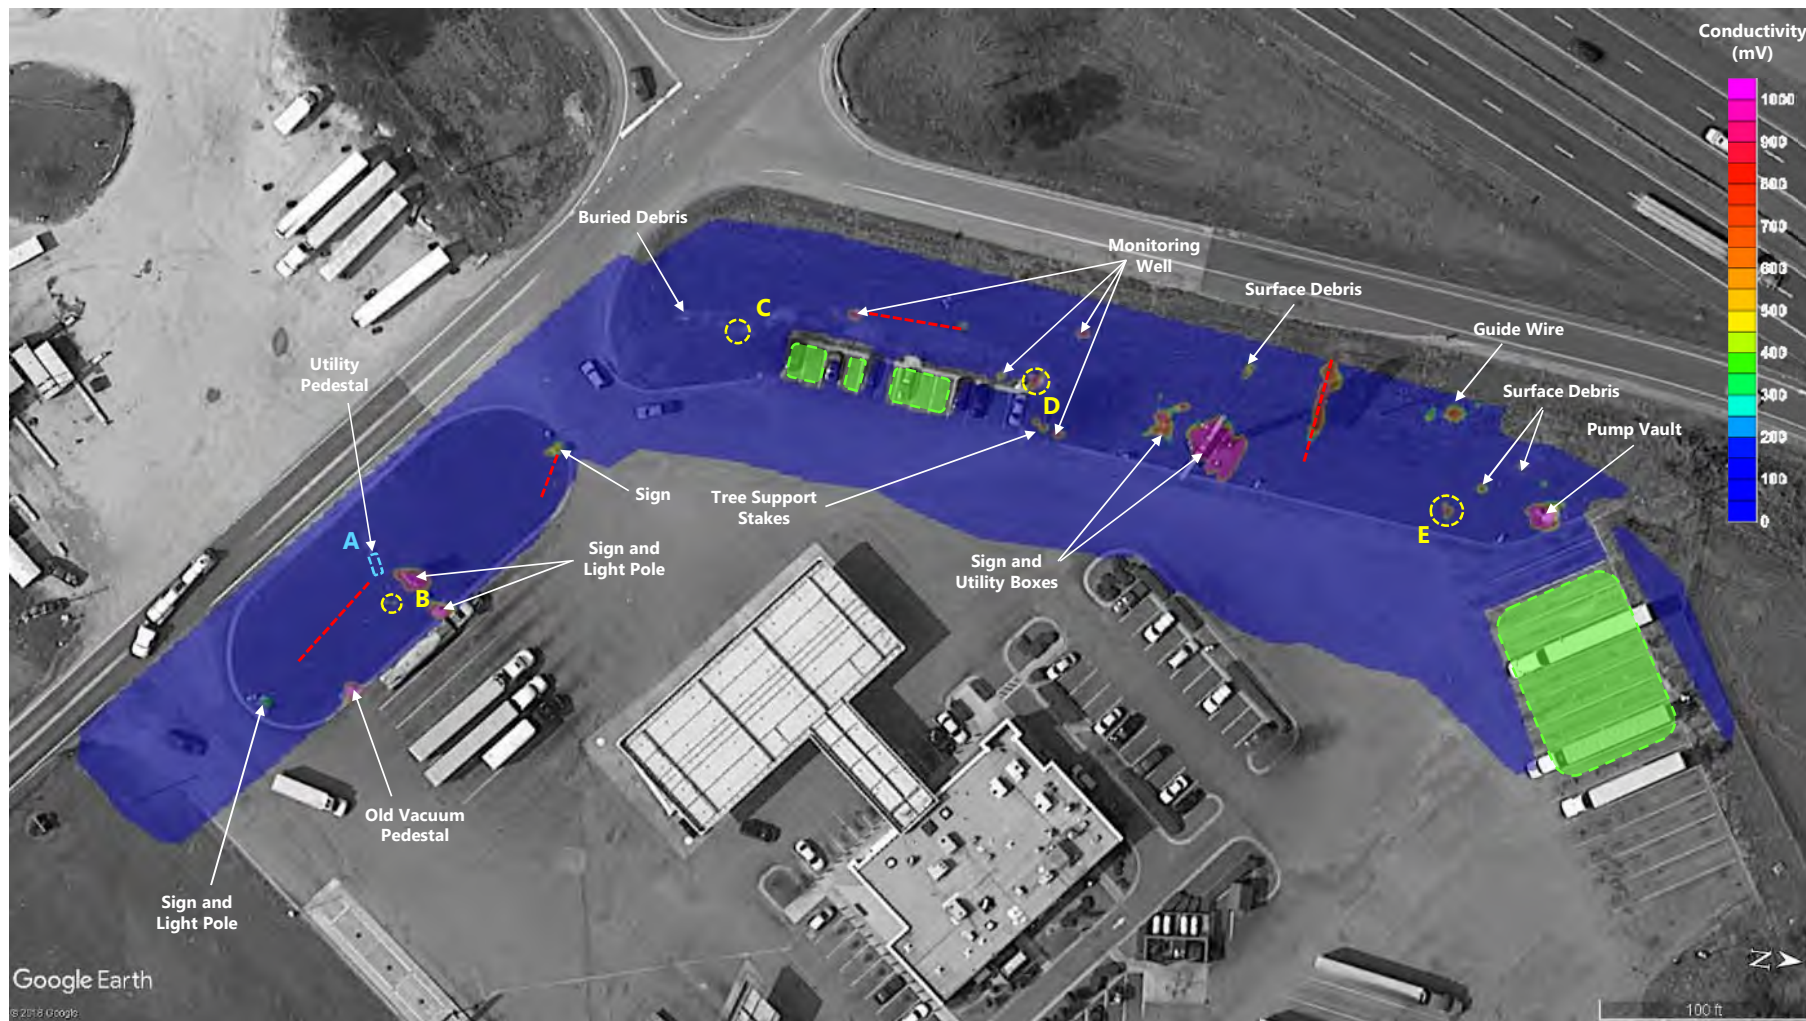
FIGURE NO.

TDEM DATA PLOT B

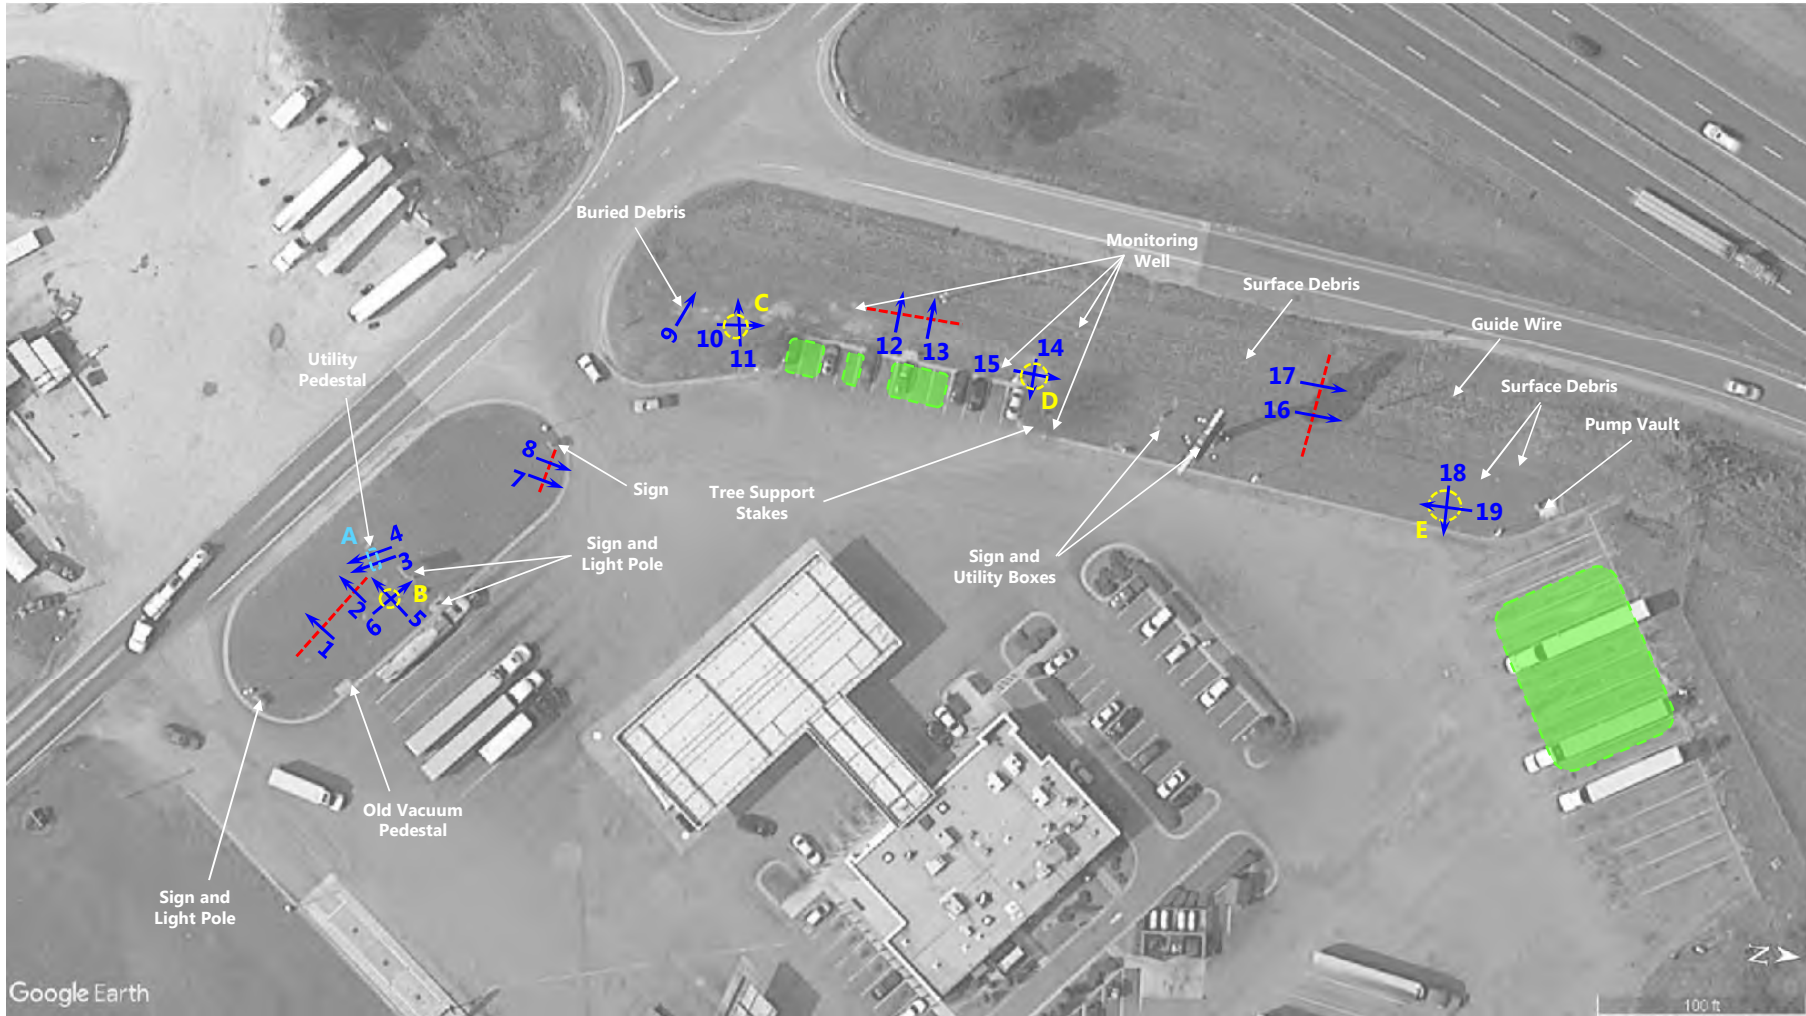
FIGURE NO.

A total of 19 GPR profiles (Lines 1 through 19) were collected for documentation (**Figure 7**). The data was post-processed using the GSSI Radan® 7 GPR software program for additional analysis.

The geophysical survey identified five anomalous features (Anomaly A through E). Anomaly A appears to be a non-metallic feature possibly related to the nearby water utility. Anomalies B through E are likely related to buried isolated metallic targets/debris. Responses indicative of a potential UST were not identified in the geophysical data sets collected at the site. Five groundwater monitoring wells were observed within the proposed ROW/easement. However, the monitoring wells appear to have been abandoned by being filled with grout.

GEOPHYSICAL ANOMALY LOCATION PLAN

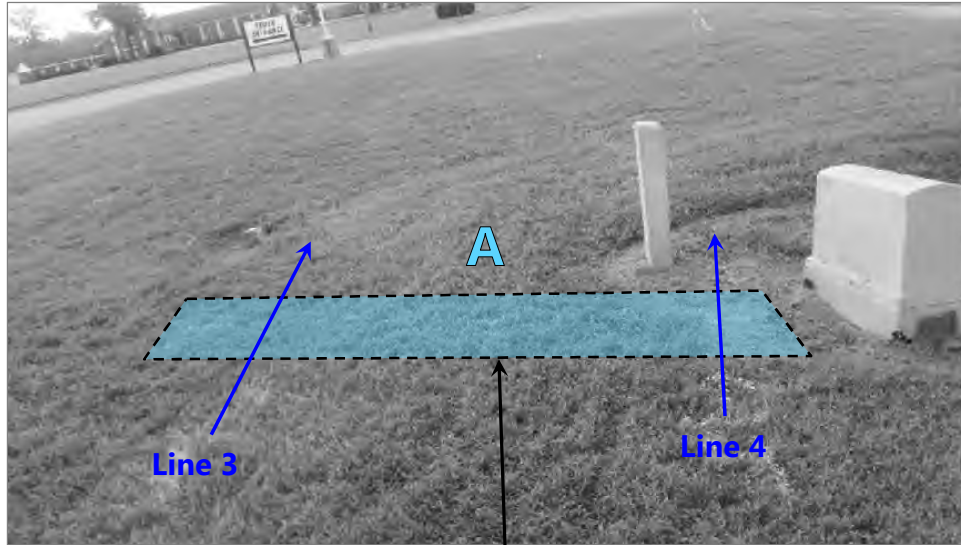
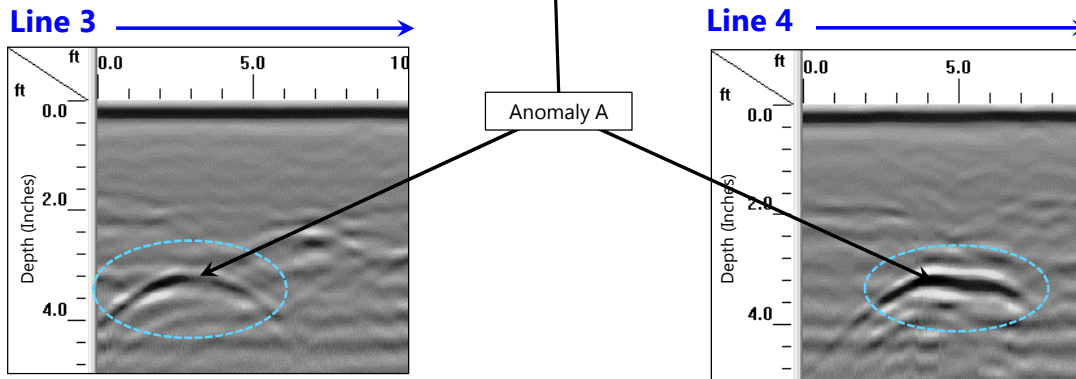
FIGURE NO.

Note: Presented GPR profile depths are based on an assumed average dielectric and should be considered approximate

EXAMPLE GPR DATA – LINES 3 AND 4

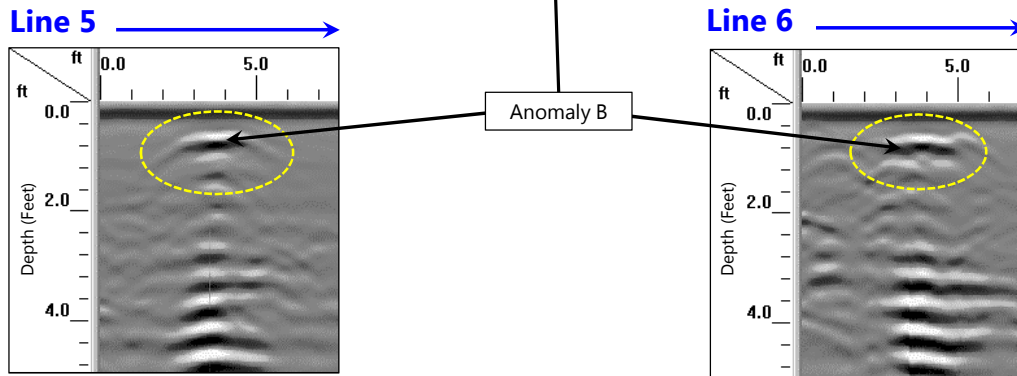
FIGURE NO.

Note: Presented GPR profile depths are based on an assumed average dielectric and should be considered approximate

EXAMPLE GPR DATA – LINES 5 AND 6

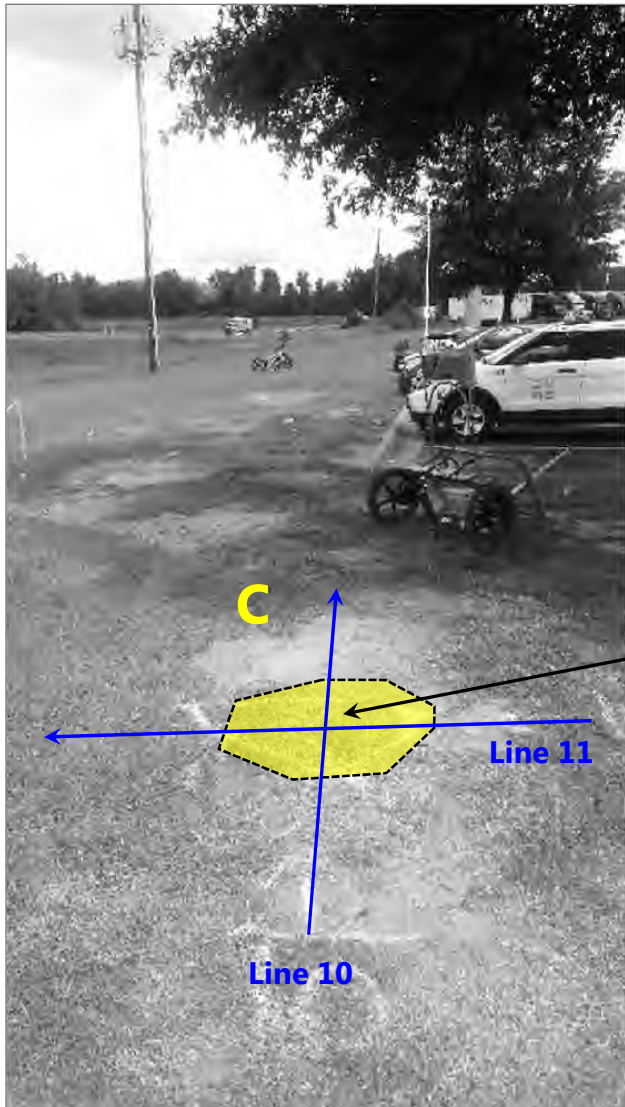
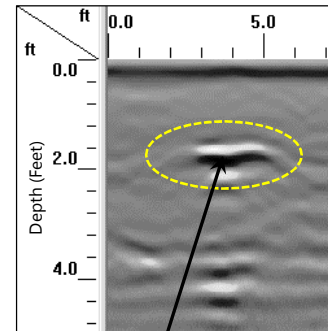
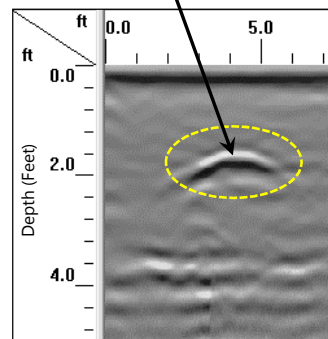
Anomaly C

Note: Presented GPR profile depths are based on an assumed average dielectric and should be considered approximate

EXAMPLE GPR DATA – LINES 10 AND 11

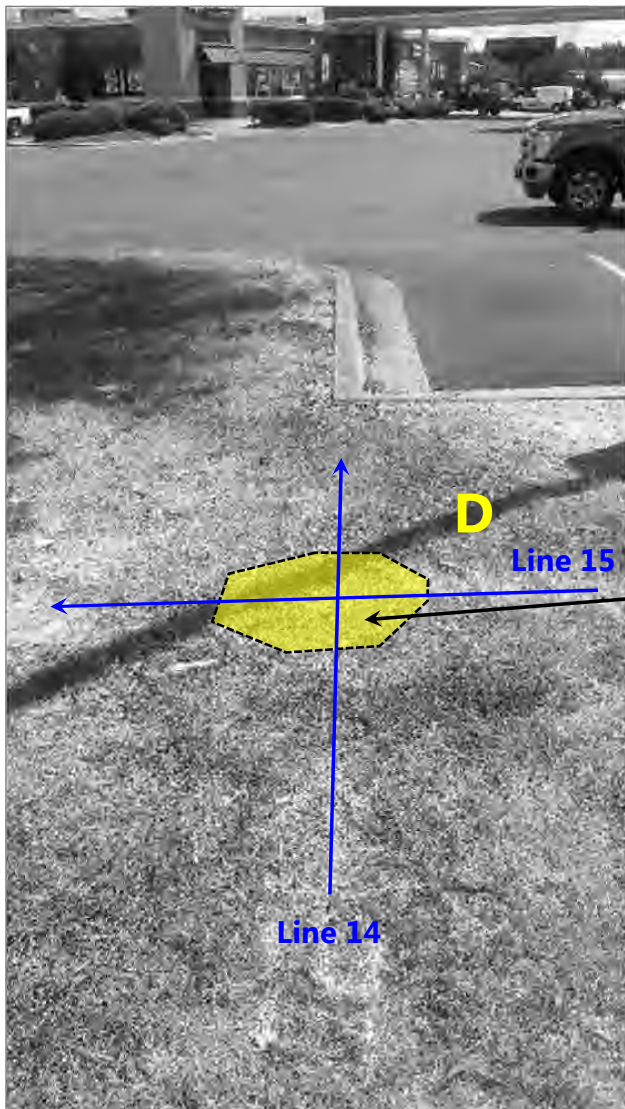
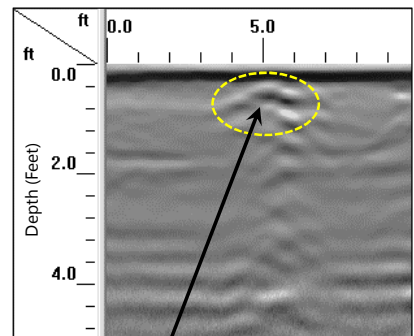
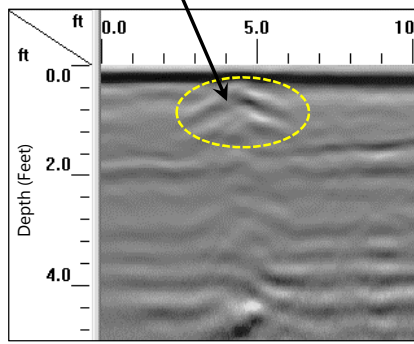
Anomaly D

Note: Presented GPR profile depths are based on an assumed average dielectric and should be considered approximate

EXAMPLE GPR DATA – LINES 14 AND 15	
<small> NCDOT PROJECT: I-59868 PARCEL 29 – (CIRCLE K/HARDEES TRUCK STOP) 873 LONG BRANCH ROAD, DUNN, HARNETT COUNTY, NORTH CAROLINA </small>	
<small>SCALE: AS SHOWN</small>	
<small>DATE: 10/30/2018</small>	
<small>PROJECT NUMBER 4305-18-175</small>	
<small>FIGURE NO.</small>	
11

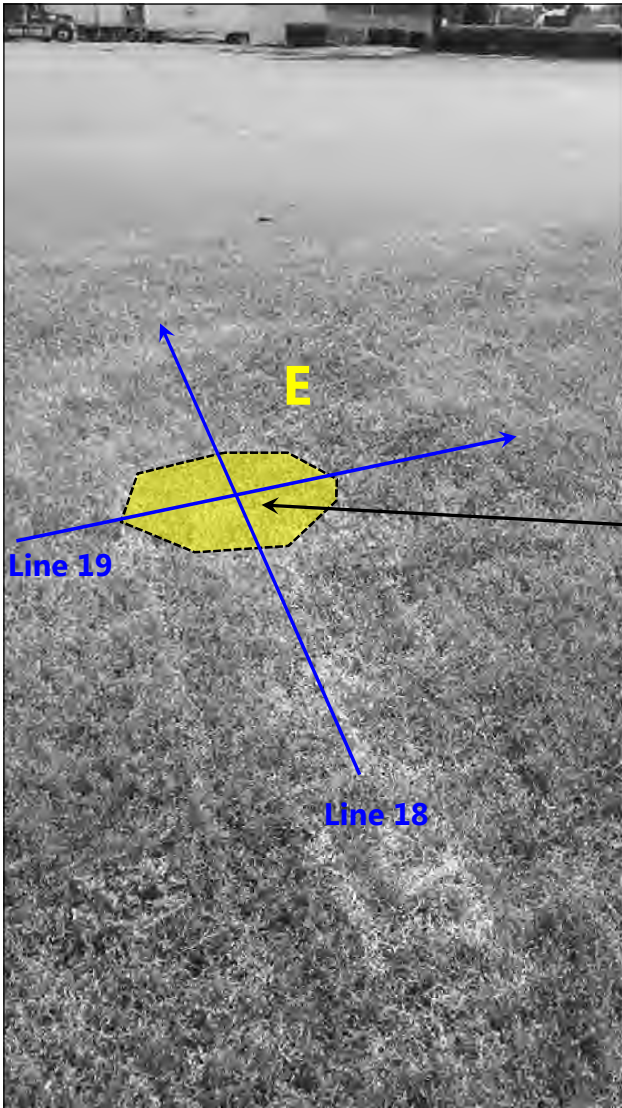
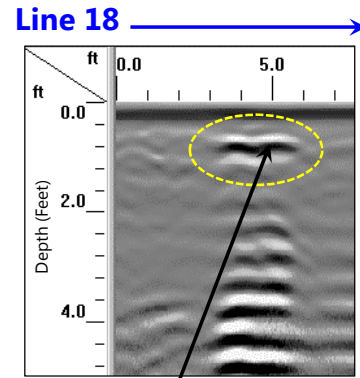
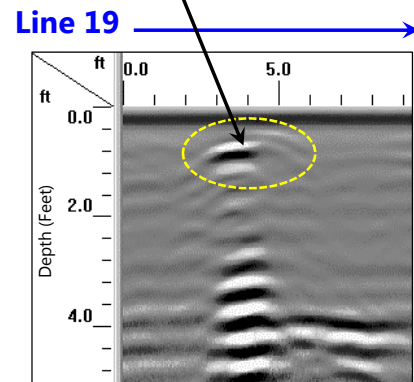
SCALE:
AS SHOWN
DATE:
10/30/2018
PROJECT NUMBER
4305-18-175
FIGURE NO.

Anomaly E

Note: Presented GPR profile depths are based on an assumed average dielectric and should be considered approximate

EXAMPLE GPR DATA – LINES 18 AND 19

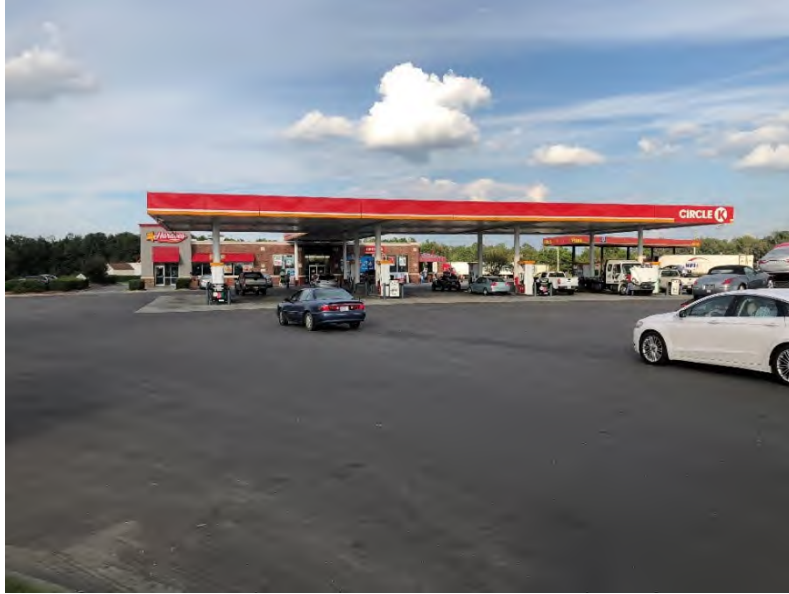
1	Location / Orientation	View of site looking north.	Date: 10/1/2018 Photographer: JTH
	Remarks	None

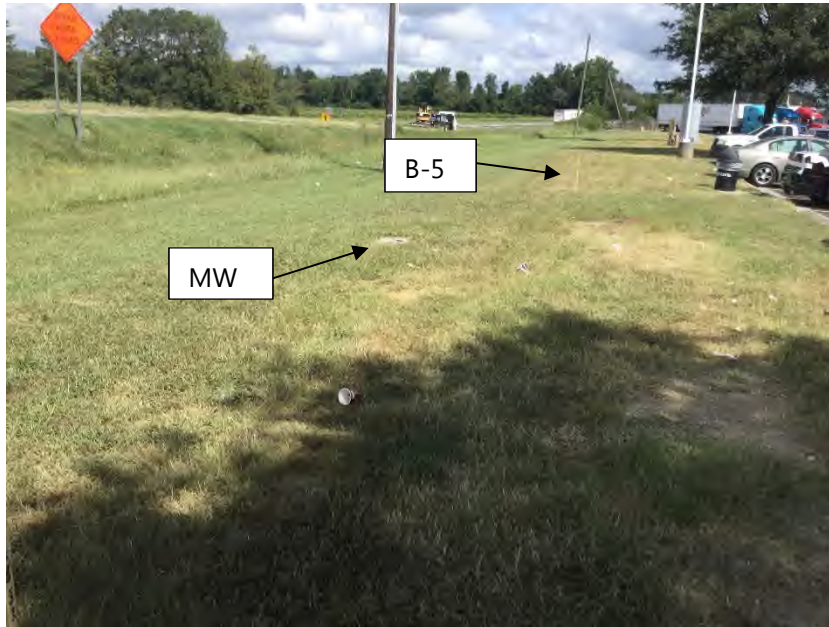
2	Location / Orientation	View looking north.	Date: 10/1/2018 Photographer: JTH
	Remarks	Soil boring B-5 and abandoned monitor well (MW).

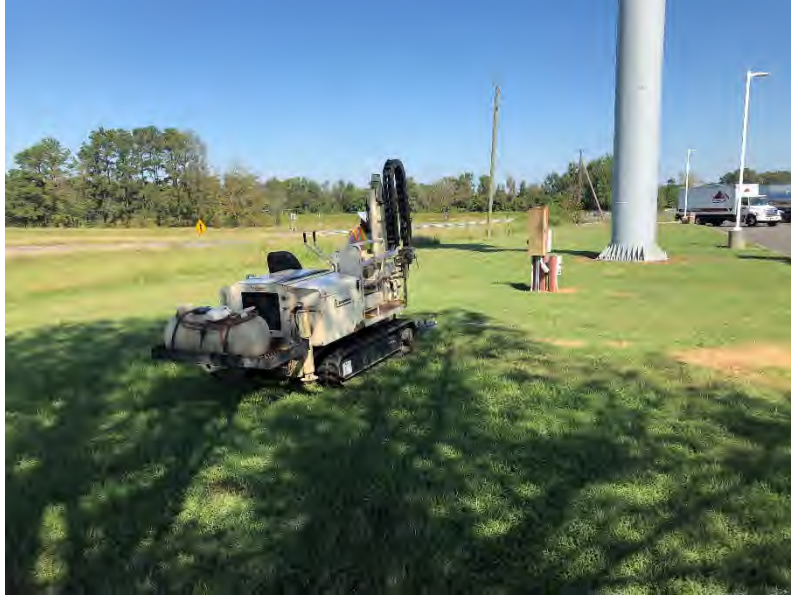
3	Location / Orientation	View of B-6 looking north.	Date: 10/1/2018 Photographer: JTH
	Remarks	None

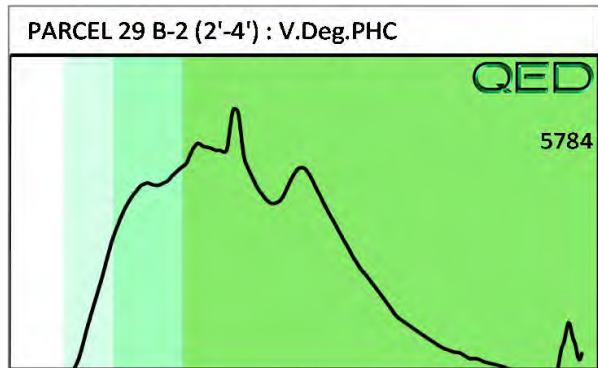
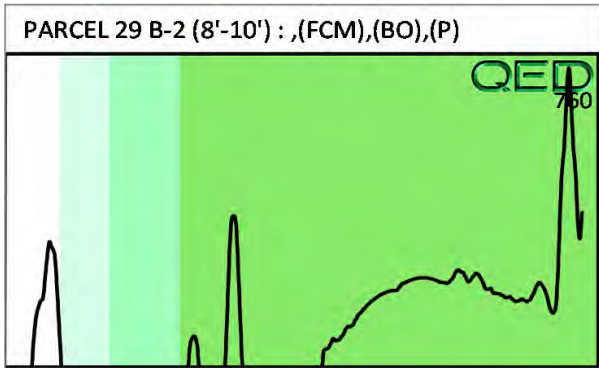
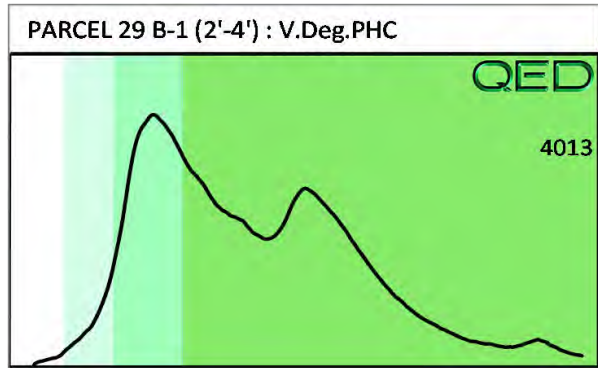
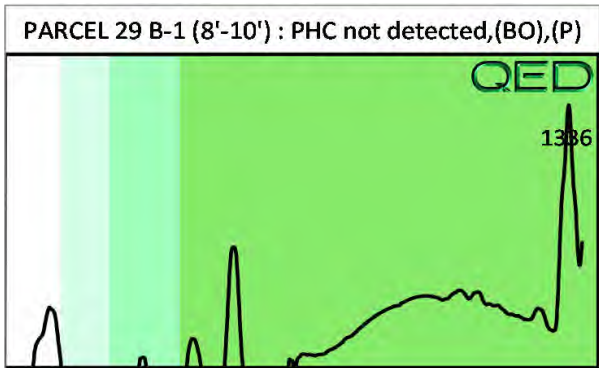
B = Blank Drift : (SBS)/(LBS) = Site Specific or Library Background Subtraction applied to result : (BO) = Background Organics detected : (OCR) = Outside cal range : (M) = Modified Result.

% Ratios estimated aromatic carbon number proportions : HC = Hydrocarbon : PHC = Petroleum HC : FP = Fingerprint only. **Data generated by HC-1 Analyser**
