Reference: **Preliminary Site Assessment Report**
NCDOT Project I-5986B, WBS Element 47532.1.3
Parcel 216-Lucky's Storage Lot
Sadler Drive
Dunn, Harnett County, North Carolina
S&ME Project 4305-18-175A

Preliminary Site Assessment Report
NCDOT Project I-5986B, WBS Element 47532.1.3
Parcel 216-Lucky's Storage Lot
Dunn, Harnett County, North Carolina
S&ME Project No. 4305-18-175A

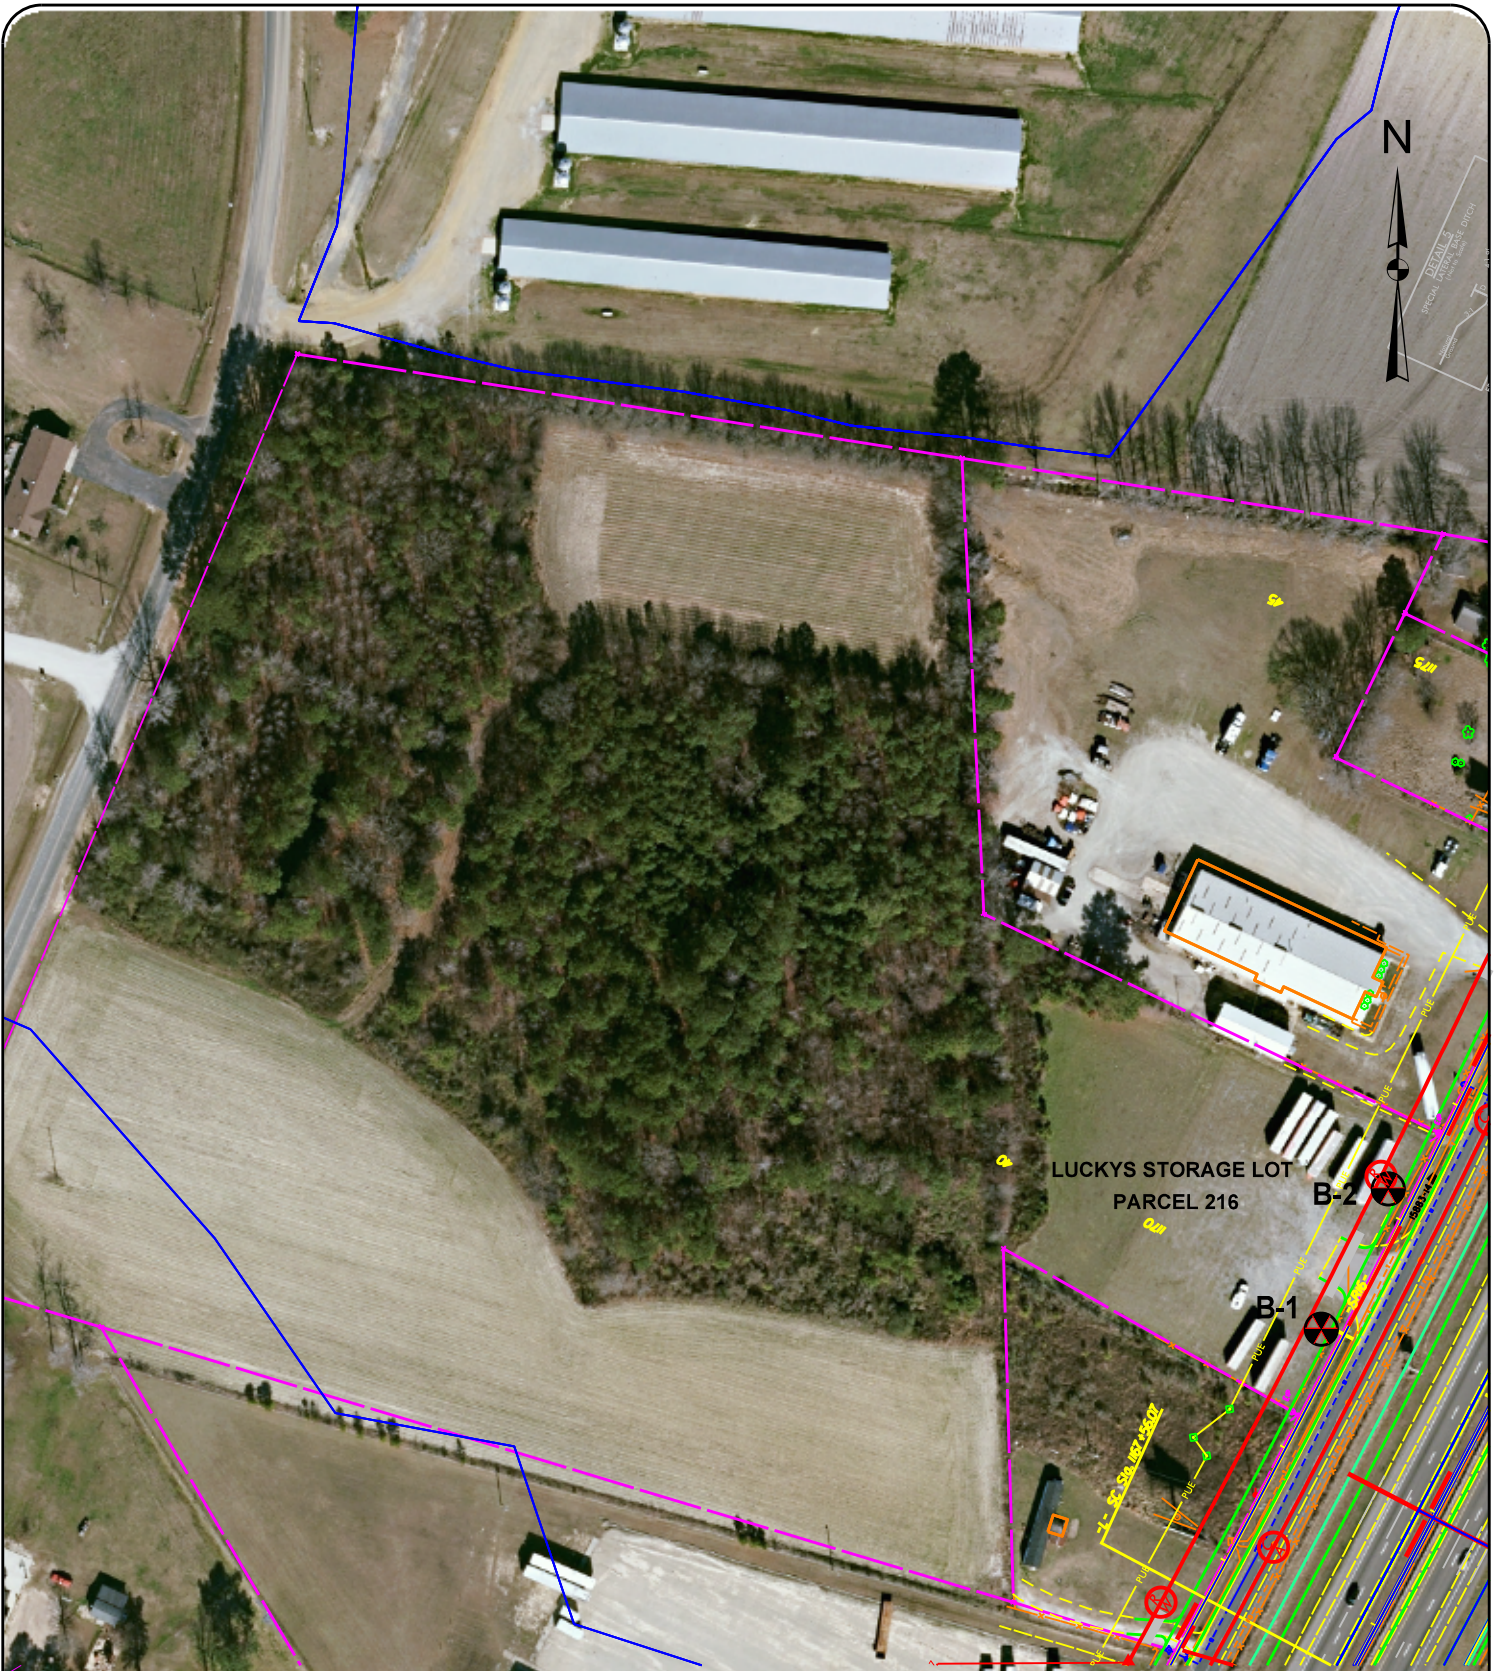
SITE MAP

On February 19, 2019, Troxler Geologic, Inc. (Troxler's) drill crew utilized a track mounted Geoprobe[®] rig to advance two soil borings (B-1 and B-2) and to collect soil samples within accessible areas of the proposed ROW/easement at Parcel 216. The approximate location of the soil borings are shown in **Figure 2**. A photographic log is included in **Appendix I**. Troxler's drill crew advanced the Geoprobe[®] borings to a depth of approximately 10 ft.-bgs. During the advancement of the soil borings, groundwater was not encountered. Soil samples were continuously collected in four-foot long disposable acetate-plastic sleeves that line the hollow stainless-steel sample probes. Soil recovered from the sleeves was classified on-site by S&ME personnel and screened with a Photoionization Detector (PID) at approximately two foot depth intervals to measure relative headspace concentrations of volatile organic compounds (VOCs).

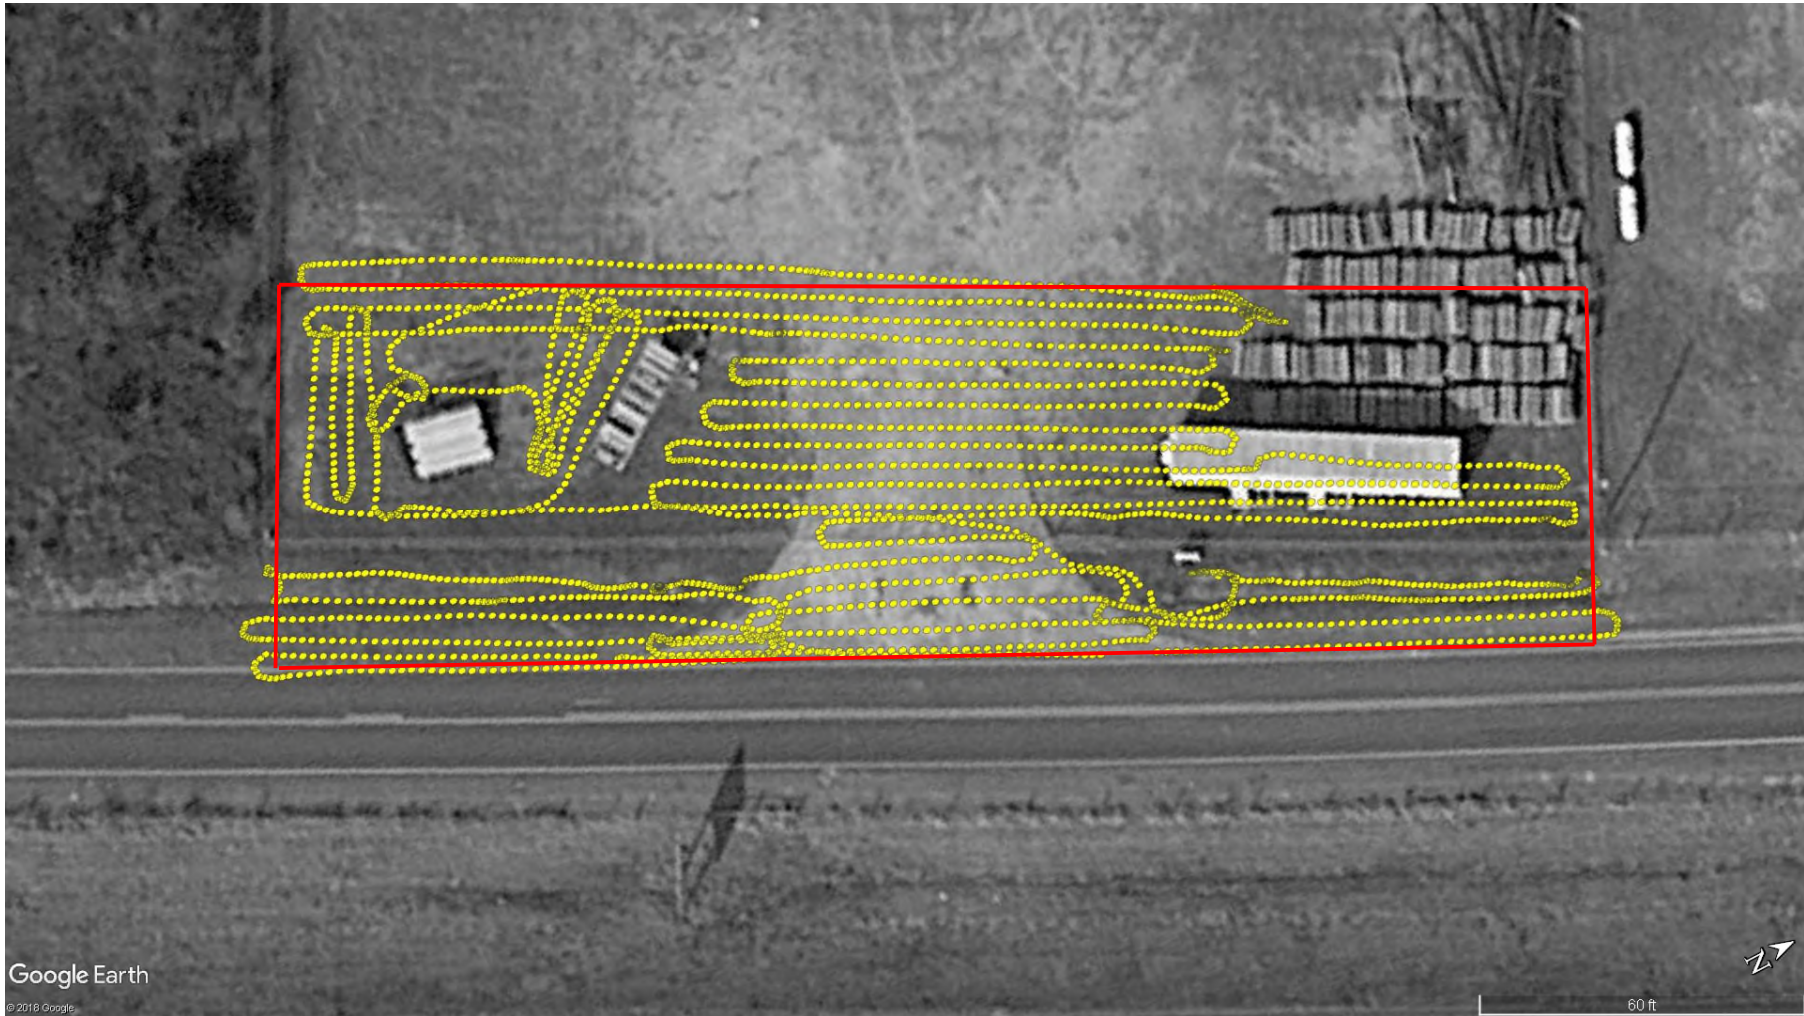
TDEM PATH LOCATION PLAN

We used a Geonics Limited EM-61 MK2 TDEM system in general accordance with ASTM D6820-02 (2007) "*Standard Guide for Use of the Time Domain Electromagnetic Method for Subsurface Investigation.*" Data was collected along lines spaced at approximately five feet using a Juniper® Systems Geode™ sub-meter GPS as positioning support. The presence of storage equipment, fences, and other surficial obstructions within the requested survey area however prevented TDEM data collection in several locations. The approximate TDEM data collection paths are presented in **Figure 4**. Golden Software's Surfer® program was used to grid and plot the data (**Figures 5 and 6**). The TDEM data has been presented as Plots A and B in order to provide both opaque and transparent views, respectively.

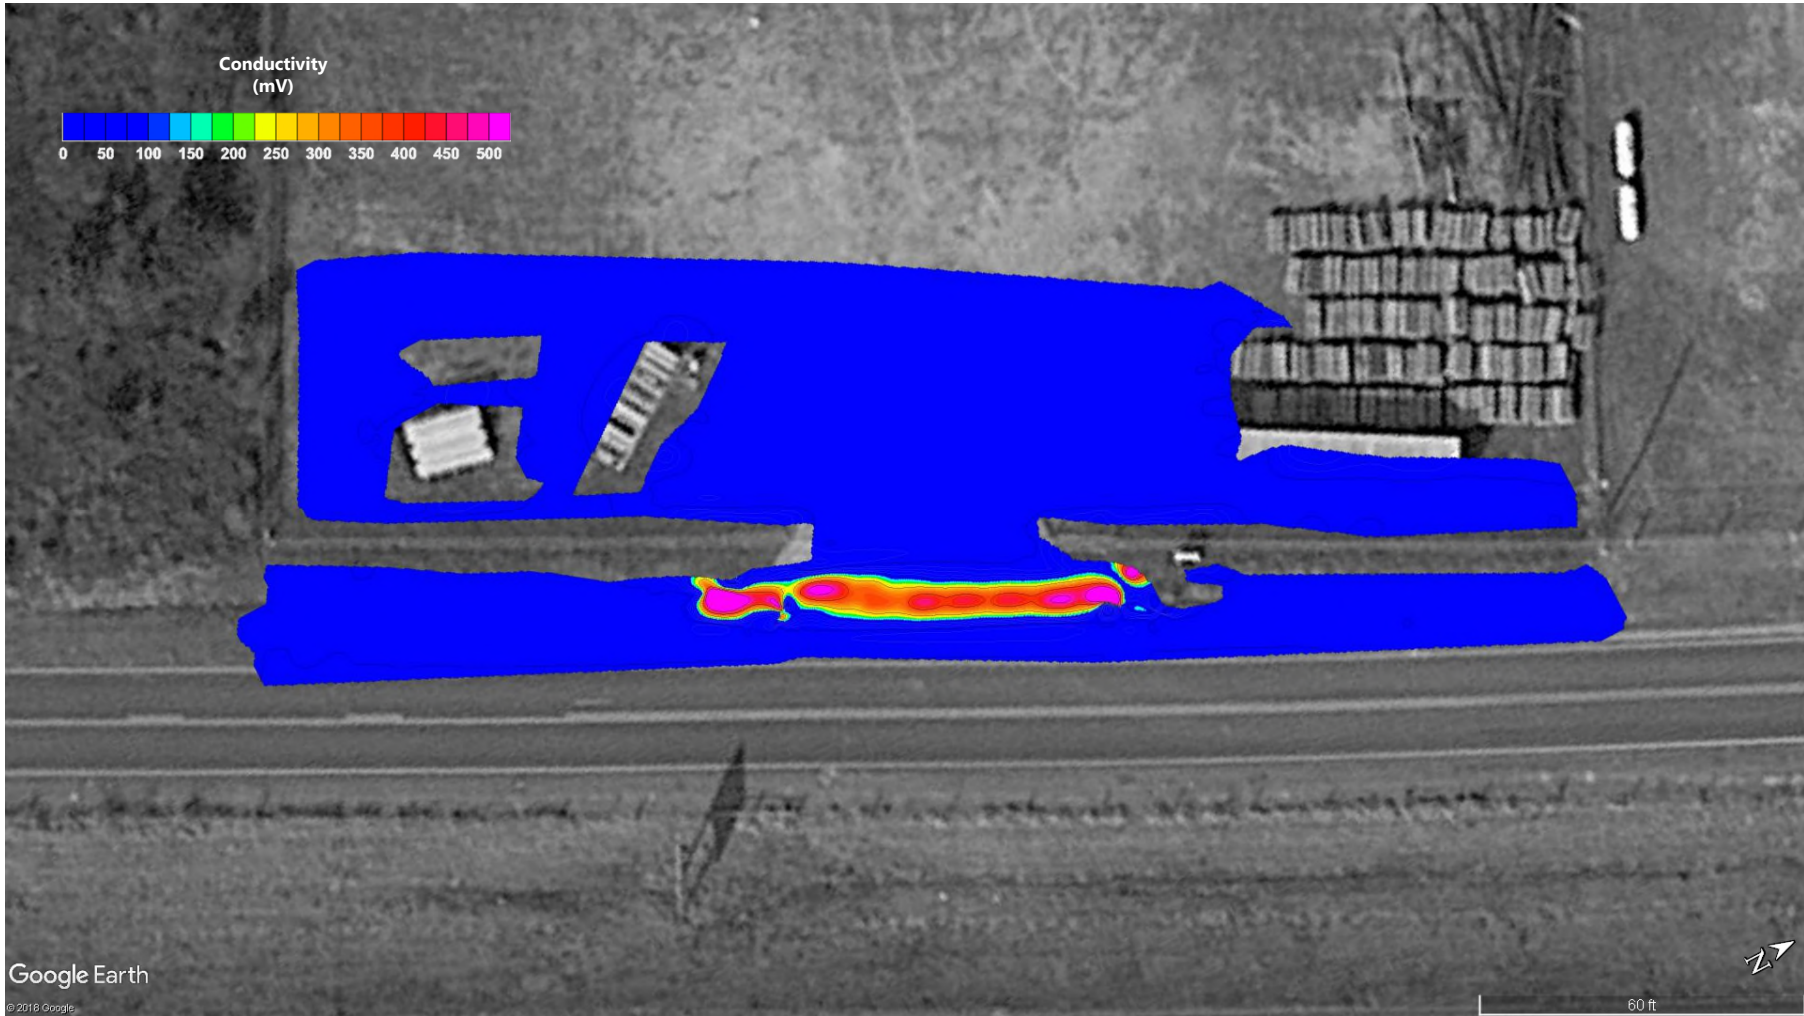
TDEM DATA PLOT A

Responses indicative of a potential UST were not identified in the geophysical data sets collected at the site. Anomalous features unrelated to known surficial targets were not identified in the geophysical data sets collected at the site. However, a culvert was identified under the paved entrance (**Figures 5 through 7**).

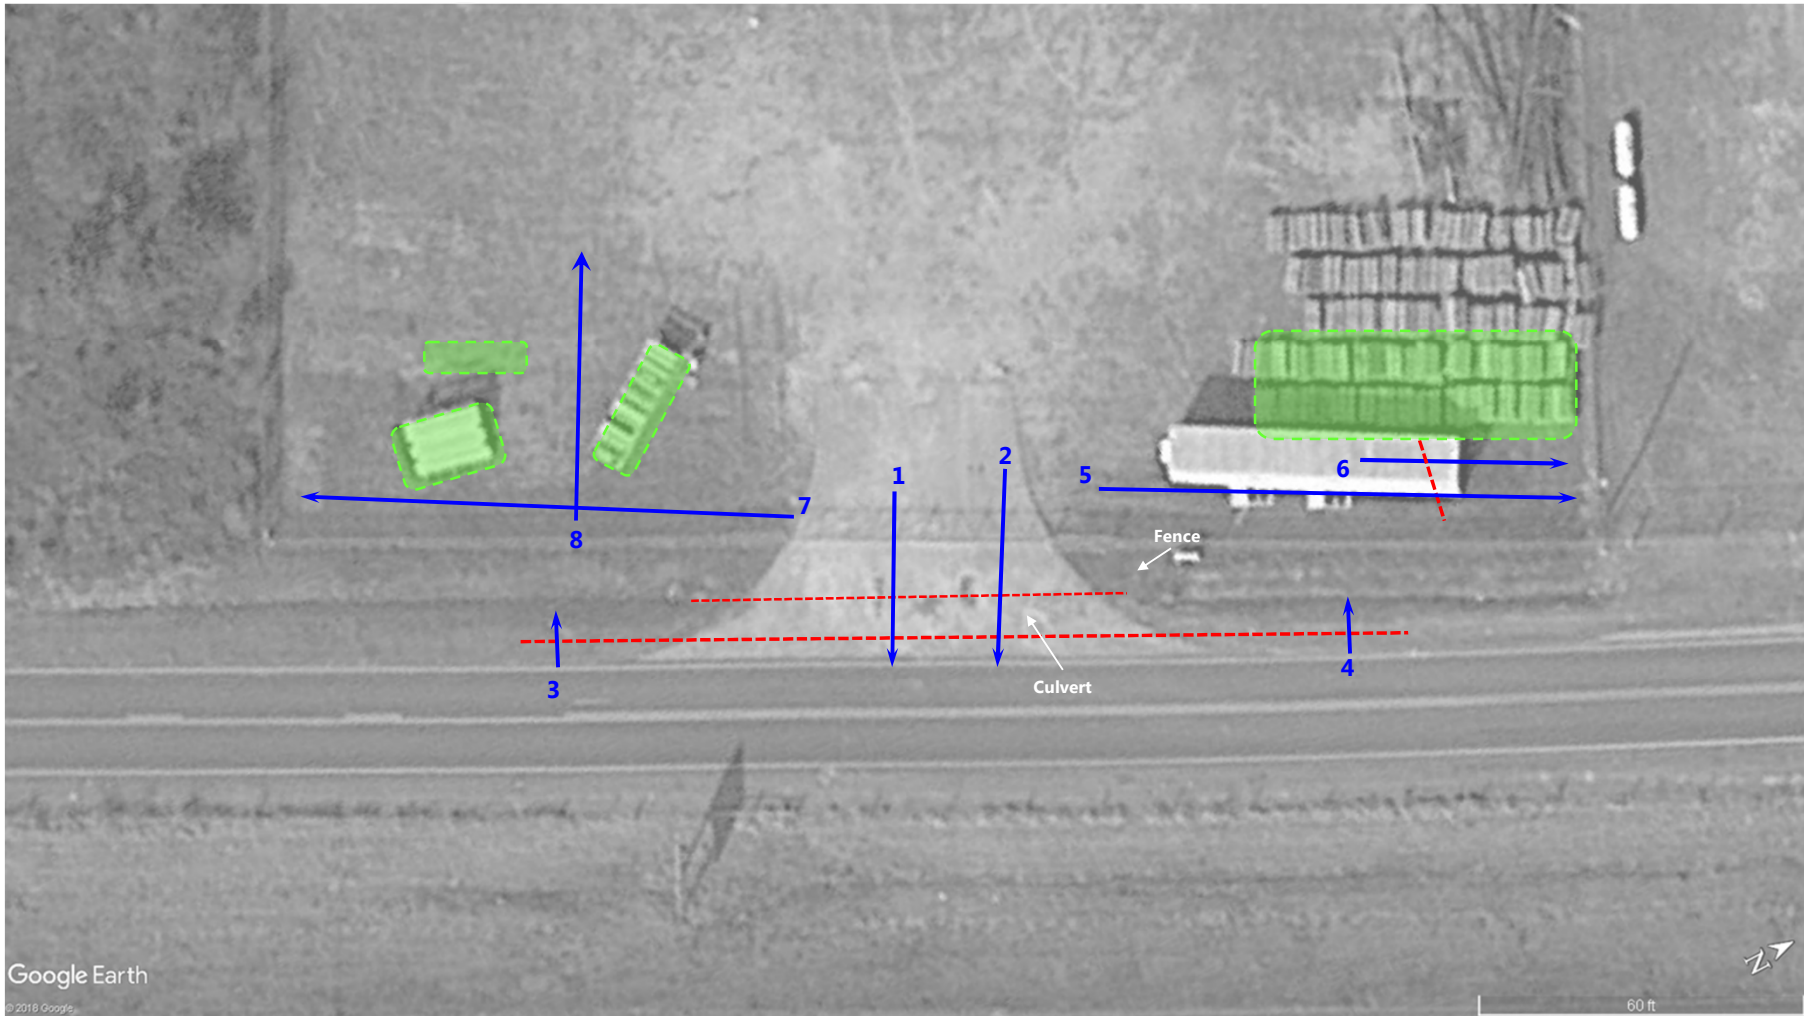
GEOPHYSICAL ANOMALY LOCATION PLAN

A total of eight GPR profiles (Lines 1 through 8) were collected for documentation (**Figure 7**). The data was post-processed using the GSSI Radan[®] 7 GPR software program for additional analysis.

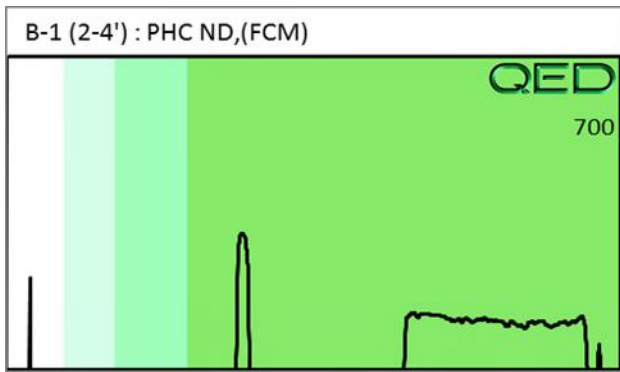
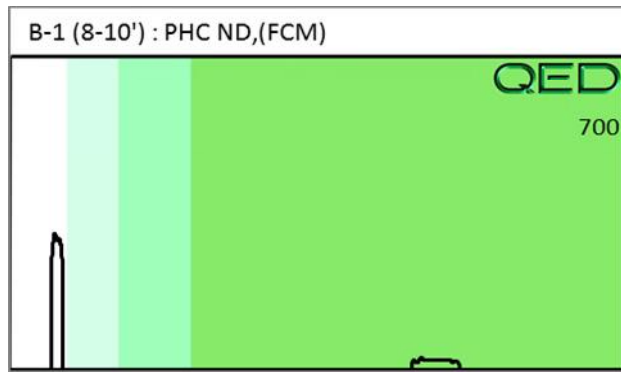
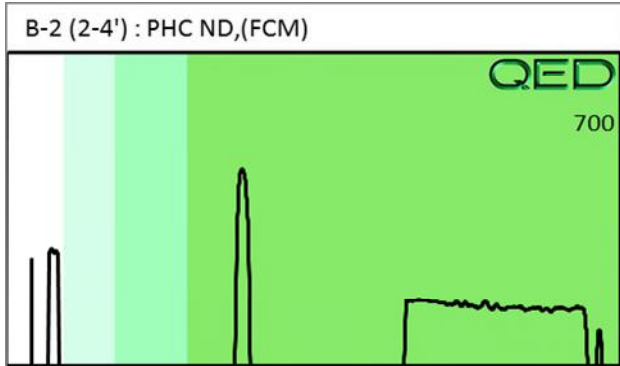
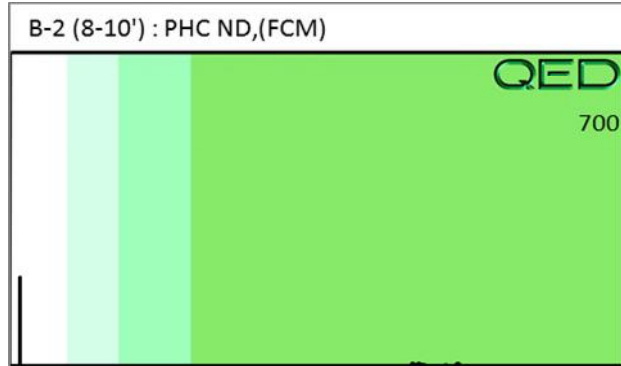
F03640		
Matrix	Sample ID	Dilution used	BTEX (C6 - C9)	GRO (C5 - C10)	DRO (C10 - C35)	TPH (C5 - C35)	Total Aromatics (C10-C35)	16 EPA PAHs	BaP	Ratios			HC Fingerprint Match
										% light	% mid	% heavy	
Soil	B-1 (2-4')	23.2	<0.58	<0.58	<0.23	<0.58	<0.01	<0.01	<0.007	0	0	0	PHC ND,(FCM)
Soil	B-1 (8-10')	17.4	<0.44	<0.44	<0.17	<0.44	<0.009	<0.009	<0.005	0	0	0	PHC ND,(FCM)
Soil	B-2 (2-4')	26.5	<0.66	<0.66	<0.27	<0.66	<0.01	<0.01	<0.008	0	0	0	PHC ND,(FCM)
Soil	B-2 (8-10')	24.1	<0.6	<0.6	<0.24	<0.6	<0.01	<0.01	<0.007	0	0	0	PHC ND,(FCM)
Initial Calibrator QC check			OK			Final FCM QC Check			OK			97.9%

Results generated by a QED HC-1 analyser. Concentration values in mg/kg for soil samples and mg/L for water samples. Soil values are not corrected for moisture or stone content
 Fingerprints provide a tentative hydrocarbon identification. The abbreviations are:- FCM = Results calculated using Fundamental Calibration Mode : % = confidence for sample fingerprint match to library
 (SBS) or (LBS) = Site Specific or Library Background Subtraction applied to result : (PFM) = Poor Fingerprint Match : (T) = Turbid : (P) = Particulate present
