Reference: **Preliminary Site Assessment Report**  
**NCDOT Project I-5986B, WBS Element 47532.1.3**  
**Parcel 214-Lucky's Truck and Trailer Sales**  
1185 Sadler Drive  
Dunn, Harnett County, North Carolina  
S&ME Project 4305-18-175A

**Preliminary Site Assessment Report  
NCDOT Project I-5986B, WBS Element 47532.1.3  
Parcel 214-Lucky's Truck and Trailer Sales  
Dunn, Harnett County, North Carolina  
S&ME Project No. 4305-18-175A**

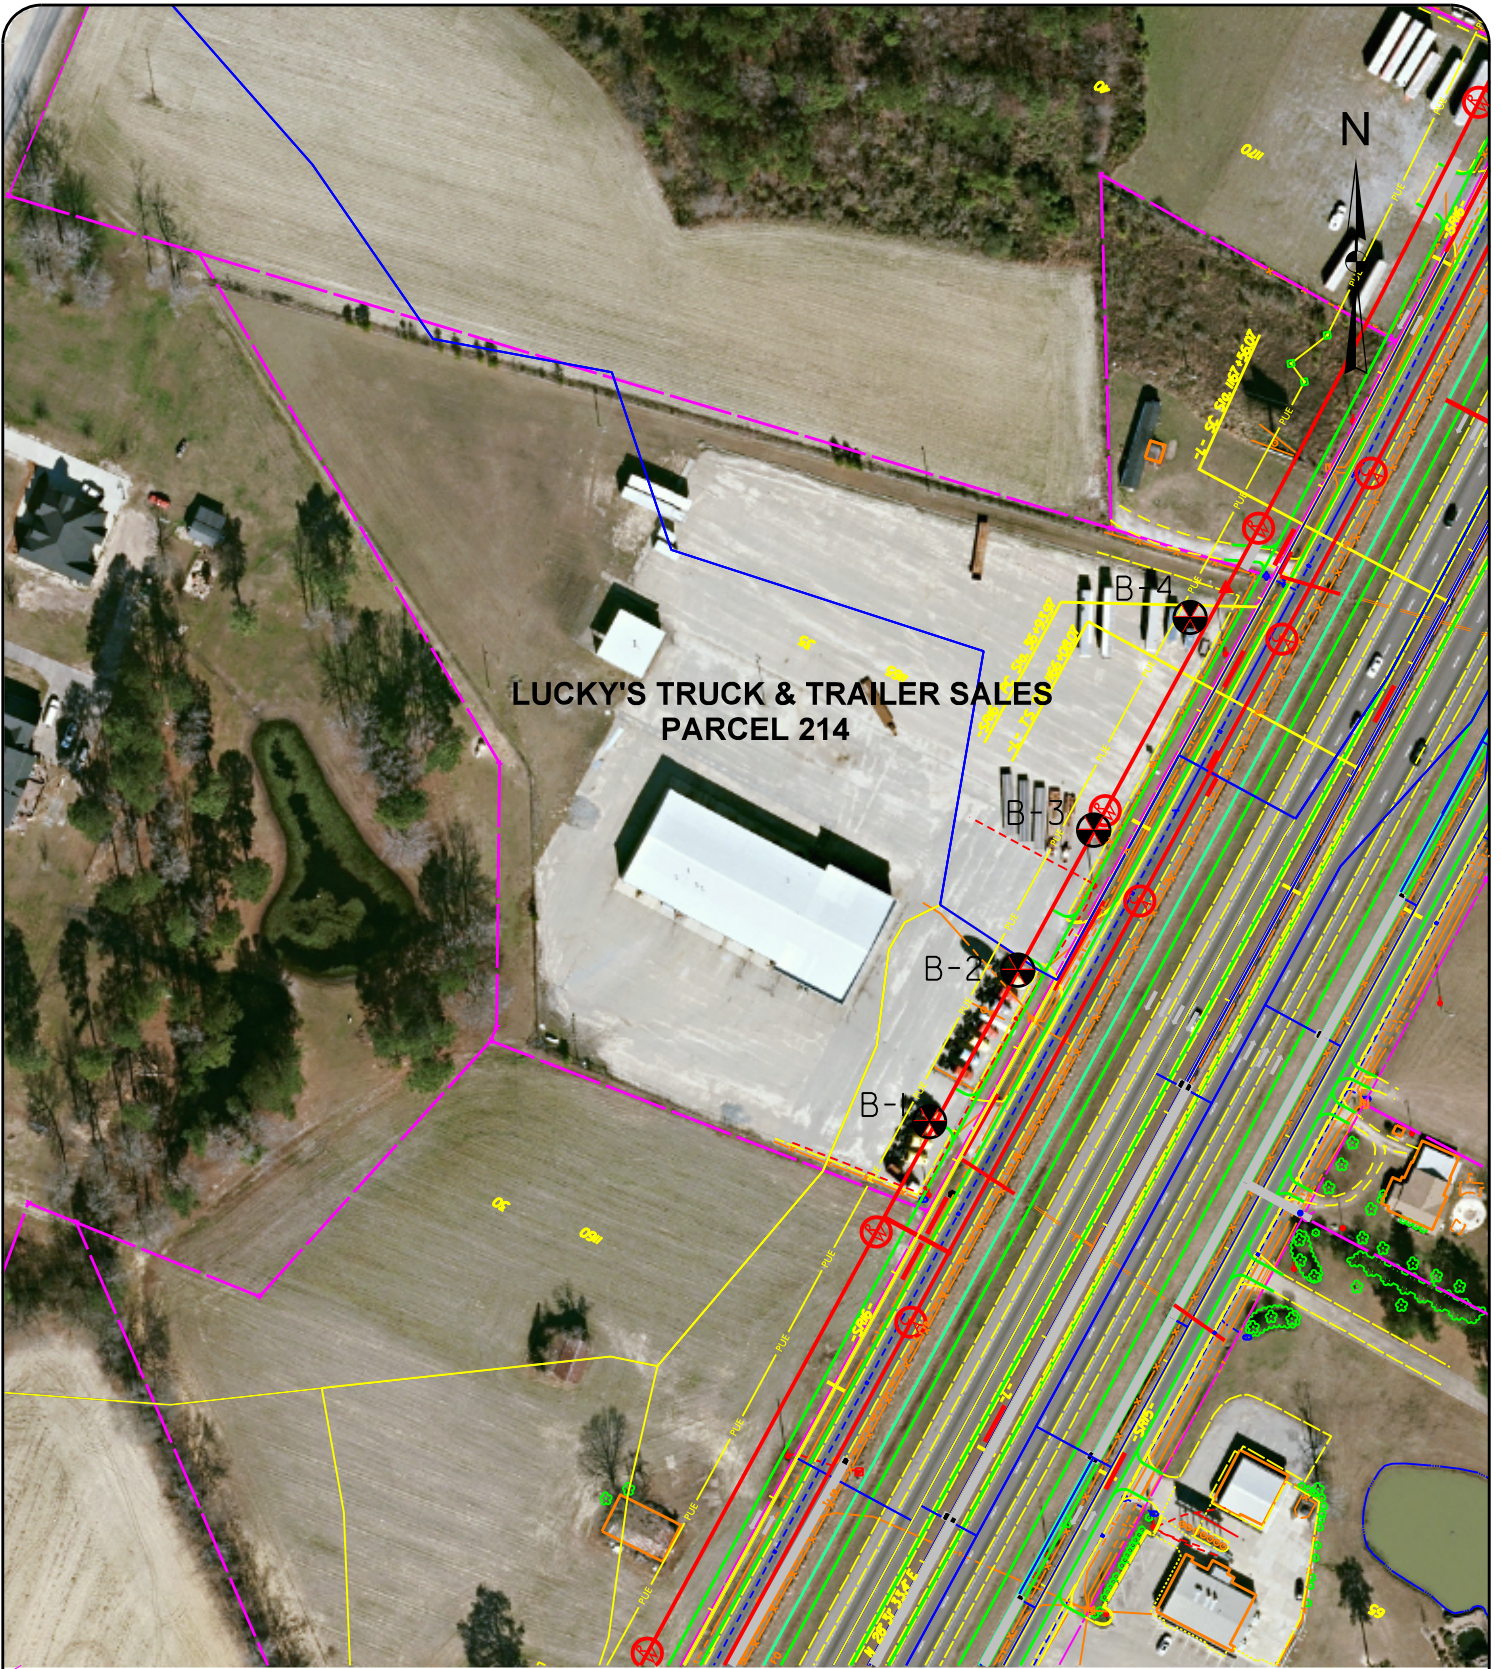
**SITE MAP**

groundwater sampling was not performed. **Figure 1** shows the vicinity and site location, and **Figure 2** shows the site and boring locations. Soil sampling results are shown on **Figure 3**.

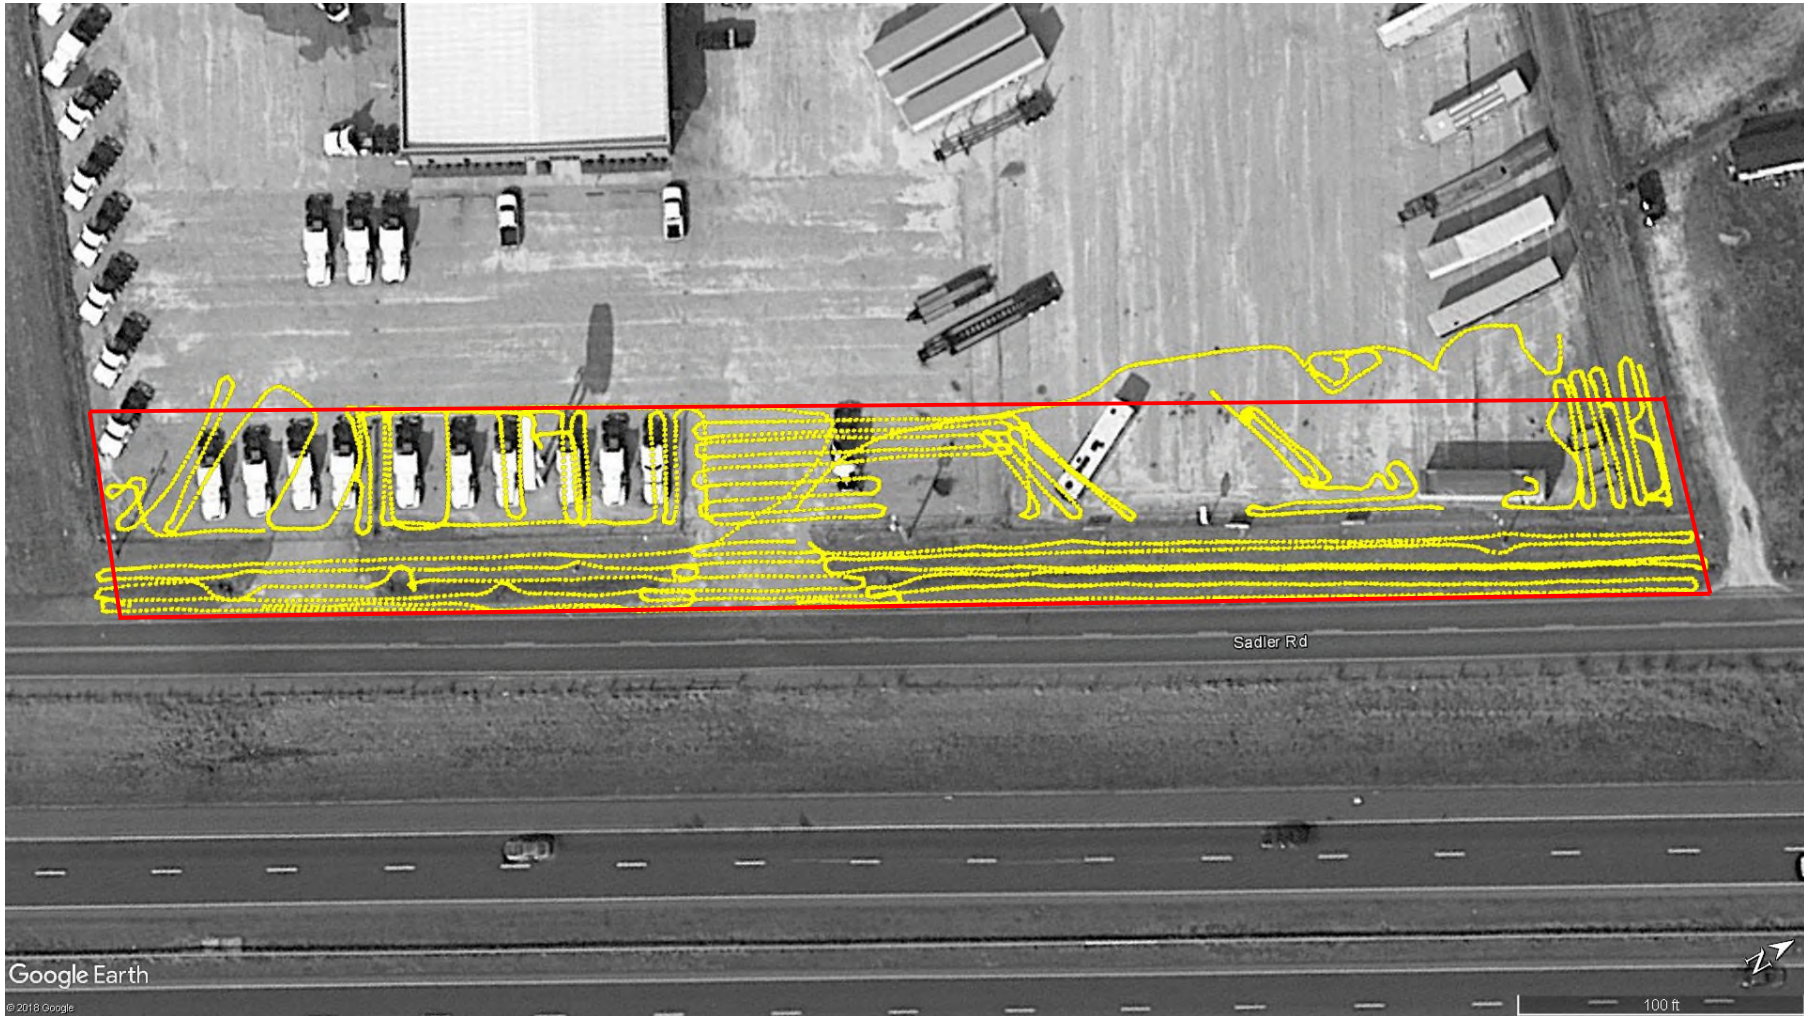
**TDEM PATH LOCATION PLAN**

We used a Geonics Limited EM-61 MK2 TDEM system in general accordance with ASTM D6820-02 (2007) "*Standard Guide for Use of the Time Domain Electromagnetic Method for Subsurface Investigation.*" Data was collected along lines spaced at approximately five feet using a Juniper® Systems Geode™ sub-meter GPS as positioning support. The presence of vehicles, fences, and other surficial obstructions within the requested survey area however prevented TDEM data collection in several locations. The approximate TDEM data collection paths are presented in **Figure 4**. Golden Software's Surfer® program was used to grid and plot the data (**Figures 5 and 6**). The TDEM data has been presented as Plots A and B in order to provide both opaque and transparent views, respectively.

- Approximate TDEM Path
- Approximate Requested Survey Area

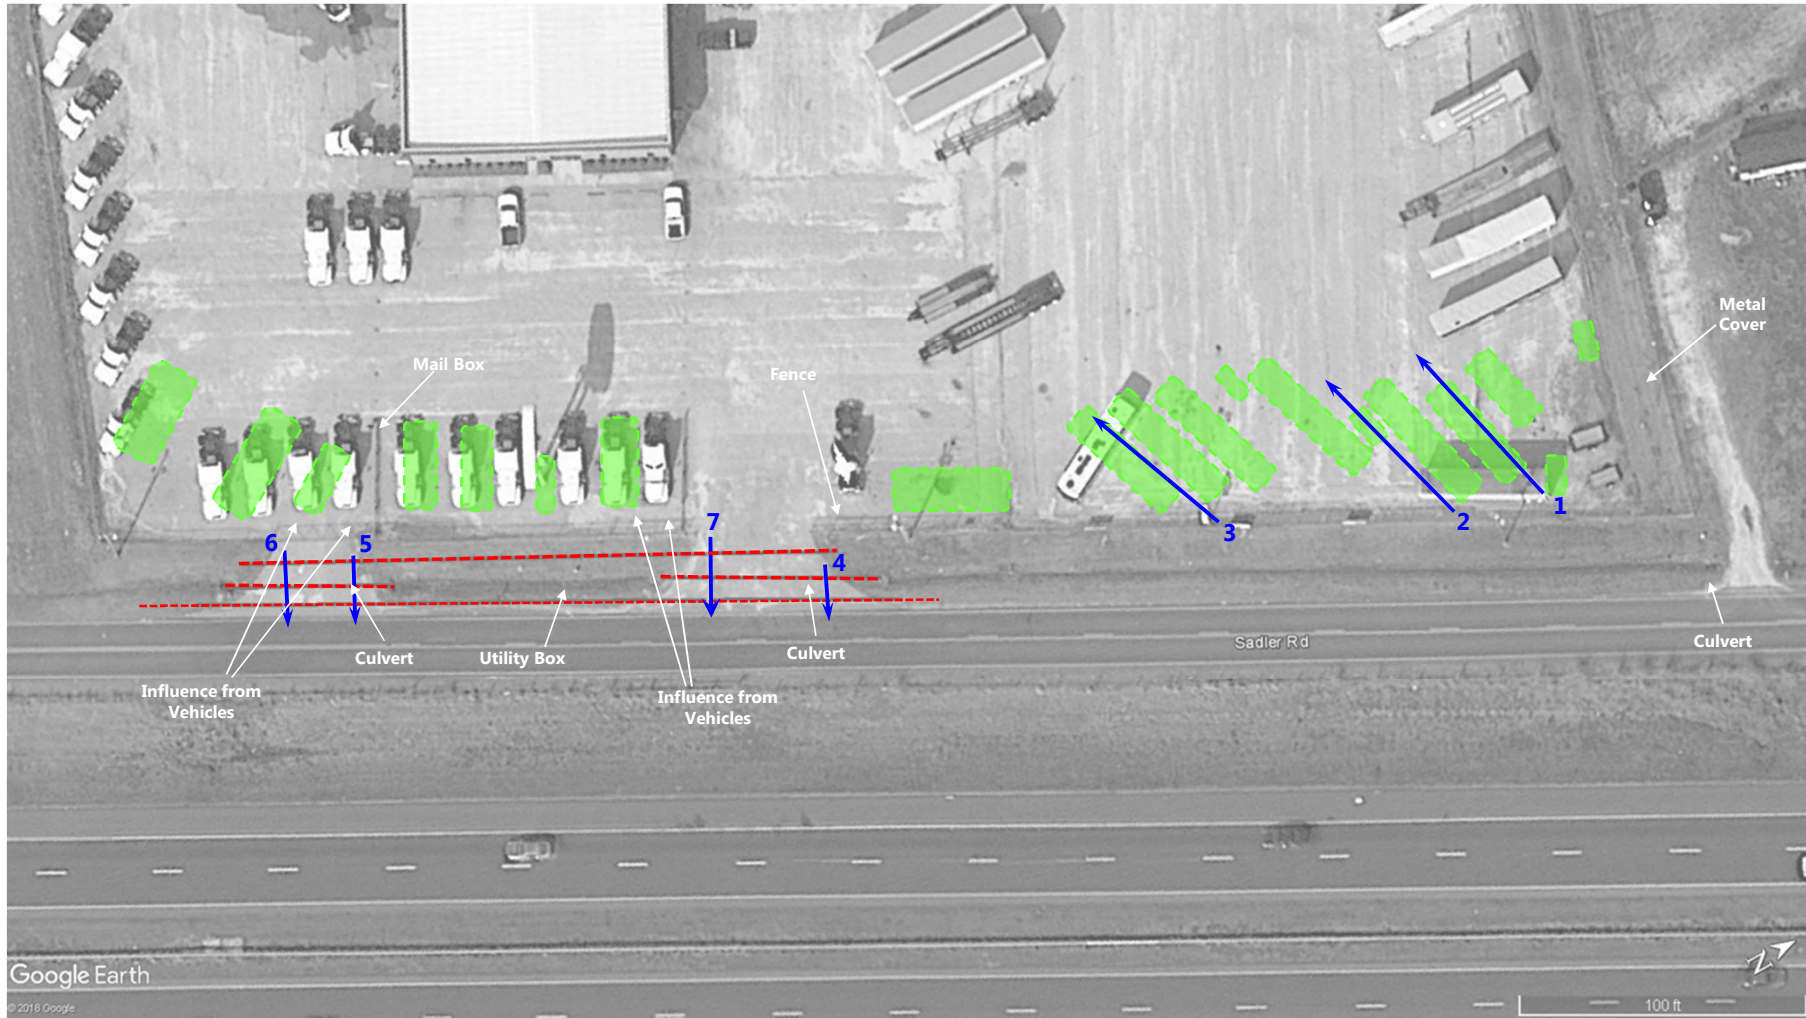
**GEOPHYSICAL ANOMALY LOCATION PLAN**

A total of seven GPR profiles (Lines 1 through 7) were collected for documentation (**Figure 7**). The data was post-processed using the GSSI Radan<sup>®</sup> 7 GPR software program for additional analysis.

Responses indicative of a potential UST were not identified in the geophysical data sets collected at the site. Anomalous features unrelated to known surficial targets were not identified in the geophysical data sets collected at the site. However, several potential utilities, including a culvert, were identified (**Figure 7**) and marked in the field with white spray paint.

- Approximate Location of GPR Profile
- Approximate Location of Vehicles
- Approximate Location of Possible Utility

The geophysical survey did not identify anomalous features unrelated to known surficial targets in the geophysical data sets collected at the site. However, several potential utilities, including a culvert, were identified. Responses indicative of a potential UST were not identified in the geophysical data sets collected at the site.

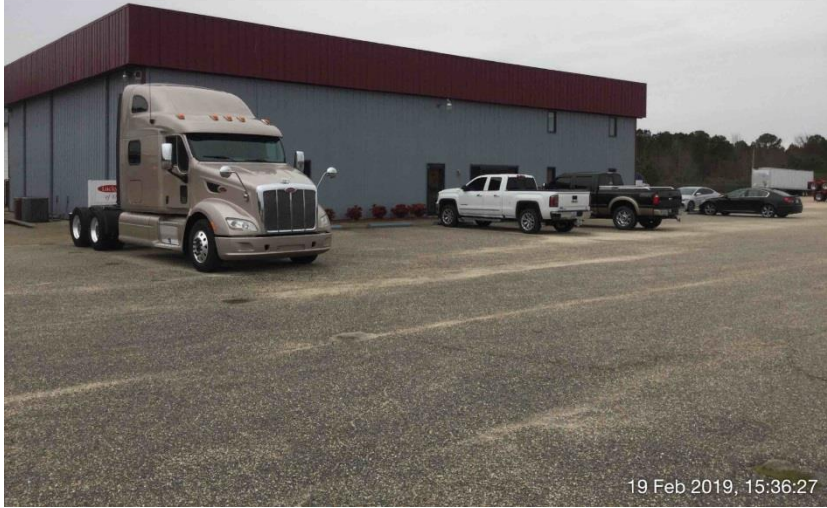
<div style="text-align: right; font-size: 0.7em; margin-top: 5px;">19 Feb 2019, 15:36:27</div> </div>	<div style="border: 1px solid black; padding: 5px; margin-bottom: 5px;">Date: 2/19/2019</div> <div style="border: 1px solid black; padding: 5px;">Photographer: JTH</div>				
	<table border="1" style="width: 100%; border-collapse: collapse;"> <tr> <td style="width: 30%; padding: 5px;"><b>Location / Orientation</b></td> <td style="padding: 5px;">Front view of site looking northwest.</td> </tr> <tr> <td style="padding: 5px;"><b>Remarks</b></td> <td style="padding: 5px;">None</td> </tr> </table>	<b>Location / Orientation</b>	Front view of site looking northwest.	<b>Remarks</b>	None	
<b>Location / Orientation</b>	Front view of site looking northwest.					
<b>Remarks</b>	None

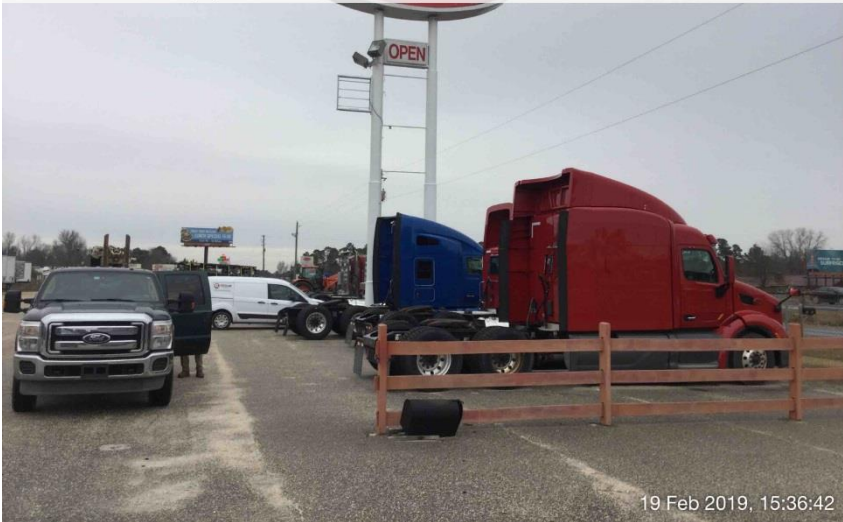
<div style="text-align: right; font-size: 0.7em; margin-top: 5px;">19 Feb 2019, 15:36:42</div> </div>	<div style="border: 1px solid black; padding: 5px; margin-bottom: 5px;">Date: 2/19/2019</div> <div style="border: 1px solid black; padding: 5px;">Photographer: JTH</div>				
	<table border="1" style="width: 100%; border-collapse: collapse;"> <tr> <td style="width: 30%; padding: 5px;"><b>Location / Orientation</b></td> <td style="padding: 5px;">Front view of site looking northeast.</td> </tr> <tr> <td style="padding: 5px;"><b>Remarks</b></td> <td style="padding: 5px;">None</td> </tr> </table>	<b>Location / Orientation</b>	Front view of site looking northeast.	<b>Remarks</b>	None	
<b>Location / Orientation</b>	Front view of site looking northeast.					
<b>Remarks</b>	None

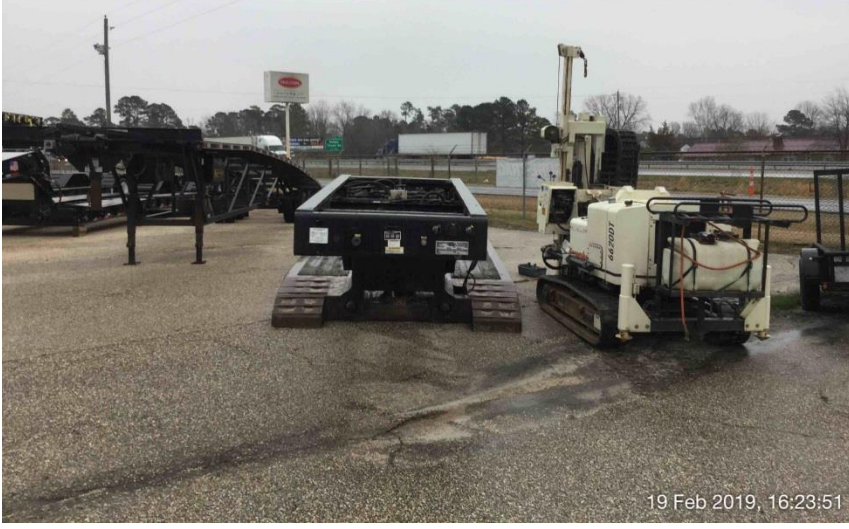
Photographer: JTH
3	Location / Orientation	Front view of site looking southeast.
	Remarks	Note soil boring B-3

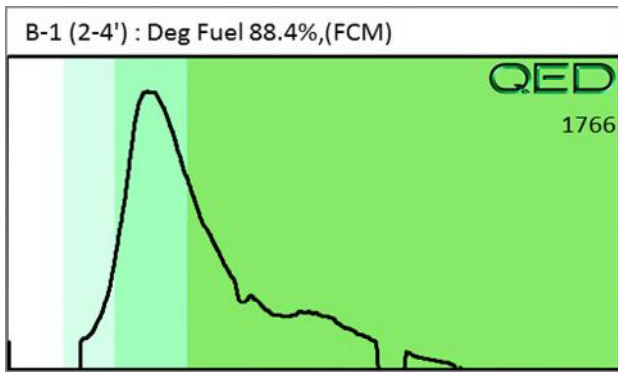
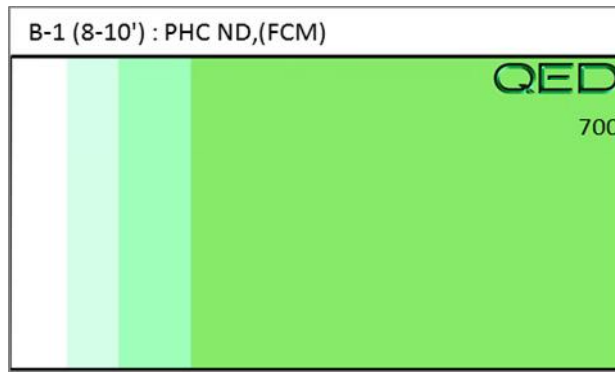
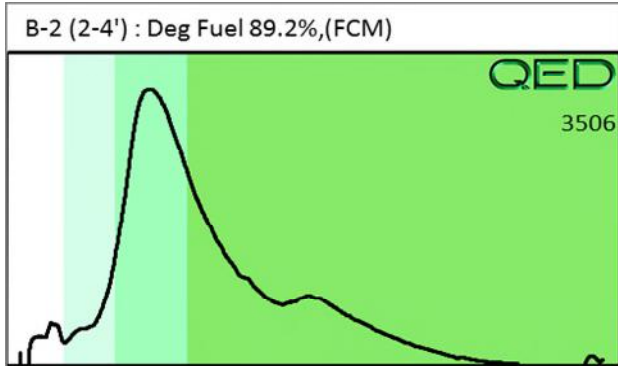
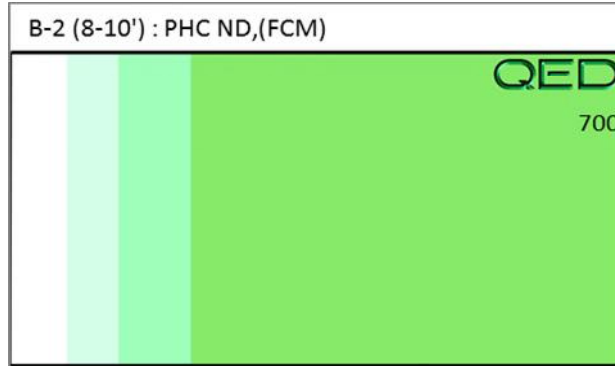
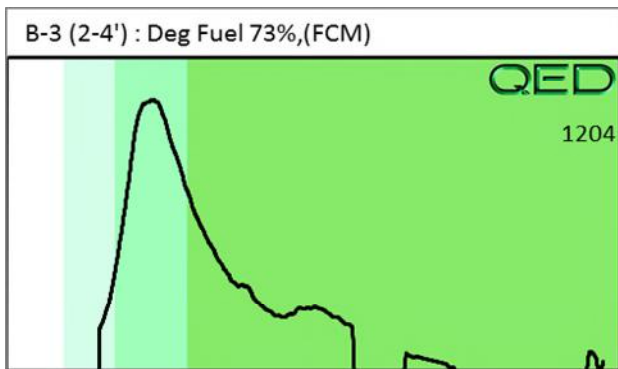
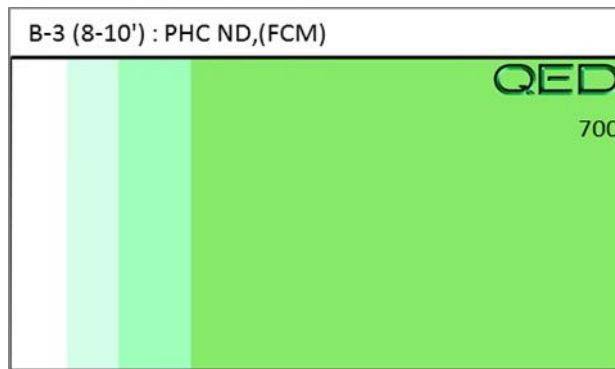
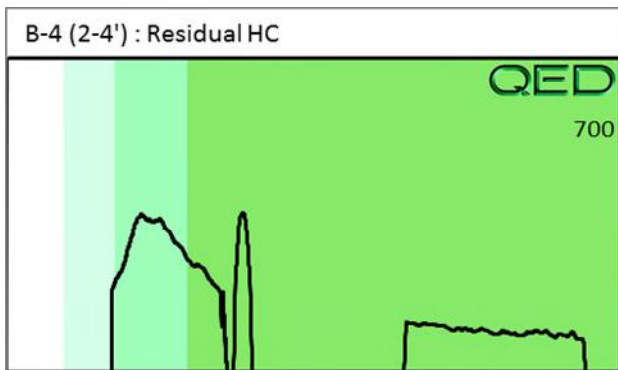
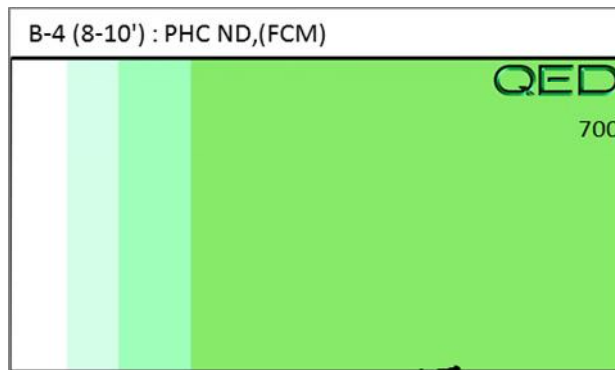
F03640		
Matrix	Sample ID	Dilution used	BTEX (C6 - C9)	GRO (C5 - C10)	DRO (C10 - C35)	TPH (C5 - C35)	Total Aromatics (C10-C35)	16 EPA PAHs	BaP	Ratios			HC Fingerprint Match
										% light	% mid	% heavy	
Soil	B-1 (2-4')	31.3	<0.78	<0.78	2.3	2.3	0.92	0.05	<0.009	0	92	8	Deg Fuel 88.4%,(FCM)
Soil	B-1 (8-10')	9.8	<0.24	<0.24	<0.1	<0.24	<0.005	<0.005	<0.001	0	0	0	PHC ND,(FCM)
Soil	B-2 (2-4')	25.1	<0.63	1.8	3.8	5.6	1.4	0.07	0.001	61.3	35.5	3.1	Deg Fuel 89.2%,(FCM)
Soil	B-2 (8-10')	22.8	<0.57	<0.57	<0.23	<0.57	<0.01	<0.01	<0.007	0	0	0	PHC ND,(FCM)
Soil	B-3 (2-4')	18.3	<0.46	<0.46	0.88	0.88	0.52	0.01	<0.005	0	87.2	12.8	Deg Fuel 73%,(FCM)
Soil	B-3 (8-10')	11.4	<0.28	<0.28	<0.11	<0.28	<0.006	<0.006	<0.001	0	0	0	PHC ND,(FCM)
Soil	B-4 (2-4')	21.8	<0.55	<0.55	0.1	0.1	0.09	0.009	<0.007	0	100	0	Residual HC
Soil	B-4 (8-10')	24.3	<0.61	<0.61	<0.24	<0.61	<0.01	<0.01	<0.007	0	0	0	PHC ND,(FCM)
Initial Calibrator QC check			OK			Final FCM QC Check			OK			107.9%

Results generated by a QED HC-1 analyser. Concentration values in mg/kg for soil samples and mg/L for water samples. Soil values are not corrected for moisture or stone content  
 Fingerprints provide a tentative hydrocarbon identification. The abbreviations are:- FCM = Results calculated using Fundamental Calibration Mode : % = confidence for sample fingerprint match to library  
 (SBS) or (LBS) = Site Specific or Library Background Subtraction applied to result : (PFM) = Poor Fingerprint Match : (T) = Turbid : (P) = Particulate present
