Reference: Preliminary Site Assessment Report

NCDOT Project I-5878, WBS Element 53078.1.1
Parcel 200-Word A Fire Ministries-Former T-Mart

S&ME Project 4305-19-161

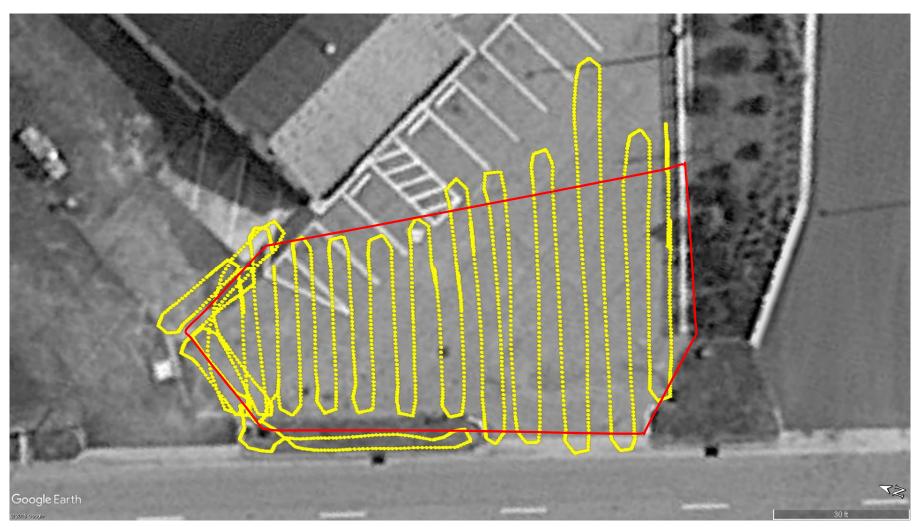
Approximate TDEM Path

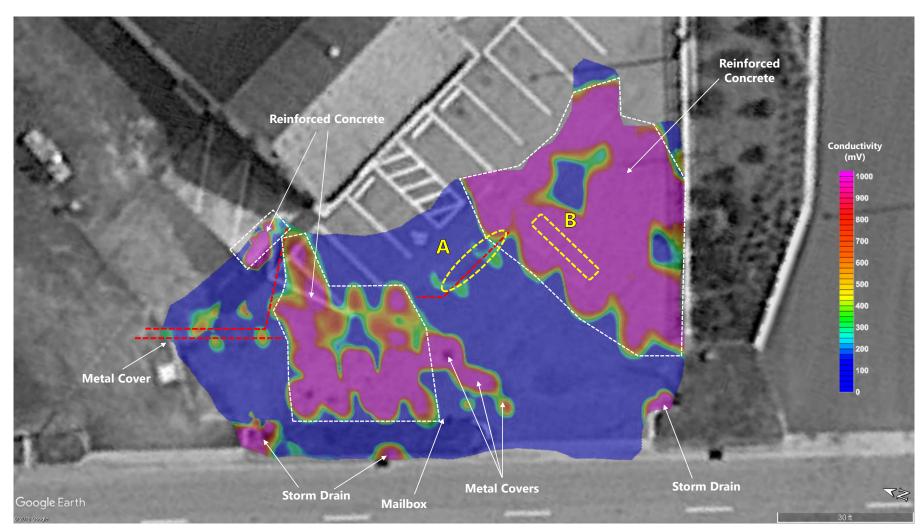
Approximate Location of GPR Profile

A total of 12 GPR profiles (Lines 1 through 12) were collected for documentation (**Figure 7**). The data was post-processed using the GSSI Radan® 7 GPR software program for additional analysis.

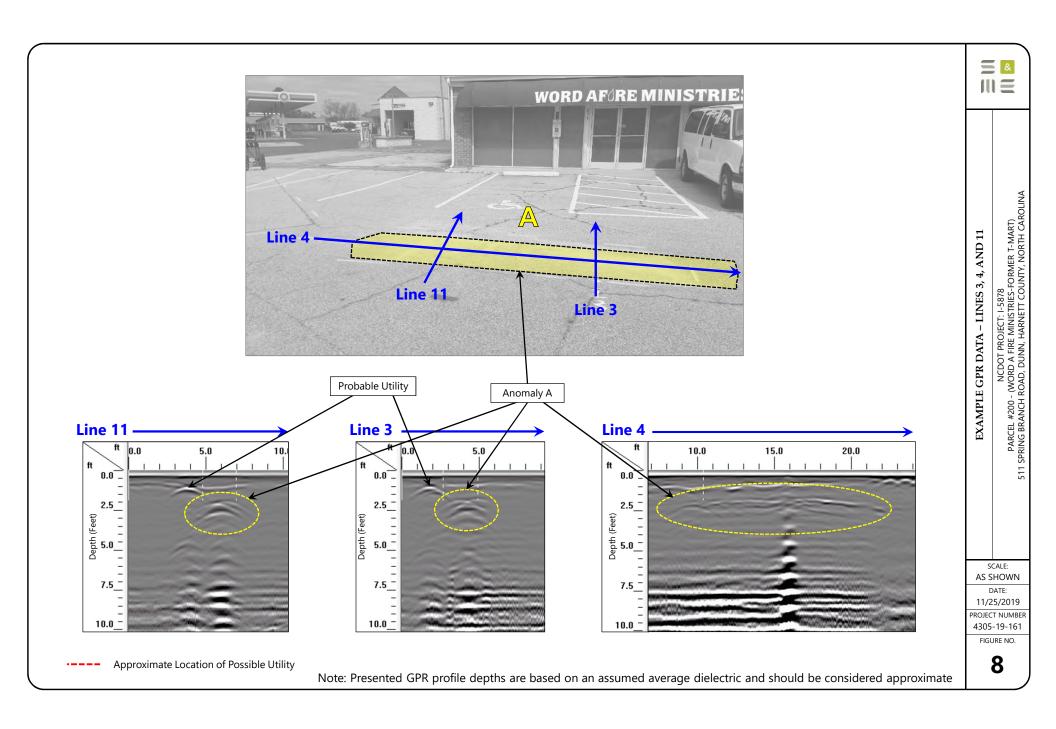
linear structure. Anomaly B is located beneath a reinforced concrete slab, and as such, material type of this feature (i.e. metal, etc.) is unable to be determined. Given the similar dimensions as Anomaly A, Anomaly B may also be related to an abandoned buried utility or other buried linear structure. The anomalies were marked in the field using white spray paint. Example GPR profiles are presented in **Figures 8 and 9**.
