Preliminary Site Assessment

I-95 Interchange Improvement

Parcel 287 PSH 42 - HQ Corporation of Benson, Inc.

TIP No. I-5986B

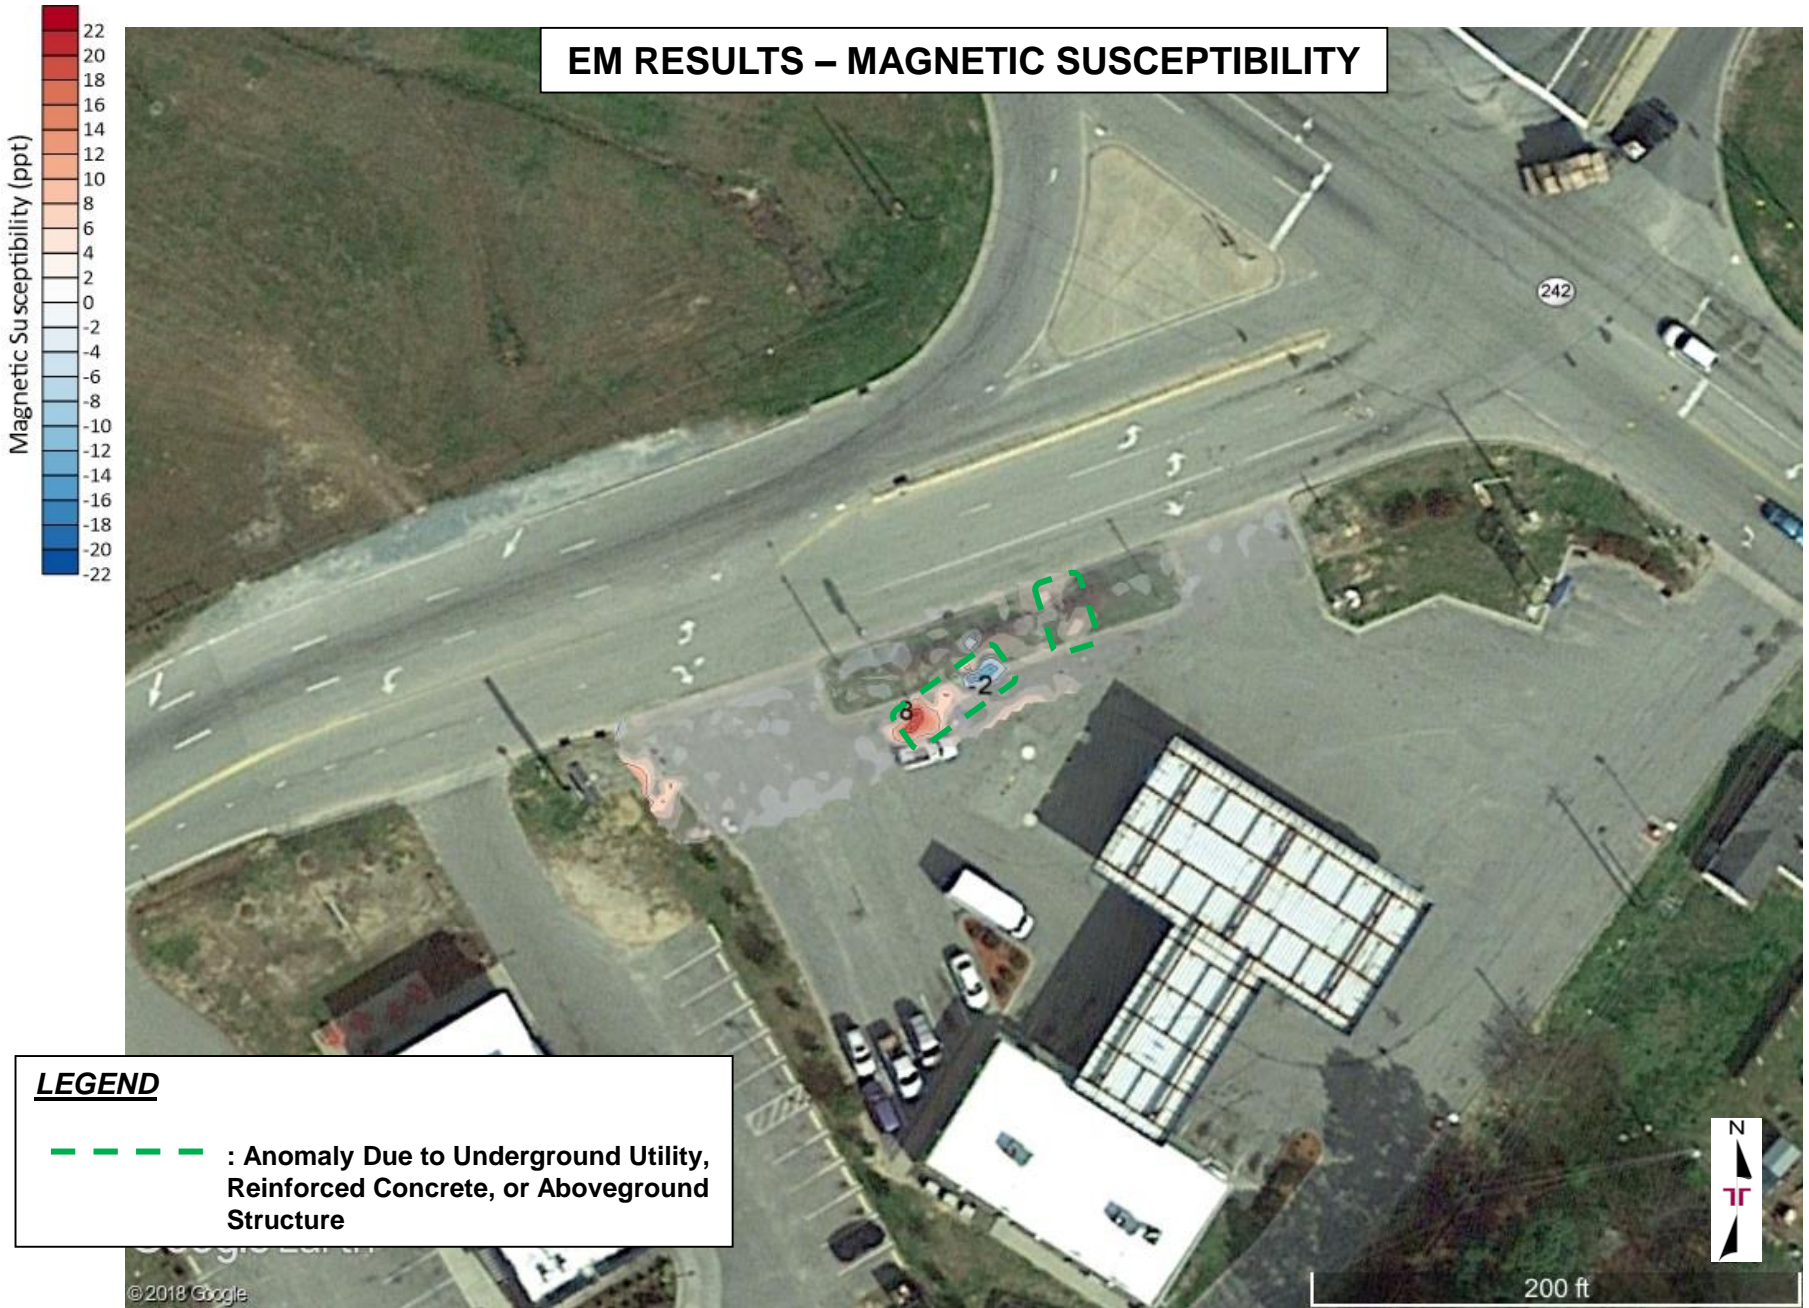
EM RESULTS – MAGNETIC SUSCEPTIBILITY

Terracon reviewed the EM and GPR data collected. Due to interference from multiple buried utilities and above-ground structures, anomalies consistent with USTs could not be isolated from the EM data. In general, soil conductivity measurements between -50 to 50 mS/m and magnetic susceptibility measurements between -5 to 5 ppt were considered “background”. Measurements outside of these ranges were interpreted to be caused by above or below ground anomalies. The depth of EM signal penetration is approximately 8-feet below the existing grade, however, the actual depth is not produced from the data collected. Upon review of the GPR data, anomalies consistent with USTs were not identified. Depth of GPR signal penetration across the site was approximately 8 feet below the existing grade.
