Reference: **Preliminary Site Assessment Report**
NCDOT Project I-5986B, WBS Element 47532.1.3
Parcel 126-Mid-Atlantic Equipment
40 George Perry Lee Road
Dunn, Harnett County, North Carolina
S&ME Project 4305-18-175A

Preliminary Site Assessment Report
NCDOT Project I-5986B, WBS Element 47532.1.3
Parcel 138- Love's Truck Stop
Dunn, Harnett County, North Carolina
S&ME Project No. 4305-18-175A

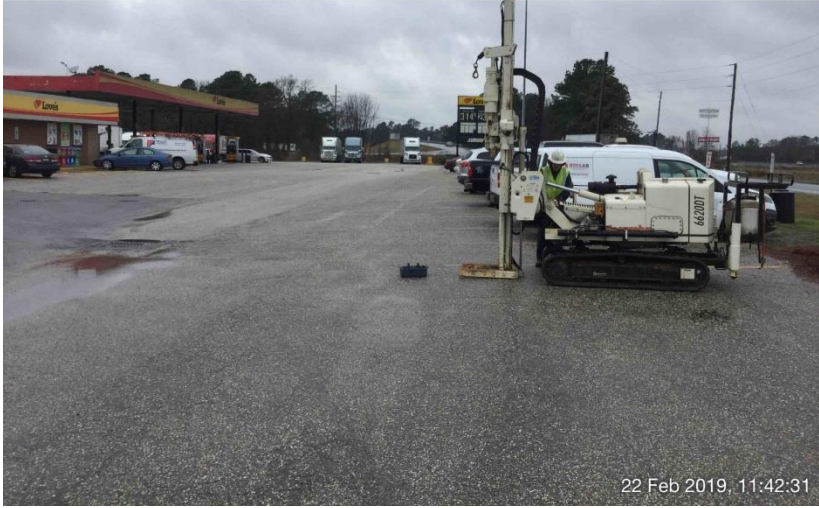
1	<table border="1" style="width: 100%; border-collapse: collapse;"> <tr> <td style="width: 40%; padding: 2px;">Location / Orientation</td> <td style="padding: 2px;">Front view of site looking northwest.</td> </tr> <tr> <td style="padding: 2px;">Remarks</td> <td style="padding: 2px;">Note soil boring B-2.</td> </tr> </table>	Location / Orientation	Front view of site looking northwest.	Remarks	Note soil boring B-2.	<div style="border: 1px solid black; padding: 5px;"> <div style="display: flex; justify-content: space-between; border-bottom: 1px solid black; margin-bottom: 5px;"> W NW N NE </div> <div style="display: flex; justify-content: space-between; border-bottom: 1px solid black; margin-bottom: 5px;"> 240 270 300 330 0 30 60 </div> <div style="display: flex; justify-content: space-between; border-bottom: 1px solid black; margin-bottom: 5px;"> ⊗ 334°NW (T) ⊙ 35°20'23"N, 78°33'23"W ±16.4ft ▲ 308ft </div>

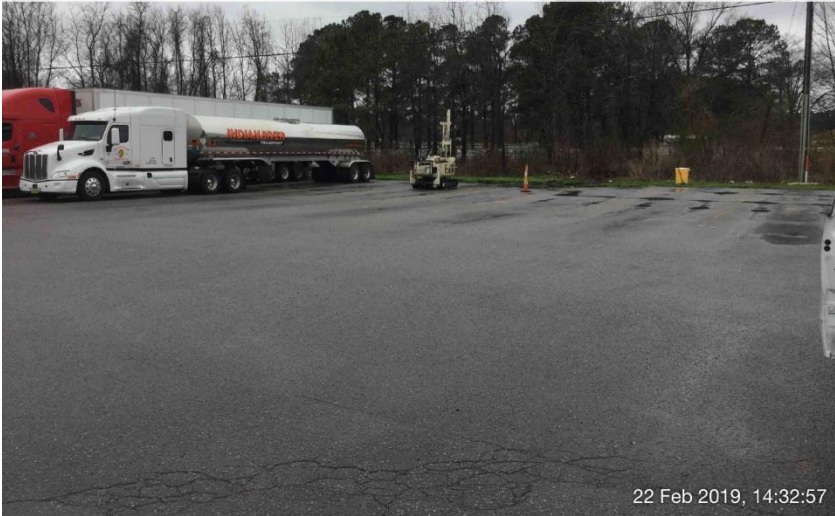
2	<table border="1" style="width: 100%; border-collapse: collapse;"> <tr> <td style="width: 40%; padding: 2px;">Location / Orientation</td> <td style="padding: 2px;">View of northern portion of site looking northwest.</td> </tr> <tr> <td style="padding: 2px;">Remarks</td> <td style="padding: 2px;">Note soil boring B-6.</td> </tr> </table>	Location / Orientation	View of northern portion of site looking northwest.	Remarks	Note soil boring B-6.	<div style="border: 1px solid black; padding: 5px;"> <div style="display: flex; justify-content: space-between; border-bottom: 1px solid black; margin-bottom: 5px;"> SW W NW N </div> <div style="display: flex; justify-content: space-between; border-bottom: 1px solid black; margin-bottom: 5px;"> 10 240 270 300 330 0 30 </div> <div style="display: flex; justify-content: space-between; border-bottom: 1px solid black; margin-bottom: 5px;"> ⊗ 305°NW (T) ⊙ 35°20'26"N, 78°33'25"W ±16.4ft ▲ 309ft </div>
