## Preliminary Site Assessment Report

November 16, 2018  
WBS Element: 44625.1.1  
State Project: U-5888  
Haywood County

**Derek Scott Oates and Jennifer Fish Oates Property**

**Parcel #011**

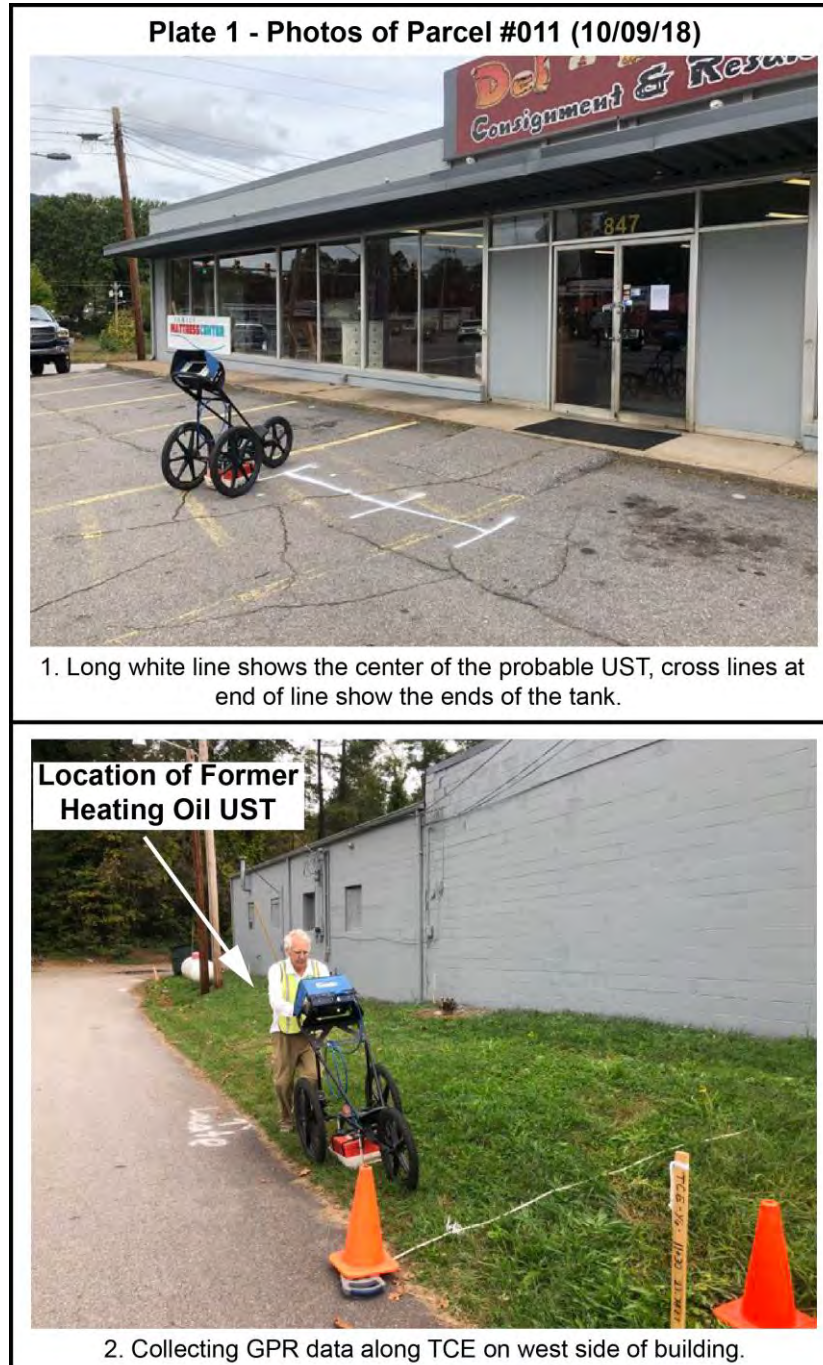
## 2.2 Plate 1 – Photos of Parcel #011

Seramur and Associates personnel made a pedestrian reconnaissance of the property during the initial site visit on September 25, 2018. At that time, the proposed work area was marked with white paint for utility locating purposes. A utility locate request was initiated with the North Carolina 811 system on October 14, 2018, approximately one week before commencing with drilling.

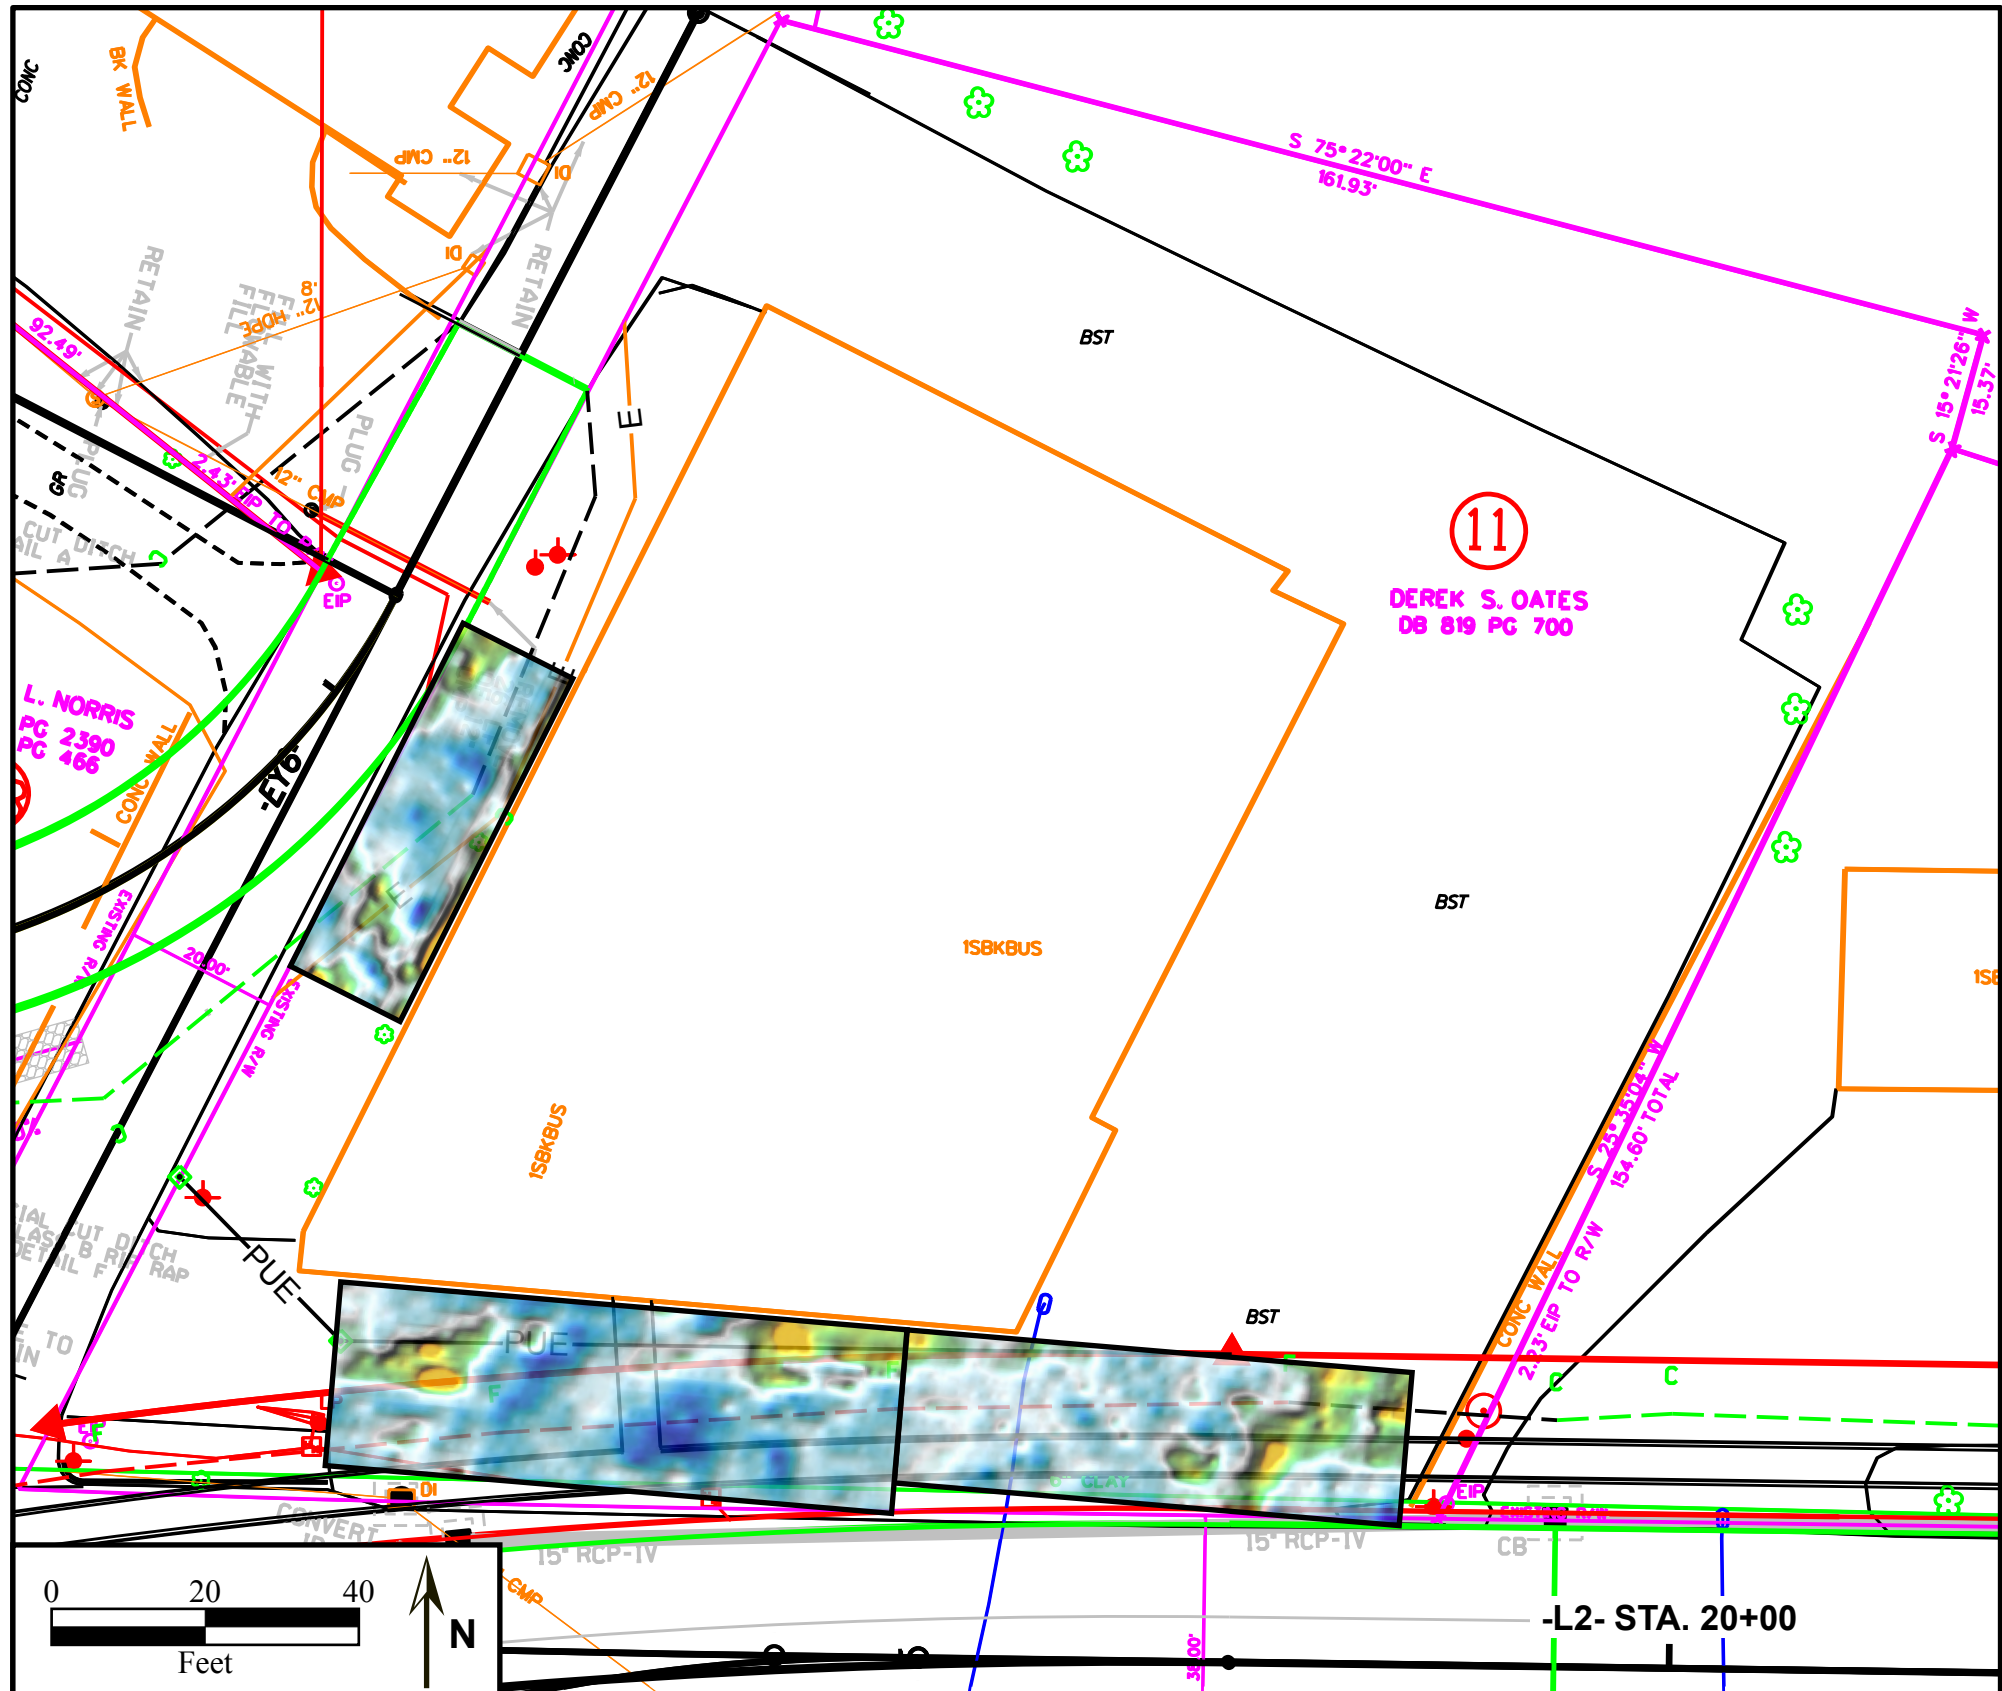
<p><b>Figure 5</b> Shallow GPR Depth Slices (0.3 - 0.8 ft.)</p>	<p>State Project: U-5888 Haywood County, NC</p>	<p>Derek S. Oates Property 847 N Main Street Waynesville, NC</p>	<p>Parcel #011 Facility I.D.: N/A</p>	<p>Seramur &amp; Associates, PC Boone, NC</p>
---	---	--	---	---

The shallow GPR depth slices (0.3-0.8 feet) imaged disorganized areas of high amplitude reflections in a background of medium to low amplitude reflections. There was no evidence of buried infrastructure observed at this depth.

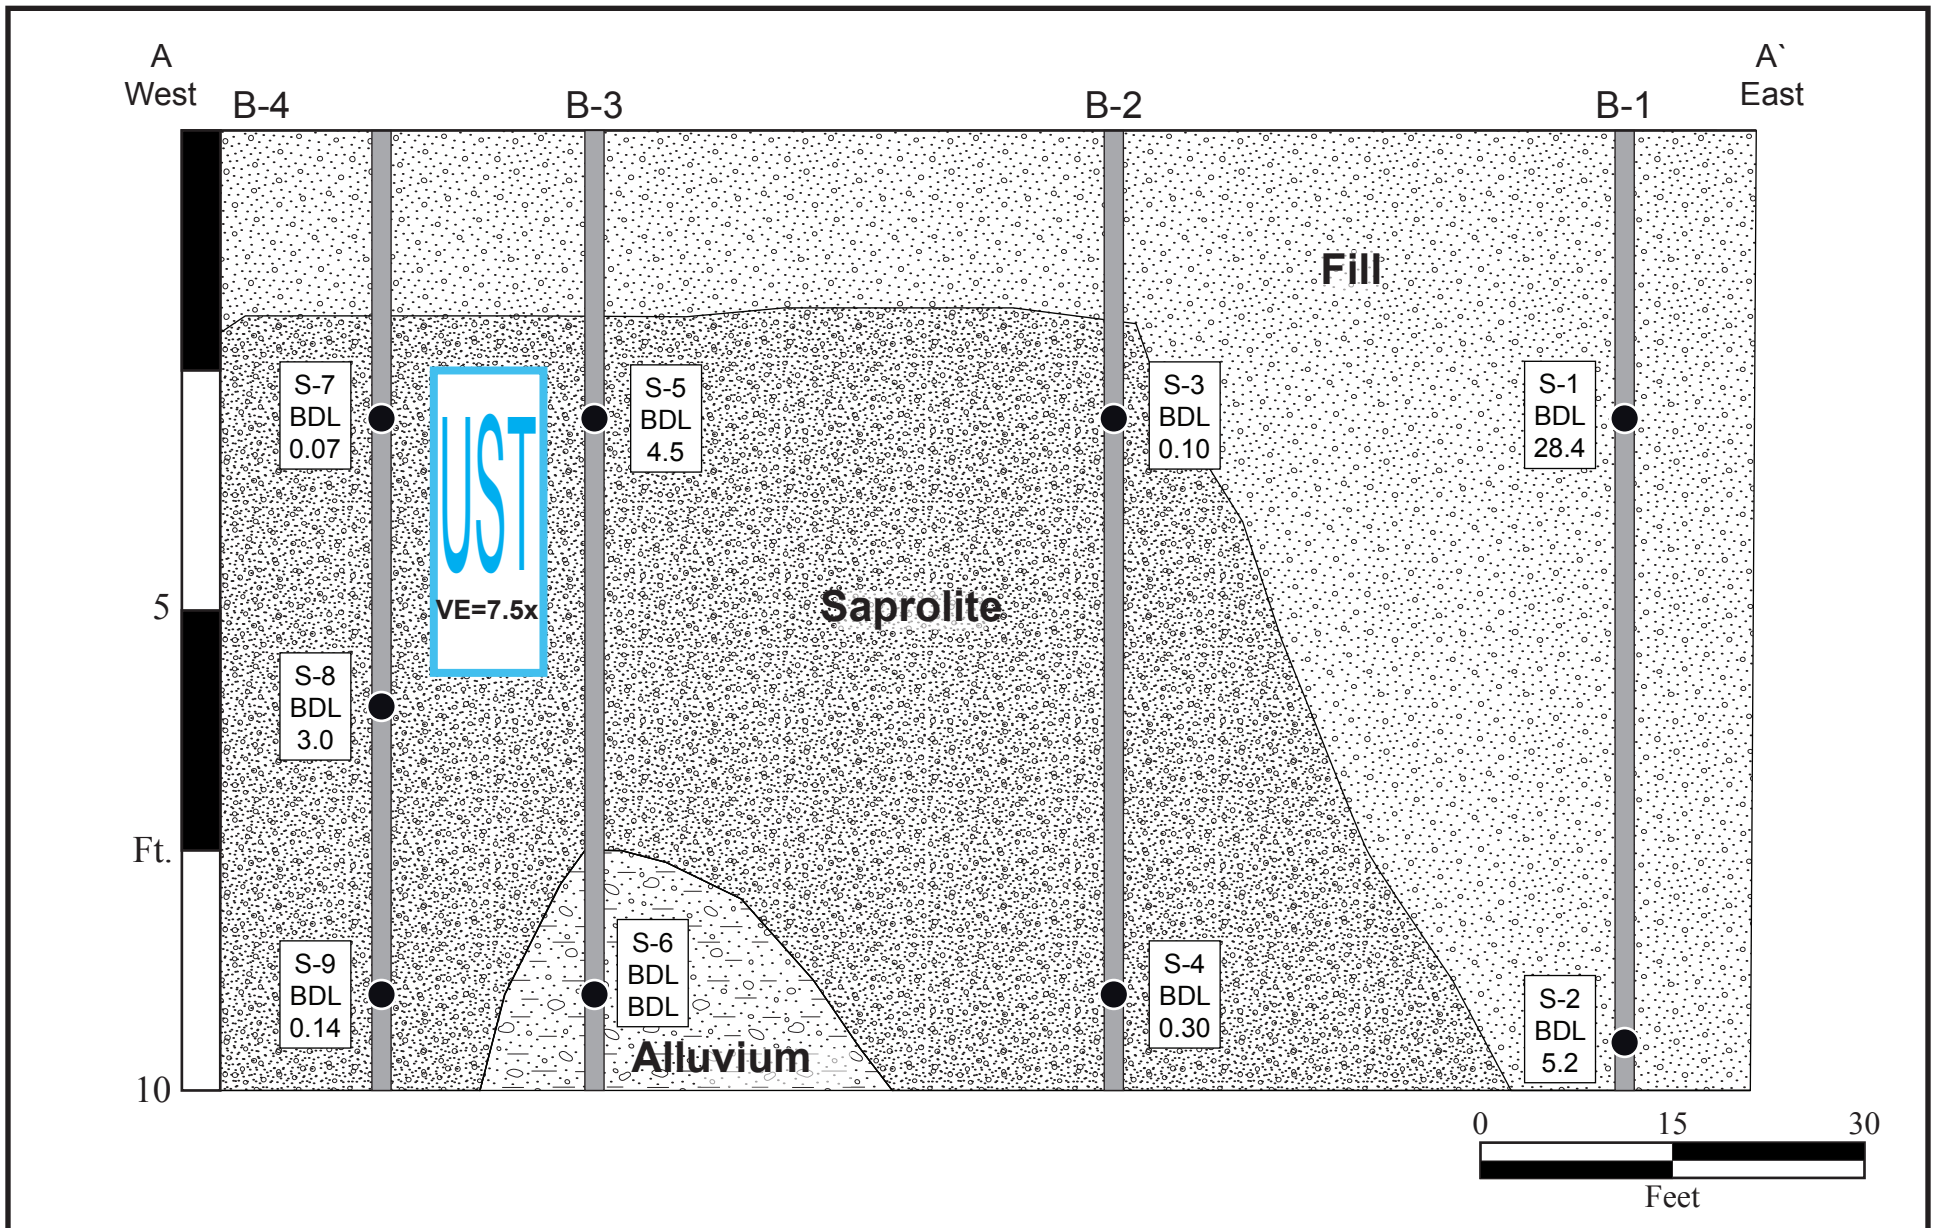
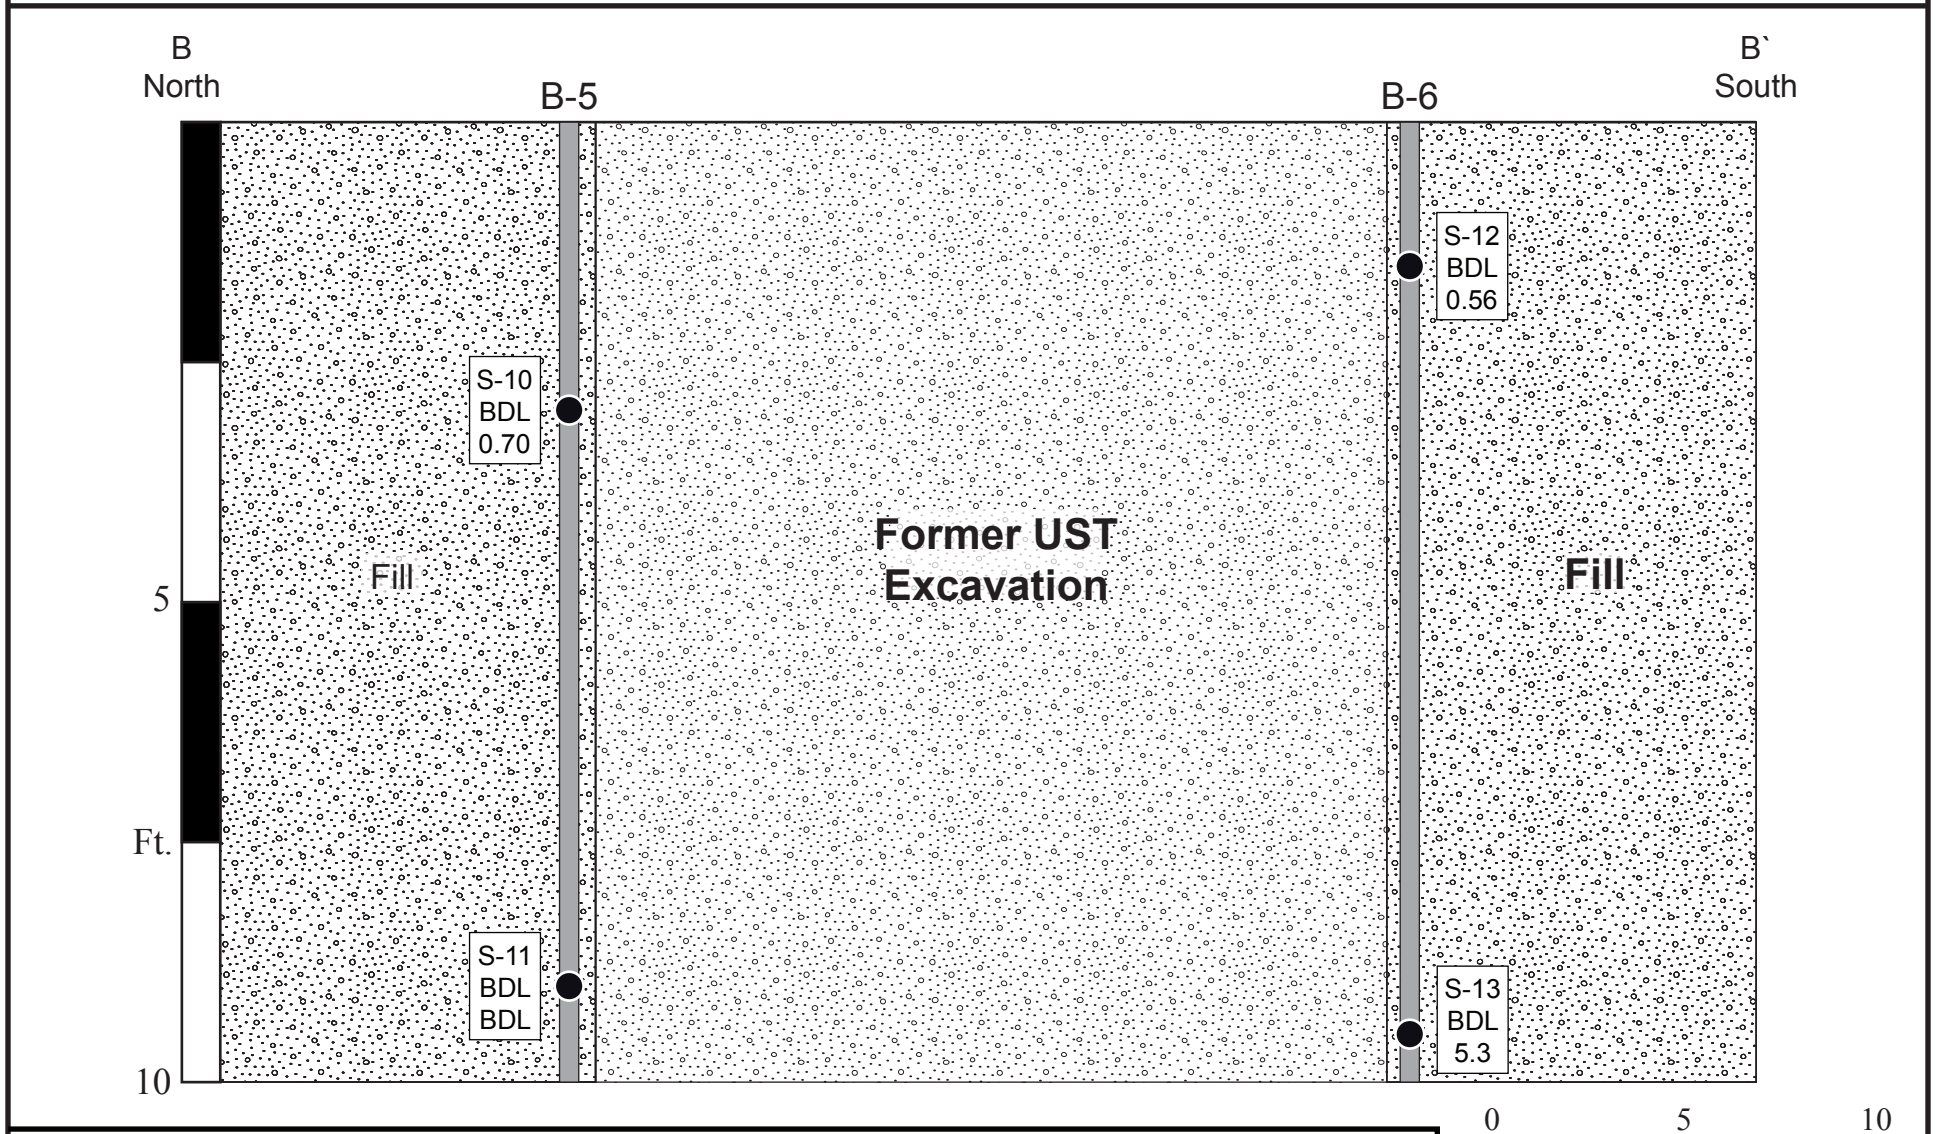
<b>Figure 9</b> Cross-Sections A-A' and B-B'	State Project: U-5888 Haywood County, NC	Derek S. Oates Property 847 N Main Street Waynesville, NC	Parcel #011 Facility I.D.: N/A	Seramur & Associates, PC Boone, NC
--	---	---	-----------------------------------	---------------------------------------

The soil type at Parcel #011 consisted of fill material and saprolite, ranging from silty sand to sandy silt. Alluvium was encountered at depth in one boring (Table 1 and Figure 9). Groundwater was not encountered in any of the soil borings.

● - Locations of Soil Samples    BDL - Below Detectable Limit    BDL - Petroleum Constituent Concentrations  
 5.2 Detected as GRO (upper) and DRO (lower)

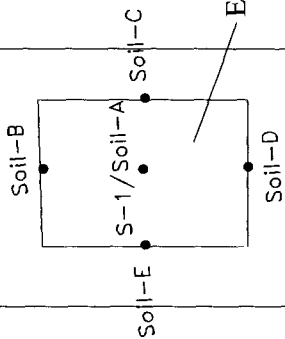
FIGURE 2  
SITE MAP

The 550-gallon heating oil UST located at the site was removed in 2006. The UST was located on the western side of the building as shown in Figure 2. On October 24, 2011, Singleton Environmental, Inc. mobilized to the site to collect a confirmation soil sample using a Giddings Drill Rig. Contaminated soils were encountered directly underneath the former UST and on February 6, 2012 soil excavation activities were initiated. The contaminated soils were excavated to a depth of 9 feet below the bottom of the former UST, to a total depth of 13 feet below existing site grade. The final excavation measured 15 feet long by 12 feet wide by 13 feet deep. The completed excavation cavity was backfilled with clean suitable soil and compacted.

One soil sample (SB-6 in Figure 2) was collected from the UST excavation on October 24, 2011 during the former UST assessment. Soil sample SB-6 was collected from directly beneath the former UST location at a depth of 5 ft-bgs. Sample SB-6 was submitted for laboratory analysis of diesel and gasoline range organics (DRO/GRO) by EPA Method 8015 with 3550 extraction.

Five additional soil samples (Soil-A, Soil-B, Soil-C, Soil-D and Soil-E in Figure 2) were collected from the UST excavation on February 7, 2012. Soil-B, Soil-C, Soil-D and Soil-E were collected from the four side walls of the excavation at a depth of approximately 13 feet below existing site grade. Soil-A was collected from the bottom of the excavation at a depth of approximately 13 feet below ground surface. Soil samples Soil-A, Soil-B, Soil-C, Soil-D and Soil-E were submitted for laboratory analysis of volatile organic compounds (VOCs) by EPA Method 8260, semi-volatile organic compounds (SVOCs) by EPA Method 8270, volatile petroleum hydrocarbons (VPH) by MADEP methods, and extractable petroleum hydrocarbons (EPH) by MADEP methods.
