## **Preliminary Site Assessment Report**

**November 20, 2018**  
**WBS Element: 44625.1.1**  
**State Project: U-5888**  
**Haywood County**

at  
**Clifford Gould LLC Property**  
**Parcel #008**  
**783 N Main Street, Waynesville, NC 28786**  
**PIN #: 8615-59-6508**  
**Facility ID No.: N/A**  
**Groundwater Incident No.: 41466**

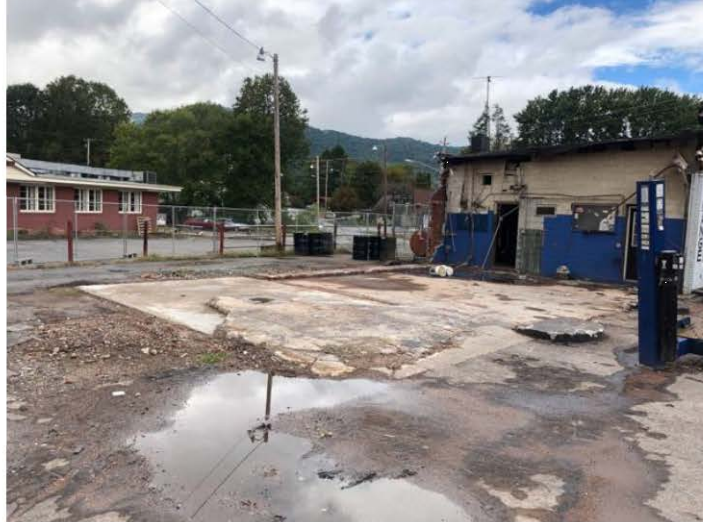
2. Building footing and remaining half of building at Parcel #008. Former restaurant building visible in background.

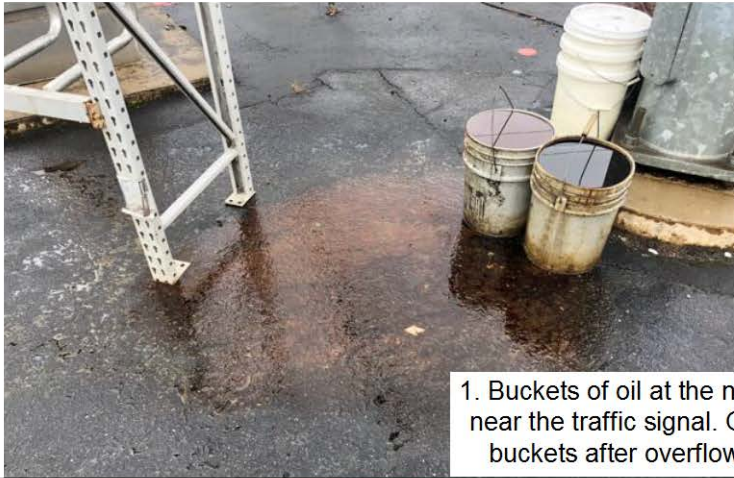
Two buckets of oil were observed on the property near the northeast parcel corner where the traffic signal box is located (Plate 2). These had overflowed in the recent rains and a puddle of oil formed on the pavement. Seramur & Associates personnel called the Town of Waynesville to inform them of the situation. The Town of Waynesville sent over a police officer who contacted the last occupants of the auto-repair shop. The occupants arrived on site and transferred the oil into the ASTs on the west side of the building. They did not clean up the puddle of oil that had spilled onto the asphalt.

1. Buckets of oil at the northeast property corner near the traffic signal. Oil has spilled from both buckets after overflowing during rain event.

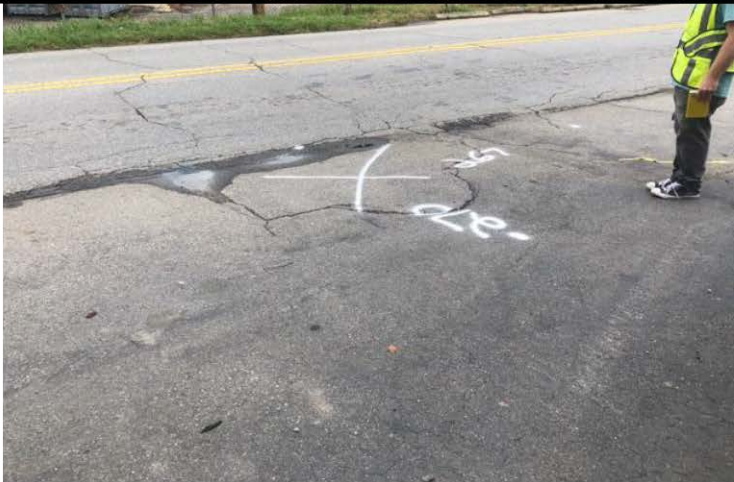
3. Magnetic anomaly C north of the auto-repair shop. Appears to be a utility under newer pavement.

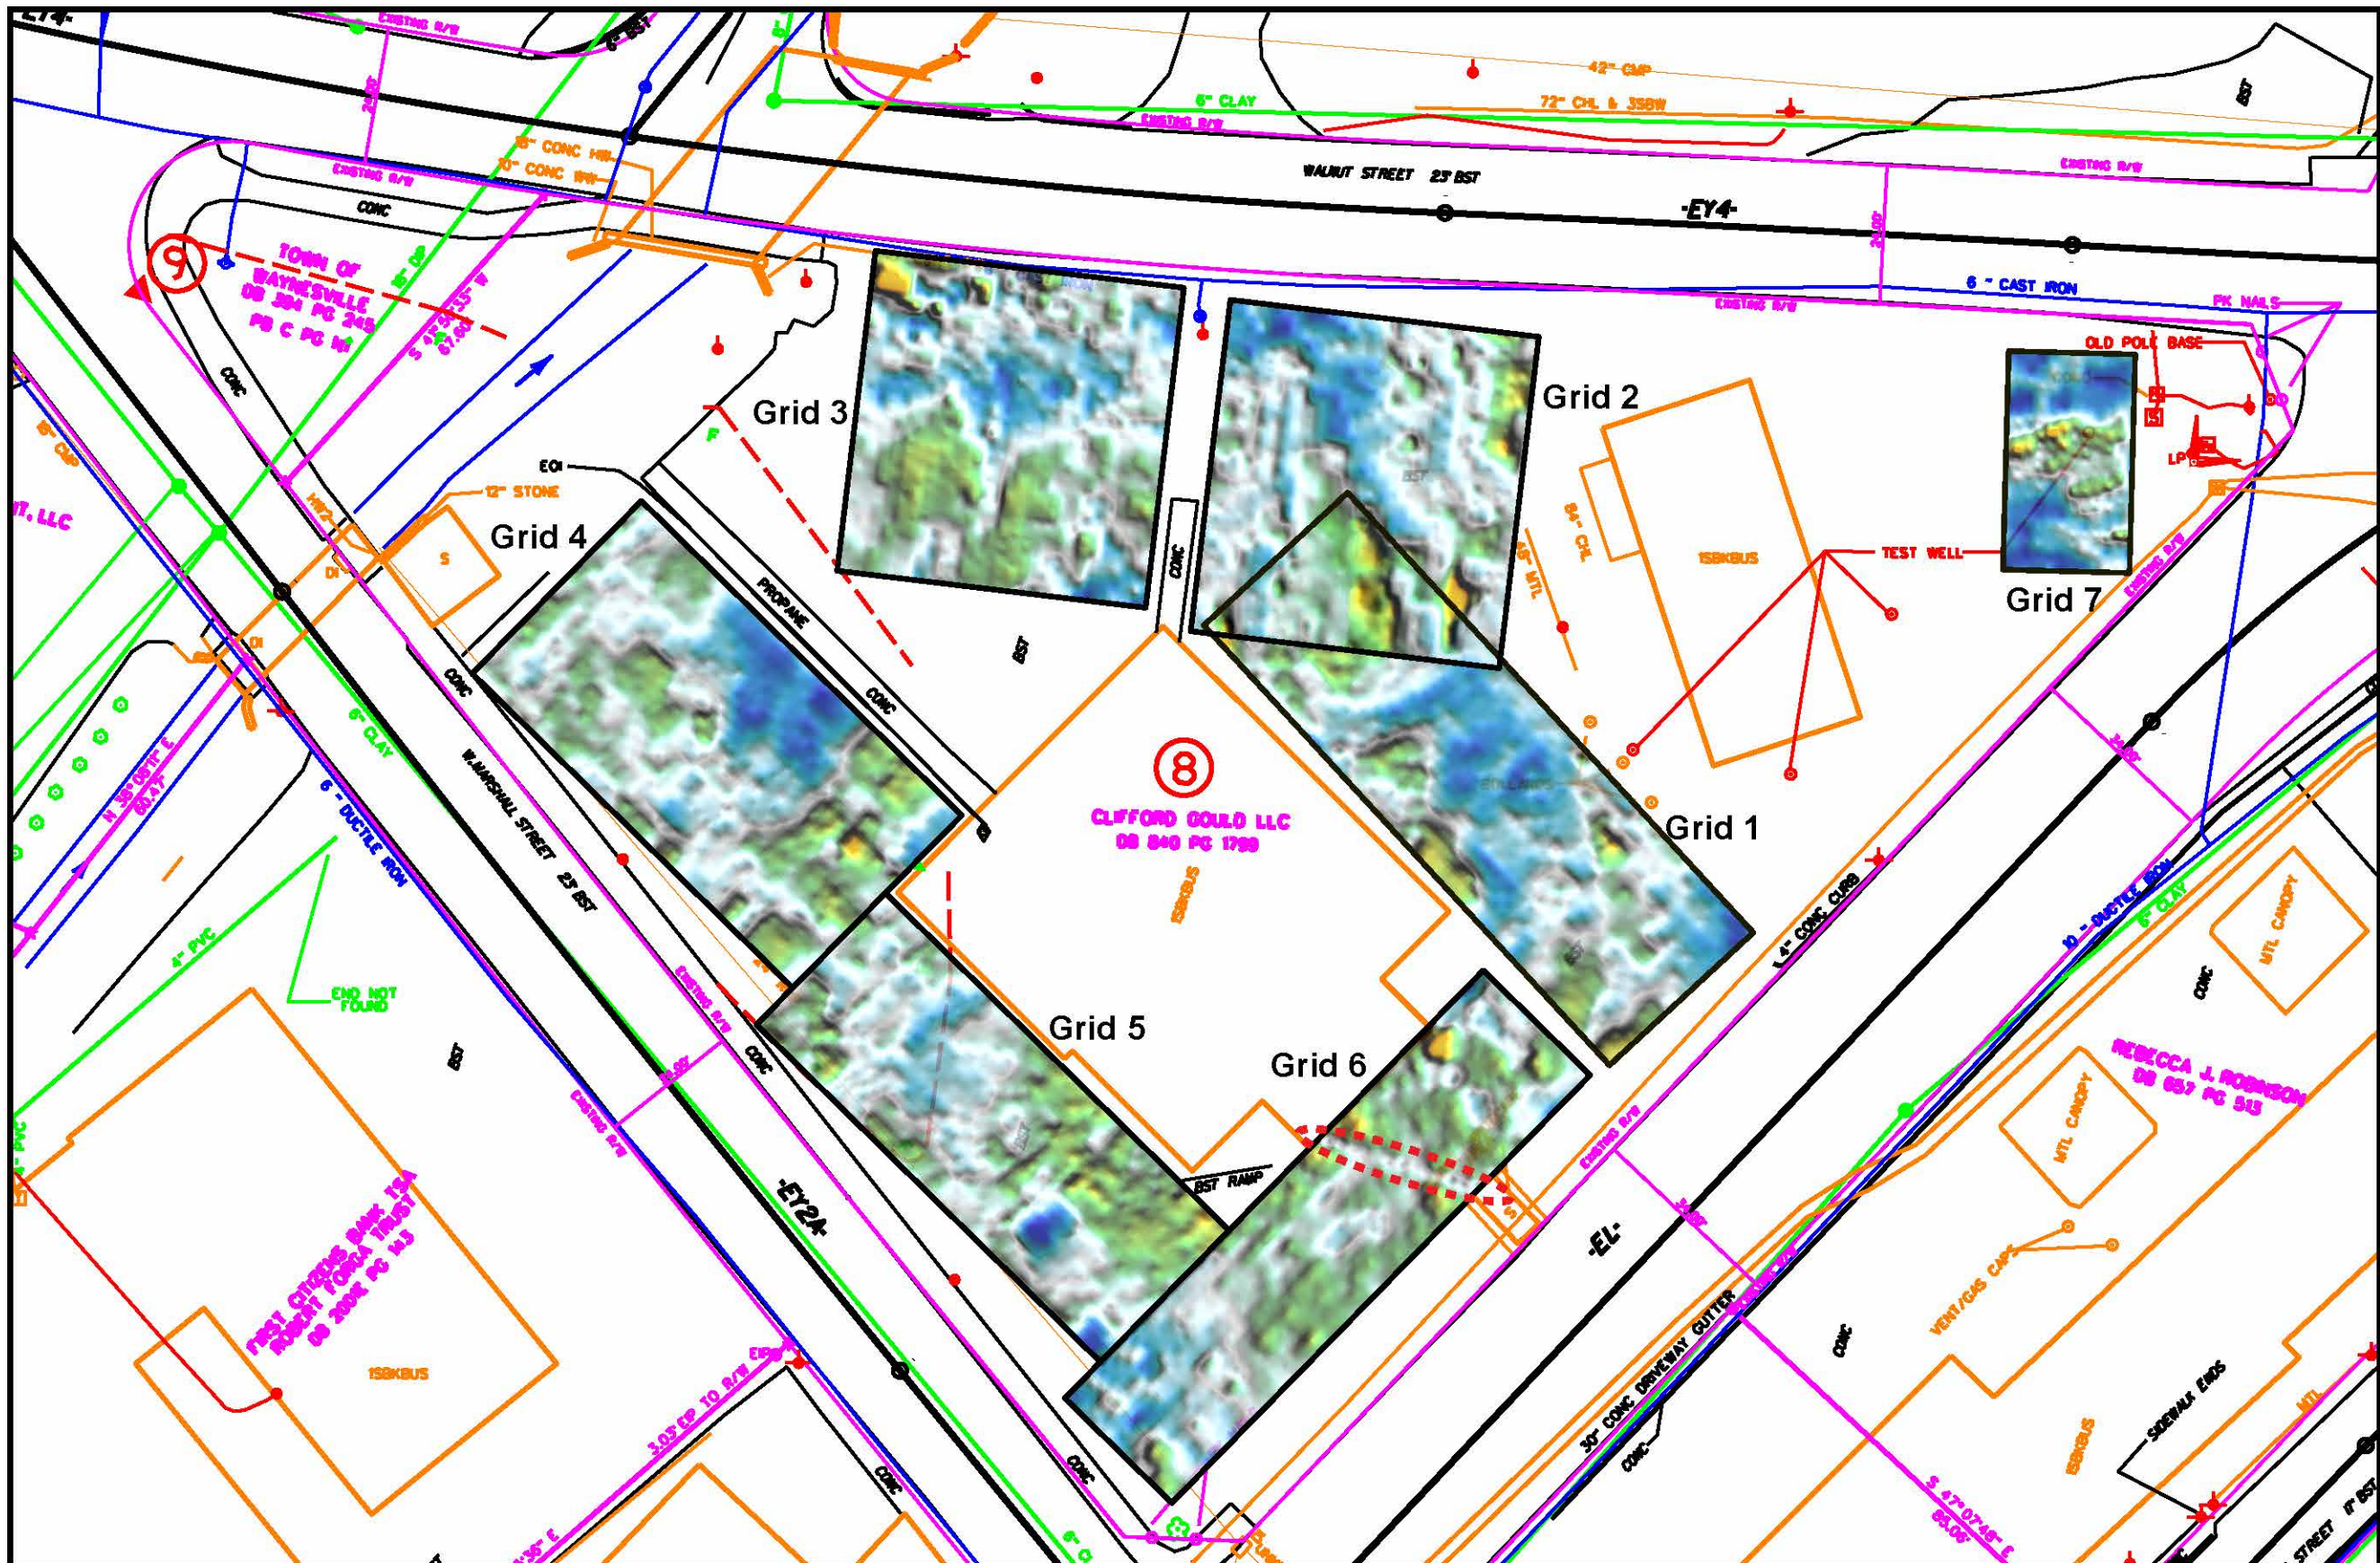
**Figure 6**

Shallow GPR  
Depth Slices  
(0.3 - 0.8 ft.)

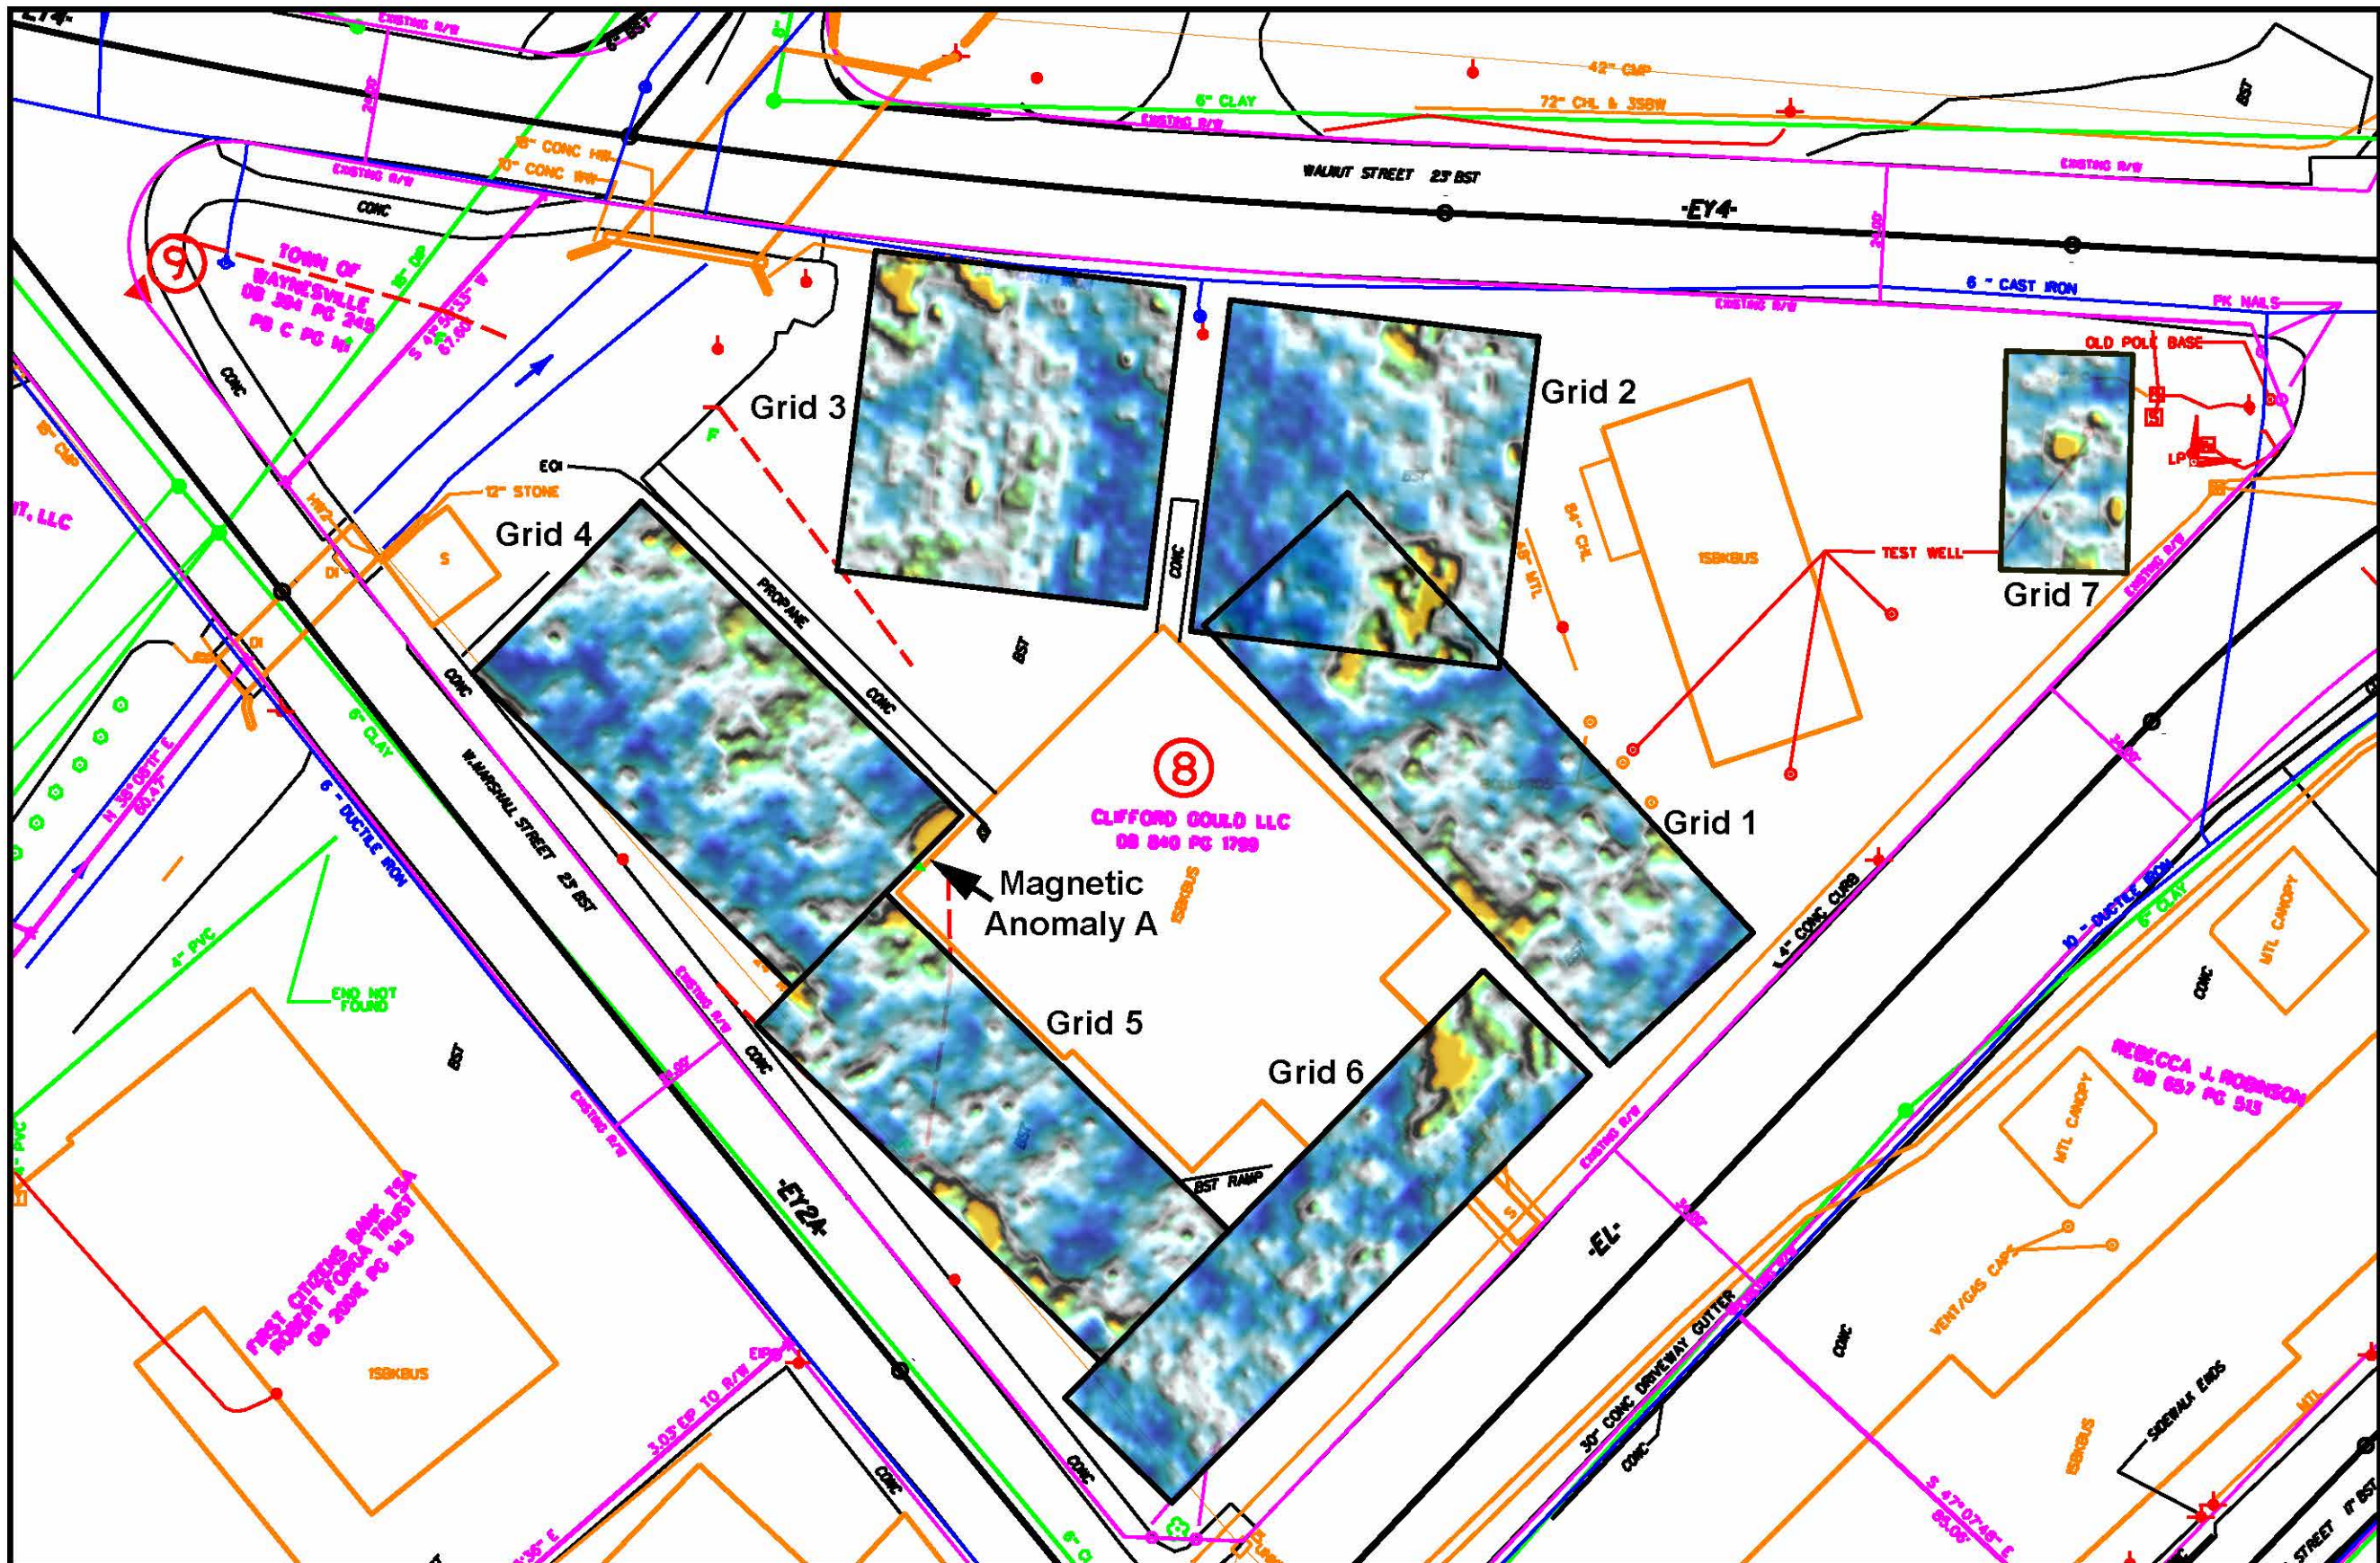
**Figure 8**

The 3.2-3.7 GPR depth slices show a couple of high amplitude reflections in Grid 7, but these reflections are between the magnetic anomalies detected in this grid (Figure 7). The high

Deep GPR  
Depth Slices  
(3.2 - 3.7 ft.)

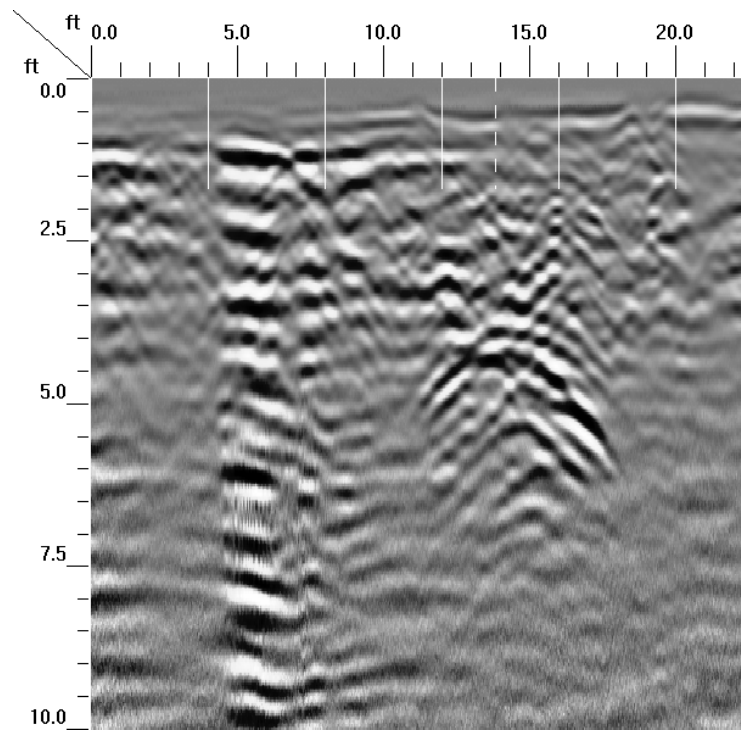
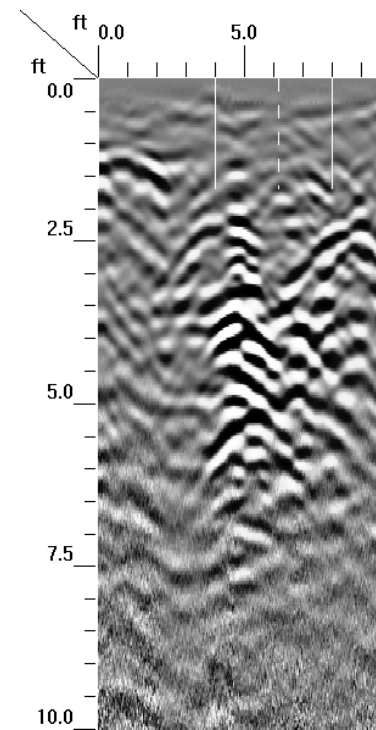
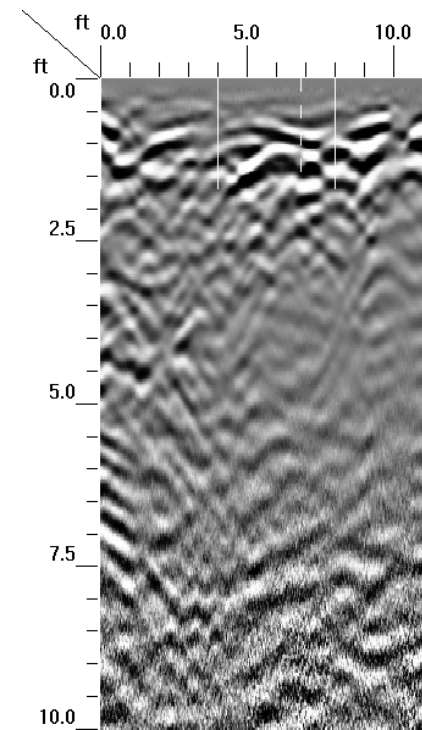
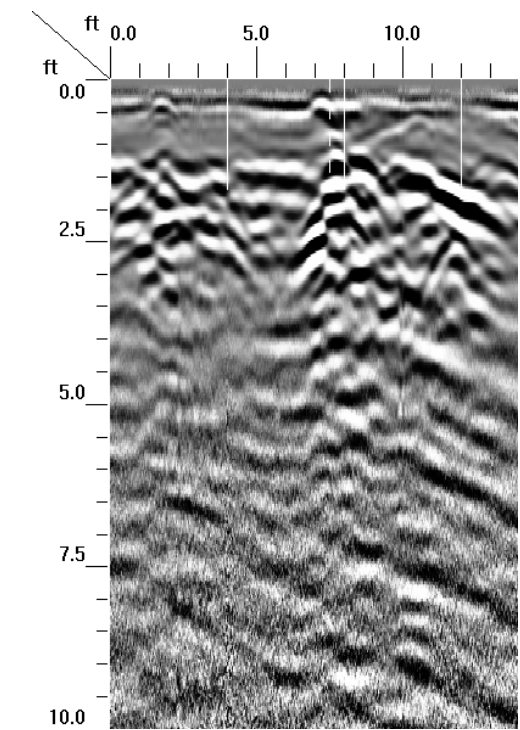
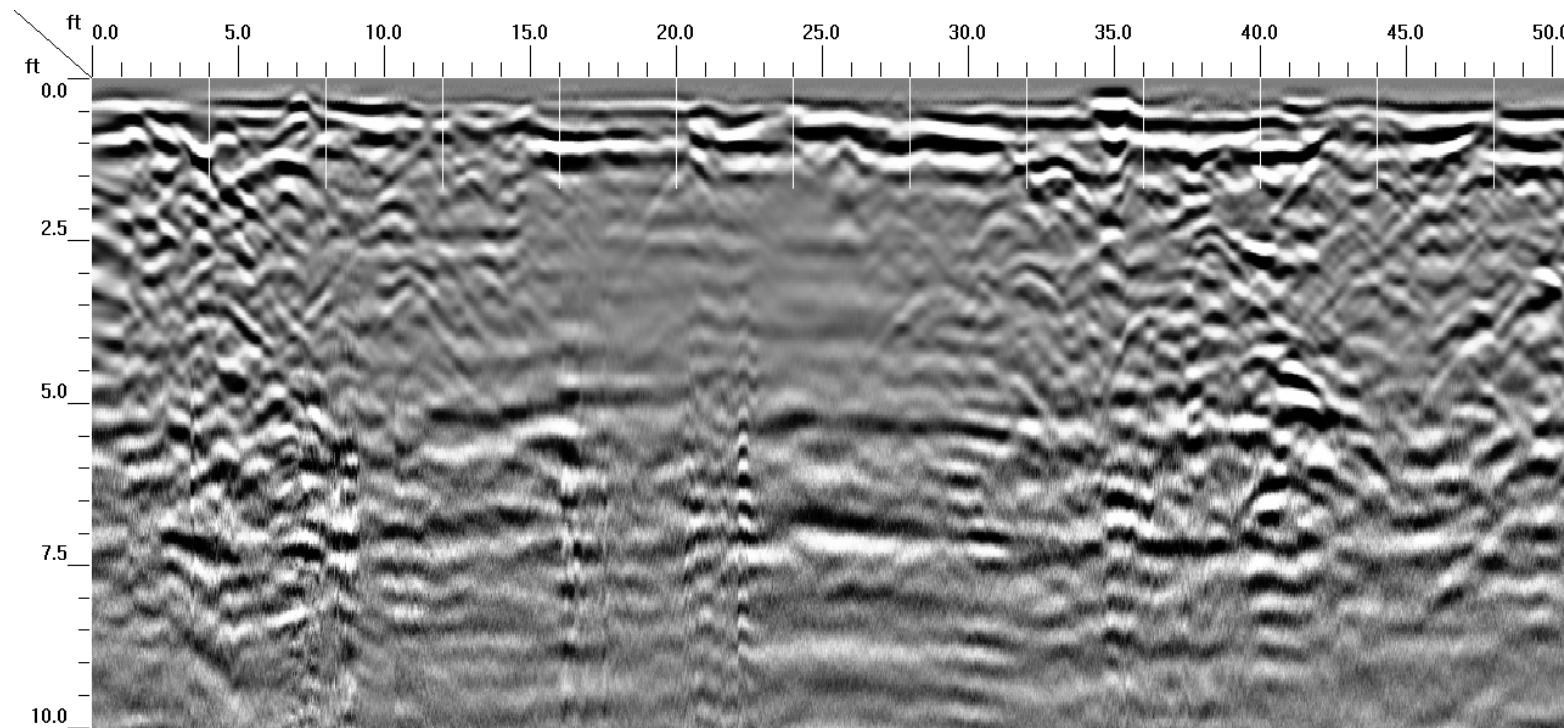
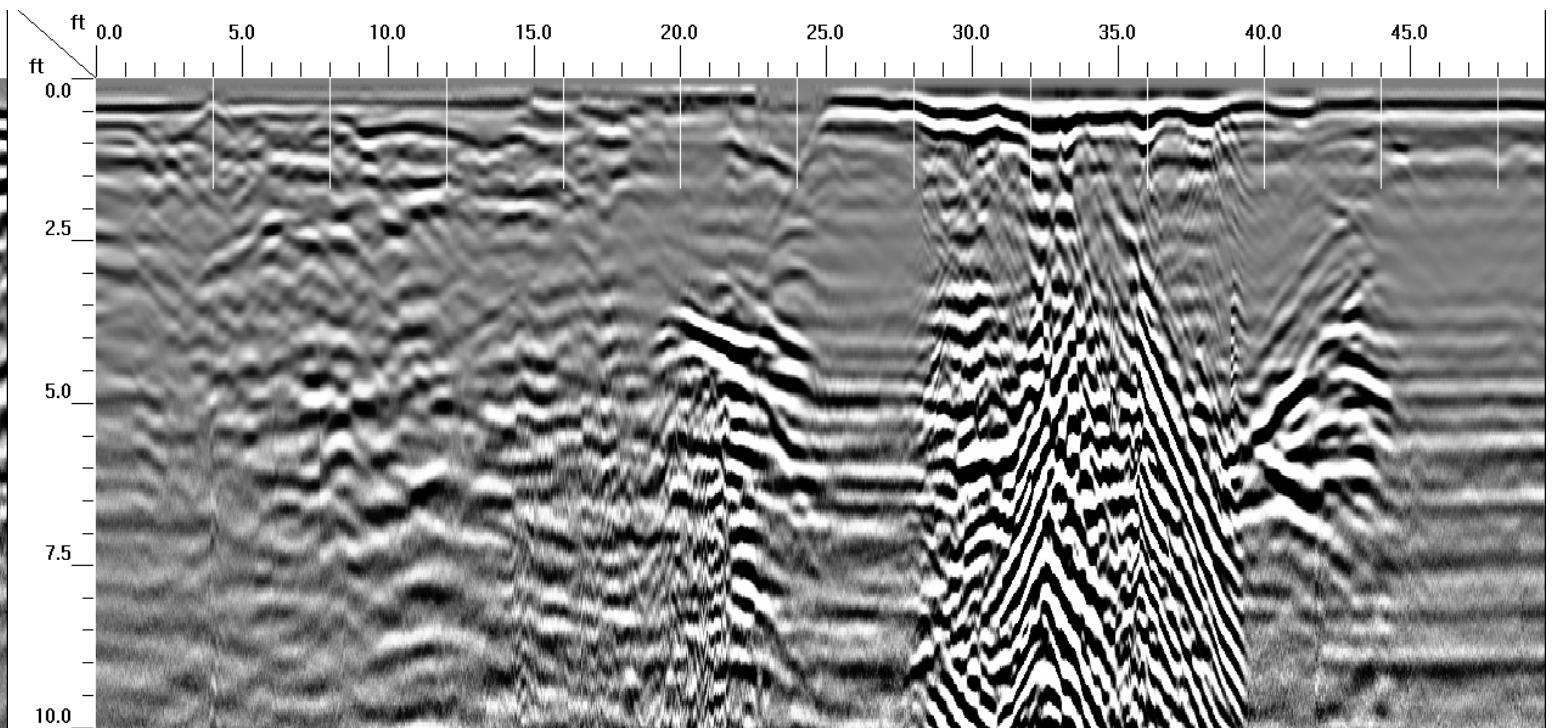
**Figure 9**  
GPR Profiles 1-6

Two GPR profiles (P5 and P6) were collected around the former auto repair shop (Figure 4). These profiles did not show any reflections characteristic of a UST (Figure 9).

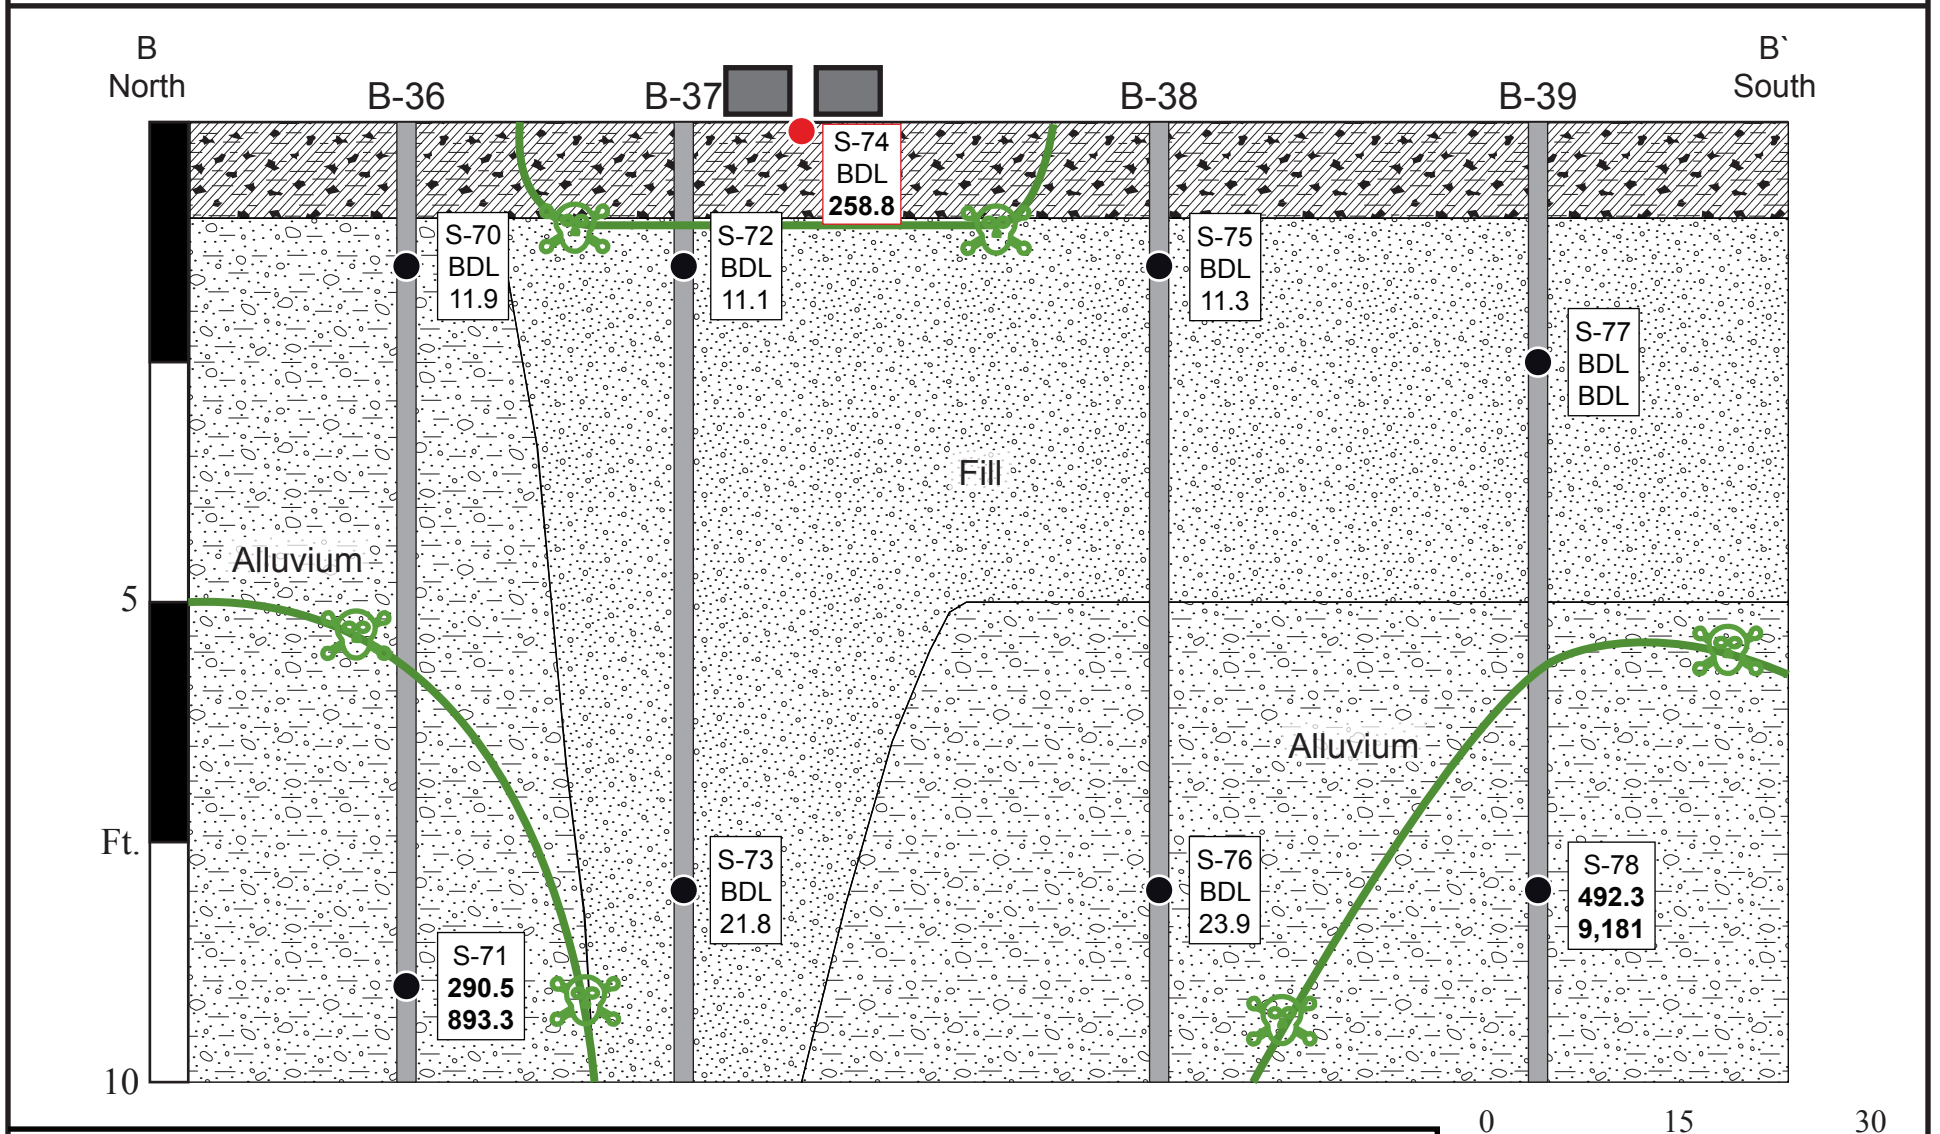
<p><b>Figure 12</b> Cross-Sections A-A' and B-B'</p>	<p>State Project: U-5888 Haywood County, NC</p>	<p>Clifford Gould LLC Property 783 N Main Street Waynesville, NC</p>	<p>Parcel #008 Facility I.D.: N/A</p>	<p>Seramur &amp; Associates, PC Boone, NC</p>
--	---	--	---	---

The soil type at Parcel #008 consisted of a fill material, saprolite and alluvium. The lithologies were primarily sandy silt and silty sand. Some cores were gravelly (Table 1). Cross-sections A-A' through E-E' show interpretations of the lithology and locations of soil borings (Figures 12-14). Groundwater was not encountered in any of the soil borings, though some of the cores contained moist soil.

● - Locations of Soil Samples    BDL - Below Detectable Limit    42.0 - Petroleum Constituent Concentrations  
 174.1 Detected as GRO (upper) and DRO (lower)

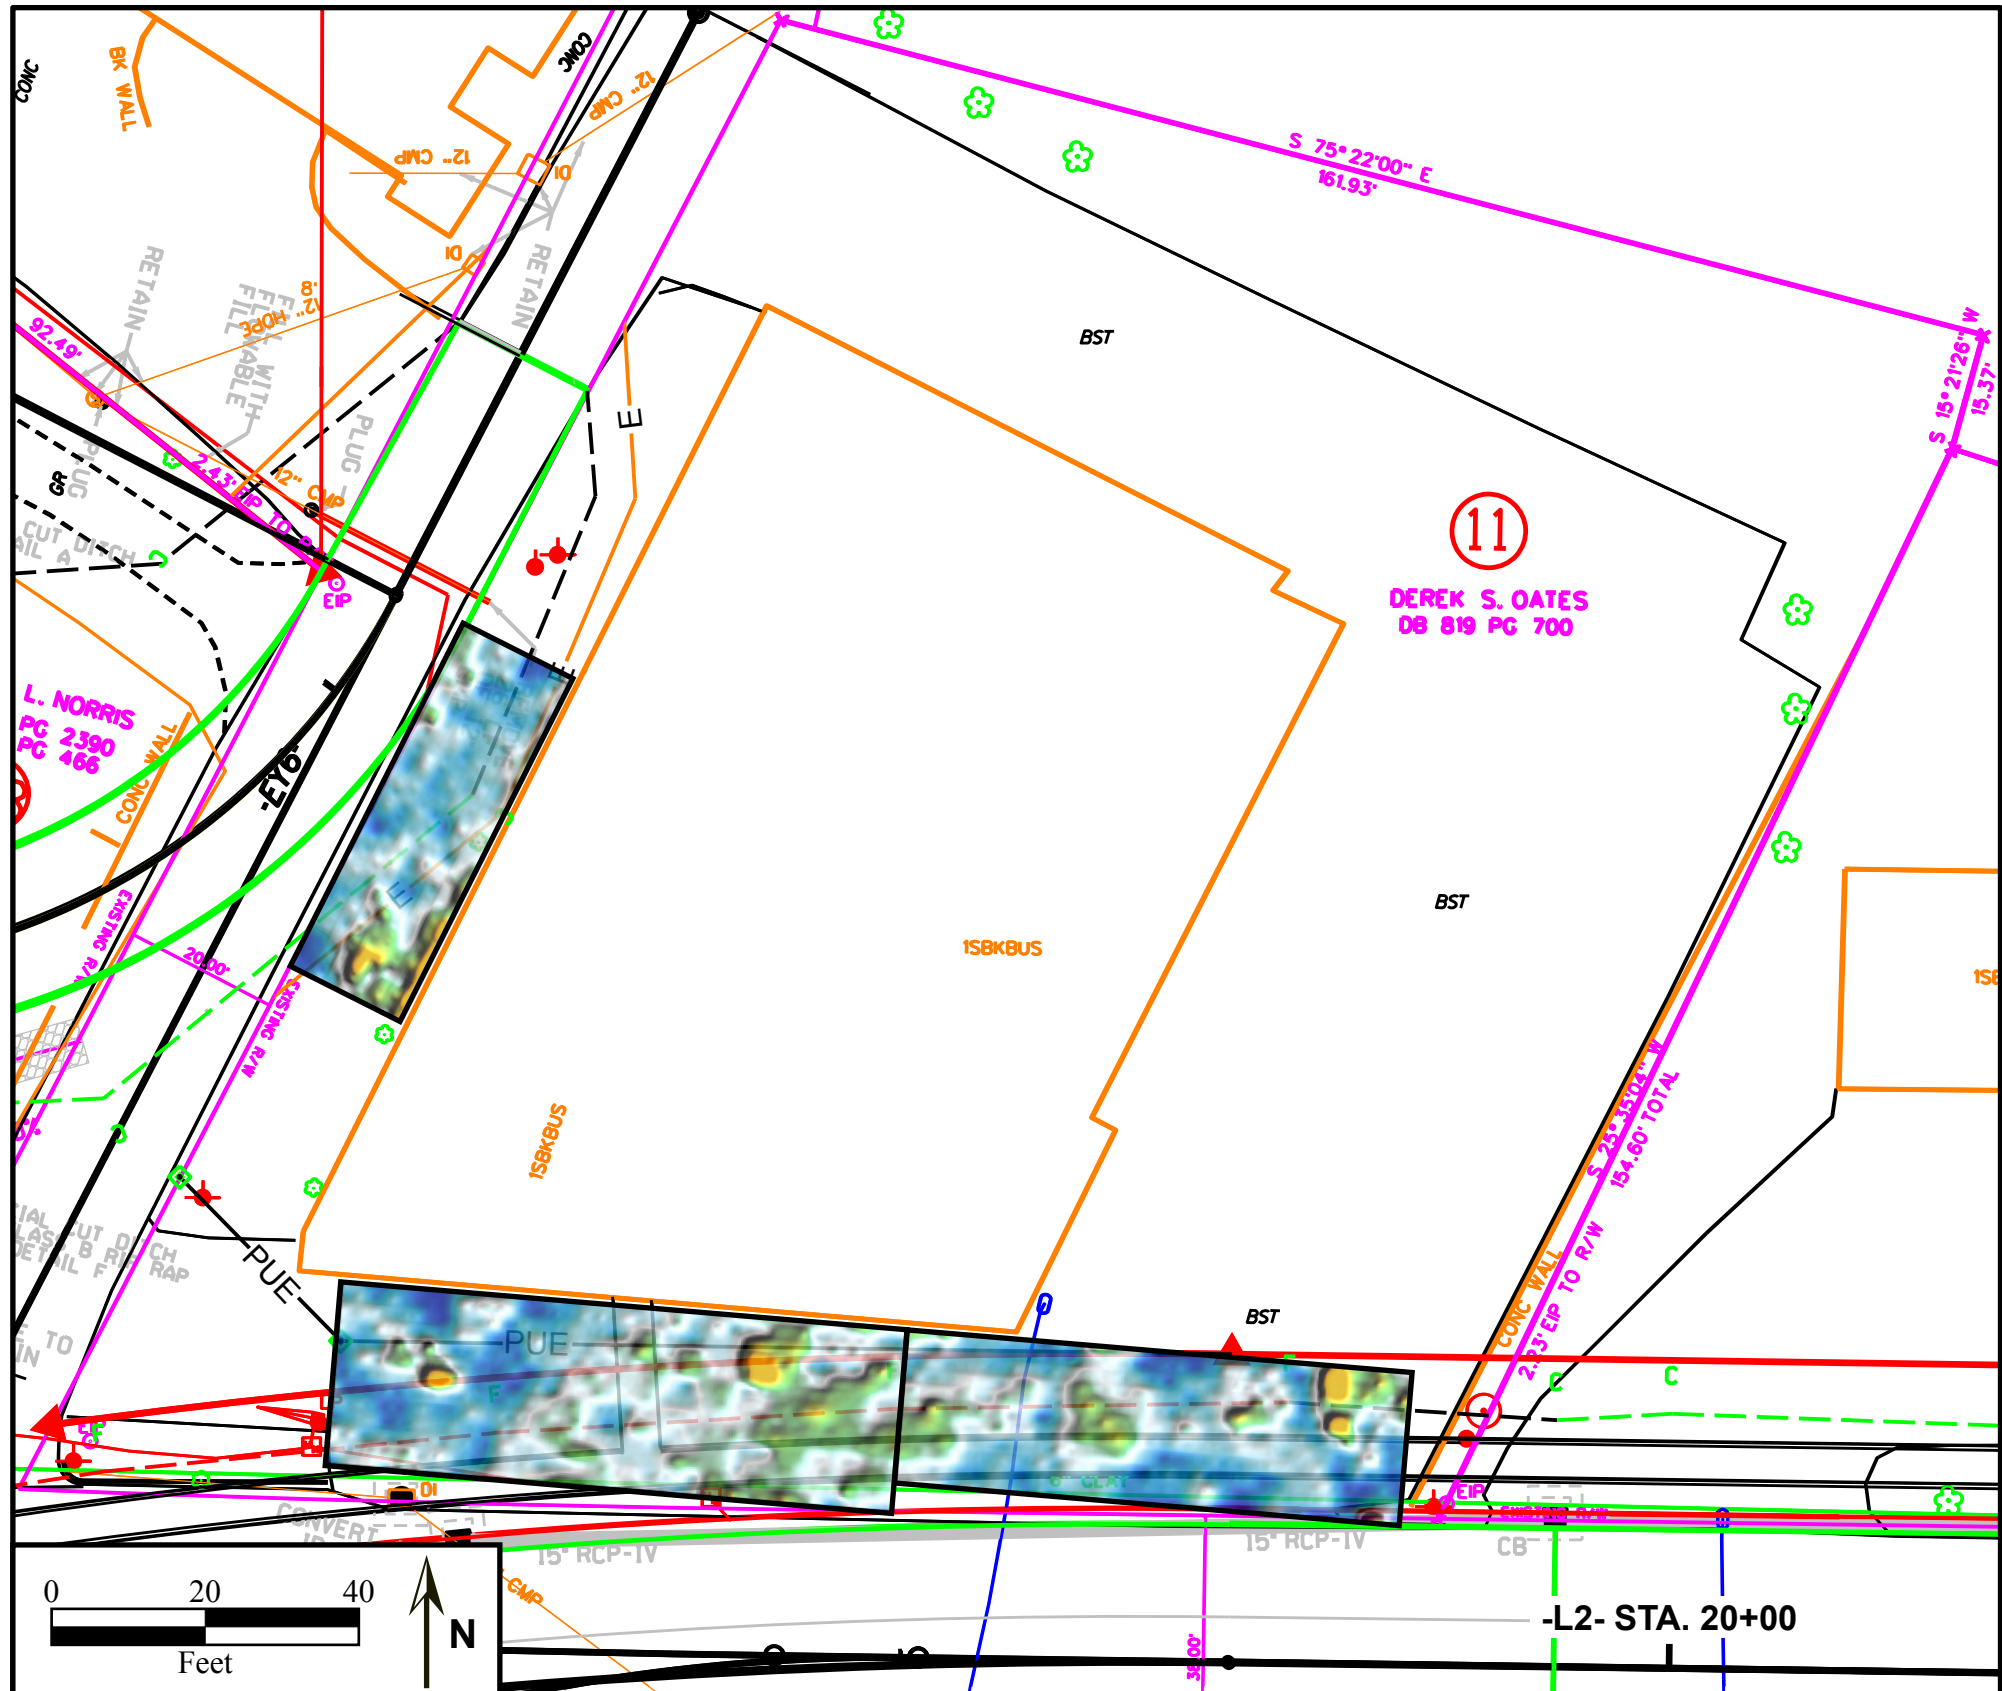
**Figure 7**  
 Deep GPR  
 Depth Slices  
 (3.2 - 3.7 ft.)

The deep GPR depth slices (3.2-3.7 feet) do not show any distinct reflections patterns related to buried infrastructure. There are a few small, high amplitude reflectors observed across the grid but there were no magnetic anomalies recorded at these locations.
