## Preliminary Site Assessment Report

November 14, 2018  
WBS Element: 44625.1.1  
State Project: U-5888  
Haywood County

Muse Brothers Construction Co Inc. Property  
Parcel #012  
871 N Main Street, Waynesville, NC 28786  
PIN #: 8615-69-2768  
Facility ID No.: N/A  
Groundwater Incident No.: 41345 and 41553

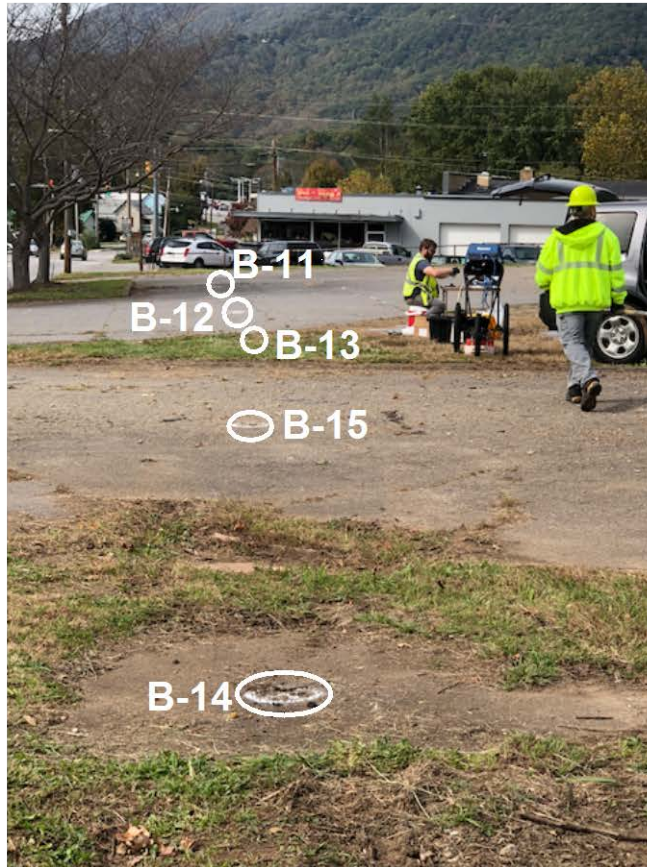
**Describing and sampling Geoprobe cores. Driveway of former gas station is in the distance.**

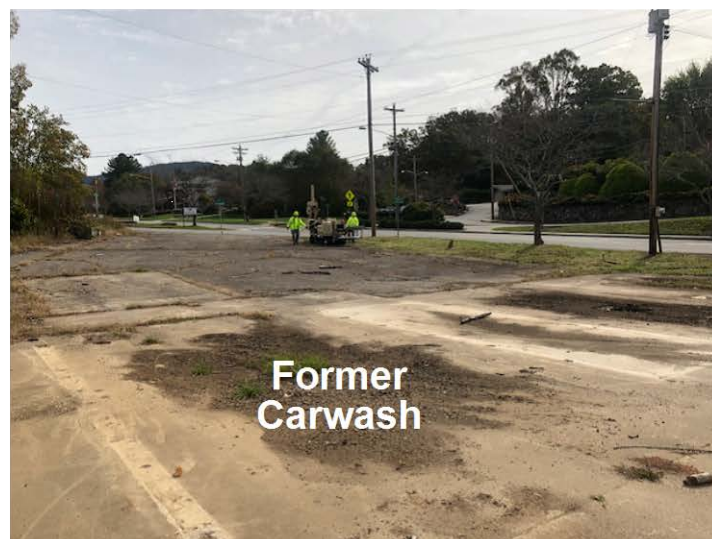
**Drillers setting up on boring B-17. Footprint of former carwash is in the foreground.**

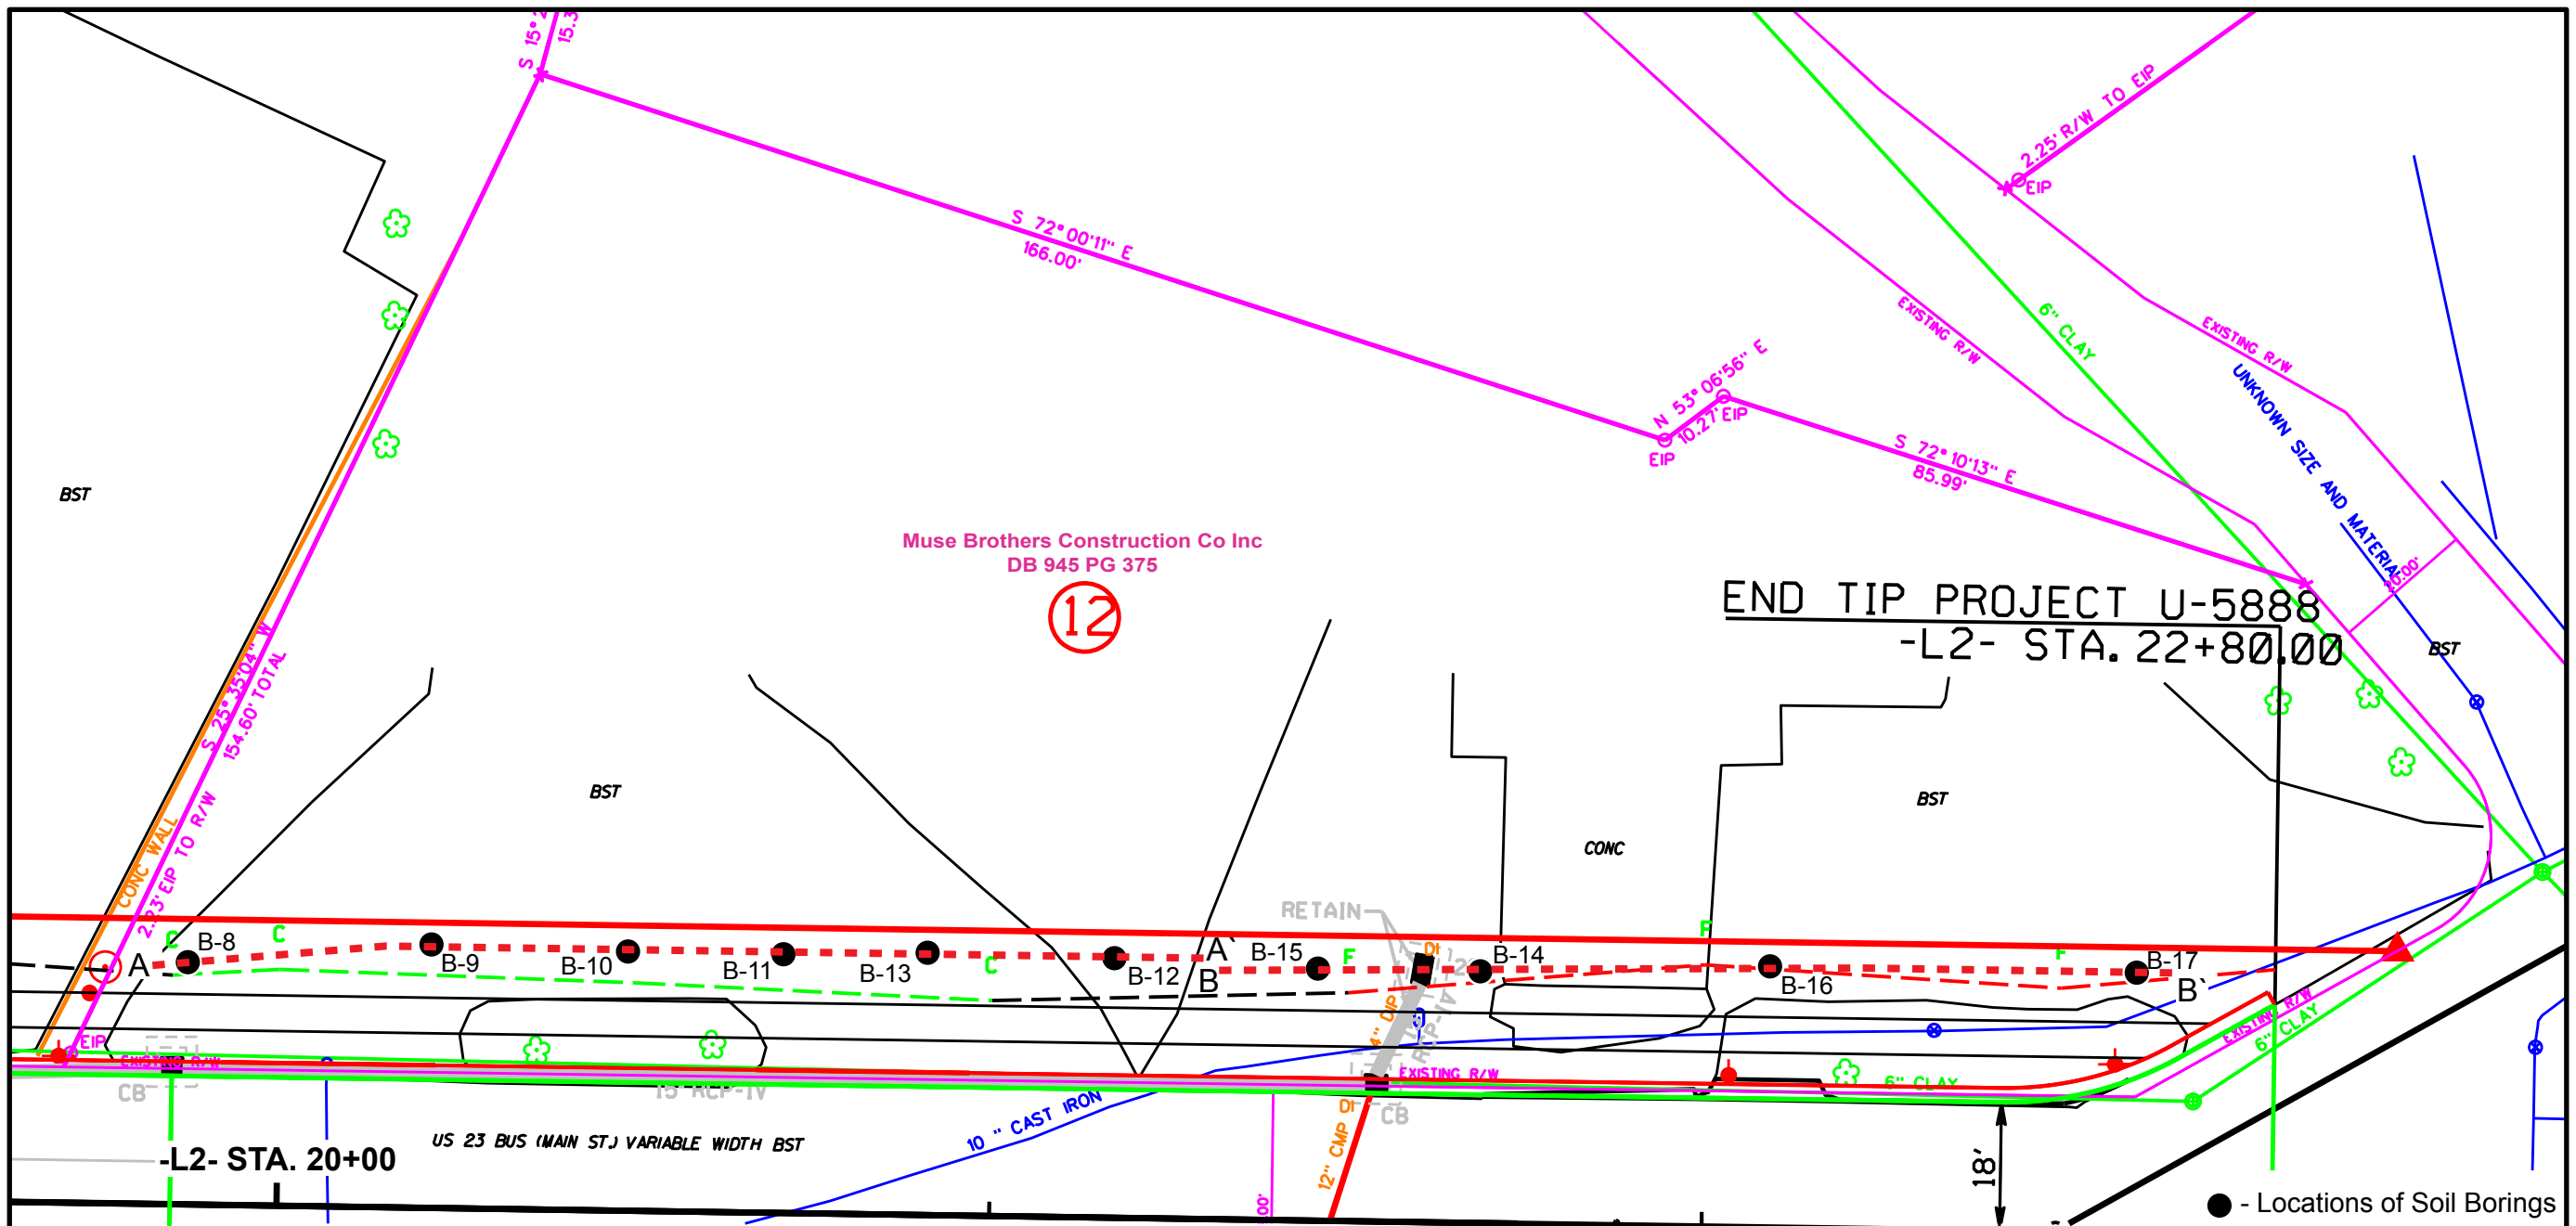
Carolina Soil Investigations, LLC mobilized to the site on October 23<sup>rd</sup> to drill Geoprobe borings and collect soil samples. Our project design called for collecting a shallow and deep soil sample from each boring (Figure 3). The purpose of collecting samples at a depth of ~3.0 feet is to test for petroleum releases related to surface spills and releases from product lines. The purpose of collecting samples at a depth of ~9.0 feet is to test for petroleum releases related to underground storage tanks. Soil samples were collected at other depths within the Geoprobe cores if soil staining or petroleum vapors were observed or if limited core recovery occurred. Soil borings were drilled in the proposed R/W along the southern side of the property (Figure 3).

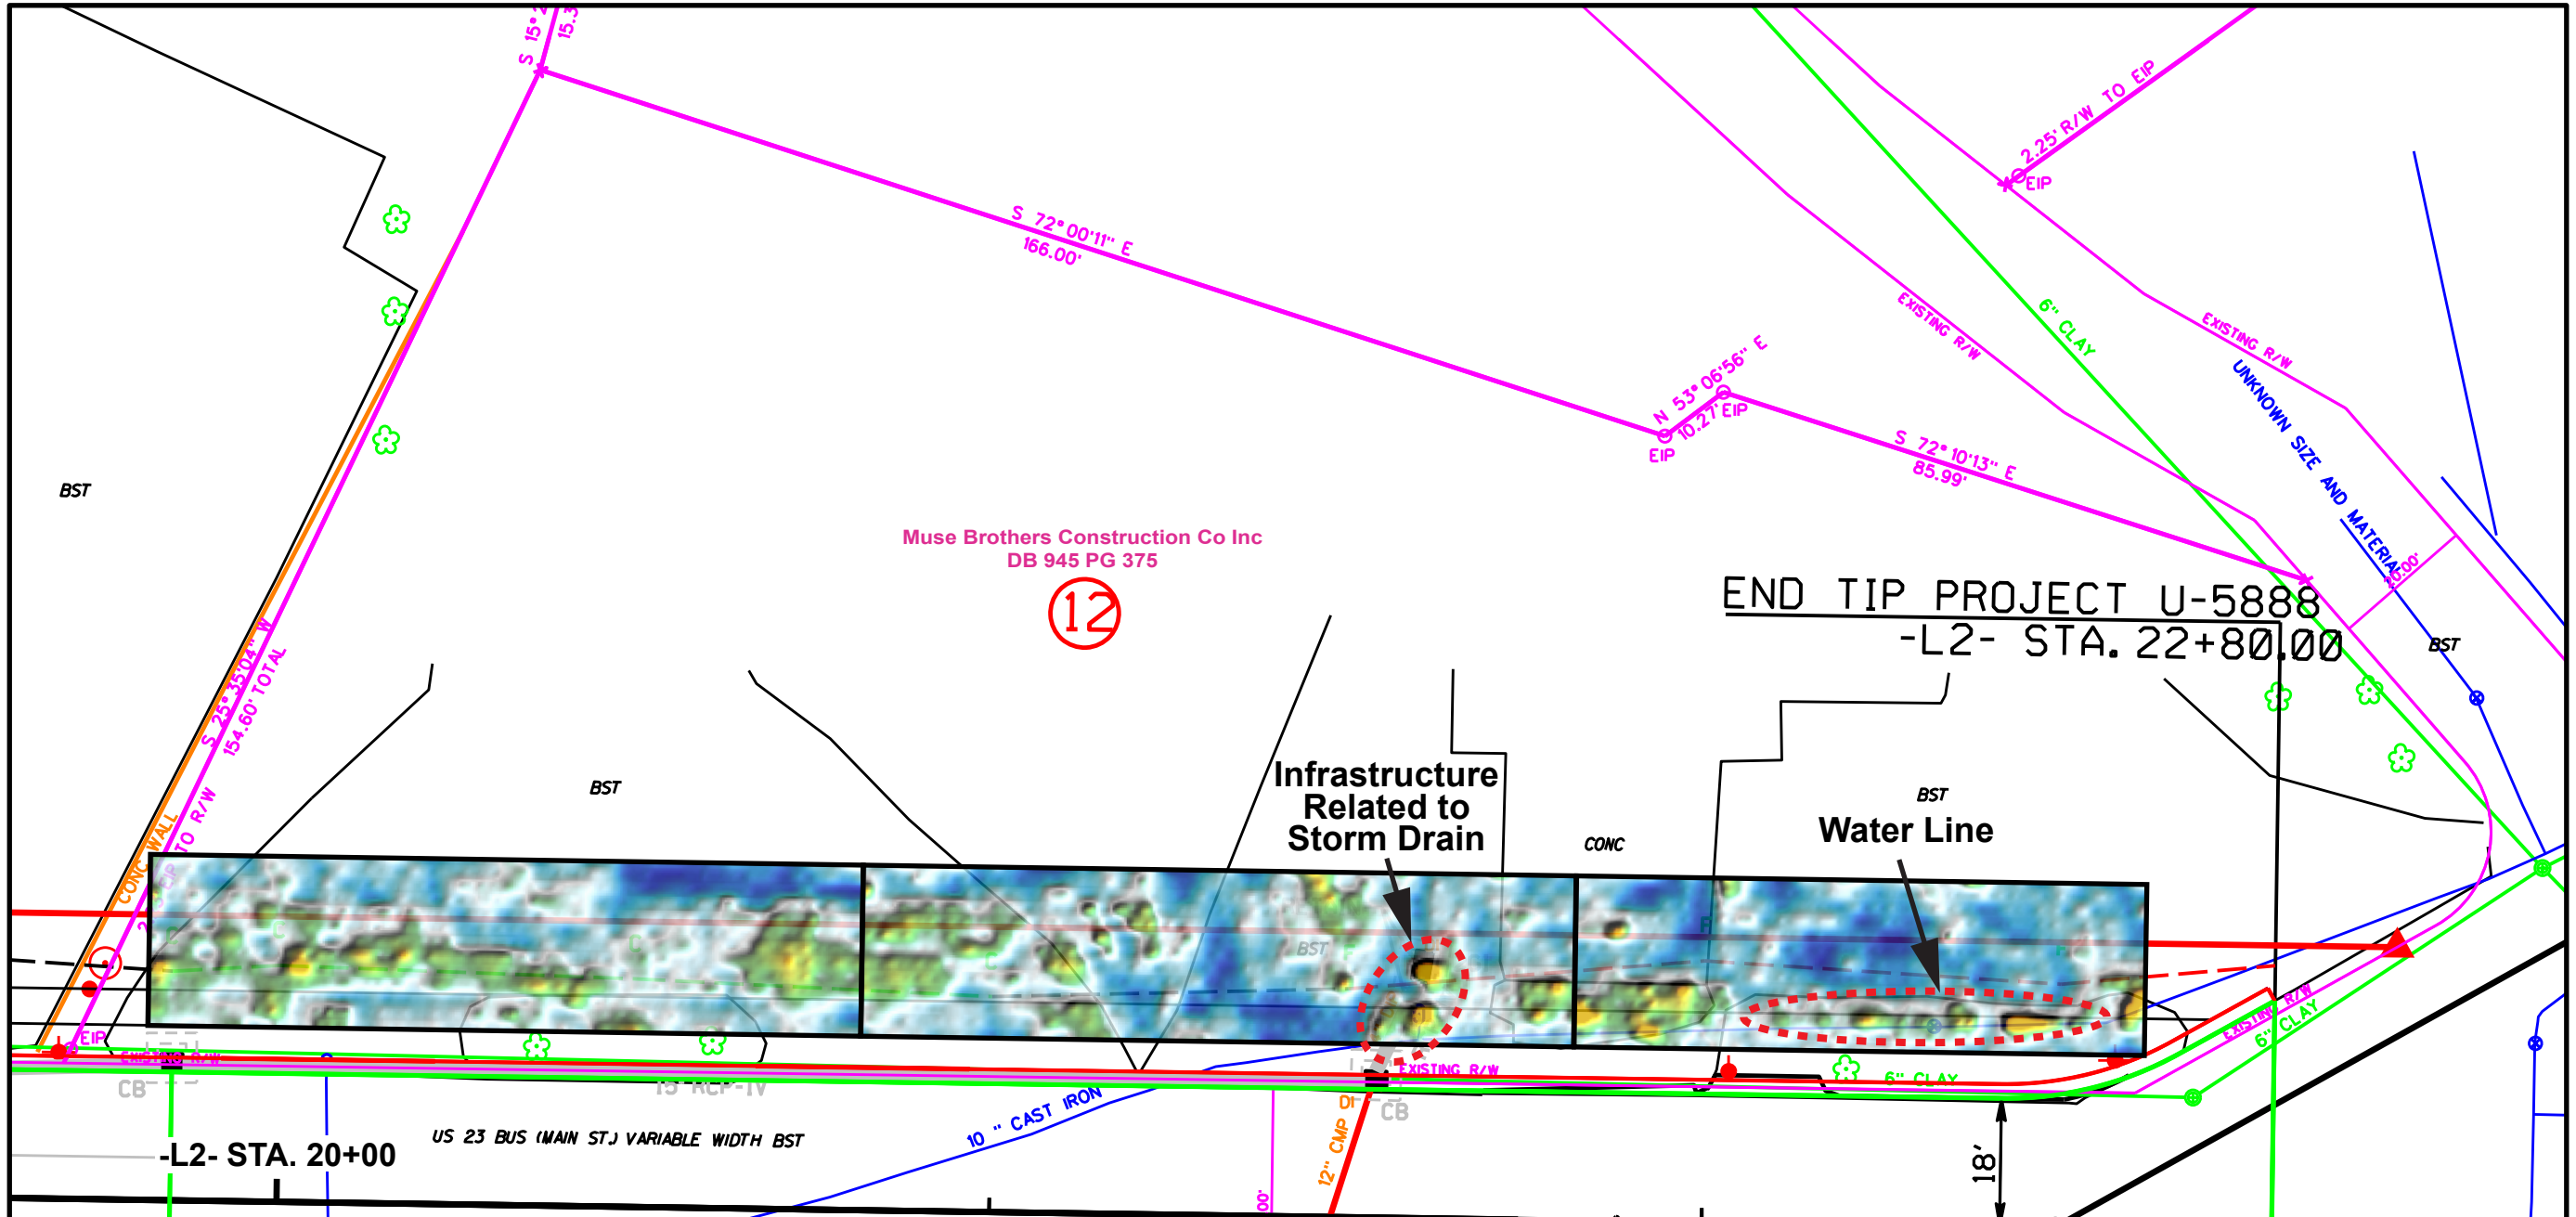
The deep GPR depth slices (2.7 to 3.2 feet) imaged utilities related to the storm drains in Grid 2 and a water line in Grid 3 (Figure 7). No evidence of USTs or a UST system was recorded in the R/W or easements by the geophysical surveys.

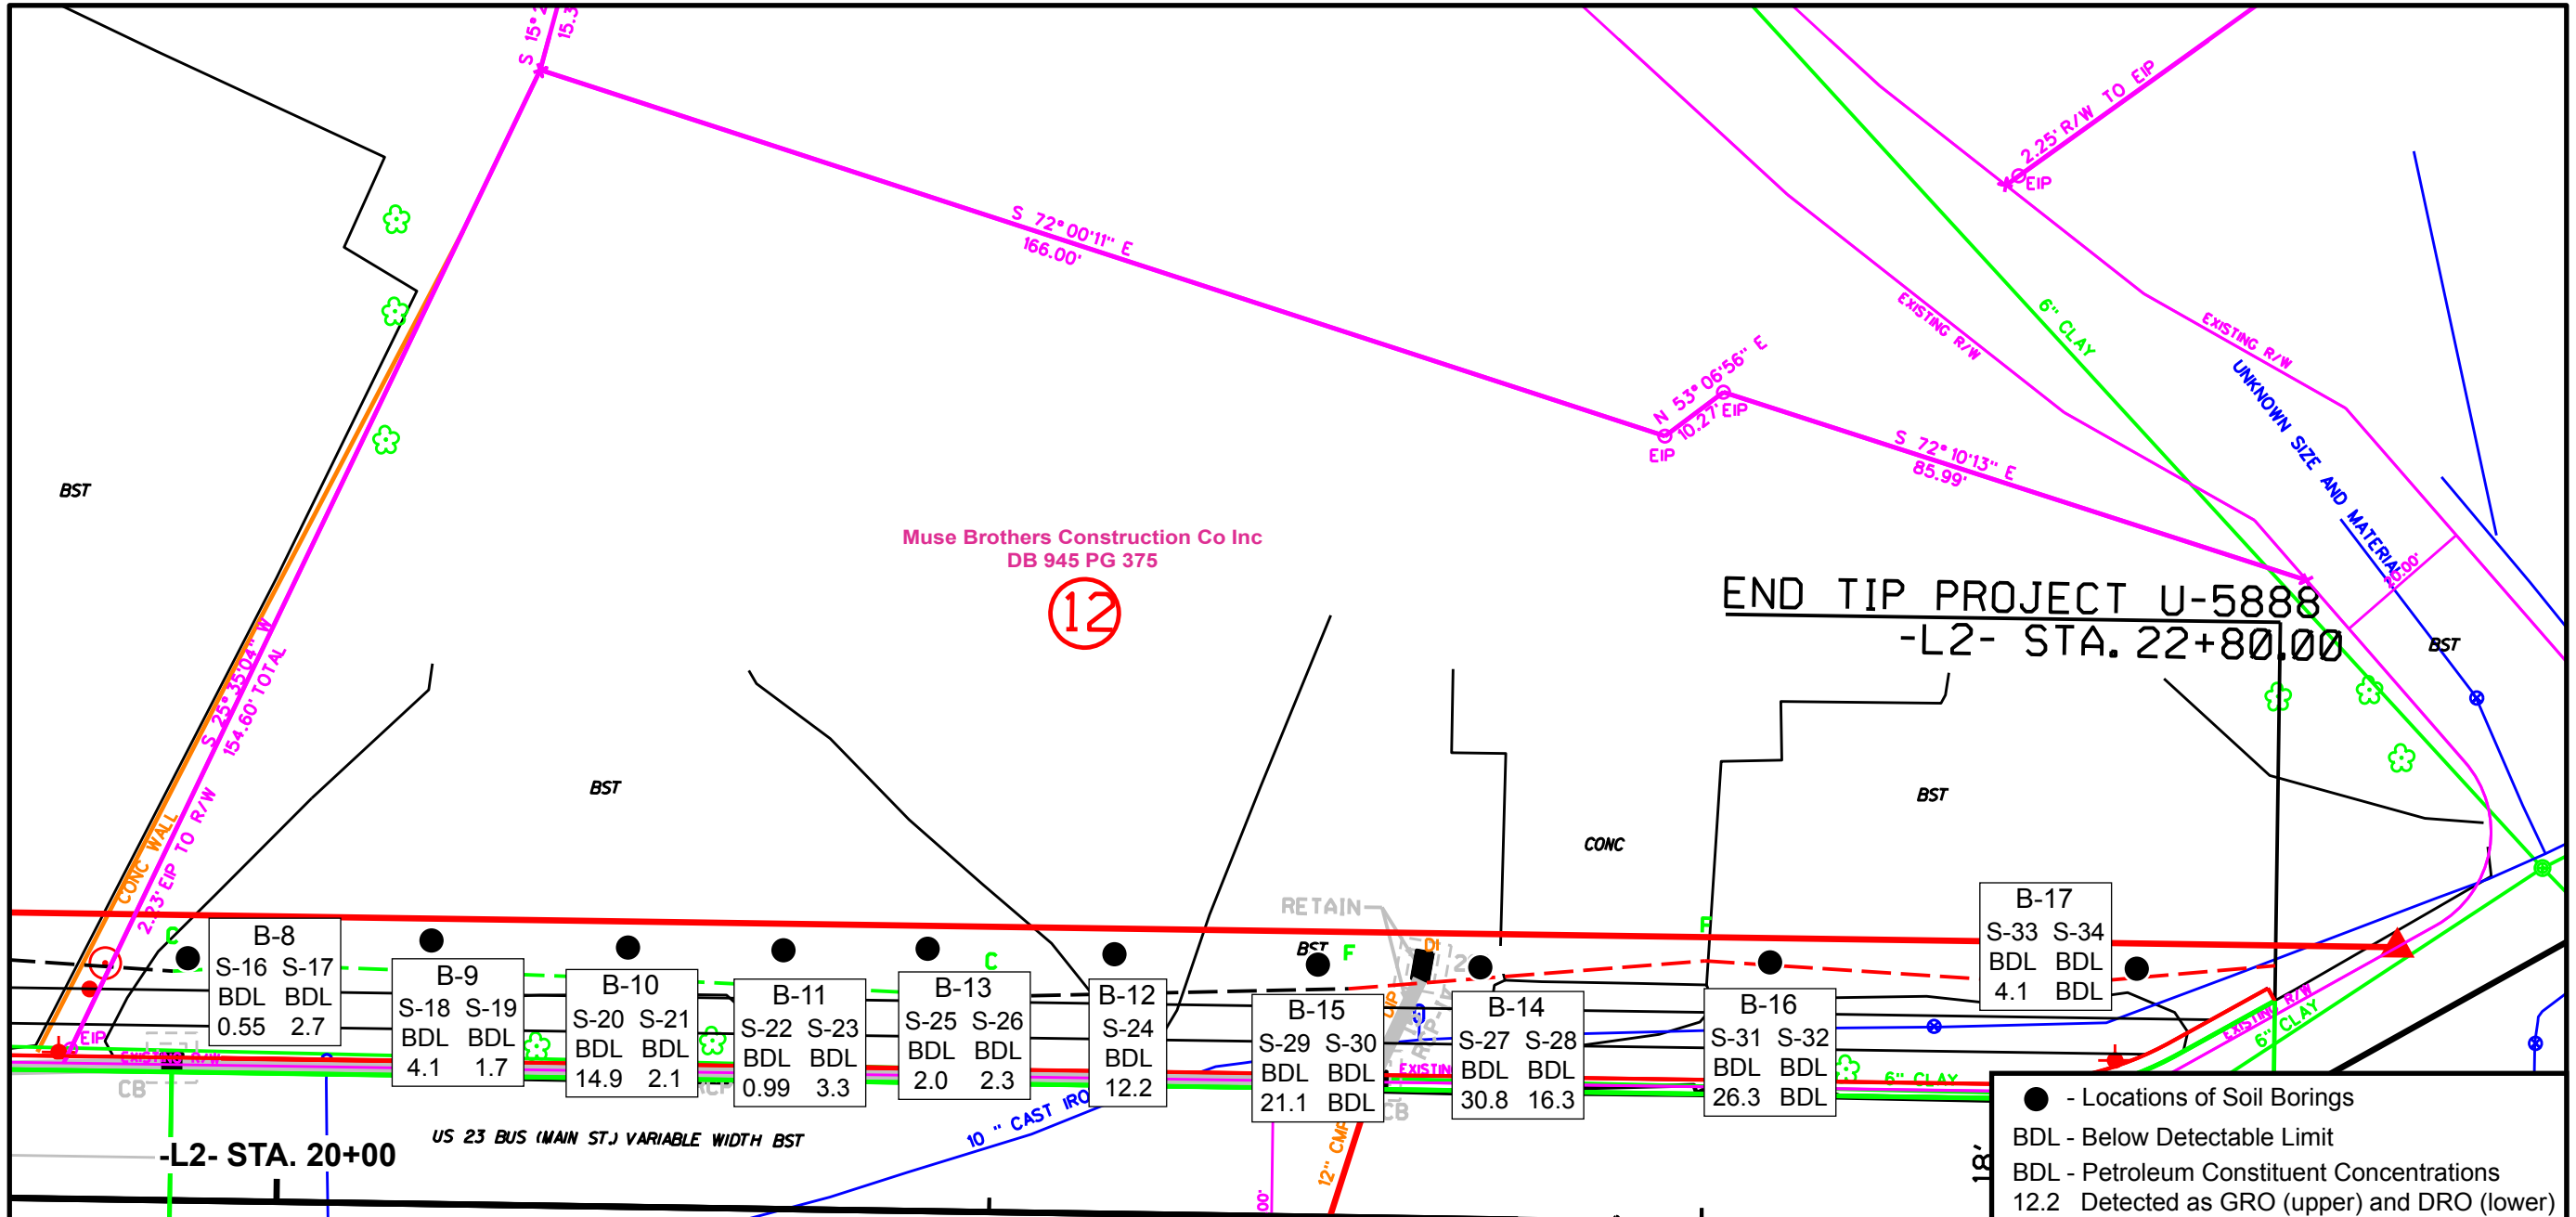
Borings B-8 through B-17 were drilled along the center of the easements and R/W from west to east. Petroleum constituents were detected in all but three of the 19 soil samples sent to the laboratory (Table B-3). Petroleum constituents were not detected above the NCDEQ Action Levels for GRO and/or DRO constituents (50 ppm and 100 ppm, respectively) in any of these soil samples. Many of the samples contained DRO concentrations at less than 10 ppm. Only samples S-20, S-24, S-27, S-28, S-29 and S-31 contained DRO concentrations greater than 10 ppm (Table B-3).

Contaminated soil, defined as GRO concentrations above 50 ppm and DRO concentrations above 100 ppm, was not detected in soil samples collected at Parcel #012.

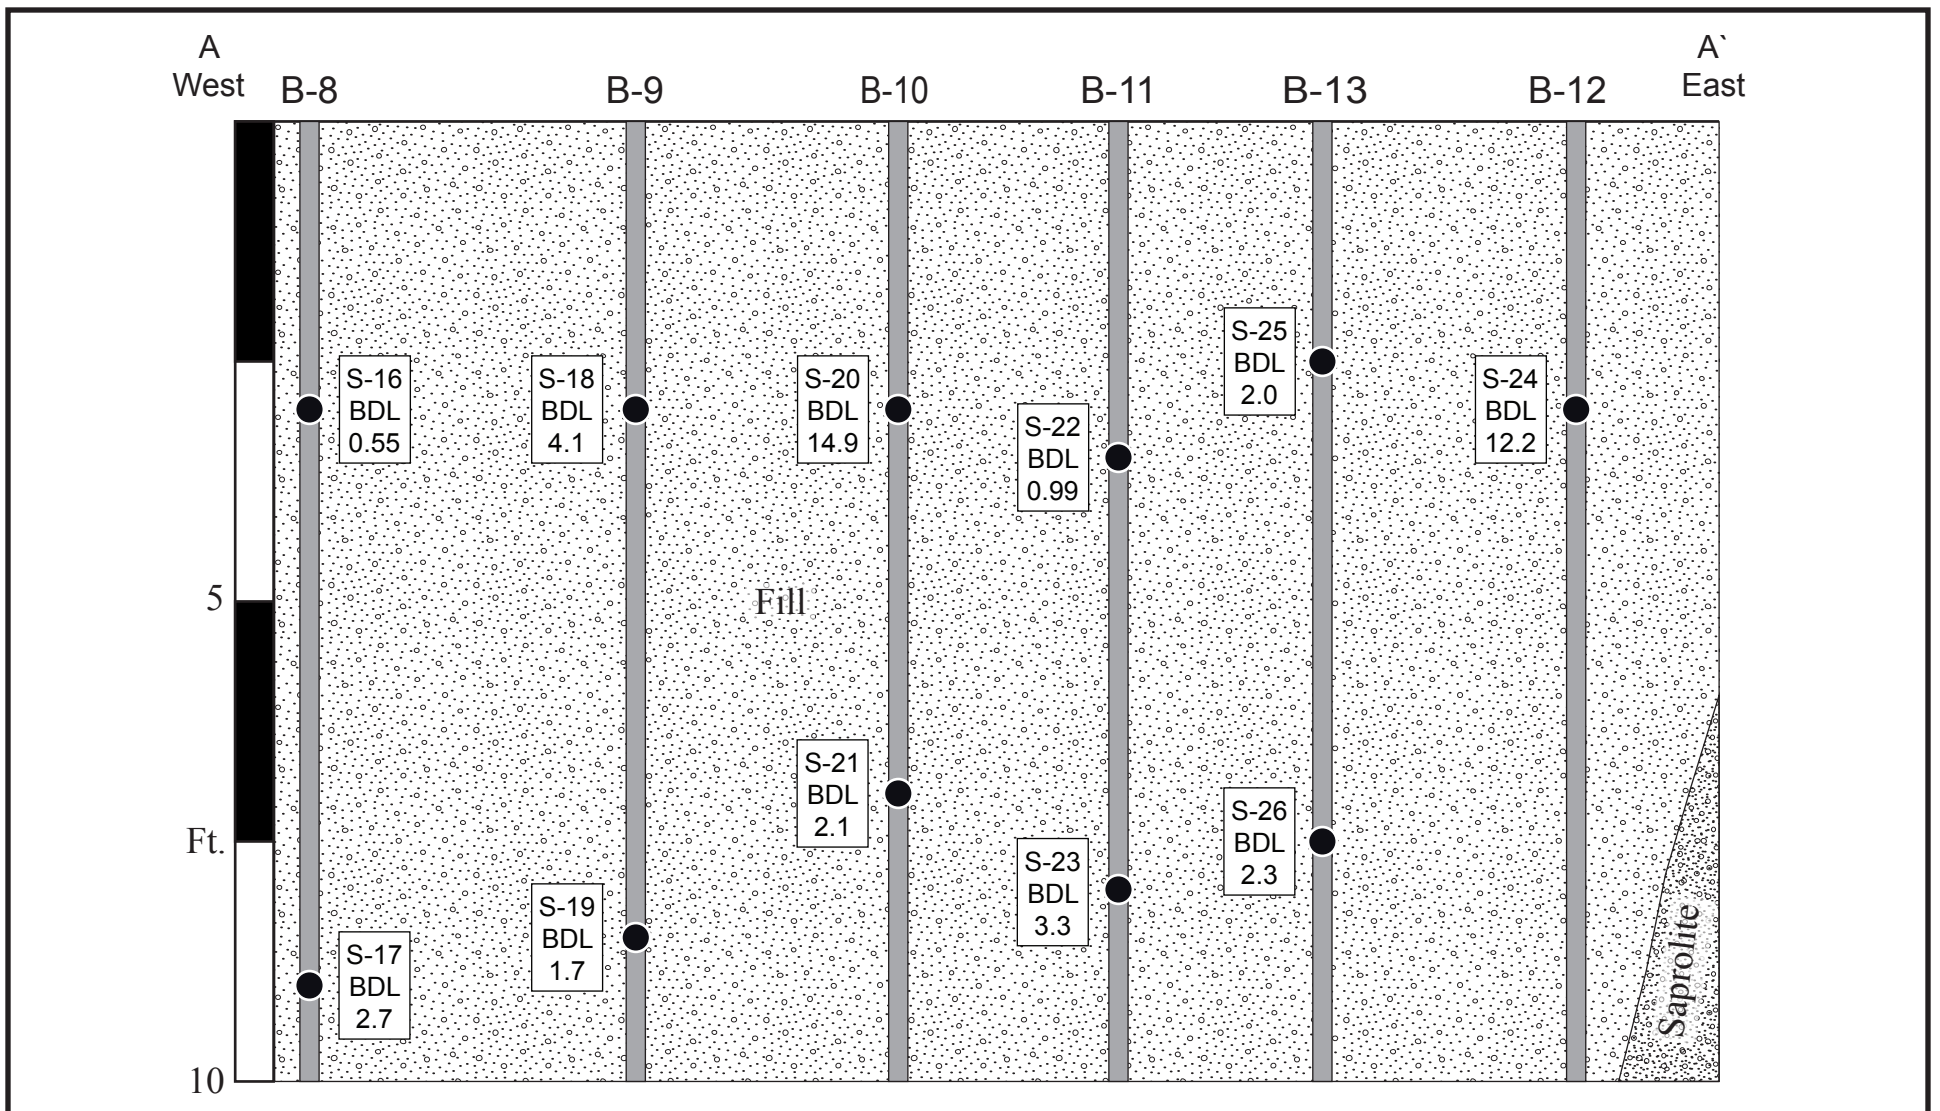
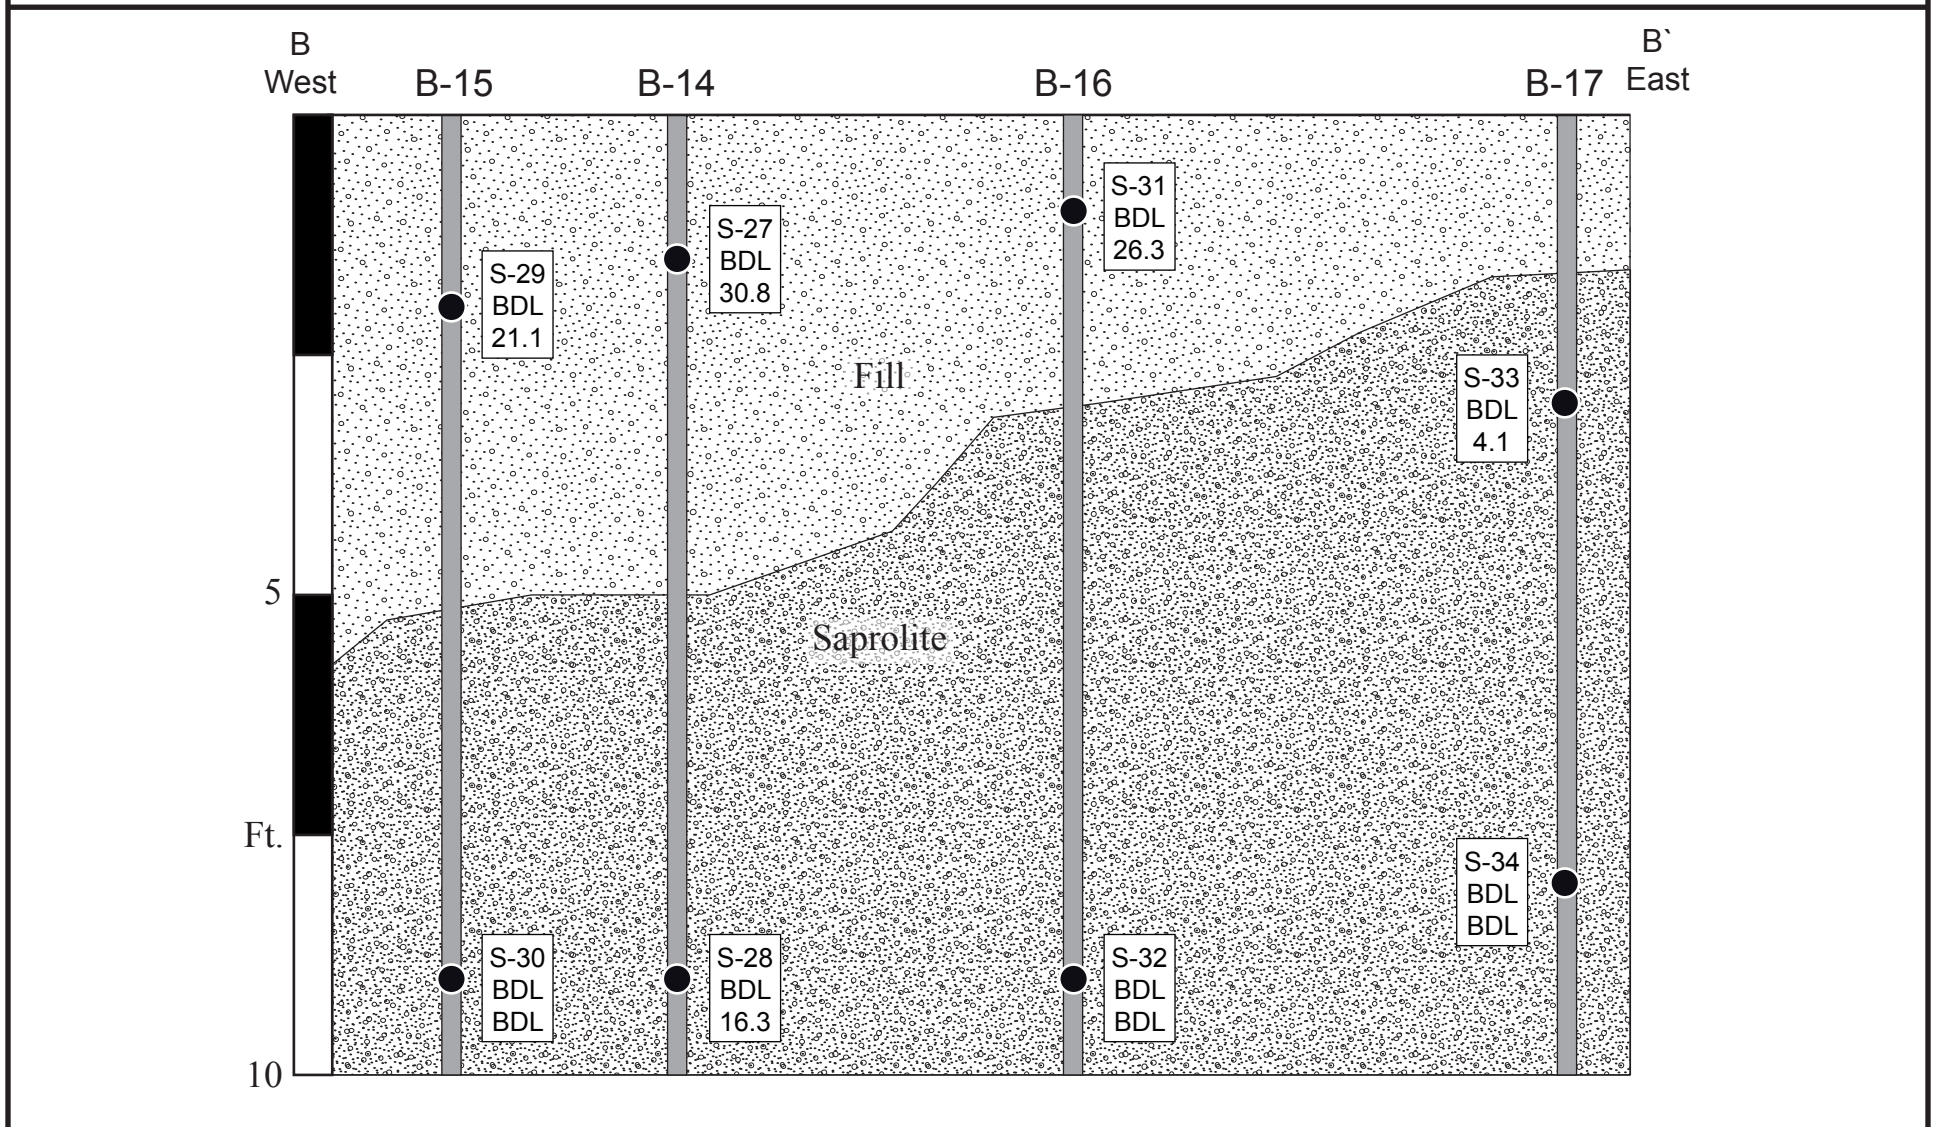
The soil type at Parcel #012 consisted mostly of a sandy silt fill material. A sandy silt saprolite was recorded at depth in some of the borings (Table 1). Groundwater was not encountered in any of the soil borings. Groundwater was reported at a depth of about 13 feet in previous environmental assessment reports.

● - Locations of Soil Samples    BDL - Below Detectable Limit    1.3 - Petroleum Constituent Concentrations  
 2.1 - Detected as GRO (upper) and DRO (lower)
