# Preliminary Site Assessment

US 221 South of US 74 Business (Charlotte Road) to North of  
SR 1366 (Roper Loop Road)  
Parcel 125 – Timothy and Lois Mace  
137 and 145 US Highway 64, Rutherfordton, North Carolina

State Project No. R-2233BB

**GEOPHYSICAL INVESTIGATION  
TO LOCATE METALLIC USTS**

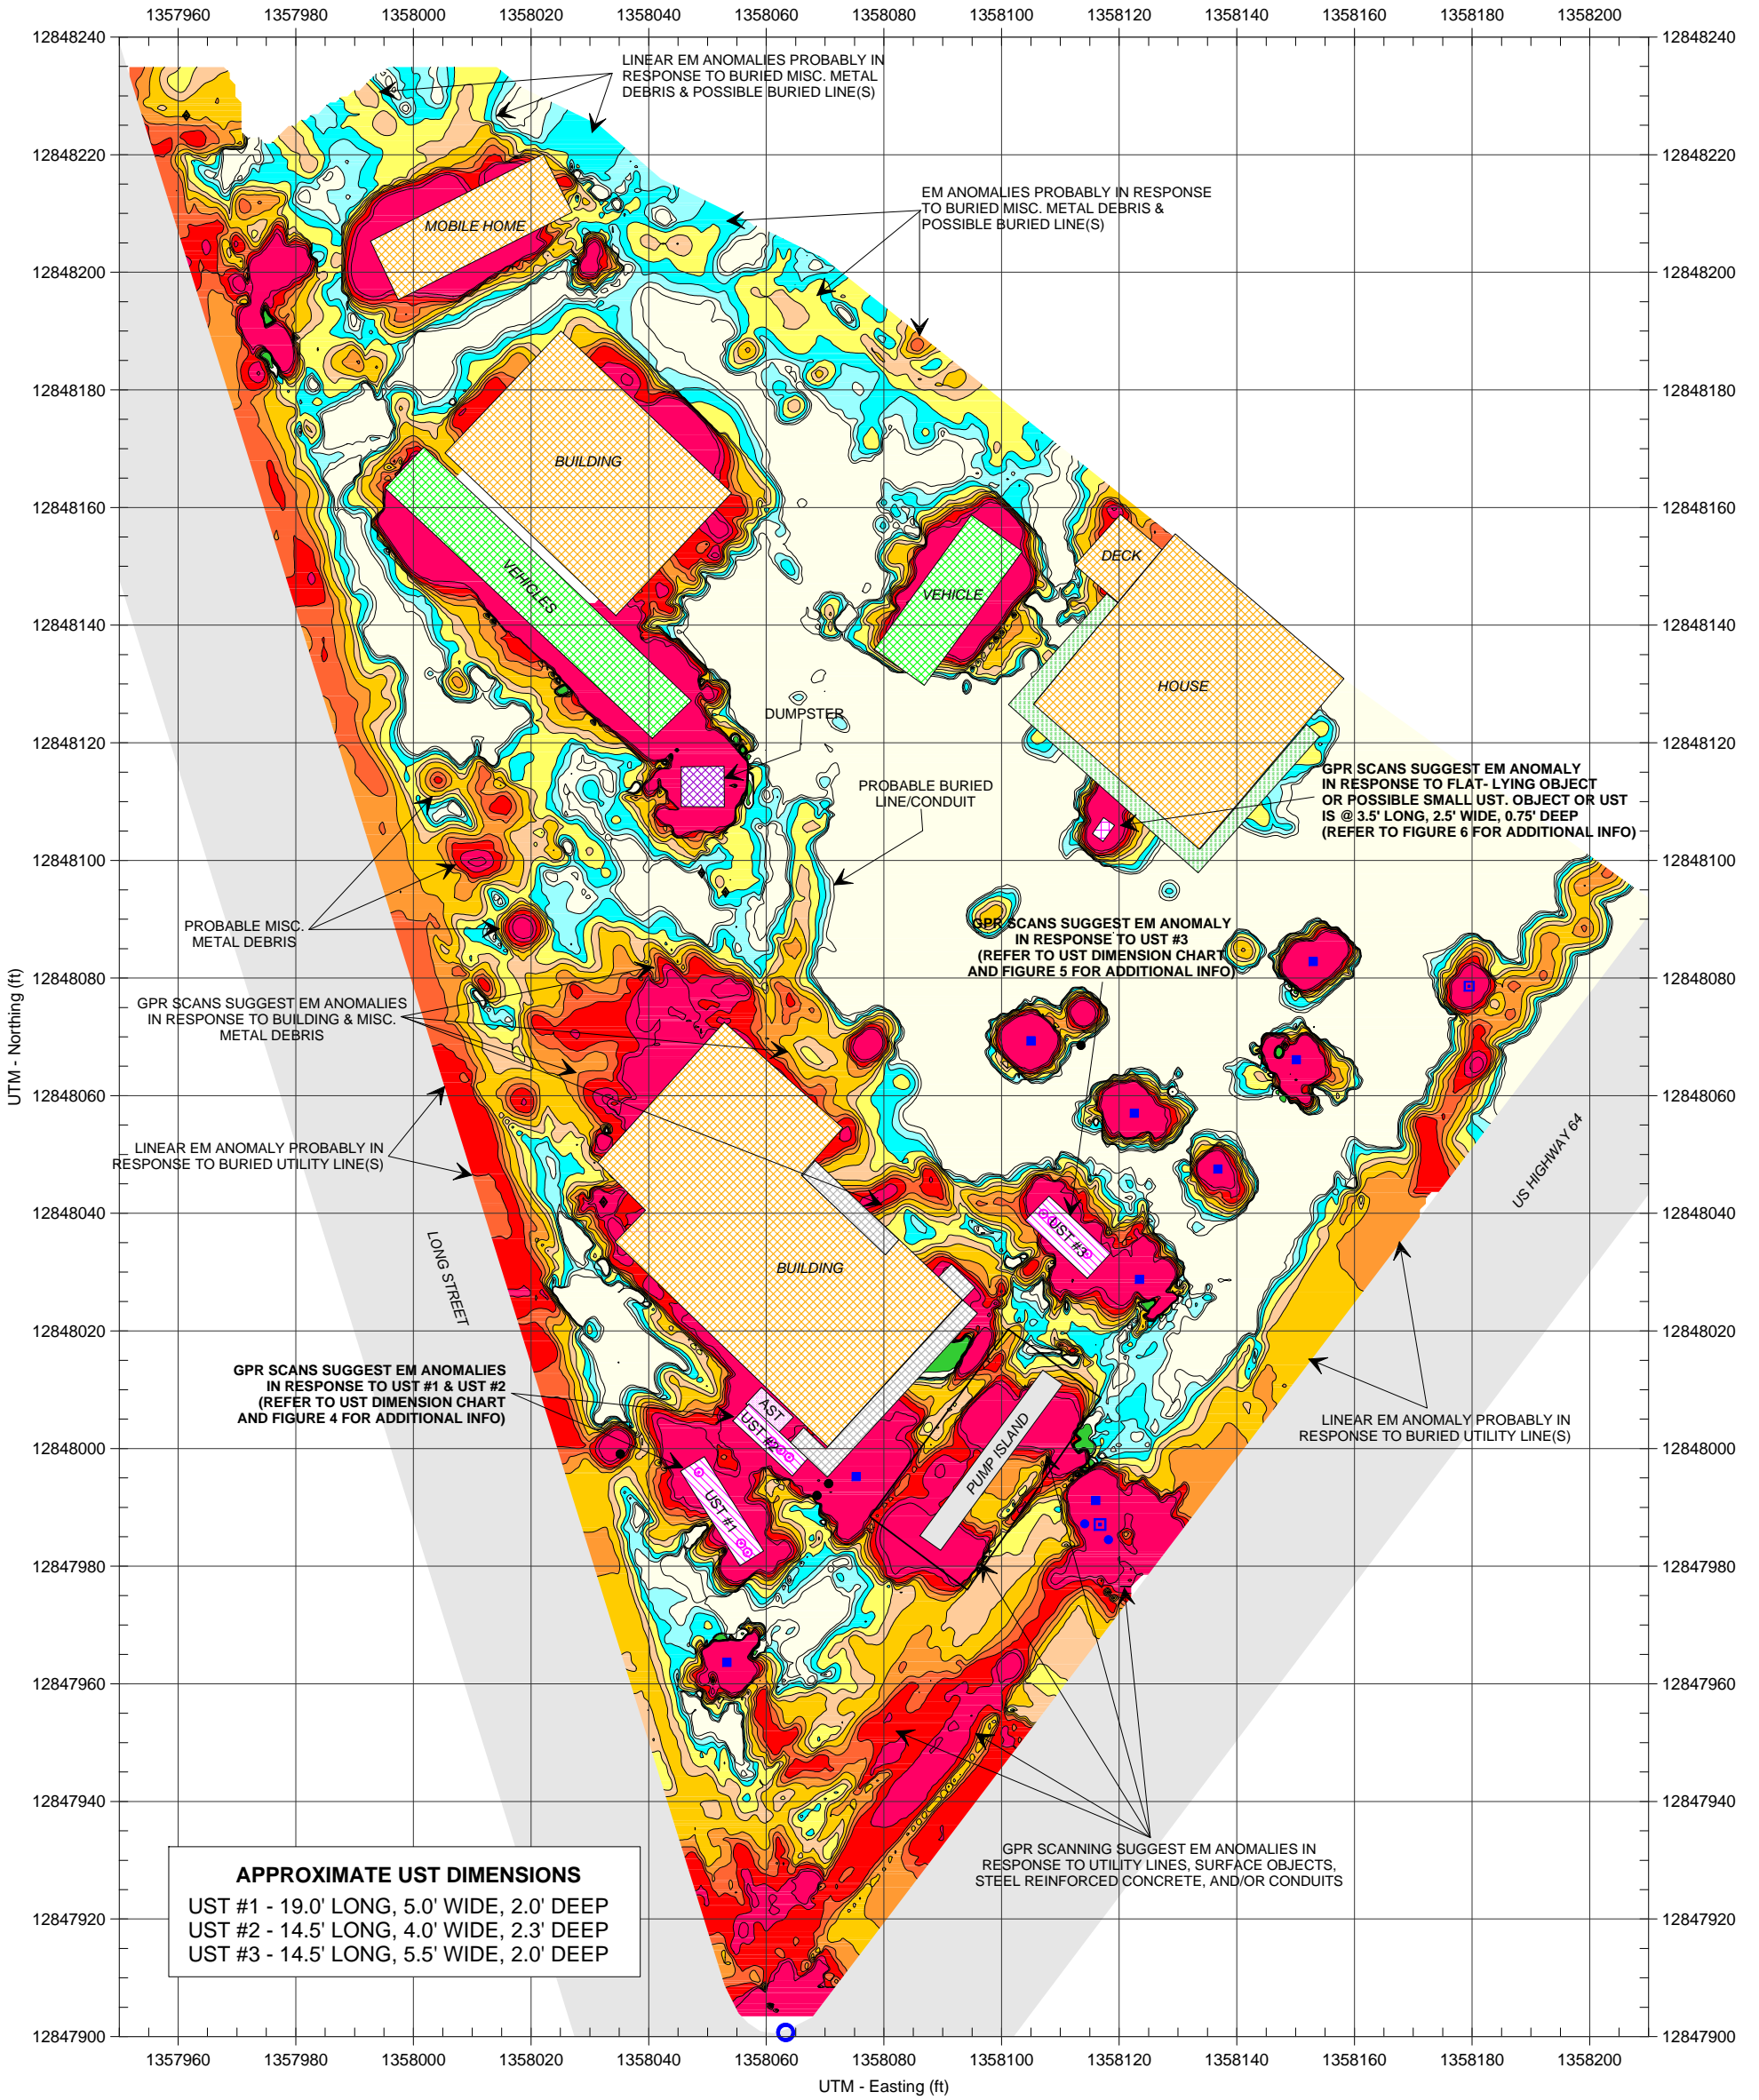
11/27/17      336-286-9718      FIGURE 2

The linear, EM61 early time gate anomalies intersecting UTM coordinates 1357987-E 12848127-N, 1358066-E 12848091-N, 1358091-E 12847950-N, and 1358155-E 12848024-N are probably in response to buried utility lines or conduits. The early time gate anomalies at 1358003-E 12848151-N, 1357996-E 12848210-N, 1358046-E 12848173-N, 1358087-E 12848153-N, and 1358100-E 12848142-N are probably in response to parked vehicles, buildings or mobile home. The early time gate anomalies centered near coordinates 1358011-E 12848105-N, 1357993-E 12848223-N and 1358068-E 12848192-N are probably in response to buried, miscellaneous debris or small objects.

**APPROXIMATE UST DIMENSIONS**  
 UST #1 - 19.0' LONG, 5.0' WIDE, 2.0' DEEP  
 UST #2 - 14.5' LONG, 4.0' WIDE, 2.3' DEEP  
 UST #3 - 14.5' LONG, 5.5' WIDE, 2.0' DEEP

The contour plot shows the early time gate (most sensitive) response of the Geonics EM61-MK2A metal detection instrument in millivolts (mV). The early time gate response shows buried, metallic objects, lines and conduits regardless of size. GPR scans were conducted across selected EM61 anomalies and steel reinforced concrete using a Geophysical Survey Systems SIR 3000 instrument with a 400 MHz antenna. The geophysical investigation was conducted on July 28 and August 2 - 3, 2017.

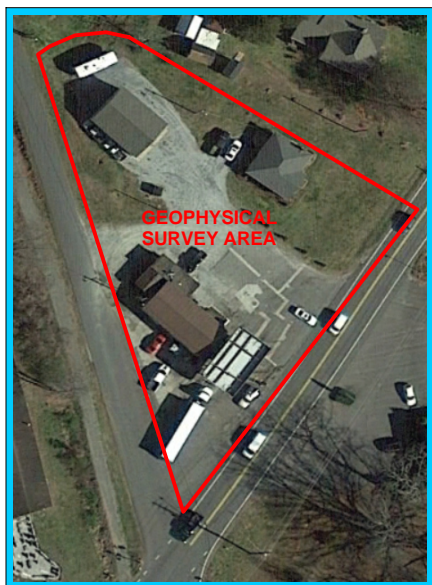
The red polygon in the aerial photograph represents the approximate perimeter of the geophysical survey area at Parcel 125

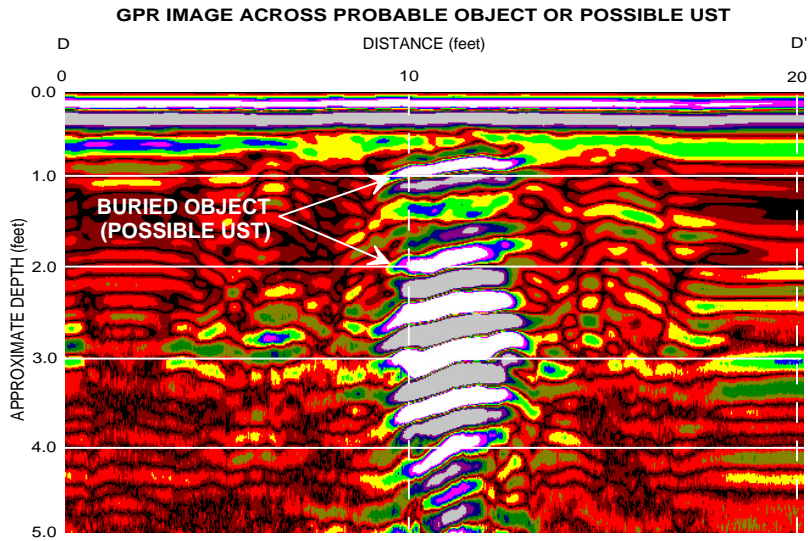
The high amplitude, flat-lying reflections in the GPR image (above) are probably in response to a miscellaneous, metal object or a possible (low confidence) UST buried approximately 0.75 feet below present grade. The purple line labeled DD' in the photograph shown below represents the approximate location of the GPR image.

GPR scanning suggests that the EM61 differential anomaly centered near UTM coordinates 1358117-E 12848105-N is probably in response to a flat-lying, miscellaneous, metallic object or to a possible (low confidence) small UST. Based on the GPR data, the probable buried object or possible UST is approximately 3.5 feet long, 2.5 feet wide and buried 0.75 feet below present grade. The foot print of the buried object was marked in the field using red marking paint and pin flags. A GPR image across the buried object and a photograph showing the location of the buried object are presented in **Figure 6**. An intrusive investigation is recommended to determine the identity of the buried object or possible UST.
