Preliminary Site Assessment

US 221 South of US 74 Business (Charlotte Road) to North of
SR 1366 (Roper Loop Road)
Parcel 212 – Janic Holdings
1360 US 221, Rutherfordton, North Carolina

State Project No. R-2233BB

Terracon Project No. 71177323

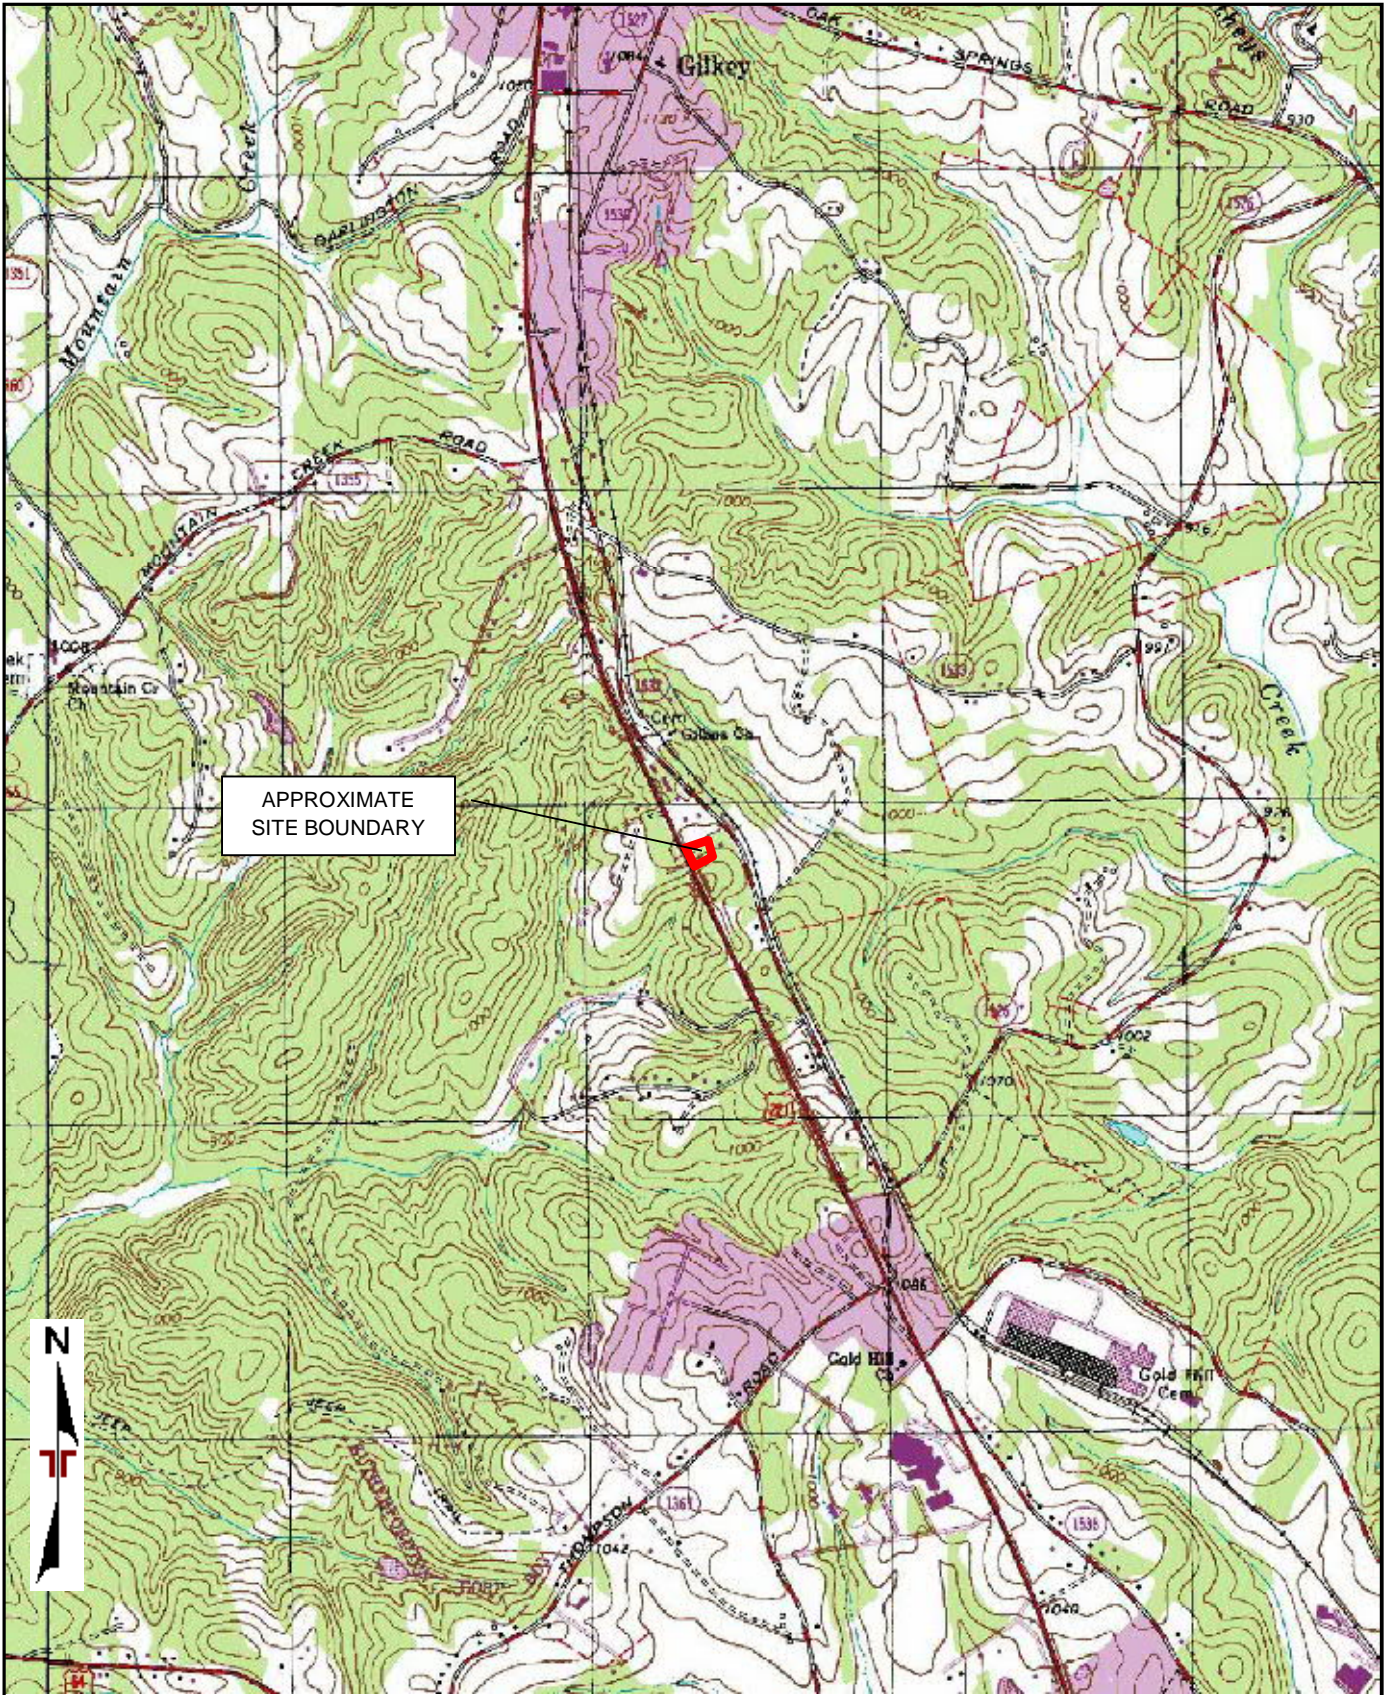
Exhibit	1
---------	---

APPROXIMATE
SITE BOUNDARY

TOPOGRAPHIC VICINITY MAP

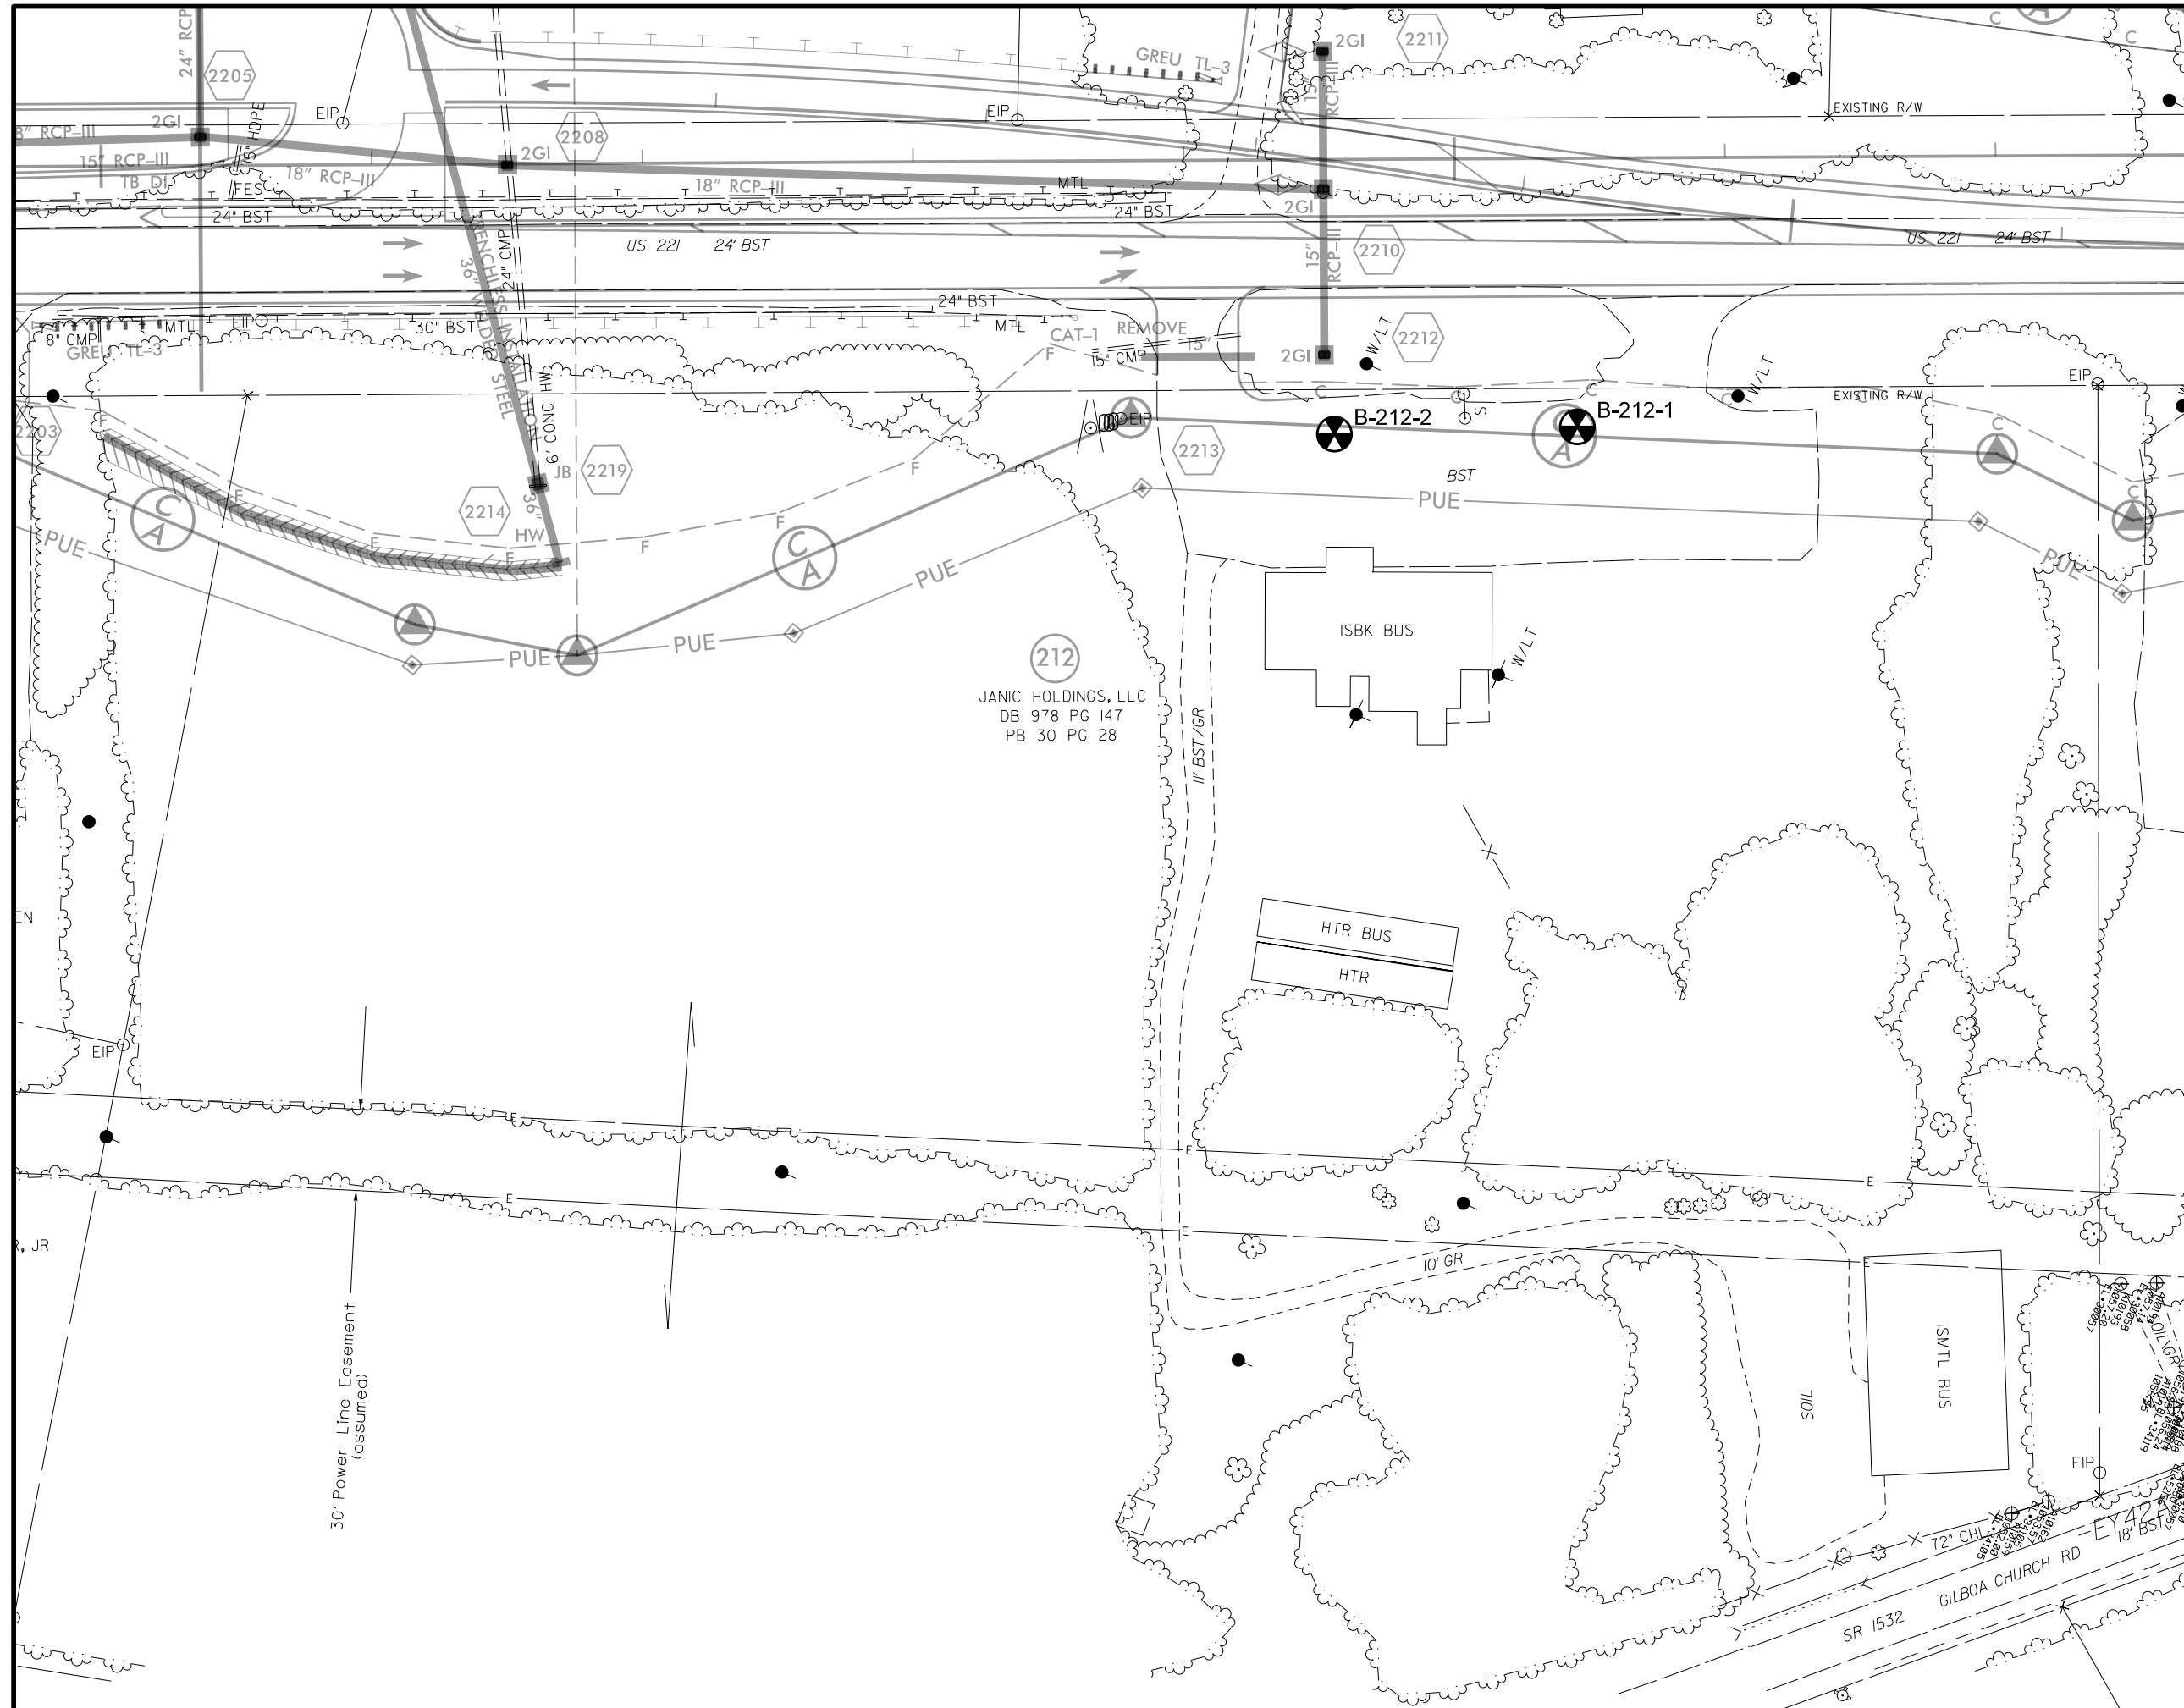
EXHIBIT 2A – SITE DIAGRAM WITH SOIL BORING LOCATIONS

SITE DIAGRAM WITH BORING LOCATIONS

PARCEL 212 - JANIC HOLDINGS, LLC PROPERTY
 1366 US 221
 RUTHERFORDTON, RUTHERFORD COUNTY

Soils generally consisted of orange brown to dark reddish brown and dark brown sandy clay. Groundwater was not encountered in the on-site borings. The soil boring logs are included in **Appendix B**. Sample locations were measured relative to site features and the locations depicted on **Exhibit 2** are approximate.

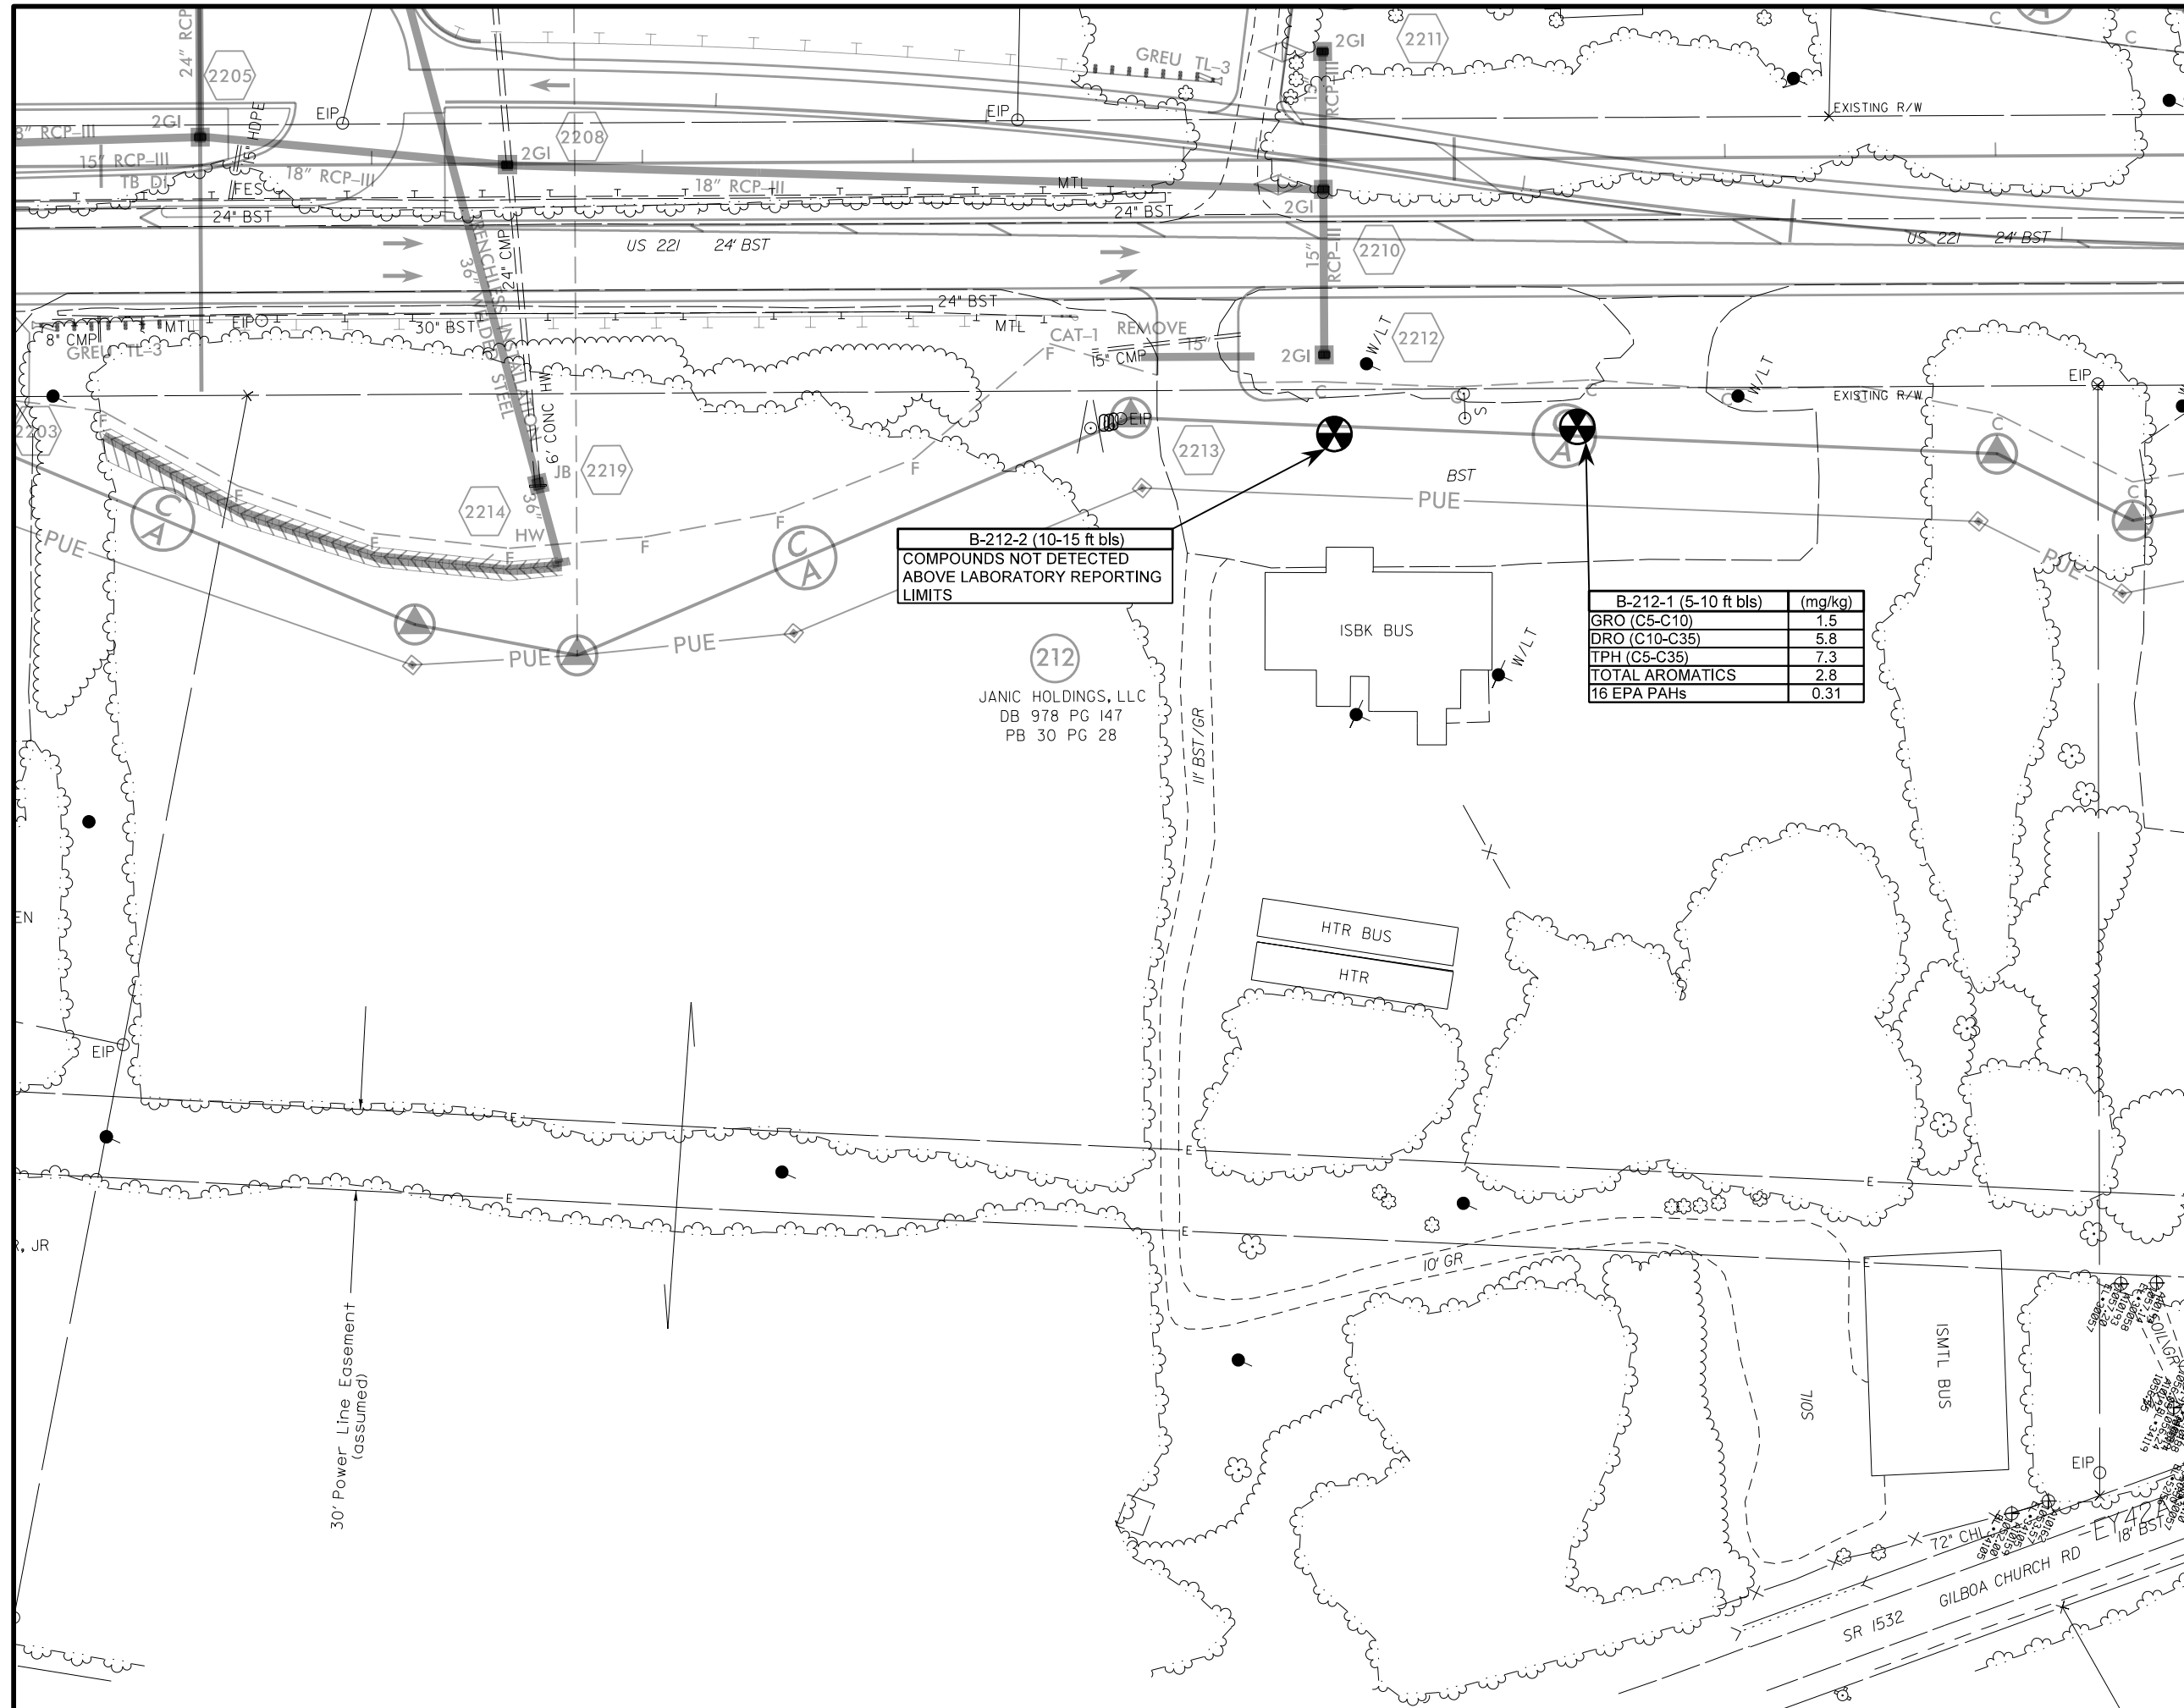
**EXHIBIT 2B – SITE DIAGRAM WITH SOIL BORING LOCATIONS
AND ANALYTICAL DATA**

B-212-2 (10-15 ft bls)
COMPOUNDS NOT DETECTED
ABOVE LABORATORY REPORTING
LIMITS

B-212-1 (5-10 ft bls)		(mg/kg)
GRO (C5-C10)		1.5
DRO (C10-C35)		5.8
TPH (C5-C35)		7.3
TOTAL AROMATICS		2.8
16 EPA PAHs		0.31

The identified constituents were detected at concentrations below their respective NCDEQ regulatory action levels (50 mg/kg for GRO and 100 mg/kg for DRO). **Table 1** summarizes the results of the UVF analyses of the soil samples.

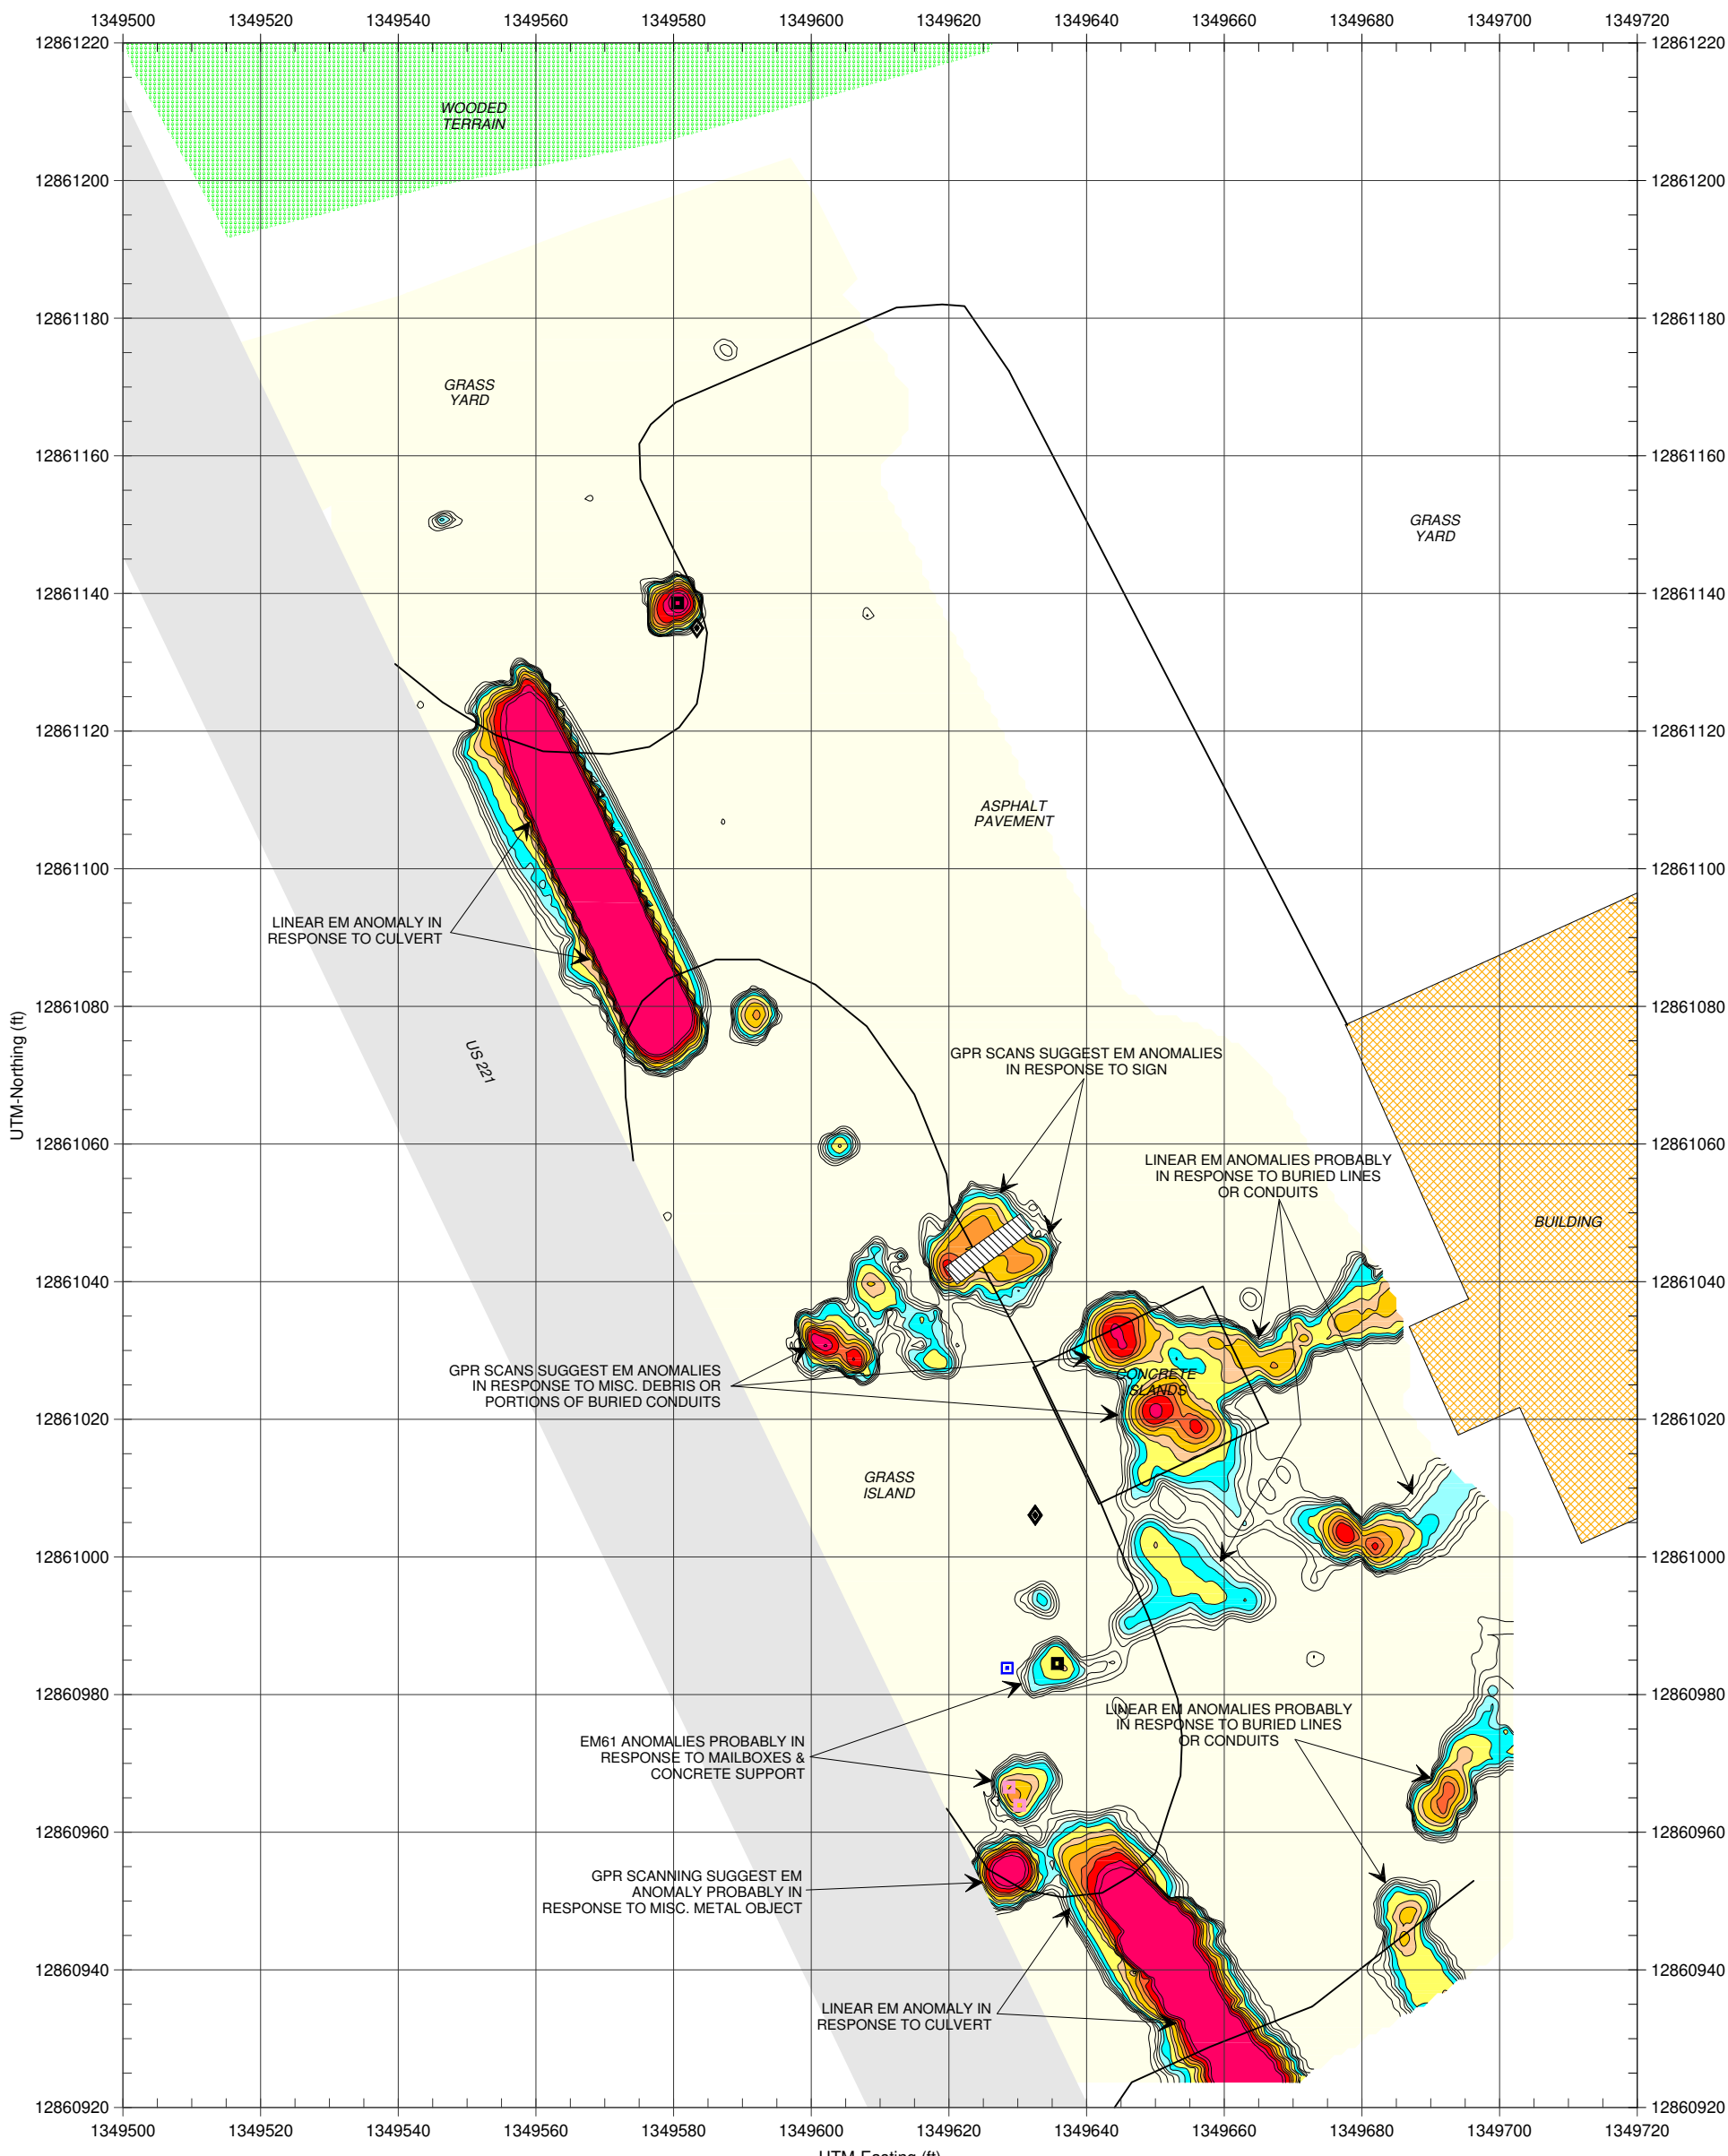
11/27/17 336-286-9718 FIGURE 2

The contour plot shows the early time gate (most sensitive) response of the Geonics EM61-MK2A metal detection instrument in millivolts (mV). The early time gate response shows buried, metallic objects, lines and conduits regardless of size. GPR scans were conducted across selected EM61 anomalies and steel reinforced concrete using a Geophysical Survey Systems SIR 3000 instrument with a 400 MHz antenna. The geophysical investigation was conducted on July 27 and August 2, 2017.

**EM61-MK2A METAL DETECTION
(EARLY TIME GATE RESULTS)**

Contour plots of the EM61 early time gate results and the EM61 differential results are presented in **Figures 2 and 3**, respectively. The early time gate results represent the most sensitive component of the EM61 instrument and detect metal objects regardless of size. The early time gate response can be used to delineate metallic conduits or utility lines, small, isolated, metal objects and areas containing insignificant metal debris. The differential results are obtained from the difference between the early time gate channel and late time gate channel of the EM61 instrument. The differential results focus on the larger metal objects such as drums and UST-size objects and ignore the smaller, insignificant, metal objects or debris.

The linear, EM61 early time gate anomalies intersecting UTM coordinates 1349566-E 12861102-N and 1349656-E 12860935-N are probably in response to metal culverts. The linear, EM61 early time gate anomalies intersecting UTM coordinates 1349677-E 12861033-N, 1349685-E 12861002-N, 1349653-E 12860997-N, and 1349692-E 12860966-N are probably in response to buried lines or conduits.

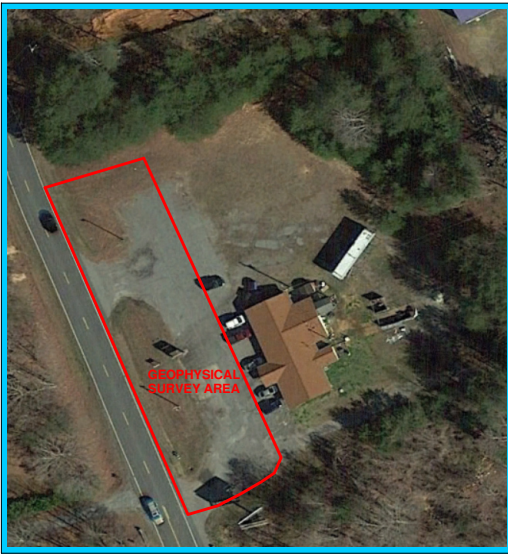
The red polygon in the aerial photograph represents the approximate perimeter of the geophysical survey area at Parcel 212.

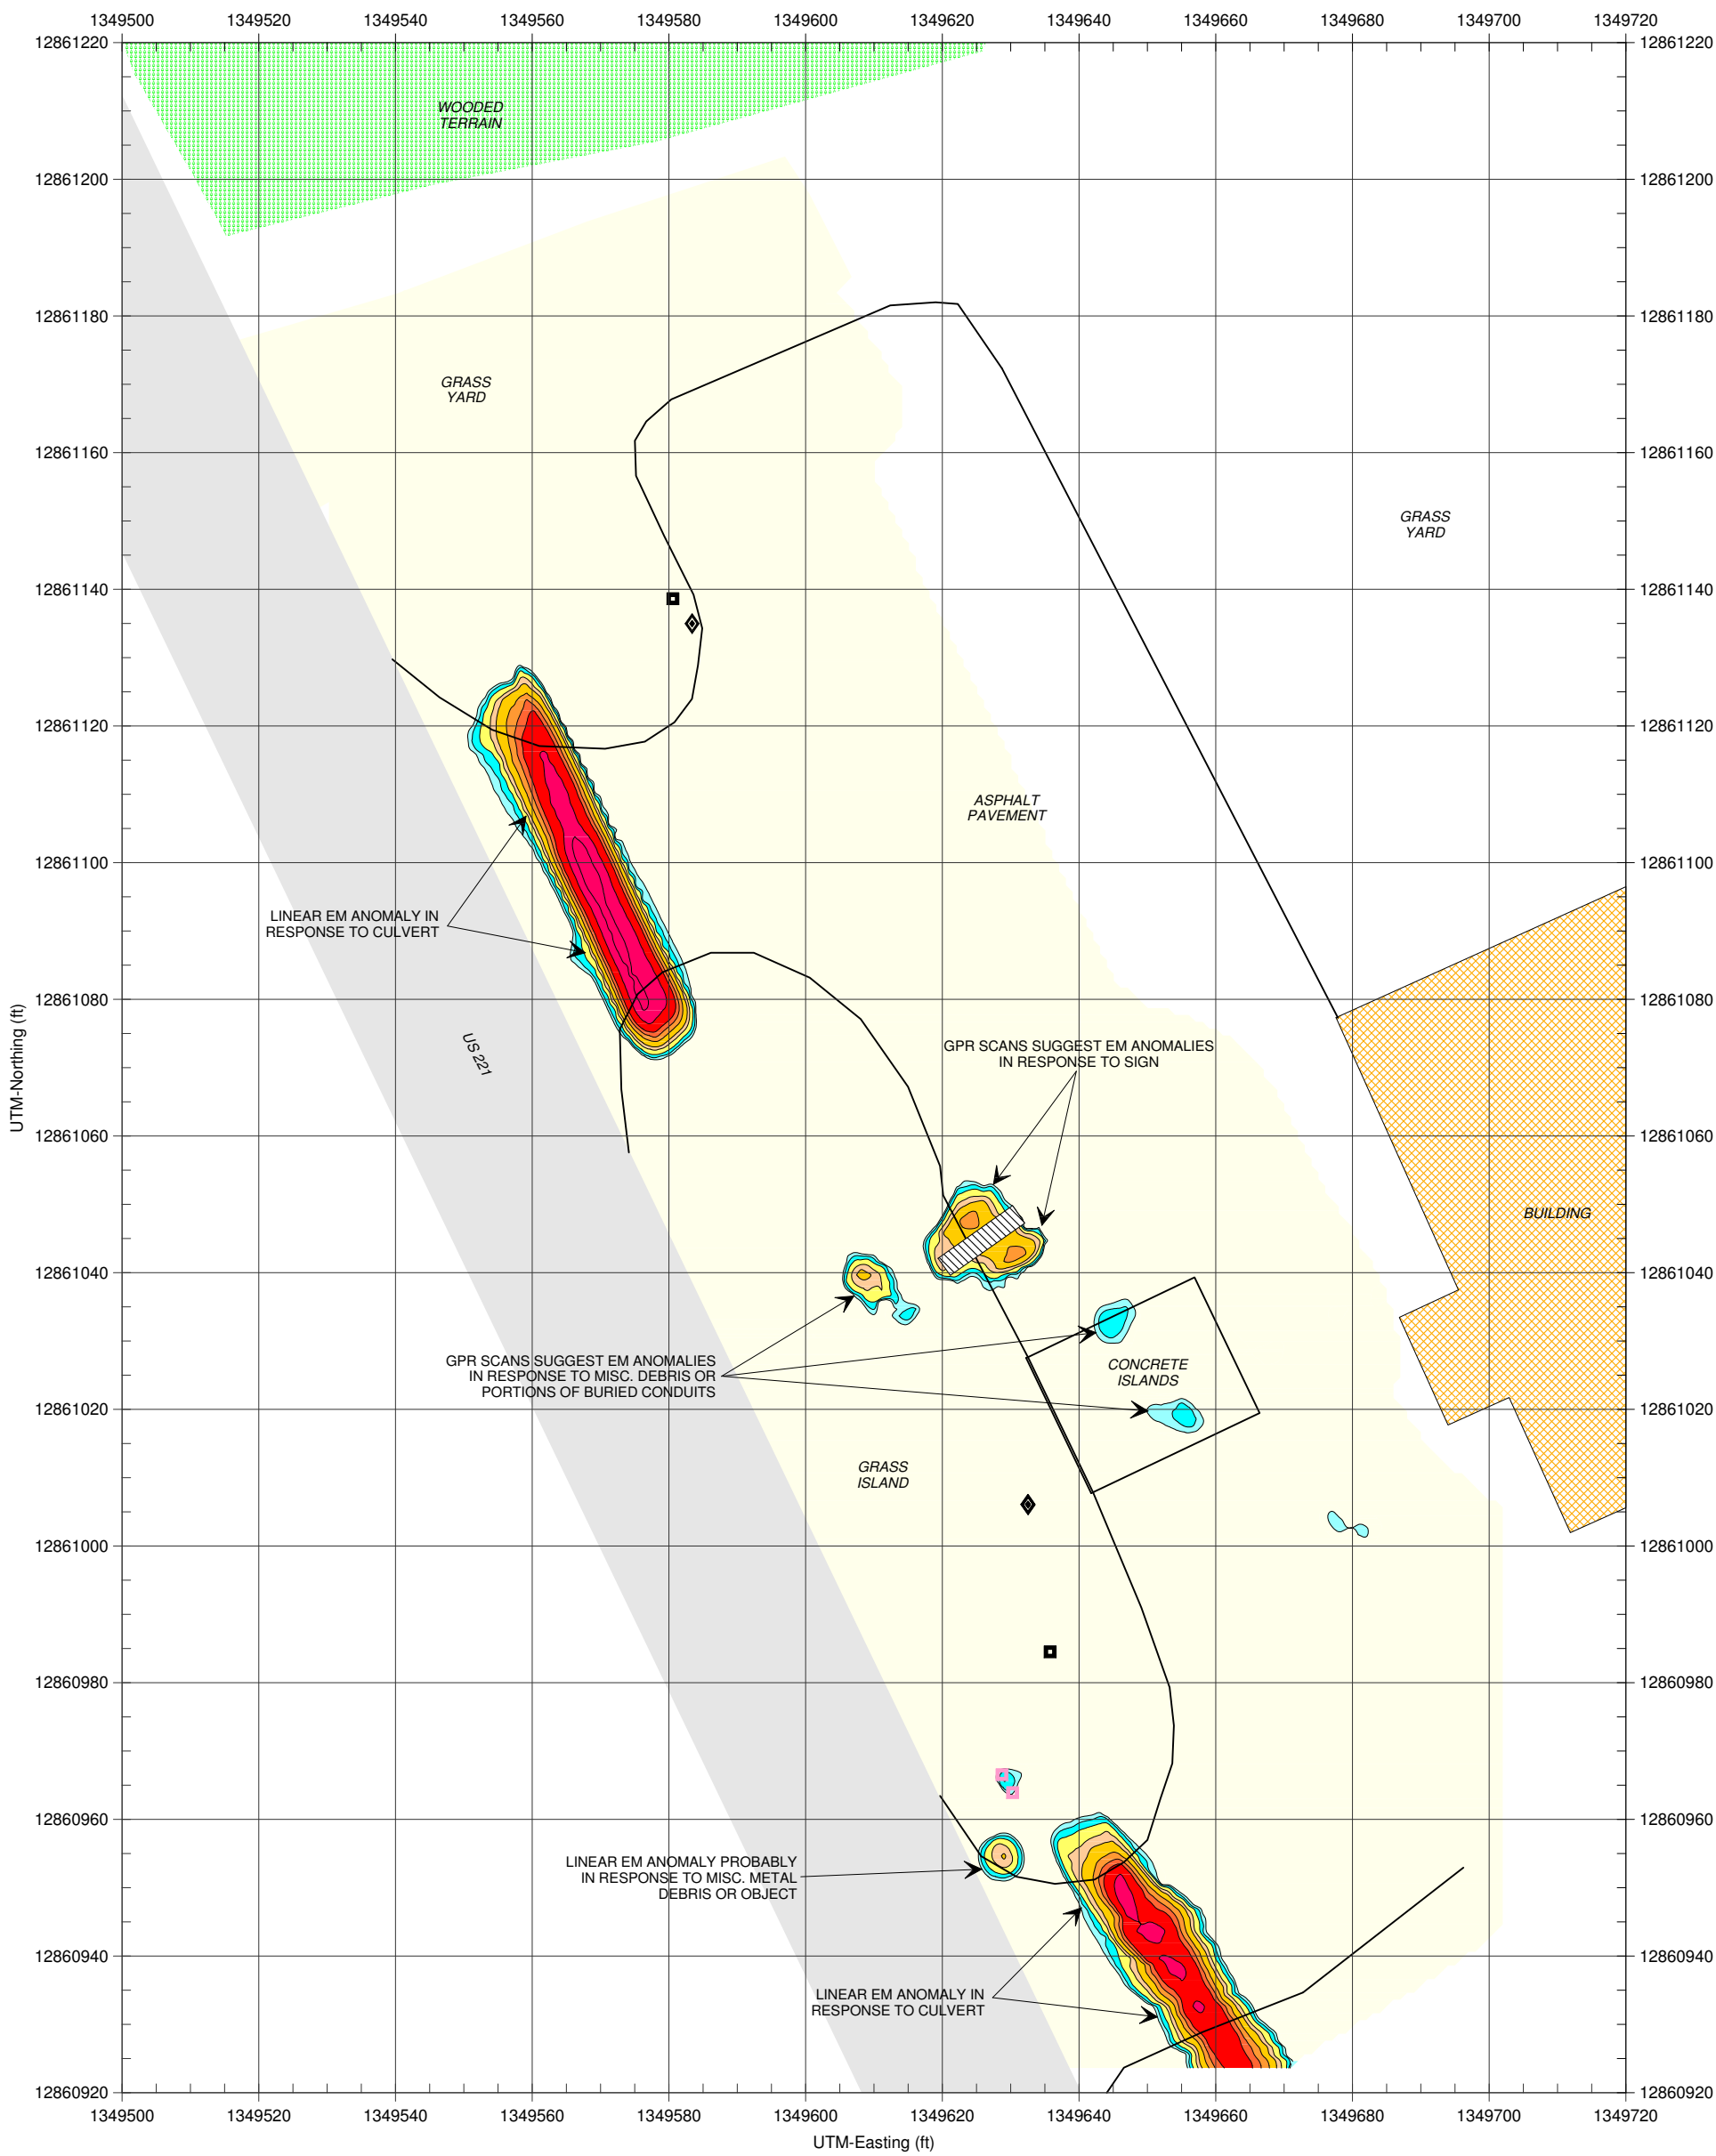
11/27/17 336-286-9718 FIGURE 3

Note: The contour plot shows the differential response between the early time gate and the late time gate channels of the Geonics EM61-MK2A metal detection instrument in millivolts (mV). The differential response focuses on larger, buried, metallic objects such as drums and USTs and ignores smaller miscellaneous, metal debris. Ground penetrating radar (GPR) scans were conducted across selected EM61 anomalies and areas containing reinforced concrete using a Geophysical Survey Systems SIR 3000 unit with a 400 MHz antenna. The geophysical investigation was conducted on July 27 and August 2, 2017.

EM61-MK2A METAL DETECTION (DIFFERENTIAL RESULTS)

GPR data suggest the EM61 differential anomalies centered near coordinates 1349625-E 12861045-N, 1349608-E 12861039-N and 1349628-E 12860954-N are in response to a metal sign and to buried, miscellaneous, metal objects, respectively. The EM61 and GPR investigation suggests the geophysical survey area (proposed ROW/PUE area) at Parcel 212 does not contain metallic USTs. Please refer to Figures 2 and 3 for additional (detailed) information regarding the geophysical findings at this site. The EM61 results are also shown on NCDOT base maps in **Figures 4 and 5**.
