RE: TIP U-5738, WBS 50163.1.1
Rowan County, North Carolina
Structure Subsurface Investigation for Bridge over Town Creek on SR 2528 between SR 2540 and US 601

Bridge over Town Creek Structure Subsurface Investigation

STRUCTURE
SUBSURFACE INVESTIGATION

COUNTY ROWAN
PROJECT DESCRIPTION BRIDGE NO. 201 ON SR 2528
(JULIAN ROAD) OVER TOWN CREEK

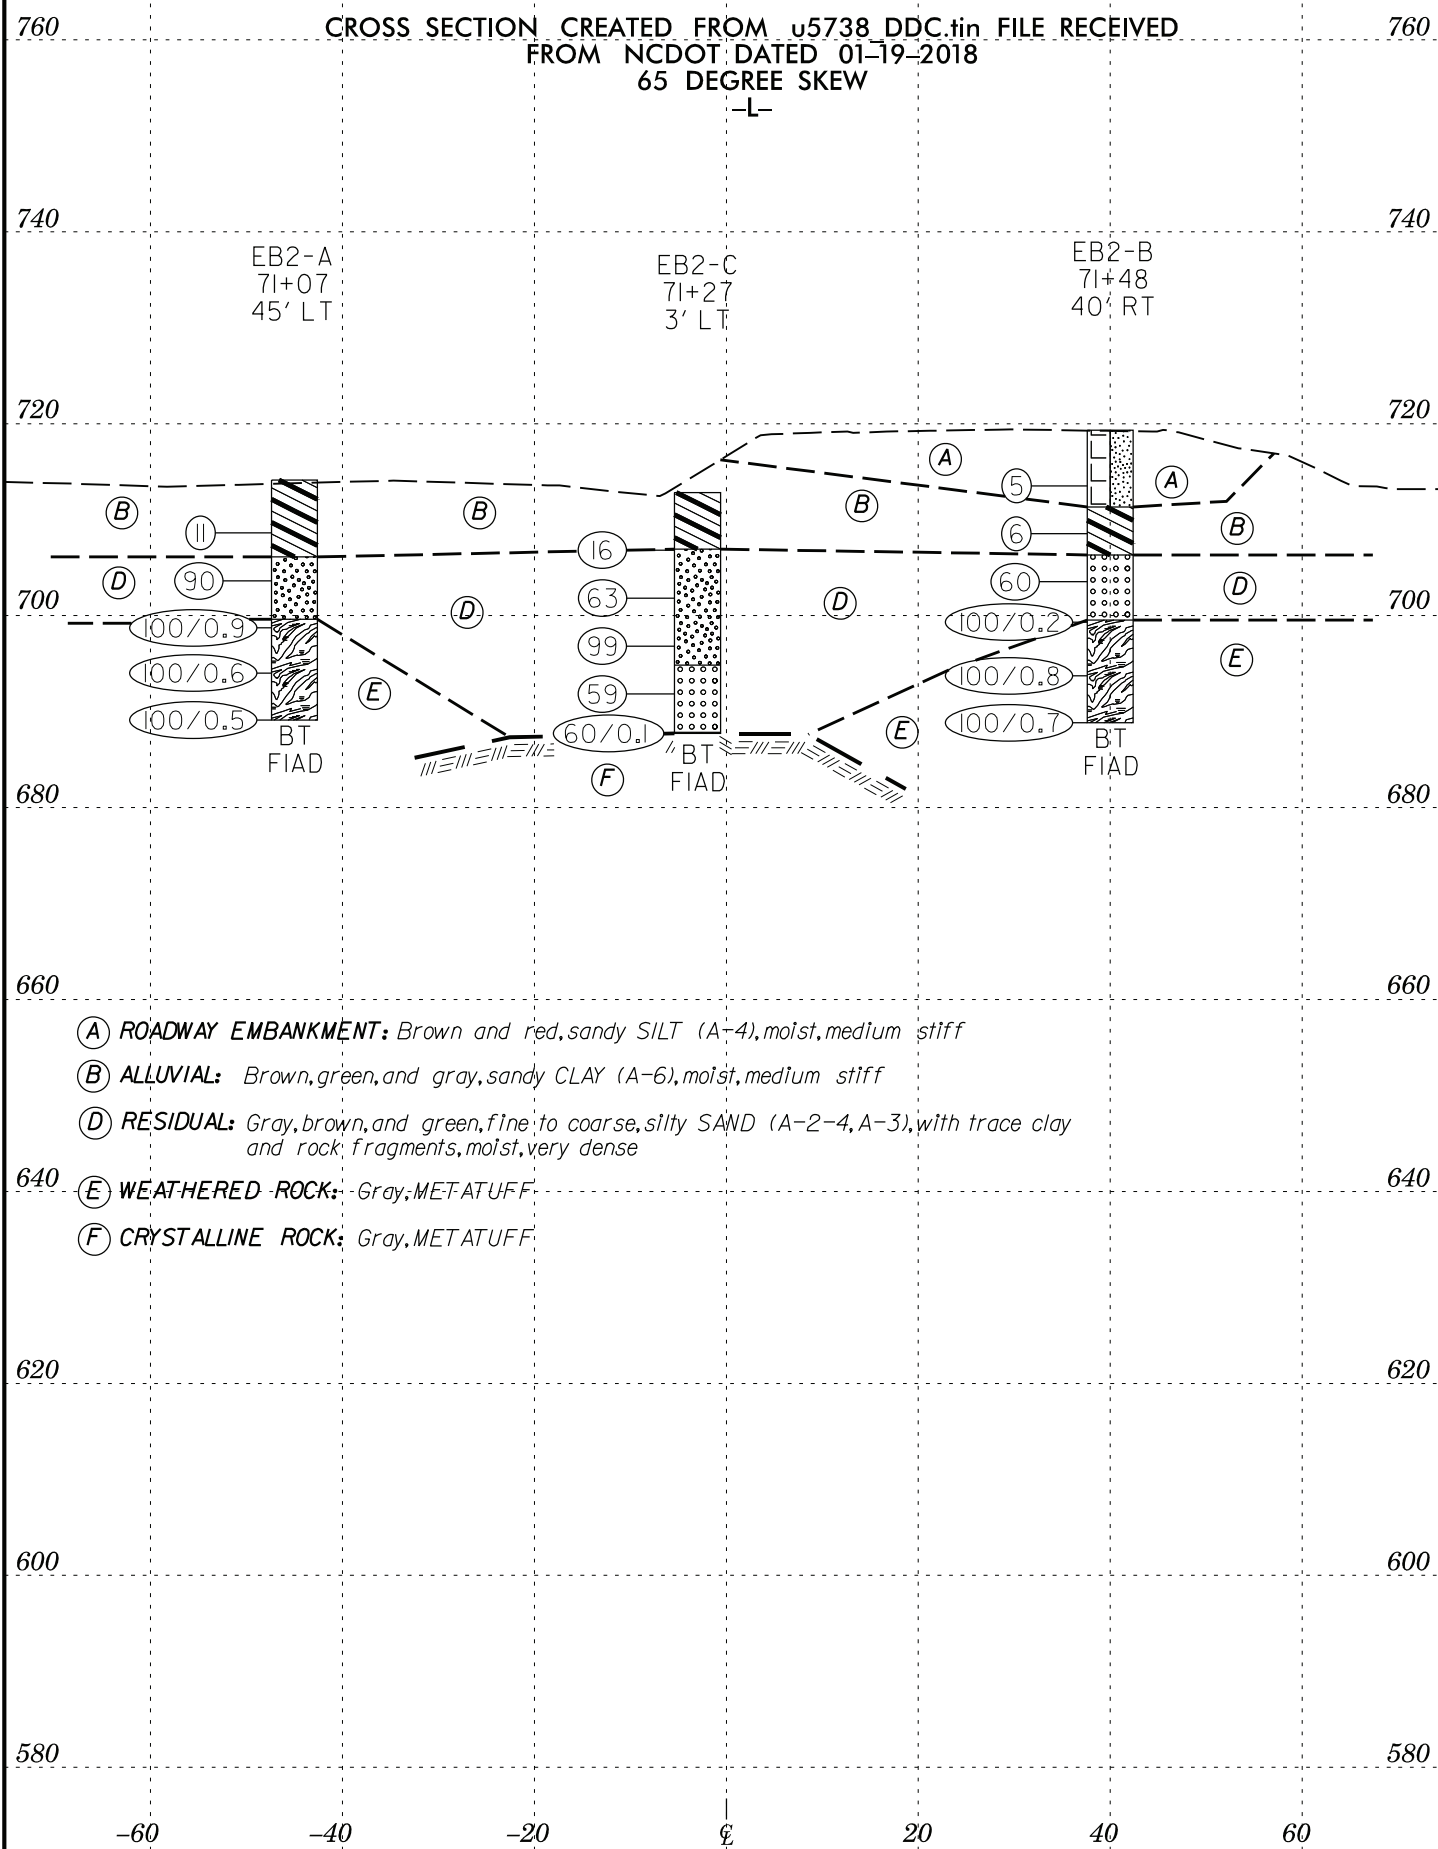
**BRIDGE NO. 201 - END BENT 2
CROSS SECTION - STA. 71+30.00**

- (A) ROADWAY EMBANKMENT: Brown and red, sandy SILT (A-4), moist, medium stiff
- (B) ALLUVIAL: Brown, green, and gray, sandy CLAY (A-6), moist, medium stiff
- (D) RESIDUAL: Gray, brown, and green, fine to coarse, silty SAND (A-2-4, A-3), with trace clay and rock fragments, moist, very dense
- (E) WEATHERED ROCK: Gray, METATUFF
- (F) CRYSTALLINE ROCK: Gray, METATUFF

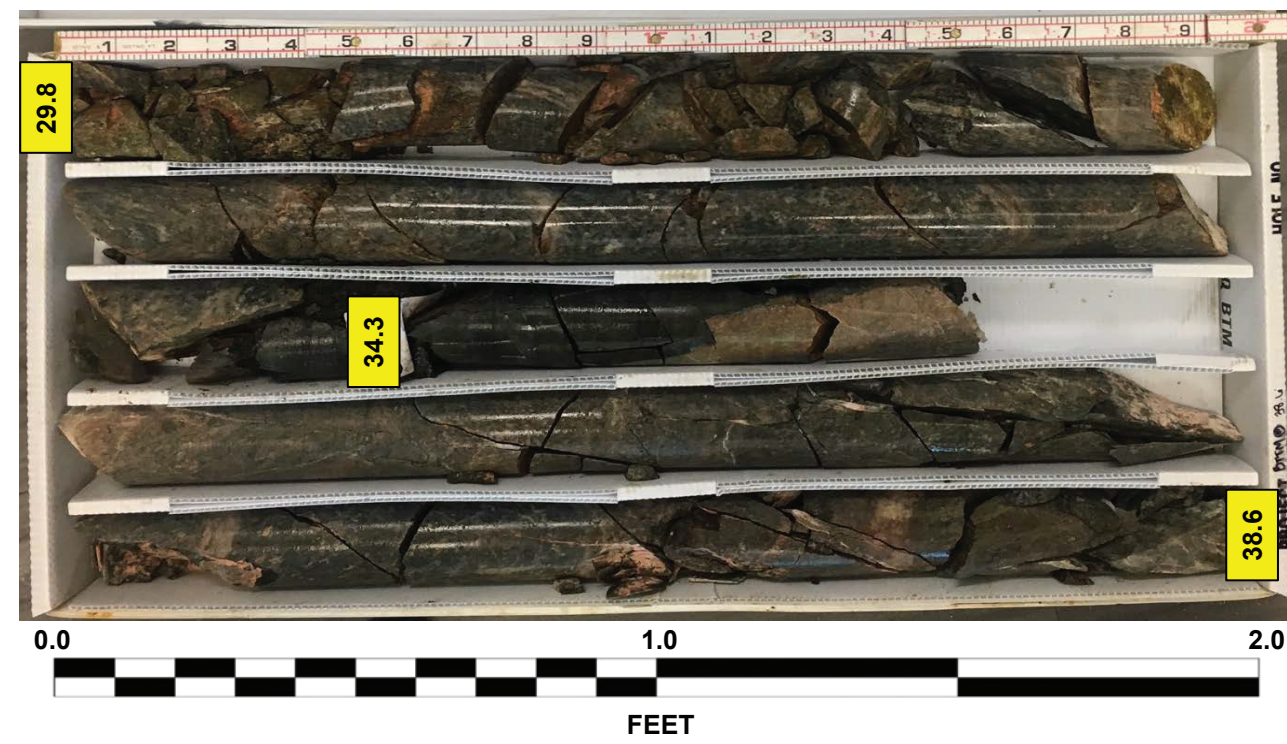
U-5738 – EB1-C
STA. 27+53 @ 27' Rt. Box 1 of 4: 8.8 FEET
WET

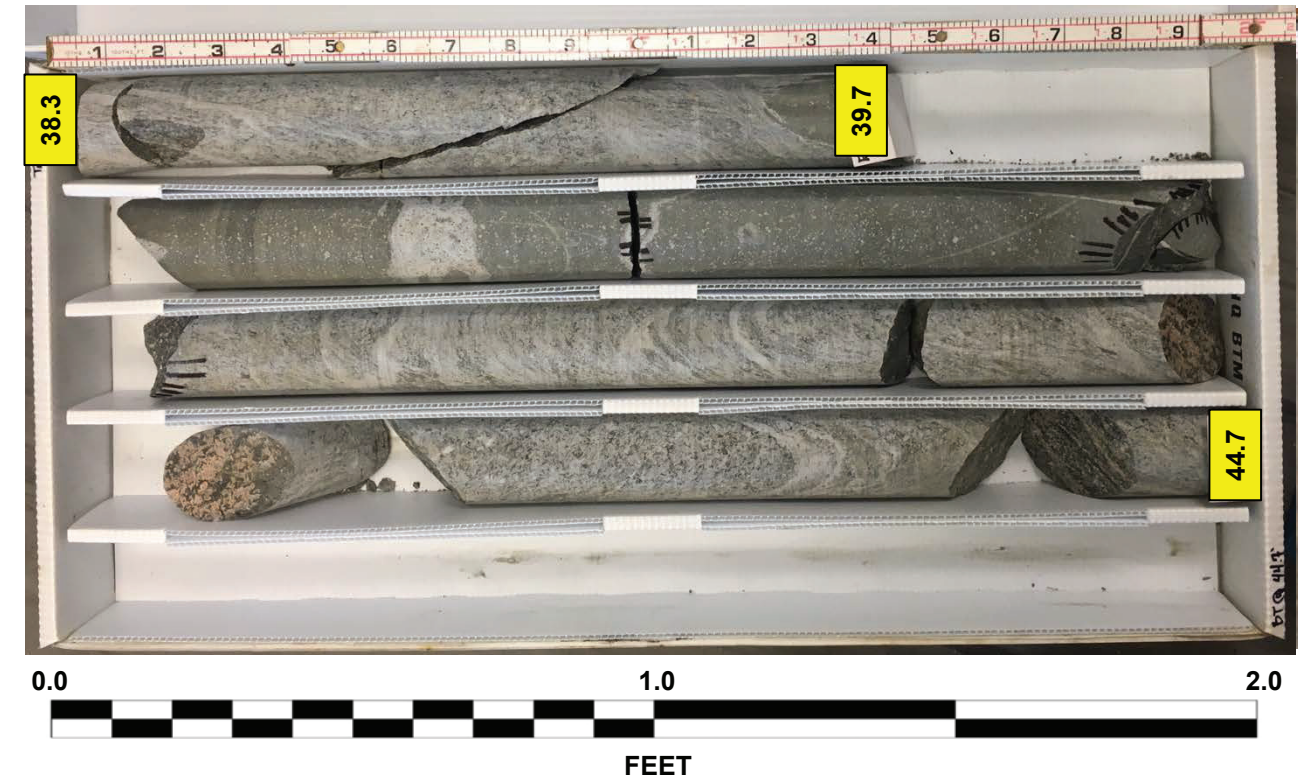
U-5738 – B1-A
STA. 27+53 @ 27' Rt. Box 4 of 4: 8.4 FEET
DRY

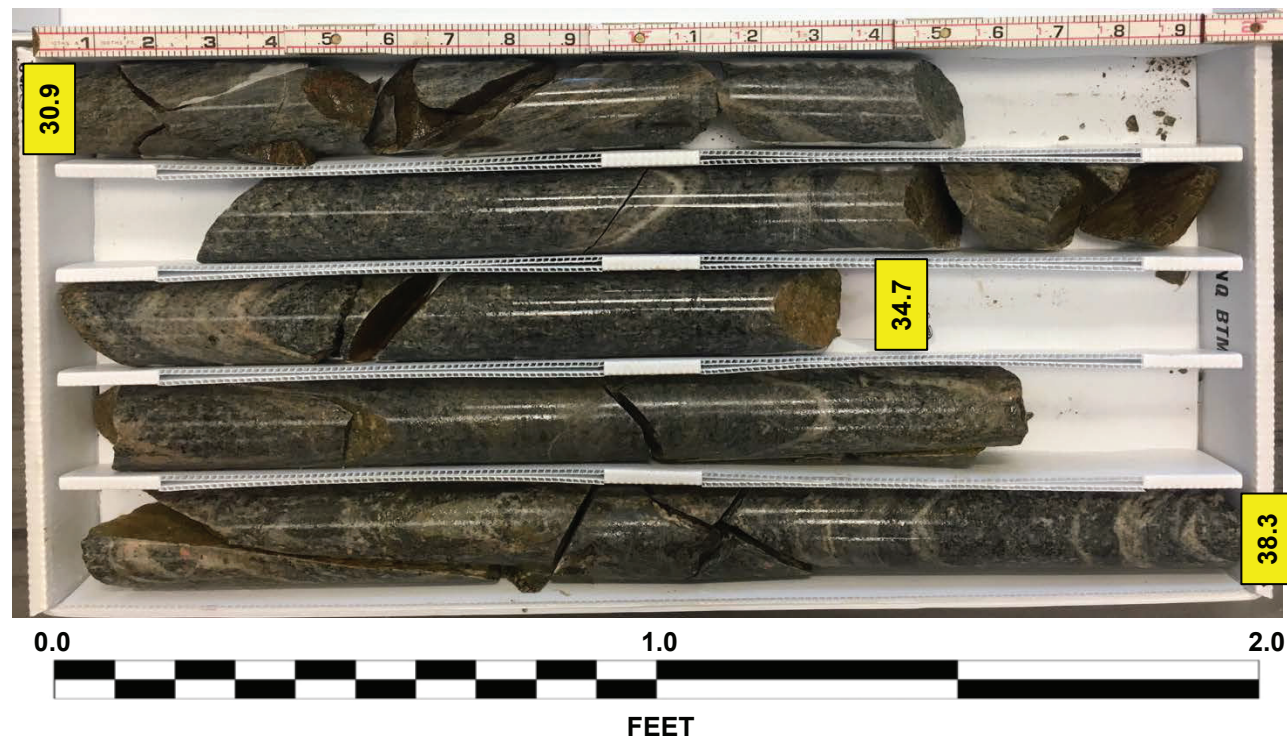
U-5738 – B1-A
STA. 27+53 @ 27' Rt. Box 3 of 4: 7.4 FEET
WET
