Preliminary Site Assessment

Replace Bridge 87 Over the Norfolk Southern Railroad on NC 33

Parcel 13 - Wilson, Jesse Ray

TIP No. B-5301

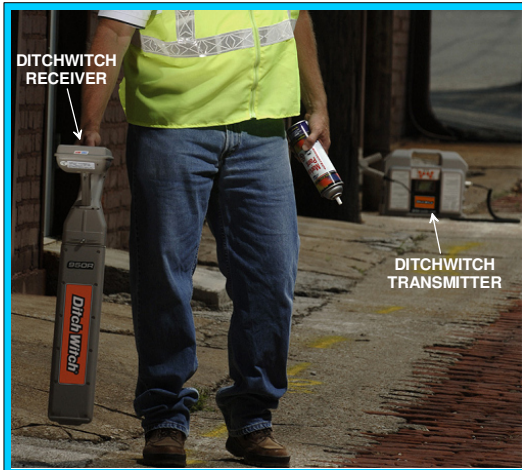
DITCHWITCH UTILITY LOCATOR

The photograph shows the DitchWitch 910 utility locator which was used to detect buried lines across the geophysical survey area.
