# Preliminary Site Assessment

Replace Bridge 87 Over the Norfolk Southern Railroad on NC 33

Parcel 15 - Sajah Properties

TIP No. B-5301

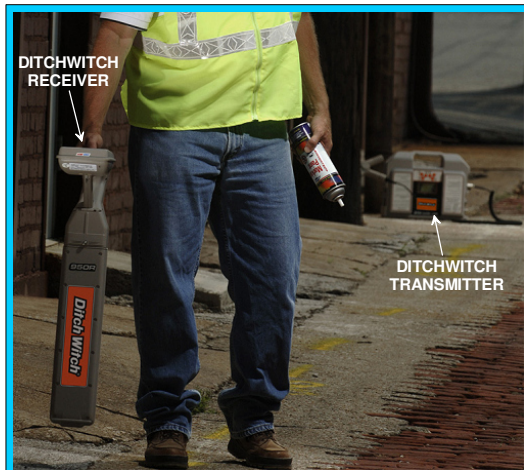
**DITCHWITCH UTILITY LOCATOR**

The photograph shows the DitchWitch 910 utility locator which was used to detect buried lines across the geophysical survey area.
