# Preliminary Site Assessment

Replace Bridge 87 Over the Norfolk Southern Railroad on NC 33

7330 NC 33 East, Grimesland, North Carolina

TIP No. B-5301

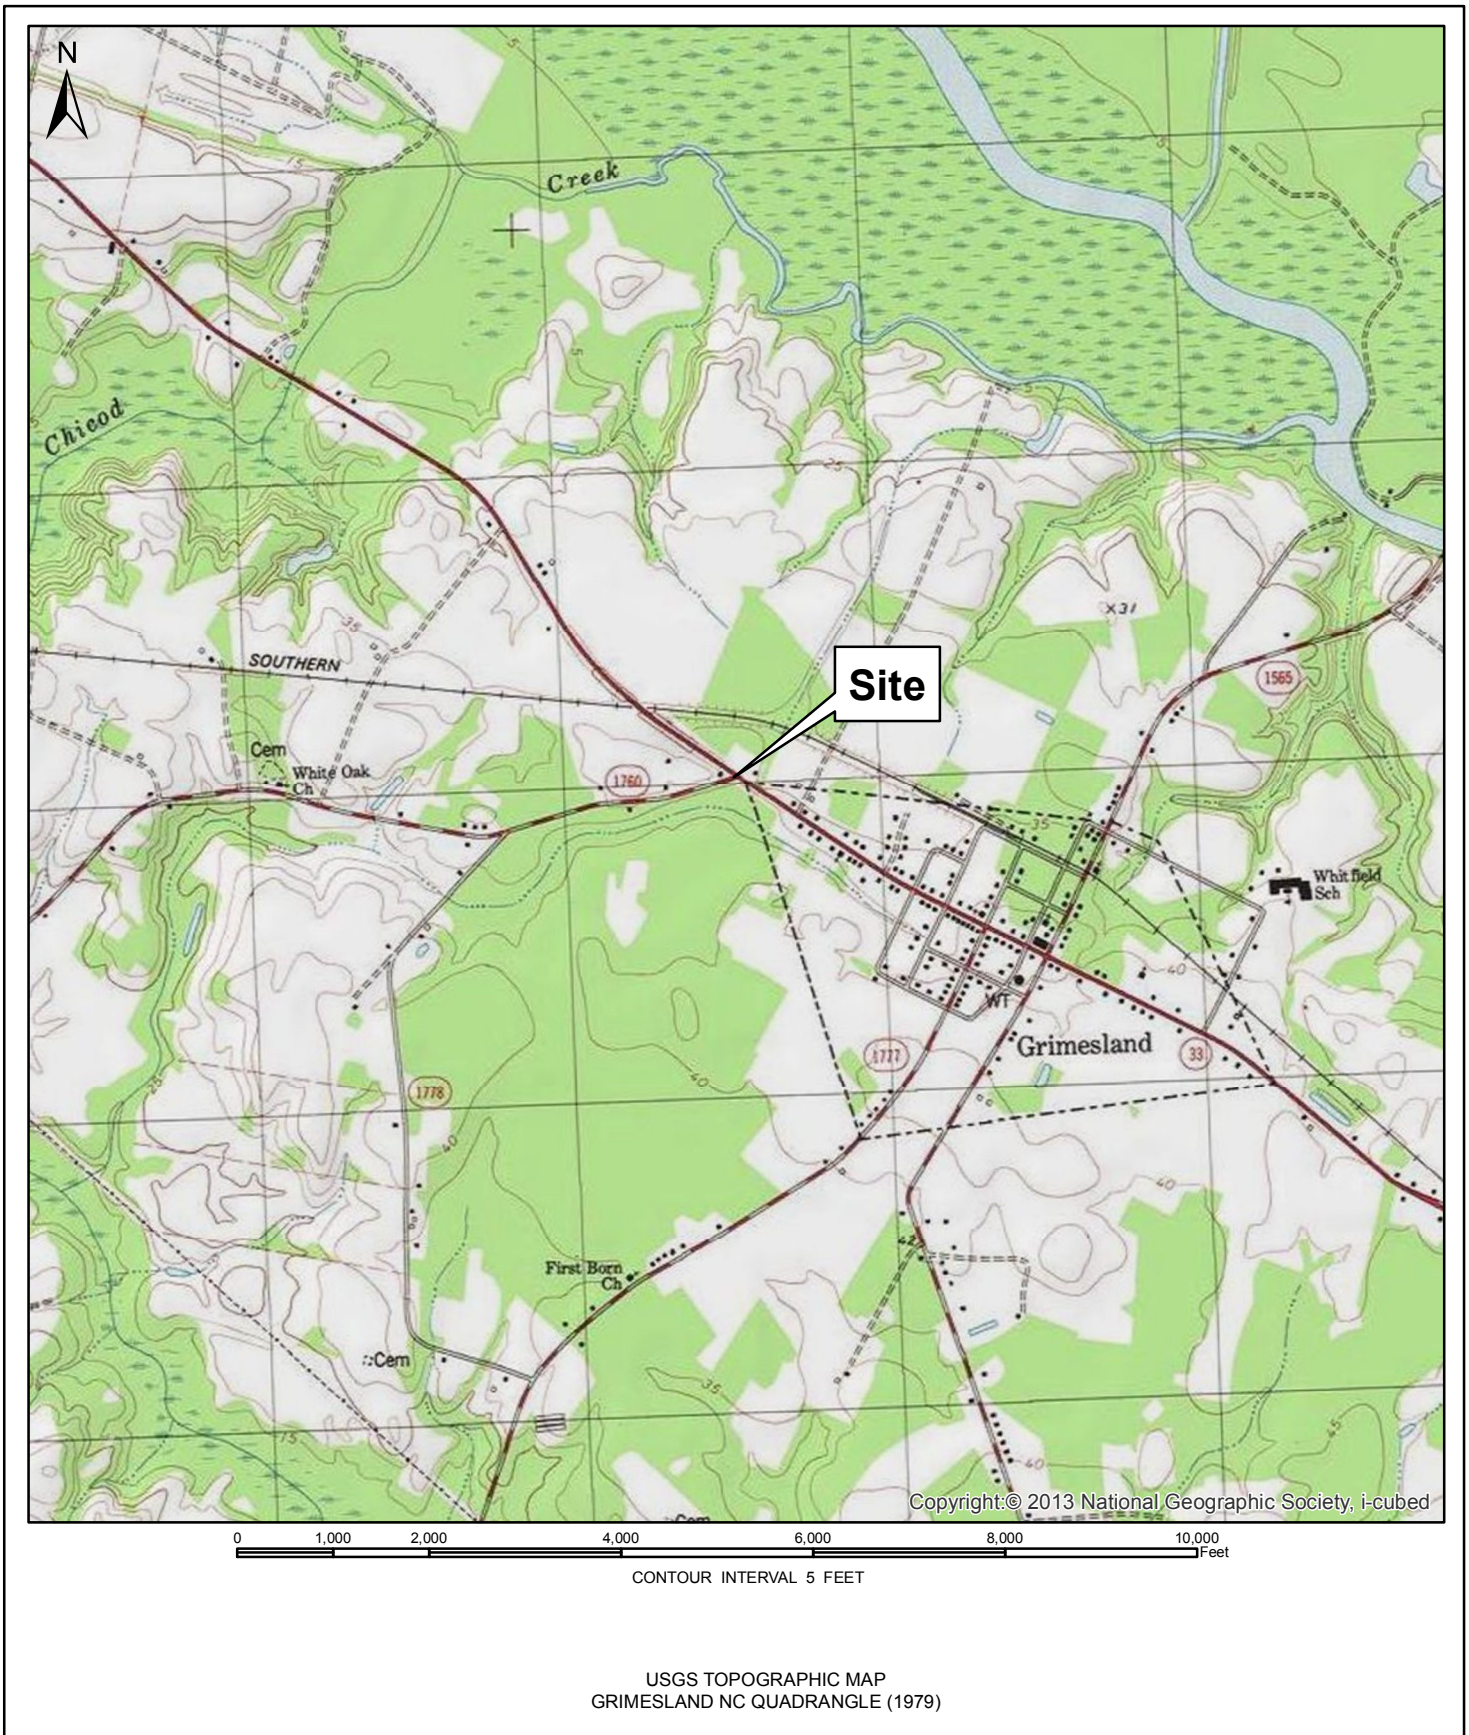
**Exhibit 1** presents the topography of the site on a portion of the USGS topographic quadrangle map of Grimesland, NC 1979. **Exhibits 2A and SB** depict a site layout plan that includes the approximate locations of the site features, soil boring locations, and analytical results.

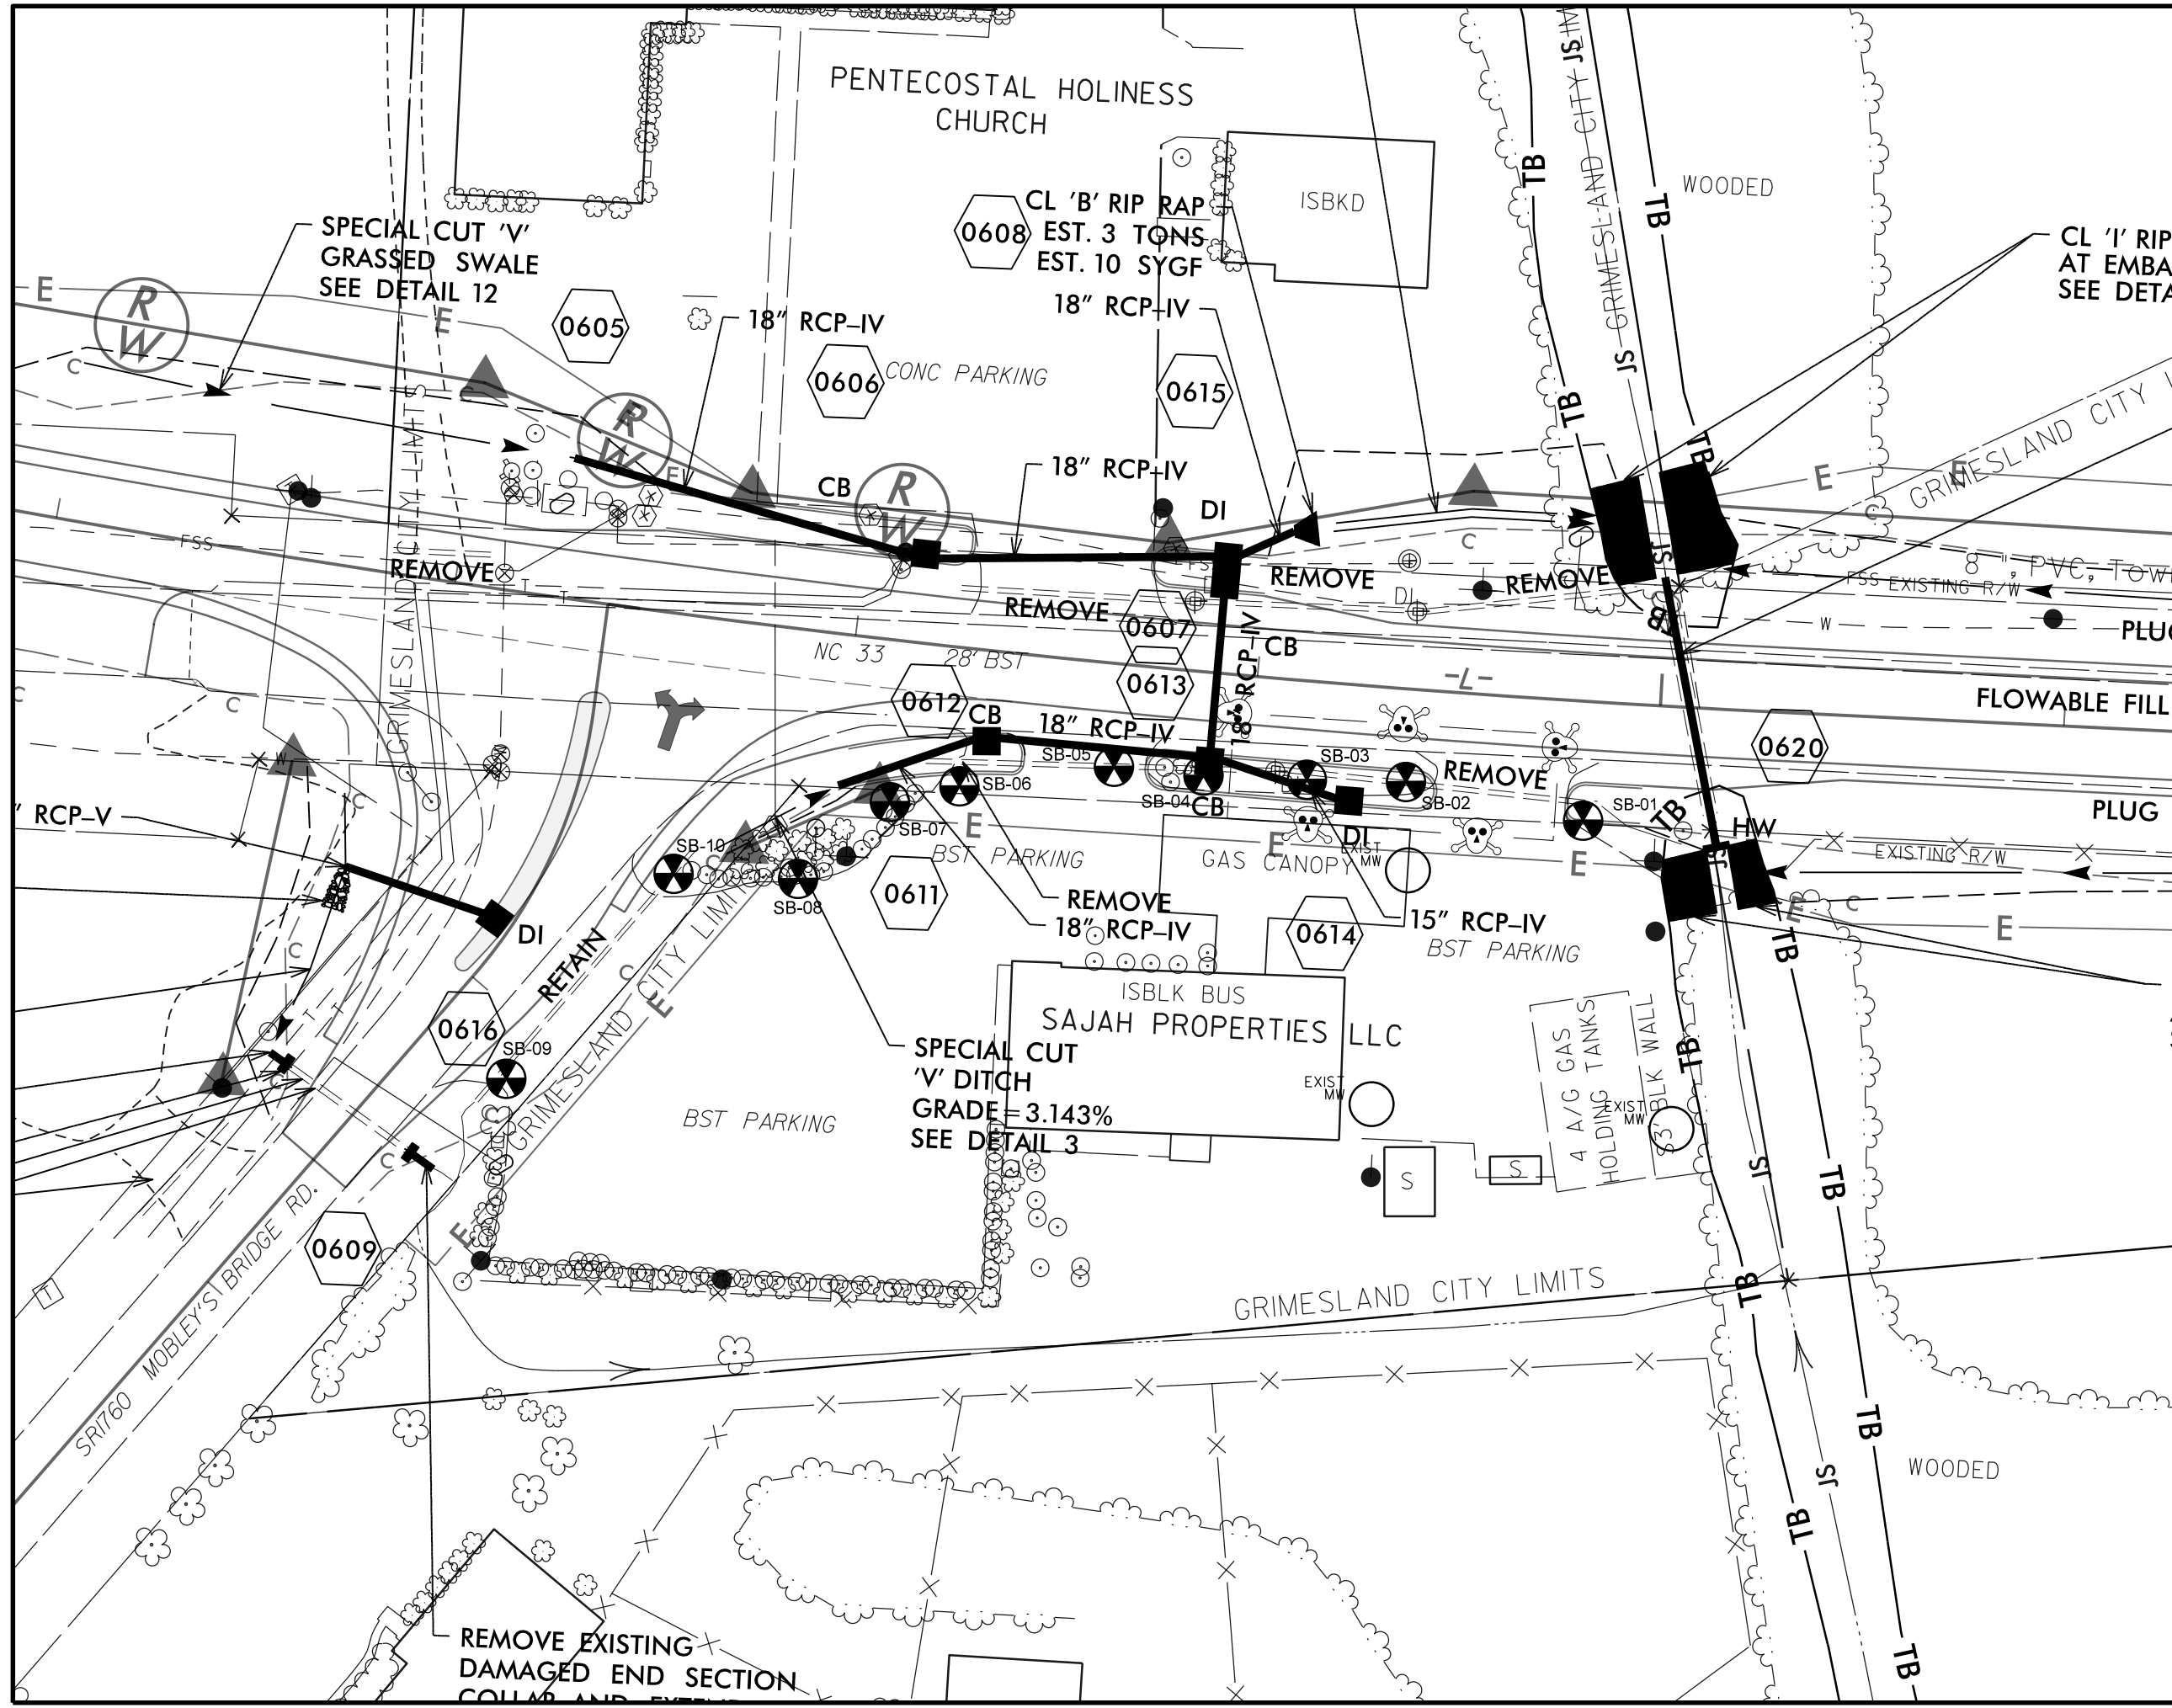
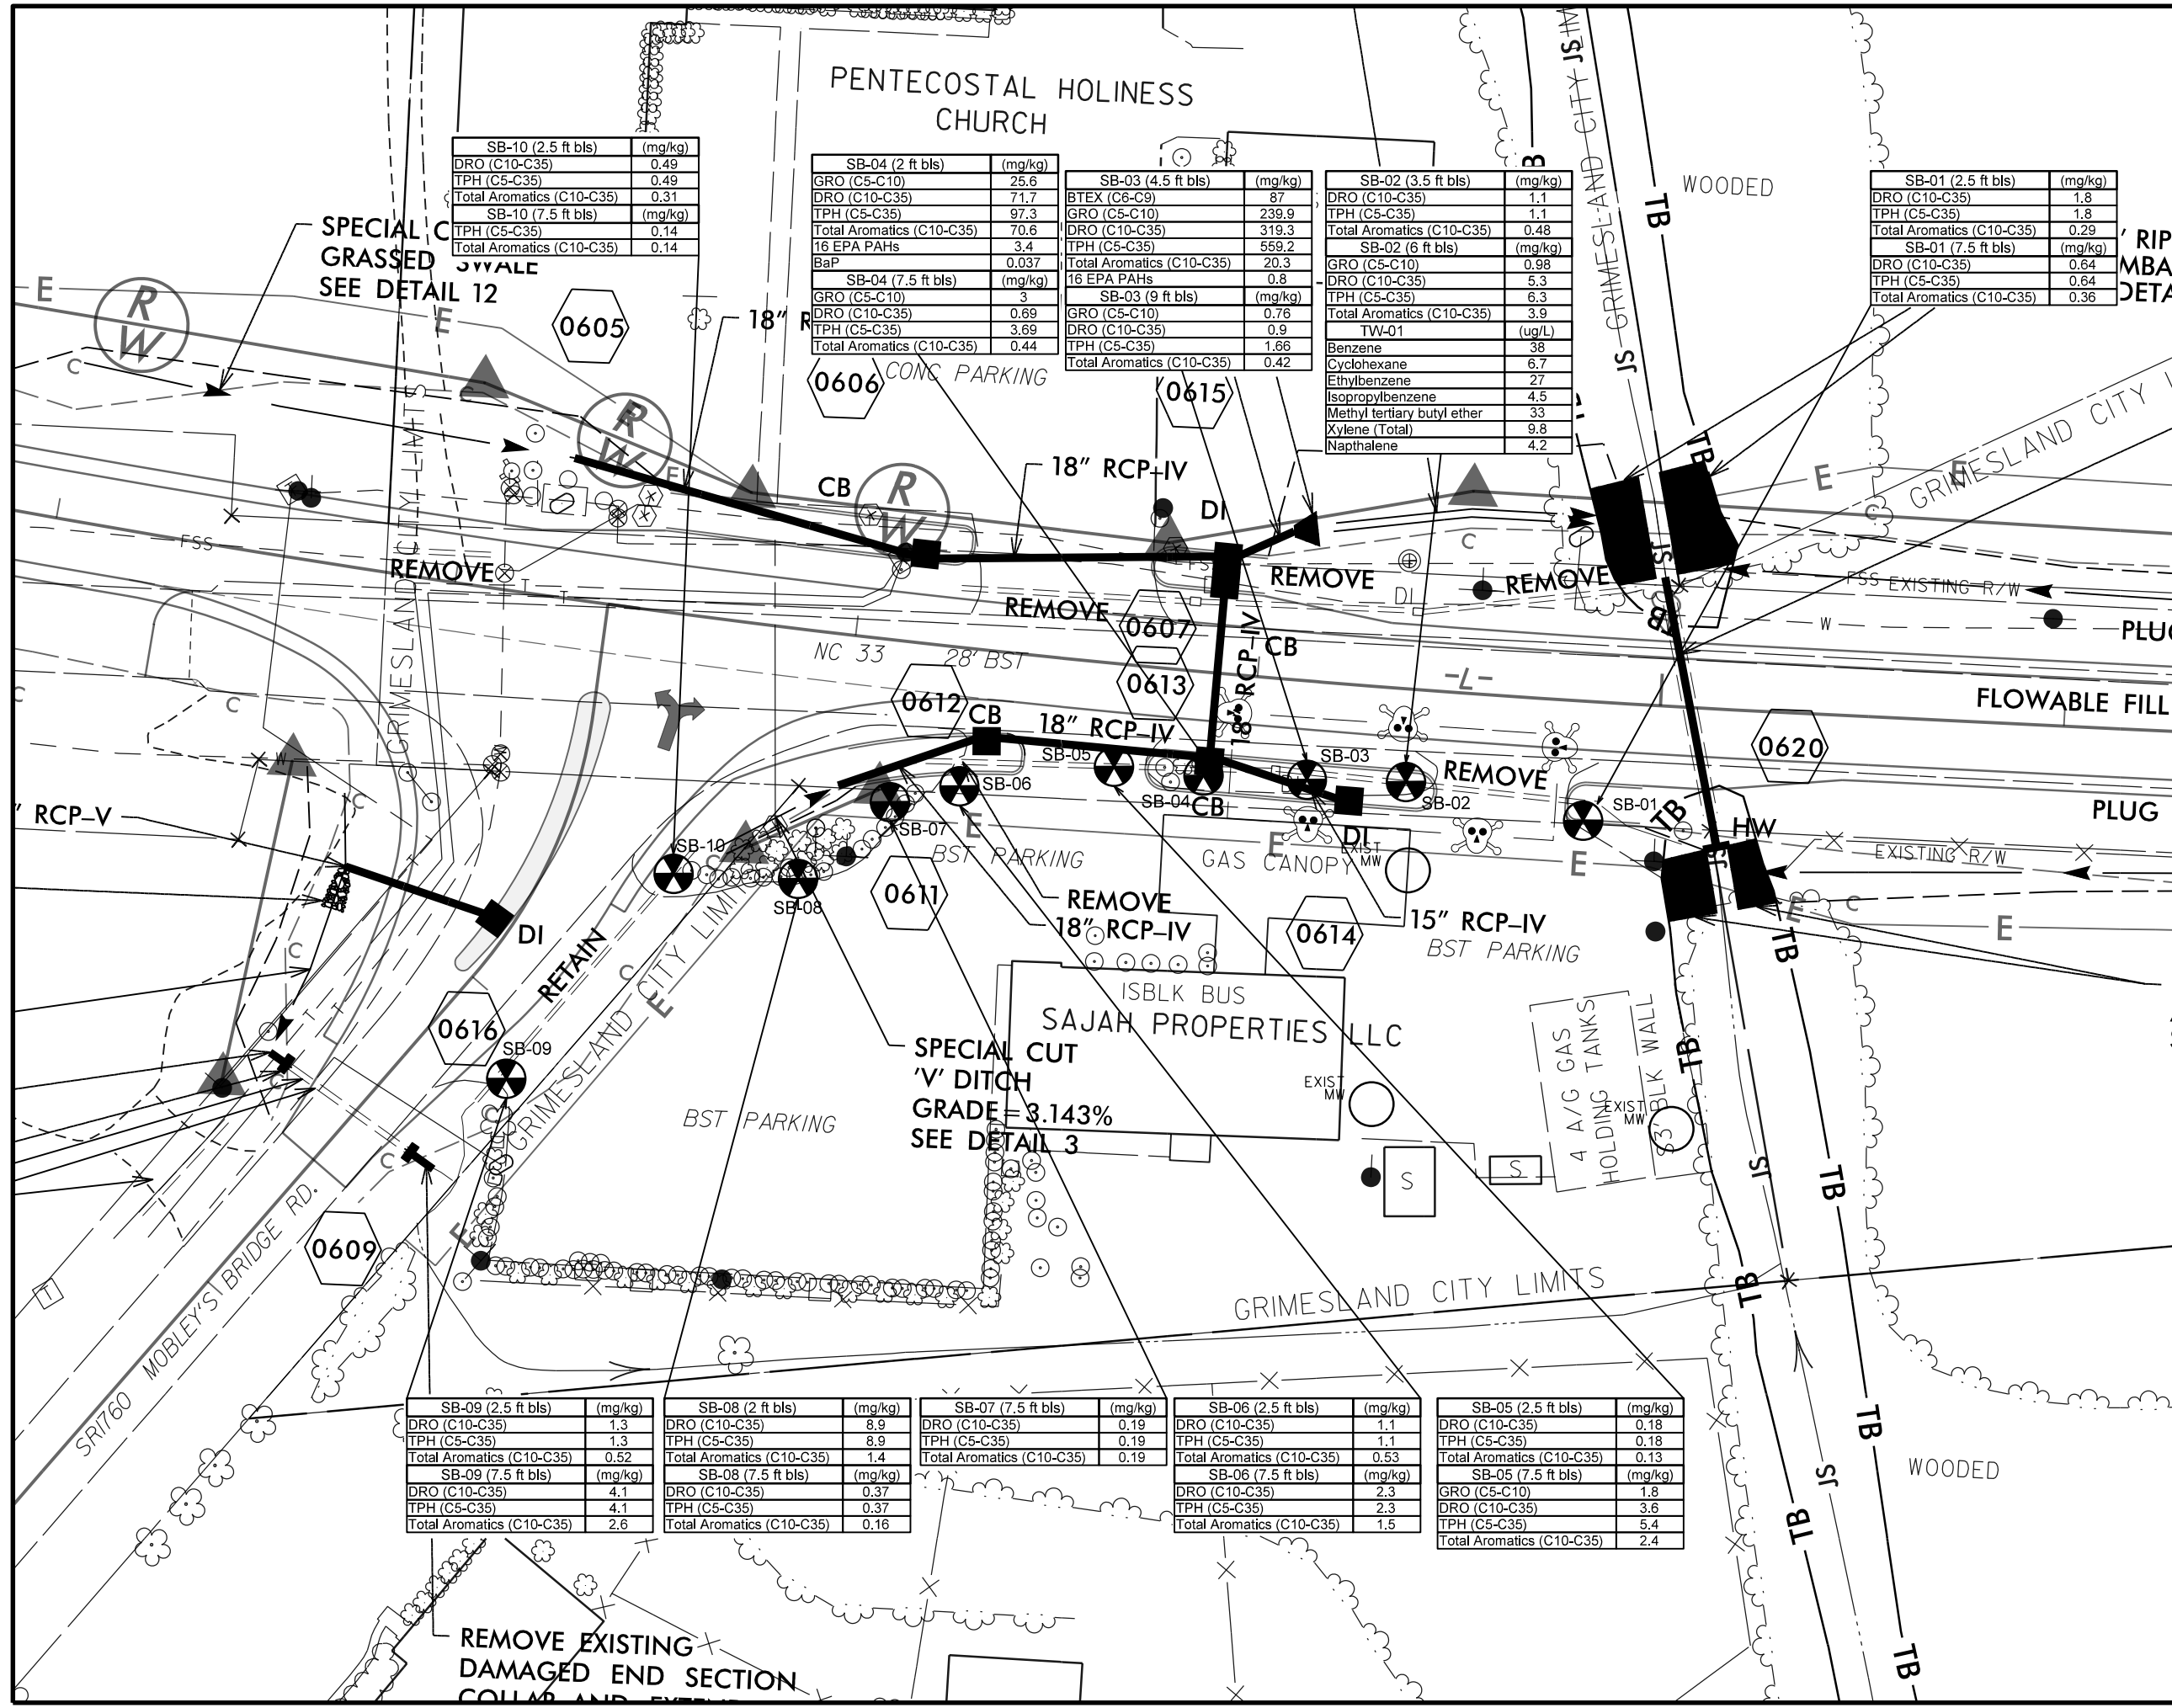
**SITE DIAGRAM WITH BORING LOCATIONS AND ANALYTICAL DATA**

**Table 1** summarizes the results of the analyses of the soil samples. **Exhibits 2A and 2B** depict the boring locations and detected compounds.

SB-10 (2.5 ft bls) (mg/kg)	
DRO (C10-C35)	0.49
TPH (C5-C35)	0.49
Total Aromatics (C10-C35)	0.31
SB-10 (7.5 ft bls) (mg/kg)	
TPH (C5-C35)	0.14
Total Aromatics (C10-C35)	0.14

SB-04 (2 ft bls) (mg/kg)	
GRO (C5-C10)	25.6
DRO (C10-C35)	71.7
TPH (C5-C35)	97.3
Total Aromatics (C10-C35)	70.6
16 EPA PAHs	3.4
BaP	0.037
SB-04 (7.5 ft bls) (mg/kg)	
GRO (C5-C10)	3
DRO (C10-C35)	0.69
TPH (C5-C35)	3.69
Total Aromatics (C10-C35)	0.44

- The area of contamination appears to be localized to the north and northeast of the existing pump islands. An estimated weight of petroleum impacted soil in this area is 507 tons, or 338 cubic yards. This calculation assumes a rectangular area of approximately 1,825 square feet and an average depth of disturbance of 5 feet (based on the proposed stormwater drainage pipe installation). The actual amount of impacted soil can only be determined after excavation or by advancing additional borings at the site to further delineate the extents of contamination.

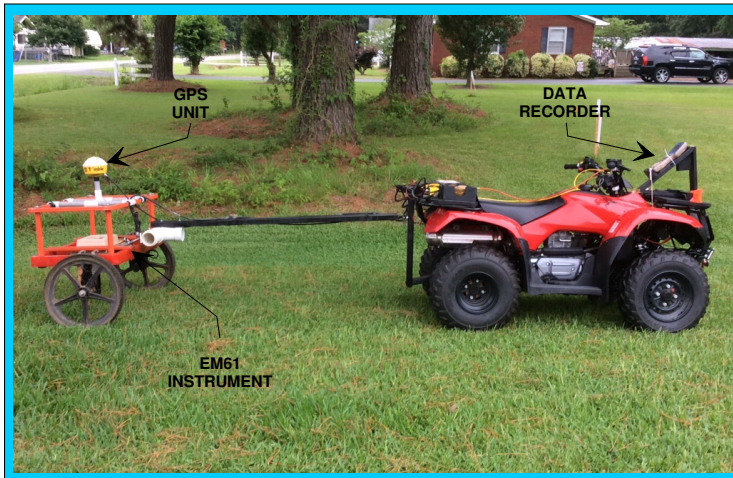
**EM61 METAL DETECTOR**

The photograph shows the Geonics EM61-MK2A metal detector, a Hemisphere A101 GPS unit, a Juniper data recorder, and a Honda Recon ATV which were used to conduct the metal detection survey across the proposed ROW & easement areas of Parcel 15.

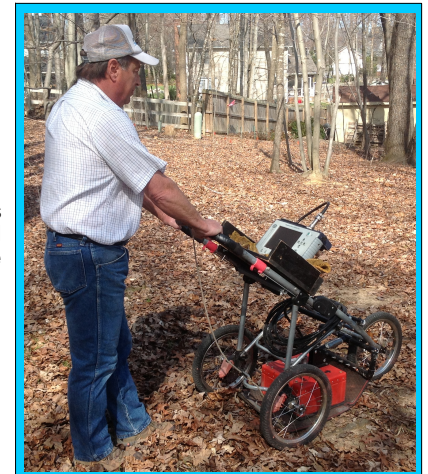
**GROUND PENETRATING RADAR UNIT**

The photograph shows the Geophysical Survey Systems SIR-3000 ground penetrating radar (GPR) unit equipped with a 400 MHz antenna that were used to conduct the GPR scanning across selected areas.

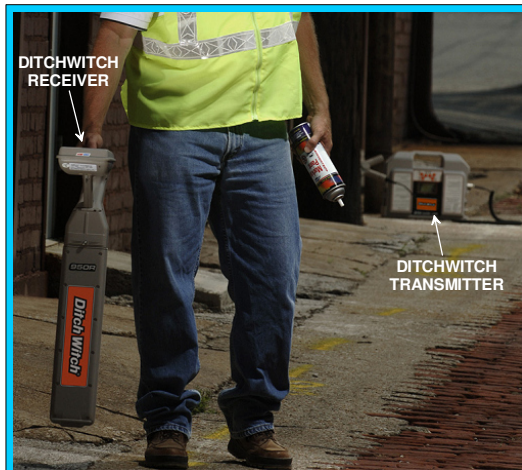
**DITCHWITCH UTILITY LOCATOR**

The photograph shows the DitchWitch 910 utility locator which was used to detect buried lines across the geophysical survey area.

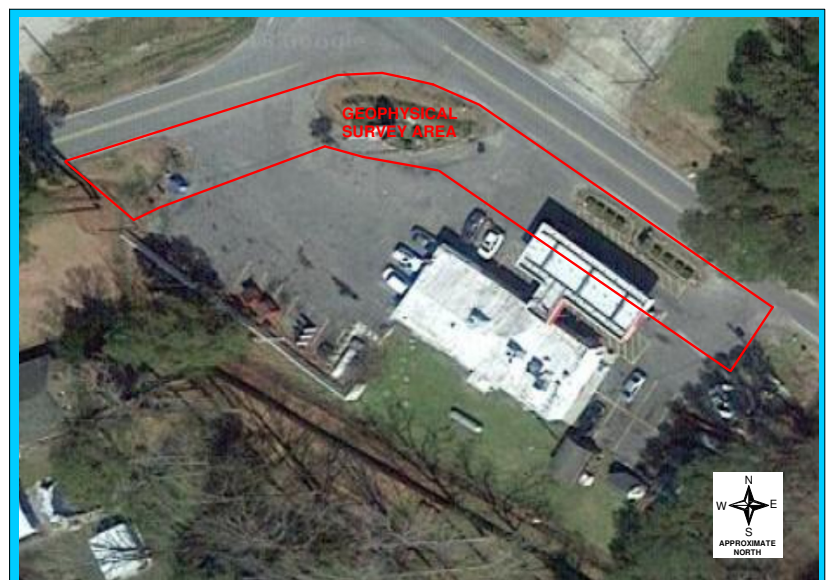
**GEOPHYSICAL SURVEY AREA**

The red polygon in the aerial photograph represents the approximate perimeter of the geophysical survey area at Parcel 15. The geophysical investigation was conducted on April 18-19, 2018.

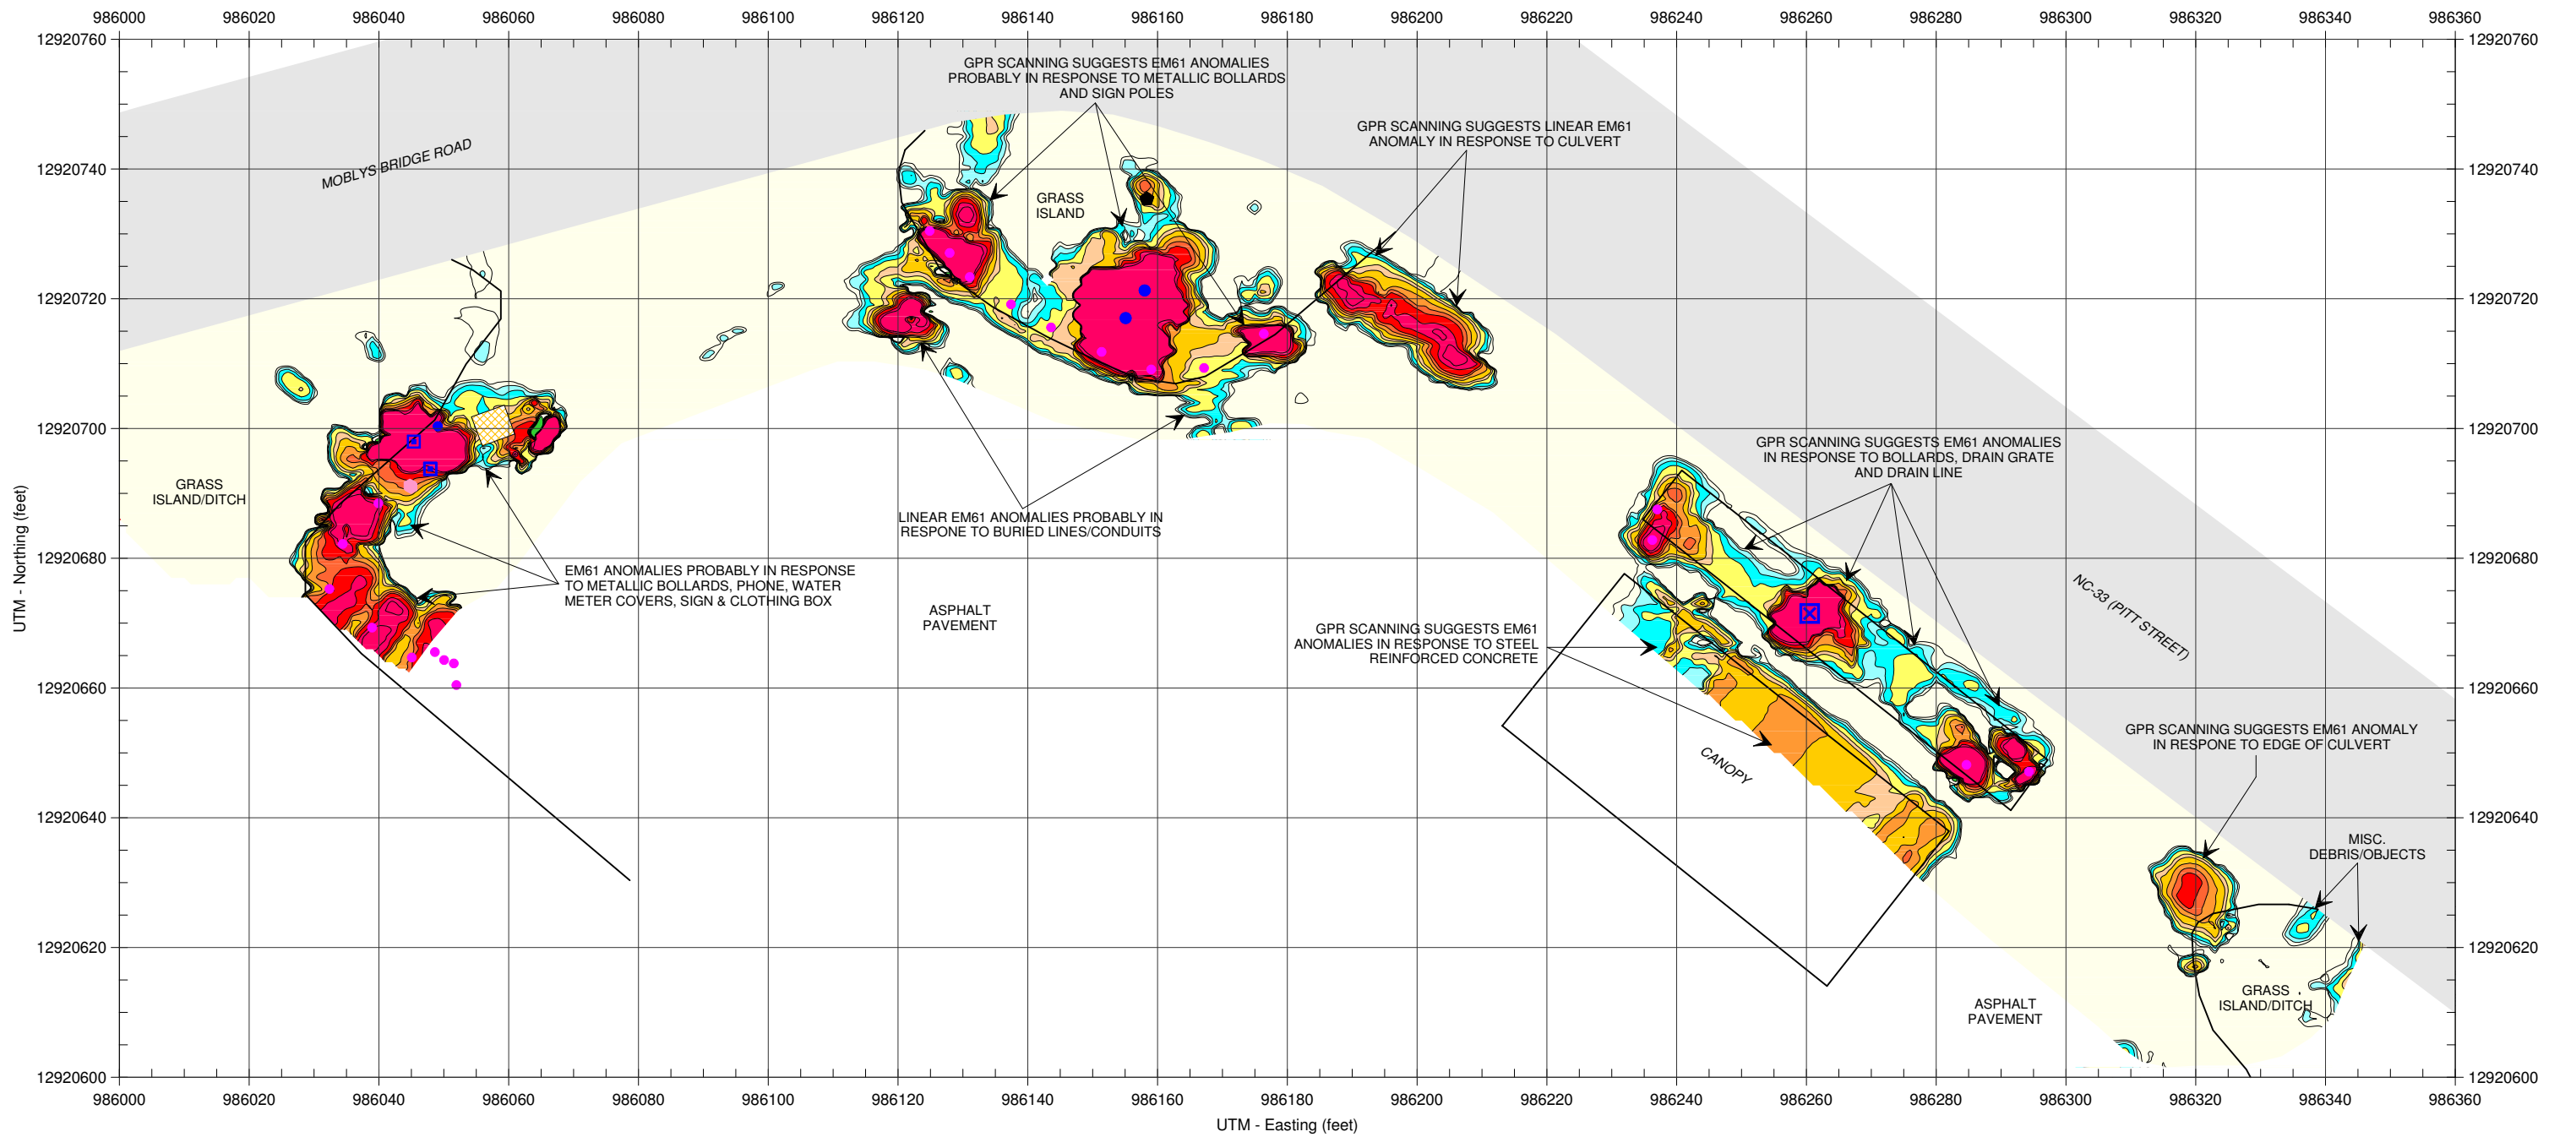
**EM61-MK2A METAL DETECTION  
(EARLY TIME GATE RESULTS)**

The contour plot shows the early time gate (most sensitive) response of the Geonics EM61-MK2A metal detection instrument in millivolts (mV). The early time gate response shows buried, metallic objects, lines and conduits regardless of size. GPR scans were conducted across selected EM61 anomalies and steel reinforced concrete using a Geophysical Survey Systems SIR 3000 instrument with a 400 MHz antenna. The geophysical investigation was conducted on April 18-19, 2018.

The geophysical investigation did not identify potential USTs or other buried objects on the parcel. In addition to metal detection and GPR scans, the NC One Call public utility locator service was used to identify underground utility lines and to clear boring locations. A copy of the geophysical report is included in **Appendix A**.

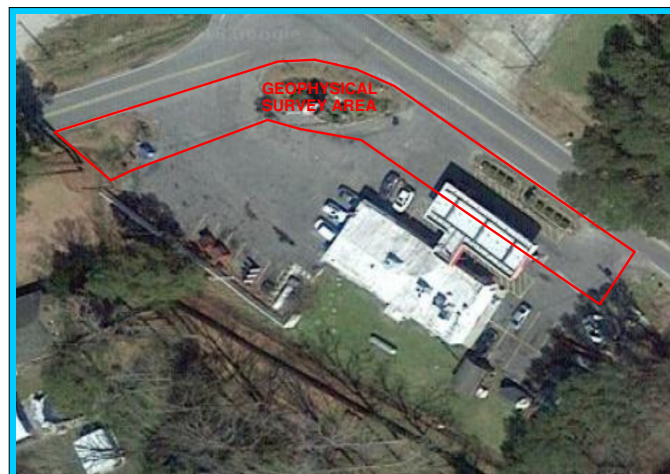
The red polygon in the aerial photograph represents the approximate perimeter of the geophysical survey area at Parcel 15.

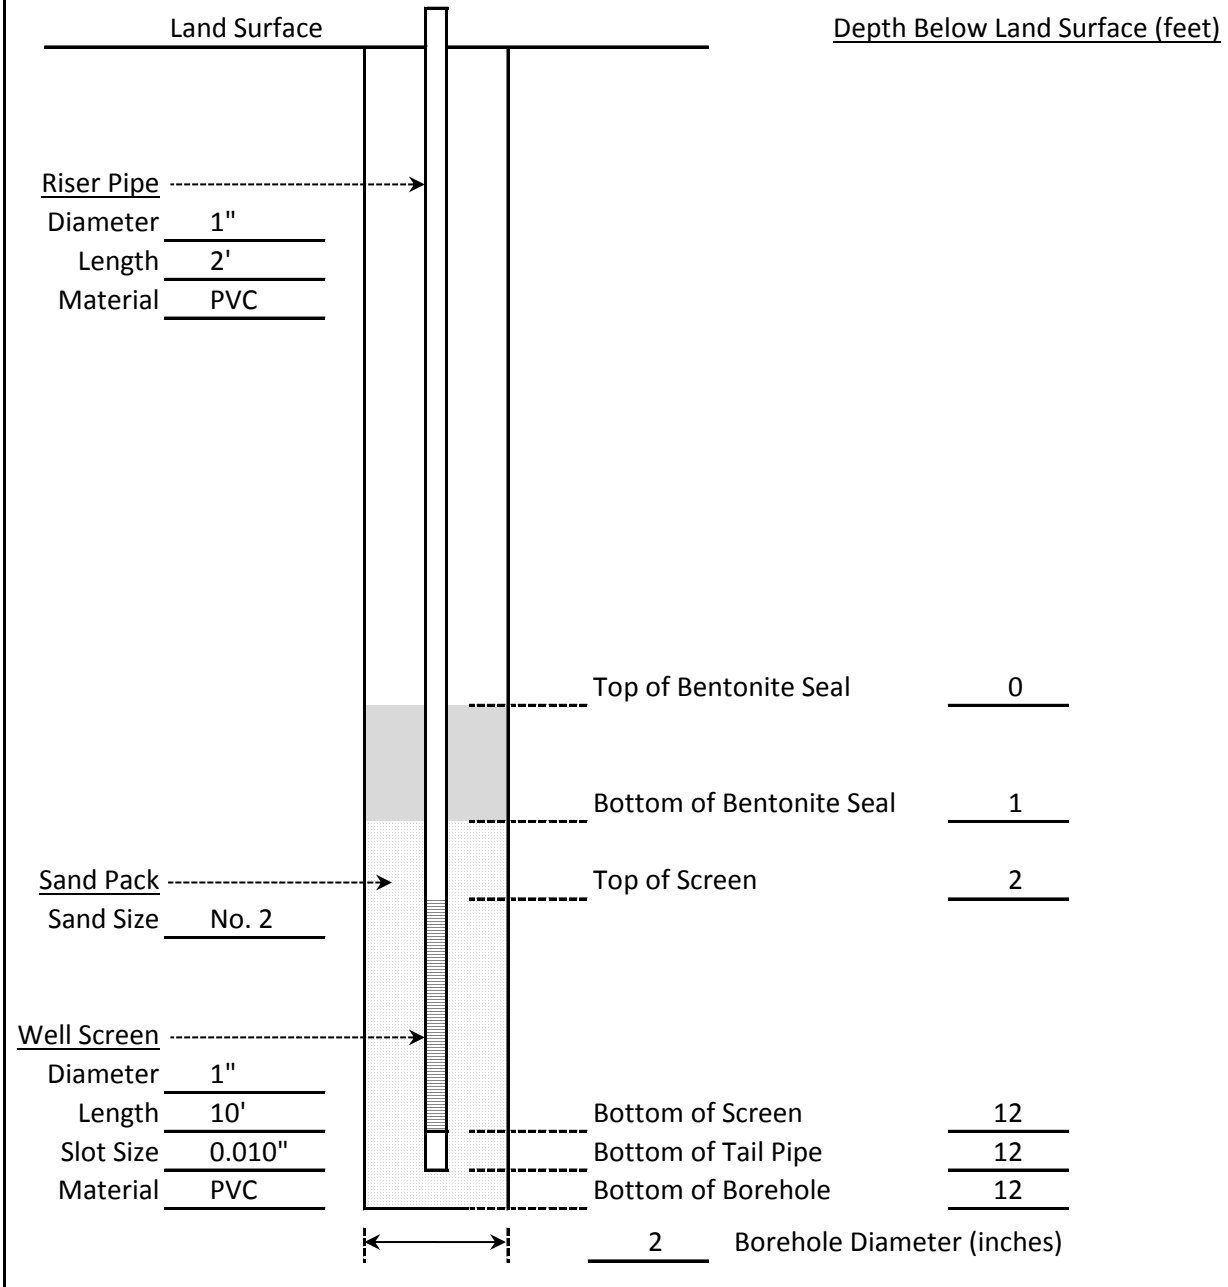
### Temporary Monitoring Well Construction Diagram

Based on the results of the field screening, boring SB-02 was advanced to 12 feet bls and converted into temporary monitoring well TW-01, which was constructed as follows:

- Installation of a 10-foot section of 1-inch diameter, 0.010-inch machine slotted PVC well screen;
- Installation of a 2-foot section of 1-inch diameter, threaded, flush-joint PVC riser pipe to the ground surface; and
- Placement of sand in the borehole annulus to approximately two feet above the screened interval, followed by a layer of hydrated bentonite.
