**Subject: Preliminary Site Assessment Report  
Parcel 114, Edna M. Dickens  
WBS Element No. 38887.1.1, TIP No. R-3830  
NC 42 from US 421 to SR 1579 (Main Street) in Sanford and  
along SR 1579 from NC 42 to SR 1538 (Buckhorn Avenue) in Broadway  
Lee County, North Carolina**

**PRELIMINARY SITE ASSESSMENT REPORT  
PARCEL 114, EDNA M. DICKENS  
PIN 9672-13-1884  
1831 BROADWAY ROAD  
SANFORD, LEE COUNTY, NORTH CAROLINA**

**NCDOT WBS ELEMENT 38887.1.1  
STATE PROJECT R-3830  
NC42 FROM US 421 TO SR 1579 (MAIN STREET) IN  
SANFORD AND ALONG SR 1579 FROM NC 42 TO SR 1538  
(BUCKHORN AVENUE) IN BROADWAY**

**PRELIMINARY SITE ASSESSMENT REPORT  
PARCEL 117 WILBUR F. THOMAS PROPERTY  
PIN 9672-22-2978  
1902 BROADWAY ROAD  
SANFORD, LEE COUNTY, NORTH CAROLINA**

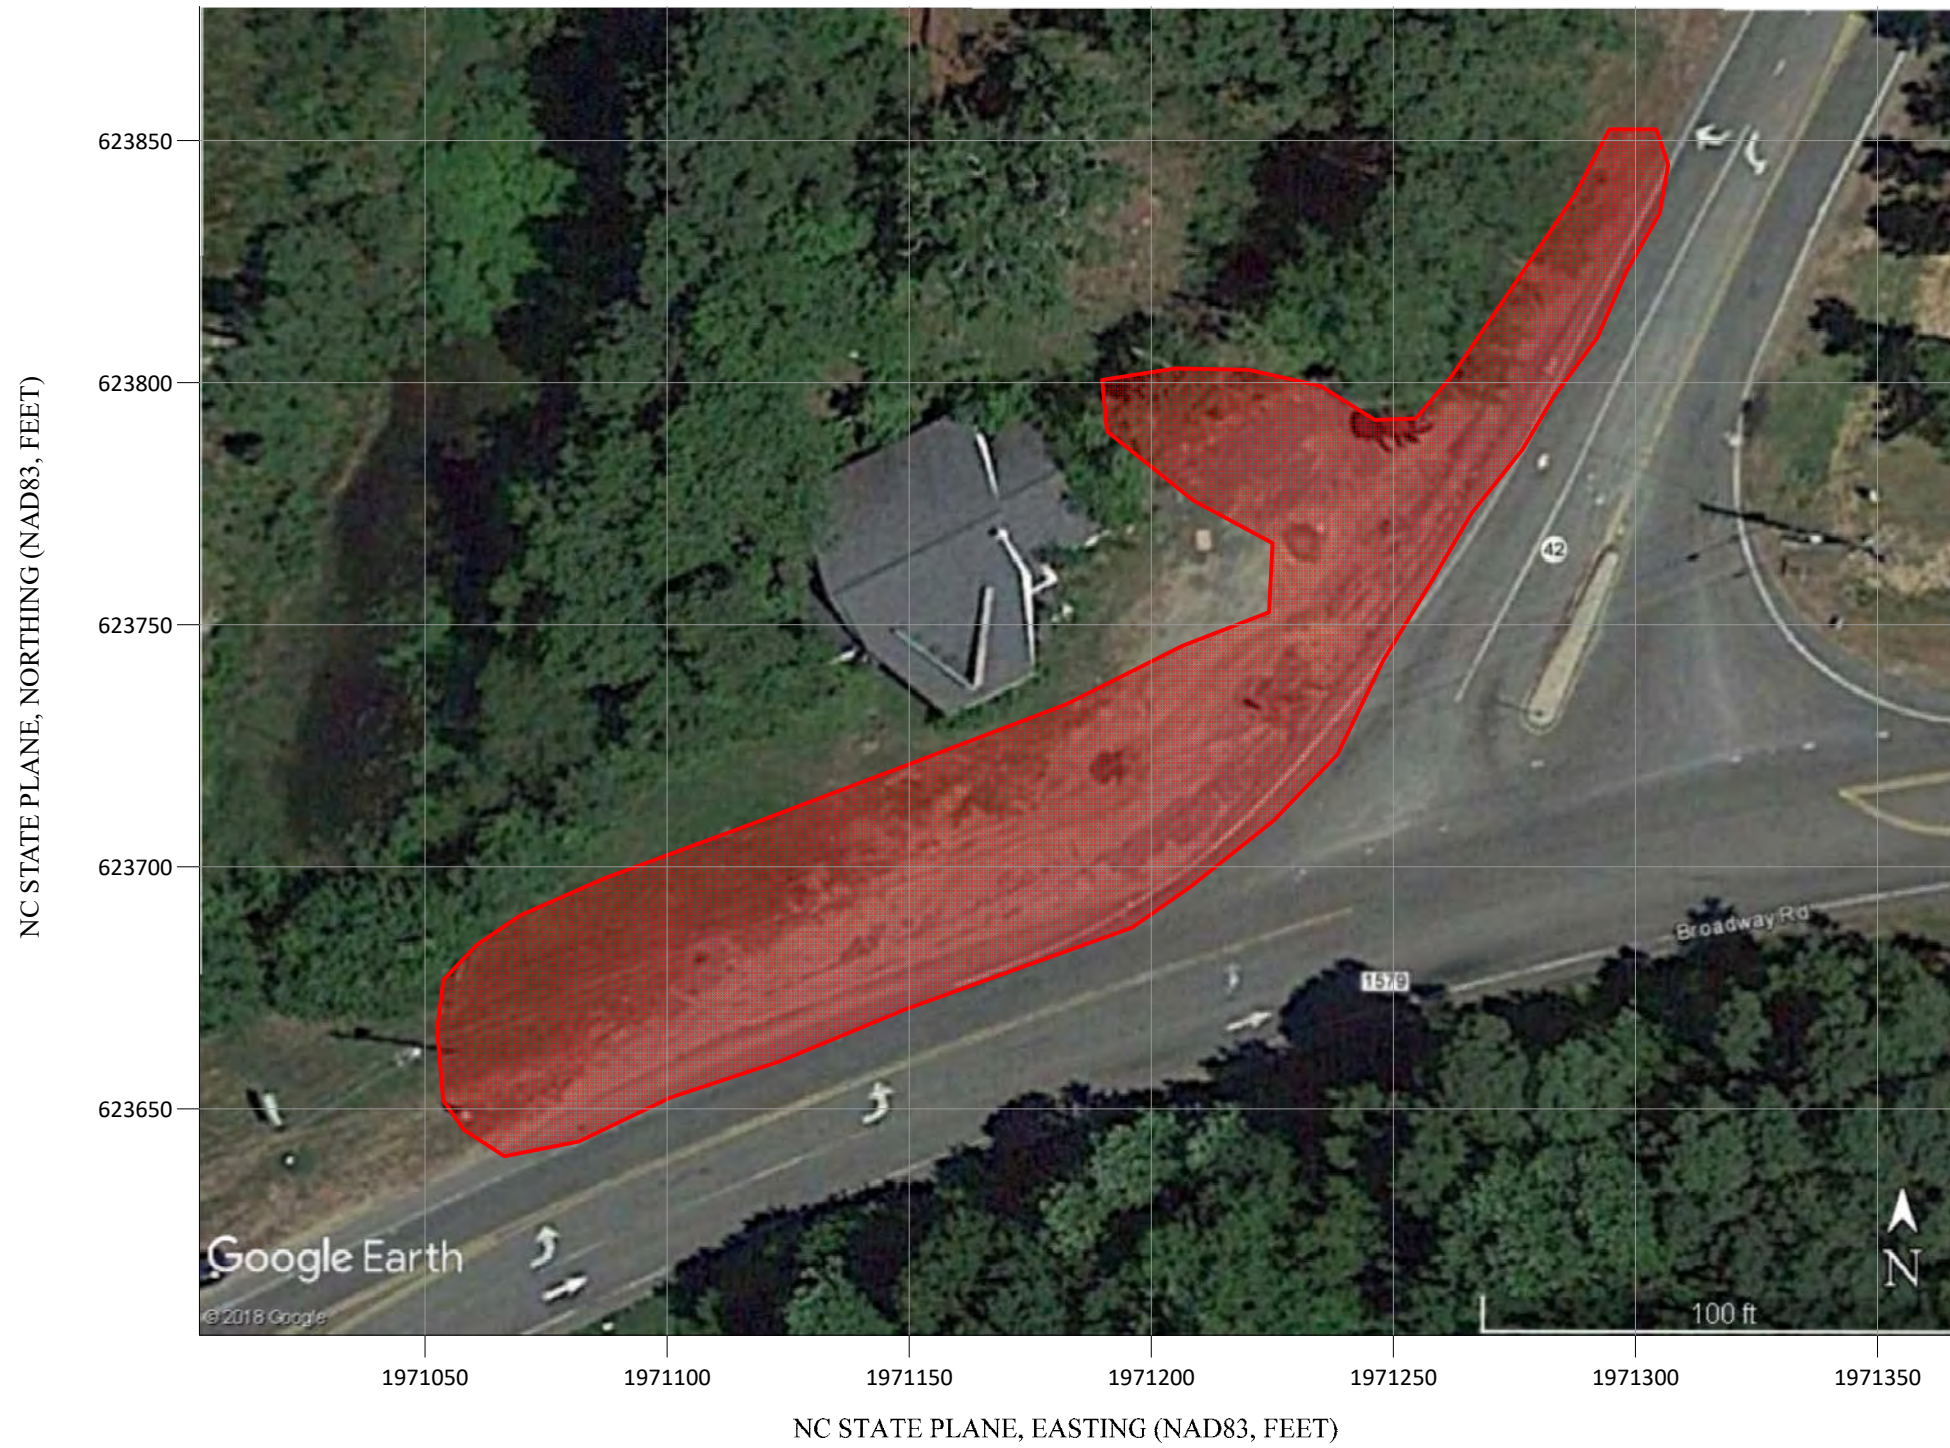
View of Survey Area  
(Facing Approximately West)

APPROXIMATE BOUNDARIES OF GEOPHYSICAL SURVEY AREA

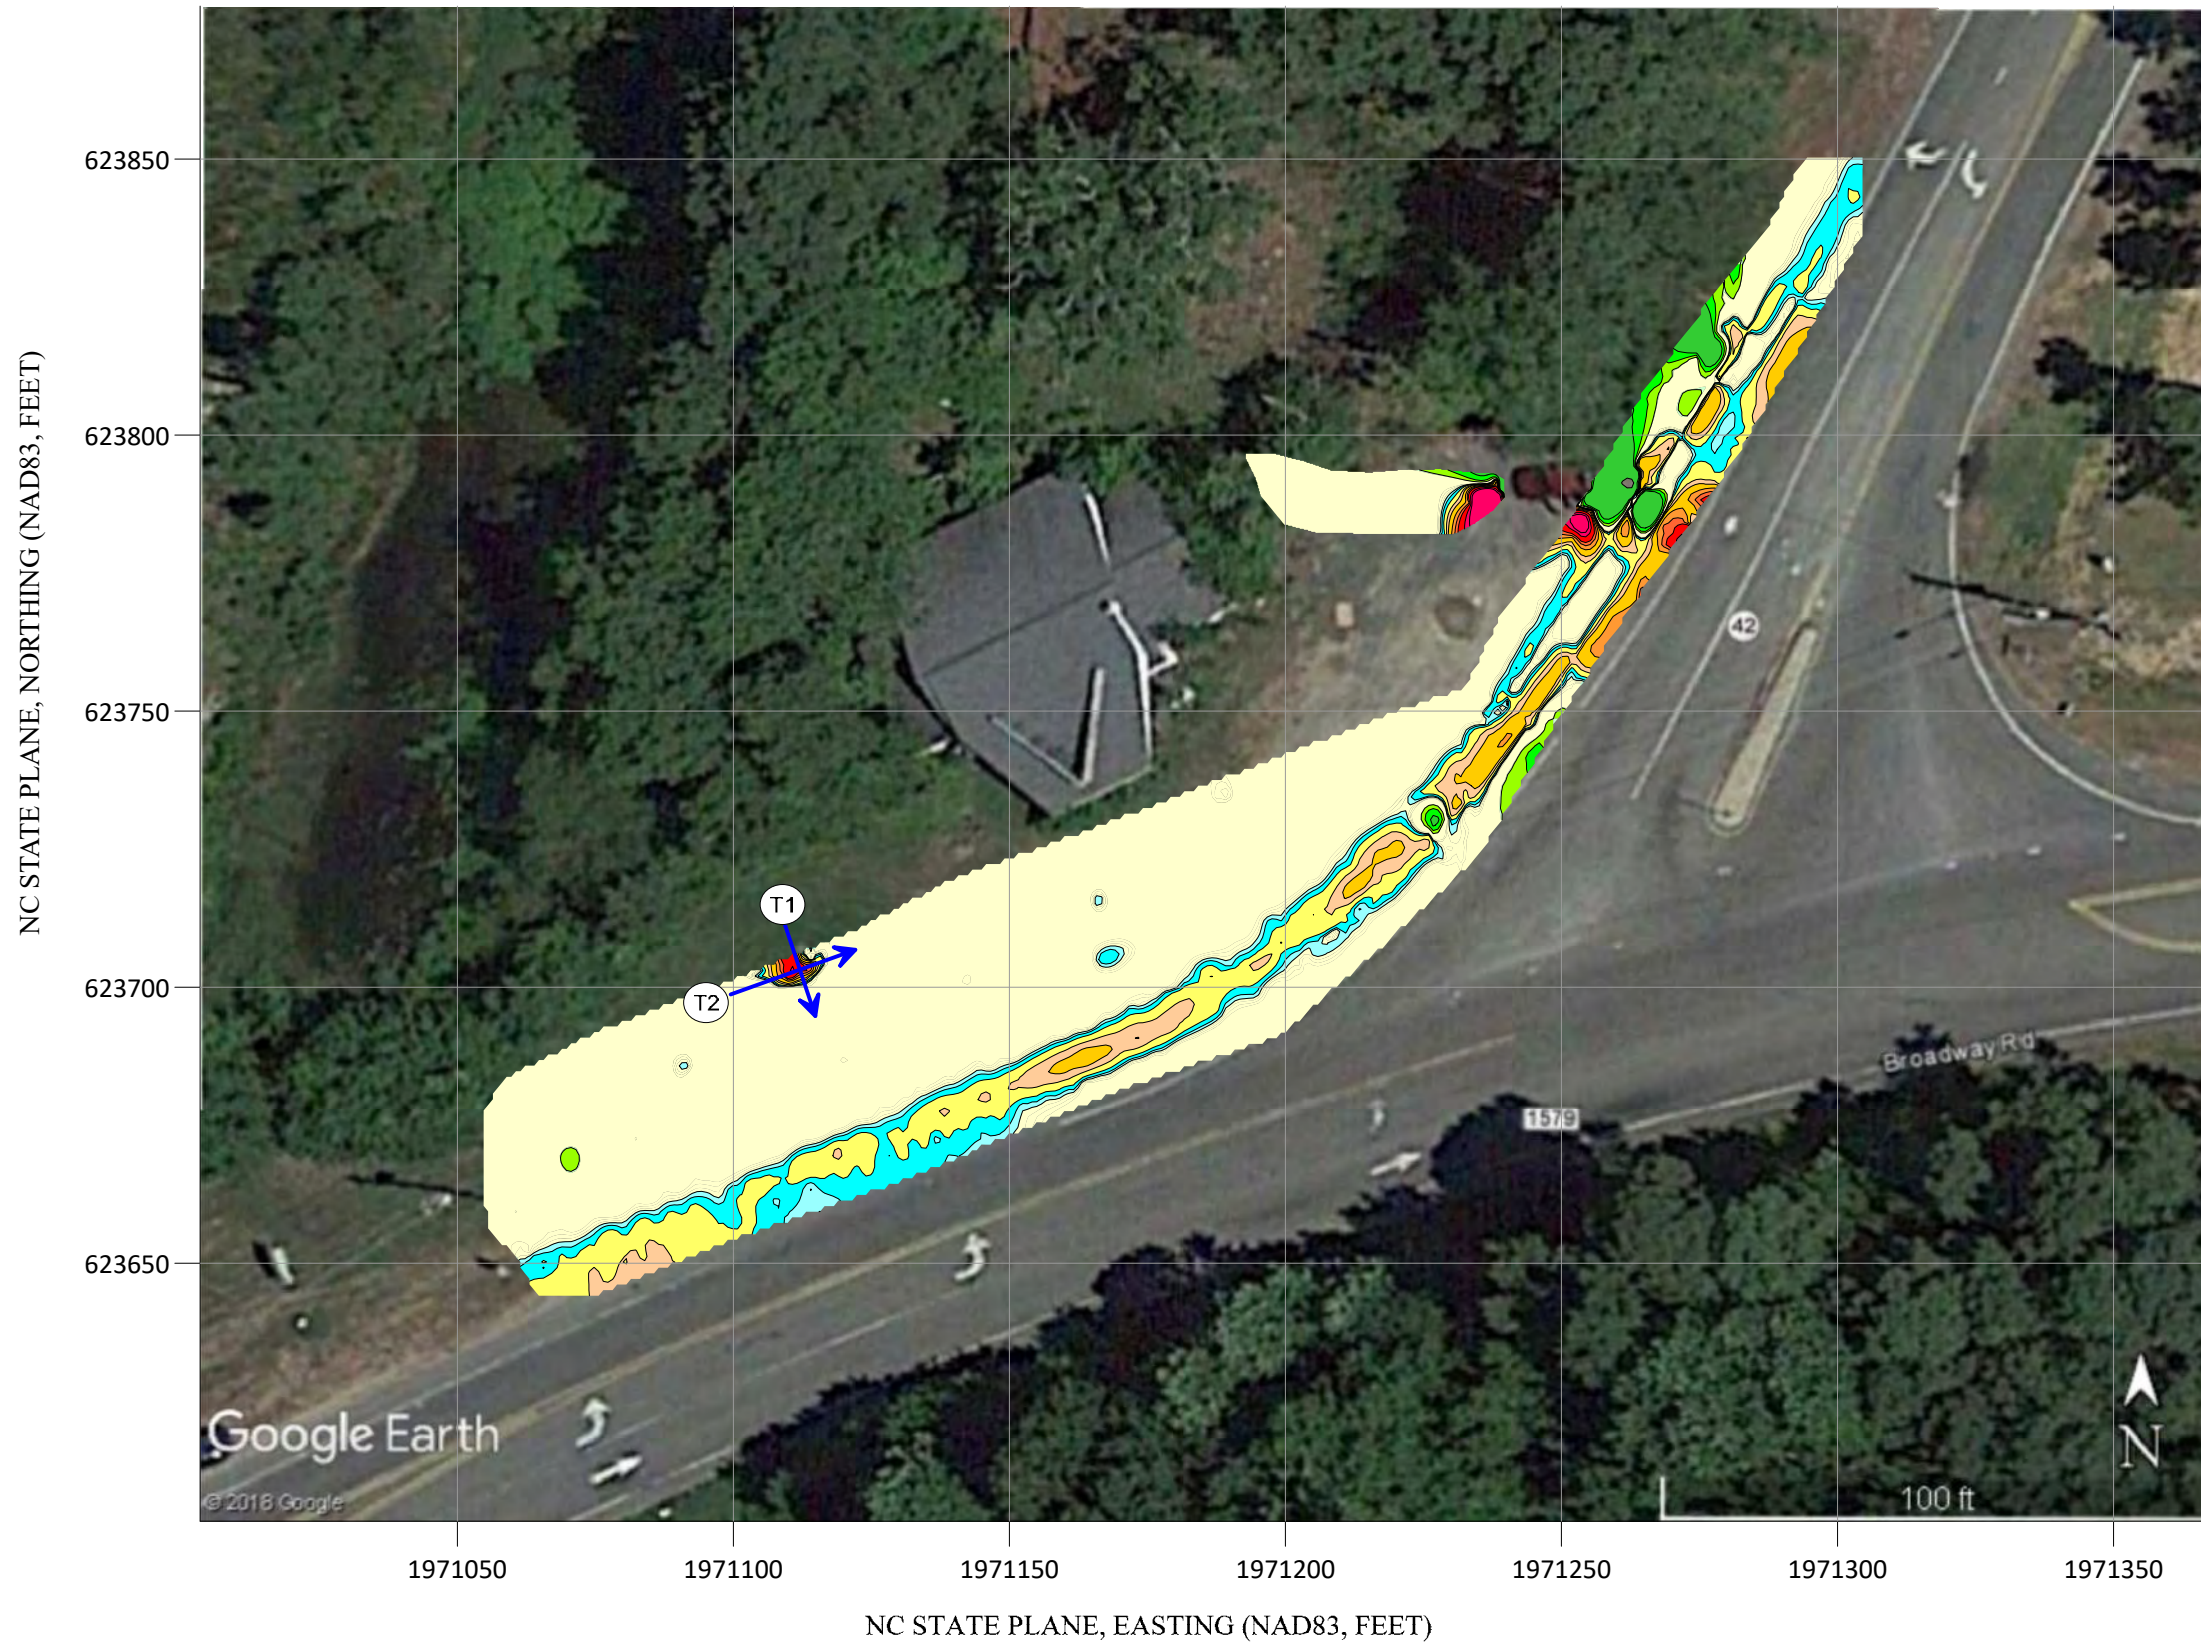
LOCATIONS OF GPR TRANSECTS

GPR TRANSECT 1 (T1)

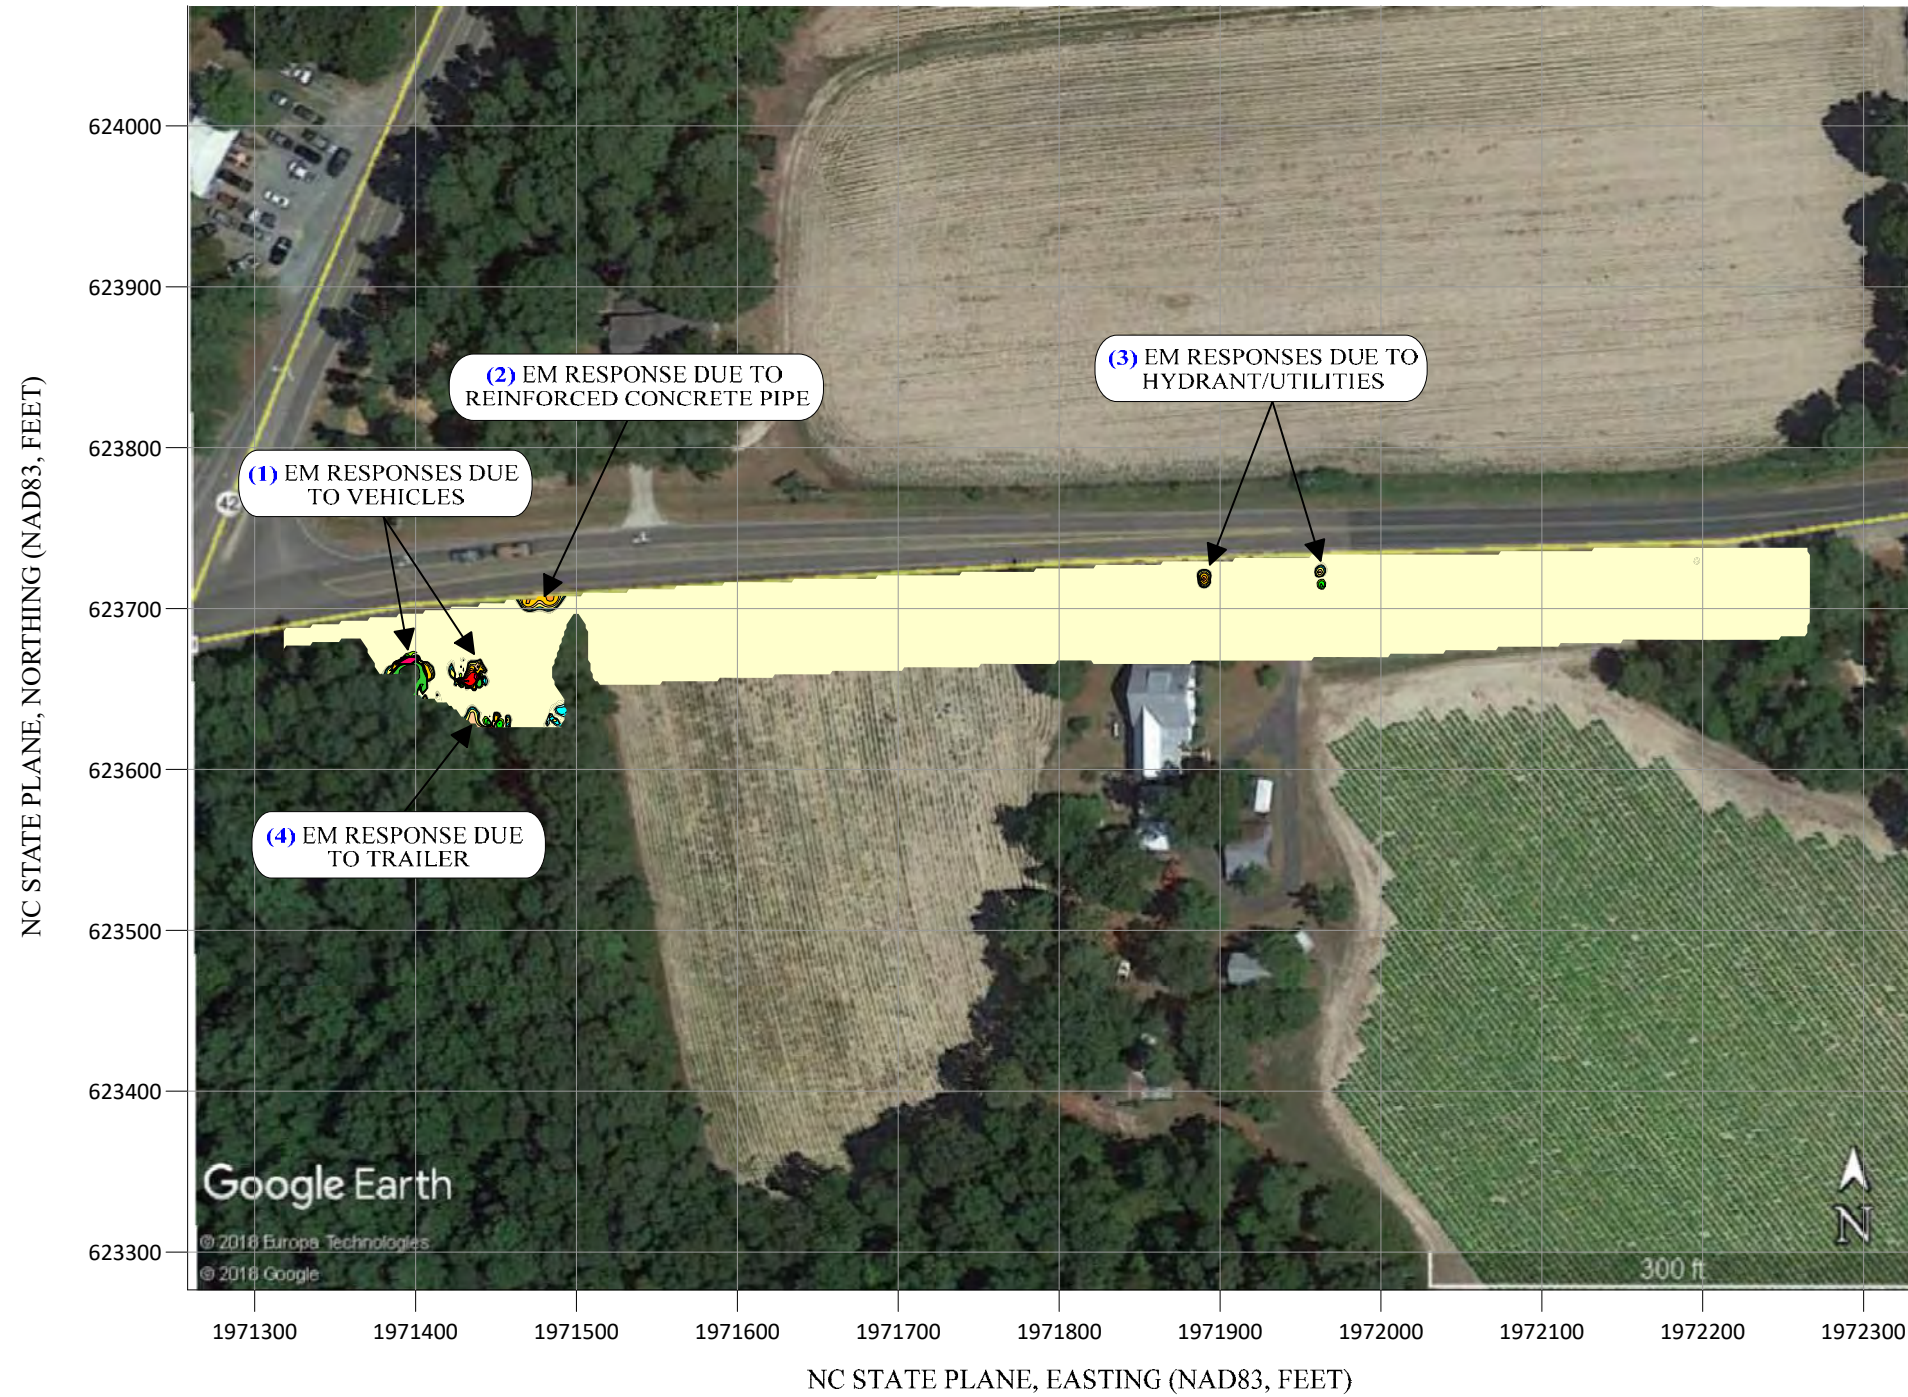
### EM61 METAL DETECTION RESULTS

NUMBERS IN BLUE (x) CORRESPOND TO EM ANOMALY TABLE IN REPORT
