Re: Phase II Preliminary Site Assessment Report  
NC 55 from South of SR 1532 to North of NC 210  
Parcel 244 – Beryl Road Properties, LLC  
8305 NC 55, Willow Spring, Wake County, North Carolina  
TIP No. R-5705B  
WBS Element: 46377.1.3

# Phase II Preliminary Site Assessment Report

NC 55 from South of SR 1532 to North of NC 210  
Parcel 244 – Beryl Road Properties, LLC  
8305 NC 55, Willow Spring, Wake County, North Carolina

TIP No. R-5705B

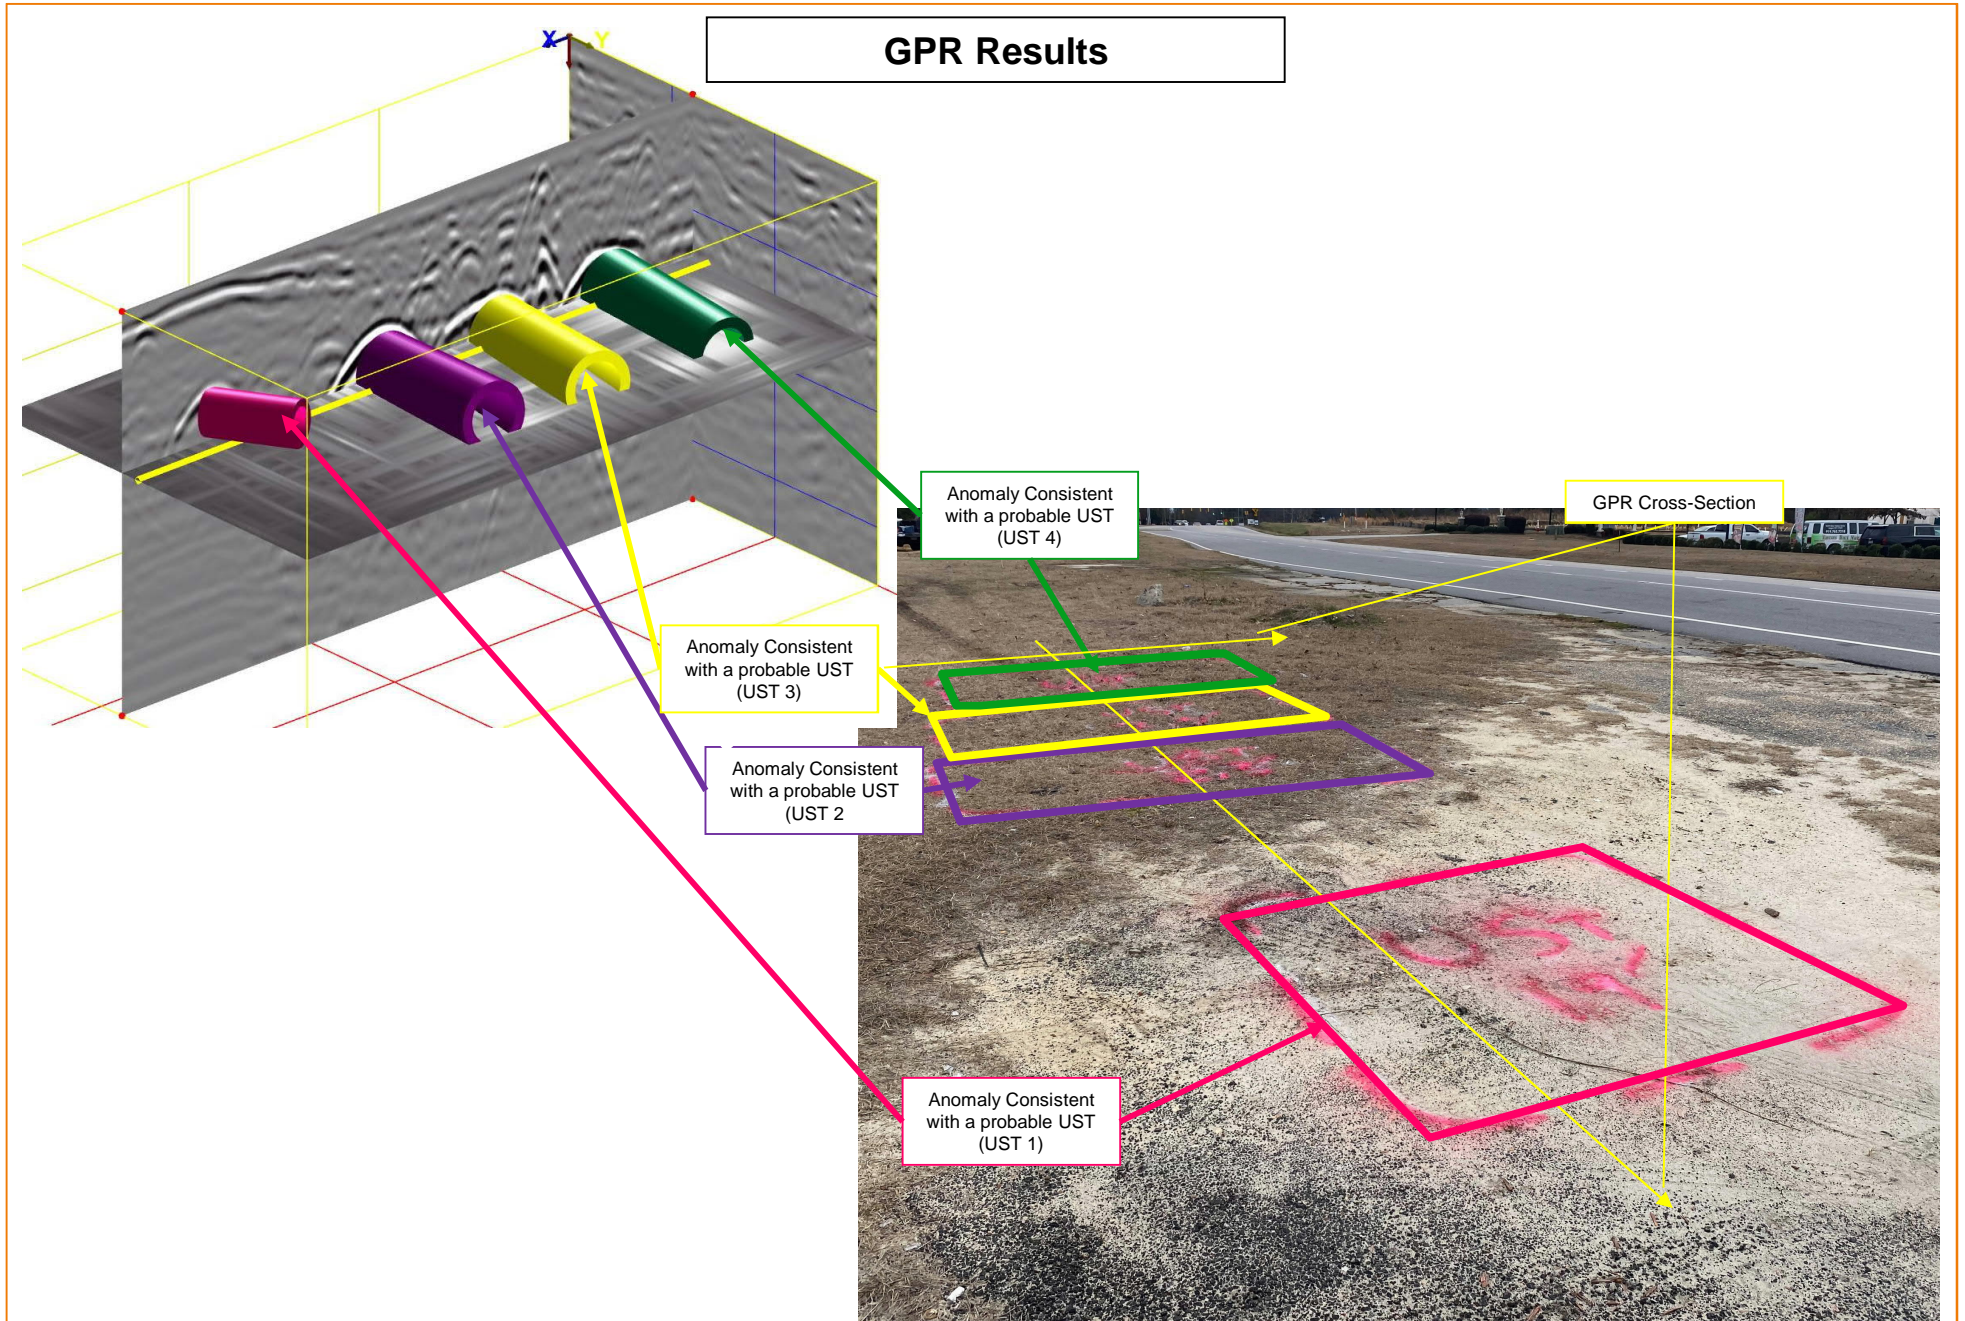
Terracon reviewed the EM and GPR data collected. Based on the EM data, an anomaly consistent with one or more probable USTs was identified on the west side of the site. Additionally, interference likely occurred from site utilities, a metal sign, and small amounts of miscellaneous debris which likely caused a “false” anomaly. In general, soil conductivity measurements between 0 to 30 mS/m and magnetic susceptibility measurements between -1 to 3 ppt were considered

“background”. Measurements outside of these ranges were interpreted to be caused by above or below ground anomalies. The depth of EM signal penetration is approximately 9 feet below the existing grade; however, the actual depth is not produced from the data collected.

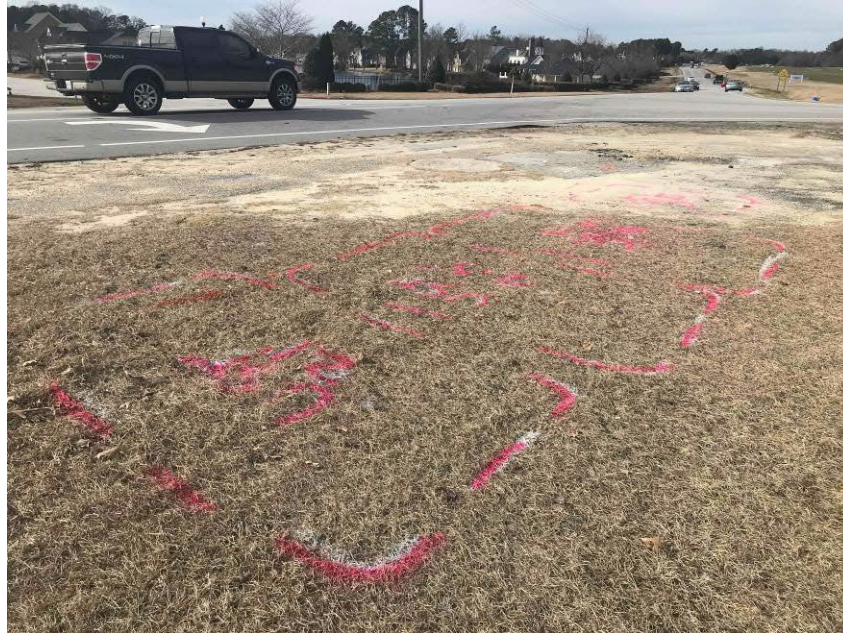
The geophysical investigation identified four probable metallic USTs located in the northwestern portion of the site along NC-55 and within the proposed ROW area. The probable USTs measured approximately 4.5 to 7 feet long and were located approximately 2 feet below land surface (bls). This area of the site was covered by grass and pavement and surface features such as vent pipes or fill ports were not observed in association with the probable USTs. Possible fuel lines on the site were not identified in the geophysical investigation.

Terracon verified the existence of the probable USTs further by advancing hand augers in the identified locations and observed a hollow sound when striking the USTs with the hand auger. Additionally, Terracon exposed the fill port for one of the USTs but was unable to remove the fill port to evaluate the presence of petroleum products.

**Photo #3** View of the four probable USTs identified in the geophysical investigation; facing northwest.

- Terracon recommends NCDOT provide a copy of the results to the owner and/or operator of the site and to NCDEQ.
- Terracon does not recommend further assessment of the ROW at this site. However, based on the probable USTs and the detections of petroleum compounds, USTs and impacted soil and groundwater encountered during the roadway construction project should be managed and/or disposed of in accordance with applicable NCDEQ Guidelines (NCDEQ, 2021). In addition, construction workers should be alert for potential soil and/or groundwater impacts at the site.

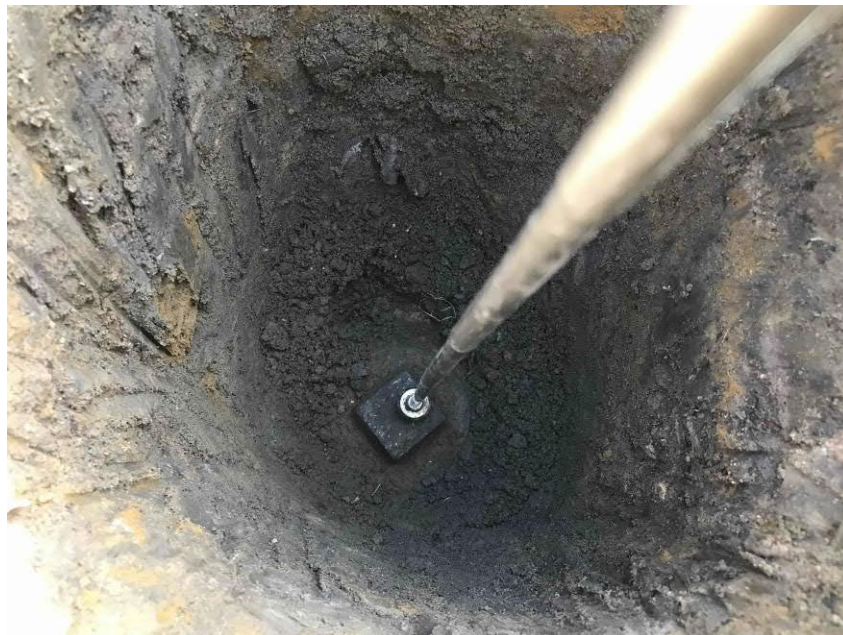
**Photo #4** View of an unearthed fill port of one of the probable USTs with a magnetic rod attached to confirm it as metal; facing south.

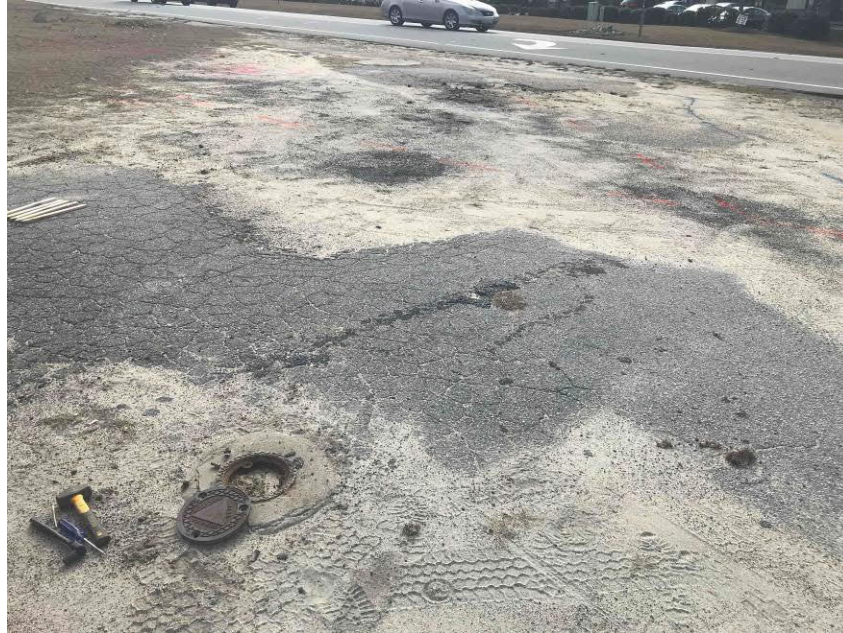
**Photo #5** View of the on-site abandoned monitoring well identified during the geophysical investigation; facing south.

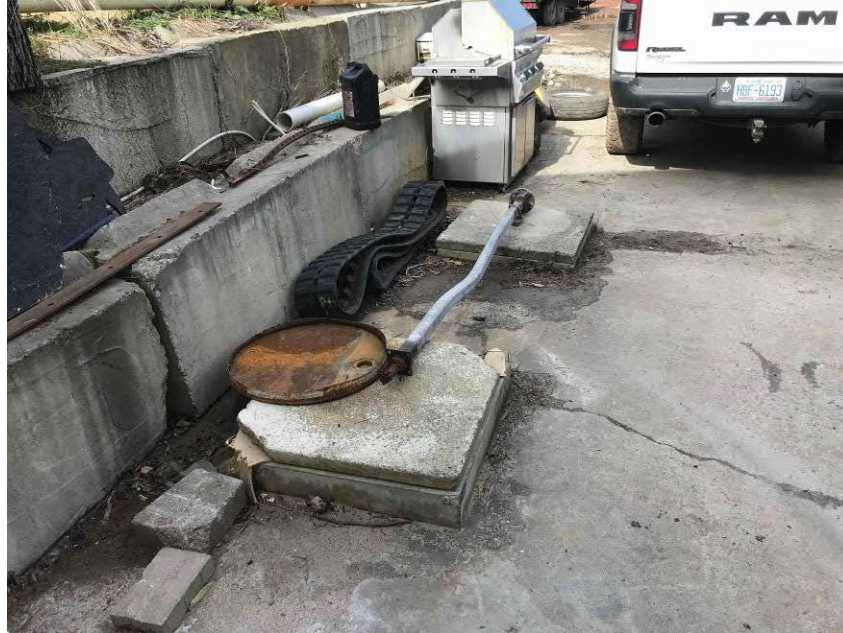
- The geophysical investigation did not identify USTs within the proposed NCDOT ROW.
- One septic tank within the ROW area was identified during the PSA, located directly north and adjacent to the on-site building.
- Laboratory analysis reported concentrations of TPH-DRO, TPH, and Total Aromatics in multiple soil borings at the site; however, the concentrations of TPH-DRO detected did not exceed NCDEQ Action Levels.
- Concentrations of BTEX, TPH-GRO, 16 EPA PAHs, and BaP were not detected above laboratory reporting limits in the soil borings.
- Terracon does not recommend further assessment of the ROW at this site. Based on minor detections of petroleum compounds in the samples, soil and groundwater encountered during NCDOT's roadway construction project should not need to be managed and/or disposed using special provisions.

**Photo #5** View of the on-site septic tank located north of the on-site building; facing northwest.
