CLEARING AND GRUBBING  
EROSION CONTROL FOR  
CONSTRUCTION SHEET 06

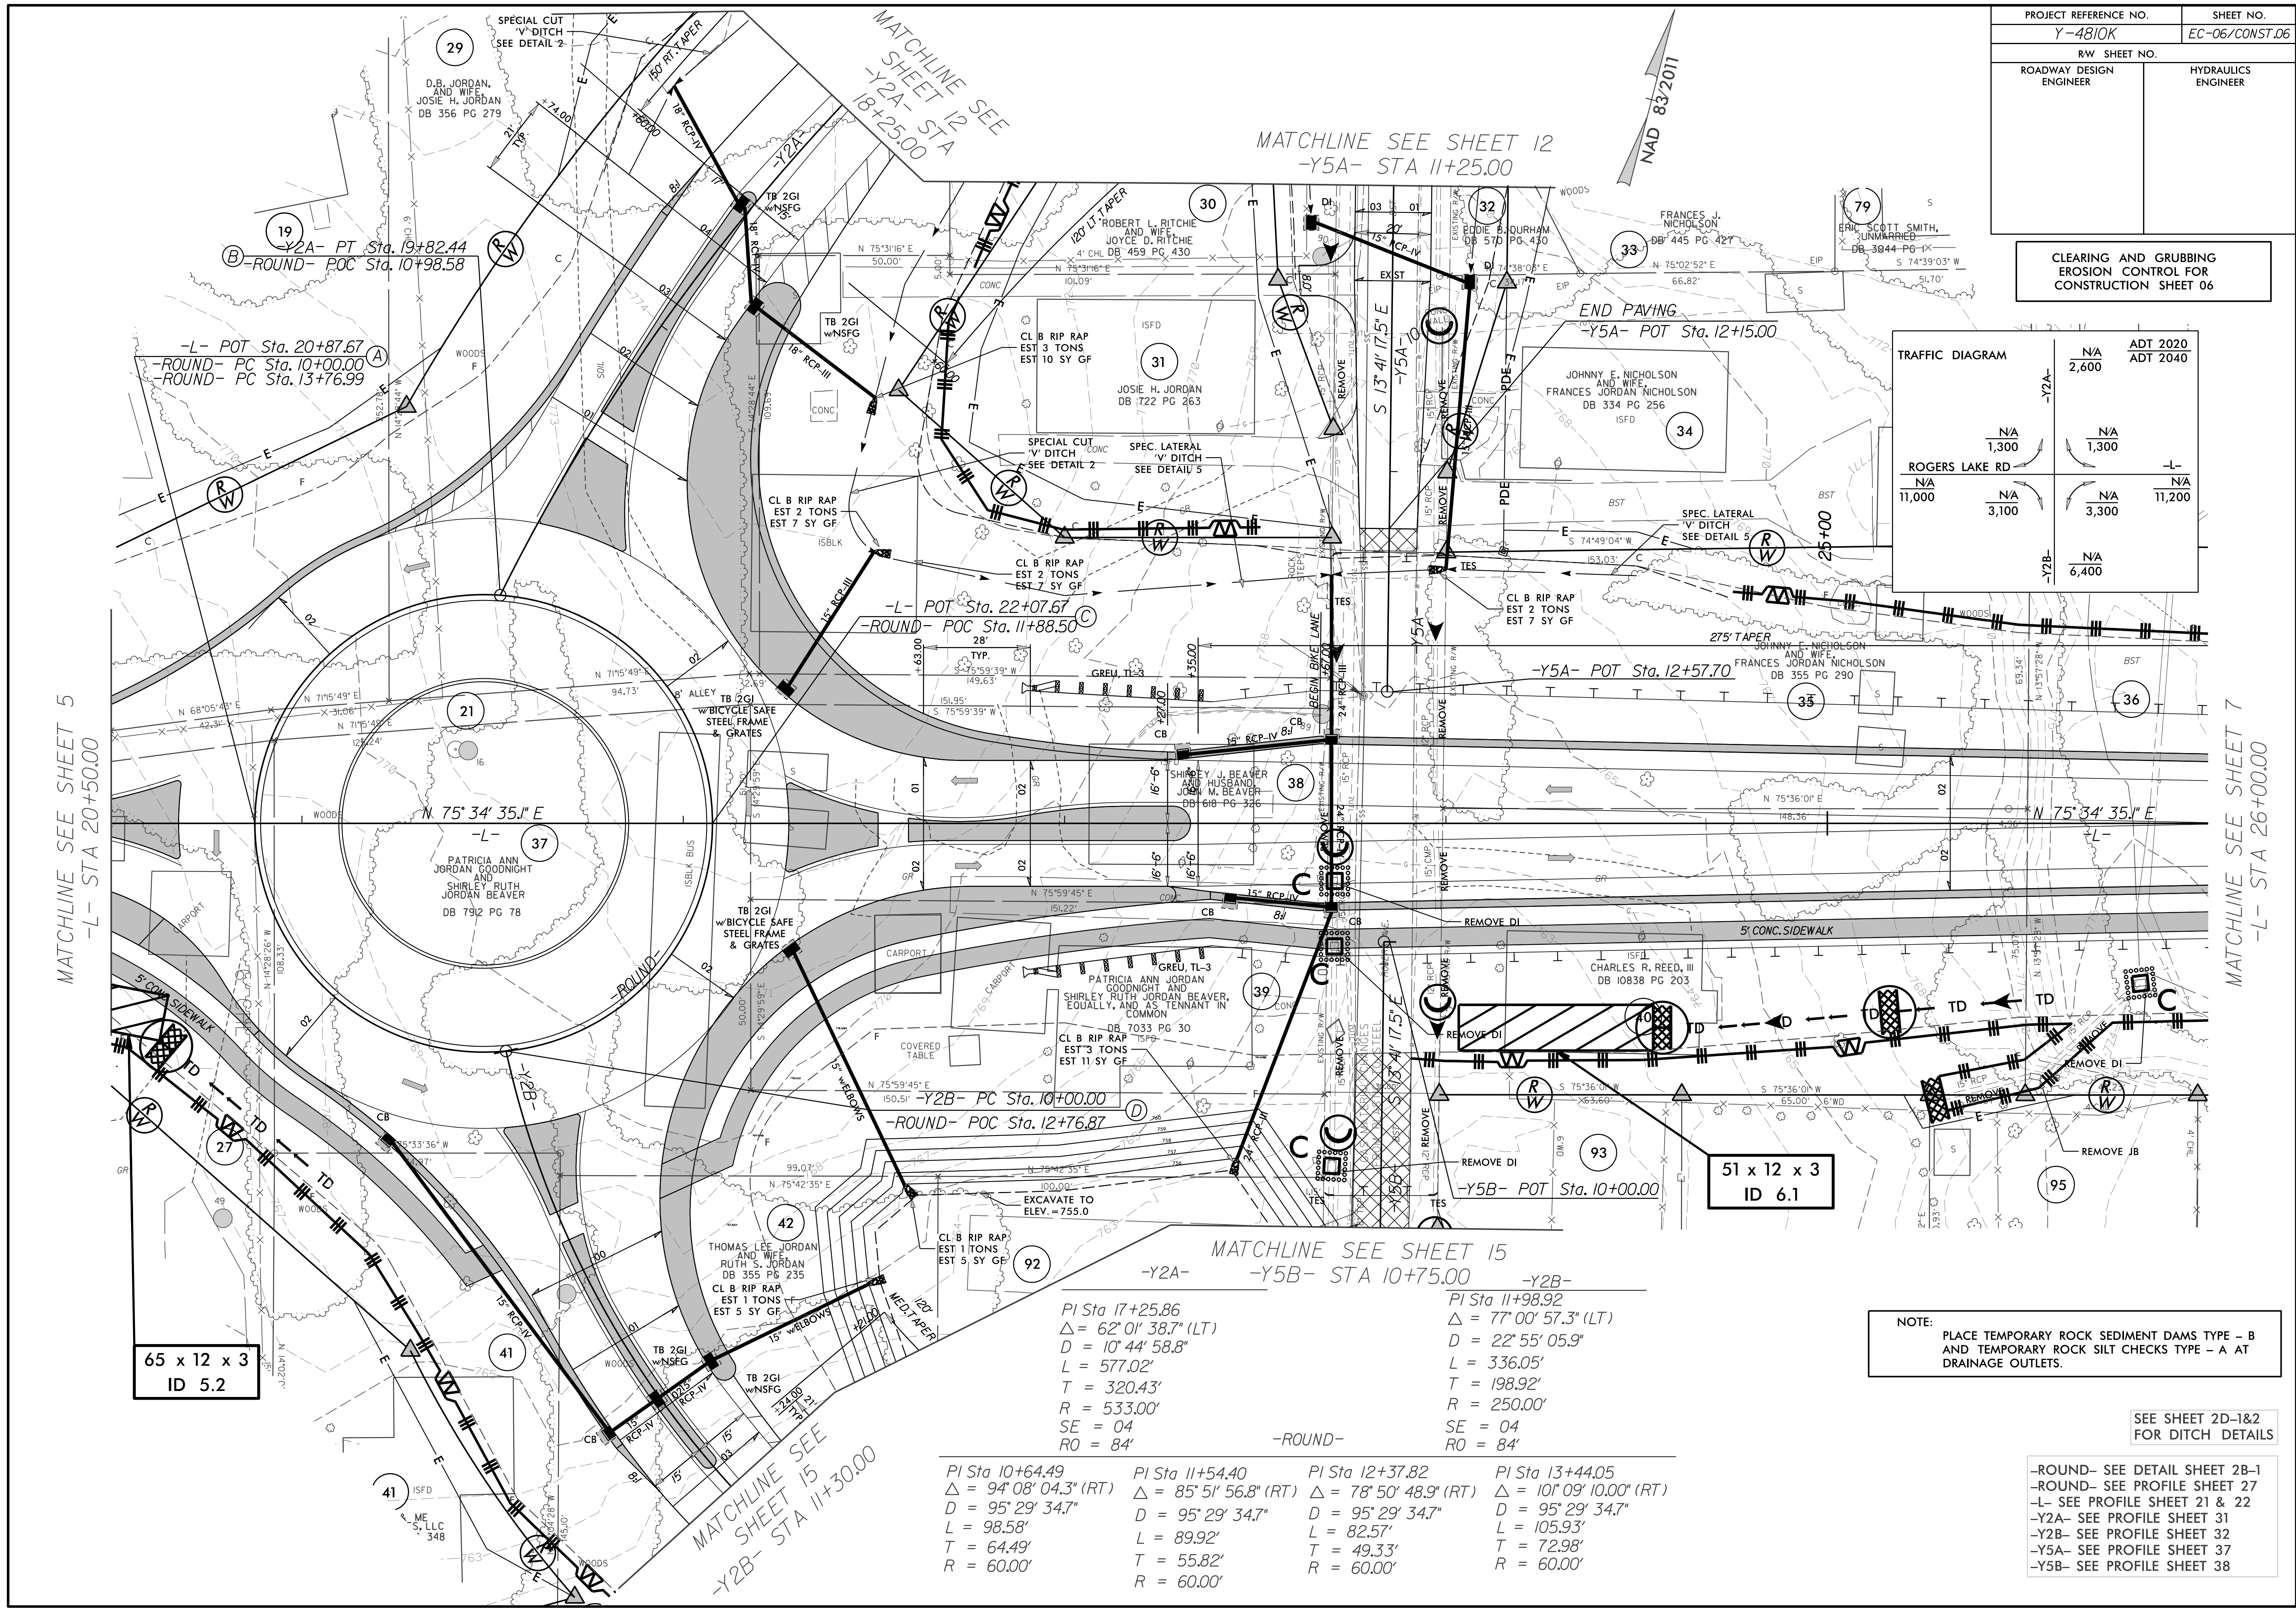
NOTE: PLACE TEMPORARY ROCK SEDIMENT DAMS TYPE - B AND TEMPORARY ROCK SILT CHECKS TYPE - A AT DRAINAGE OUTLETS.

SEE SHEET 2D-1&2 FOR DITCH DETAILS

<p>PI Sta 10+64.49 Δ = 94° 08' 04.3" (RT) D = 95' 29' 34.7" L = 98.58' T = 64.49' R = 60.00'</p>	<p>PI Sta 11+54.40 Δ = 85° 51' 56.8" (RT) D = 95' 29' 34.7" L = 89.92' T = 55.82' R = 60.00'</p>	<p>PI Sta 12+37.82 Δ = 78° 50' 48.9" (RT) D = 95' 29' 34.7" L = 82.57' T = 49.33' R = 60.00'</p>	<p>PI Sta 13+44.05 Δ = 101° 09' 10.00" (RT) D = 95' 29' 34.7" L = 105.93' T = 72.98' R = 60.00'</p>
--	--	--	---

<p>MATCHLINE SEE SHEET 15 -Y2A- PI Sta 17+25.86 Δ = 62° 01' 38.7" (LT) D = 10' 44' 58.8" L = 577.02' T = 320.43' R = 533.00' SE = 04 RO = 84'</p>	<p>MATCHLINE SEE SHEET 15 -Y5B- STA 10+75.00 PI Sta 11+98.92 Δ = 77° 00' 57.3" (LT) D = 22' 55' 05.9" L = 336.05' T = 198.92' R = 250.00' SE = 04 RO = 84'</p>
---	--
