STATE OF NORTH CAROLINA
DEPARTMENT OF TRANSPORTATION

TIP NO: Y-4810K
WBS: 40325
COUNTY: Cabarrus
DIVISION: 10
DESCRIPTION: Proposed Grade Separation crossing on Universal Street/Rogers Lake Road in Kannapolis.

SUBJECT: **GeoEnvironmental Report for Planning**

Hazardous Materials Report

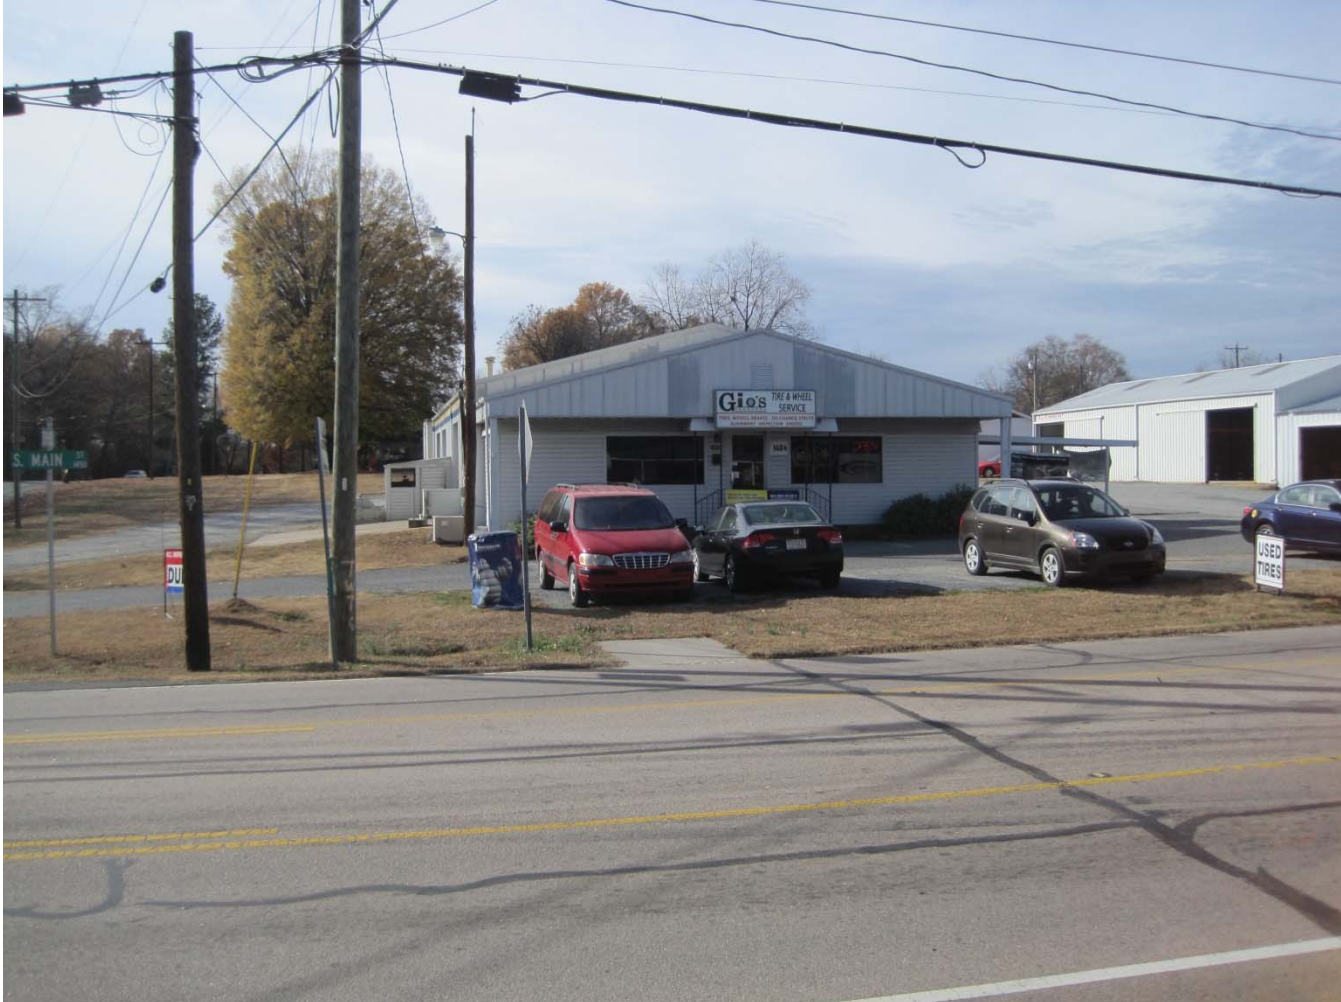
| 3) | Property Name Gio's Tire & Wheel Service 1404 S. Main Street Kannapolis, NC 28081 | Property Owner: Alternative # 1 Harry L. Smith 810 Rogers Lake Road Kannapolis, NC 28081 |

This facility currently operates as auto tire and repair shop. It is the former location of Reds Oil Company. It is located in the northwest quadrant of S. Main Street and Tiece Street. There is one AST located on the south side of the building. According to the UST Section Registry two tanks were removed in 1993. This facility does appear in the ground water incident database by the UST # but there is no ground water incident # associated with this facility. No monitoring wells were noted on site. The ASTs for the former Oil Company were located in the northwestern corner of the property. **This site is anticipated to present low geoenvironmental impacts to the project.**

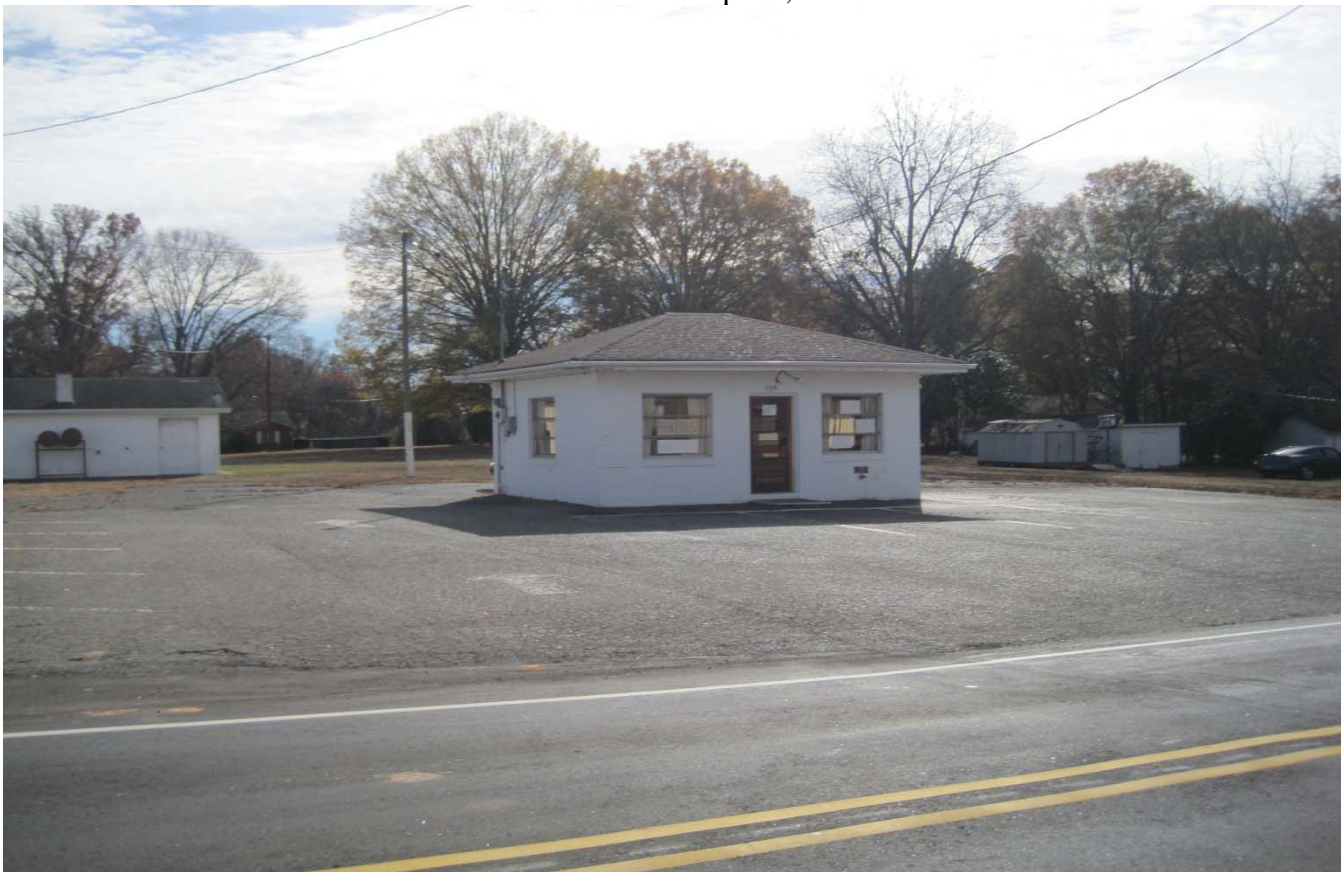
| 5) | Property Name Sales Office (Former Atomic Oil Co) 129 Rogers Lake Road Kannapolis, NC 28081 | Property Owner: Lance & Frances Middleton 1132 Windsor Drive Kannapolis, NC 28081 | Alternative # 1 |

The building on this property is currently used as a sales office. The type of business is unknown. It is the former location of Atomic Oil Company. It is located on the south side of Rogers Lake Road approximately 260 feet west of S. Main Street. According to the UST Section Registry two tanks were removed in 1989. The facility does appear in the ground water incident database by the UST # but there is no ground water incident # associated with this facility. No monitoring wells were noted on site. The ASTs for the former Oil Company were located on the southern portion of the property. **This site is anticipated to present low geoenvironmental impacts to the project**

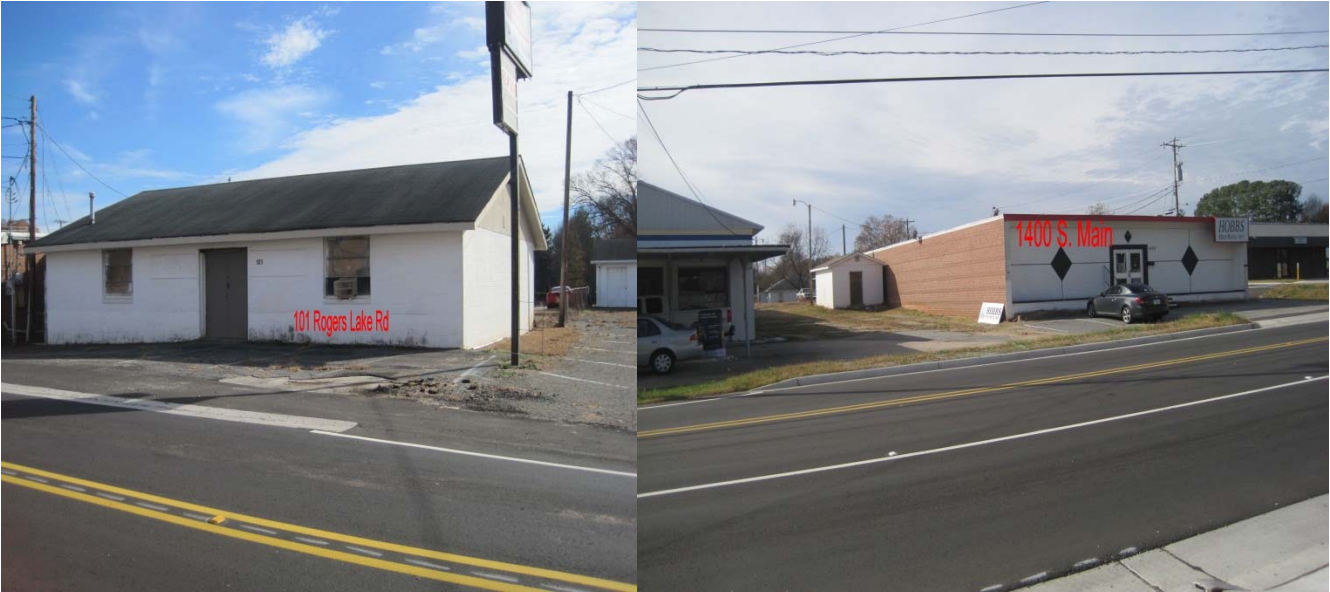
| 6) | Property Name Hobbs Mixed Martial Arts 1400 S. Main Street. 101 Rogers Lake Rd Kannapolis, NC 28081 Facility ID #: N/A Incident #: N/A | Property Owner: Adam Cantero Juan Preciada 6506 S. Kimball Street Hodgkins, IL, 60525 UST Owner: N/A | Alternative # 1 |

There are two address associated with this parcel. The parcel is located in the south west quadrant of S. Main Street and Rogers Lake Road. The main building operates as Hobbs Martial Arts, the second building appears to be a vacant shop/garage. Neither facility appears on the UST Section Registry. There is no evidence of any UST system and there is no ground water incident associated with this facility. No Monitoring wells were noted on site. **This site is anticipated to present low geoenvironmental impacts to the project**

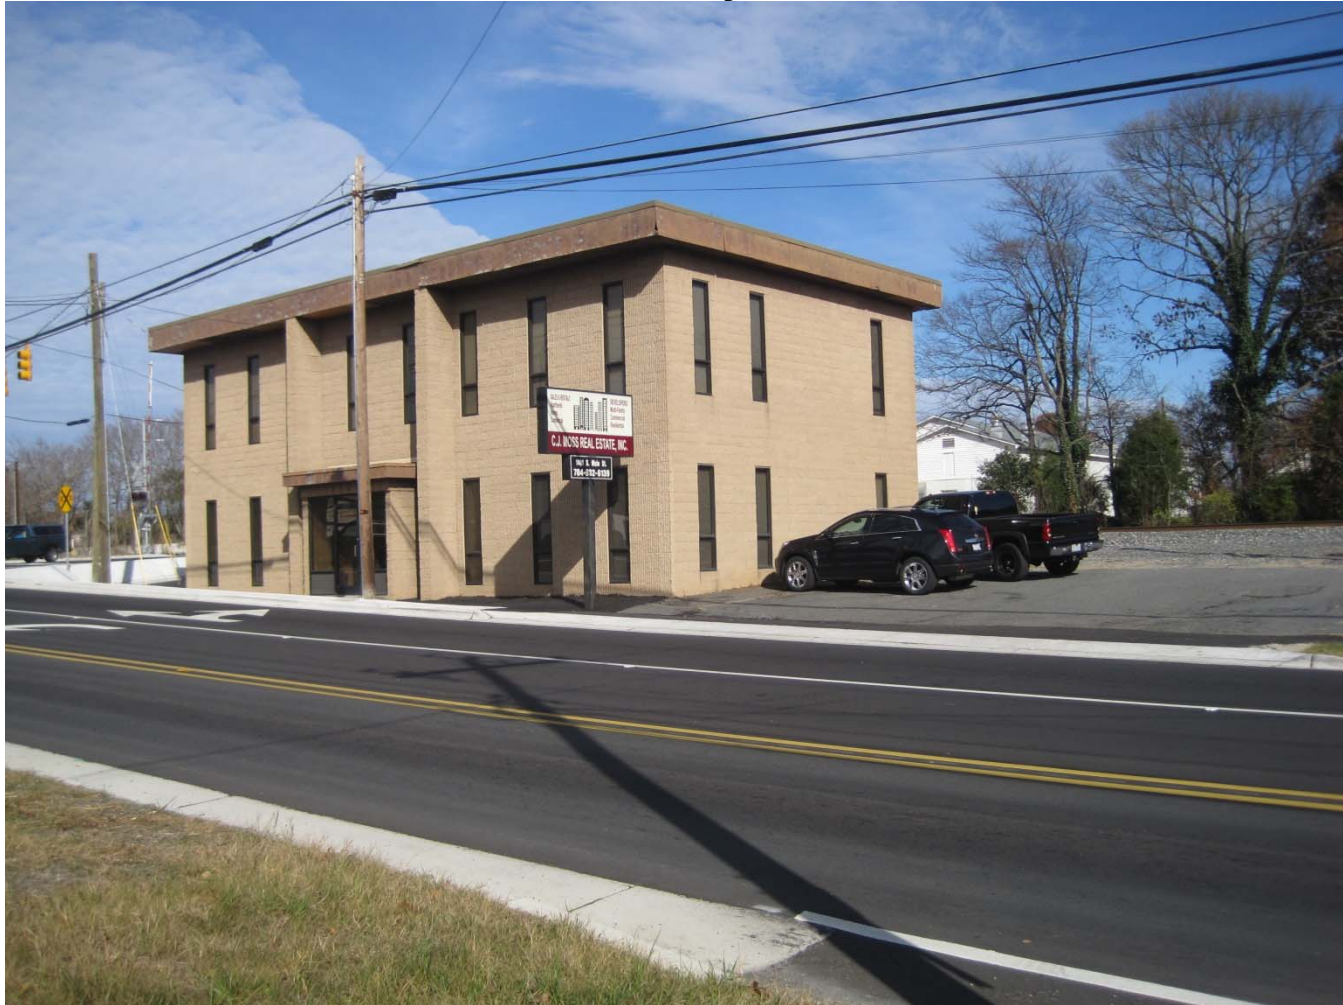
This facility currently operates as a Real Estate office. It is located in the south east quadrant of S. Main Street and Rogers Lake Road. According to the UST Section Registry one tank was removed in 1991. There appears to be a UST located near the south east corner of the building. No monitoring wells were noted on site and there is no ground water incident associated with this facility. **This site is anticipated to present low geoenvironmental impacts to the project**

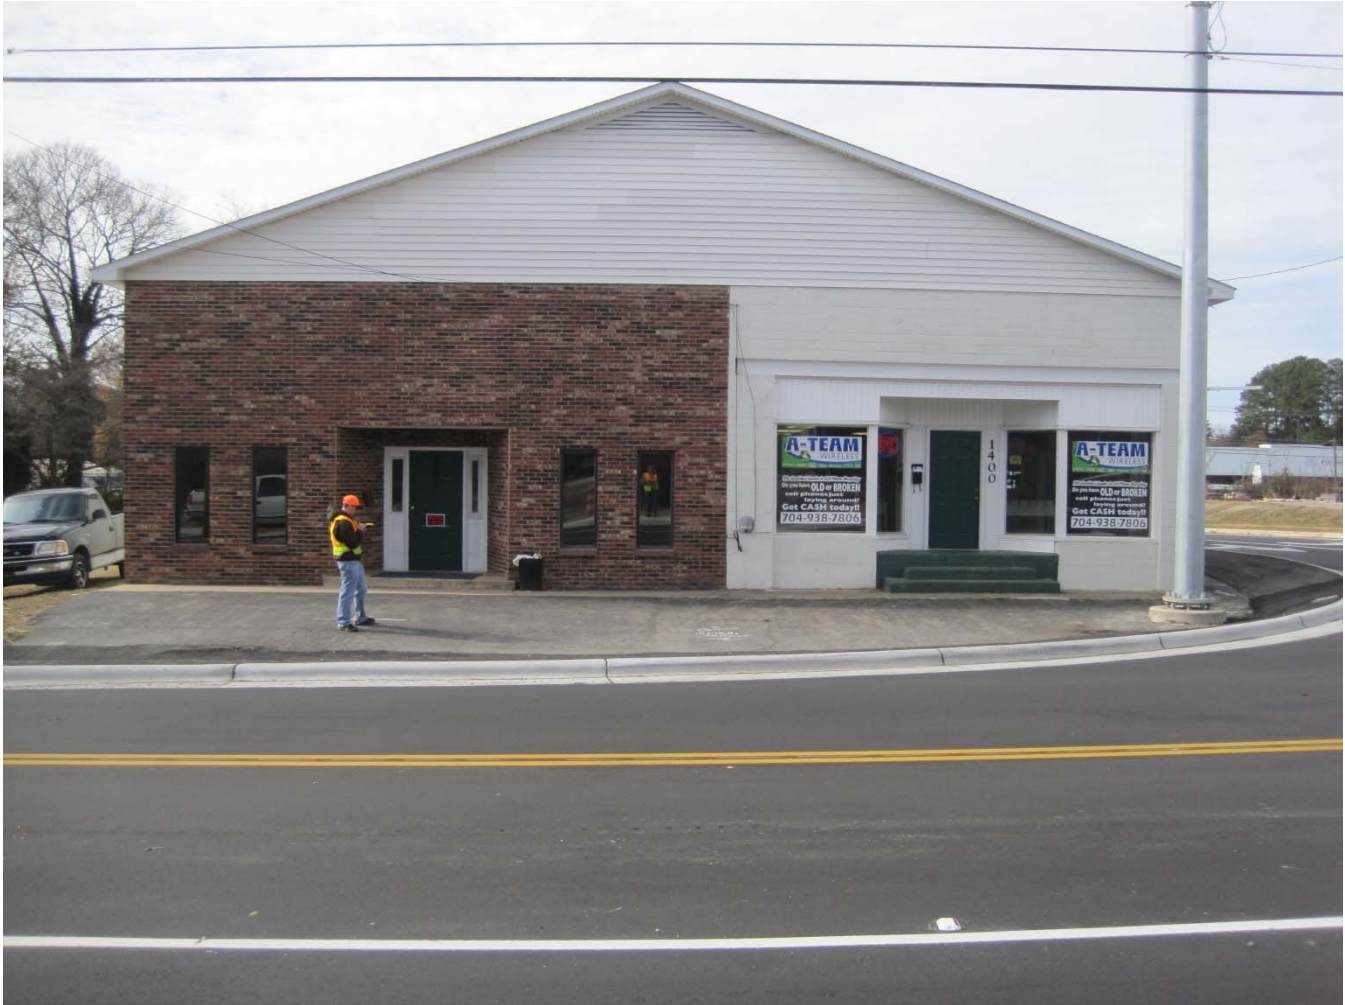
| 11) | Property Name A-Team Wireless 1400 S. Ridge Avenue Kannapolis, NC 28083 | Property Owner: John R. Triage Trustee Phillip T. Triage Trustee 827 Evergreen Avenue Kannapolis, NC 28081 | Alternative # 1 |

This facility currently operates as cell phone retail store. It is the former location of Plain or Fancy Catering. It is located in the south west quadrant of S. Ridge Ave. and Rogers Lake Rd. There is no evidence of any UST system but the age and the design of portion of the building that has not been remodeled suggest it could have operated as an old service station. The facility does not appear on the UST Section Registry. There is no ground water incident associated with this facility. No Monitoring wells were noted on site. **This site is anticipated to present low geoenvironmental impacts to the project**

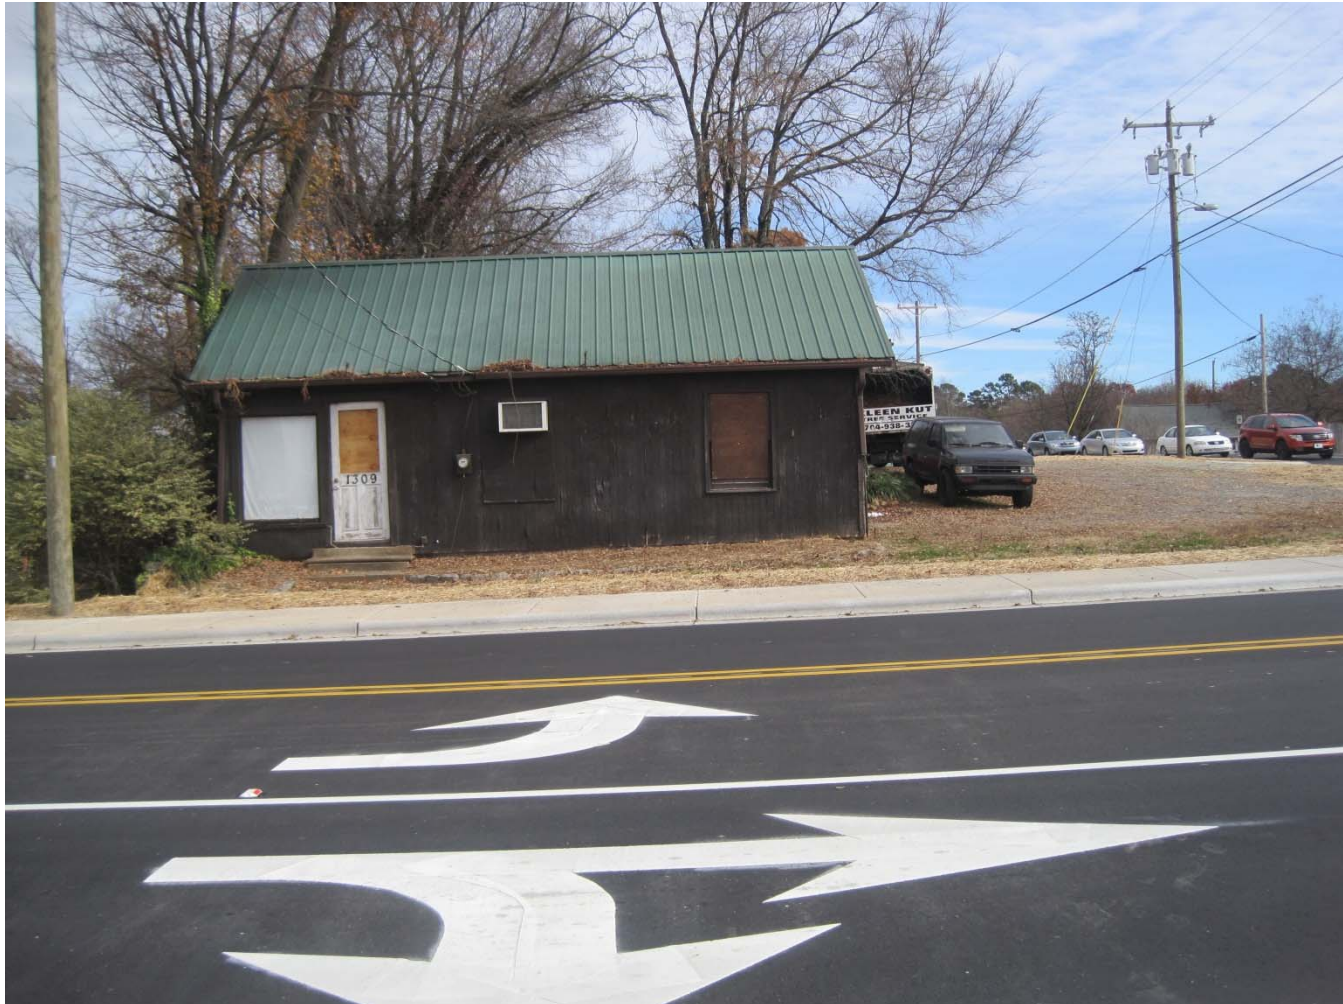
| 12) | Property Name Kleen Cut Tree Service 1309 S. Ridge Ave. Kannapolis, NC 28083 | Property Owner: Patricia Cook 1069 Canoby Ct Woodleaf, NC 27054 | Alternative # 2 |

This facility is used by Kleen Cut tree service for equipment storage. It is located in the north east quadrant of S. Ridge Avenue and Rogers Lake Road. The facility does not appear on the UST Section Registry. There is no ground water incident associated with this facility. No Monitoring wells were noted on site. **This site is anticipated to present low geoenvironmental impacts to the project**

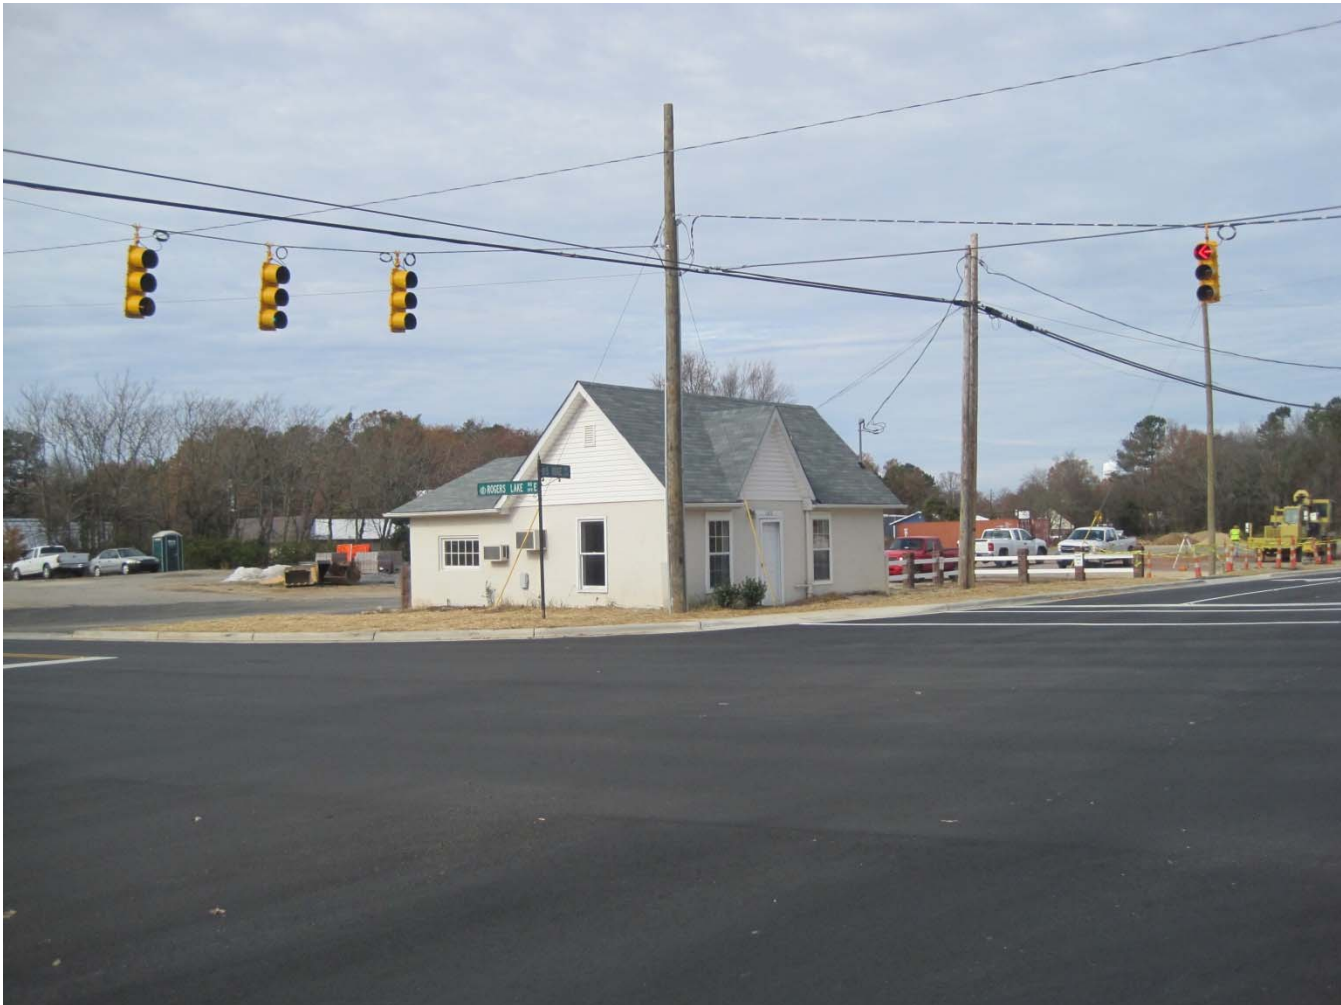
14) **Property Name**
Former Triage Block Company
1310-1306 S. Ridge Avenue
Kannapolis, NC 28083

This vacant lot is the former location of Triage Block Company. It is located in the north west quadrant of S. Ridge Avenue and Rogers Lake Road. The vacant lot was recently used as a construction staging area for the recent upgrade to S. Ridge Avenue and Rogers Lake Road Intersection and rail crossing. The facility does not appear on the UST Section Registry. There is no ground water incident associated with this facility. No monitoring wells were noted on site. **This site is anticipated to present low geoenvironmental impacts to the project**

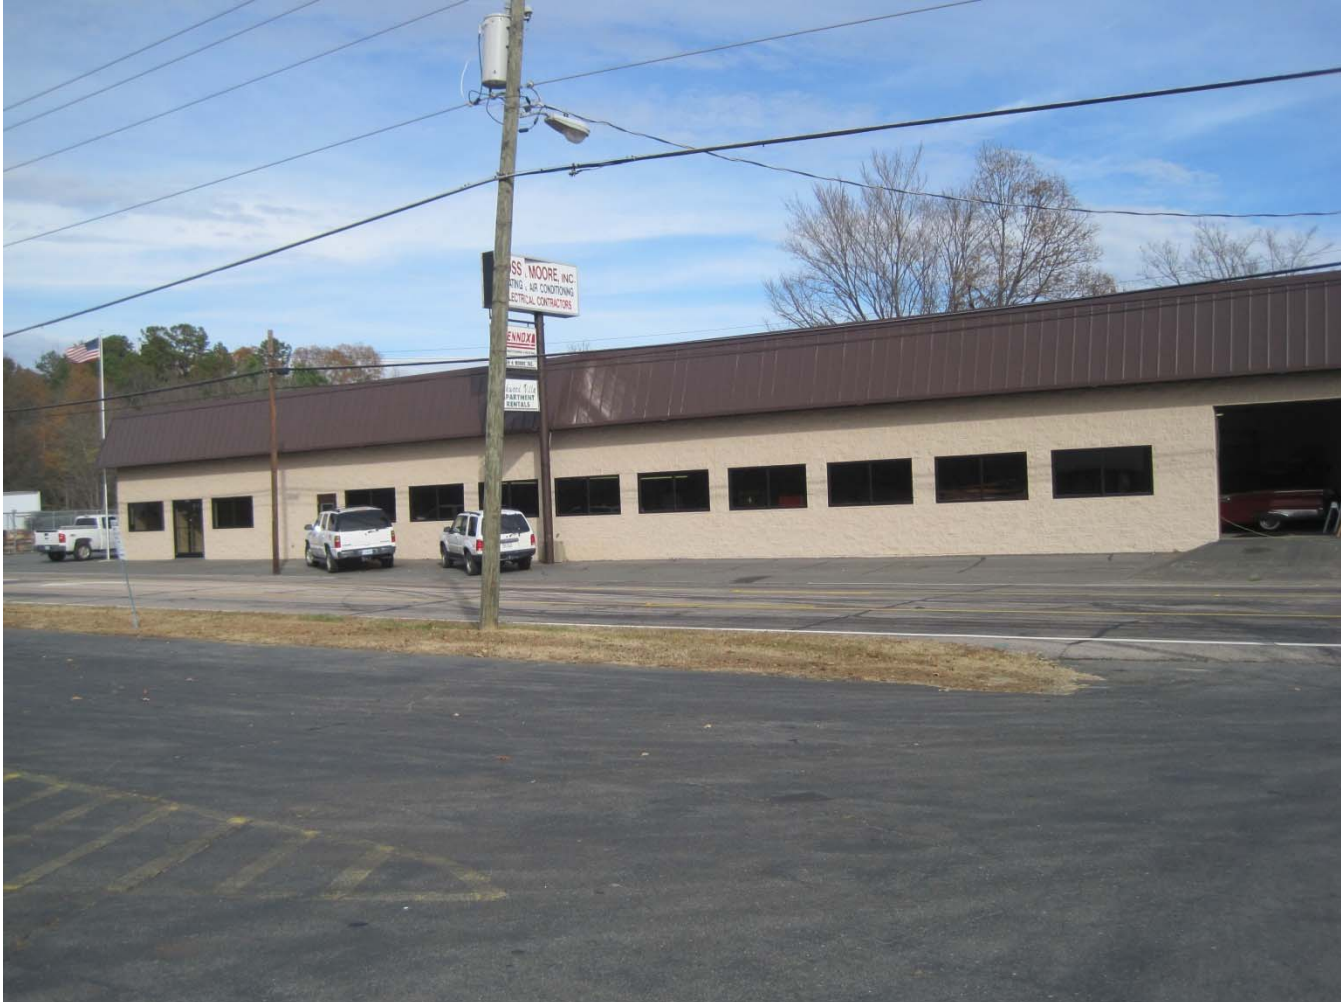
| 15) | Property Name Moss & Moore Inc. 1307 S. Main Street Kannapolis, NC 28081 | Property Owner: Carl & Betty Moore 1307 S. Main Street Kannapolis, NC 28081 | Alternative # 2,3 |

This facility currently operates as a Heating & Air conditioning business. It is located on the east side of S. Main Street approximately 350 feet north of Rogers Lake Road. According to the UST Section Registry one tank was closed in 1992. The facility does appear in the ground water incident database by the UST # but there is no ground water incident # associated with this facility. No Monitoring wells were noted on site. **This site is anticipated to present low geoenvironmental impacts to the project**

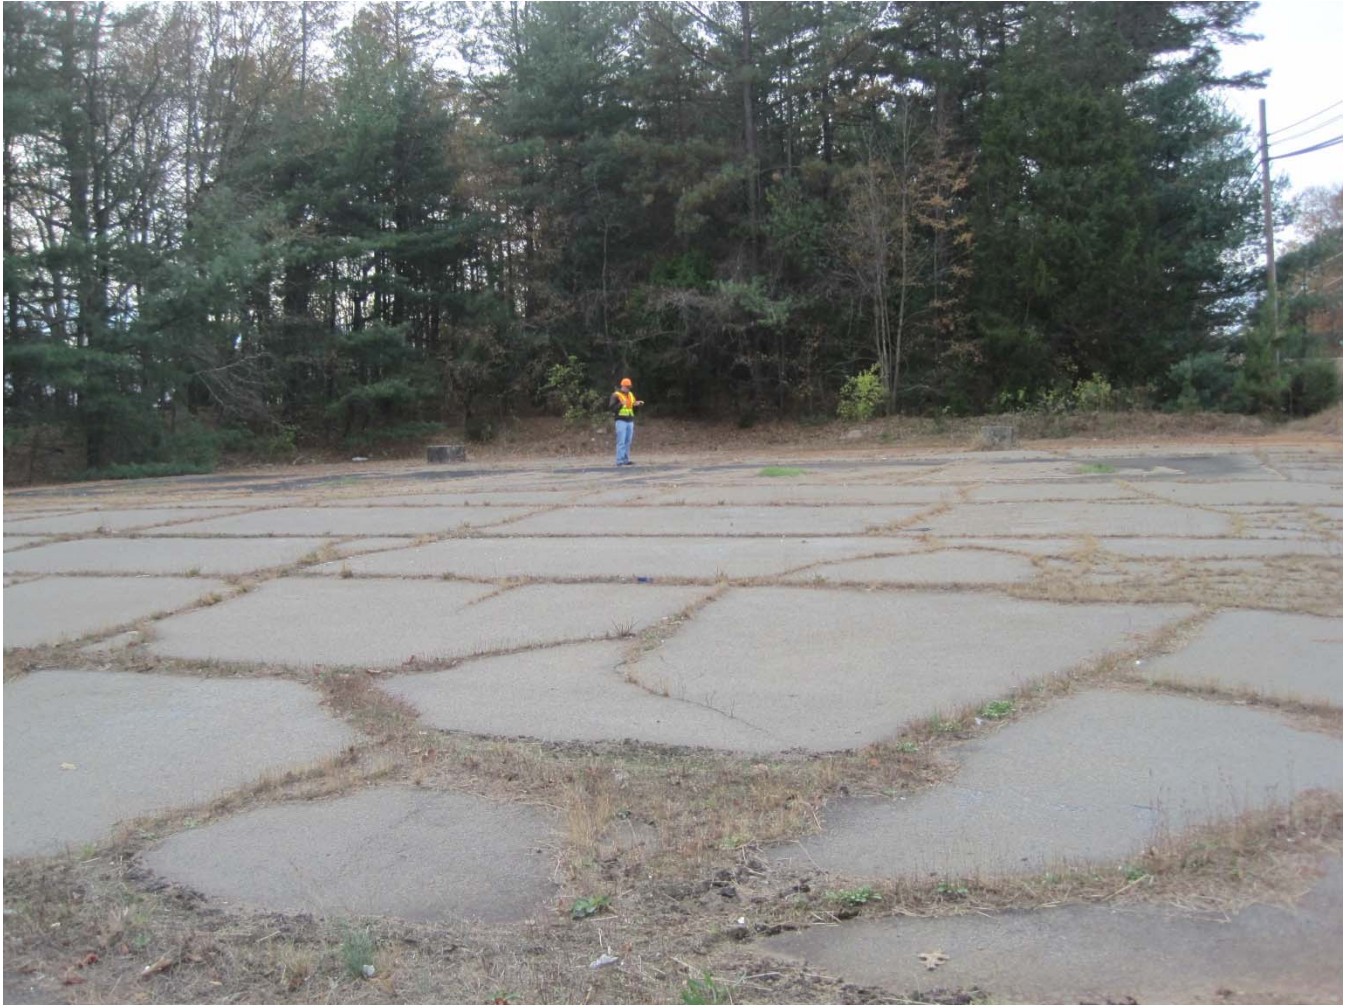
| 16) | Property Name Vacant Lot S. Main Street (No Address) Kannapolis, NC 28081 | Property Owner: GFS Properties LLC C/O James H. Slaughter PO Box 41027 Greensboro, NC 27404 | Alternative # 3 |

This vacant lot is the former location of a car wash. It is located in the south west quadrant of S. Main Street and Lowrance Avenue. The facility does not appear on the UST Section Registry. There is no evidence of any UST system and there is no ground water incident associated with this facility. No monitoring wells were noted on site. **This site is anticipated to present low geoenvironmental impacts to the project**
