Re: Preliminary Site Assessment (PSA)
Norfolk Southern Mainline Grade Crossing Separation at Rogers Road Crossing in
Kannapolis
Parcel 48 - John, Phillip, Douglas Tricee Trustee Property
1306-1310 S. Ridge Avenue, Kannapolis, North Carolina
TIP No. Y-4810K
WBS Element: 40325.1.46

Preliminary Site Assessment

Norfolk Southern Mainline Grade Crossing Separation at Rogers Road in Kannapolis

**Parcel 48 – John, Phillip, Douglas Triage Trustee Property
1306-1310 S. Ridge Avenue, Kannapolis, North Carolina**

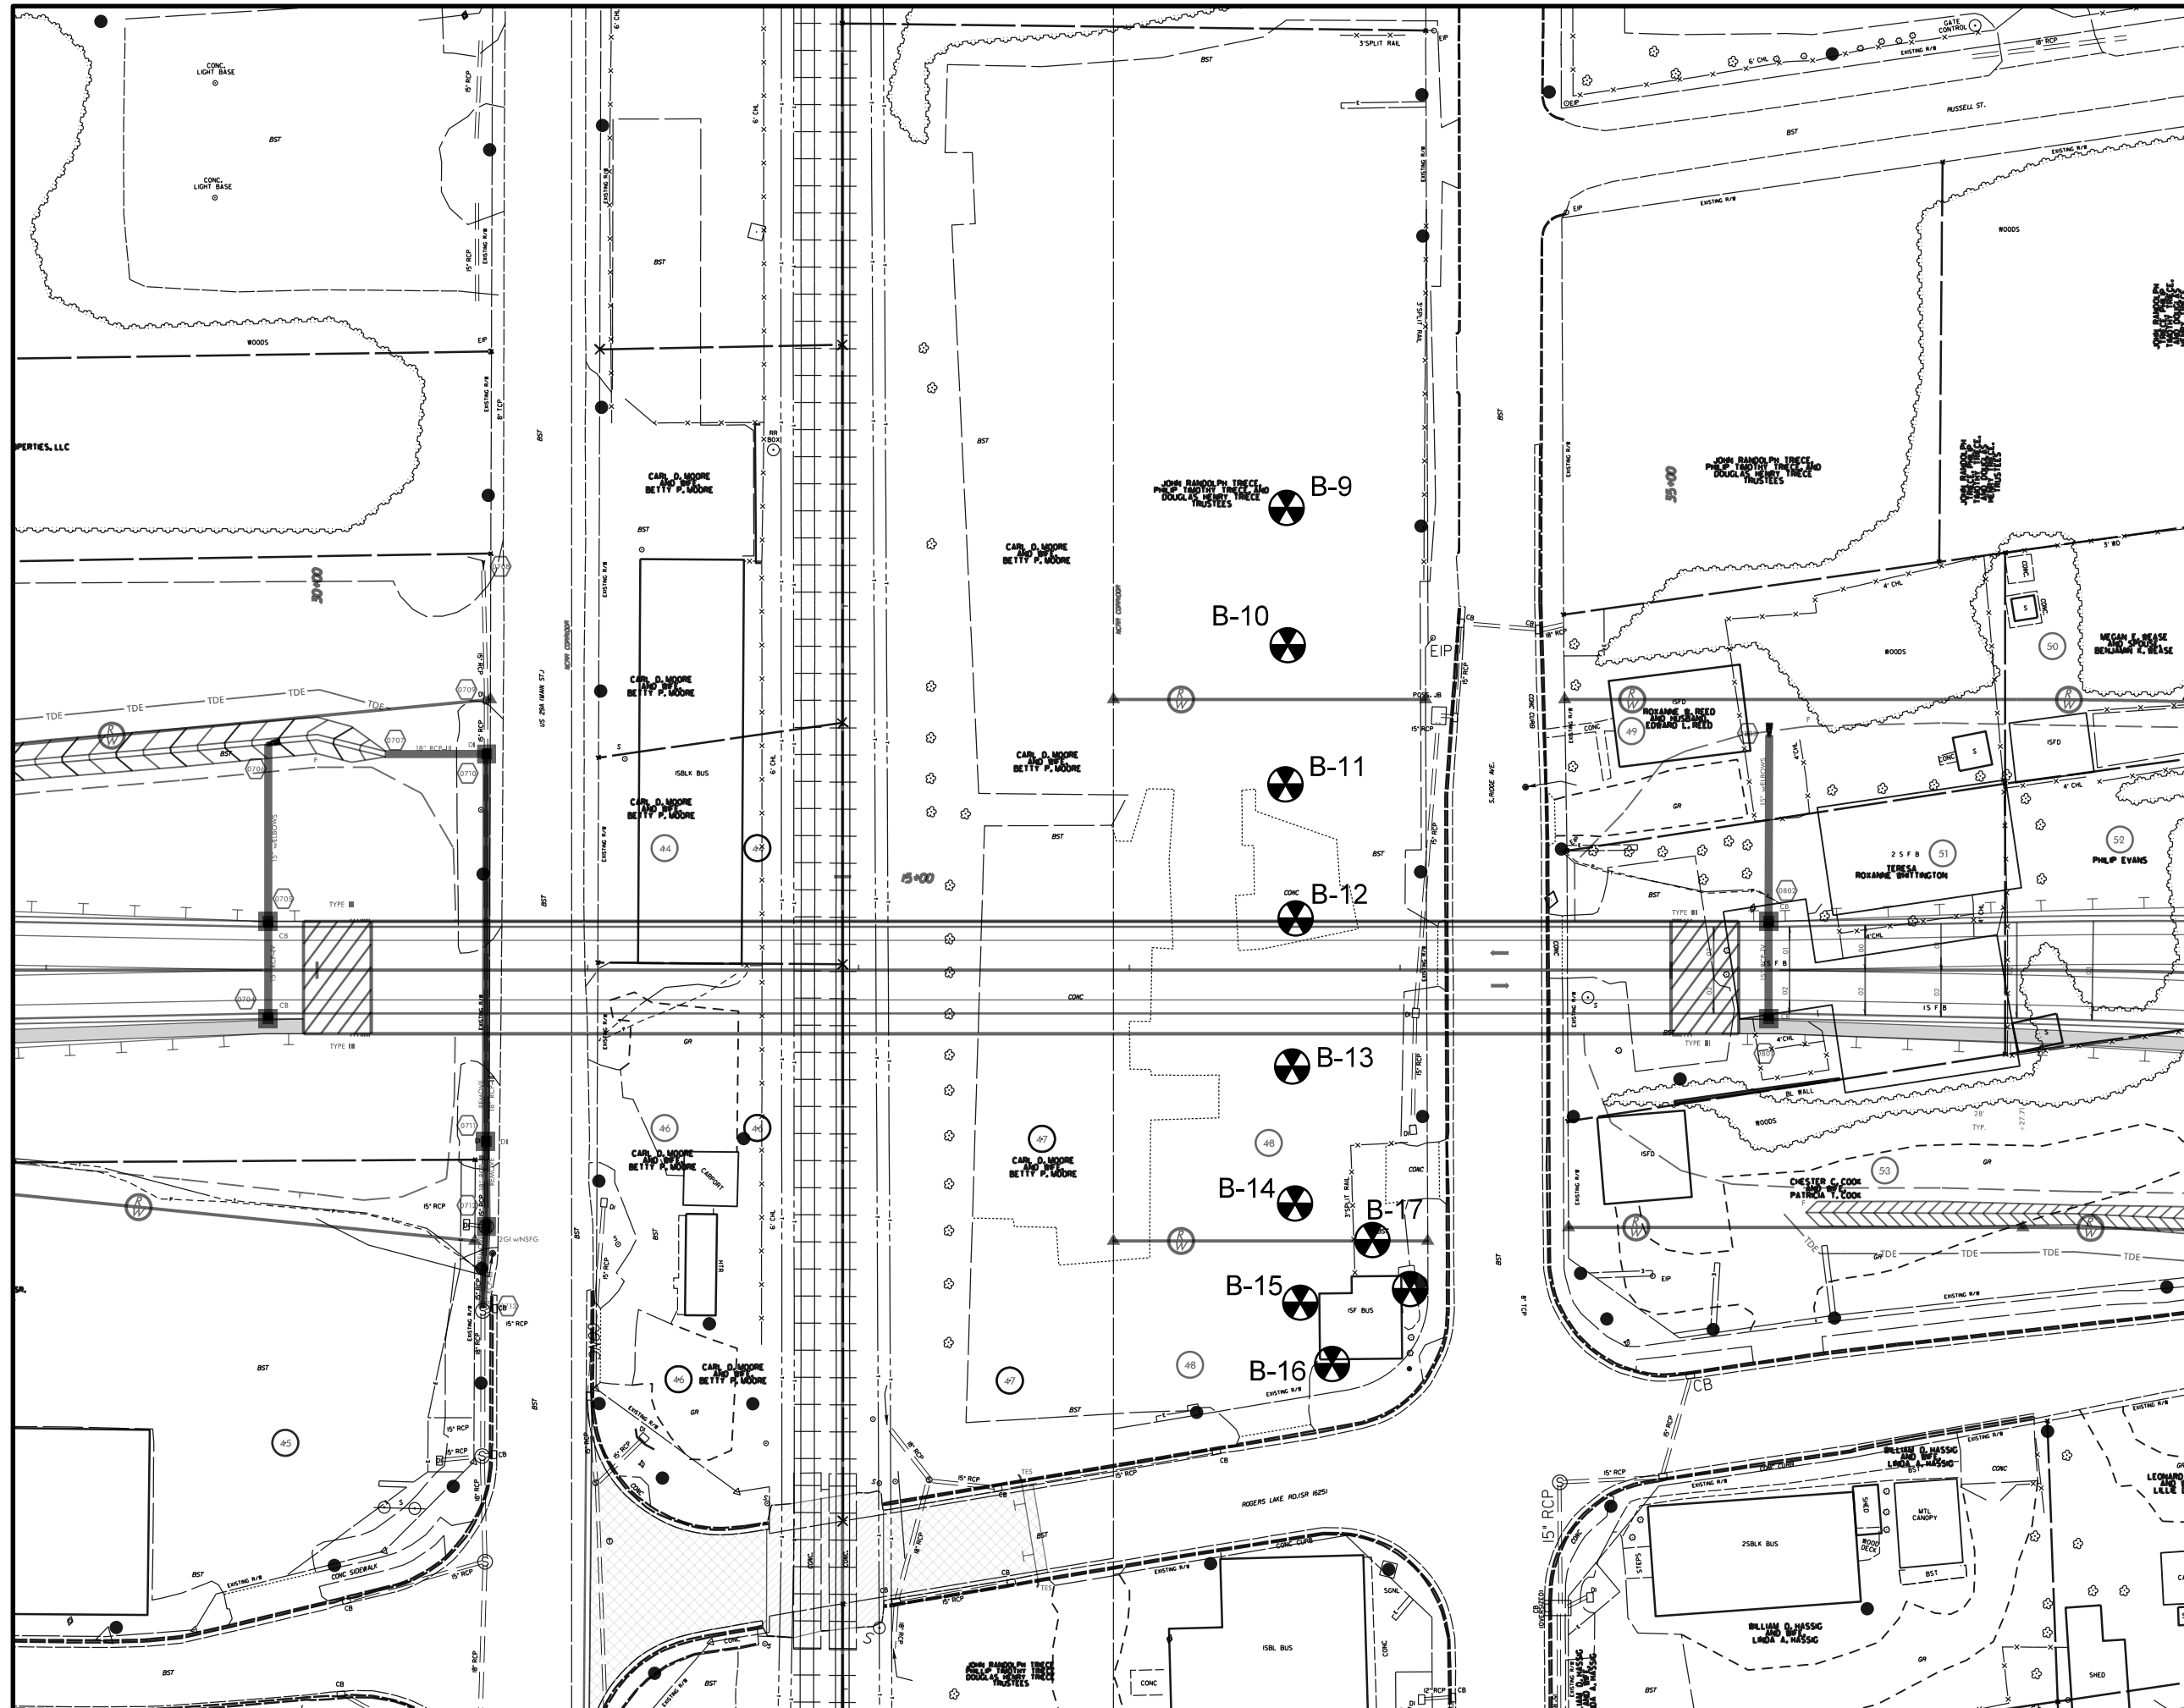
SITE DIAGRAM WITH BORING LOCATIONS

PARCEL 48
TRICEE TRUSTEE PROPERTY
1306-1310 SOUTH RIDGE AVENUE
KANNAPOLIS, CABARRUS COUNTY,
NORTH CAROLINA

Exhibit 1 presents the topography of the site on a portion of the USGS topographic quadrangle map of Concord, NC (1987). **Exhibits 2A and 2B** depict a site layout plan that includes the approximate locations of the site features, soil boring locations, and analytical results.

Soil generally consisted of silty clay to depths of approximately 4 to 6 feet bls underlain by silty sand. Fill (sand) was also observed in some of the borings B-12, B-13, and B-14 within the first four feet. Groundwater was not encountered in these borings. The soil boring logs are included in **Appendix B**. Sample locations were measured using a Trimble Geo7x GPS and are depicted on **Exhibits 2A and 2B**.

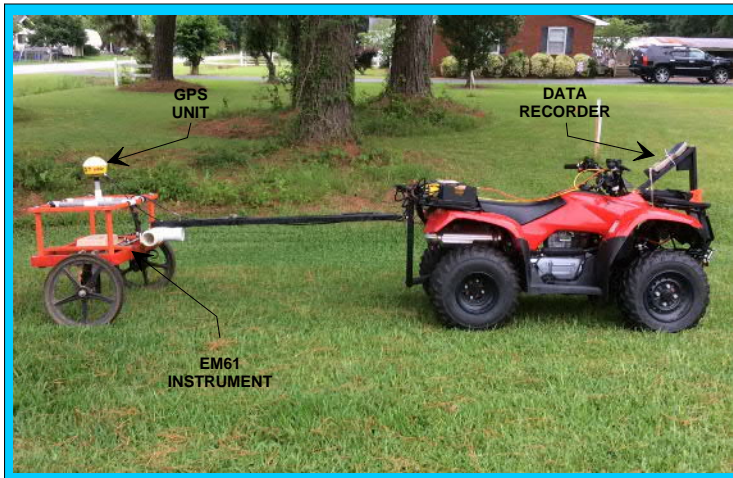
EM61 METAL DETECTOR

The photograph shows the Geonics EM61-MK2A metal detector, a Hemisphere A101 GPS unit, a Juniper data recorder, and a Honda Recon ATV which were used to conduct the metal detection survey across the proposed ROW & easement areas of Parcel 48.

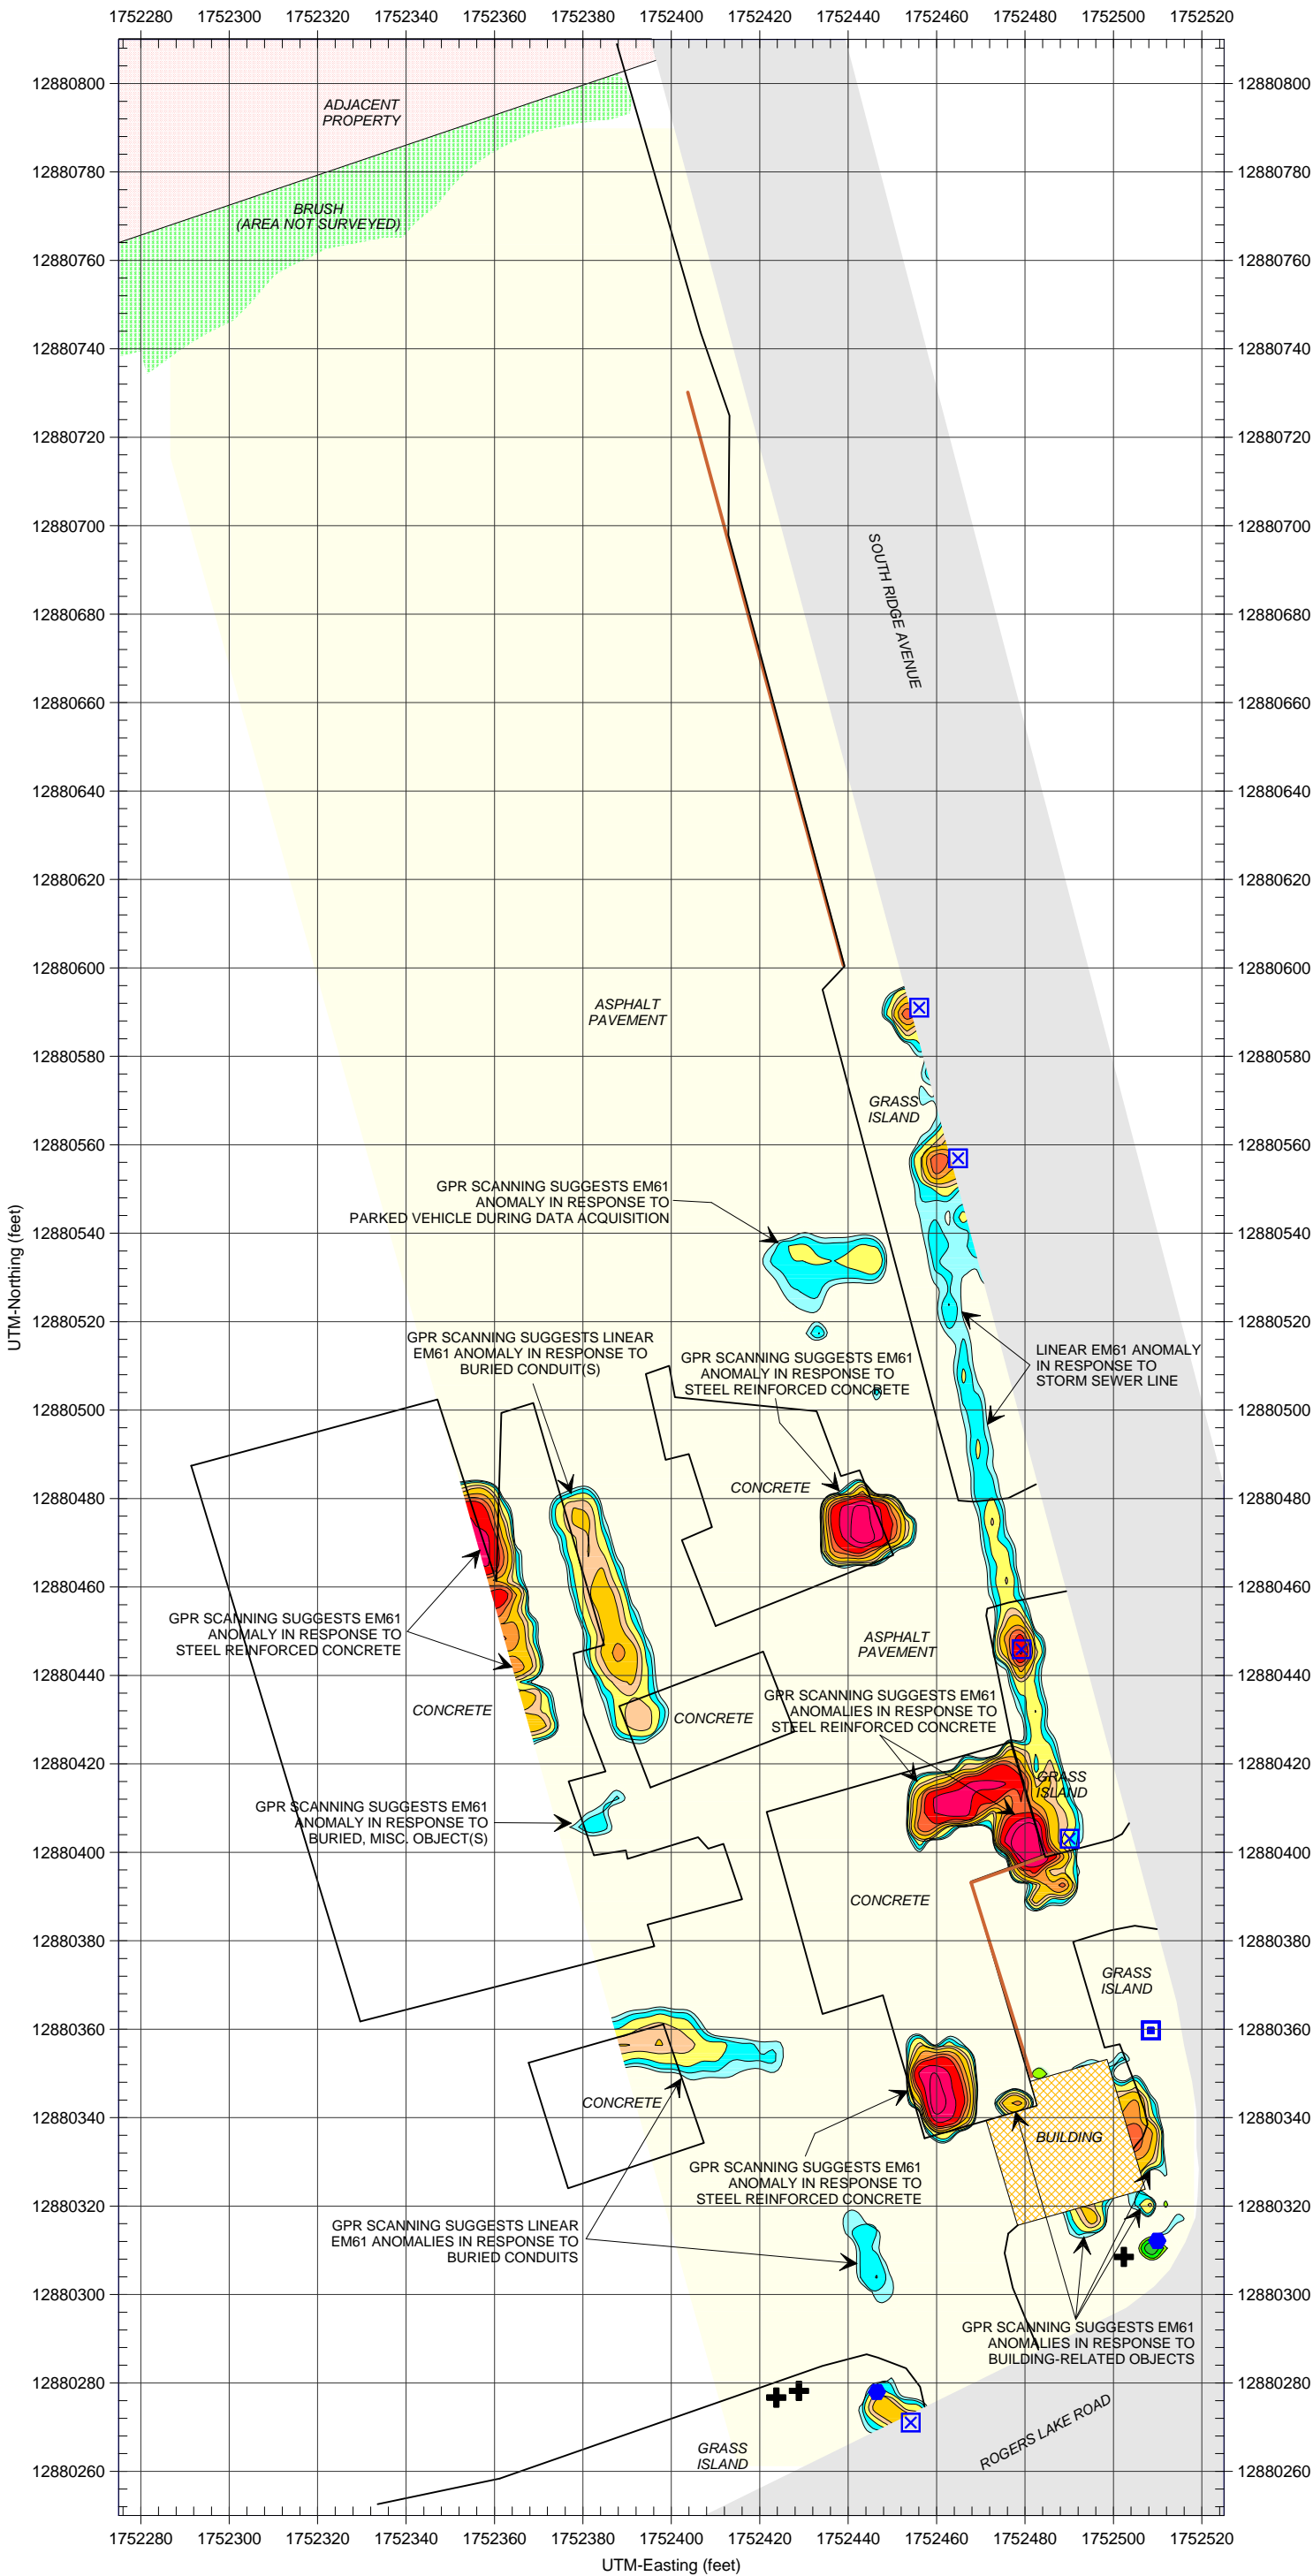
Note: The contour plot shows the differential response between the early time gate and the late time gate channels of the Geonics EM61-MK2A metal detection instrument in millivolts (mV). The differential response focuses on larger, buried, metallic objects such as drums and USTs and ignores smaller miscellaneous, metal debris. Ground penetrating radar (GPR) scans were conducted across selected EM61 anomalies and areas containing reinforced concrete using a Geophysical Survey Systems SIR 3000 unit with a 400 MHz antenna. The geophysical investigation was conducted on June 19-21, 2018.
