Preliminary Site Assessment

Norfolk Southern Mainline Grade Crossing Separation at Rogers
Road in Kannapolis

Parcel 51 – Teresa Whittington Property

TIP No. Y-4810K

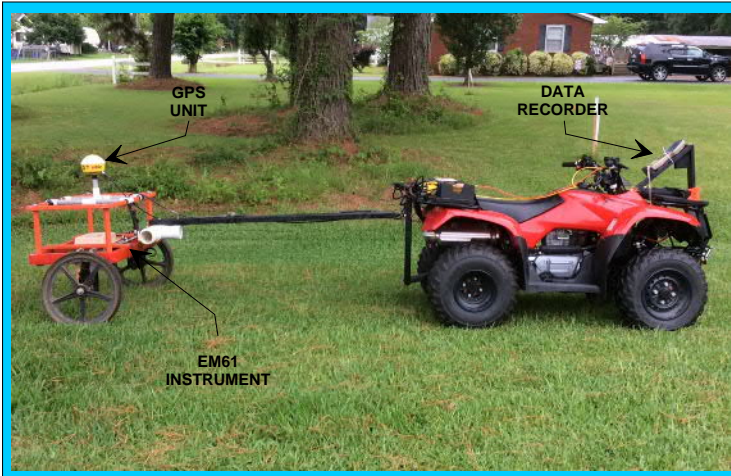
EM61 METAL DETECTOR

The photograph shows the Geonics EM61-MK2A metal detector, a Hemisphere A101 GPS unit, a Juniper data recorder, and a Honda Recon ATV which were used to conduct the metal detection survey across the proposed ROW & easement areas of Parcel 51.

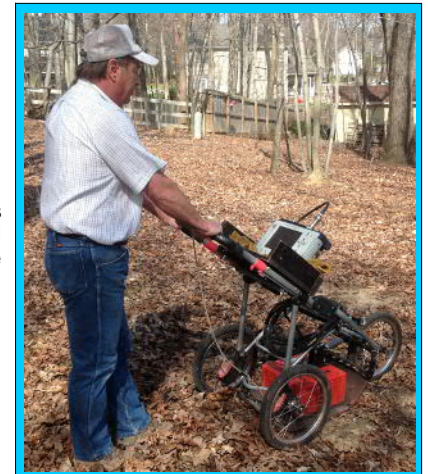
GROUND PENETRATING RADAR UNIT

The photograph shows the Geophysical Survey Systems SIR-3000 ground penetrating radar (GPR) unit equipped with a 400 MHz antenna that were used to conduct the GPR scanning across selected areas.

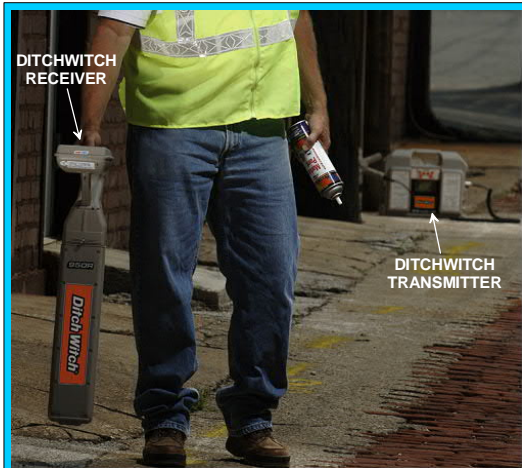
DITCHWITCH UTILITY LOCATOR

The photograph shows the DitchWitch 910 utility locator which was used to detect buried lines across the proposed boring locations.

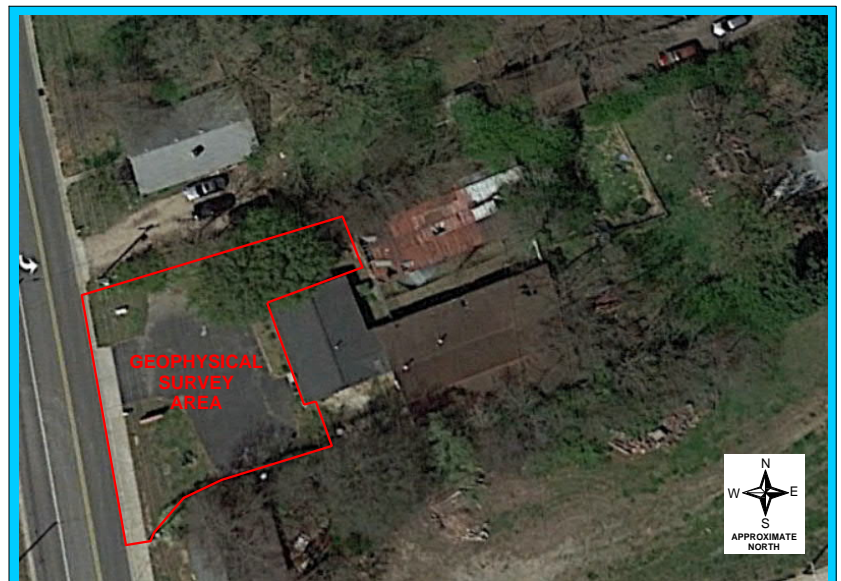
GEOPHYSICAL SURVEY AREA

The red polygon in the aerial photograph represents the approximate perimeter of the geophysical survey area at Parcel 51. The geophysical investigation was conducted on June 19-21, 2018.

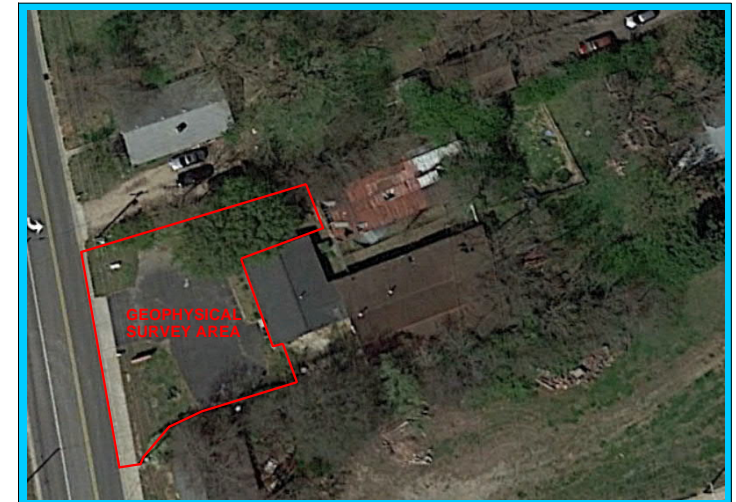
The red polygon in the aerial photograph represents the approximate perimeter of the geophysical survey area at Parcel 51.

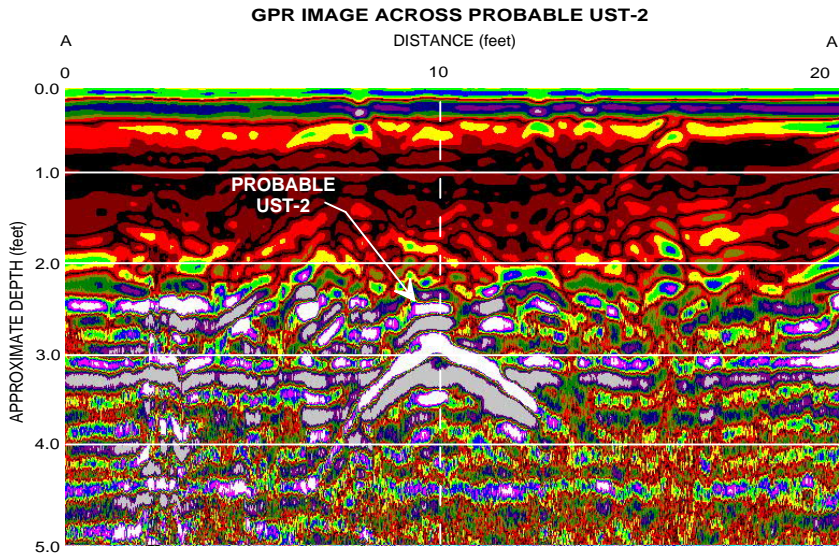
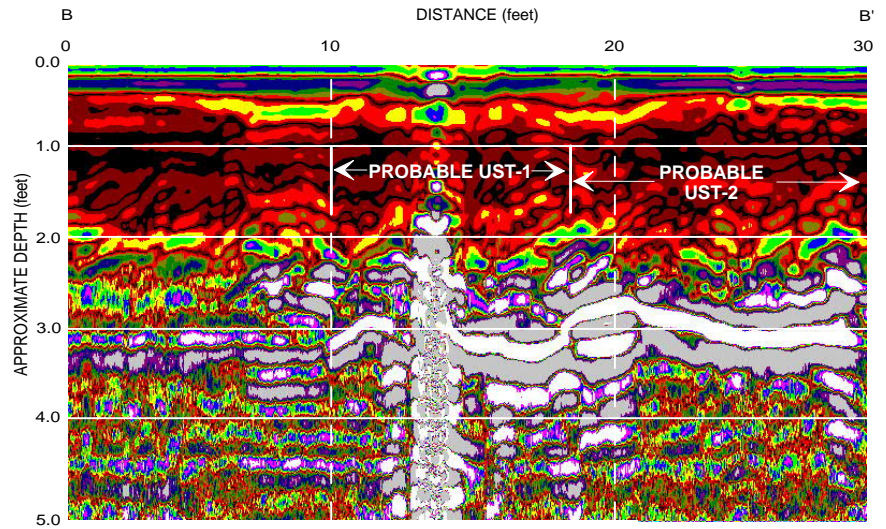
GPR IMAGE ACROSS PROBABLE USTS

GPR scanning across the EM61 differential anomalies centered near UTM coordinates 1752546-E 12880450-N and 1752549-E, 12880444-N yielded high amplitude, hyperbolic reflections in GPR images AA' and BB'. The GPR anomalies are probably in response to metallic UST-1 and UST-2 buried approximately 3.0 and 2.8 feet below present grade, respectively.

The purple lines labeled AA' and BB' in the photograph shown below represent the approximate locations of the two GPR images.

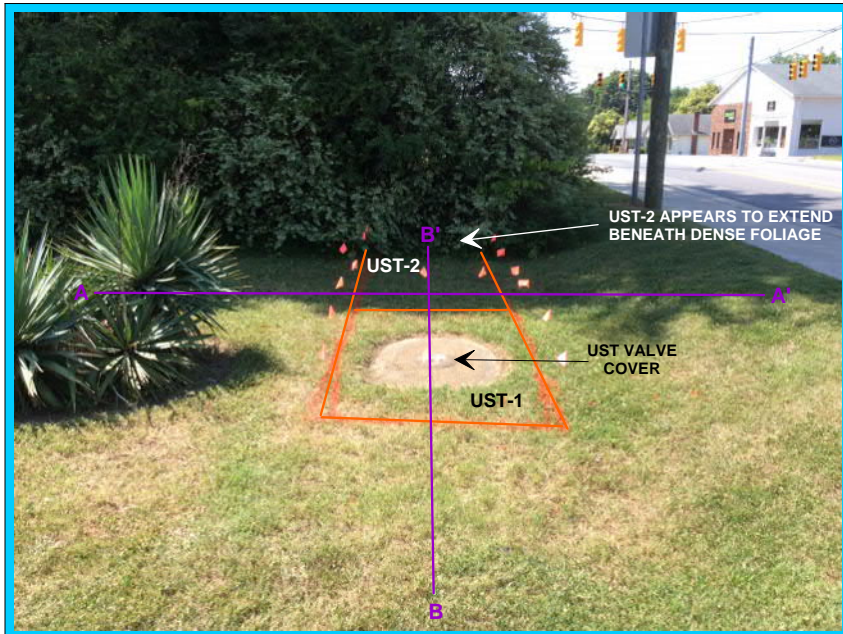
The orange rectangles in the photograph represent the approximate foot prints of two probable USTs that were detected by the geophysical investigation. Based on the GPR data, UST-1 is approximately 7.5 feet long, 5.0 feet wide and buried 3.0 feet below present grade. UST-2 is more than 12.0 feet long, 5.0 feet wide and 2.8 feet deep.

The solid purple lines labeled AA' and BB' in the photograph represent the approximate locations of GPR images AA' and BB' shown above. The photograph is viewed in a southerly direction.
