TIP NO: Y-4810K
WBS: 40325
COUNTY: Cabarrus
DIVISION: 10
DESCRIPTION: Proposed Grade Separation crossing on Universal Street/Rogers Lake Road in Kannapolis.

SUBJECT: **GeoEnvironmental Report for Planning**

Hazardous Materials Report

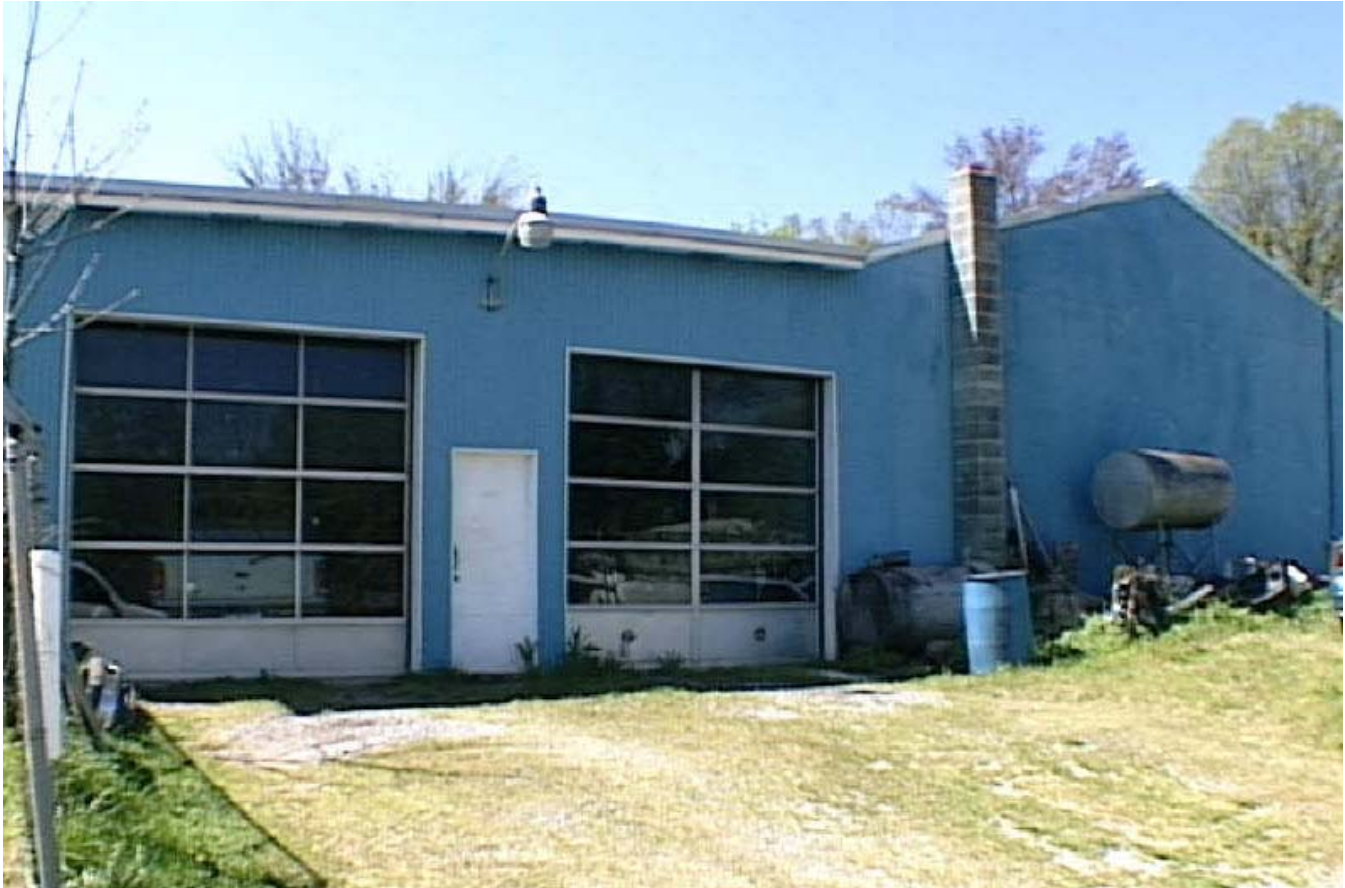
1)	Property Name Morgan's Garage 1300 Todd Avenue Kannapolis, NC 28081 Facility ID #: N/A Incident #: N/A	Property Owner: Tommy Wayne Weatherford Daniel Ray Rosenbalm 5308 Randolph Road Kannapolis, NC 28081 UST Owner: N/A	Alternative # 1
----	--	--	------------------------

This facility operates as an auto repair shop. It is located on the west side of Todd Avenue approximately 125 feet south of Rogers Lake Road. This facility sits behind the residents at 405 Rogers Lake Road. This facility does not appear on the UST Section Registry. There is no evidence of any UST system and there are no ground water incident's associated with this facility. **This site is anticipated to present low geoenvironmental impacts to the project.**

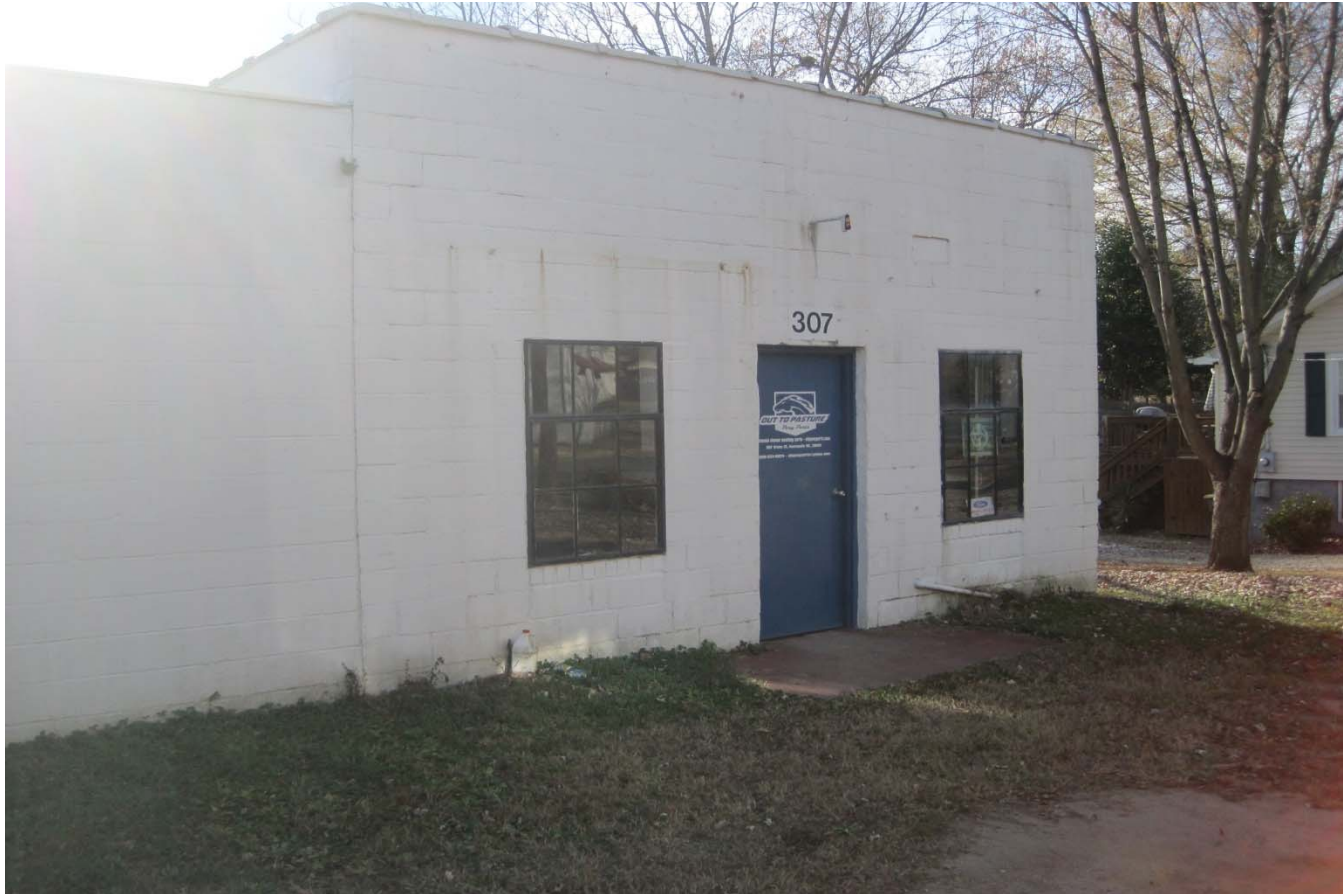
2)	Property Name Out to Pasture 307 Triage Street Kannapolis, NC 28081	Property Owner: Paul M. Poteat 1450 N. Main Street China Grove, NC 28023	Alternative # 1
	Facility ID #: N/A	UST Owner: N/A	
	Incident #: N/A

This facility appears to be an out of business used auto part store/repair shop. It is the former location of Kannapolis Engine Service. It is located in the southwest quadrant of Triage Street and Sexton Street. The age and design of the building suggest it may have operated as a service station at one time. The facility does not appear on the UST Section Registry. There is no evidence of any UST system and there are no ground water incident's associated with this facility. **This site is anticipated to present low geoenvironmental impacts to the project.**

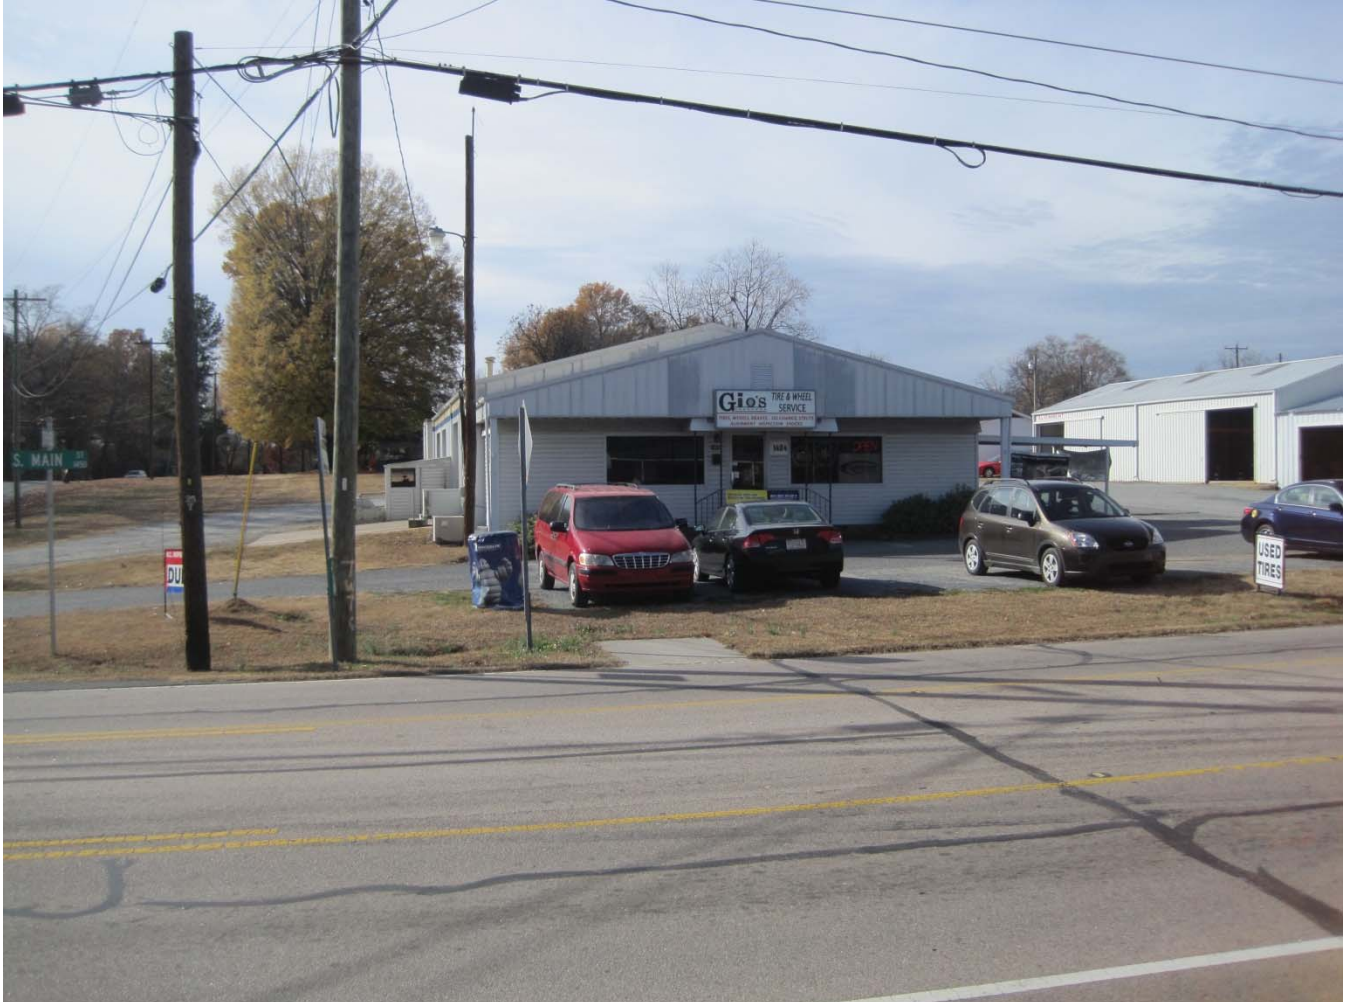
This facility currently operates as auto tire and repair shop. It is the former location of Red's Oil Company. It is located in the northwest quadrant of S. Main Street and Tiece Street. There is one AST located on the south side of the building. According to the UST Section Registry two tanks were removed in 1993. This facility does appear in the ground water incident database by the UST # but there is no ground water incident # associated with this facility. No monitoring wells were noted on site. The ASTs for the former Oil Company were located in the northwestern corner of the property. **This site is anticipated to present low geoenvironmental impacts to the project.**

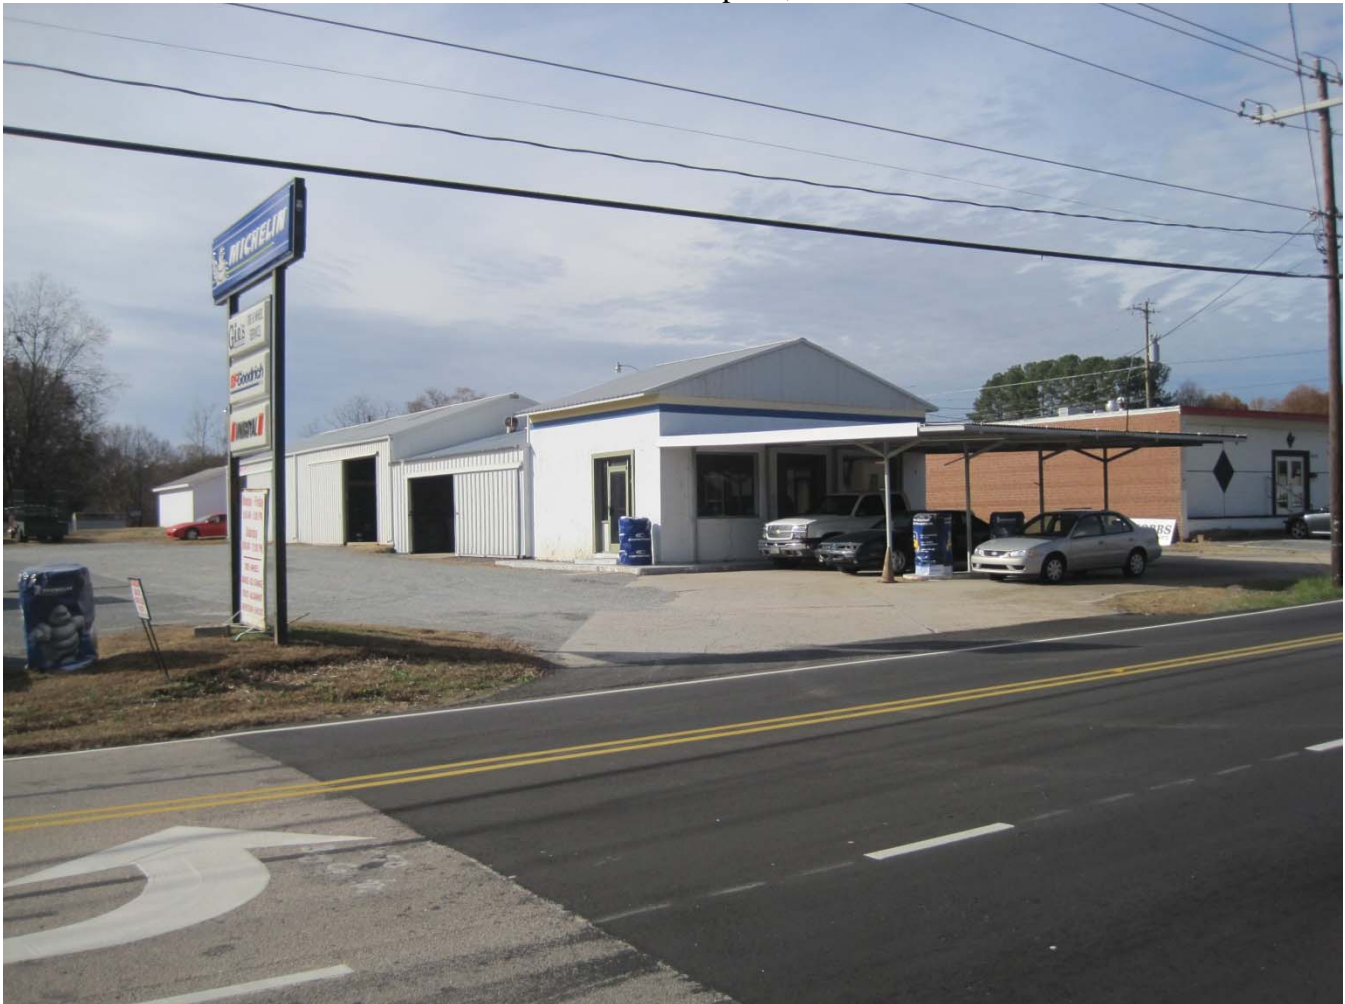
This facility currently operates as the warehouse for Gio's Tire & Wheel Service. It is the former location of Reds Service Station. It is located on the west side of S. Main Street approximately 170 feet north of Triece Street. The pump island is located approximately 20 feet from the edge of pavement on S. Main St. Two ASTs are located in the northwestern corner of the building. According to the UST Section Registry three tanks were removed in 1989. There is no ground water incident associated with this facility and no monitoring wells were noted on site. **This site is anticipated to present low geoenvironmental impacts to the project**

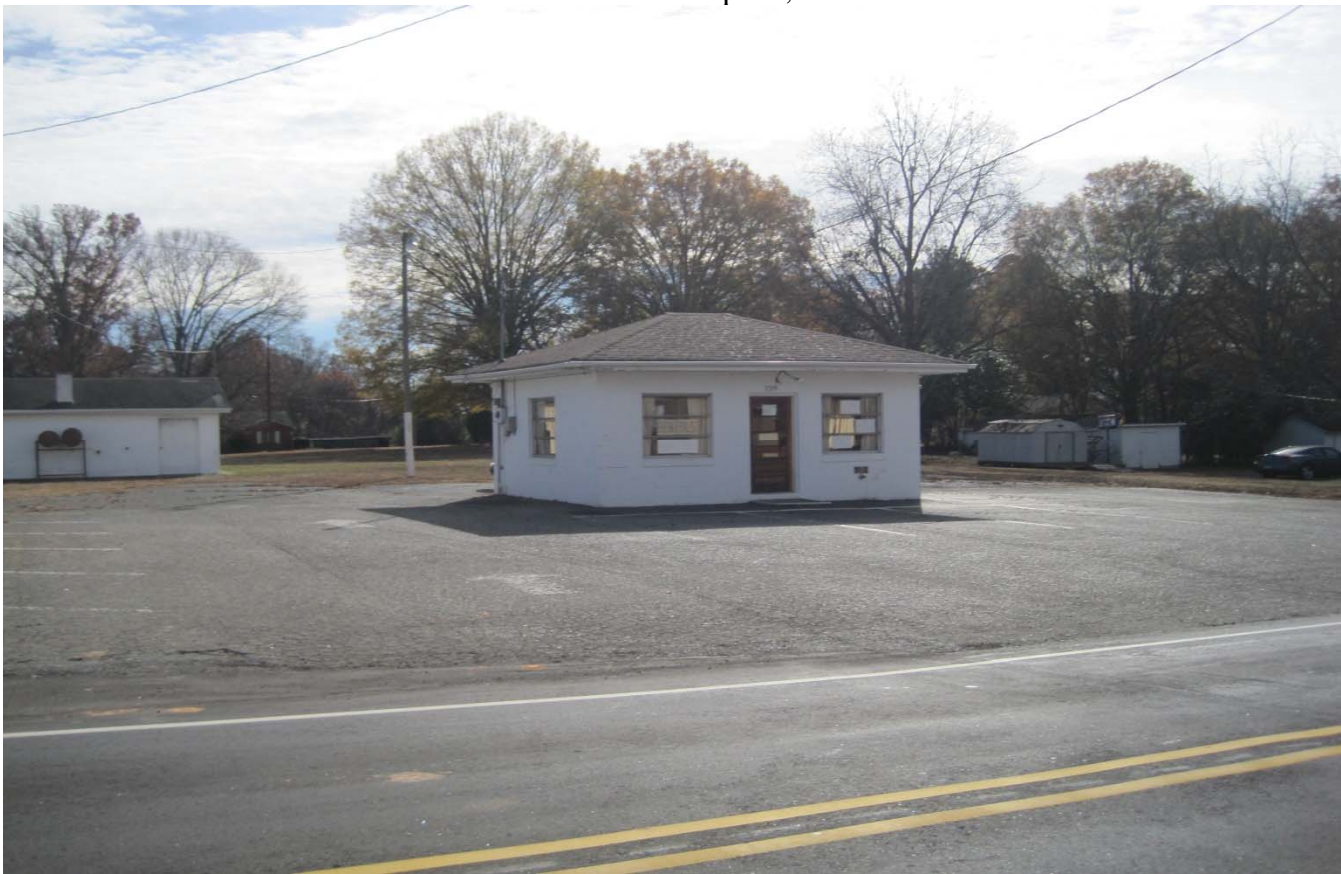
The building on this property is currently used as a sales office. The type of business is unknown. It is the former location of Atomic Oil Company. It is located on the south side of Rogers Lake Road approximately 260 feet west of S. Main Street. According to the UST Section Registry two tanks were removed in 1989. The facility does appear in the ground water incident database by the UST # but there is no ground water incident # associated with this facility. No monitoring wells were noted on site. The ASTs for the former Oil Company were located on the southern portion of the property. **This site is anticipated to present low geoenvironmental impacts to the project**

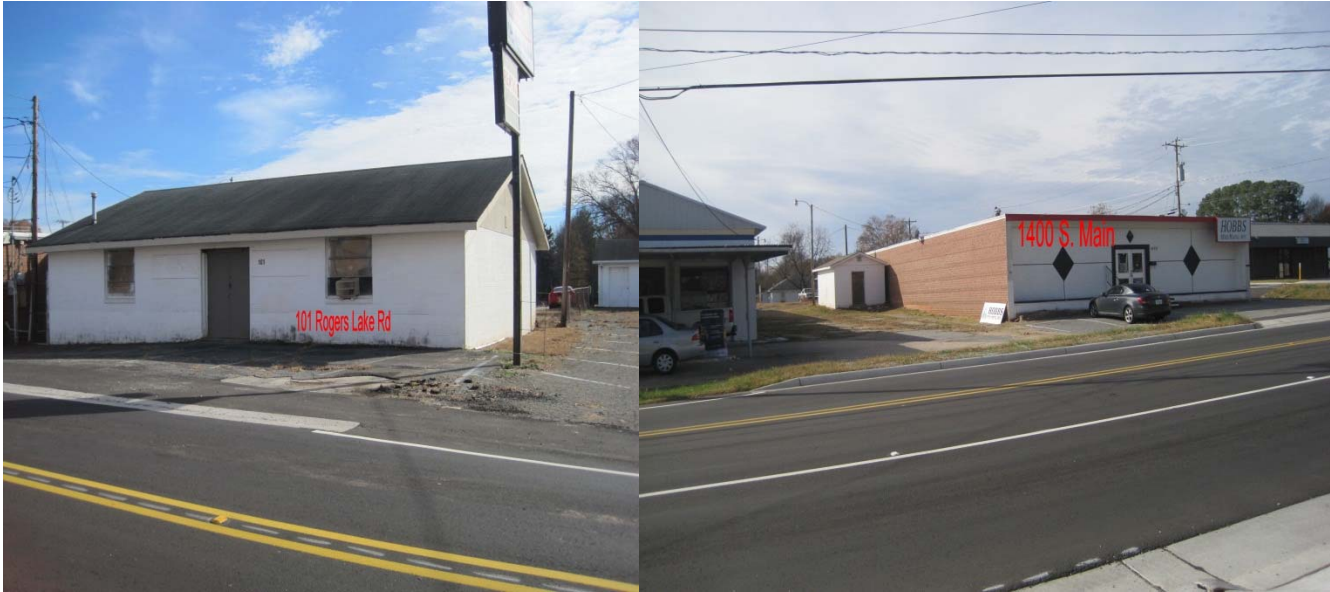
6)	Property Name Hobbs Mixed Martial Arts 1400 S. Main Street. 101 Rogers Lake Rd Kannapolis, NC 28081 Facility ID #: N/A Incident #: N/A	Property Owner: Adam Cantero Juan Preciada 6506 S. Kimball Street Hodgkins, IL, 60525 UST Owner: N/A	Alternative # 1
----	---	---	------------------------

There are two address associated with this parcel. The parcel is located in the south west quadrant of S. Main Street and Rogers Lake Road. The main building operates as Hobbs Martial Arts, the second building appears to be a vacant shop/garage. Neither facility appears on the UST Section Registry. There is no evidence of any UST system and there is no ground water incident associated with this facility. No Monitoring wells were noted on site. **This site is anticipated to present low geoenvironmental impacts to the project**

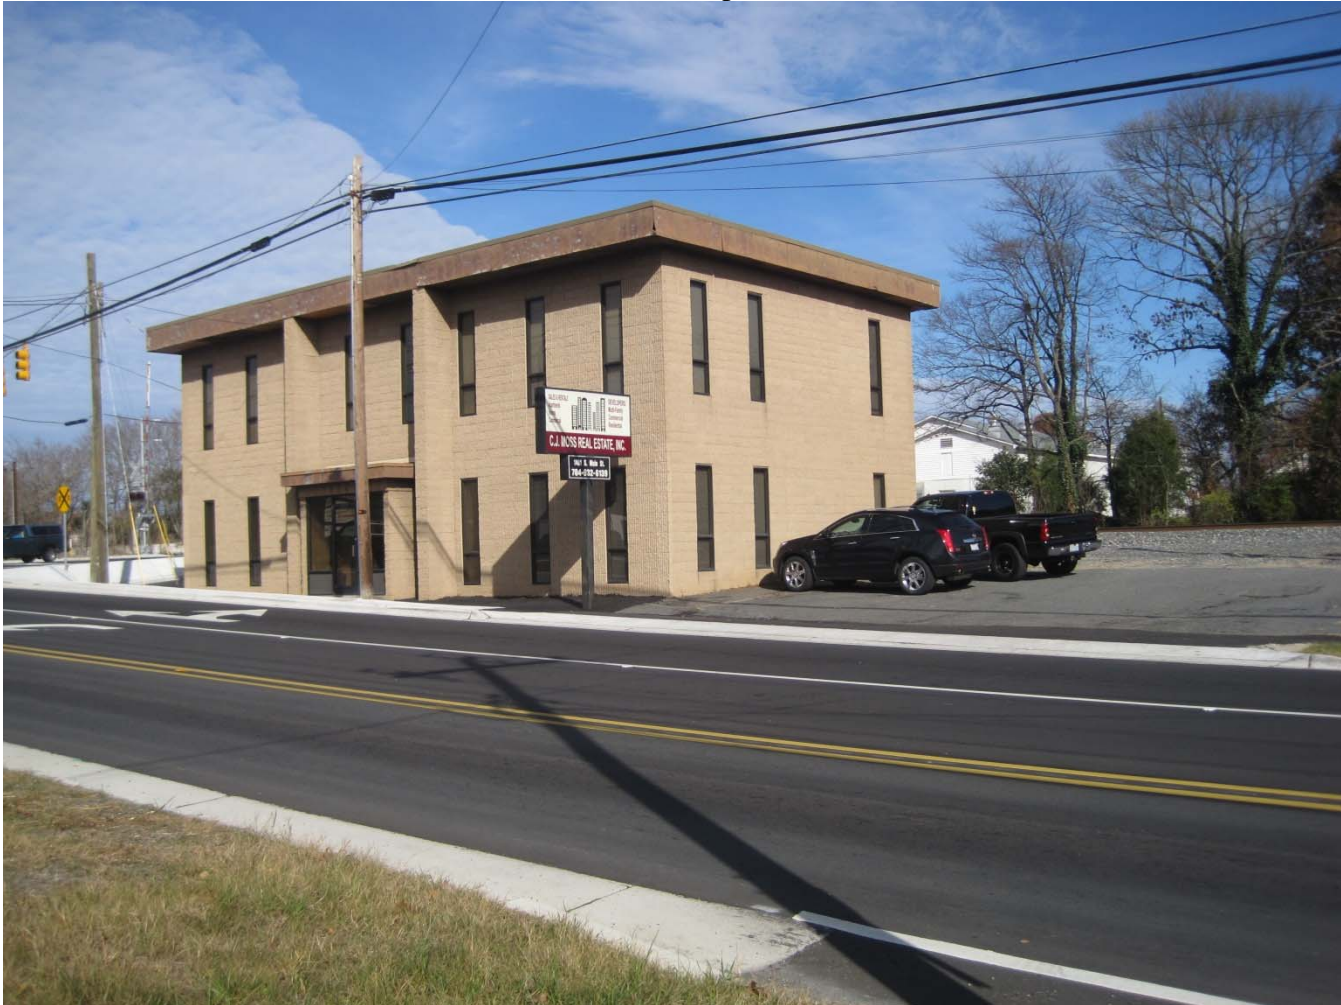
This facility currently operates as a Real Estate office. It is located in the south east quadrant of S. Main Street and Rogers Lake Road. According to the UST Section Registry one tank was removed in 1991. There appears to be a UST located near the south east corner of the building. No monitoring wells were noted on site and there is no ground water incident associated with this facility. **This site is anticipated to present low geoenvironmental impacts to the project**

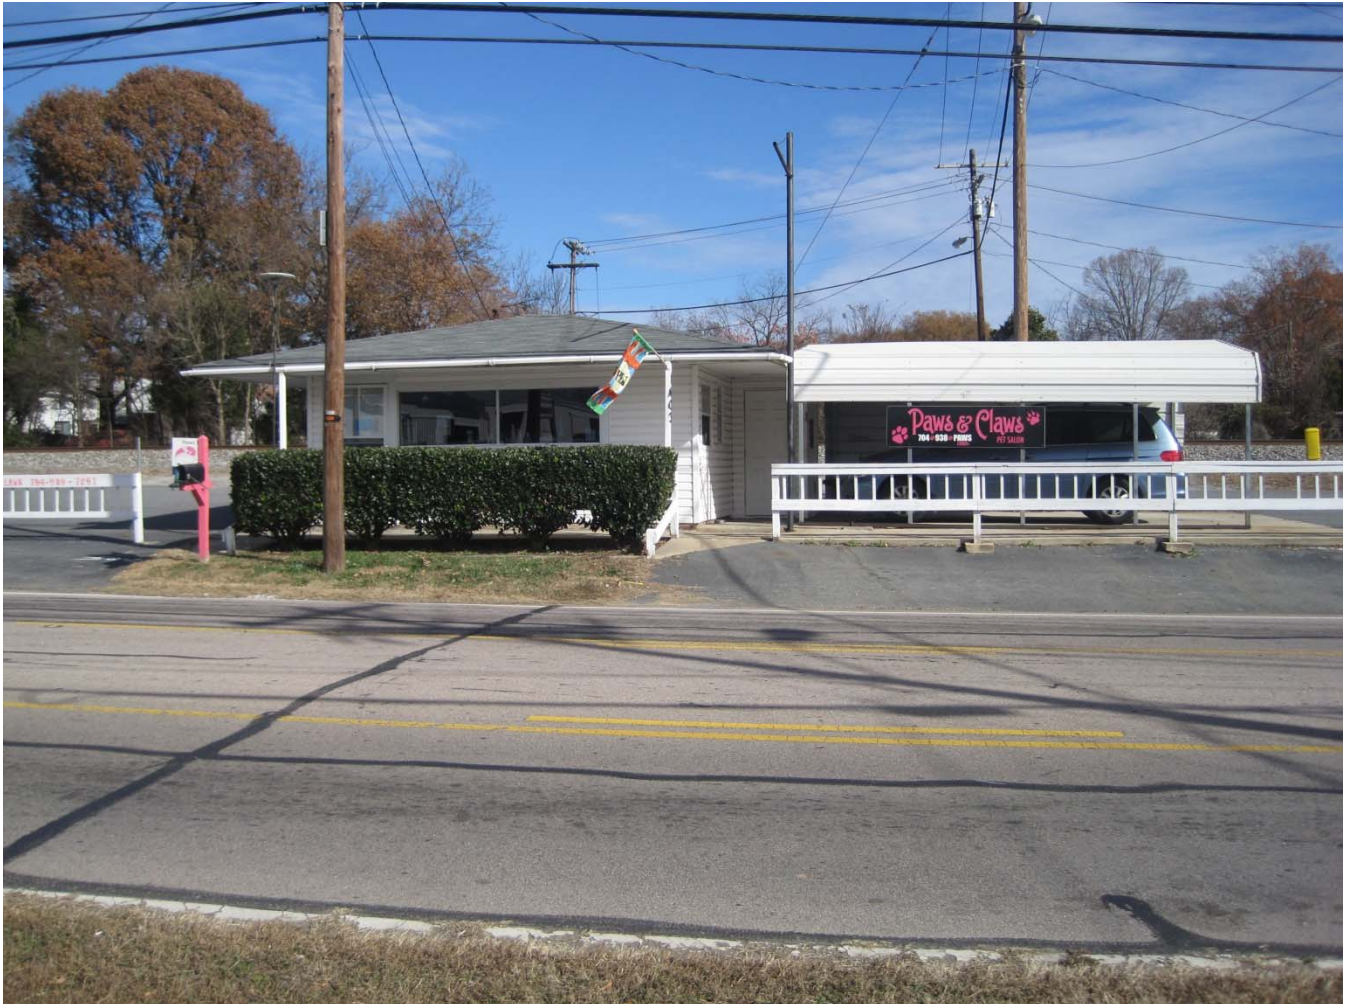
8)	Property Name Paws & Claws 1403 S. Main Street Kannapolis, NC 28081	Property Owner: Joe & Ava Plott 32052 Rowland Road Albemarle, NC 28001	Alternative # 1
	Facility ID #: N/A	UST Owner: N/A	
	Incident #: N/A

This facility currently operates as pet grooming salon. It once operated as Childress Used Car .It is located on the east side of S. Main Street approximately 250 feet south of Rogers Lake Road. The facility does not appear on the UST Section Registry. There is no evidence of any UST system and there is no ground water incident associated with this facility. No monitoring wells were noted on site. **This site is anticipated to present low geoenvironmental impacts to the project**

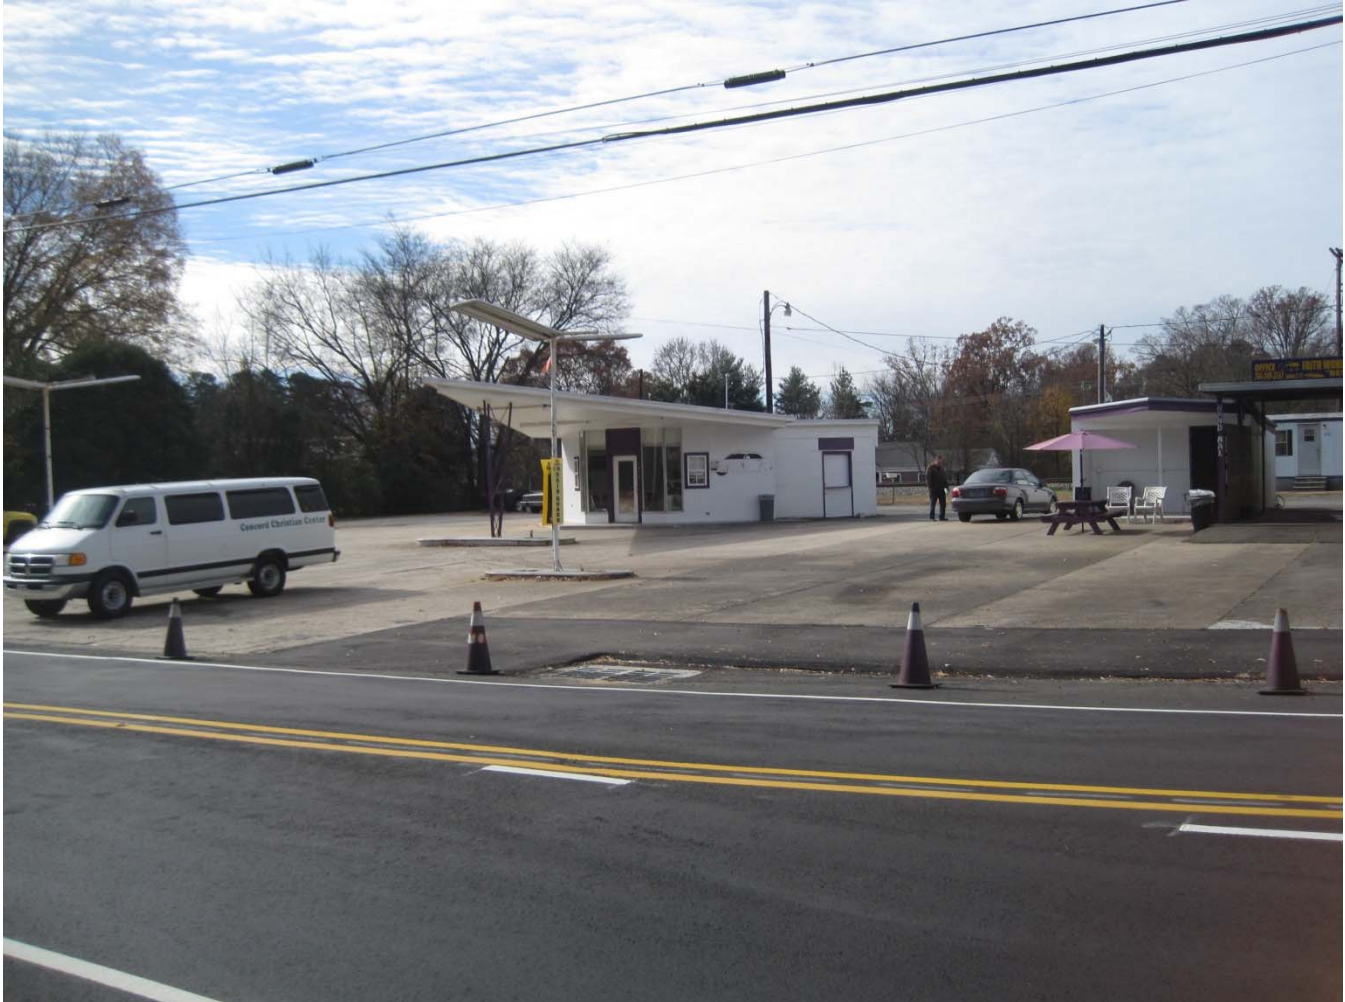
This facility currently operates as a full service car wash. It previously operated as a service station and an automatic coin operated car wash. It is located on the west side of S. Ridge Avenue approximately 480 feet south of Rogers Lake Road. There are three pump islands located in front of the former service station and one in ground hydraulic car lift located on the south side of the former service station. According to the UST Section Registry three tanks were closed in 1983, one in 1984 and four in 1989. The facility does appear in the ground water incident database by the UST # but there is no ground water incident # associated with this facility. No Monitoring wells were noted on site. **This site is anticipated to present low geoenvironmental impacts to the project**

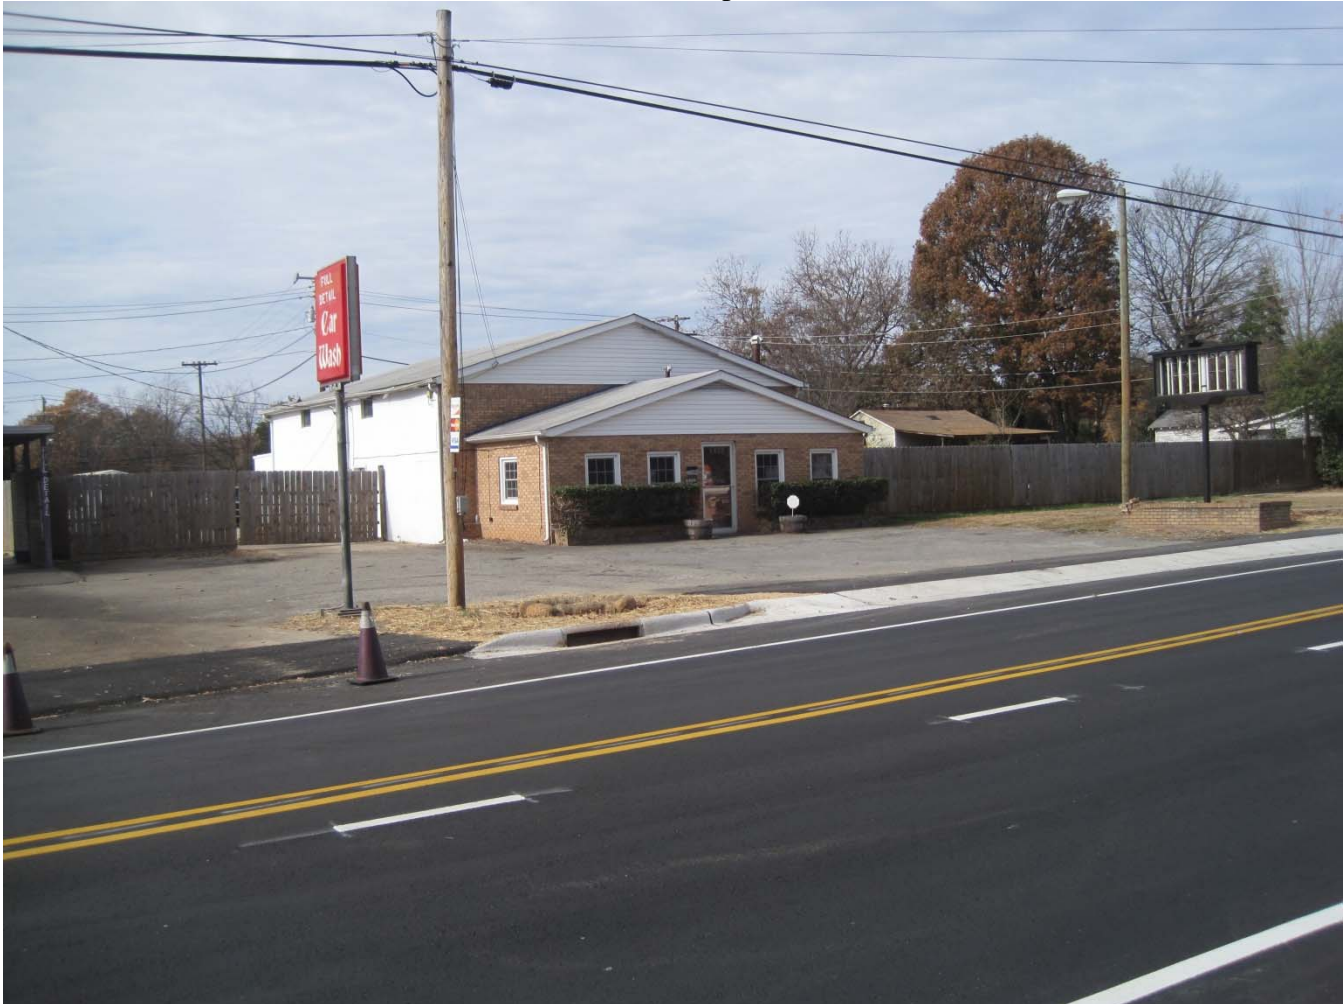
This facility currently operates as a storage lot for Le Bleu's Towing. The facility previously operated as Patriot Auto Service and as European Import Classics. It is located on the west side of S. Ridge Avenue approximately 200 feet south of Rogers Lake Road. According to the UST Section Registry three tanks were registered to European Import Classics and were closed in 1991. Ground water incident # 20355 is assigned to this facility. No monitoring wells were noted on site. **This site is anticipated to present low geoenvironmental impacts to the project**

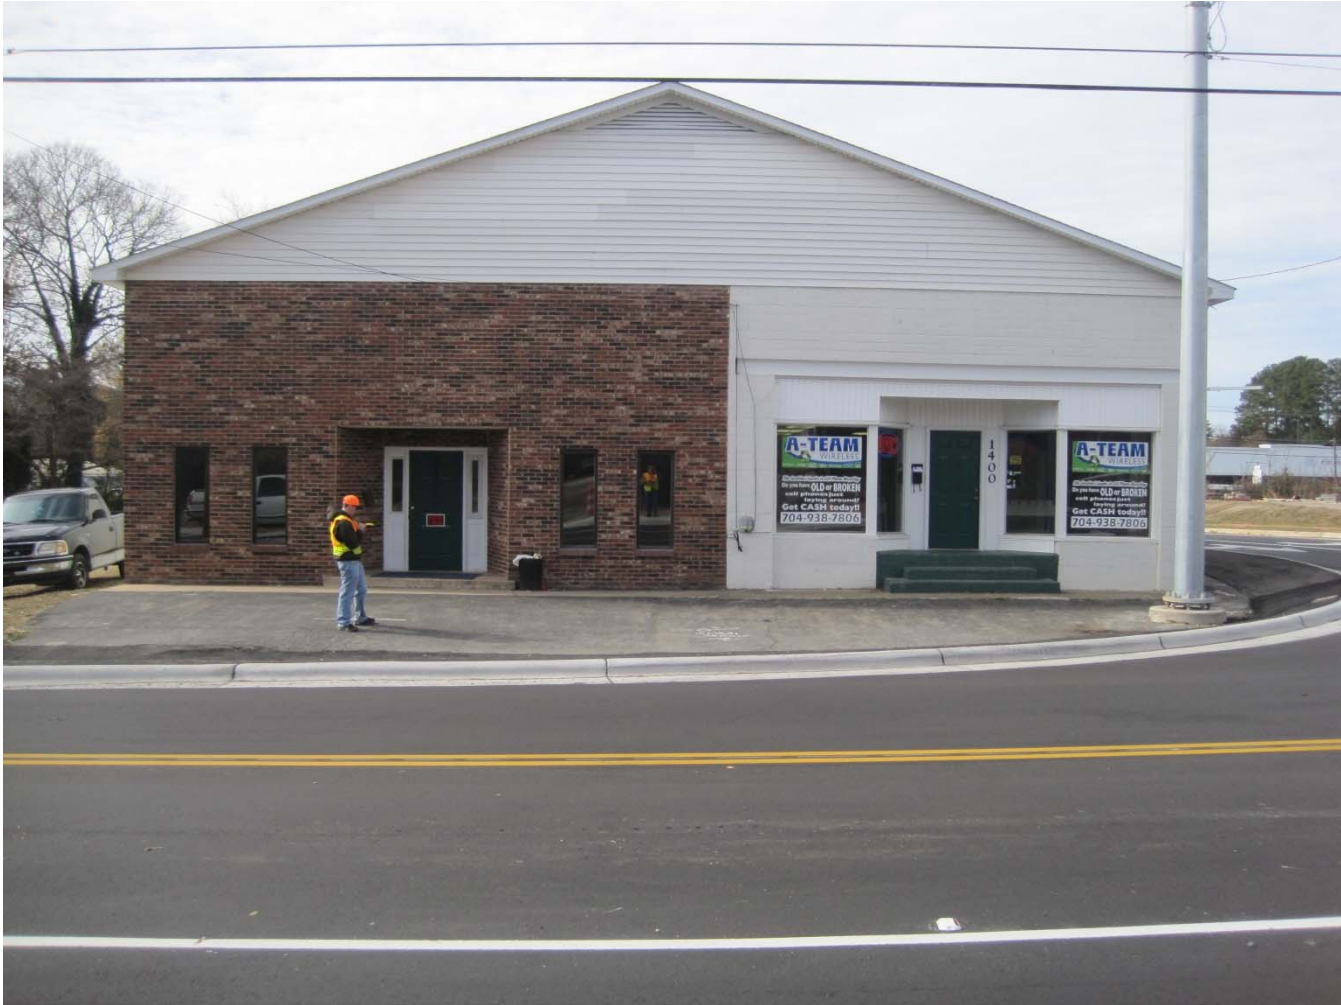
11)	Property Name A-Team Wireless 1400 S. Ridge Avenue Kannapolis, NC 28083	Property Owner: John R. Tricee Trustee Phillip T. Tricee Trustee 827 Evergreen Avenue Kannapolis, NC 28081	Alternative # 1
	Facility ID #: N/A Incident #: N/A	UST Owner: N/A

This facility currently operates as cell phone retail store. It is the former location of Plain or Fancy Catering. It is located in the south west quadrant of S. Ridge Ave. and Rogers Lake Rd. There is no evidence of any UST system but the age and the design of portion of the building that has not been remodeled suggest it could have operated as an old service station. The facility does not appear on the UST Section Registry. There is no ground water incident associated with this facility. No Monitoring wells were noted on site. **This site is anticipated to present low geoenvironmental impacts to the project**

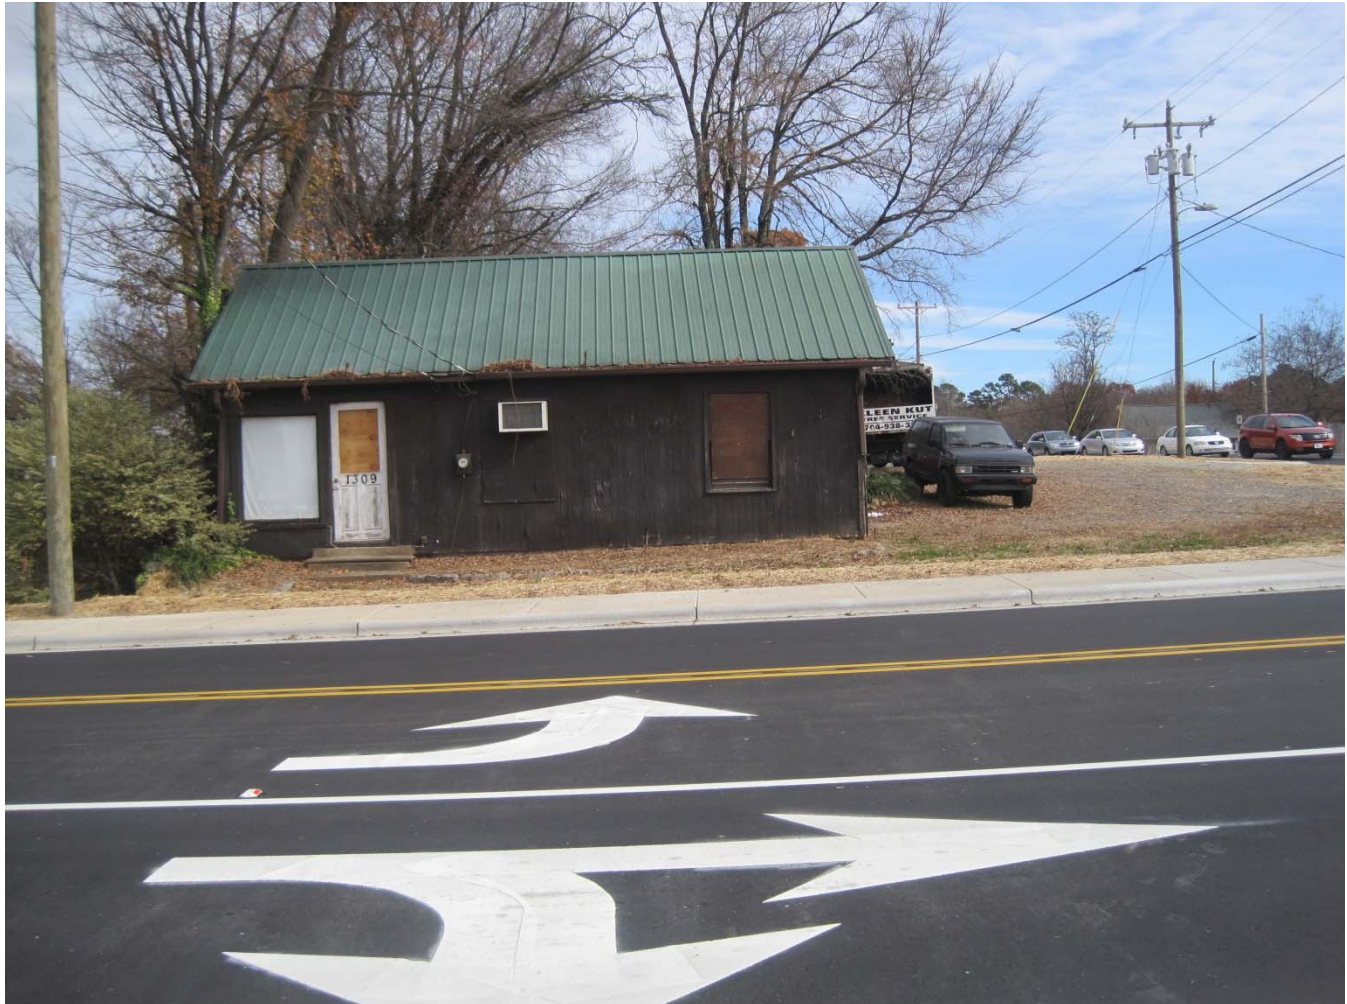
12)	Property Name Kleen Cut Tree Service 1309 S. Ridge Ave. Kannapolis, NC 28083	Property Owner: Patricia Cook 1069 Canoby Ct Woodleaf, NC 27054	Alternative # 2
	Facility ID #: N/A	UST Owner: N/A	
	Incident #: N/A

This facility is used by Kleen Cut tree service for equipment storage. It is located in the north east quadrant of S. Ridge Avenue and Rogers Lake Road. The facility does not appear on the UST Section Registry. There is no ground water incident associated with this facility. No Monitoring wells were noted on site. **This site is anticipated to present low geoenvironmental impacts to the project**

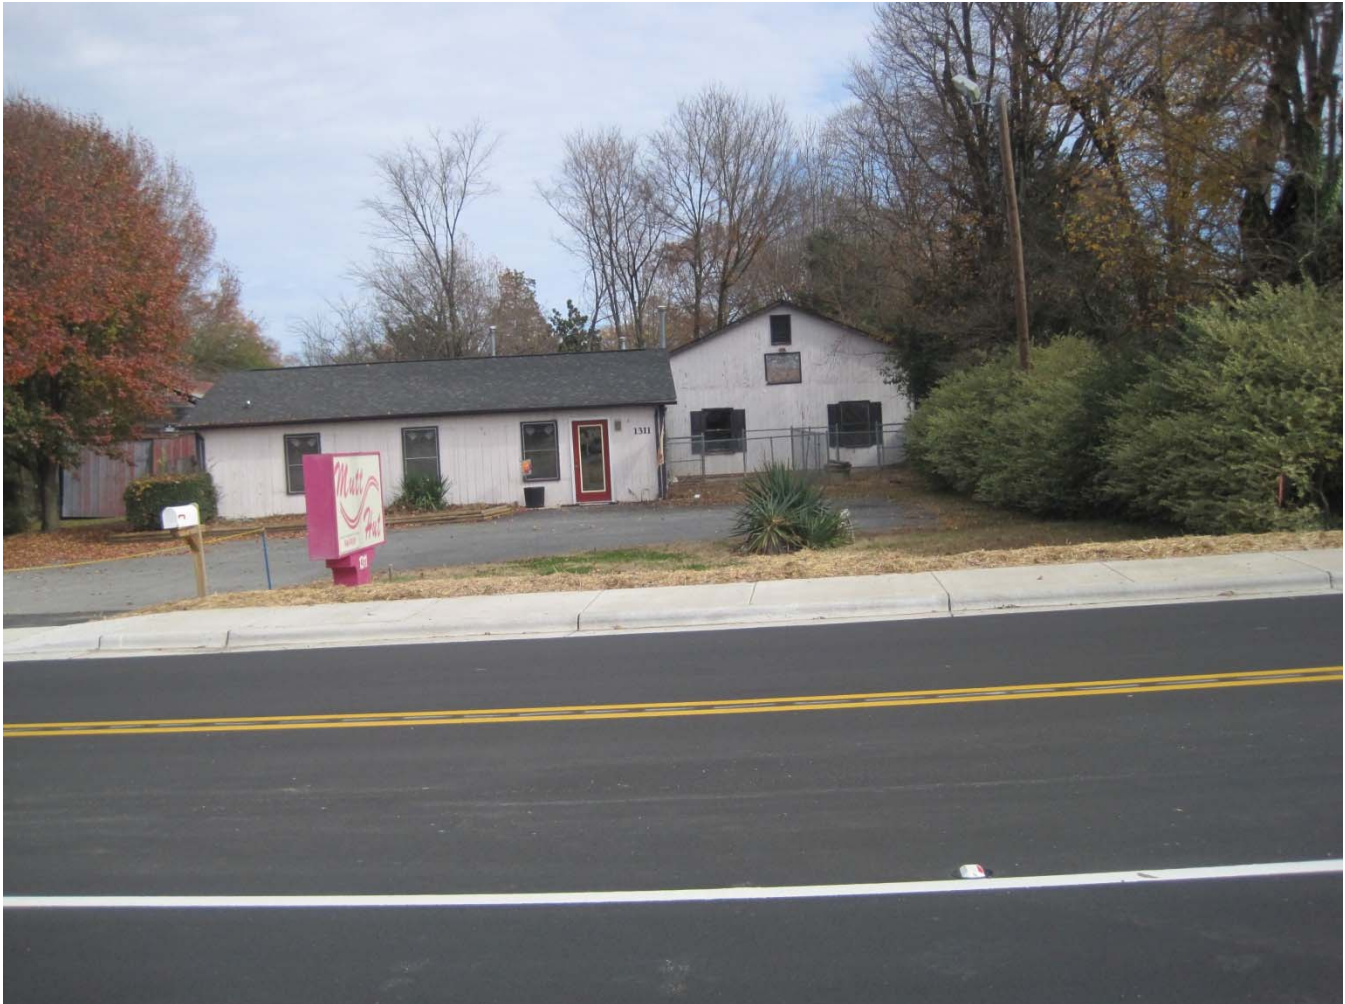
13)	Property Name Mutt Hut 1311 S. Ridge Avenue Kannapolis, NC 28083	Property Owner: Teresa Hamilton 112 Dunsmere Lane Mooresville, NC 28115	Alternative # 2,3
	Facility ID #: N/A	UST Owner: N/A	
	Incident #: N/A

This facility currently operates as a pet grooming salon. It is located on the east side of S. Ridge Avenue approximately 180 north of Rogers Lake Rd. There was one UST identified in the front lawn approximately 15 feet from the edge of pavement. The facility does not appear on the UST Section Registry. There is no ground water incident associated with this facility. No Monitoring wells were noted on site. **This site is anticipated to present low geoenvironmental impacts to the project**

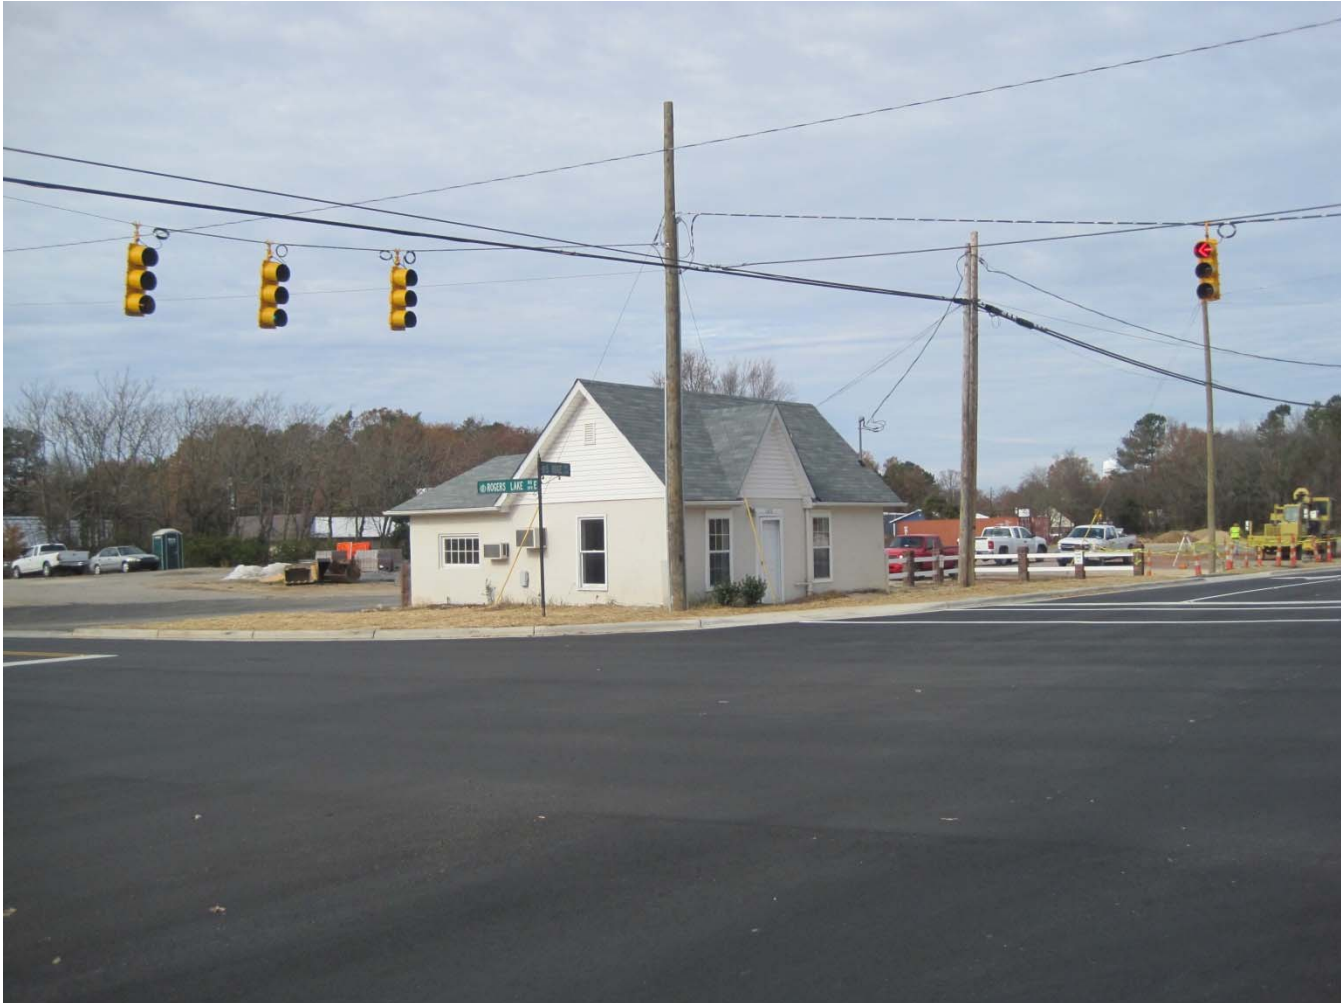
This vacant lot is the former location of Triage Block Company. It is located in the north west quadrant of S. Ridge Avenue and Rogers Lake Road. The vacant lot was recently used as a construction staging area for the recent upgrade to S. Ridge Avenue and Rogers Lake Road Intersection and rail crossing. The facility does not appear on the UST Section Registry. There is no ground water incident associated with this facility. No monitoring wells were noted on site. **This site is anticipated to present low geoenvironmental impacts to the project**

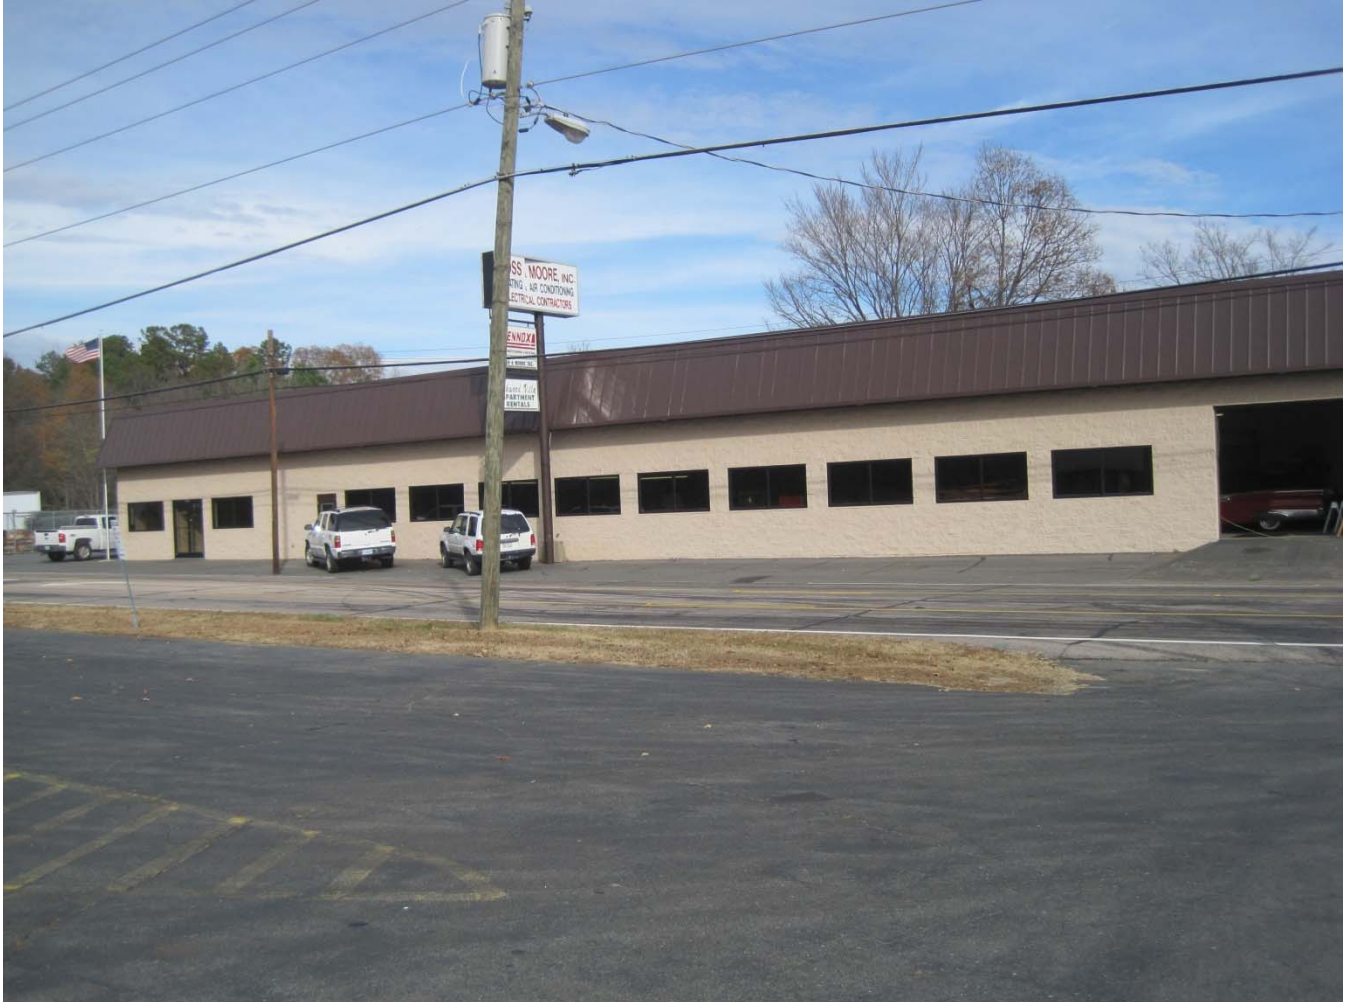
15)	Property Name Moss & Moore Inc. 1307 S. Main Street Kannapolis, NC 28081	Property Owner: Carl & Betty Moore 1307 S. Main Street Kannapolis, NC 28081	Alternative # 2,3
	Facility ID #: 0-019485 Incident# - UST #: MO-1608	UST Owner: Widenhouse Services Inc. PO Box 10 Concord, NC 28025

This facility currently operates as a Heating & Air conditioning business. It is located on the east side of S. Main Street approximately 350 feet north of Rogers Lake Road. According to the UST Section Registry one tank was closed in 1992. The facility does appear in the ground water incident database by the UST # but there is no ground water incident # associated with this facility. No Monitoring wells were noted on site. **This site is anticipated to present low geoenvironmental impacts to the project**
