TIP NO: Y-4810K
WBS: 40325
COUNTY: Cabarrus
DIVISION: 10
DESCRIPTION: Proposed Grade Separation crossing on Universal Street/Rogers Lake Road in Kannapolis.

SUBJECT: **GeoEnvironmental Report for Planning**

Hazardous Materials Report

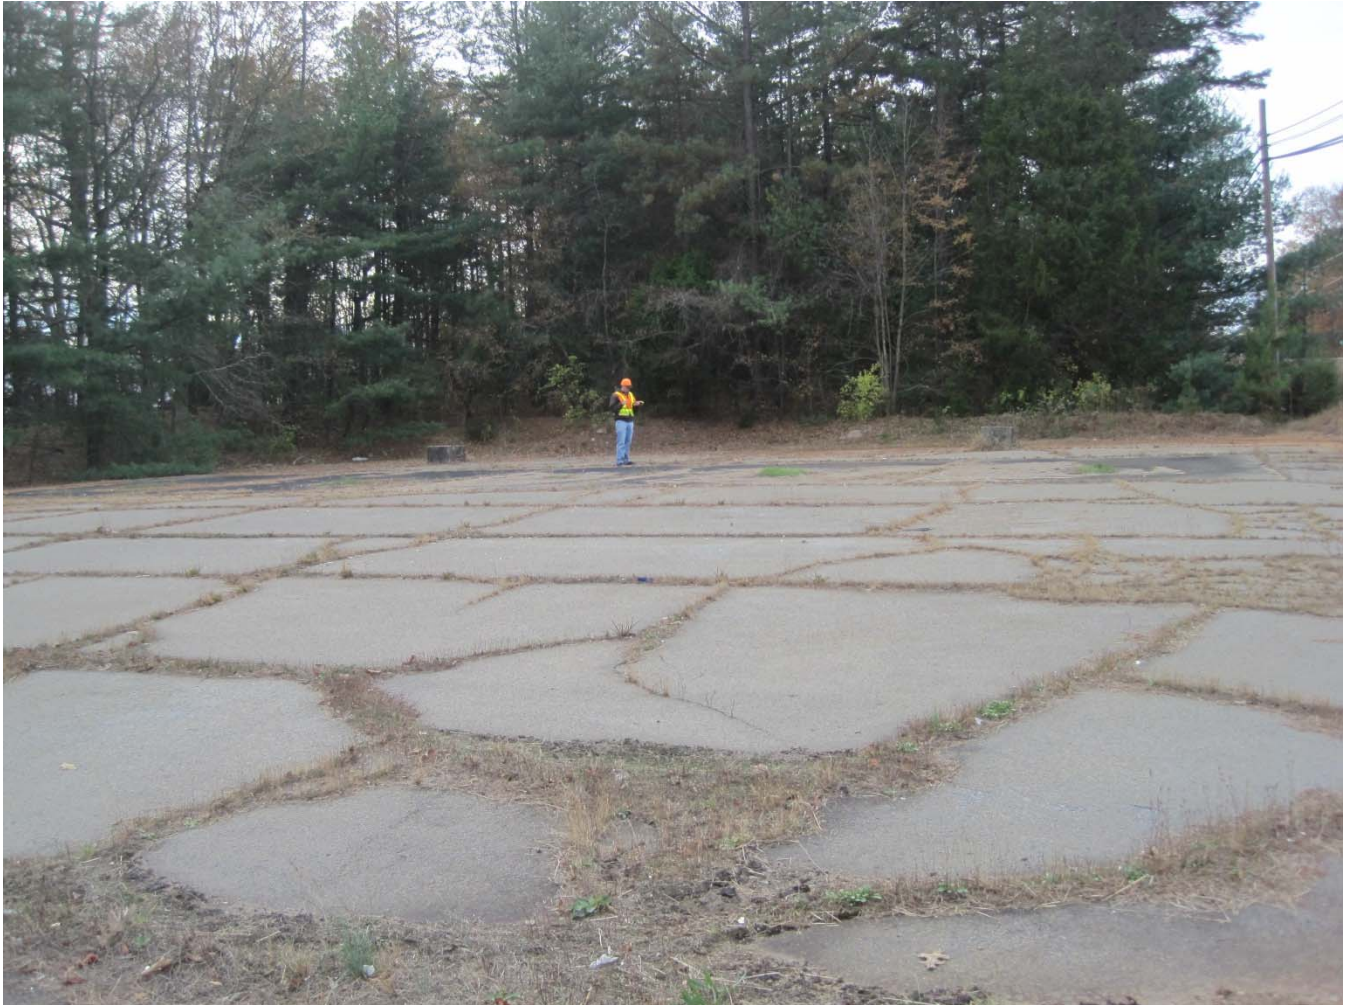
16)	Property Name Vacant Lot S. Main Street (No Address) Kannapolis, NC 28081	Property Owner: GFS Properties LLC C/O James H. Slaughter PO Box 41027 Greensboro, NC 27404	Alternative # 3
	Facility ID #: N/A Incident #: N/A	UST Owner: N/A

This vacant lot is the former location of a car wash. It is located in the south west quadrant of S. Main Street and Lowrance Avenue. The facility does not appear on the UST Section Registry. There is no evidence of any UST system and there is no ground water incident associated with this facility. No monitoring wells were noted on site. **This site is anticipated to present low geoenvironmental impacts to the project**

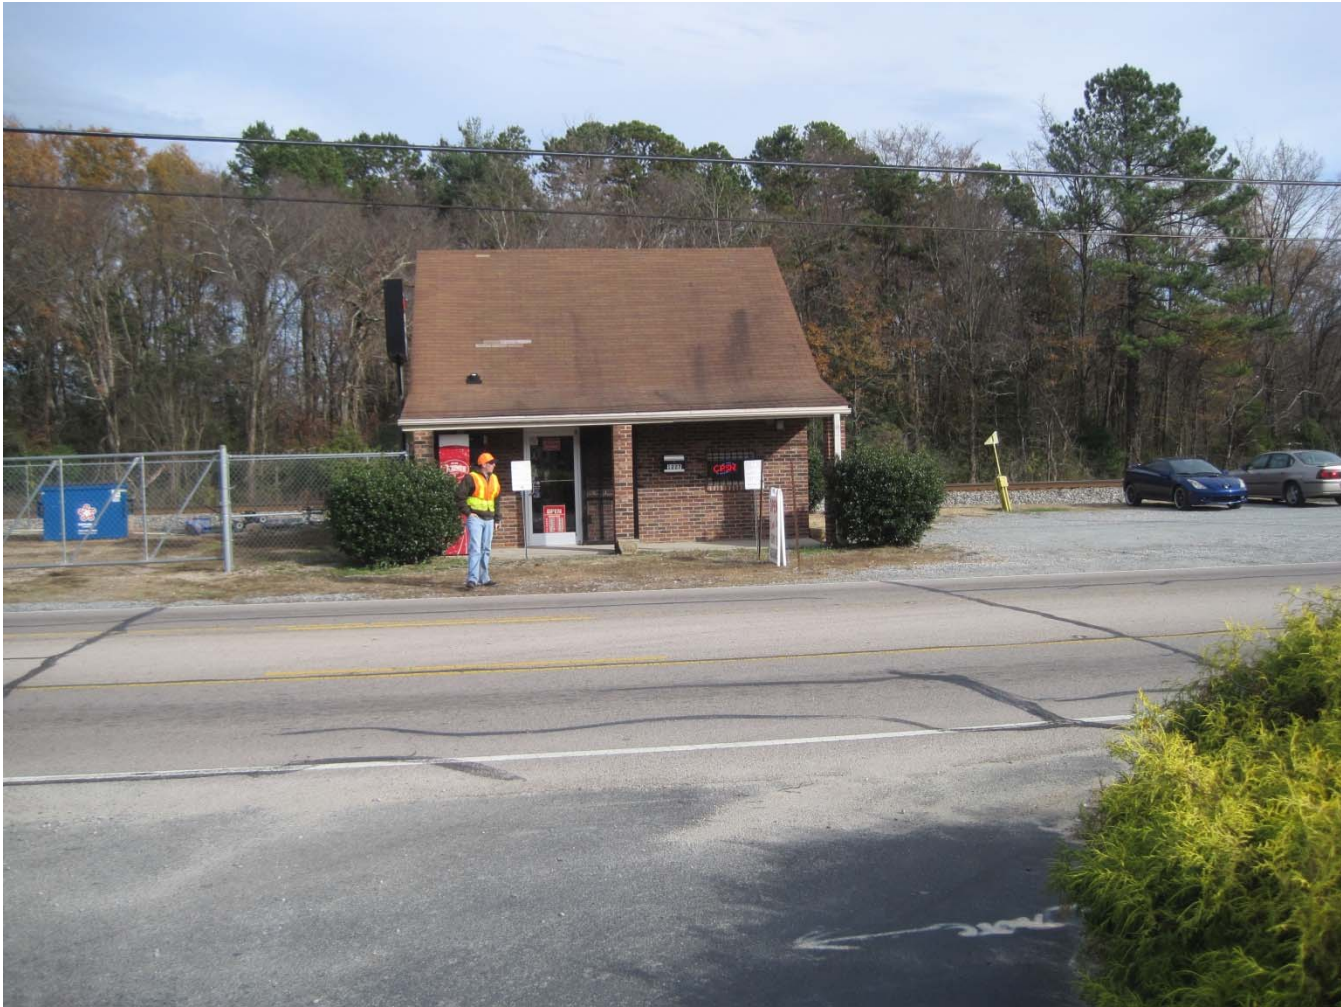
This facility currently operates as a gun shop. It is located on the east side of S. Main Street approximately 130 feet north of Lowrance Avenue. The facility does not appear on the UST Section Registry. There is no evidence of any UST system and there is no ground water incident associated with this facility. No monitoring wells were noted on site. **This site is anticipated to present low geoenvironmental impacts to the project**

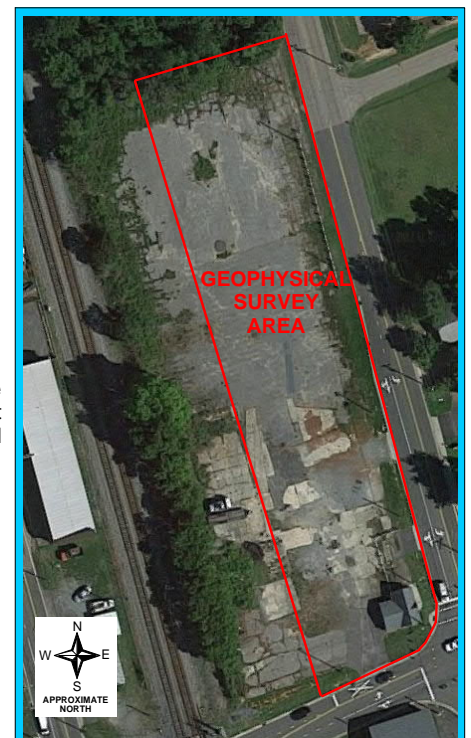
GEOPHYSICAL SURVEY AREA

The red polygon in the aerial photograph represents the approximate perimeter of the geophysical survey area at Parcel 48. The geophysical investigation was conducted on June 19-21, 2018.

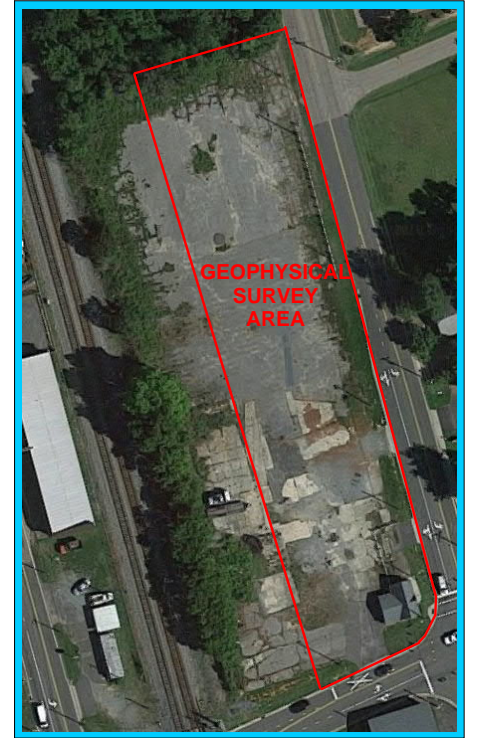
The red polygon in the aerial photograph represents the approximate perimeter of the geophysical survey area at the Triage Trustee (Parcel 48) property.

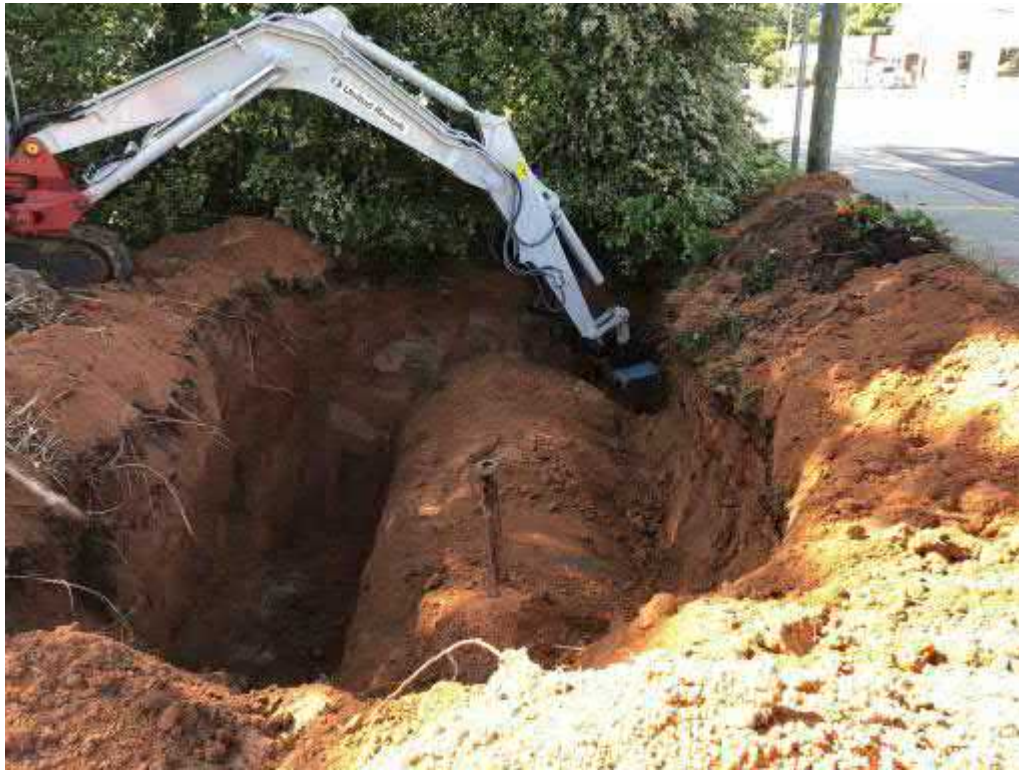
Photo 1 - View of excavation facing south-southeast

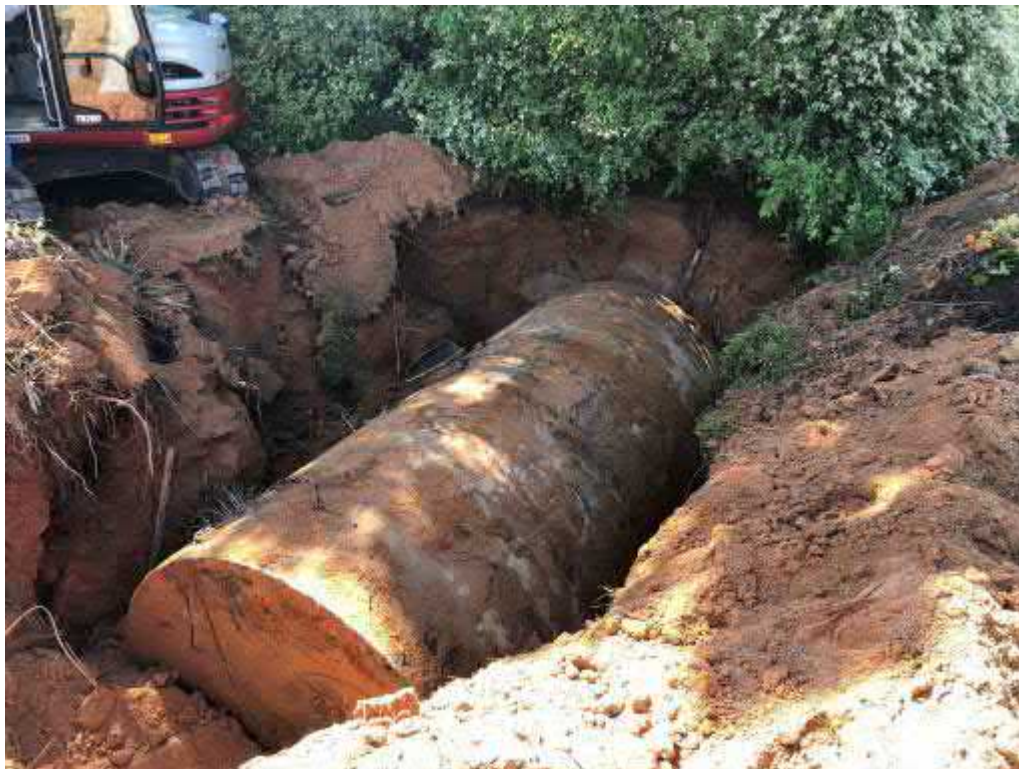
Photo 2 - Additional view of excavation facing east-southeast

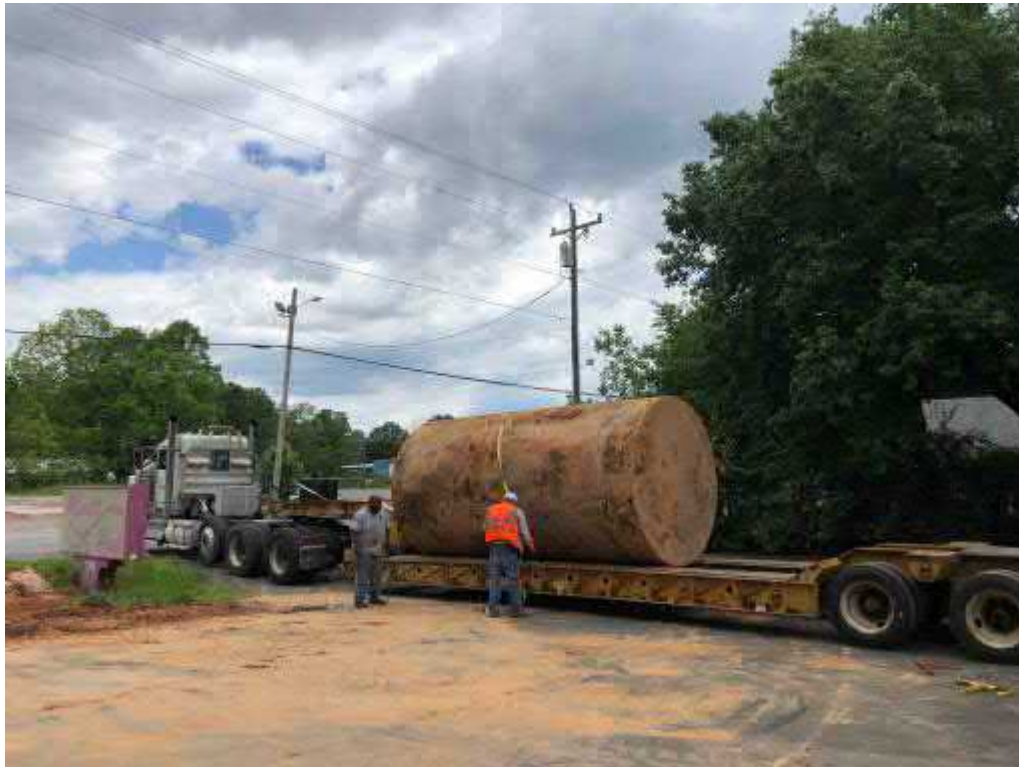
Photo 9 - View of UST being loaded onto tractor trailer for off-site disposal

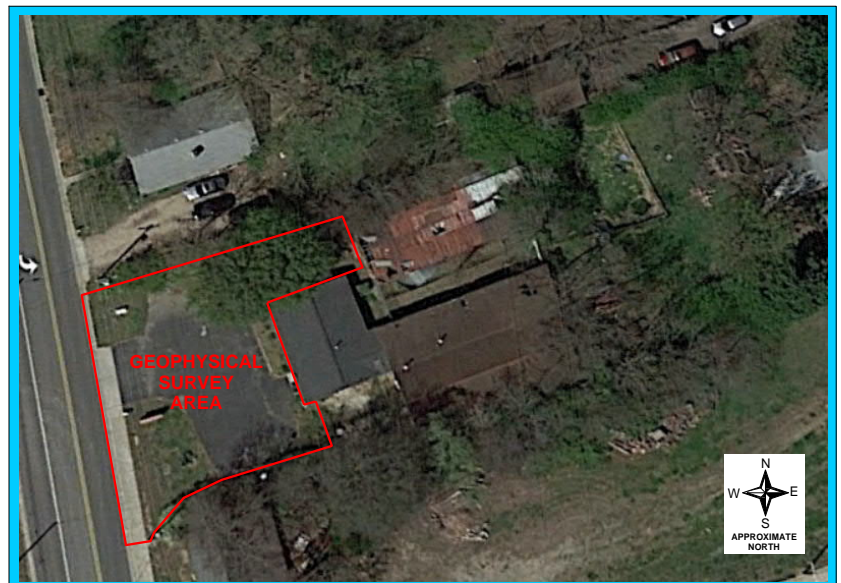
GEOPHYSICAL SURVEY AREA

The red polygon in the aerial photograph represents the approximate perimeter of the geophysical survey area at Parcel 51. The geophysical investigation was conducted on June 19-21, 2018.

The red polygon in the aerial photograph represents the approximate perimeter of the geophysical survey area at Parcel 51.

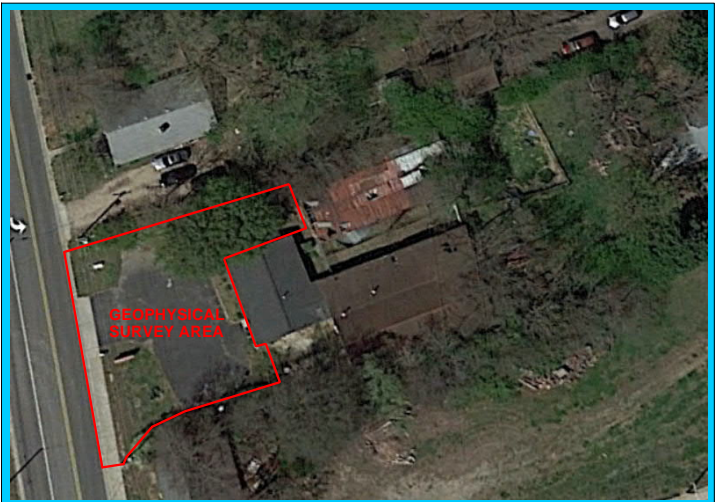
The red polygon in the aerial photograph represents the approximate perimeter of the geophysical survey area at Parcel 51.
