PRELIMINARY SITE ASSESSMENT REPORT
MALISSA B. SAULS PROPERTY
PARCEL NO 22

US 13 (Berkeley Blvd) – Realignment of SR 1709
(Central Heights Road) at Berkeley Blvd.
TIP No.: U-5724
WBS Element: 54016.1.2

Report Date: October 30, 2018
MAA Job #: 000R3203.00

**PRELIMINARY SITE ASSESSMENT REPORT
MALISSA B. SAULS PROPERTY
PARCEL NO. 22
TIP NO: U-5724
WBS ELEMENT: 54016.1.2
WAYNE COUNTY
WAYNE COUNTY PIN 3519741687.00**

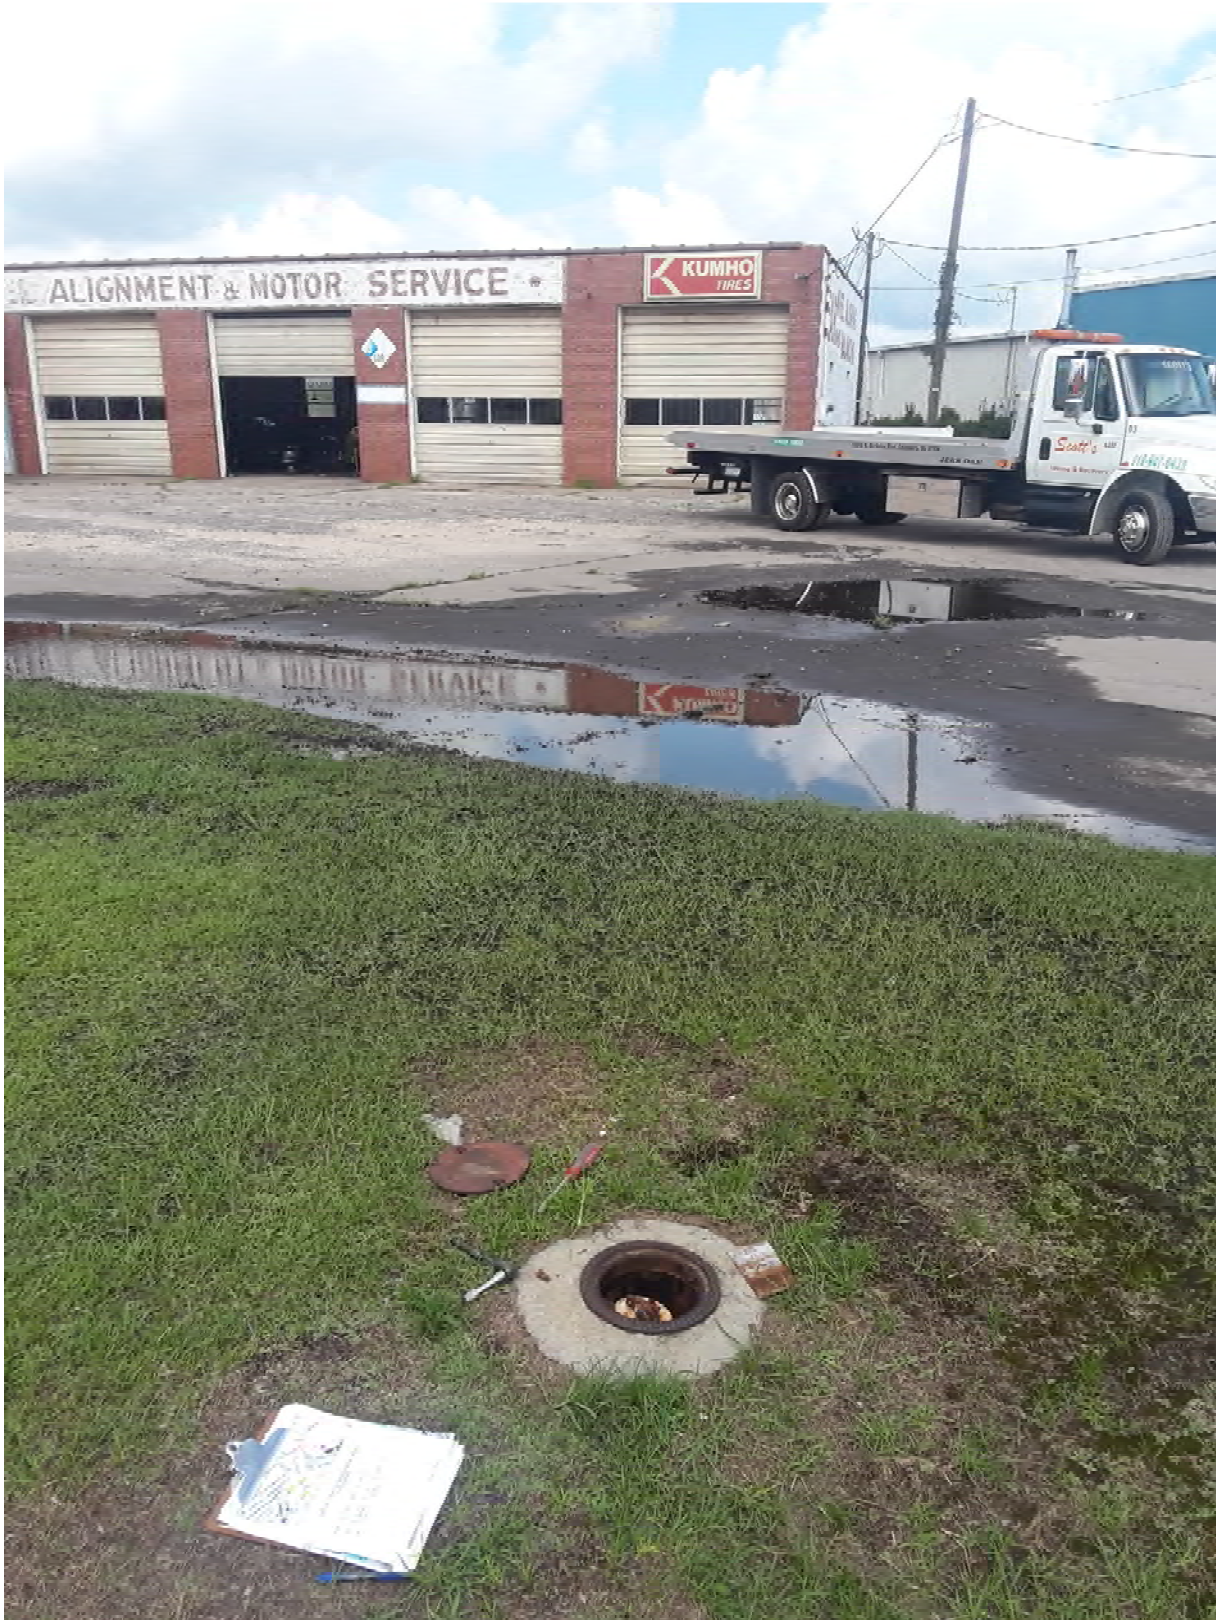
Photo 2 – A view of well RMW-1 (not abandoned), looking west.

Mid-Atlantic observed one former groundwater monitoring well (RMW-1) on the Subject Site. The location of the well is shown on **Drawing 3.1**. Mid-Atlantic's technician opened the well cover and discovered that the well is four inches in diameter, PVC and had an approximate 1.5-inch diameter horizontal PVC pipe connected to the casing, suggesting it may have been used for remedial purposes in the past (photo in **Appendix A**). The well identification tag labeled the well as 15 feet deep. The well has not been abandoned and the manhole and pad is still intact. A report for the former groundwater incident at Parcel No. 24 (Delmus Bridgers/Cash Farm Supplies, Incident No.6695) did not make reference to this well, but it is assumed that the well is

Mid-Atlantic observed one former groundwater monitoring well (RMW-1) on the Subject Site. The location of the well is shown on **Drawing 3.1**. The well is four inches in diameter and 15 feet deep. The well has not been abandoned and the manhole and pad is still intact. A report for the former groundwater incident at Parcel No. 24 (Delmus Bridgers/Cash Farm Supplies, Incident No.6695) referenced a monitoring well MW-6 on Parcel 22, but this well could not be located during site reconnaissance activities. See Section 3.1 for further information.

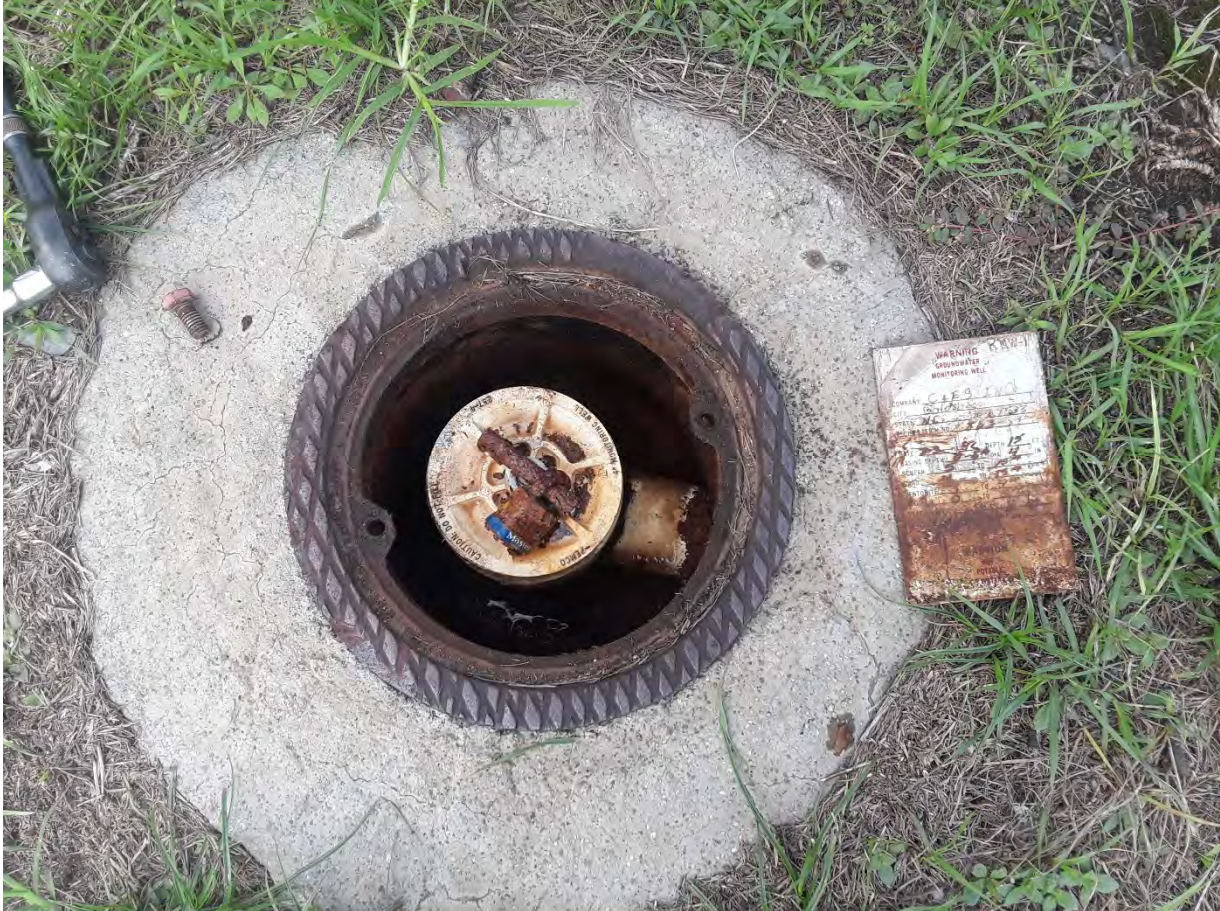
Photo 3 – A close-up view of well RMW-1 (not abandoned) – note horizontal pipe connected to well.

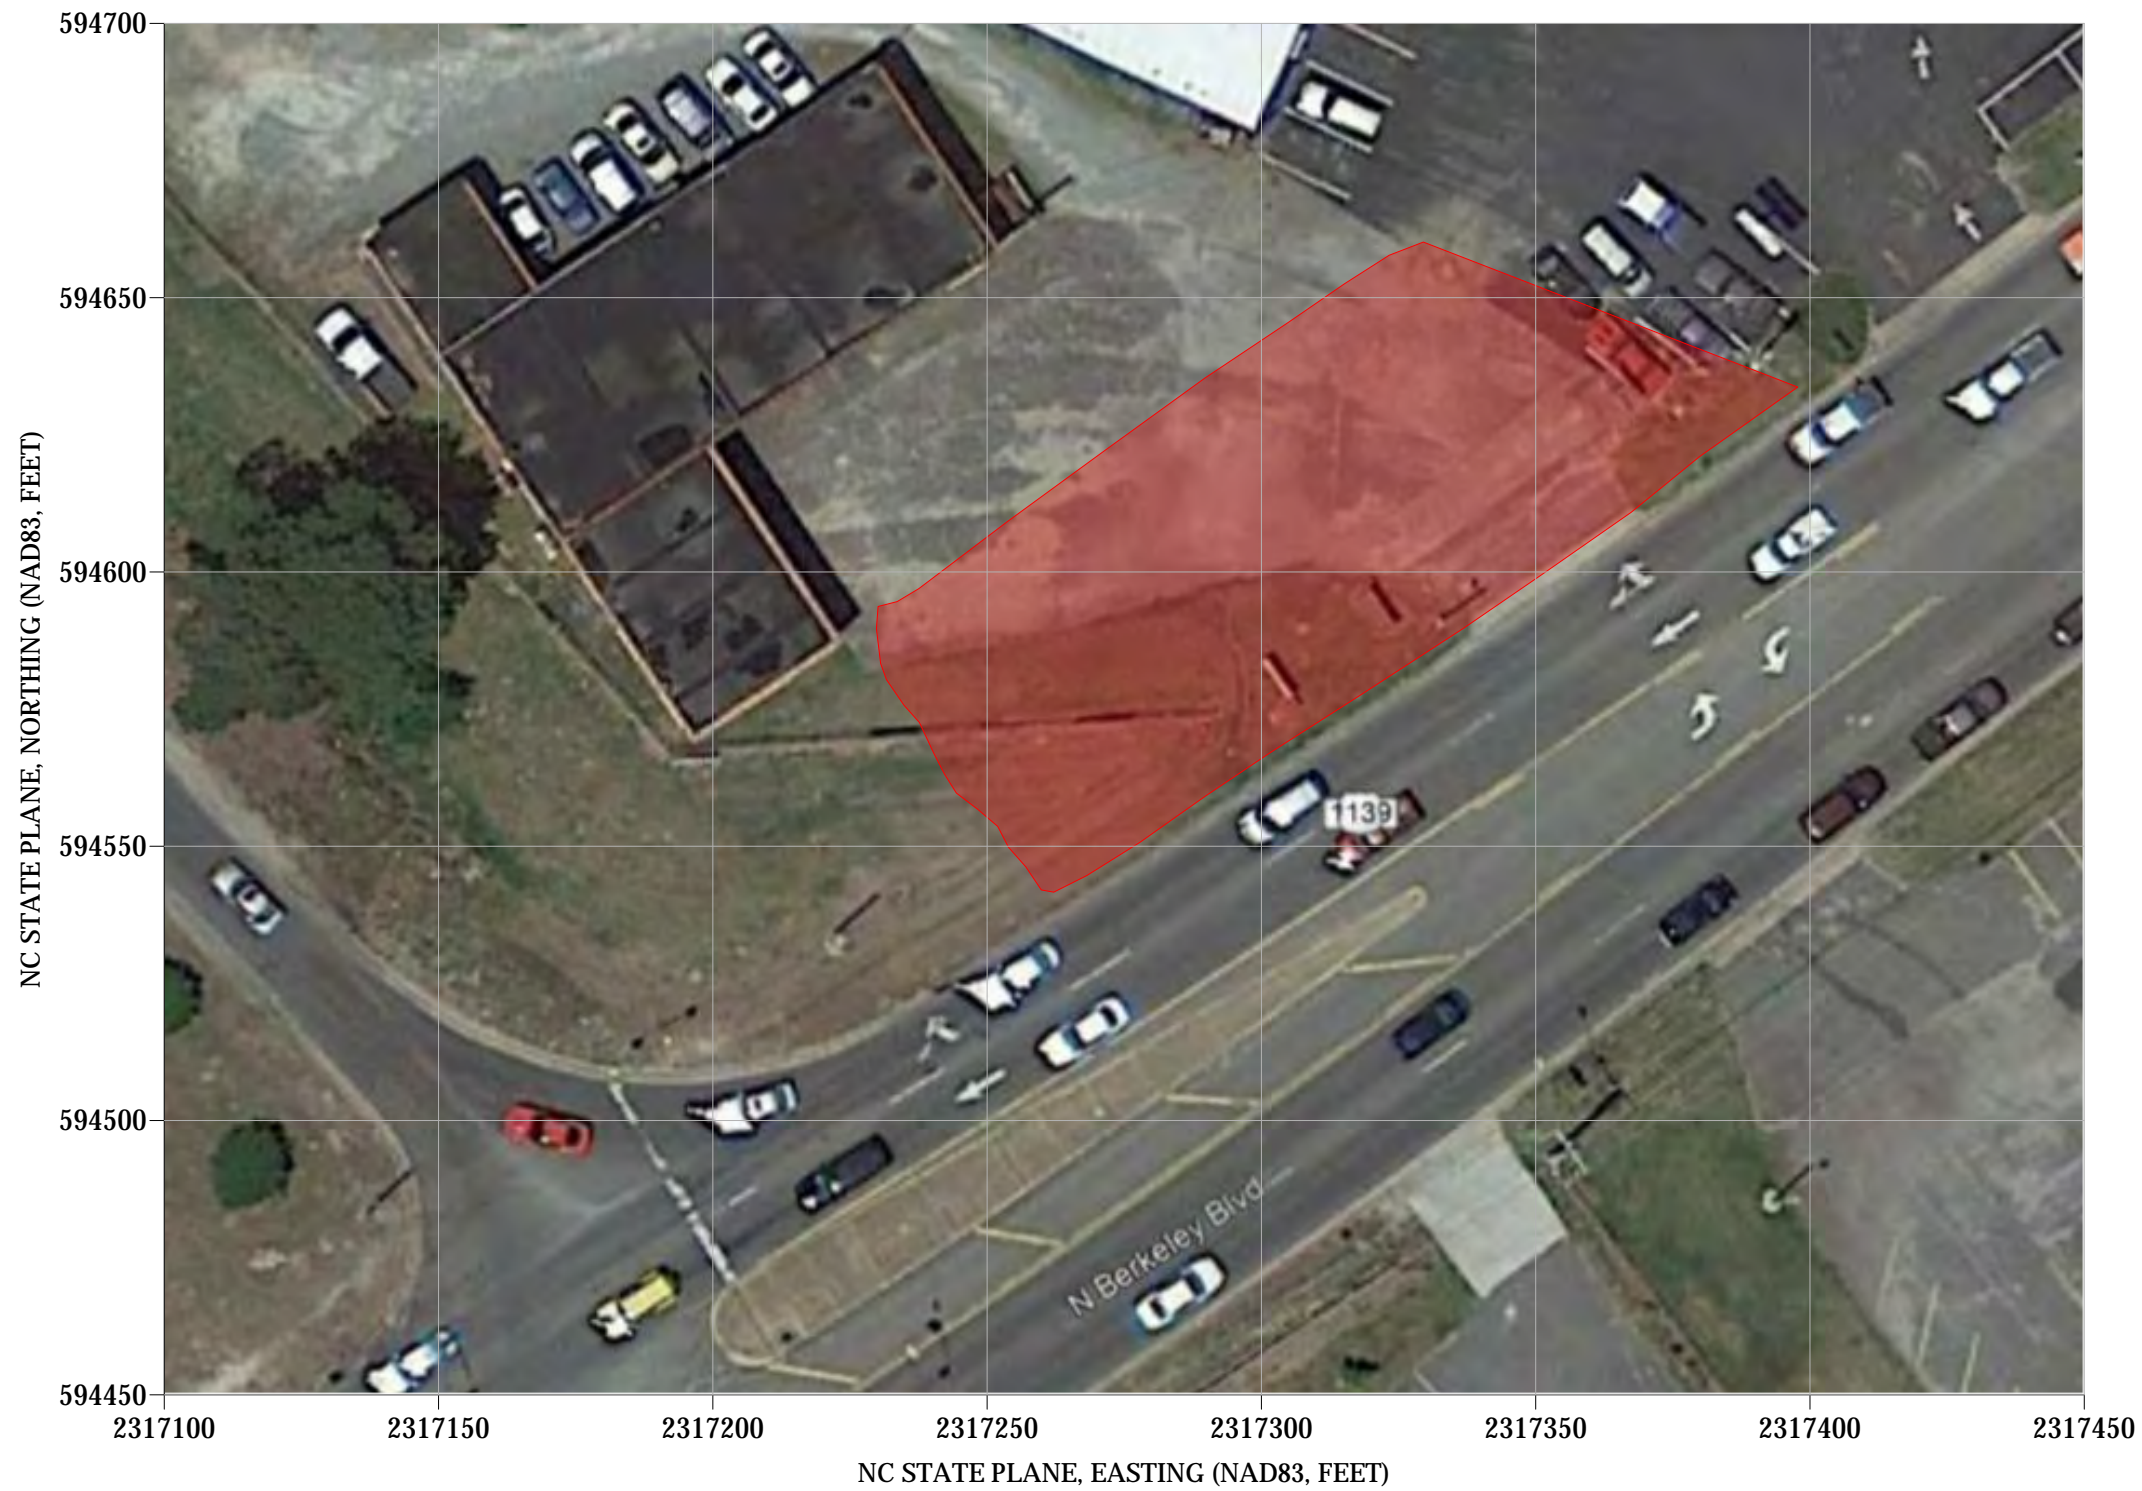
APPROXIMATE BOUNDARIES OF GEOPHYSICAL SURVEY AREA
