PRELIMINARY SITE ASSESSMENT REPORT
MALISSA B. SAULS PROPERTY
PARCEL NO 22

US 13 (Berkeley Blvd) – Realignment of SR 1709
(Central Heights Road) at Berkeley Blvd.
TIP No.: U-5724
WBS Element: 54016.1.2

Report Date: October 30, 2018
MAA Job #: 000R3203.00

PRELIMINARY SITE ASSESSMENT REPORT
DELMUS BRIDGERS-FAMILY LIMITED PARTNERSHIP PROPERTY
PARCEL NO 24

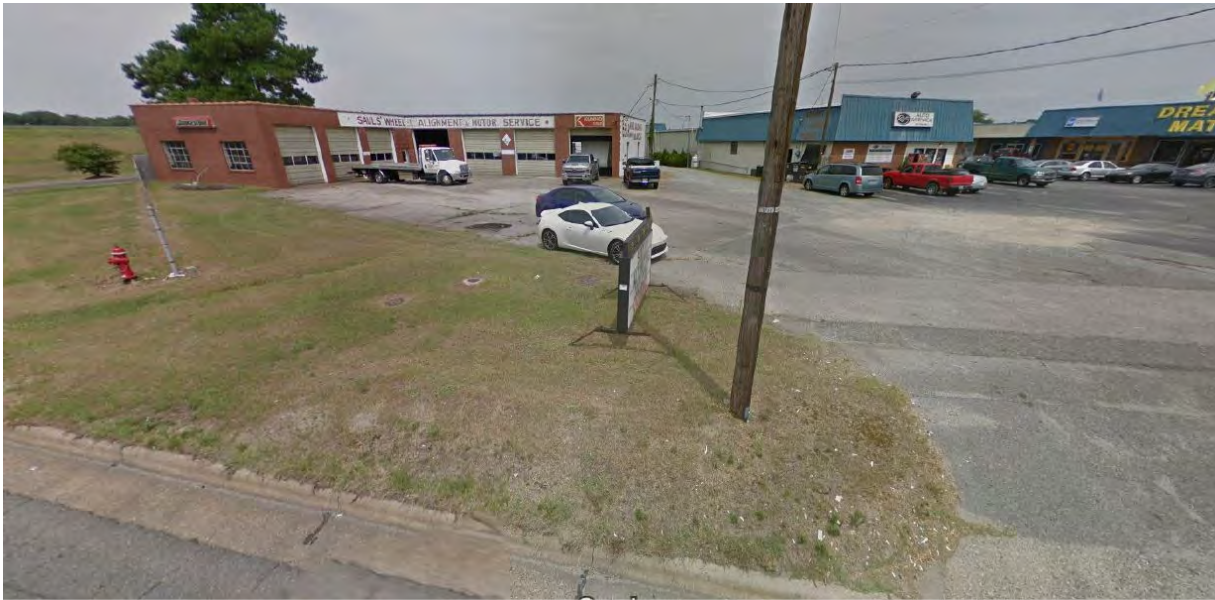
Photo 1 – A general view of site, looking west from Berkeley Boulevard.
(photo courtesy of Google Earth)

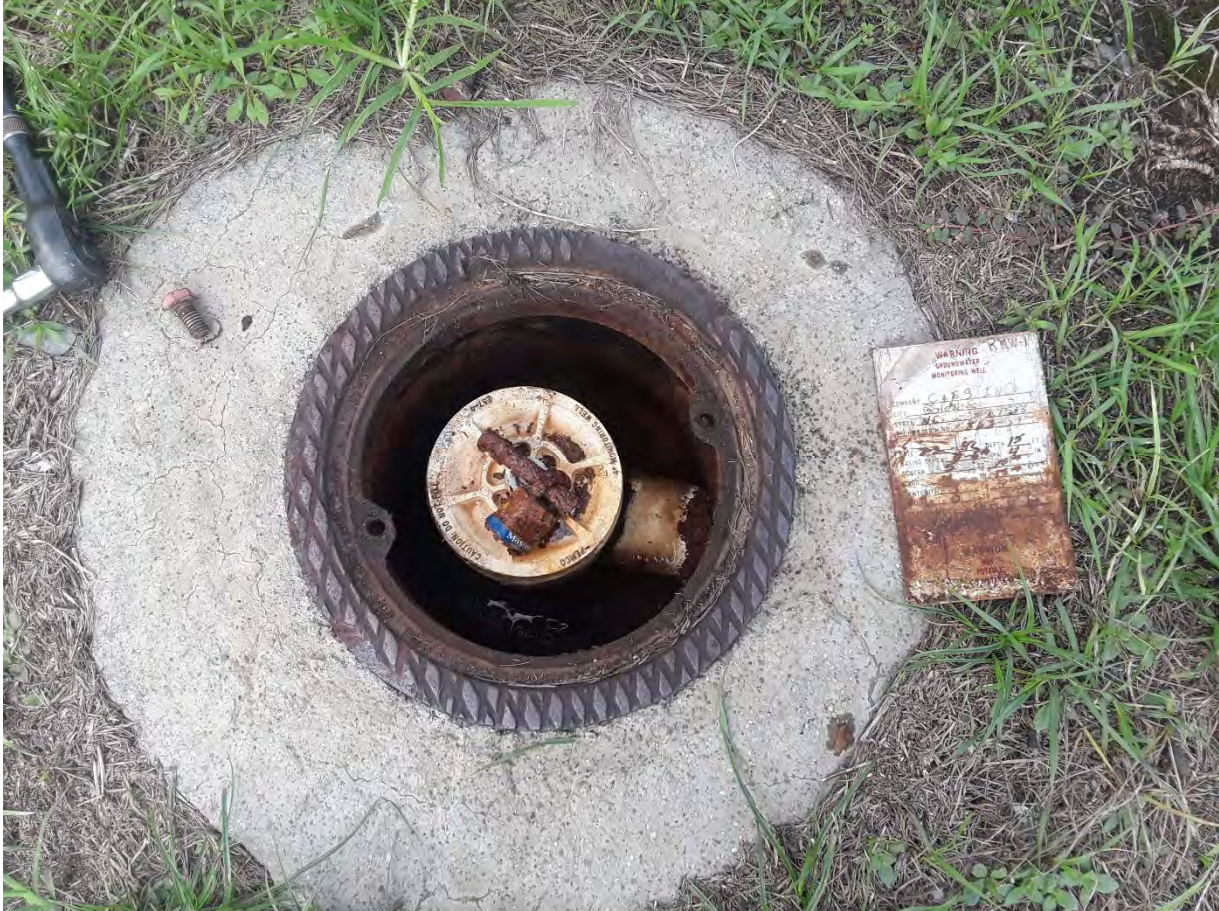
Photo 3 – A close-up view of well RMW-1 (not abandoned) – note horizontal pipe connected to well.

Mid-Atlantic observed one former groundwater monitoring well (RMW-1) on the Subject Site. The location of the well is shown on **Drawing 3.1**. Mid-Atlantic's technician opened the well cover and discovered that the well is four inches in diameter, PVC and had an approximate 1.5-inch diameter horizontal PVC pipe connected to the casing, suggesting it may have been used for remedial purposes in the past (photo in **Appendix A**). The well identification tag labeled the well as 15 feet deep. The well has not been abandoned and the manhole and pad is still intact. A report for the former groundwater incident at Parcel No. 24 (Delmus Bridgers/Cash Farm Supplies, Incident No.6695) did not make reference to this well, but it is assumed that the well is

Mid-Atlantic observed one former groundwater monitoring well (RMW-1) on the Subject Site. The location of the well is shown on **Drawing 3.1**. The well is four inches in diameter and 15 feet deep. The well has not been abandoned and the manhole and pad is still intact. A report for the former groundwater incident at Parcel No. 24 (Delmus Bridgers/Cash Farm Supplies, Incident No.6695) referenced a monitoring well MW-6 on Parcel 22, but this well could not be located during site reconnaissance activities. See Section 3.1 for further information.

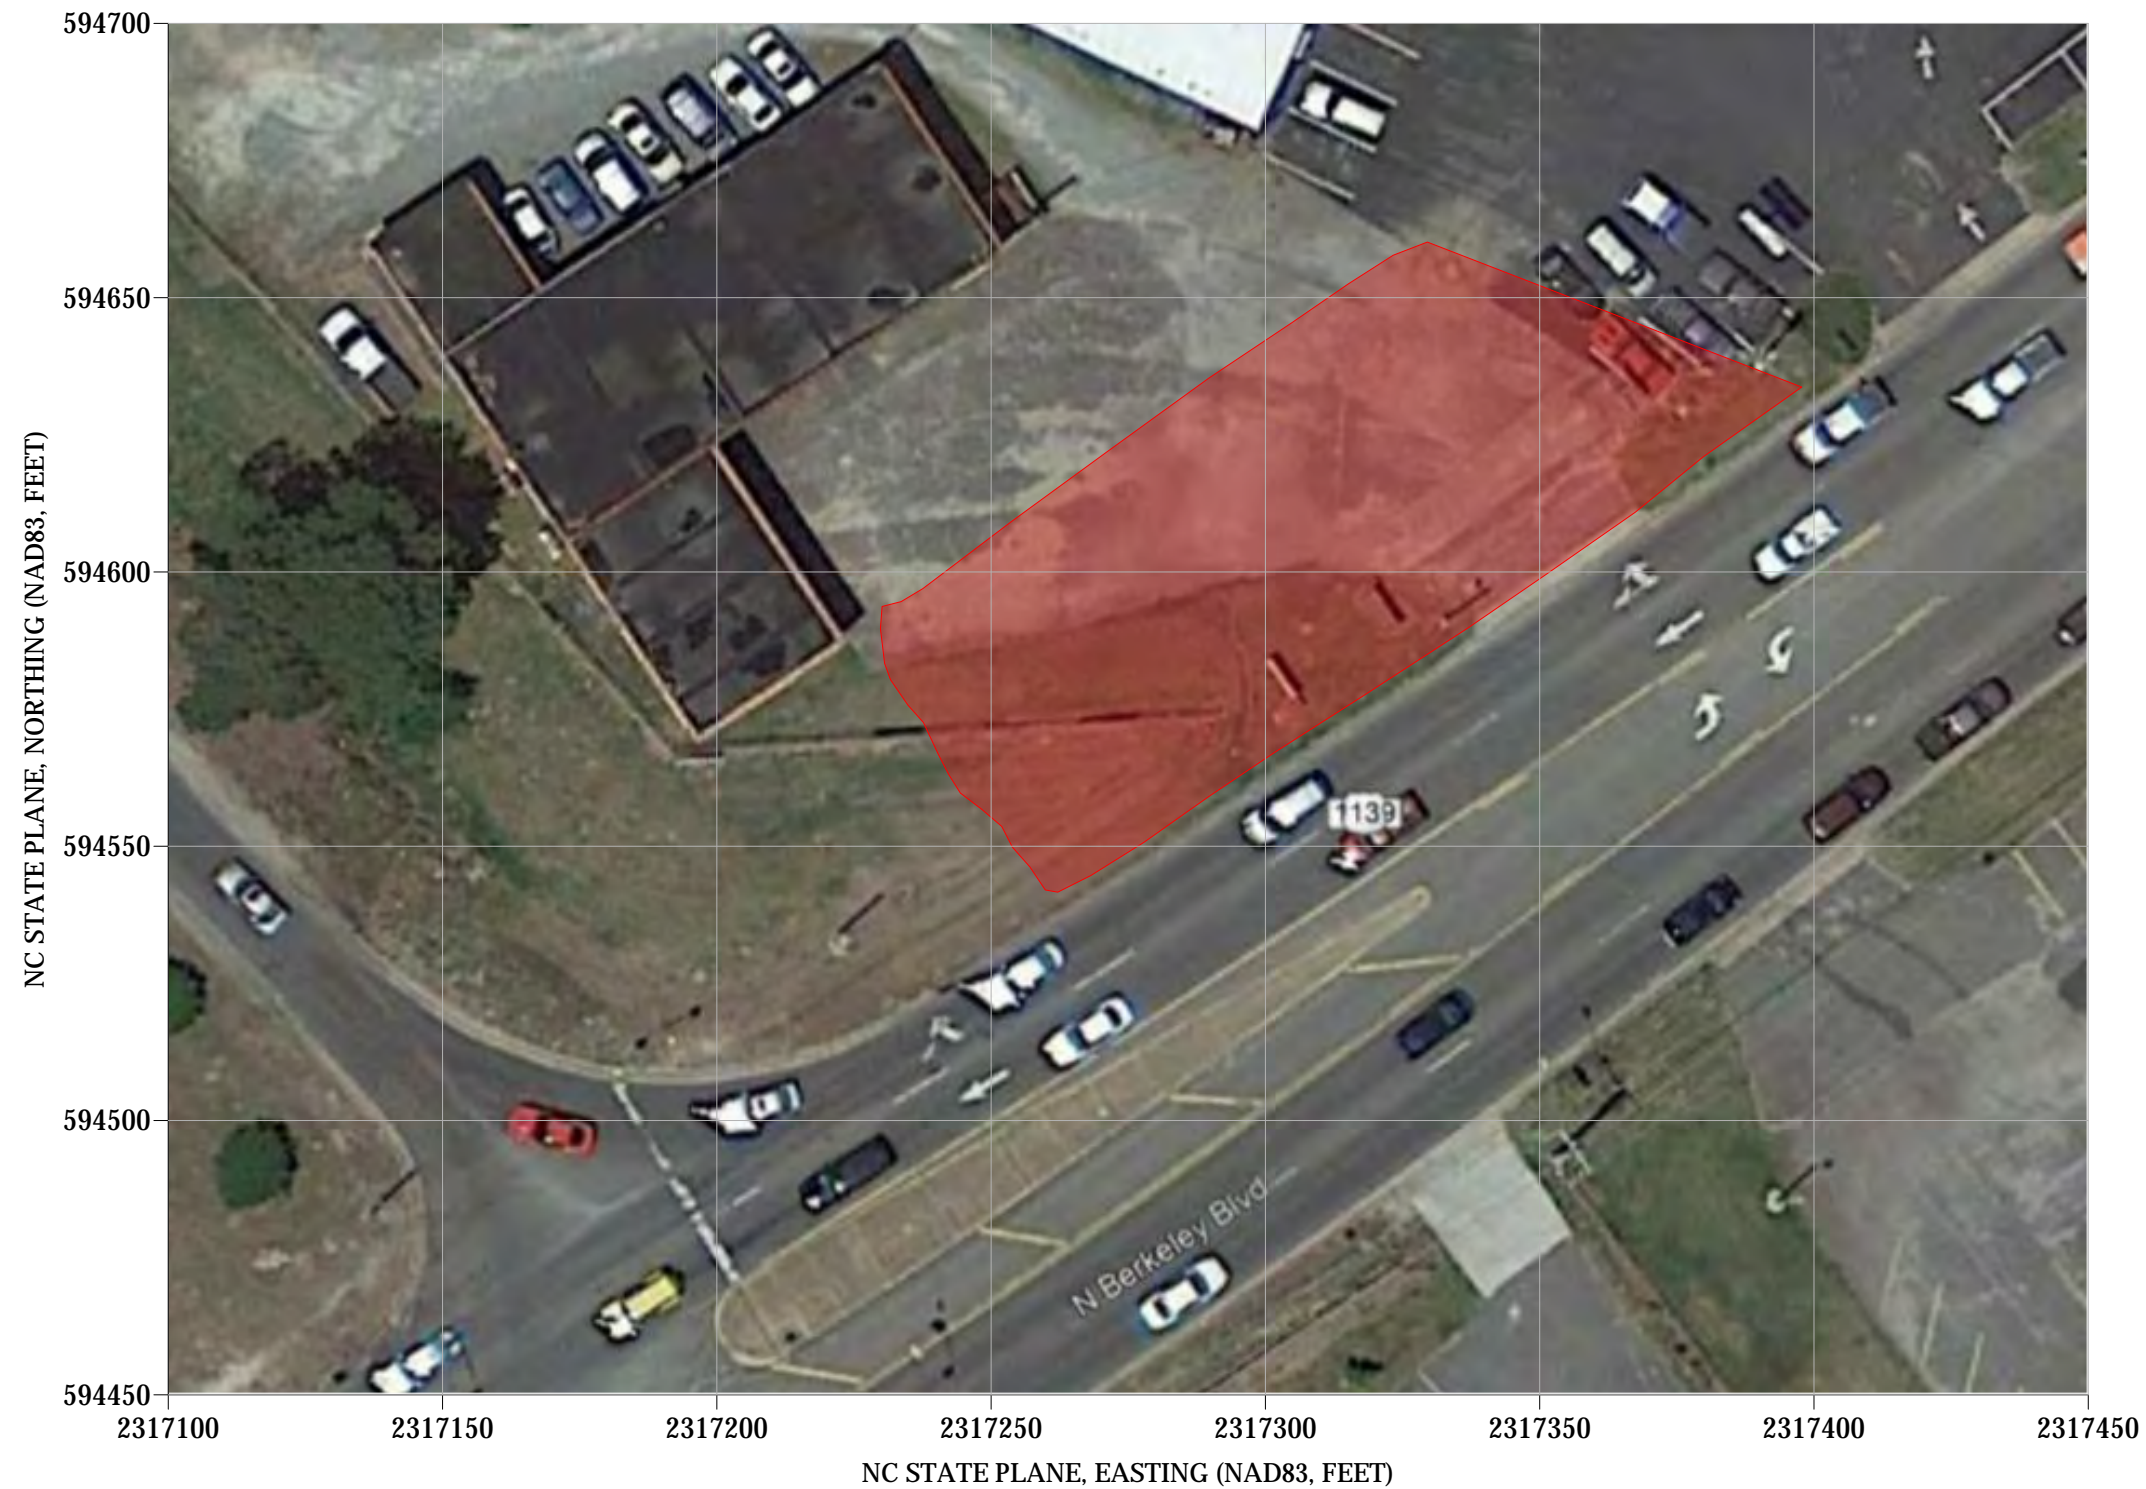
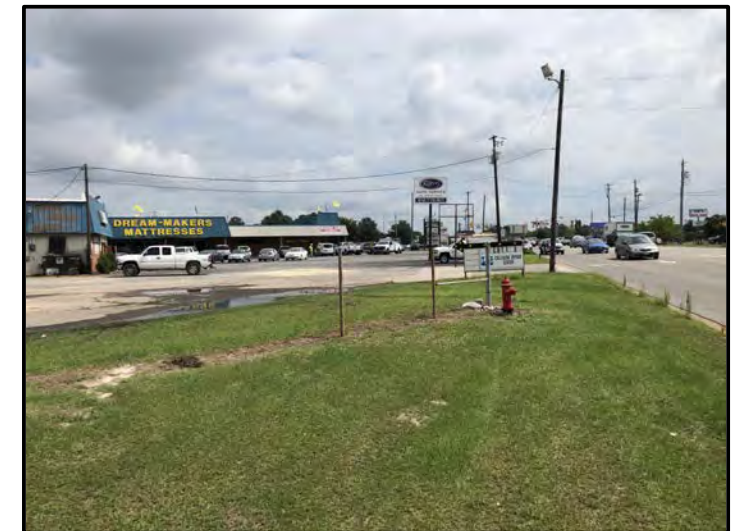
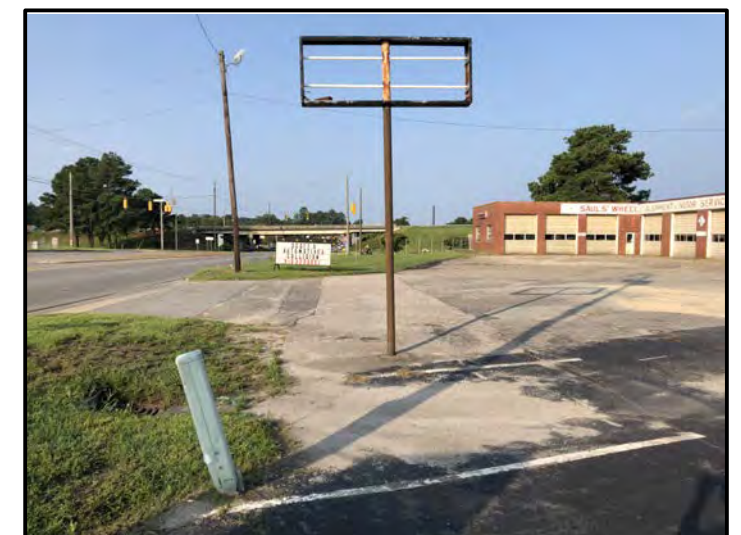
The site included one former and one active service garage in a shopping plaza surrounded by grass, asphalt, and gravel surfaces. An aerial photograph showing the survey area boundaries and ground-level photographs are shown in **Figure 1**.

APPROXIMATE BOUNDARIES OF GEOPHYSICAL SURVEY AREA

View of Survey Area
(Facing Approximately Northeast)

View of Survey Area
(Facing Approximately Southwest)

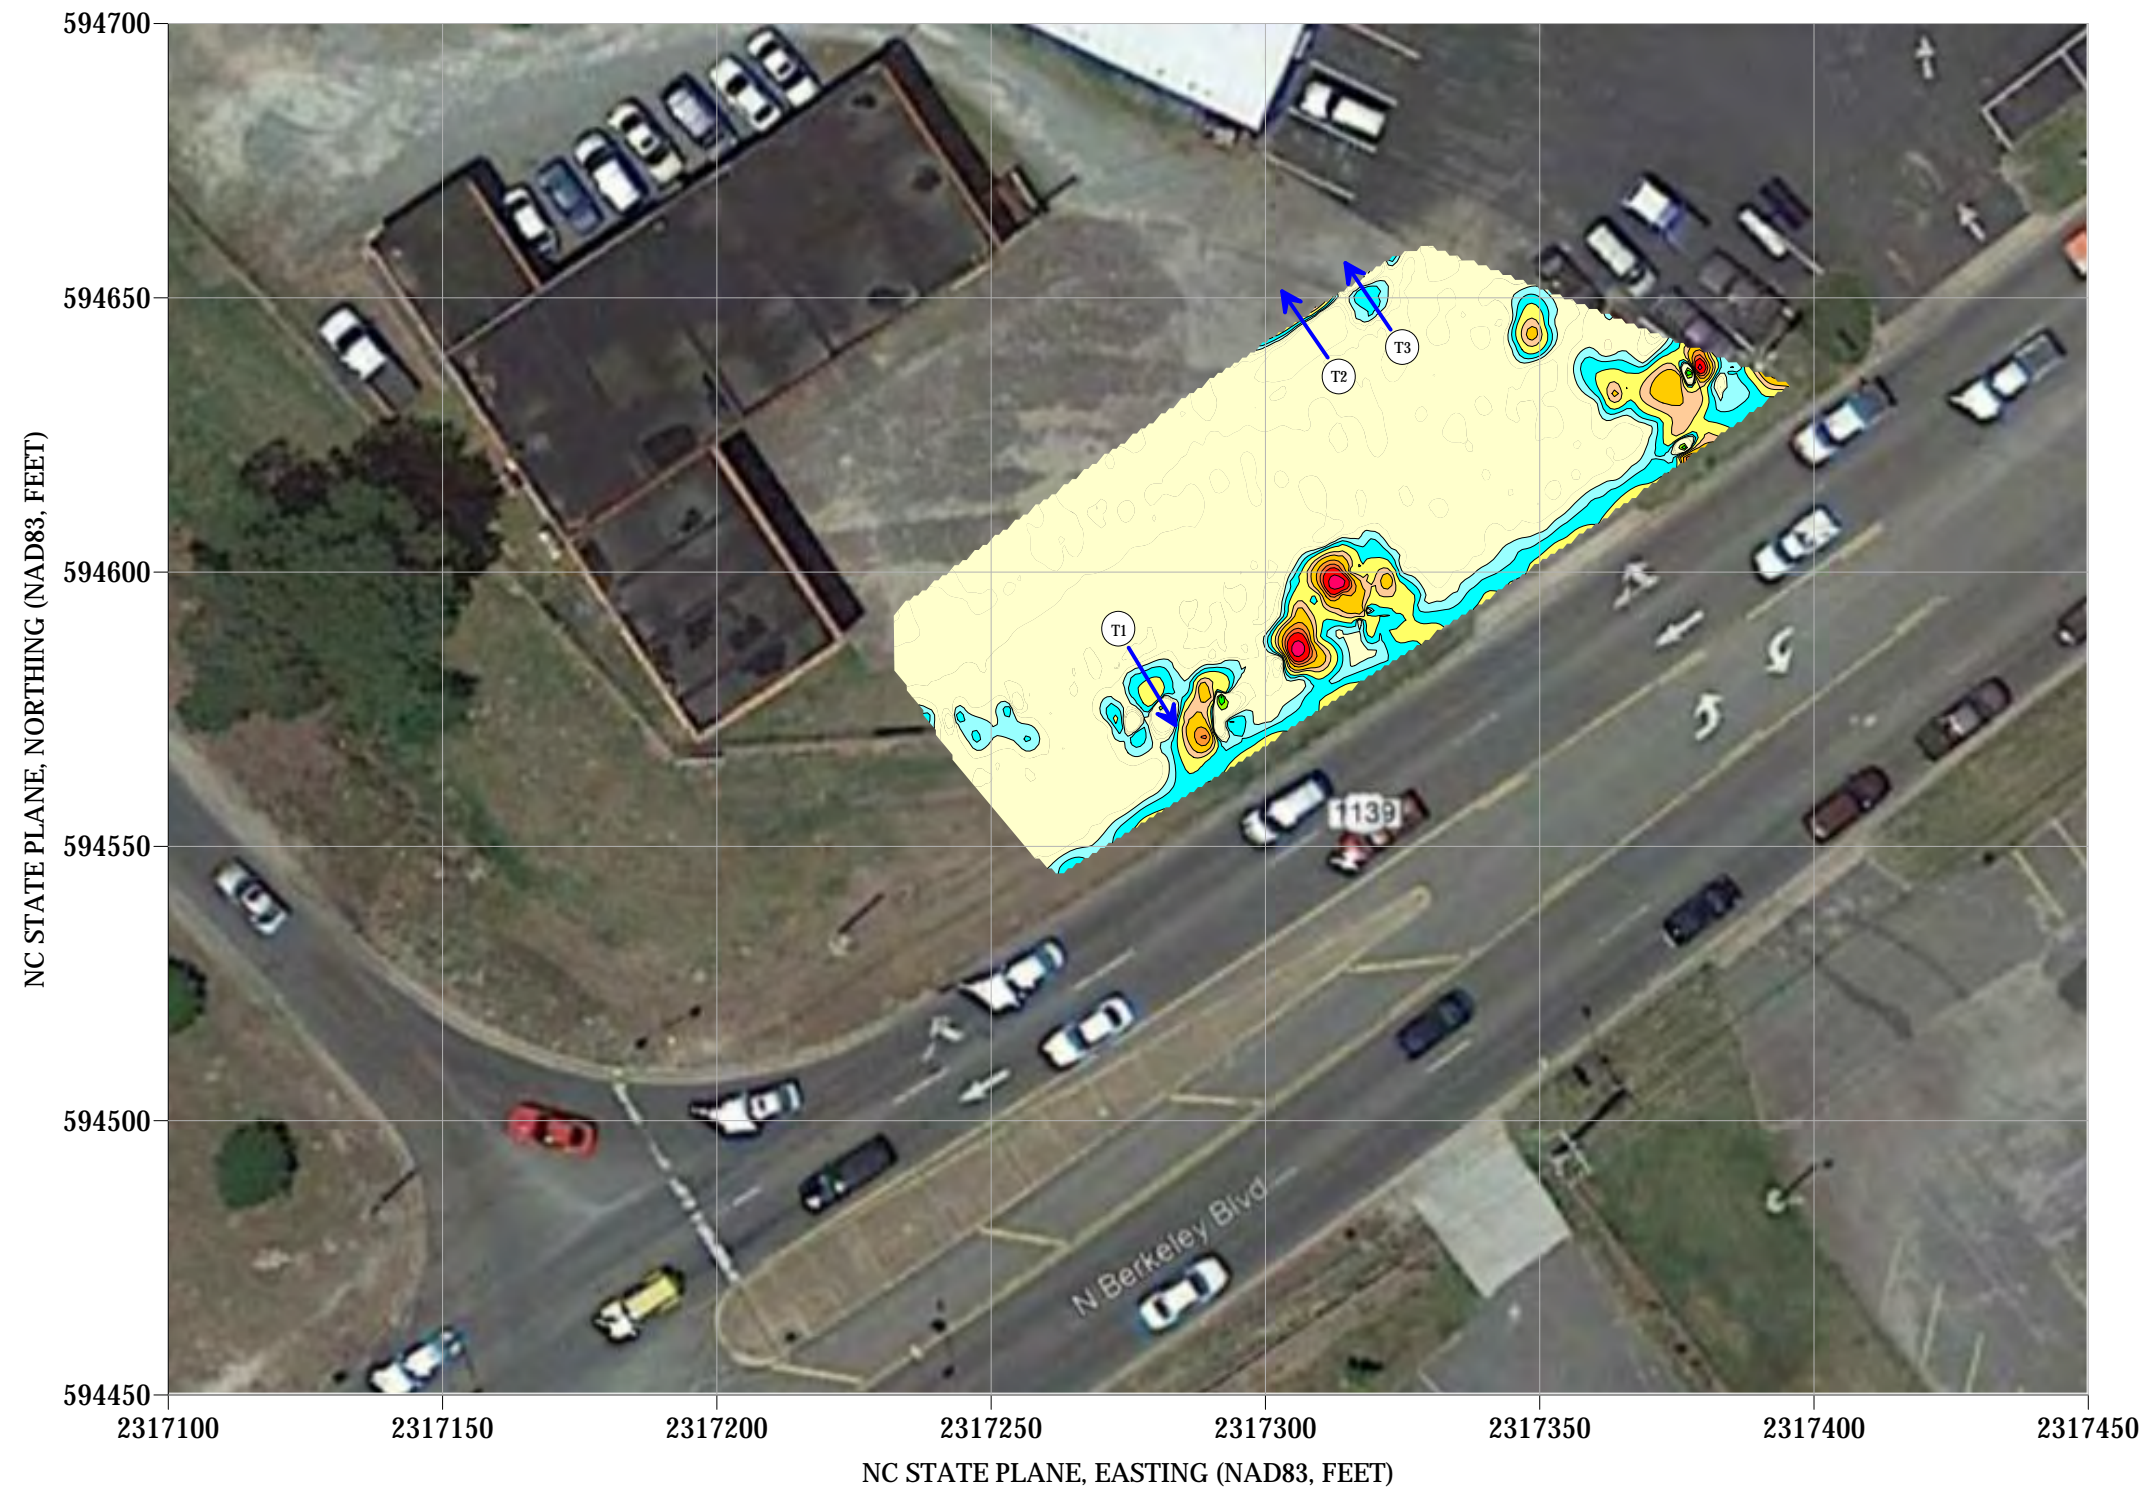
LOCATIONS OF GPR TRANSECTS

*EXTENSIVE GPR SCANS WERE CONDUCTED OVER THE ENTIRE SITE. TRANSECT LINES ON THE MAP ABOVE INDICATE LOCATIONS WHERE DATA WERE SAVED. THESE LOCATIONS WERE CHOSEN TO HIGHLIGHT STRUCTURES IDENTIFIED IN THE SUBSURFACE OR TRANSECTS THAT ARE REPRESENTATIVE OF GENERAL SUBSURFACE CONDITIONS.

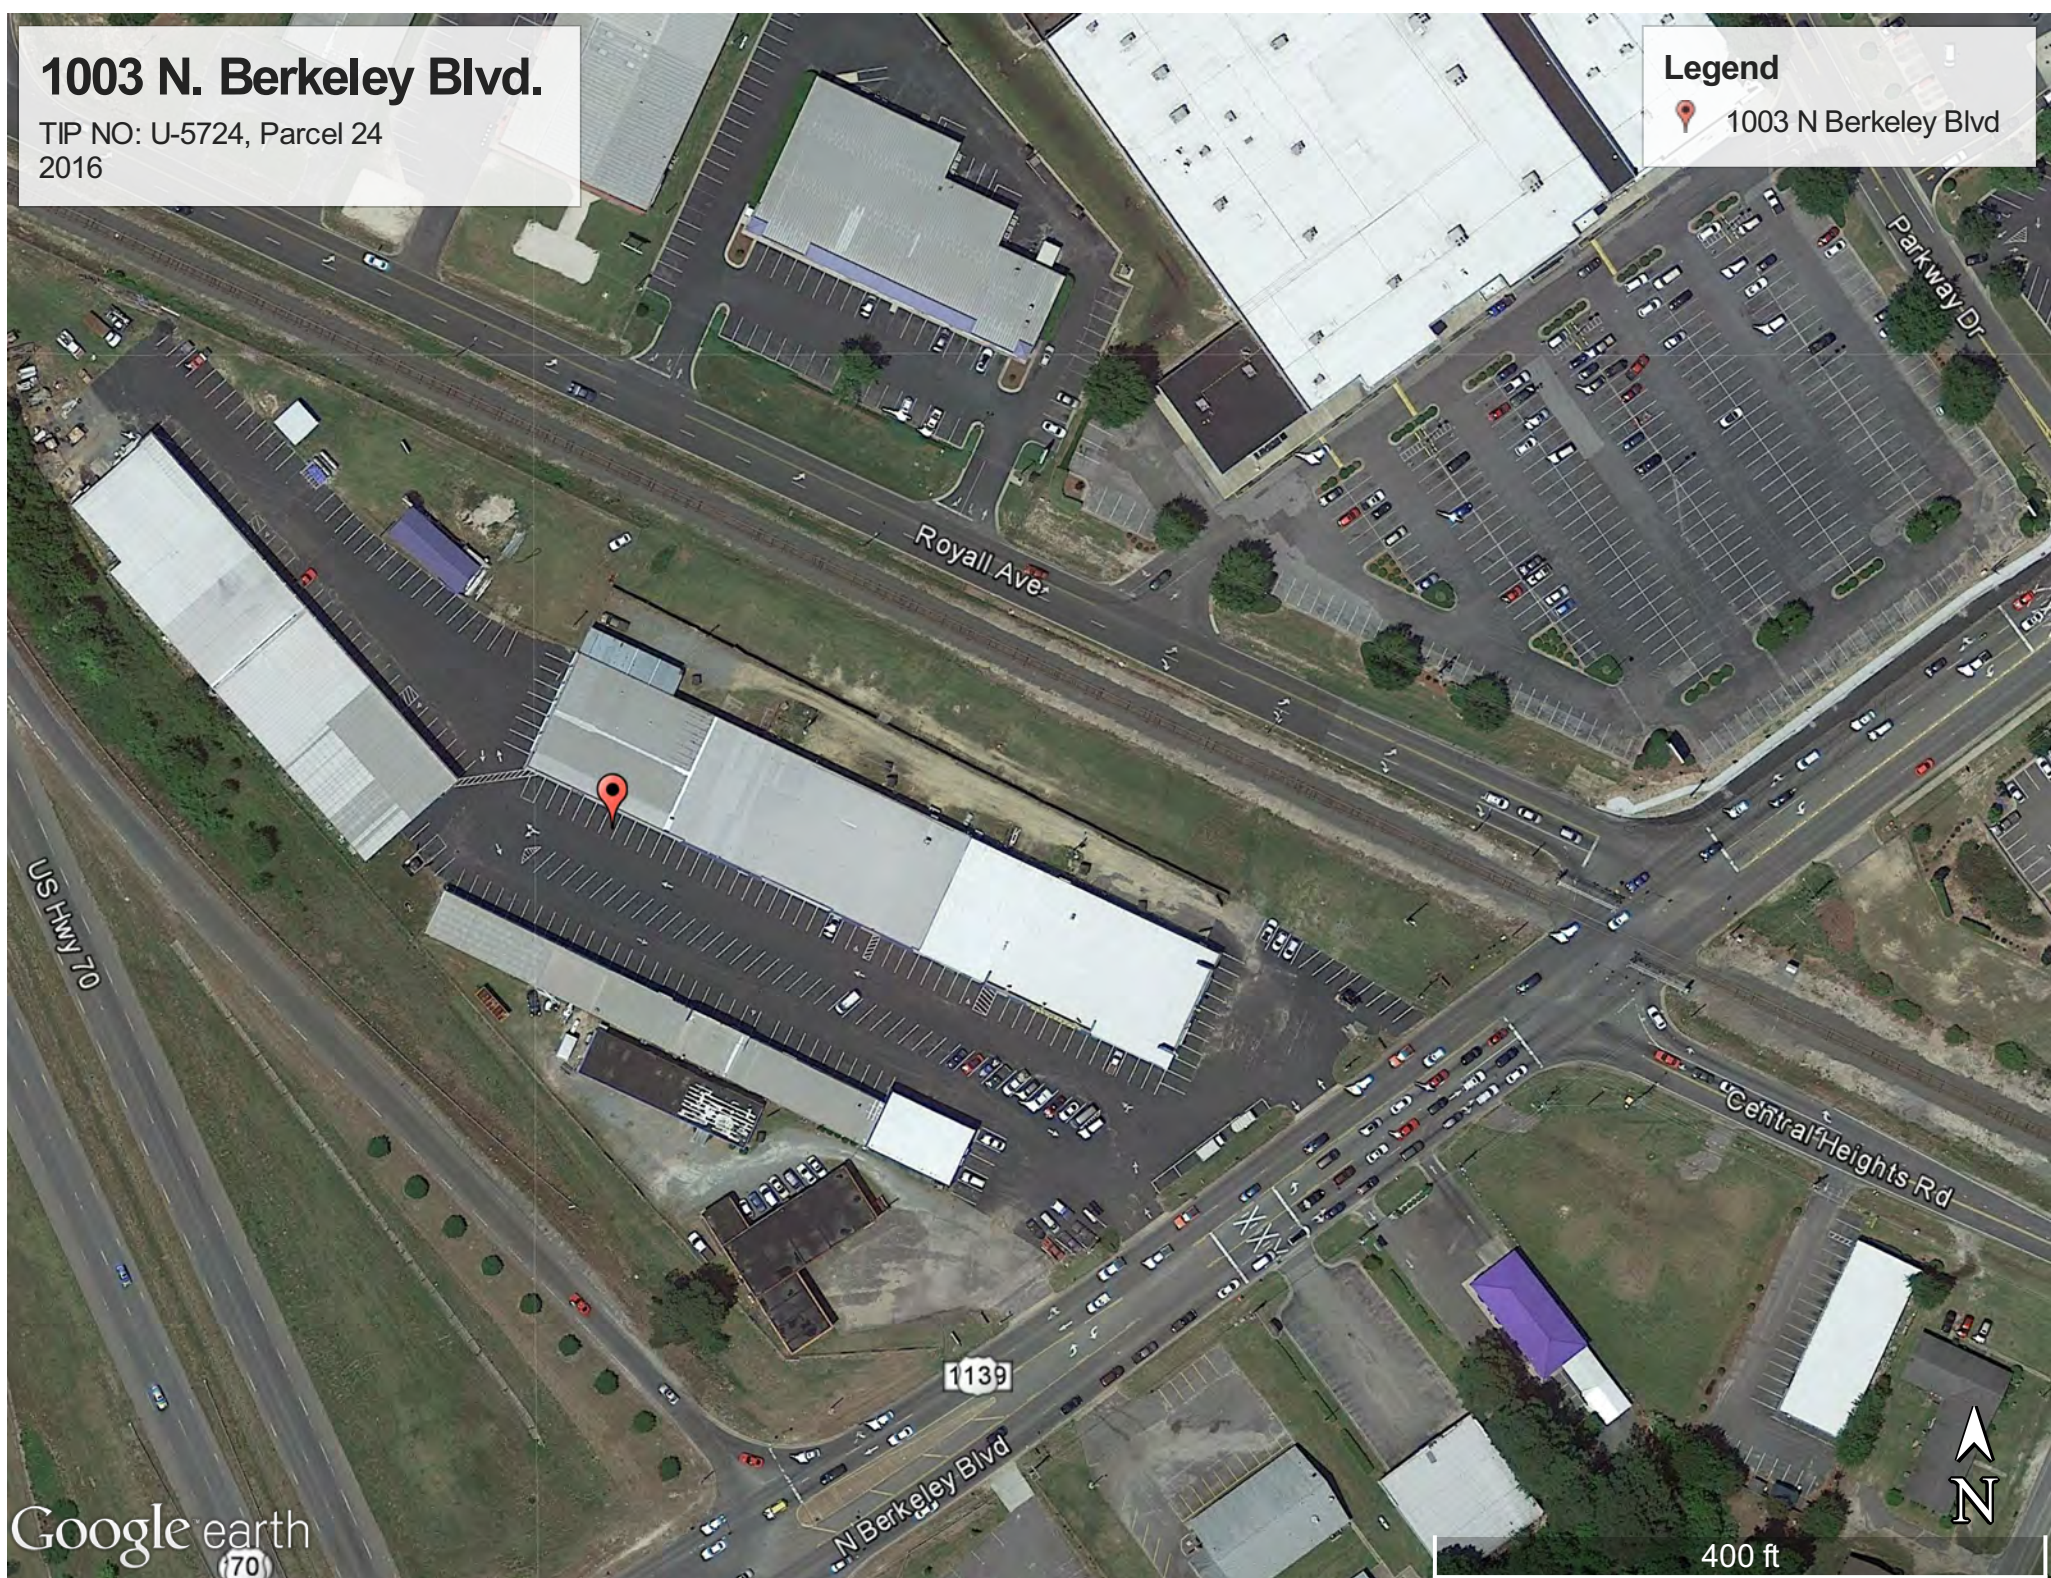
Photo 1 – A general view of site, looking west from Berkeley Boulevard.
(photo courtesy of Google Earth)

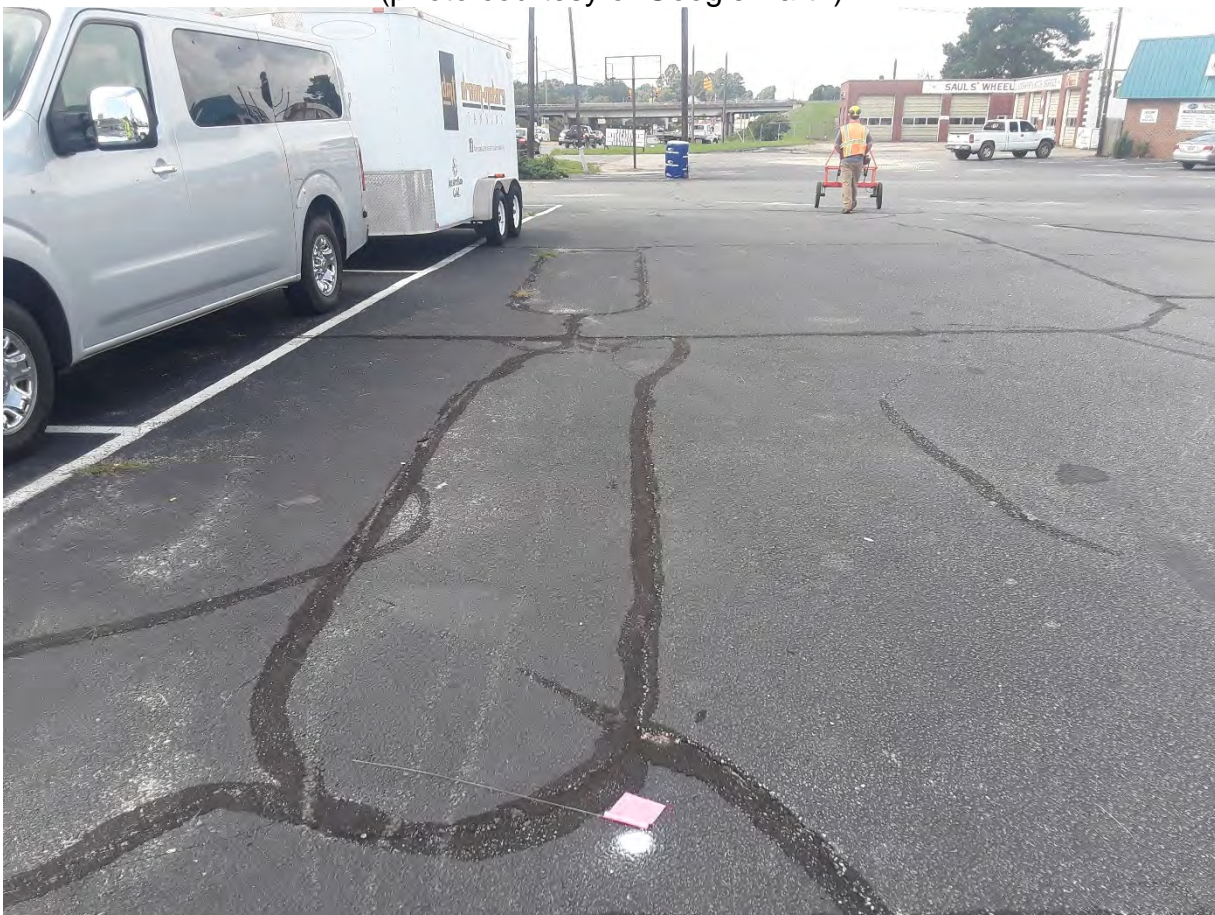
Photo 2 – Apparent former pump island area, looking southwest.

As shown in **Appendix C**, the geophysical survey found evidence characteristic of metal reinforcement (rebar or the like) beneath the apparent former pump island, but did not find evidence of USTs existing within the area of the survey. The USTs were reportedly removed in 1989.

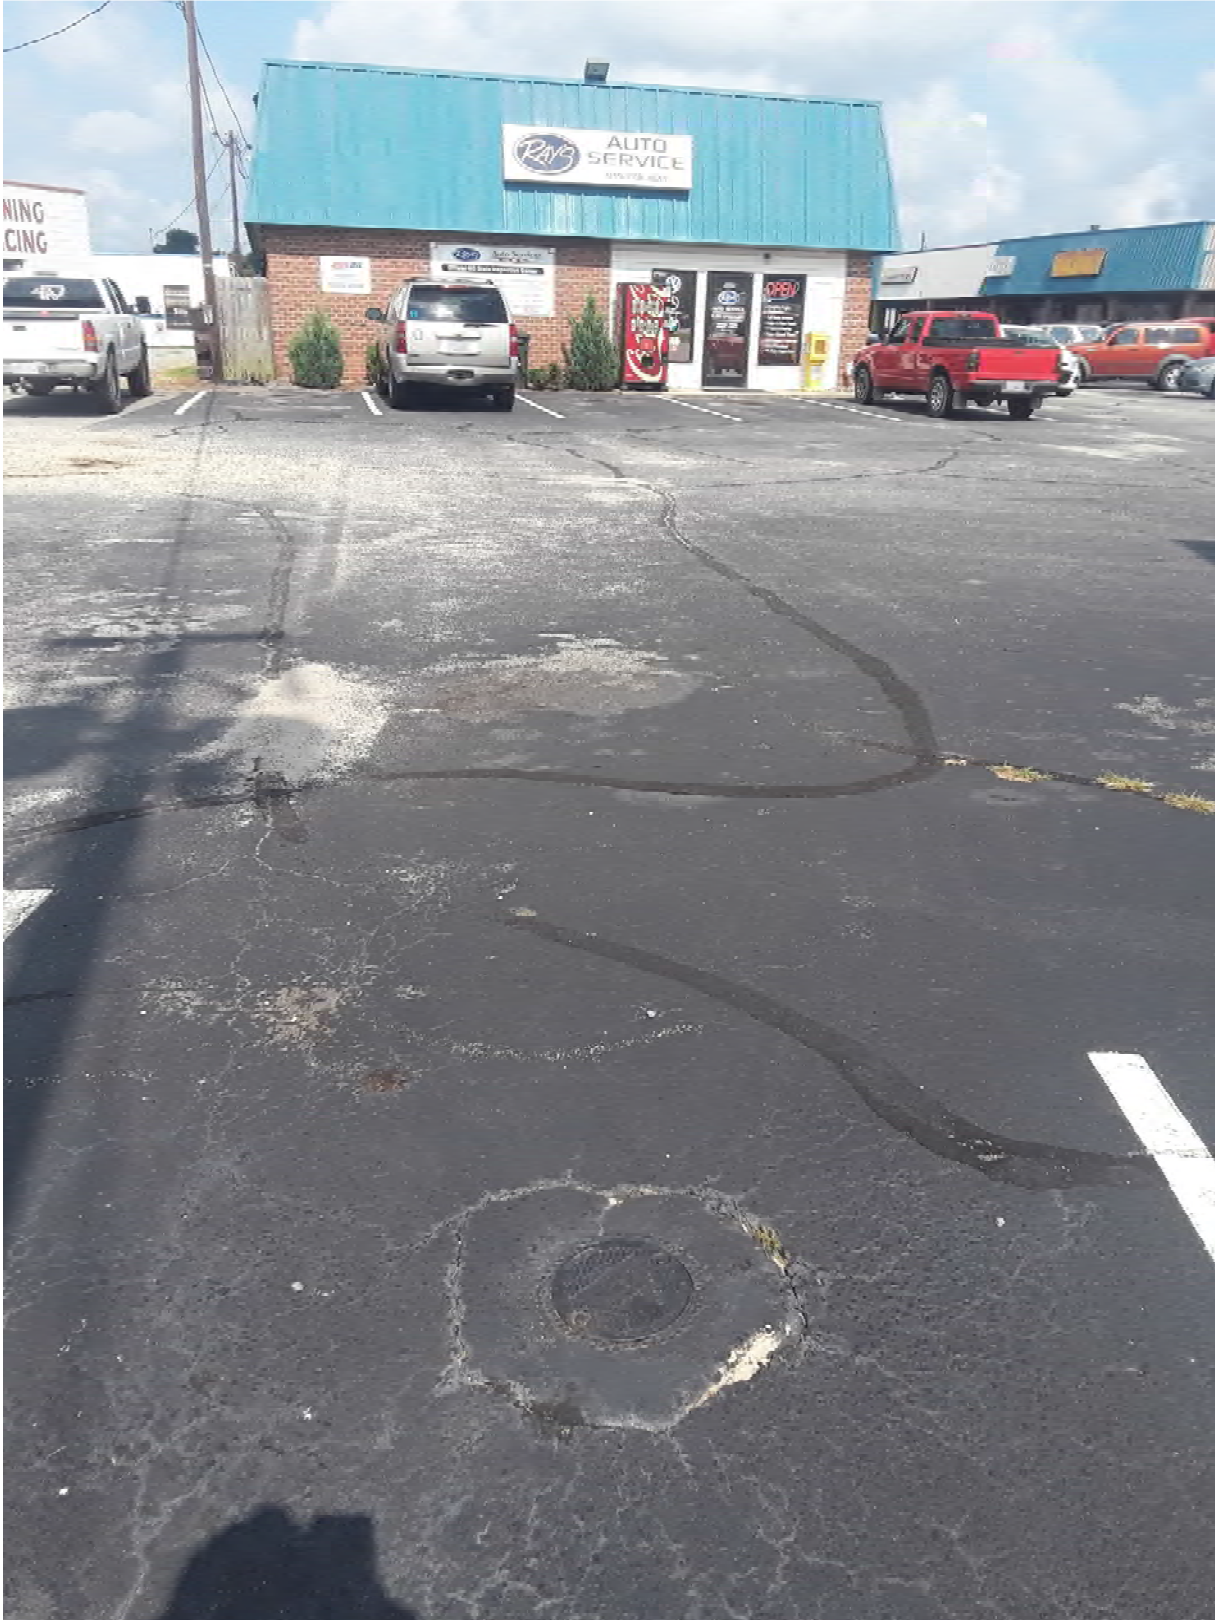
Photo 3 – A view of well MW-2 (not abandoned), looking northwest.

Mid-Atlantic observed several historical groundwater monitoring wells on the Subject Site, two of which were located in the proposed right of way acquisition area or temporary construction easement (MW-2 and MW-3). The locations of these wells are shown on **Drawing 3.1**. Mid-Atlantic's technician opened the well covers and discovered that the wells are two inches in diameter and constructed of PVC. Well construction records, which are shown in CES's CSA report in **Appendix A**, show the wells as 11 feet deep. The wells have not been abandoned and the manholes and pads are still intact. A copy of the 2013 Monitoring Report, which includes a site map showing the locations of the monitoring wells constructed in association with Incident No. 6695, is provided in **Appendix A**.

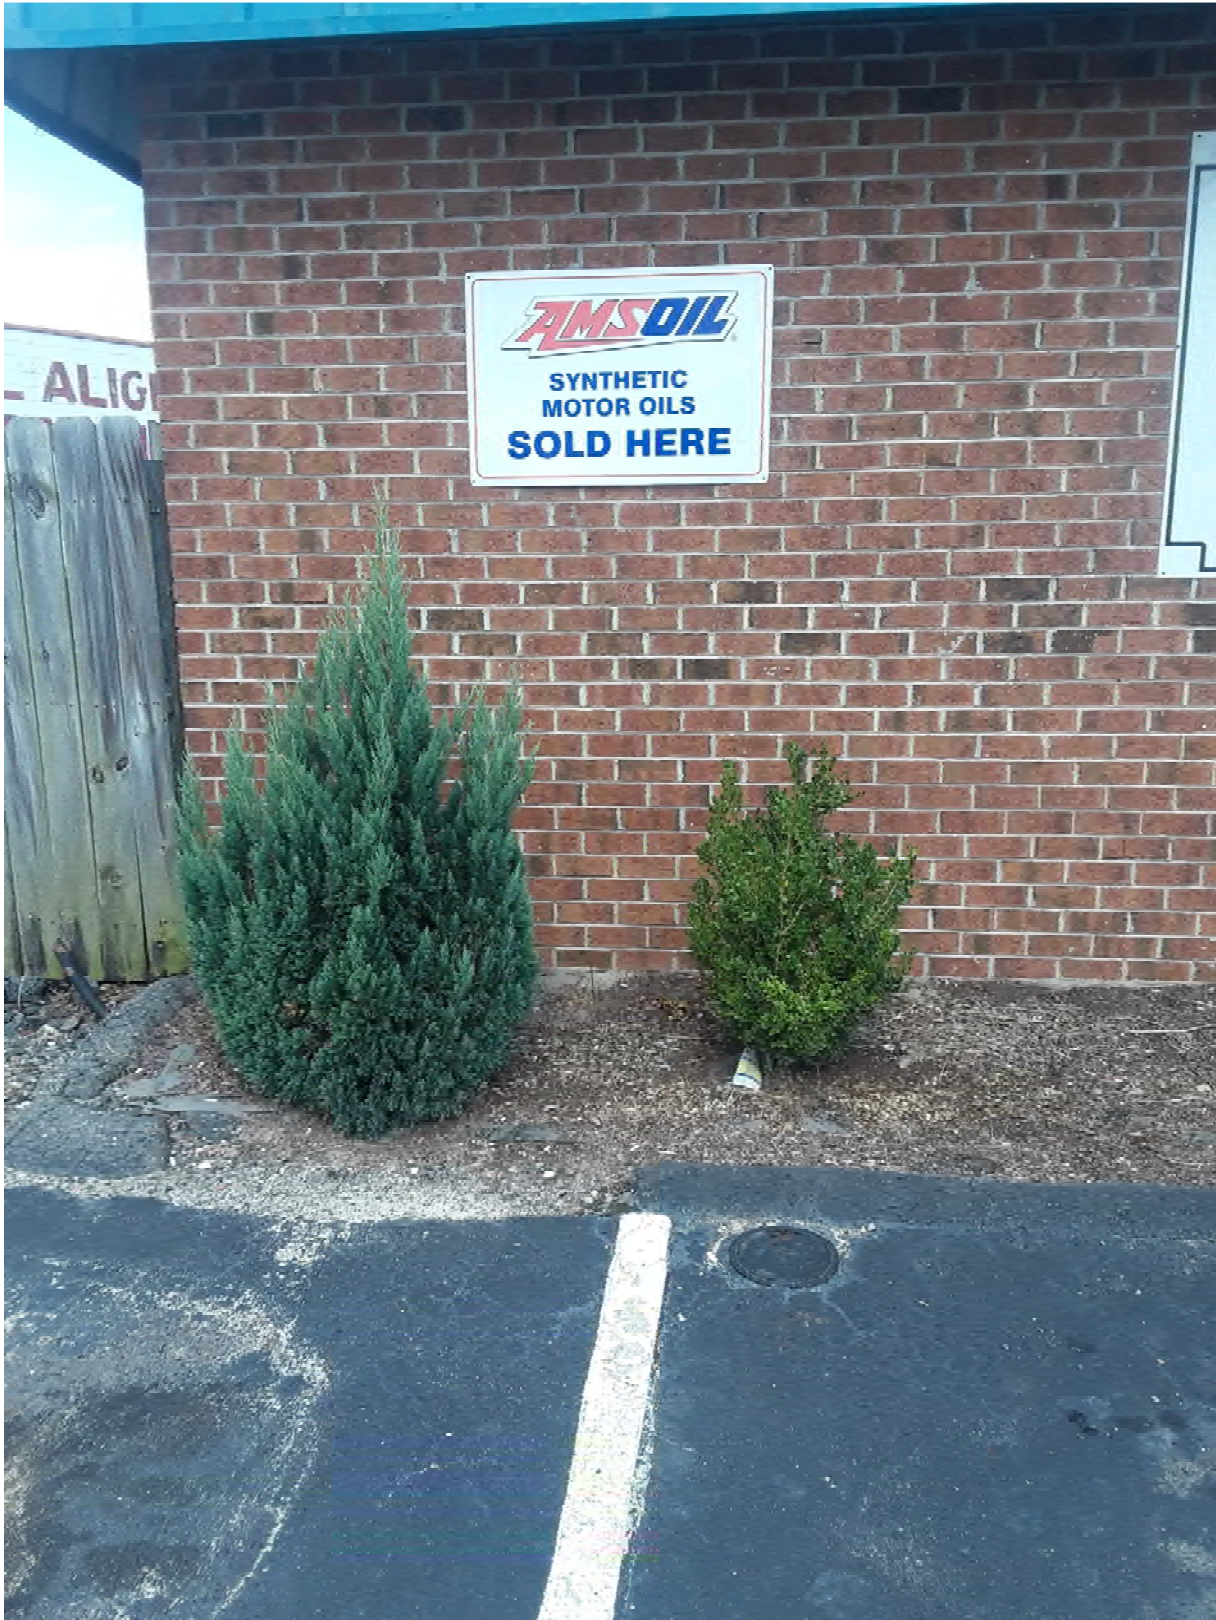
Photo 4 – A view of well MW-3 (not abandoned), adjacent to Ray's Auto, looking northwest.

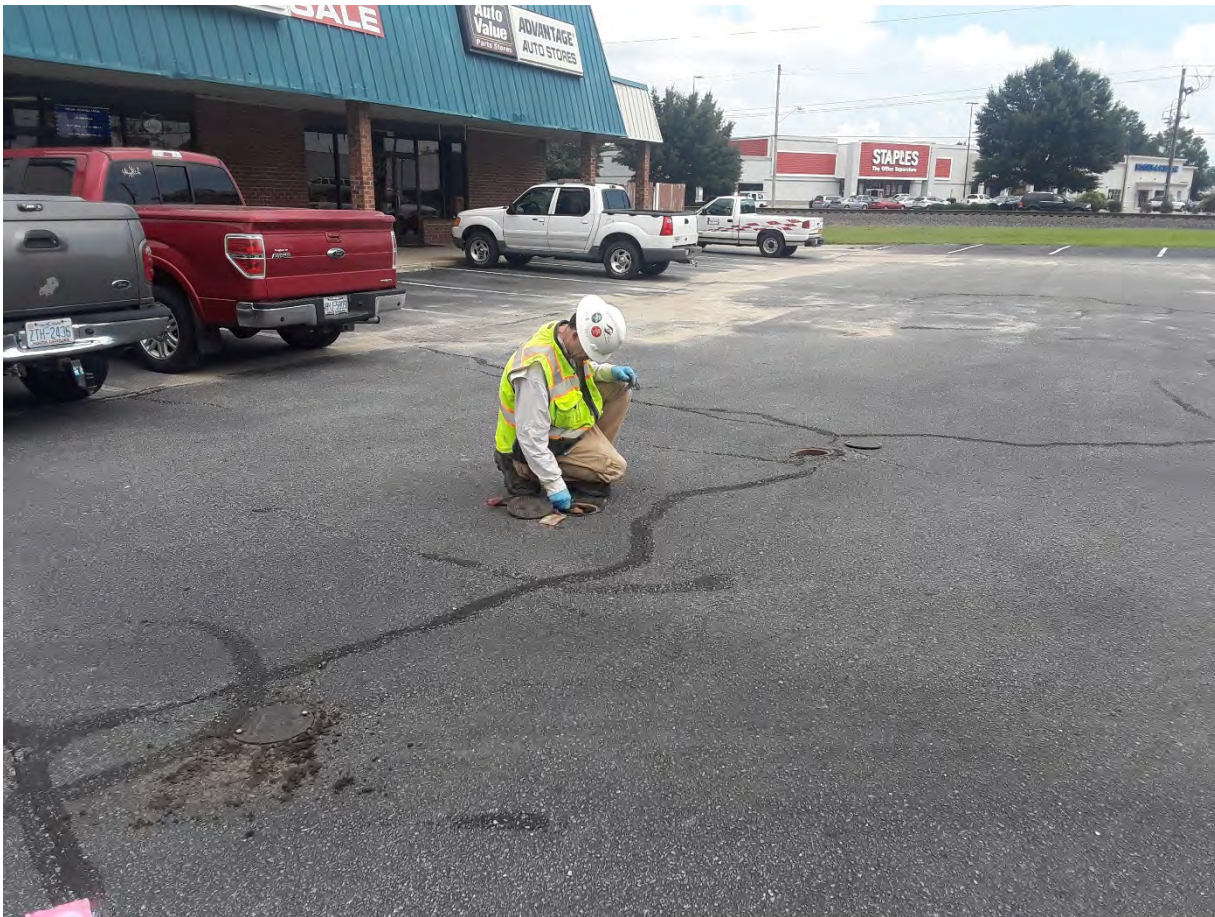
Photo 5 – A view of well MW-11A (middle, not abandoned) and two unknown wells (to the right and left of MW-11A), looking north.

Four additional monitoring wells were observed during the August 22, 2018 site reconnaissance. On the drawing provided in the 2013 Monitoring Report in **Appendix A**, two of these wells are listed as MW-5 (which is slightly outside of the parcel property line) and MW-11A. The other two wells, which are not on the drawing, are located close to MW-11A. The use of these wells is unknown. Monitoring well MW-4, which is shown on Drawing 3.1, could not be located.
