PRELIMINARY SITE ASSESSMENT REPORT
MALISSA B. SAULS PROPERTY
PARCEL NO 22

US 13 (Berkeley Blvd) – Realignment of SR 1709
(Central Heights Road) at Berkeley Blvd.
TIP No.: U-5724
WBS Element: 54016.1.2

Report Date: October 30, 2018
MAA Job #: 000R3203.00

PRELIMINARY SITE ASSESSMENT REPORT
DELMUS BRIDGERS-FAMILY LIMITED PARTNERSHIP PROPERTY
PARCEL NO 24

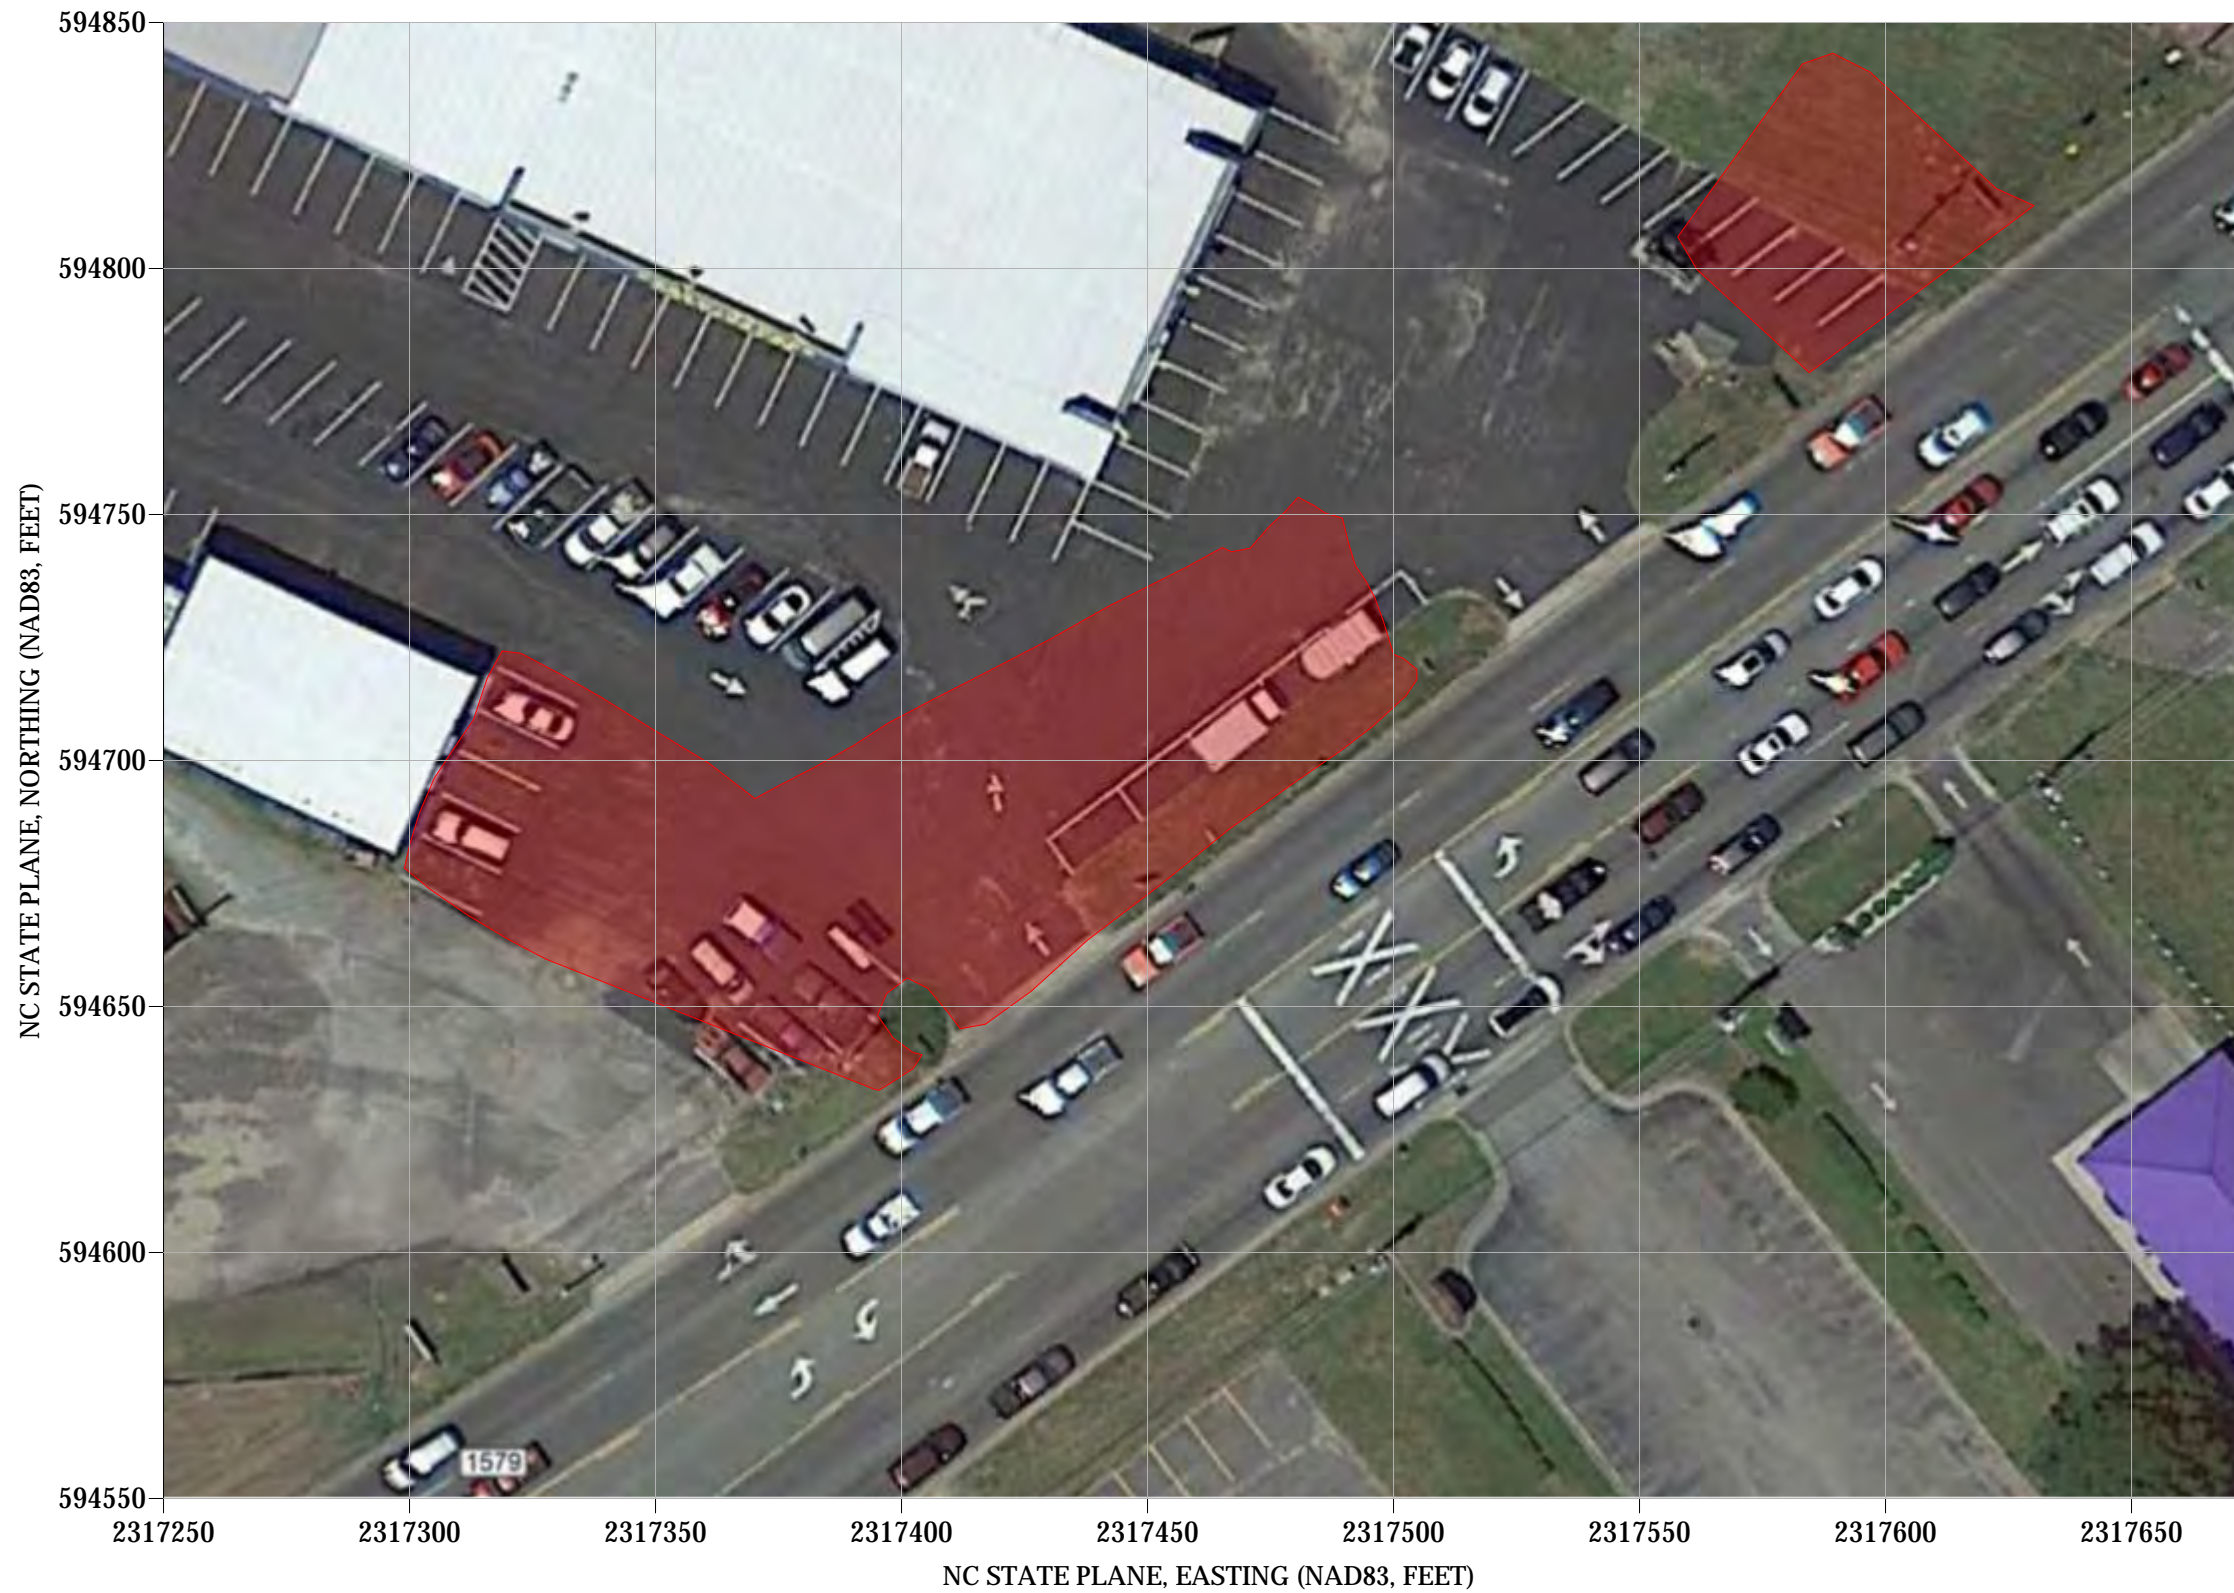
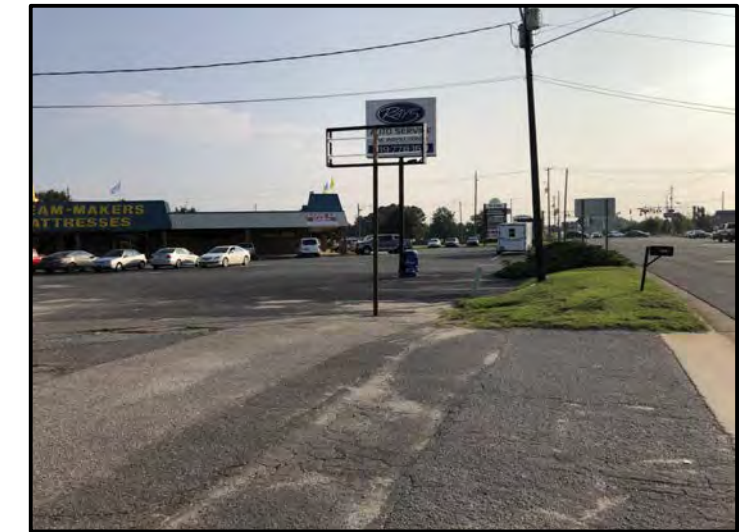
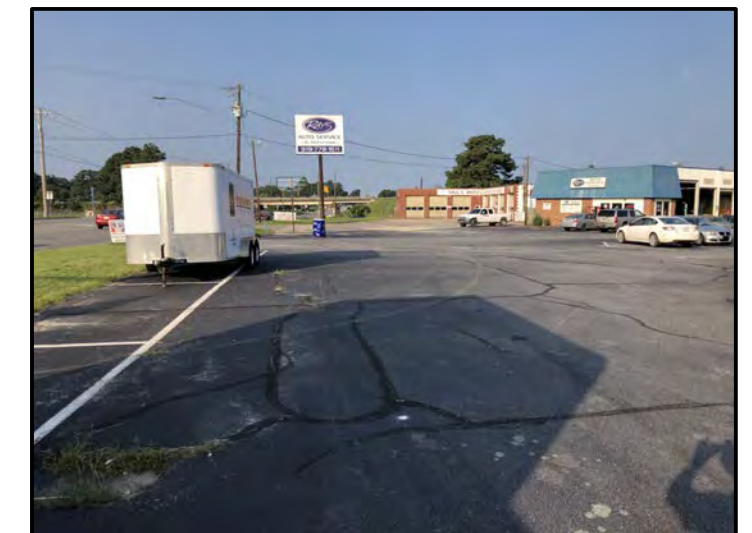
The site included an active service garage in a shopping plaza surrounded by grass, asphalt, and gravel surfaces. An aerial photograph showing the survey area boundaries and ground-level photographs are shown in **Figure 1**.

APPROXIMATE BOUNDARIES OF GEOPHYSICAL SURVEY AREA

View of Survey Area
(Facing Approximately Northeast)

View of Survey Area
(Facing Approximately Southwest)

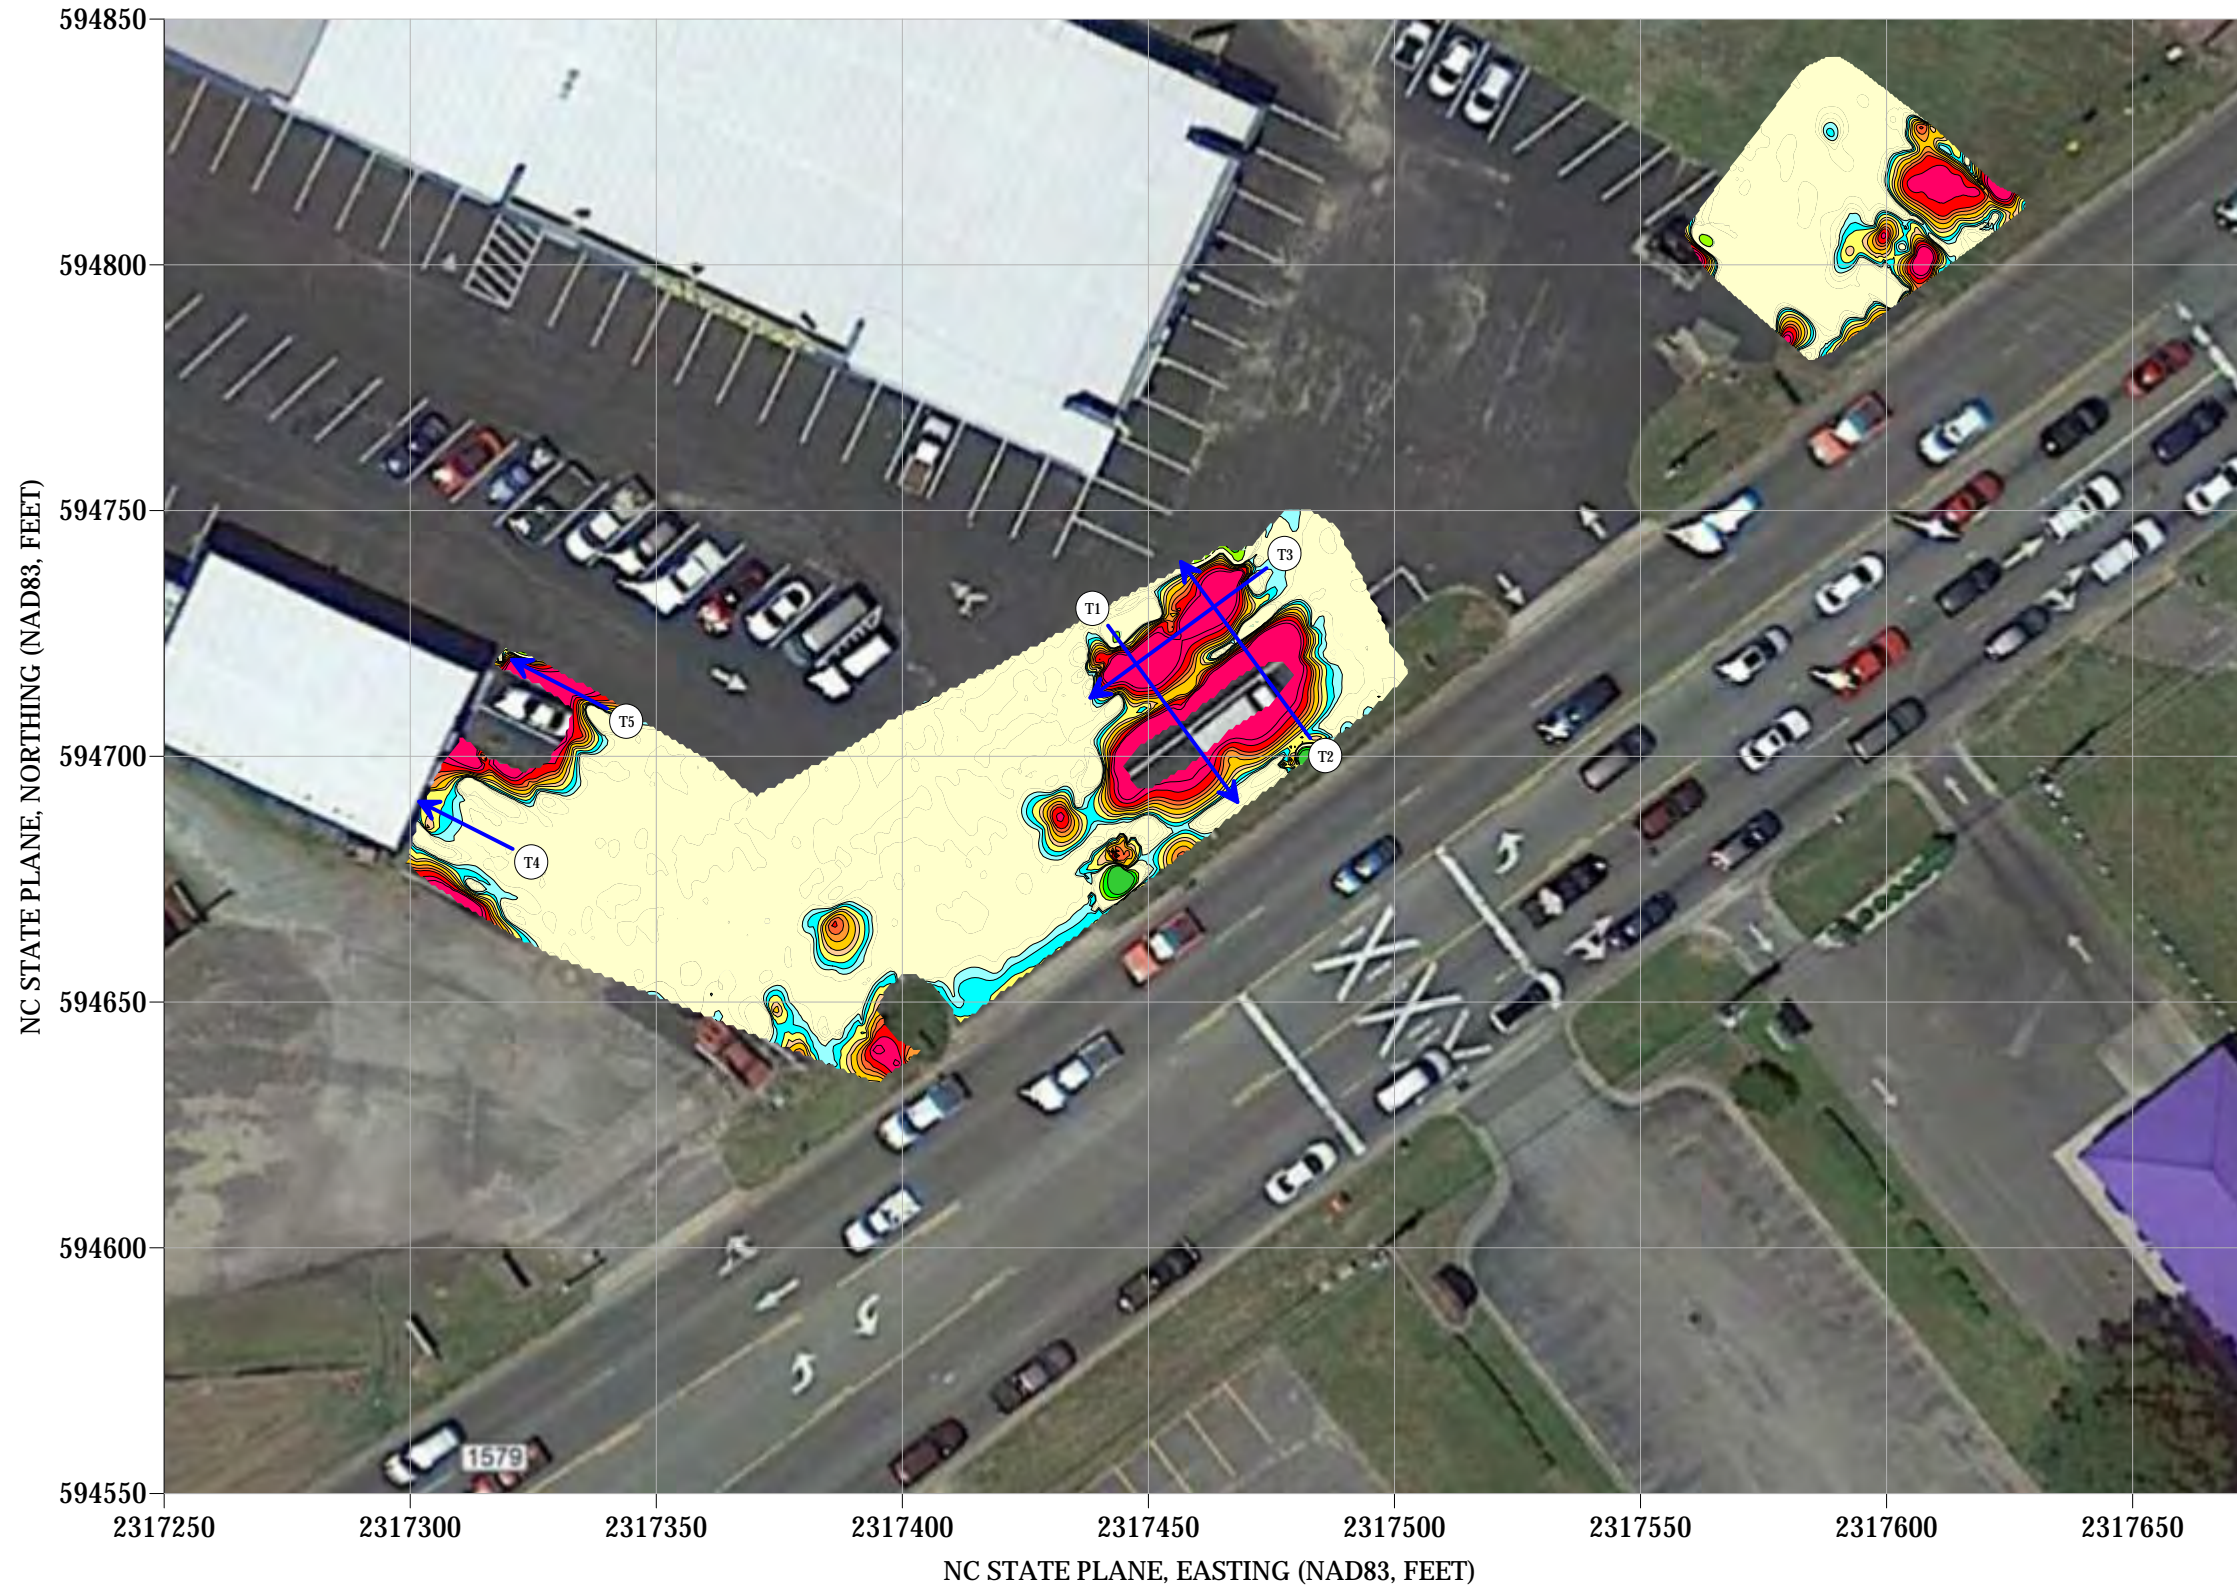
LOCATIONS OF GPR TRANSECTS

*EXTENSIVE GPR SCANS WERE CONDUCTED OVER THE ENTIRE SITE. TRANSECT LINES ON THE MAP ABOVE INDICATE LOCATIONS WHERE DATA WERE SAVED. THESE LOCATIONS WERE CHOSEN TO HIGHLIGHT STRUCTURES IDENTIFIED IN THE SUBSURFACE OR TRANSECTS THAT ARE REPRESENTATIVE OF GENERAL SUBSURFACE CONDITIONS.
