GEOENVIRONMENTAL PHASE II INVESTIGATION
PARCEL 001 – HUNTER & CYNTHIA WILLIARD
425 MAIN STREET
WALNUT COVE, STOKES COUNTY, NORTH CAROLINA
STATE PROJECT: R-5768
WBS ELEMENT: 44670.1.1
APRIL 30, 2019

METALLIC UST INVESTIGATION: PARCEL 1 NCDOT PROJECT R-5768 (44670.1.1)

GEOPHYSICAL INVESTIGATION REPORT
Parcel 1 – 425 Main Street
Walnut Cove, Stokes County, North Carolina

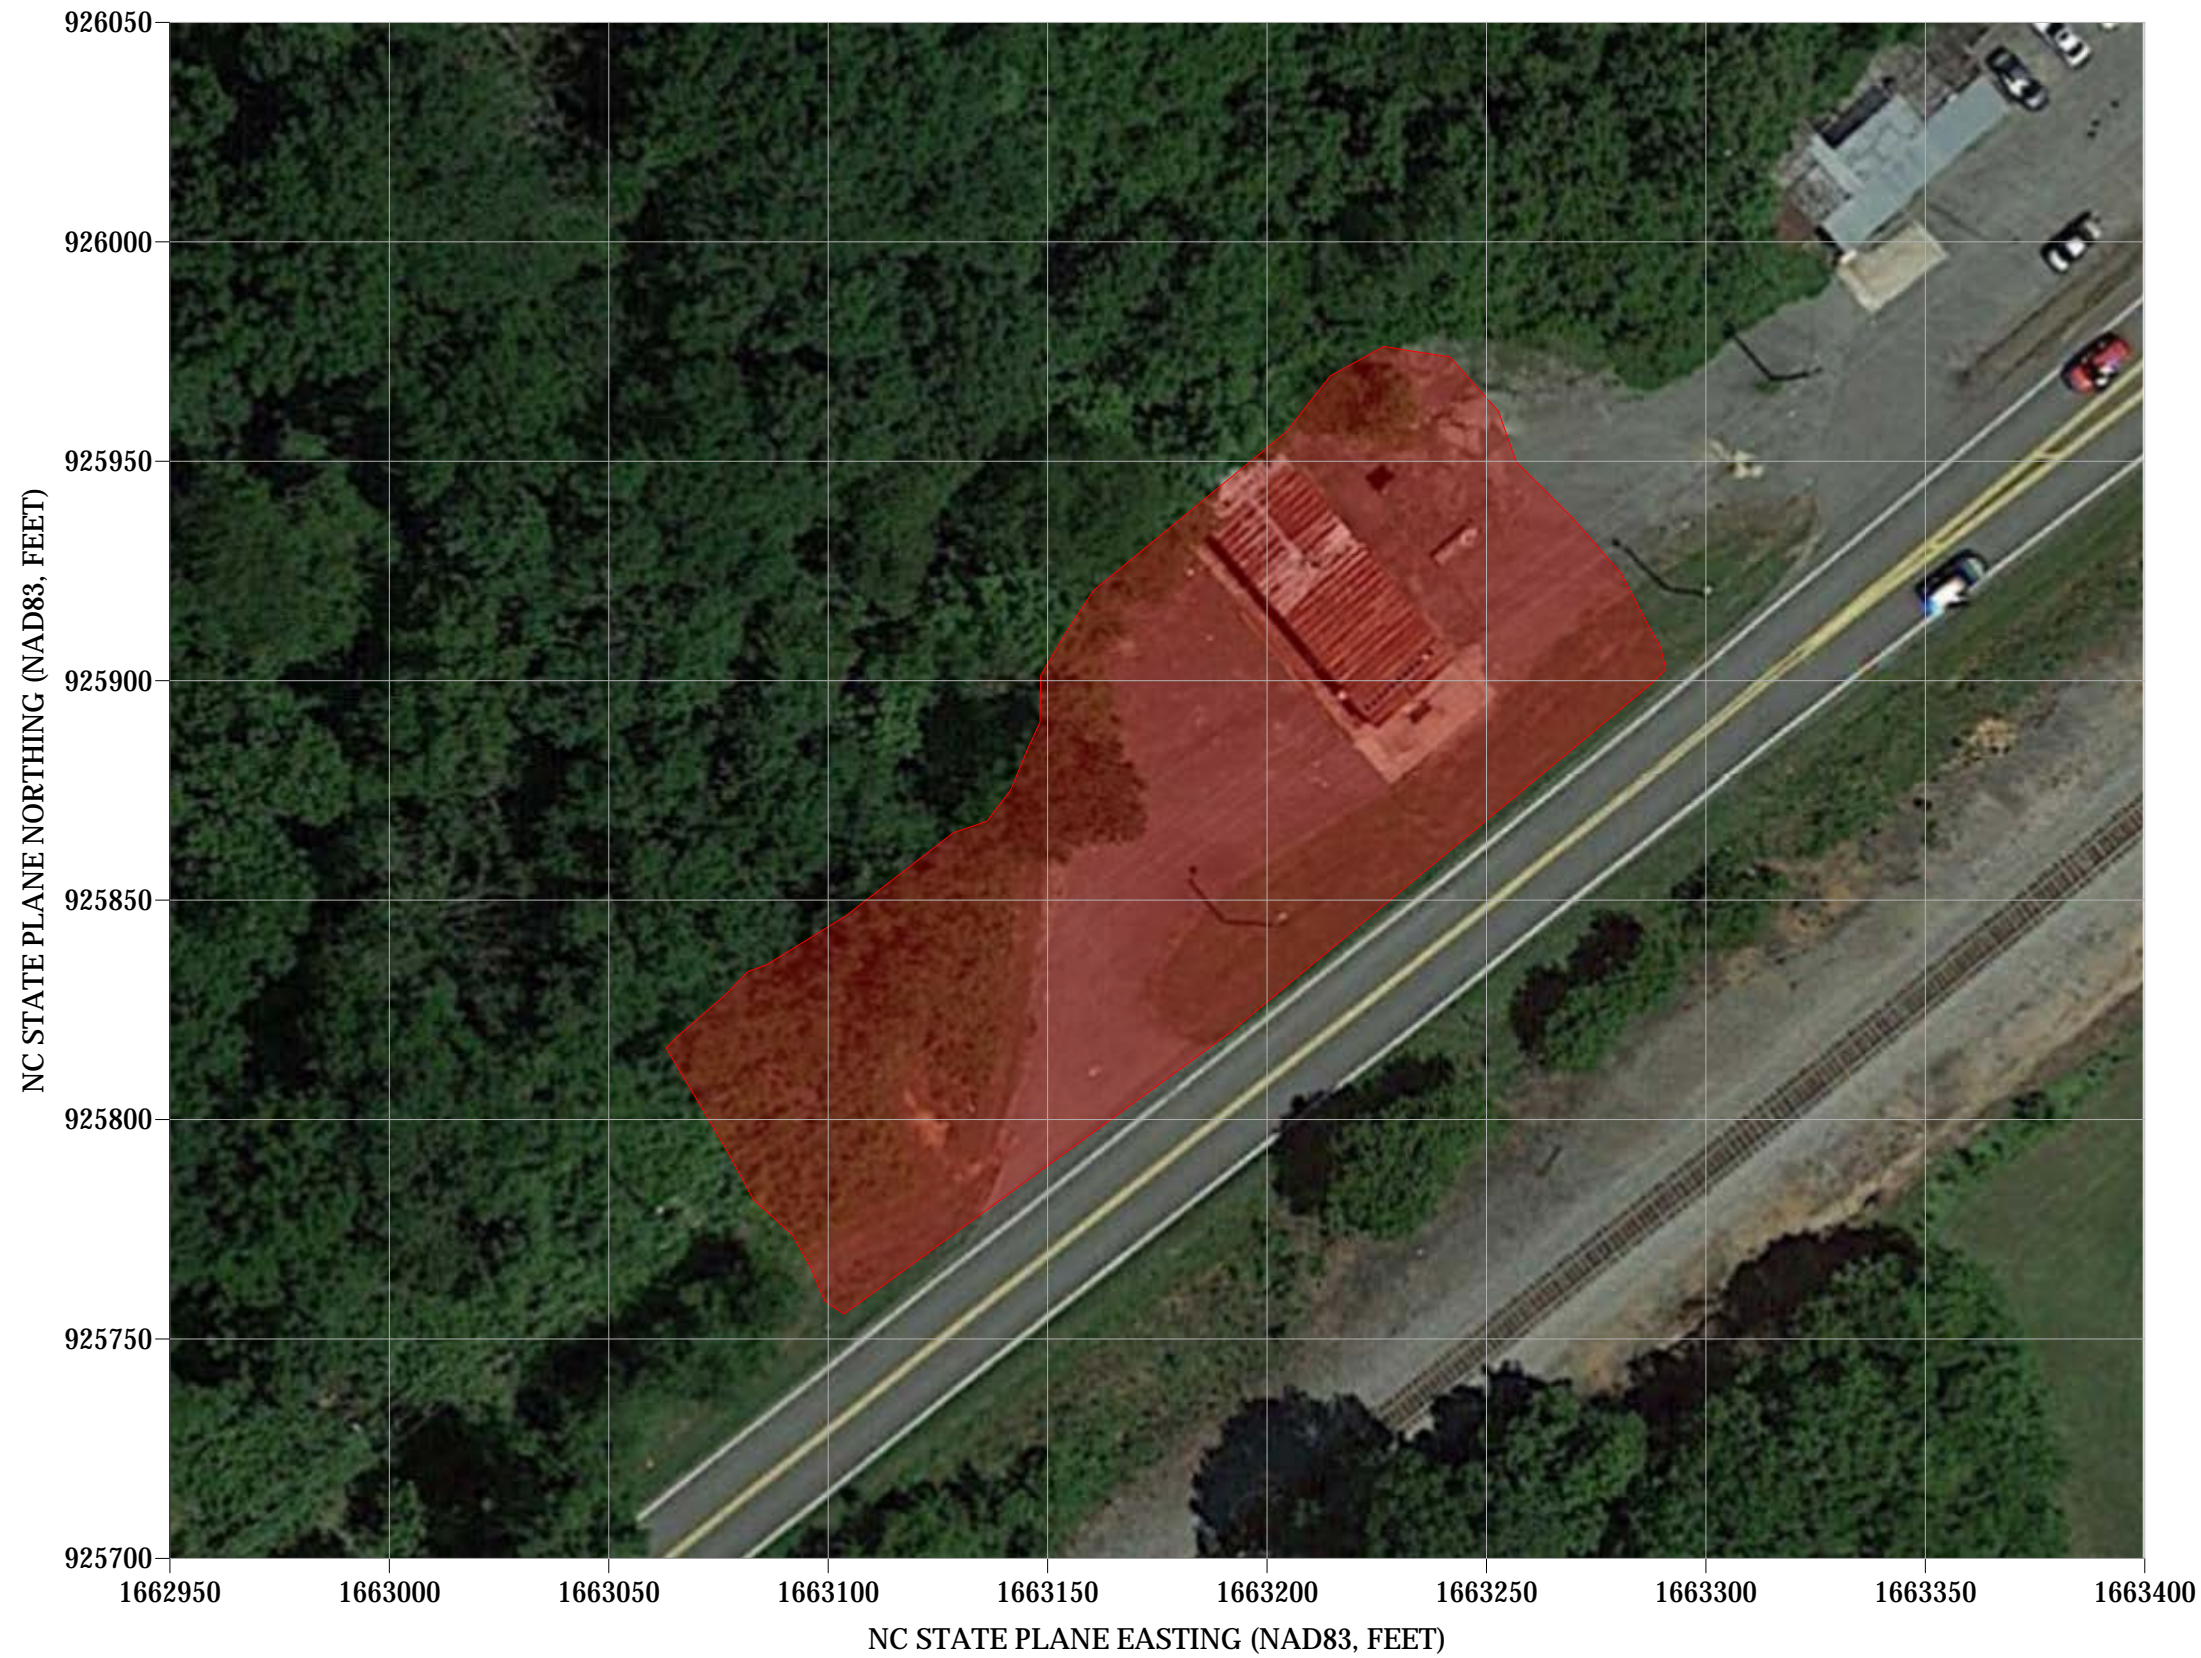
The site included a former car wash surrounded by asphalt and grass/dirt surfaces. An aerial photograph showing the survey area boundaries and ground-level photographs are shown in **Figure 1**.

APPROXIMATE BOUNDARIES OF GEOPHYSICAL SURVEY AREA

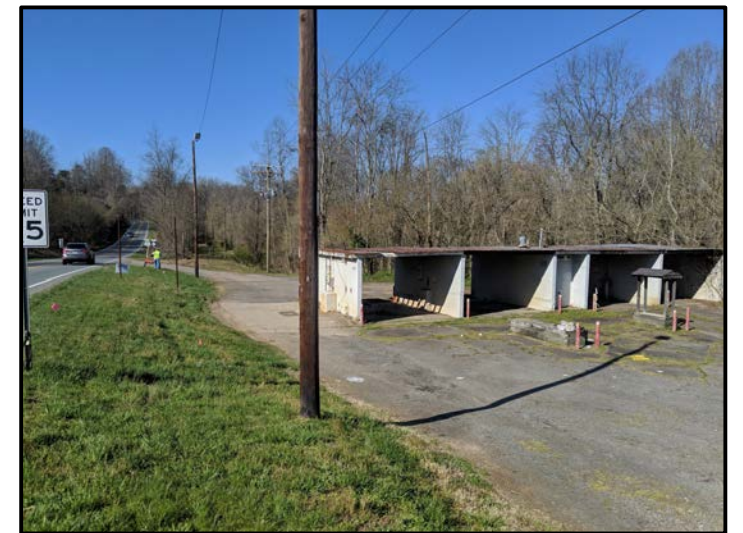
View of Survey Area
(Facing Approximately Southwest)

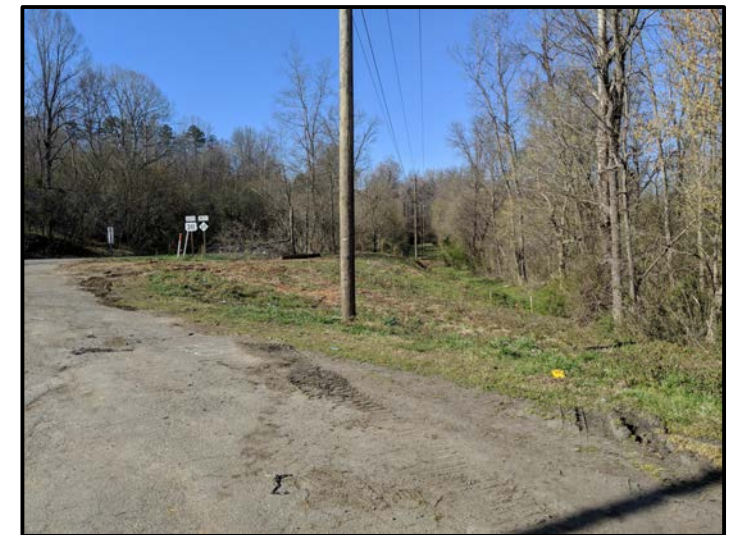
View of Survey Area
(Facing Approximately Southwest)

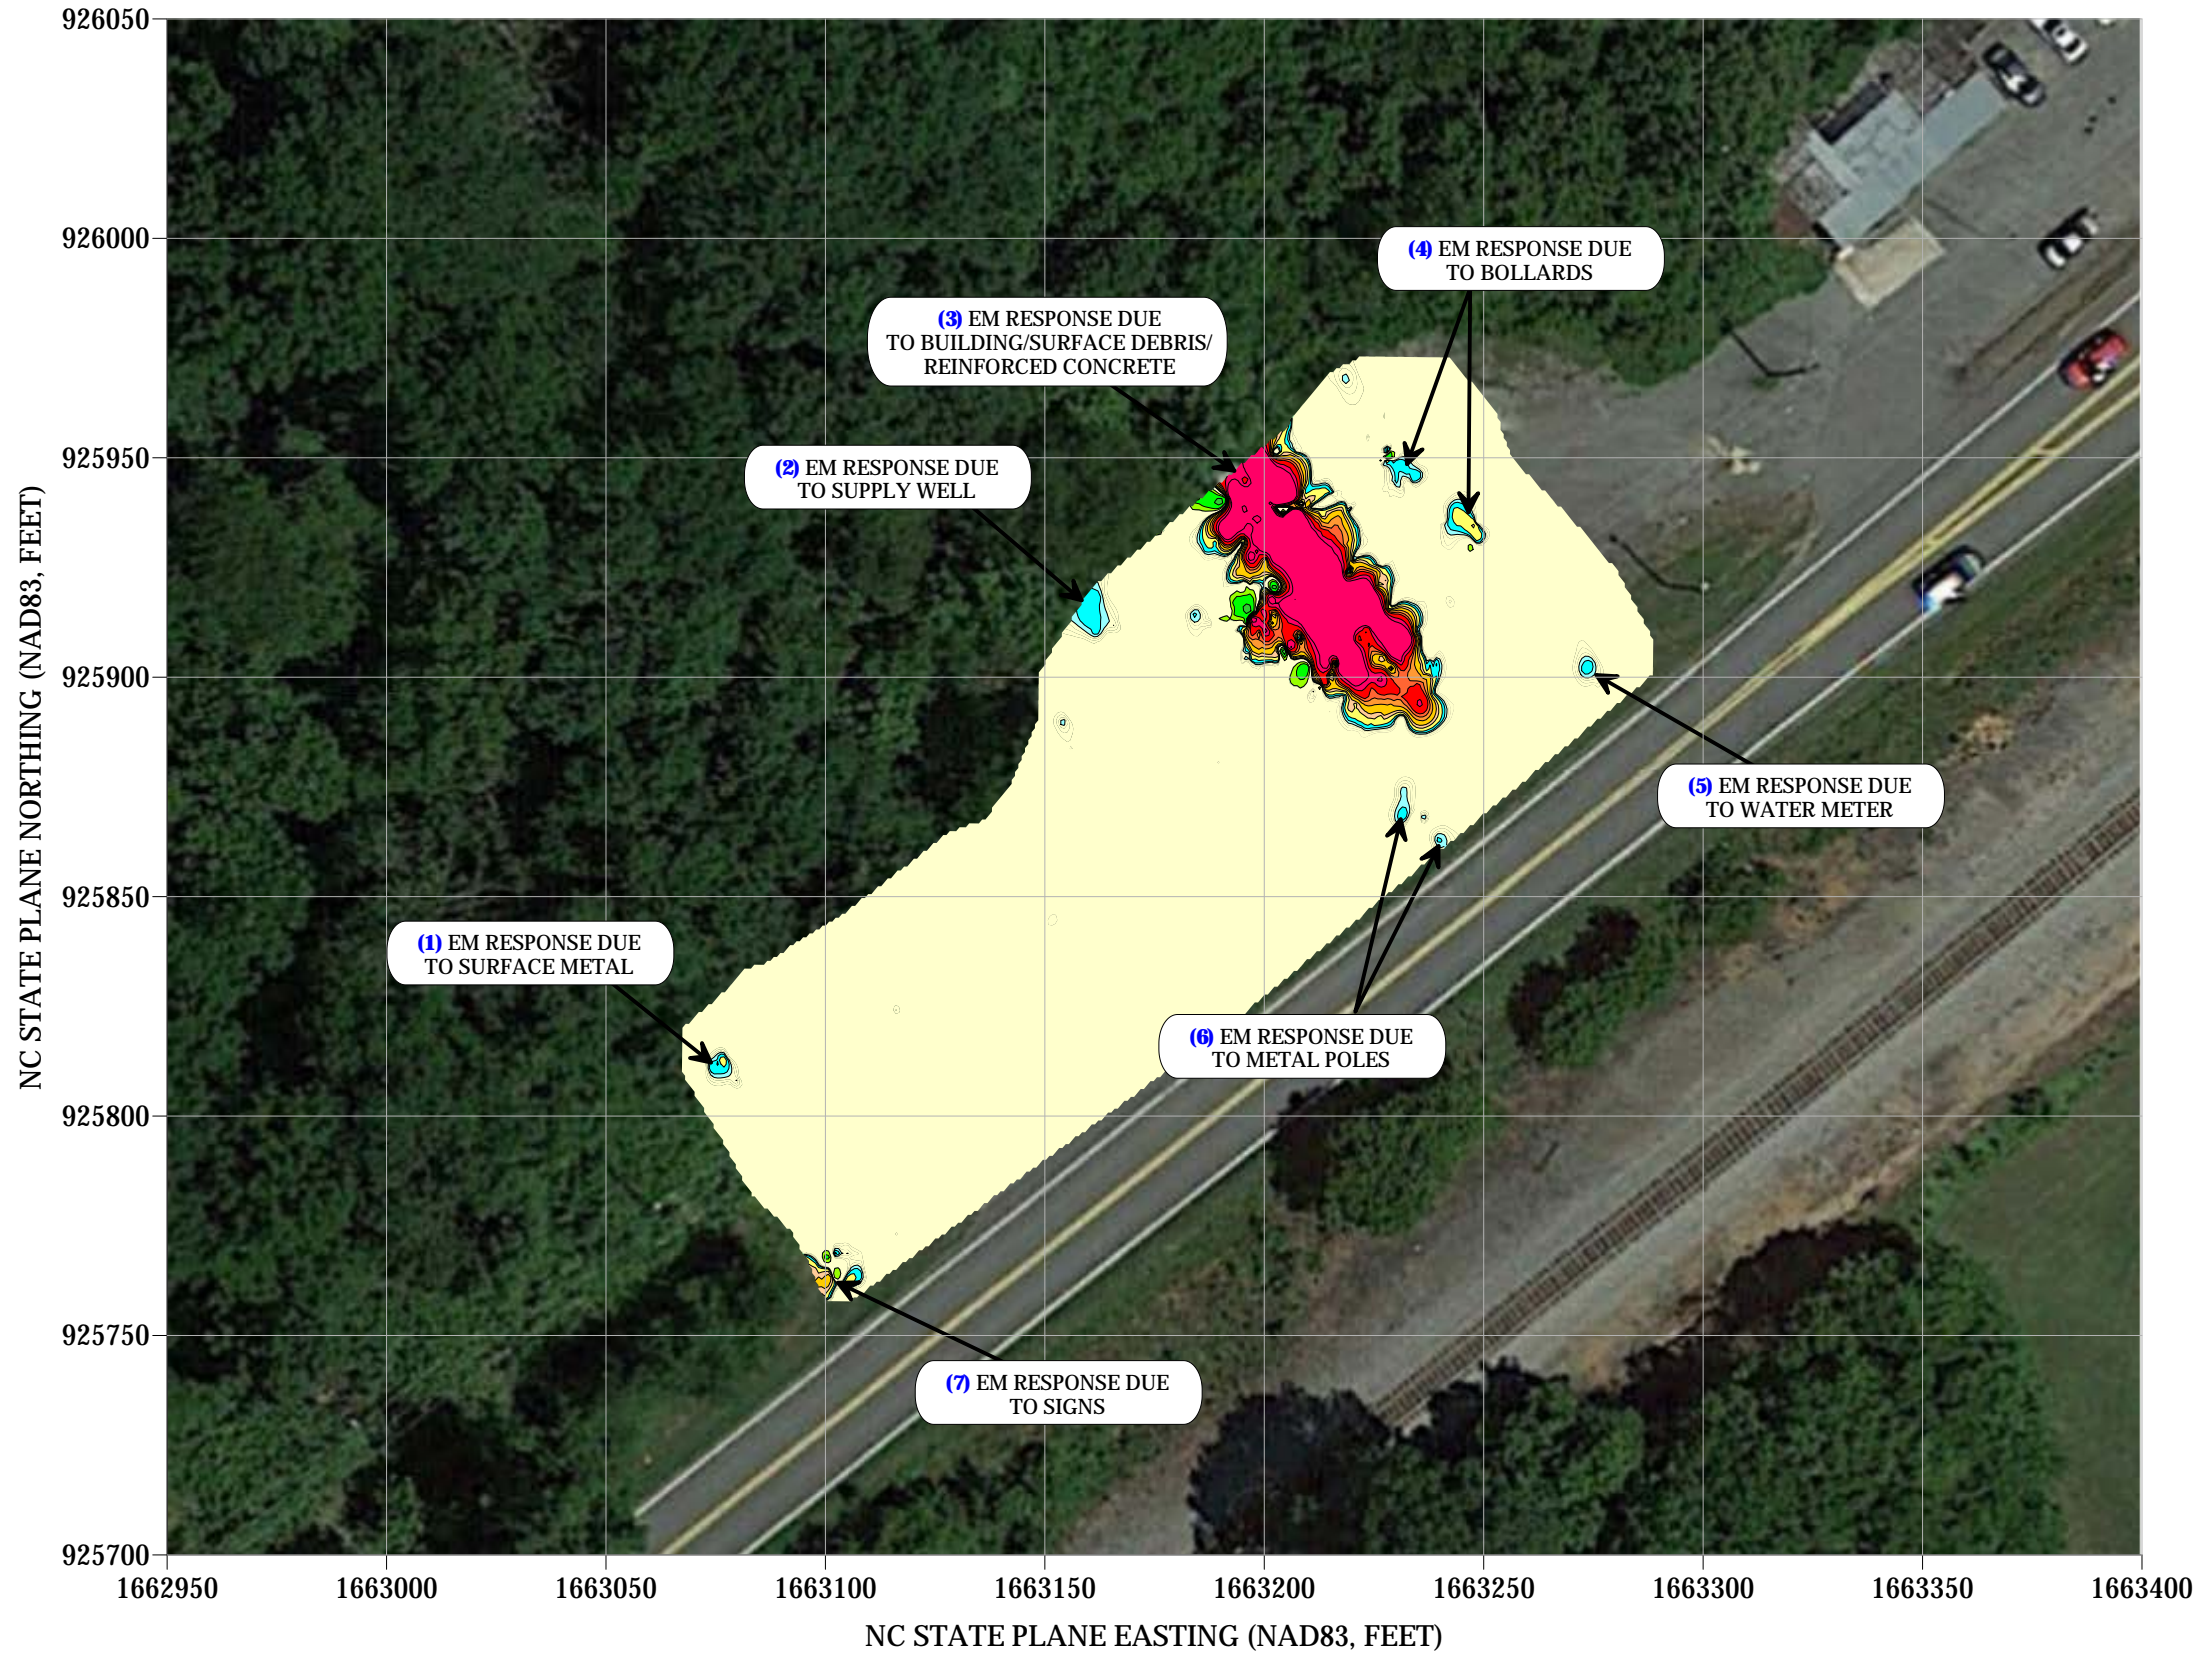
CLIENT
NCDOT
FIGURE 2

A contour plot of the EM61 results obtained across the survey area at the property is presented in **Figure 2**. Each EM anomaly is numbered for reference in the figure. The

NO EVIDENCE OF METALLIC USTs WAS OBSERVED.

The contour plot shows the differential results of the EM61 instrument in millivolts (mV). The differential results focus on larger metallic objects such as USTs and drums. The EM61 data were collected on April 3, 2019, using a Geonics EM61 instrument. Verification GPR data were collected using a GSSI UtilityScan DF instrument with a dual frequency 300/800 MHz antenna on April 3, 2019.

All of the EM anomalies were directly attributed to visible cultural features at the ground surface, including metal debris, a supply well, a building, reinforced concrete, bollards, a water meter, metal poles, and signs. EM Anomaly 3 was investigated with GPR to confirm that these surface features did not obscure any potential USTs and that there was reinforcement in the concrete slab.

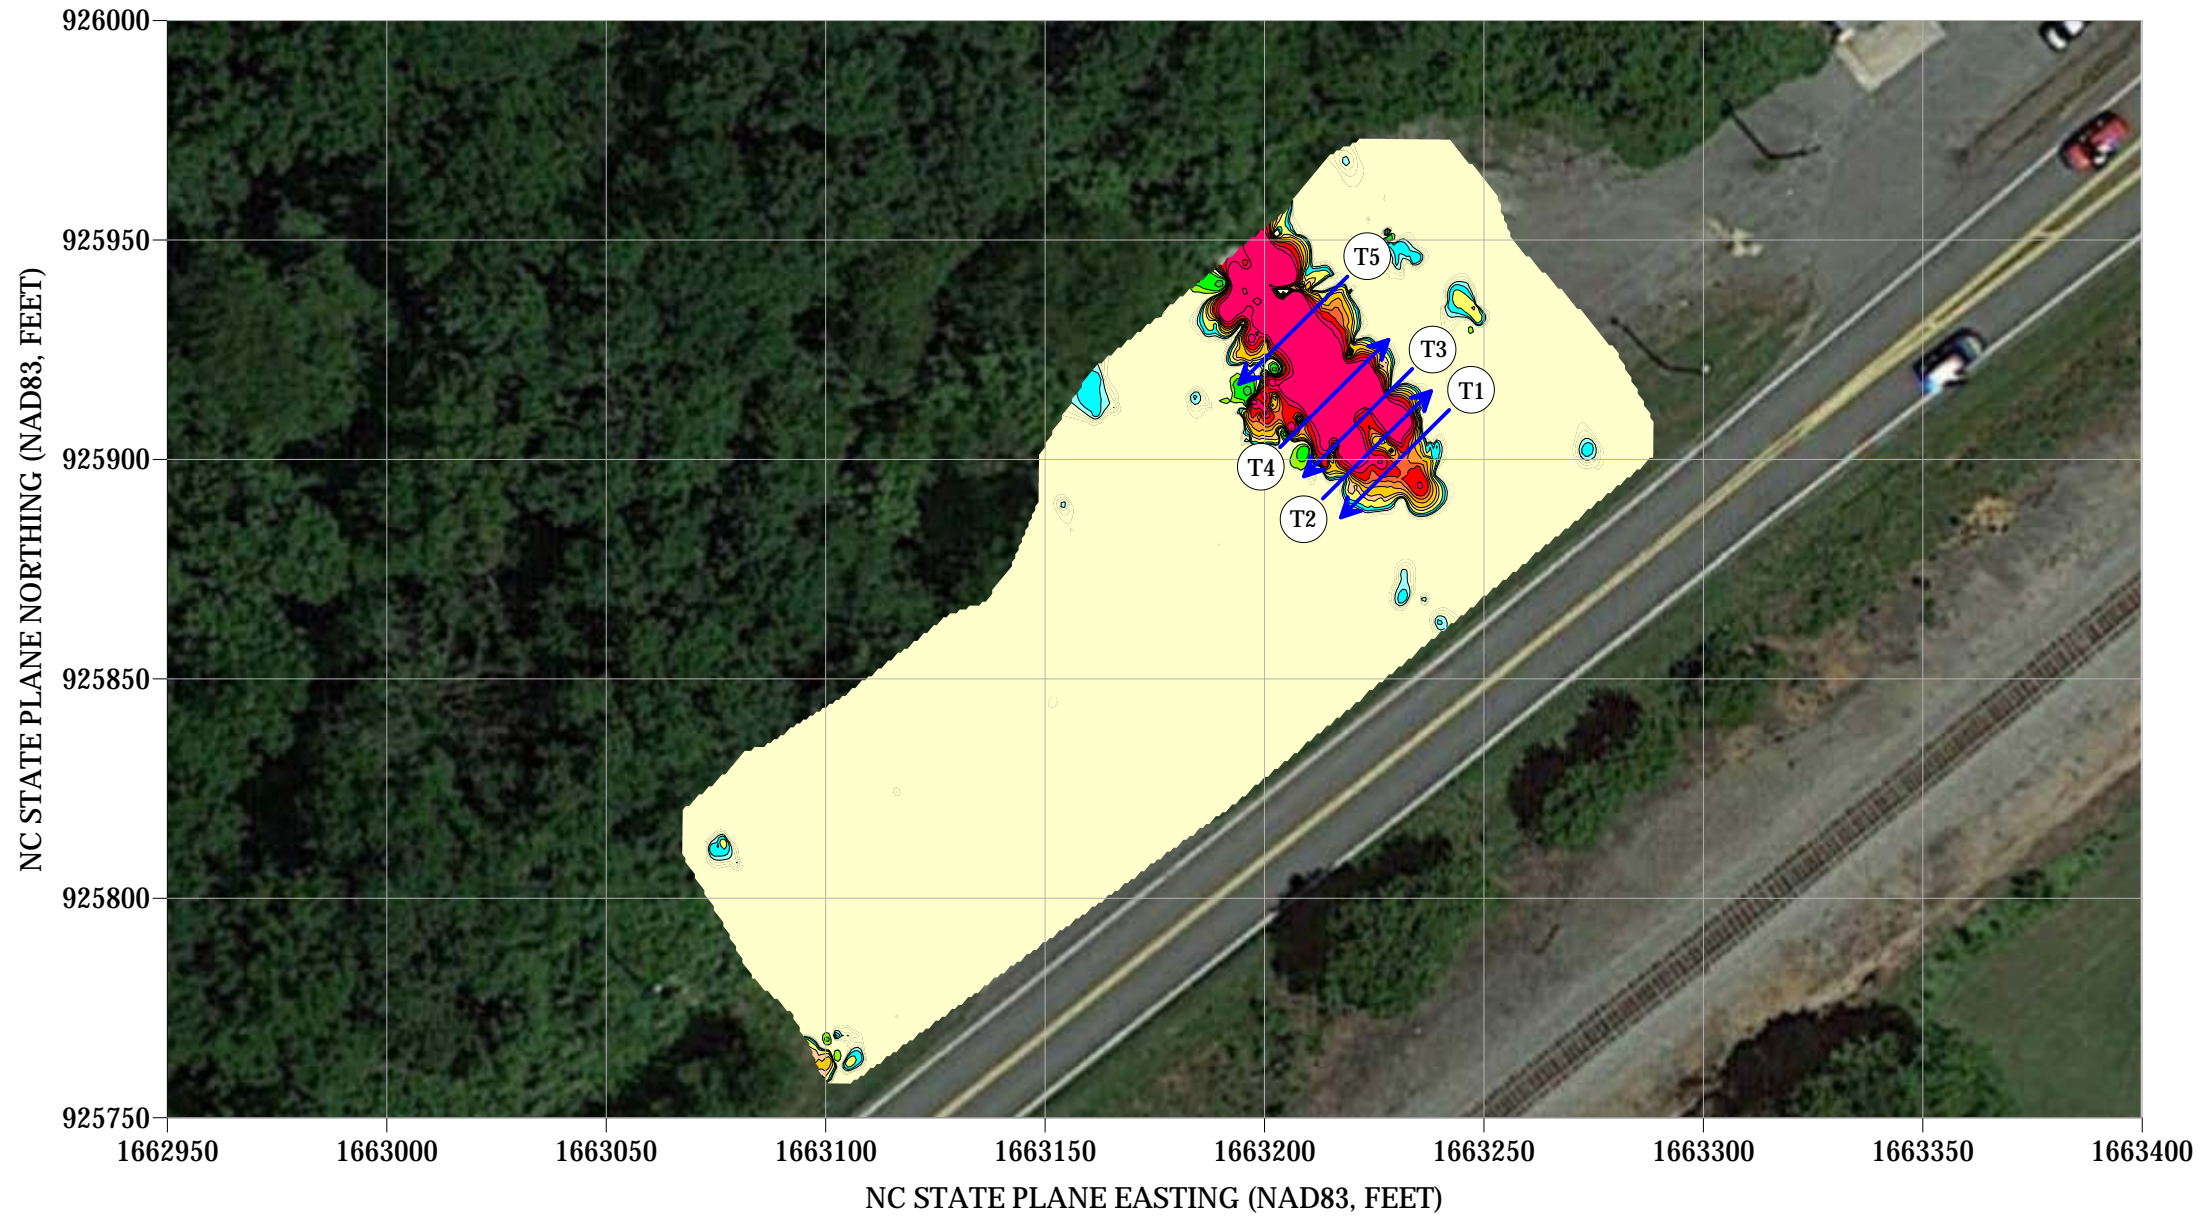
GPR TRANSECT LOCATIONS

Figure 3 presents the locations of the formal GPR transects performed at the property, as well as the transect images. A total of five formal GPR transects were performed at the site. GPR Transects 1-5 were performed across EM Anomaly 3. These transects confirmed the presence of reinforcement in the concrete slab. No evidence of any buried structures such as USTs was observed.
