GEOENVIRONMENTAL PHASE II INVESTIGATION
PARCEL 003 – DUANE SUTPHIN
407 MAIN STREET
WALNUT COVE, STOKES COUNTY, NORTH CAROLINA
STATE PROJECT: R-5768
WBS ELEMENT: 44670.1.1
APRIL 30, 2019

**GEOENVIRONMENTAL PHASE II INVESTIGATION
PARCEL 003 – DUANE SUTPHIN
407 MAIN STREET
WALNUT COVE, STOKES COUNTY, NORTH CAROLINA**

METALLIC UST INVESTIGATION: PARCEL 3 NCDOT PROJECT R-5768 (44670.1.1)

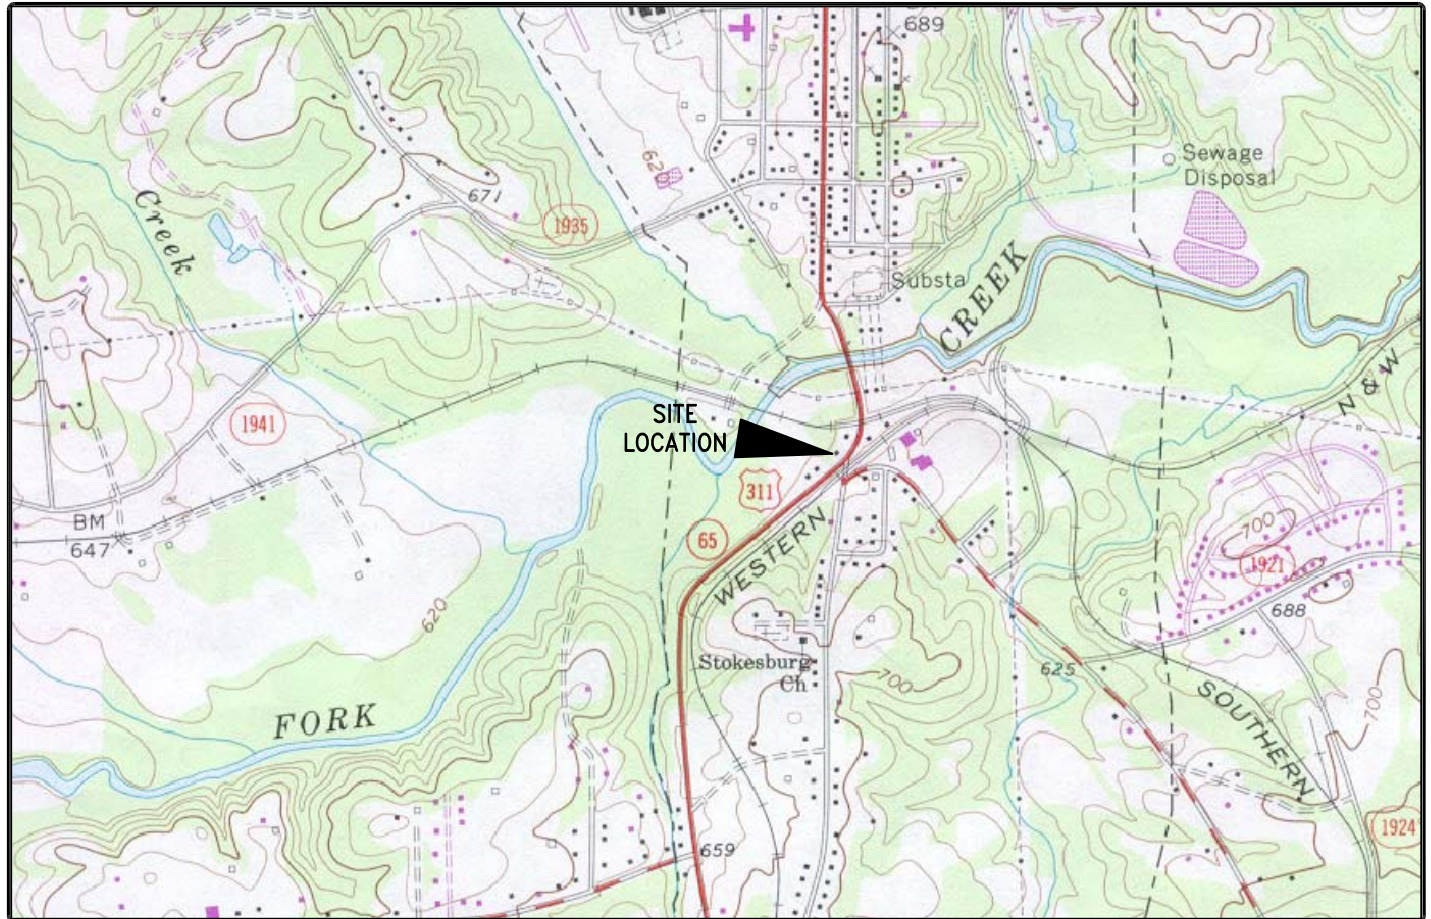
SCALE: 1"=2000'
 DATE: 4/4/19
 DRAWING NAME: USGSTOPO
 DRAWN BY: KAM
 CHECK BY: EC
 JOB NO.: 2019-074
 TYPE: PSA
 FIGURE NUMBER: 1

The purpose of this assessment was to determine the presence or absence of underground storage tanks (USTs) and impacted soils between the existing edge of pavement and the proposed Right-Of-Way (ROW) and/or easements, whichever distance was greater. The Phase II was conducted with particular attention to the areas to be cut as indicated by slope stake lines and cross-sections or to be excavated for the installation of drainage features. The location of the subject site is shown on **Figure 1**.

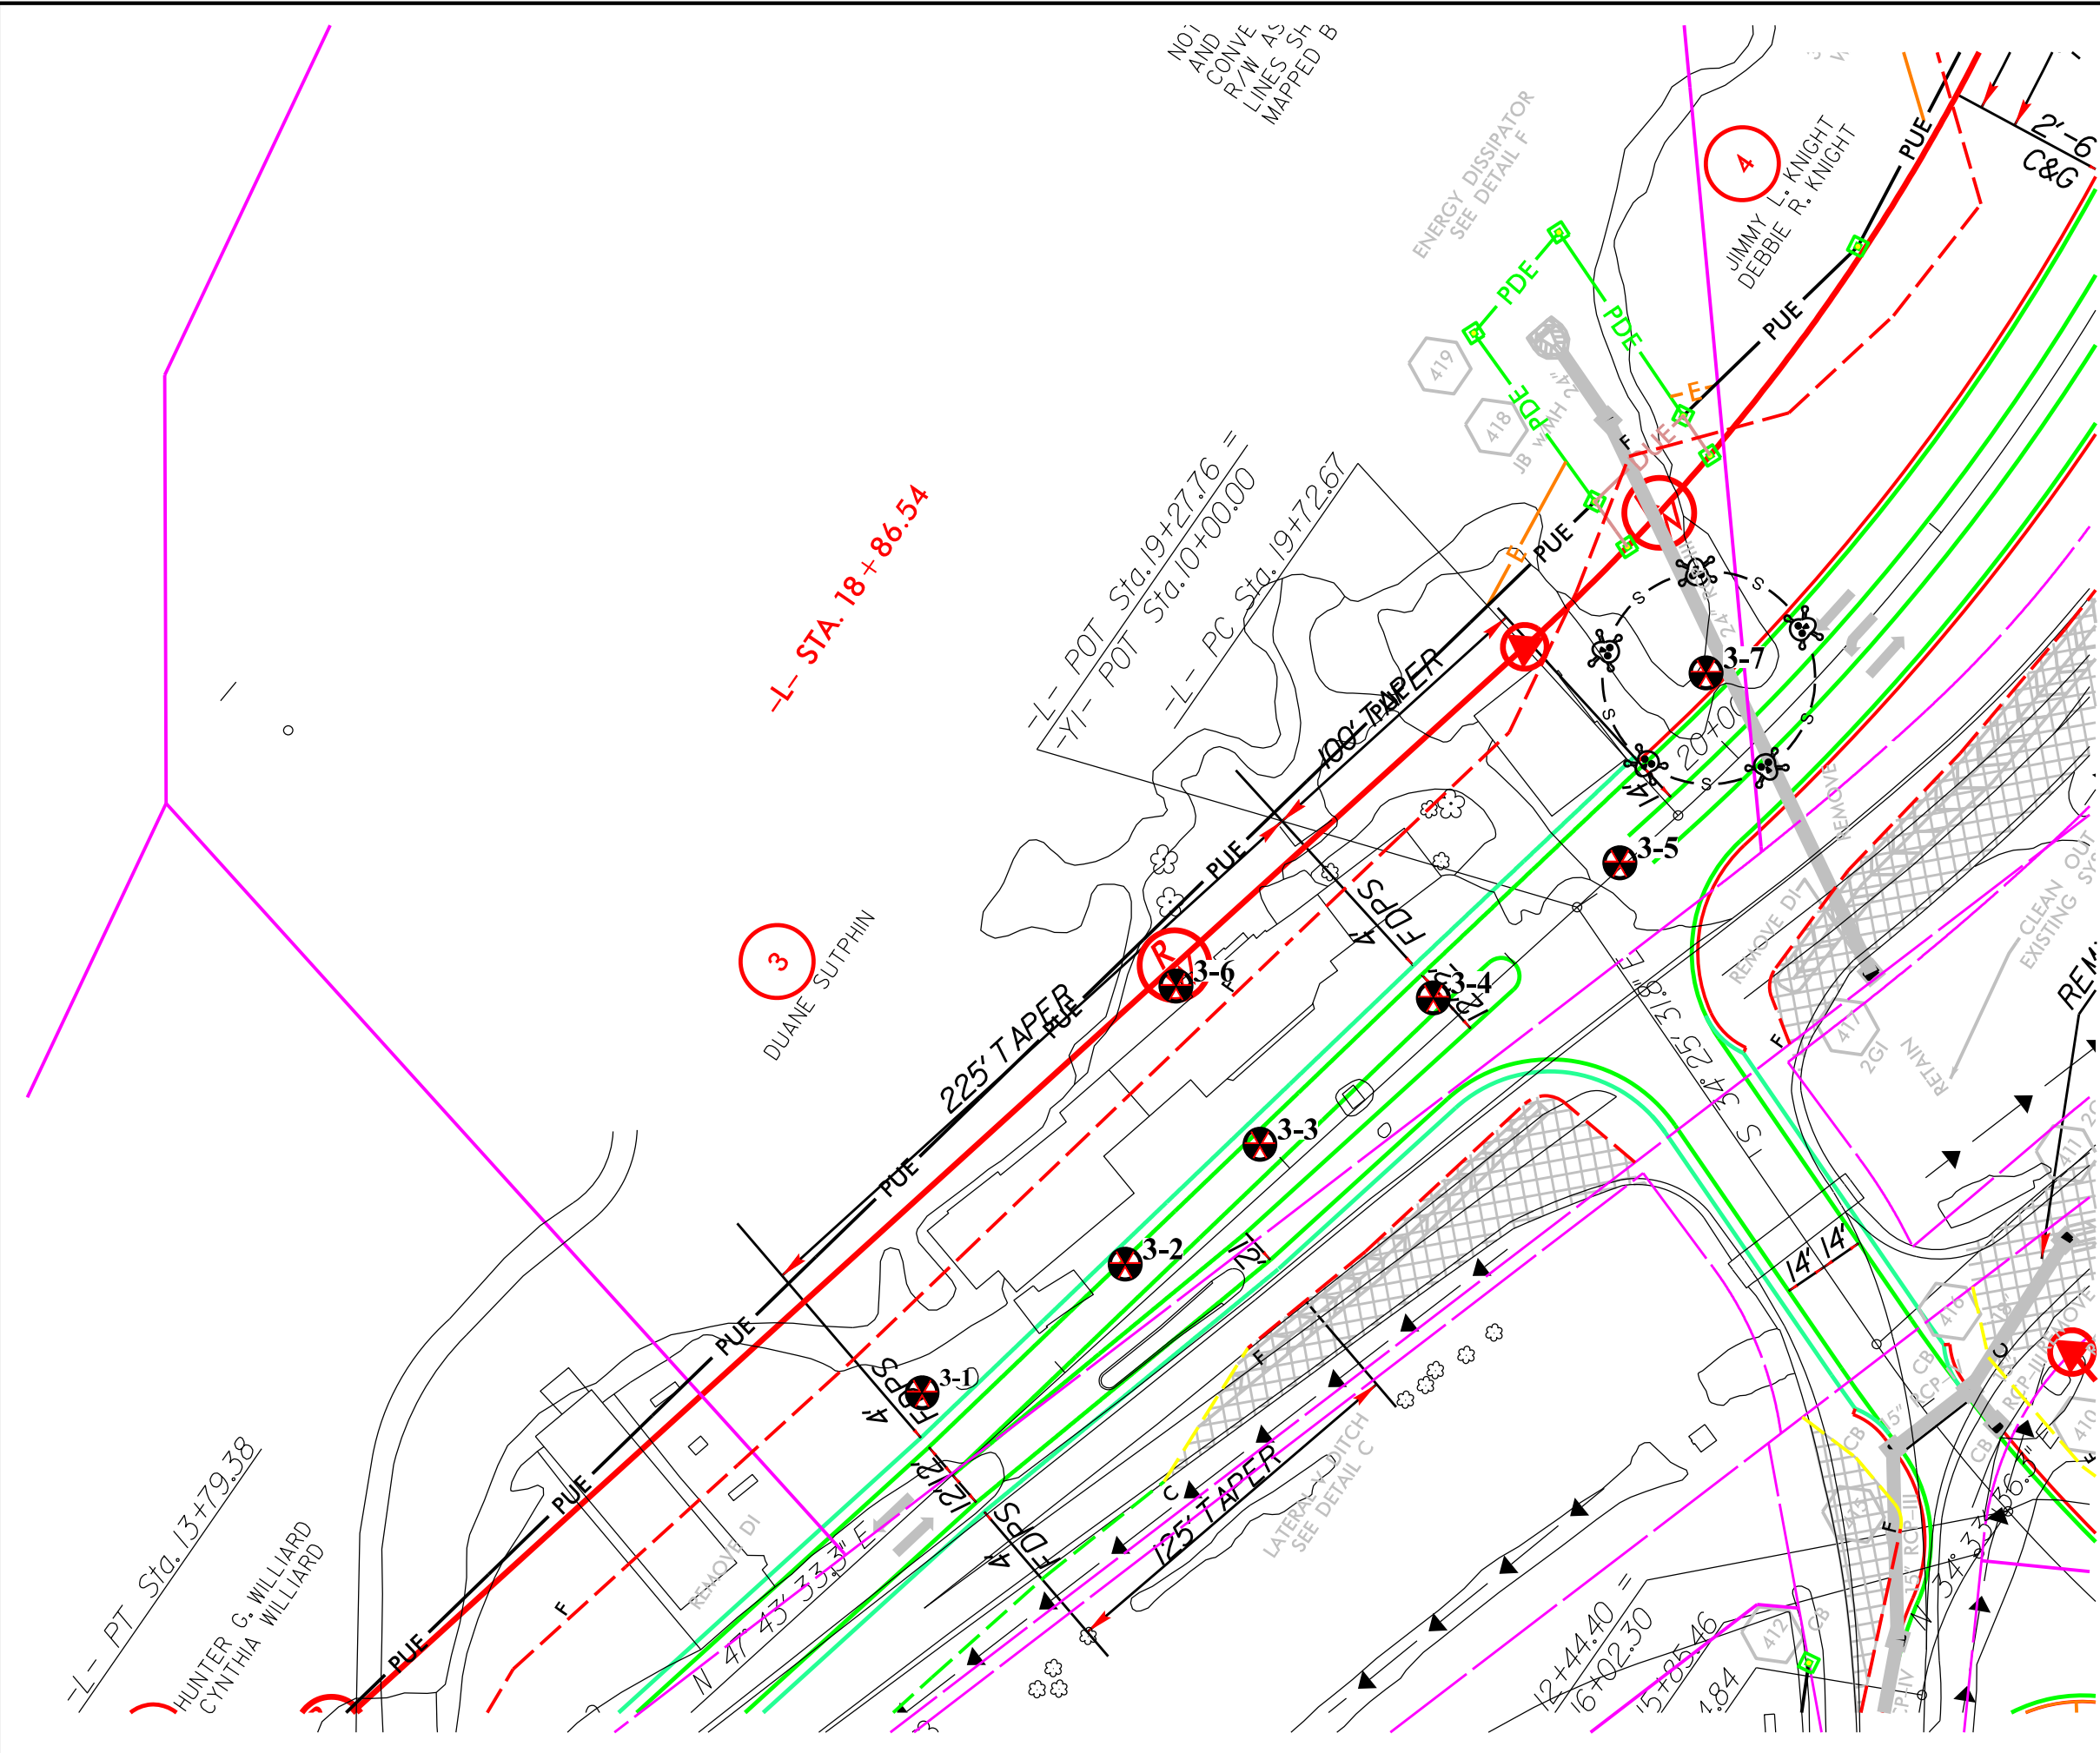
On April 23, 2019, Pyramid mobilized to the site, drilled soil borings and collected the proposed soil samples for the Phase II. Seven (7) soil borings (3-1 through 3-7) were advanced on the subject property. The soil borings were completed using a truck-mounted Geoprobe drill rig. The selected locations were chosen to avoid public utilities along the adjacent roads and private utilities associated with the business while remaining in the proposed ROW and/or easement, or within other areas of concern such as proposed drainage features and areas designated for soil removal as indicated by the NCDOT engineering plans. The locations of the borings are shown on **Figure 2**.

The estimated area of contamination is depicted on **Figure 2**. The boundaries of the area of contamination are generally estimated by applying a circular area of contamination around a boring exhibiting DRO/GRO levels above action levels with a radius equal to half the distance between that boring and the nearest “clean” boring. In cases where this

Pyramid's PSA investigation resulted in an **estimated volume of 428 cubic yards of impacted soil at the location of boring 3-7**. This was calculated using the bottom depth of the contaminated sample (3 feet below ground surface). The NCDOT engineering plans indicate that these contaminated soils are within a potential zone of planned soil excavation associated with a proposed drainage feature. The boundaries of the areas of contamination are approximate due to limited soil analytical data.

During road construction activities, it is possible the NCDOT may encounter petroleum impacted soil near soil boring 3-7. DRO concentrations of a soil sample from this boring exceeded action levels. The direct source of this petroleum was not evident during this investigation. The NCDOT MicroStation plans indicate a proposed drainage feature at this location that may require excavation for installation.

It should be noted that, if impacted soil is encountered during road construction outside of the area analyzed by this investigation, the impacted soil should be managed according to NC DEQ Division of Waste Management (DWM) UST Section Guidelines and disposed of at a permitted facility.

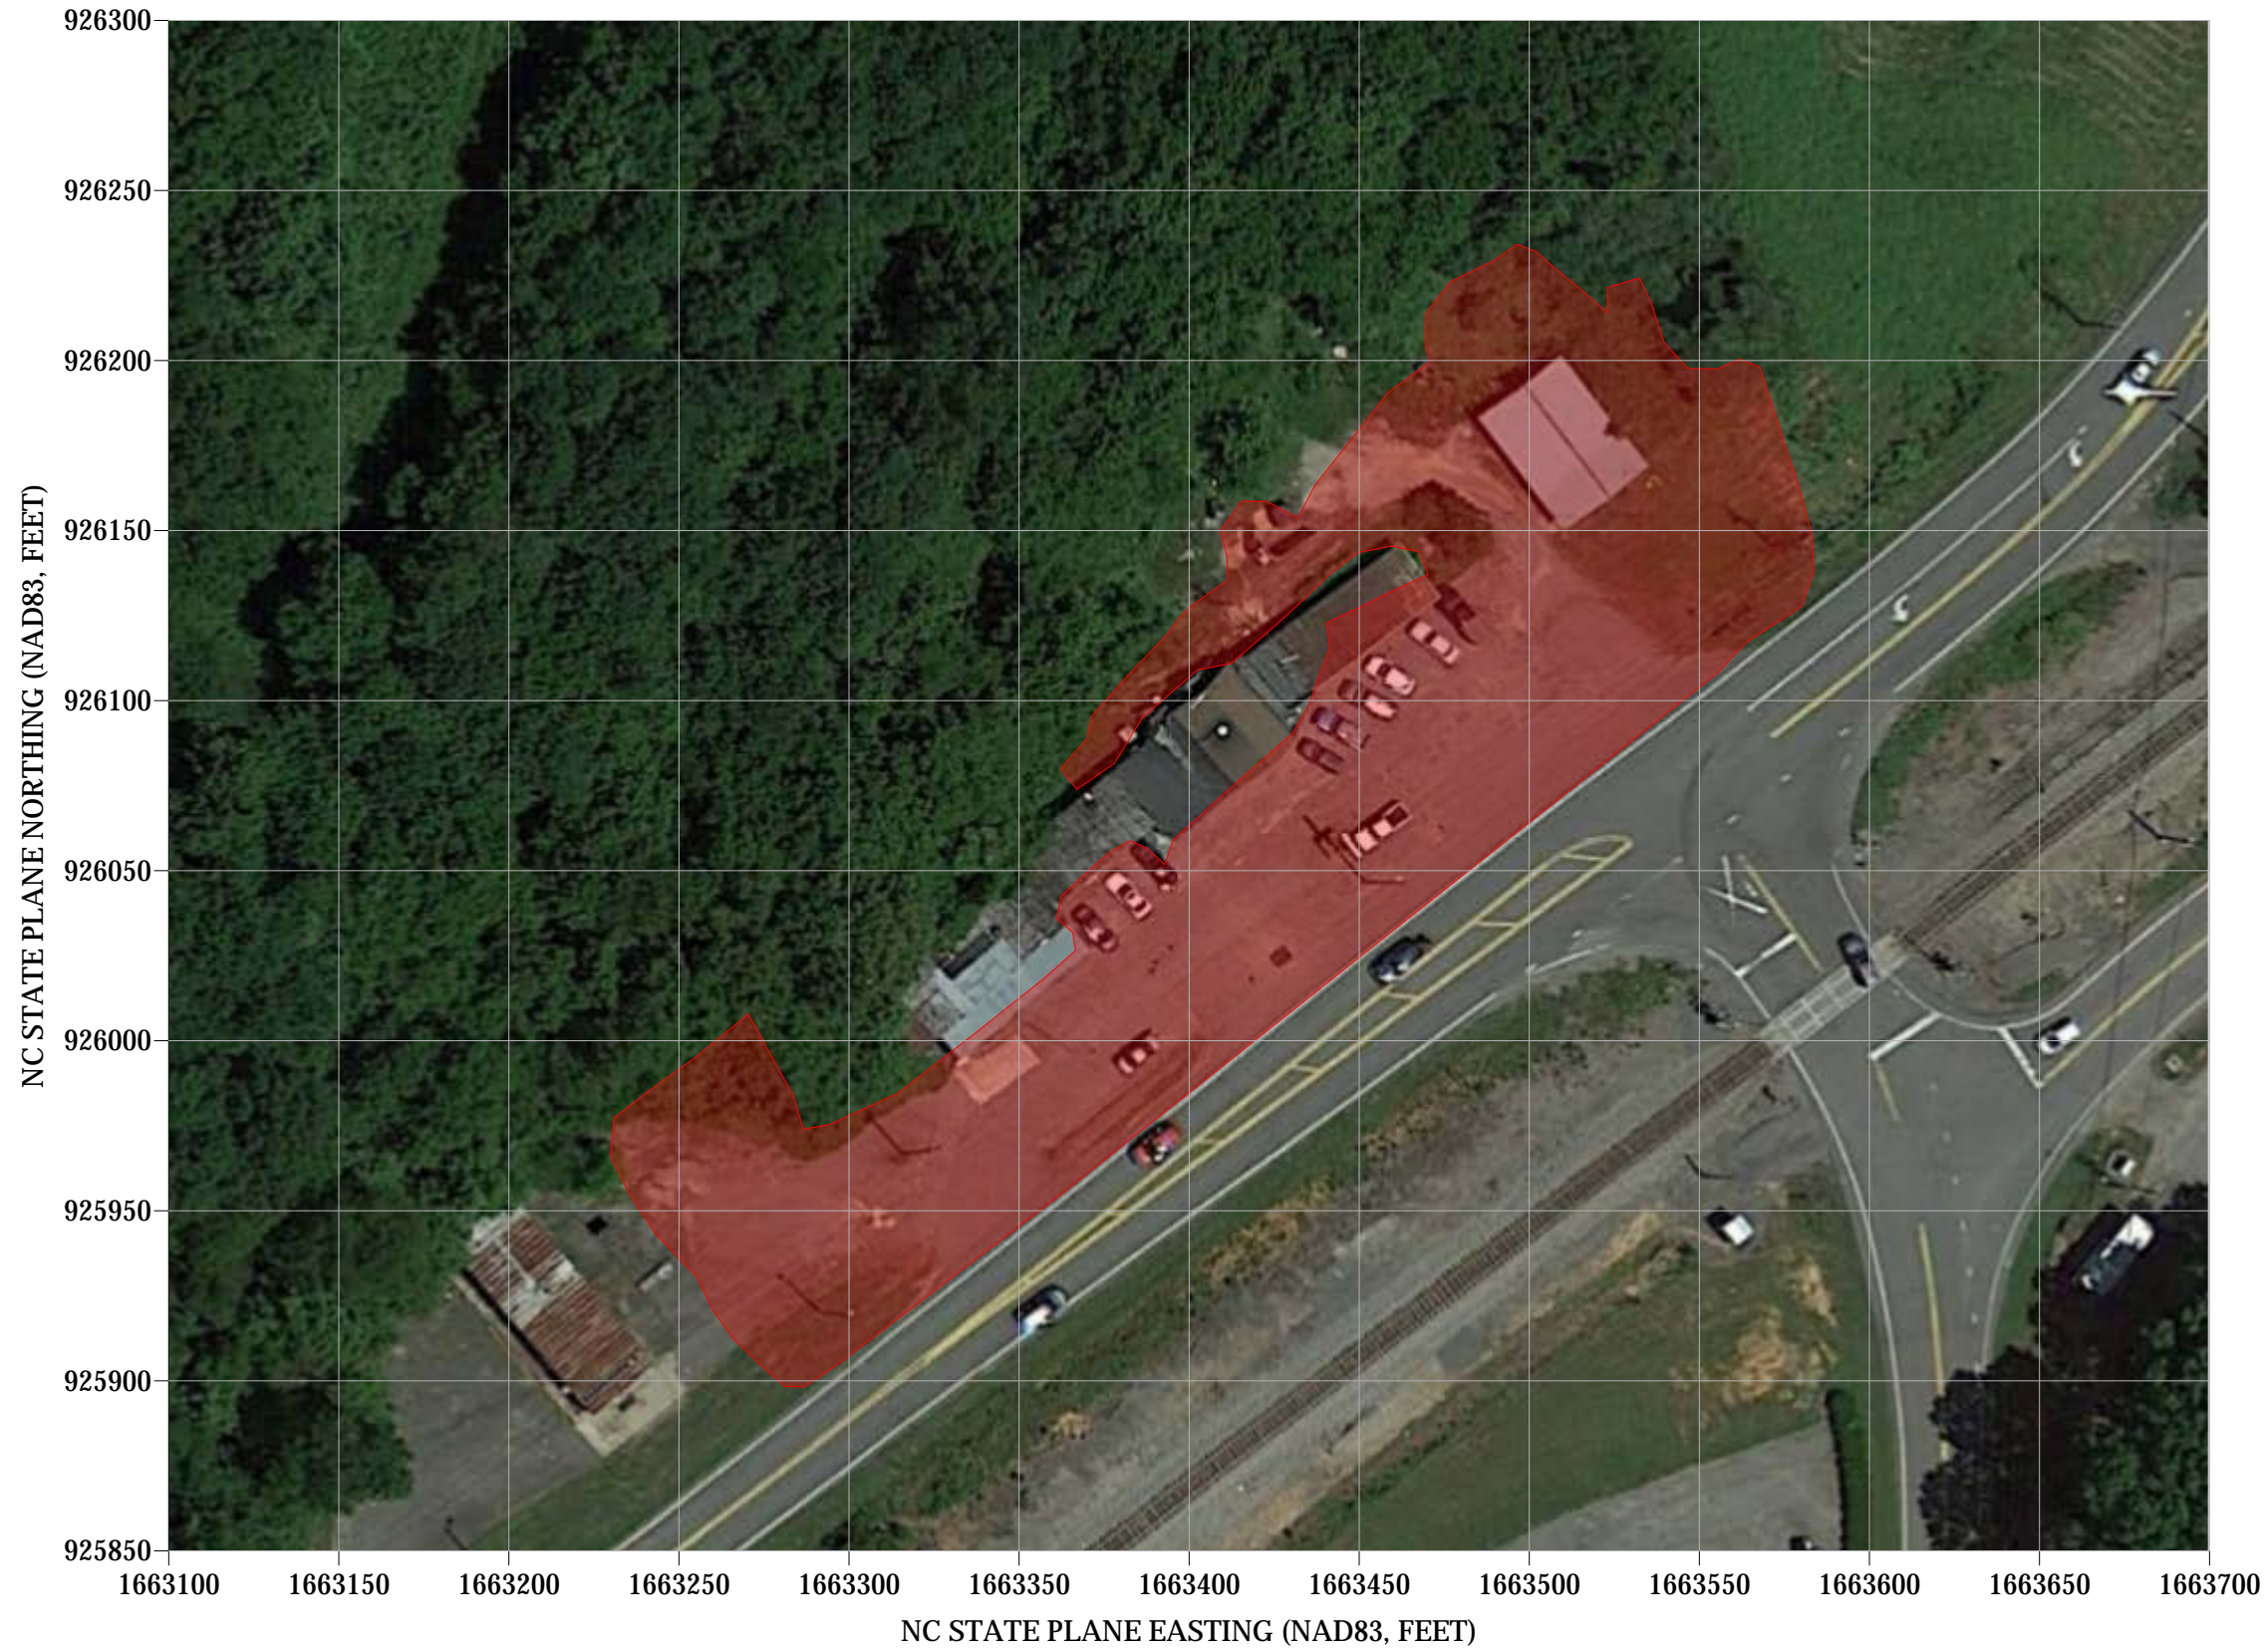
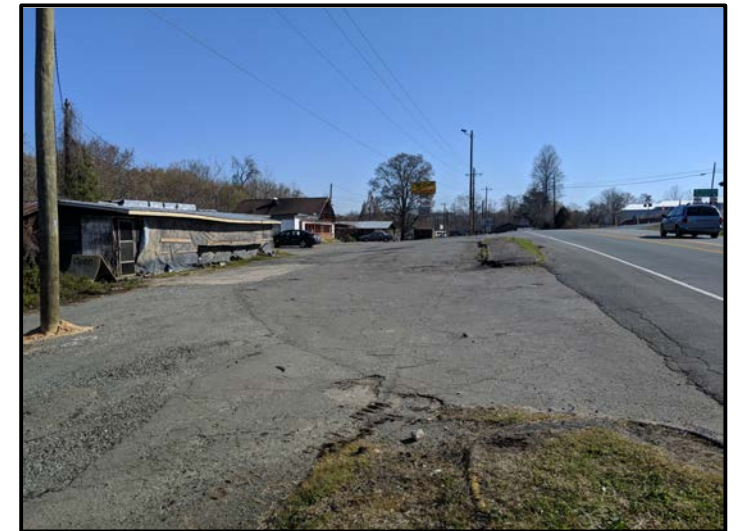
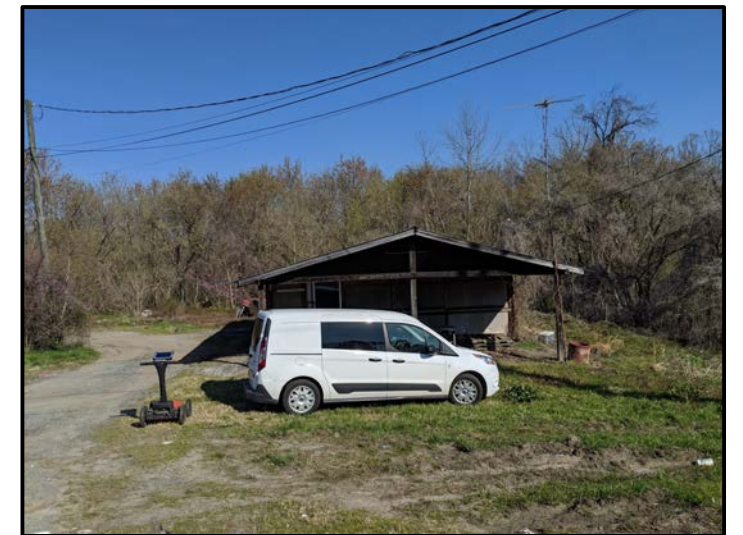
APPROXIMATE BOUNDARIES OF GEOPHYSICAL SURVEY AREA

View of Survey Area
(Facing Approximately Northeast)

View of Survey Area
(Facing Approximately Northwest)

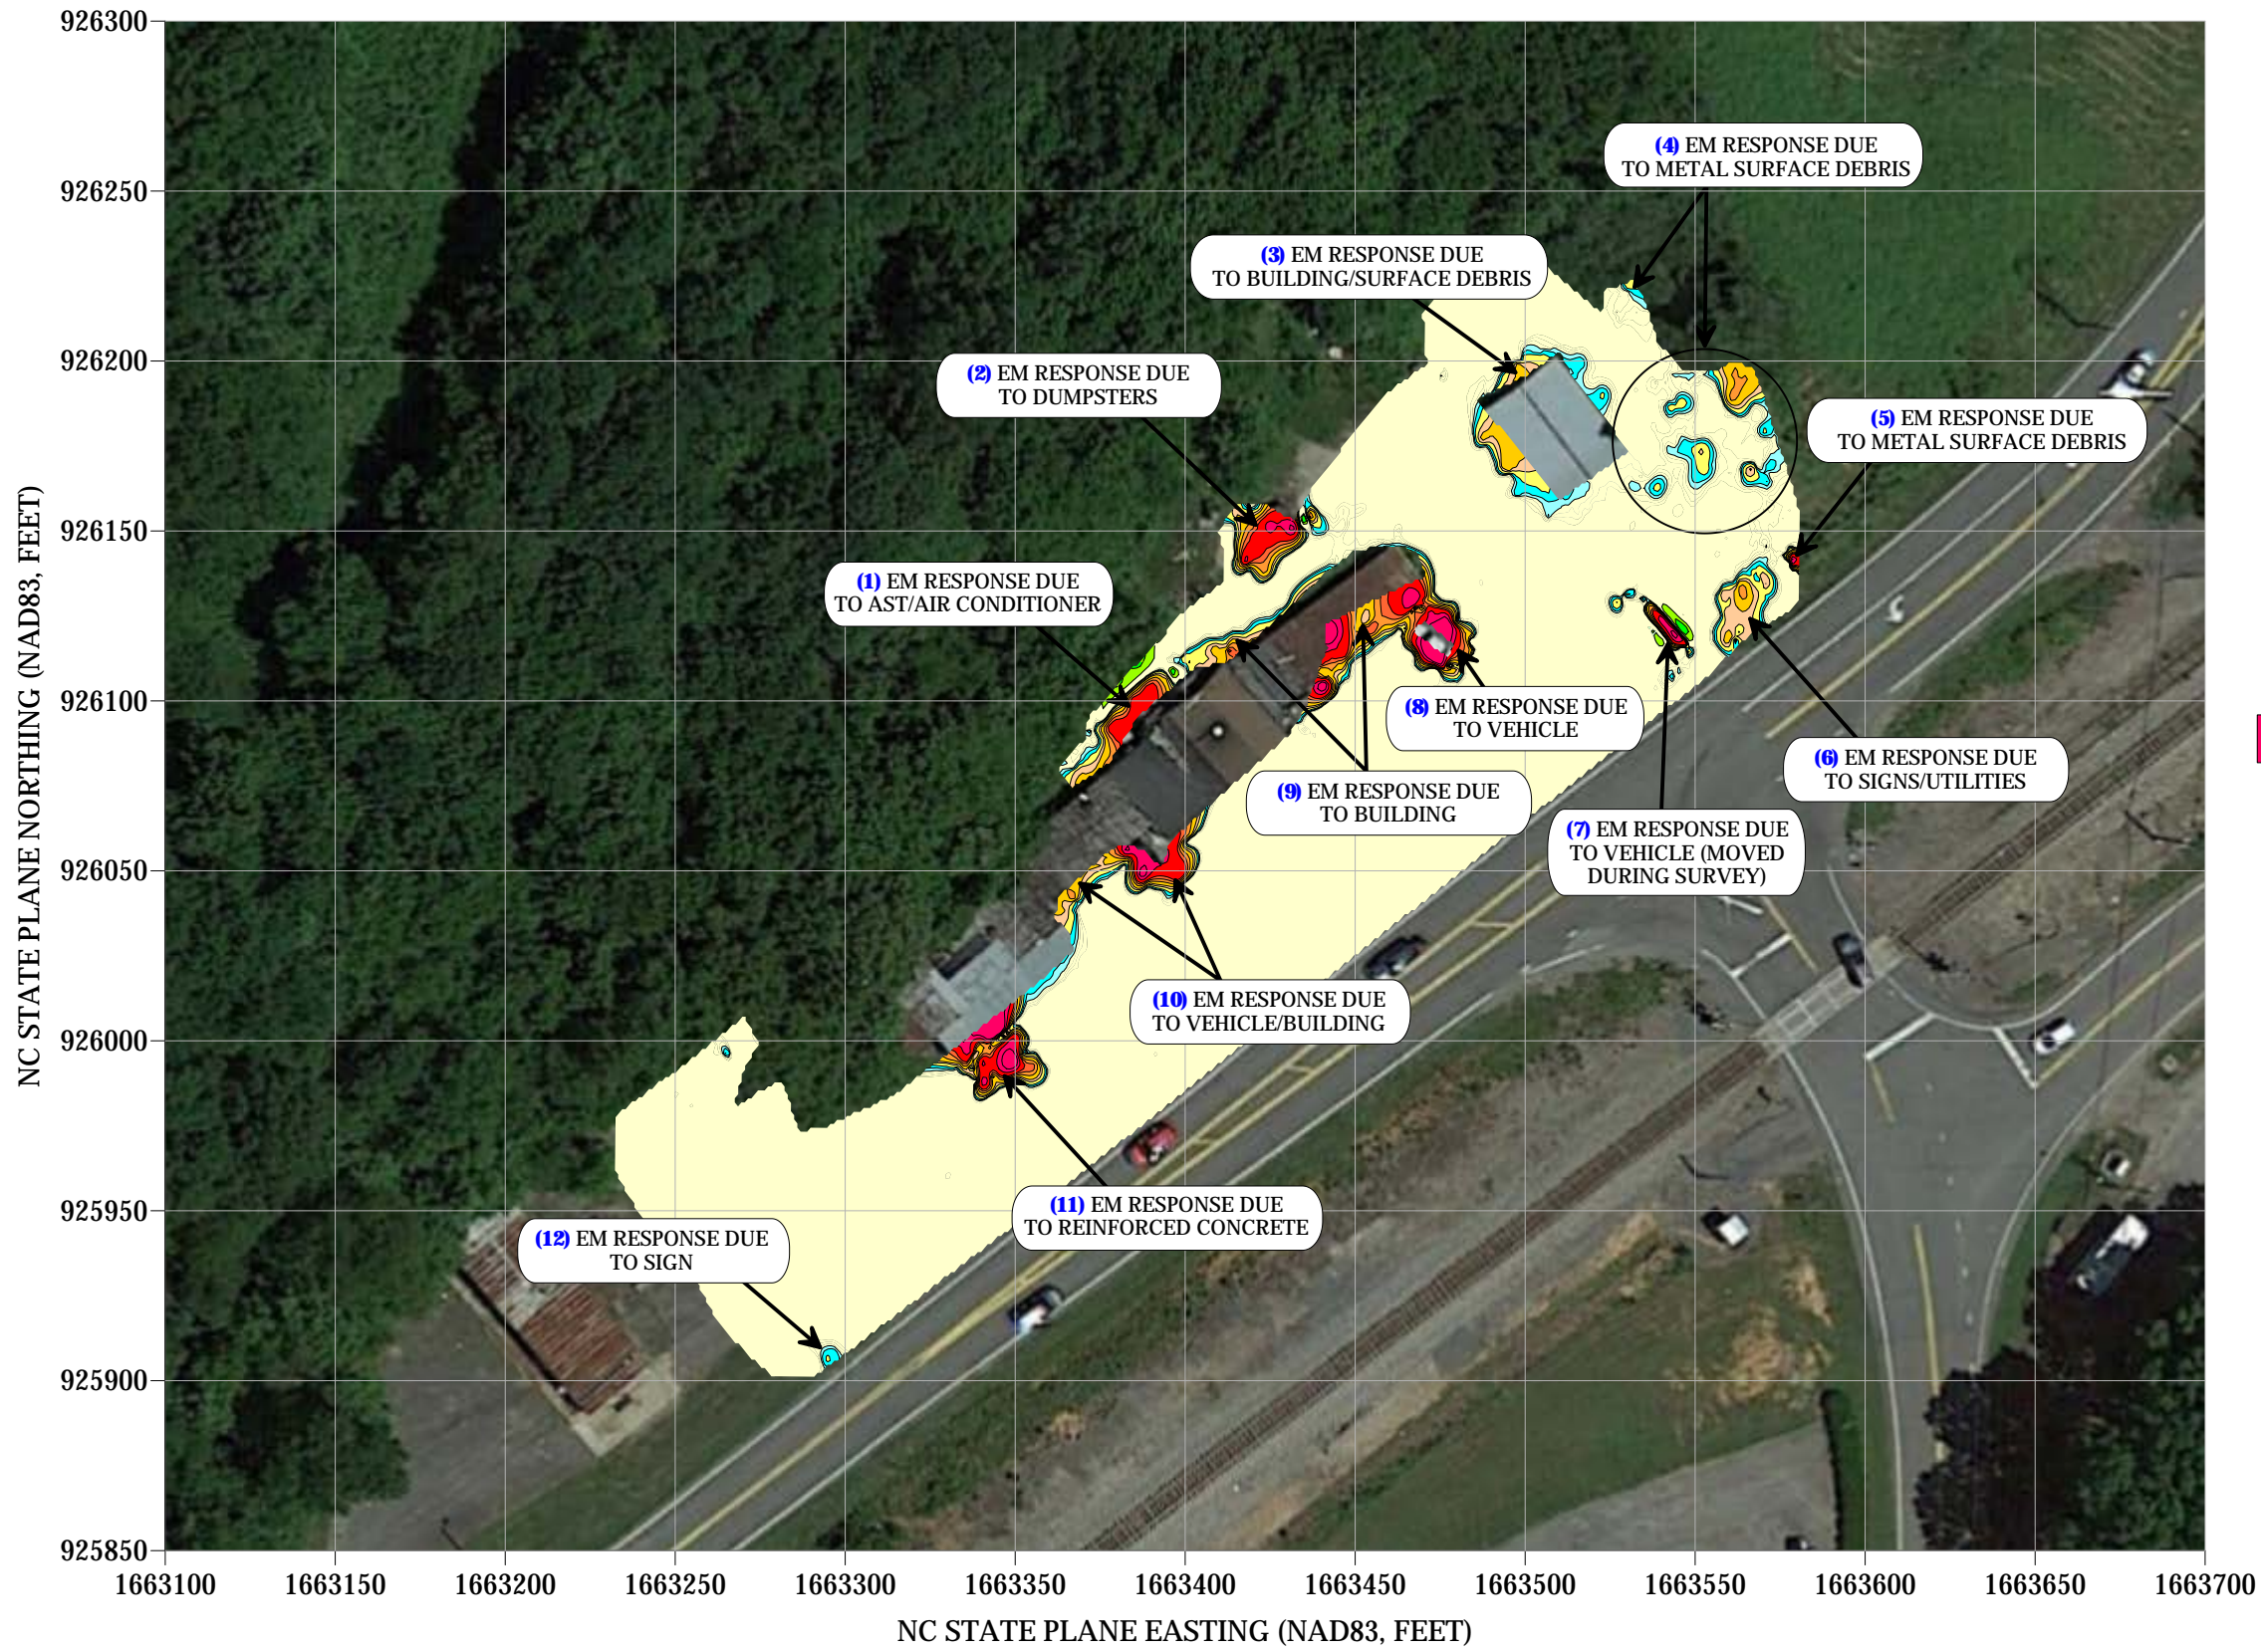
EM61 METAL DETECTION RESULTS

All of the EM anomalies were directly attributed to visible cultural features at the ground surface, including an AST, an air conditioner, dumpsters, a building, metal surface debris, signs, utilities, vehicles, and reinforced concrete. EM Anomalies 3 and 7-10 were investigated with GPR to confirm that these surface features did not obscure any potential USTs. EM Anomaly 11 was investigated with GPR to confirm that there was reinforcement in the concrete slab and the reinforcement did not obscure any potential USTs.

NO EVIDENCE OF METALLIC USTs WAS OBSERVED.

The contour plot shows the differential results of the EM61 instrument in millivolts (mV). The differential results focus on larger metallic objects such as USTs and drums. The EM61 data were collected on April 3, 2019, using a Geonics EM61 instrument. Verification GPR data were collected using a GSSI UtilityScan DF instrument with a dual frequency 300/800 MHz antenna on April 3, 2019.

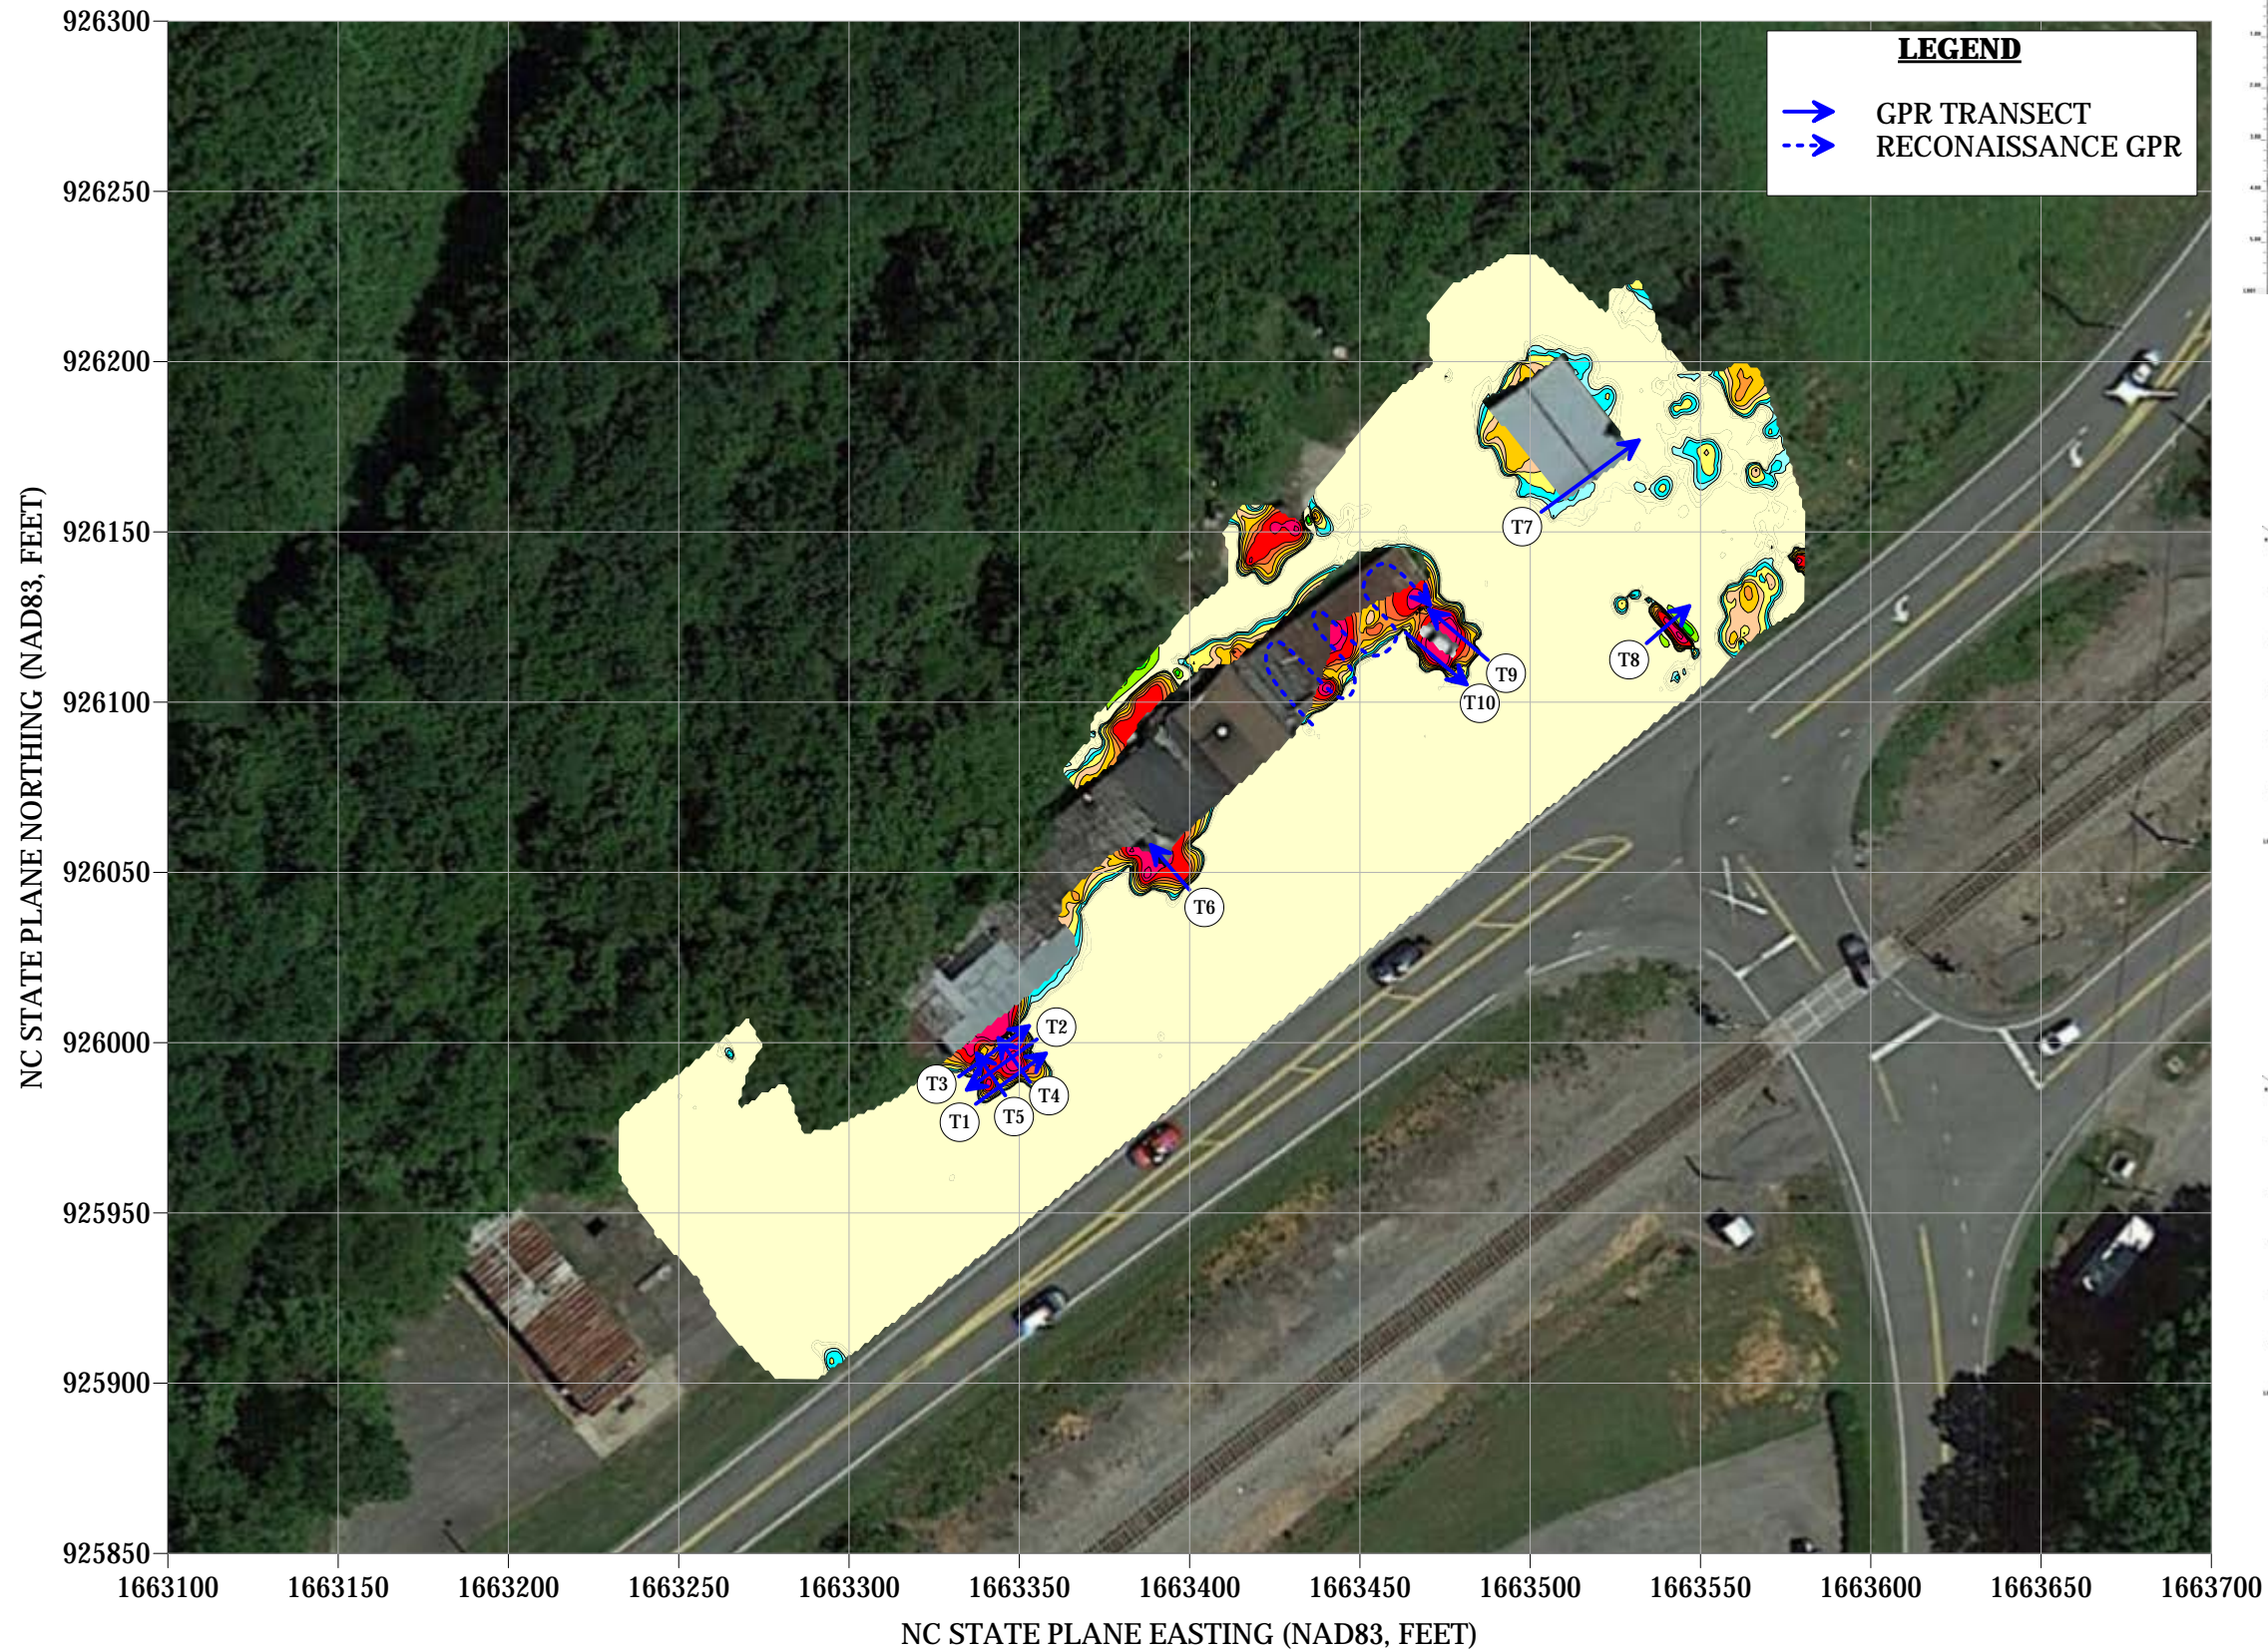
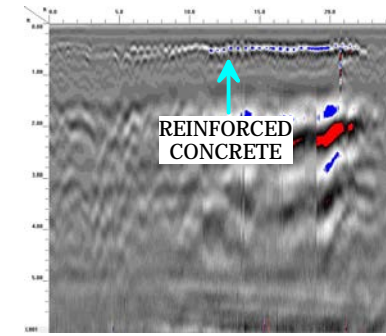
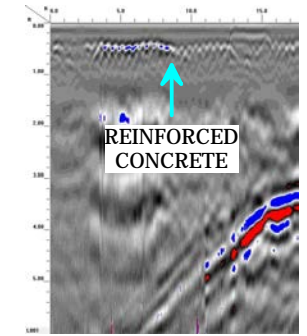
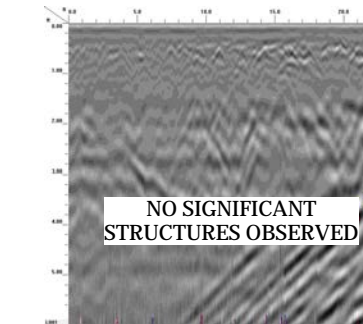
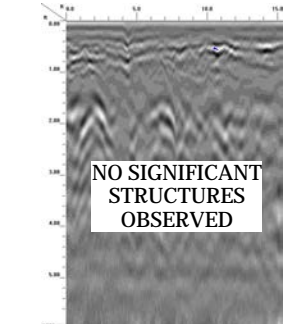
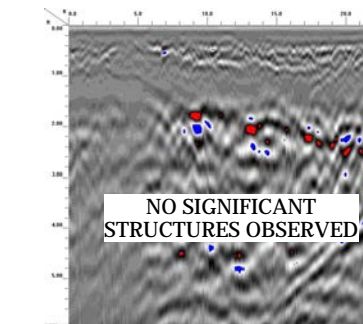
GPR TRANSECT LOCATIONS

Figure 3 presents the locations of the formal GPR transects and reconnaissance GPR performed at the property, as well as select transect images. All of the transect images are included in **Appendix A**. A total of 10 formal GPR transects were performed at the site. GPR Transects 1-5 were performed across EM Anomaly 11. These transects confirmed the presence of reinforcement in the concrete slab. No evidence of any buried structures such as USTs was observed.

GPR Transects 6-10 and reconnaissance GPR were performed across EM Anomalies 3 and 7-10. No evidence of any buried structures such as USTs was observed.
