GEOENVIRONMENTAL PHASE II INVESTIGATION
PARCEL 004 – JIMMY & DEBBIE KNIGHT
301 MAIN STREET
WALNUT COVE, STOKES COUNTY, NORTH CAROLINA
STATE PROJECT: R-5768
WBS ELEMENT: 44670.1.1
APRIL 30, 2019

**GEOENVIRONMENTAL PHASE II INVESTIGATION
PARCEL 004 – JIMMY & DEBBIE KNIGHT
301 MAIN STREET
WALNUT COVE, STOKES COUNTY, NORTH CAROLINA**

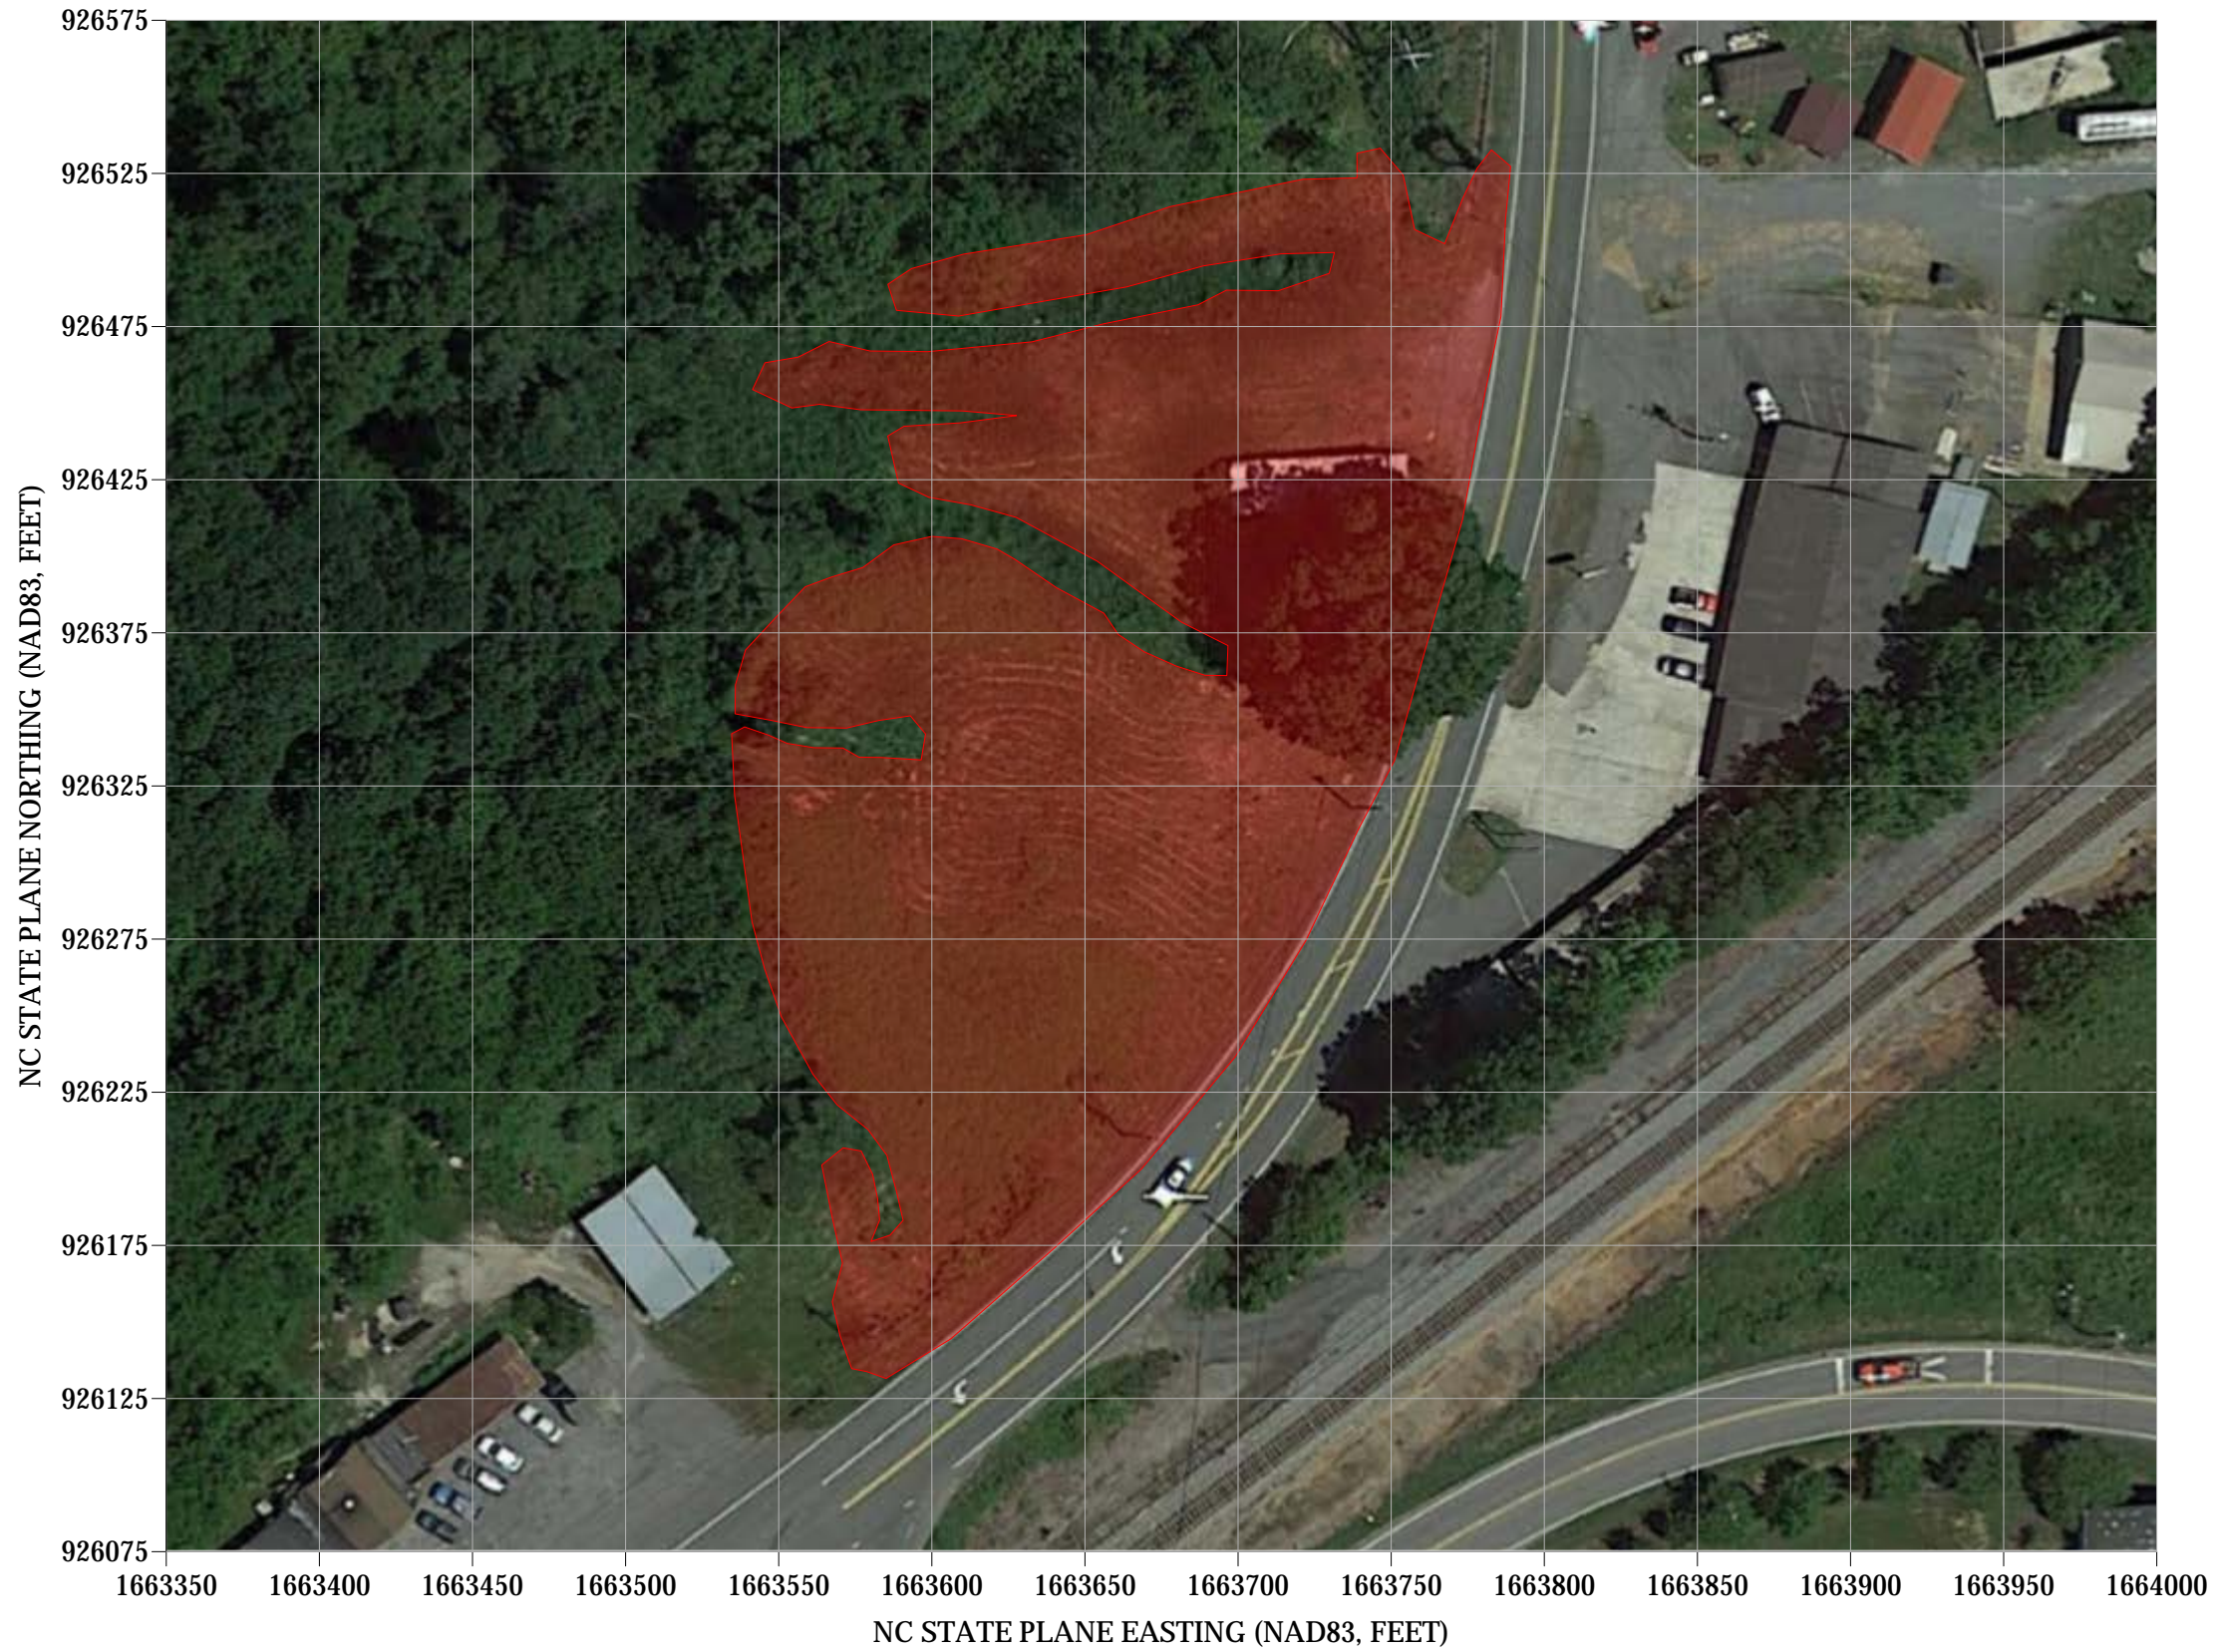
APPROXIMATE BOUNDARIES OF UST GEOPHYSICAL SURVEY AREA

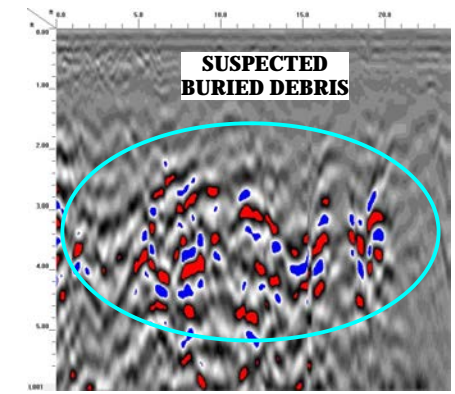
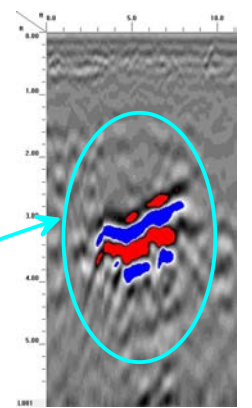
CLIENT
NCDOT
FIGURE 4

GPR TRANSECT LOCATIONS

GPR TRANSECT 1 (T1)

GPR TRANSECT 3 (T3)

GPR TRANSECT 4 (T4)

NO CONFIDENCE ANOMALY

Figure 4 presents the locations of the formal GPR transects performed at the property associated with the UST geophysical survey, as well as select transect images. All of the transect images can be found in **Appendix A**. A total of 8 formal GPR transects were

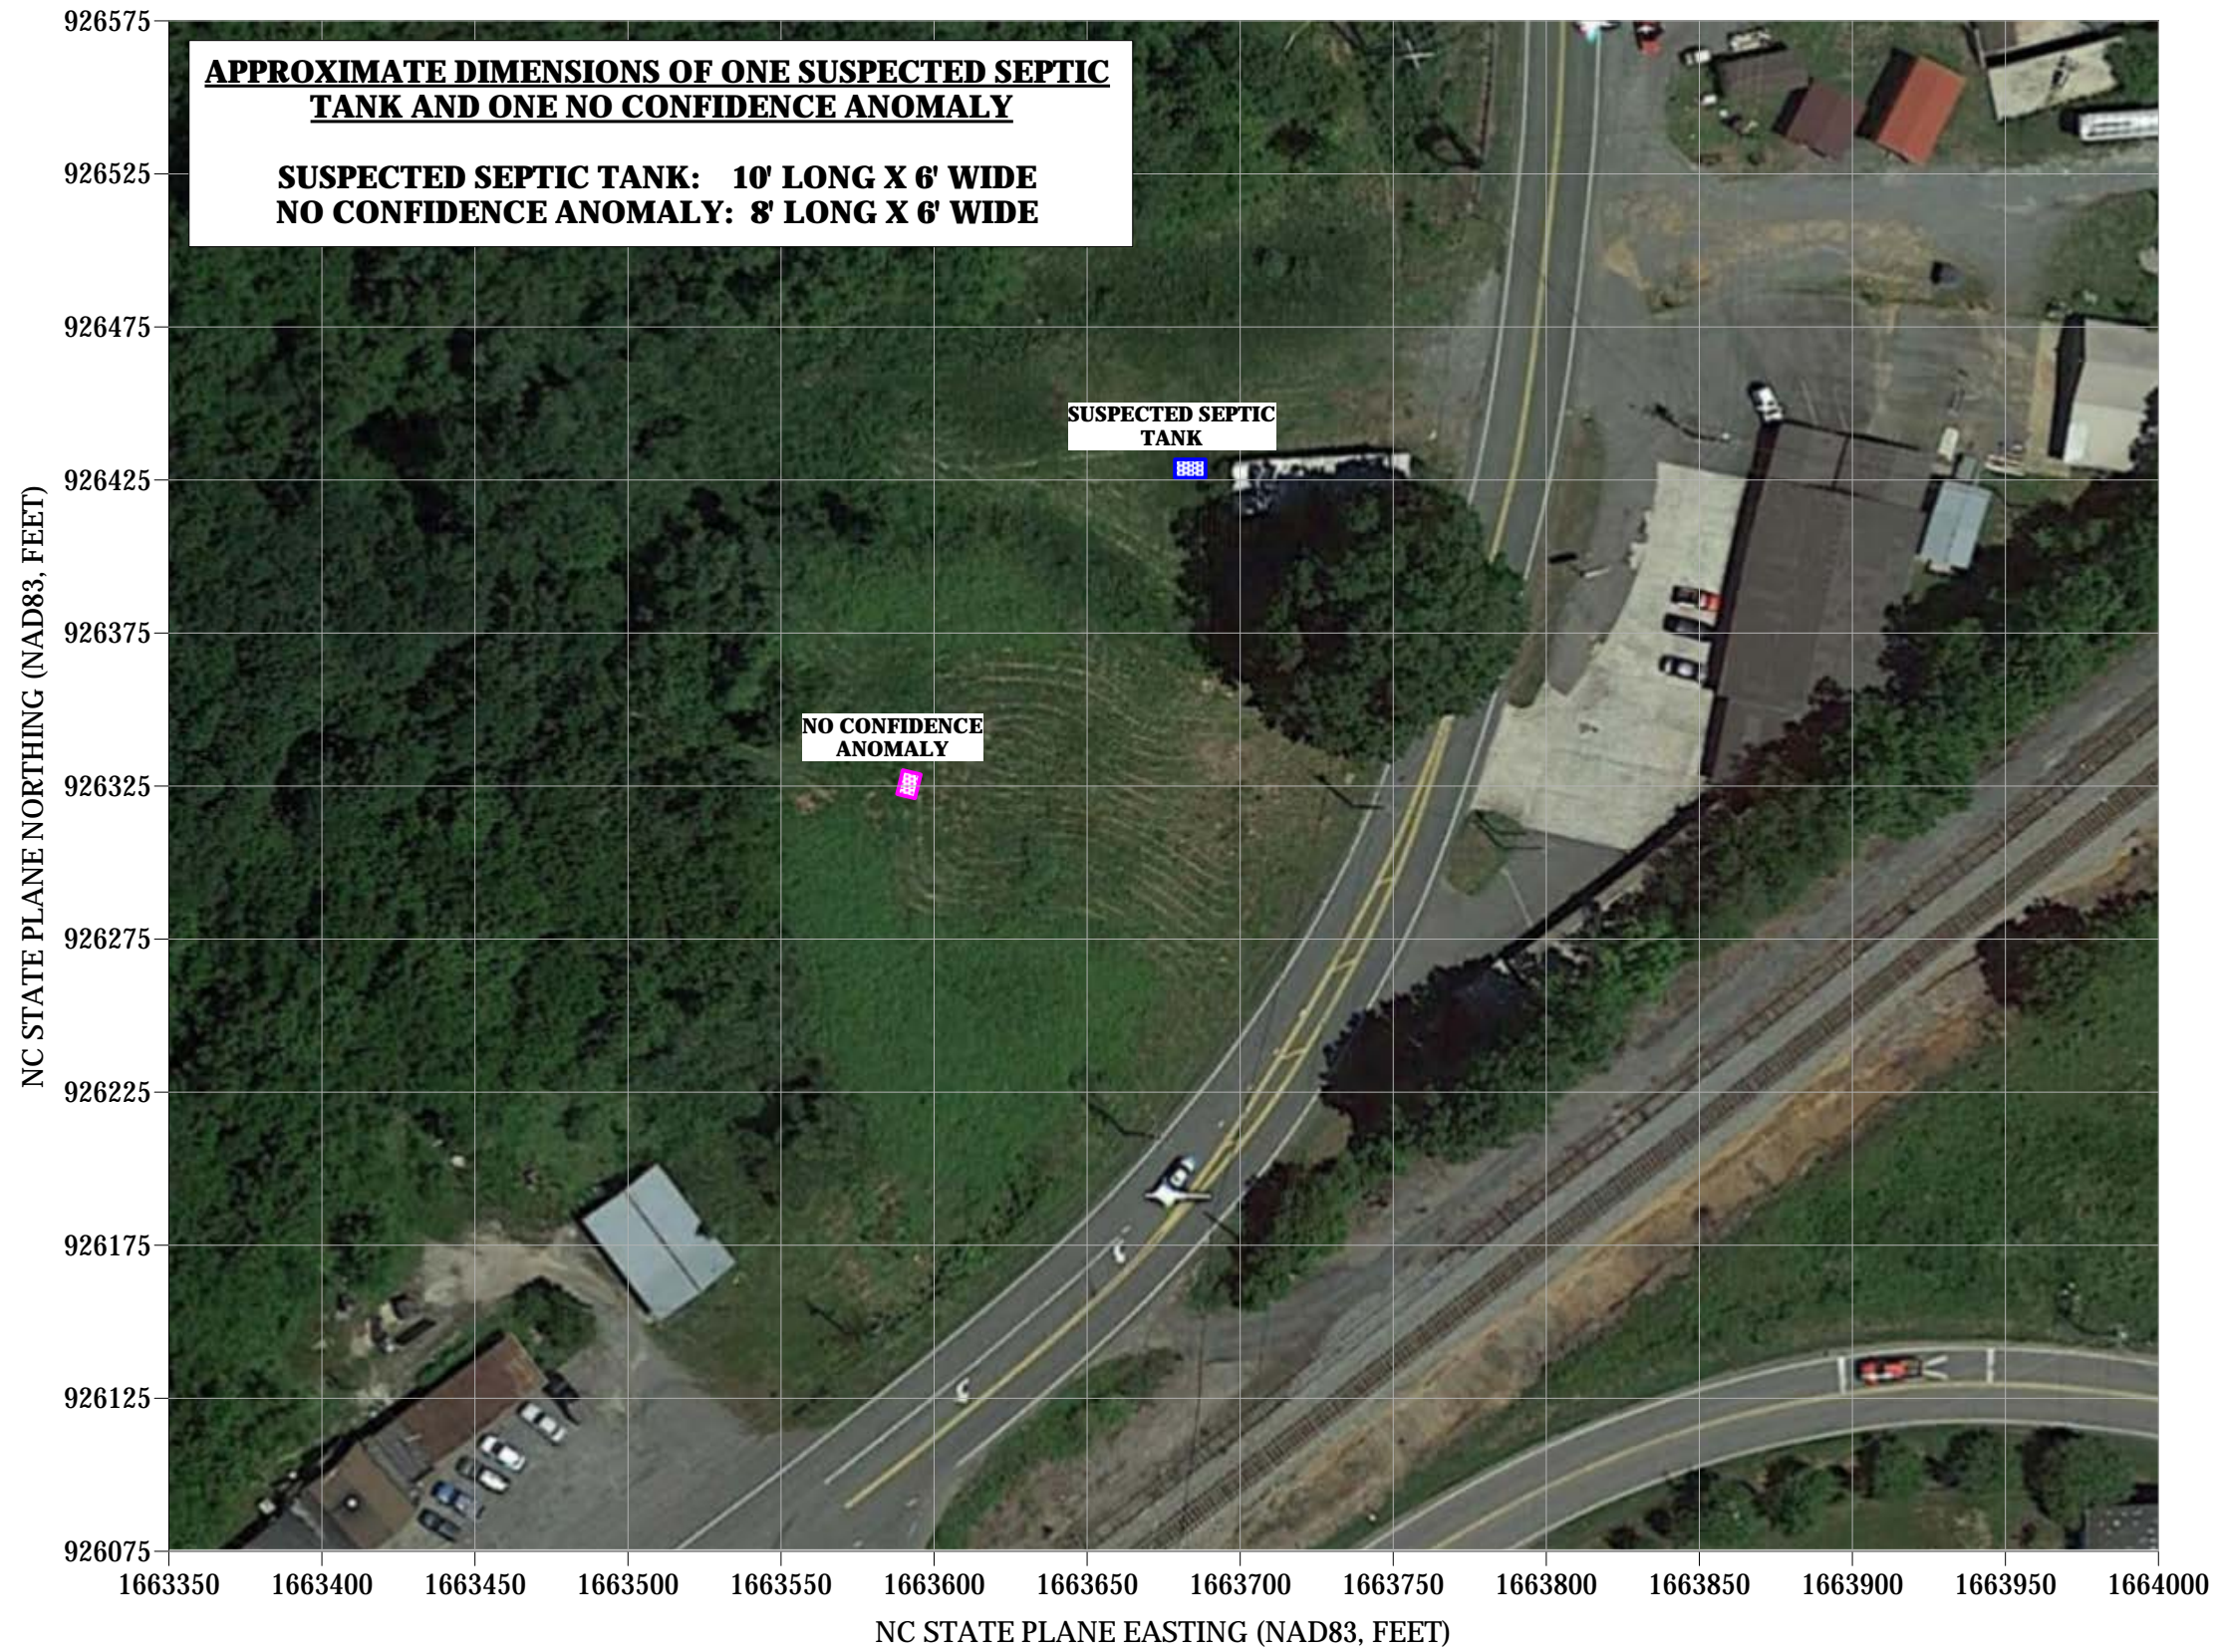
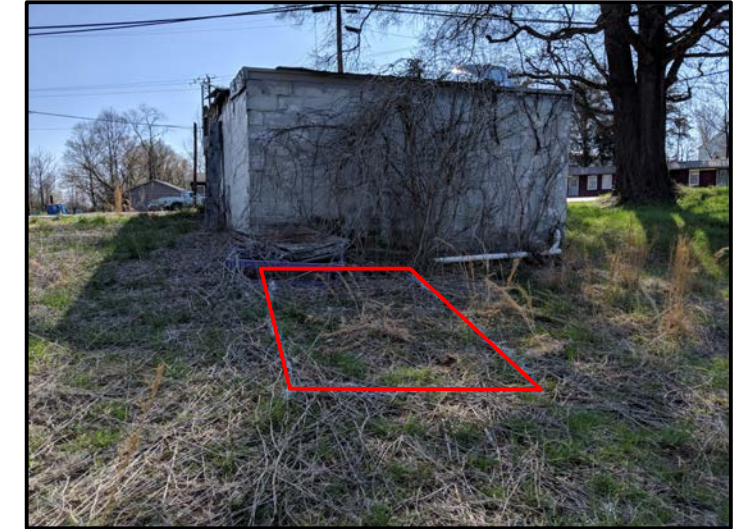
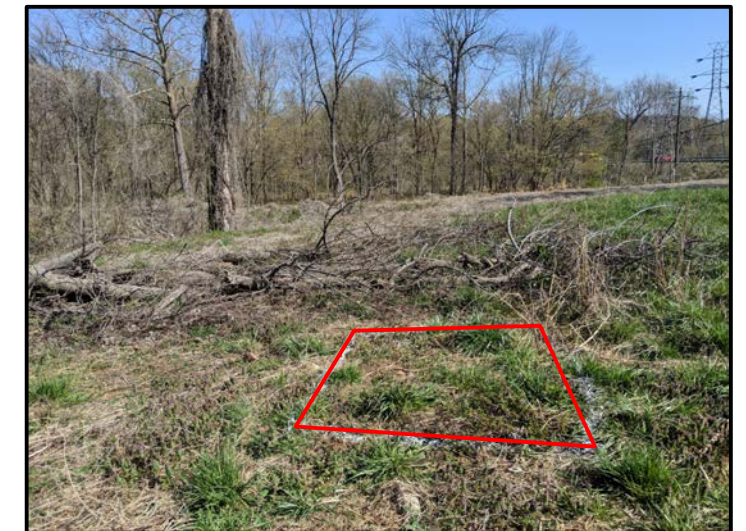
The EM61 and GPR also identified a suspected septic tank off the northwest corner of the building. The suspected septic tank was approximately 10 feet long by 6 feet wide. A sewer pipe was observed entering the ground above the suspected septic tank.

LOCATIONS AND SIZES OF ONE SUSPECTED SEPTIC TANK AND ONE NO CONFIDENCE ANOMALY

View of Suspected Septic Tank
(Facing Approximately East)

View of No Confidence Anomaly
(Facing Approximately West)

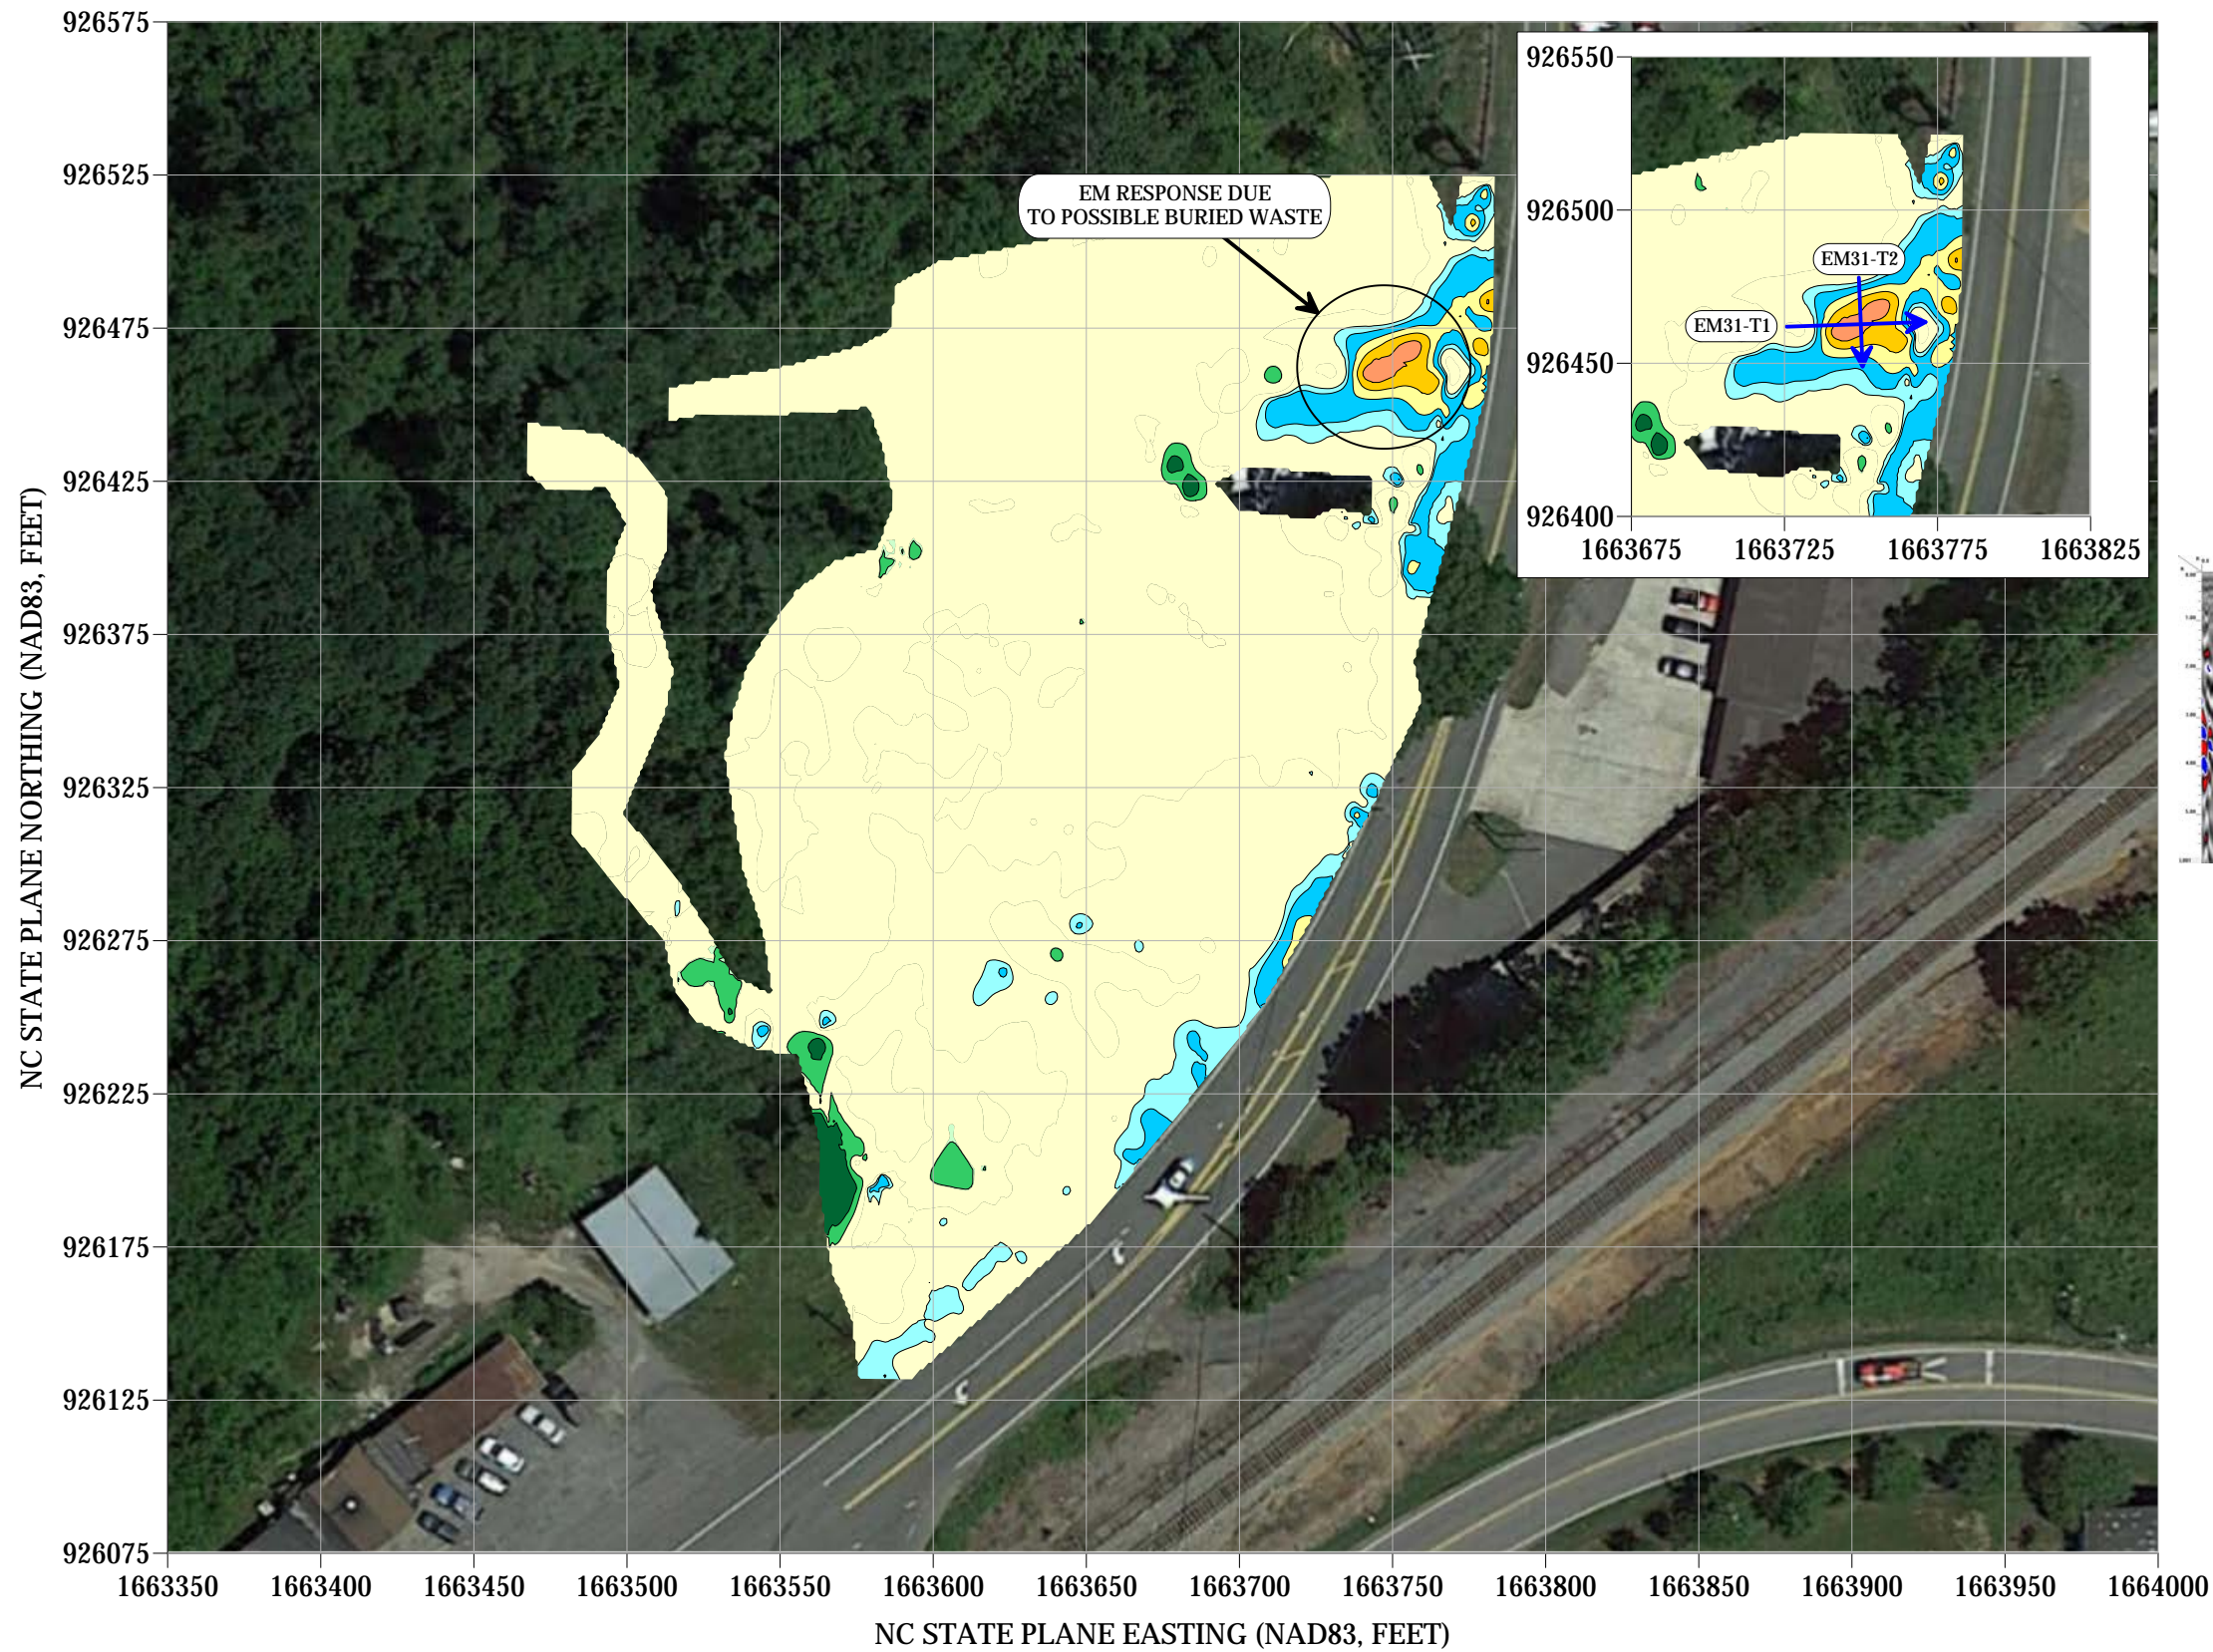
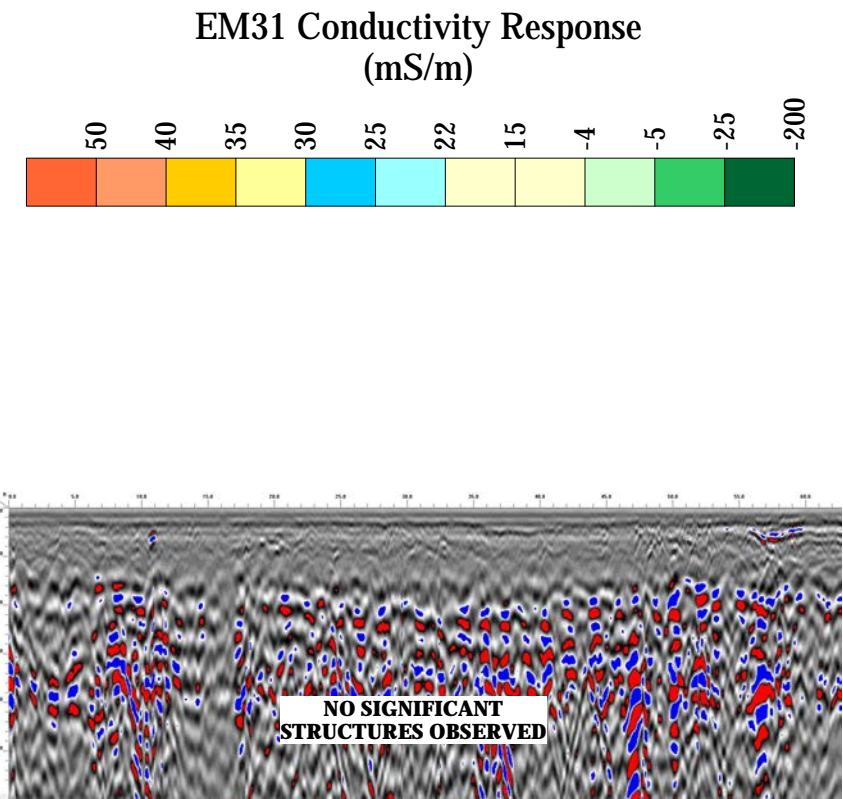
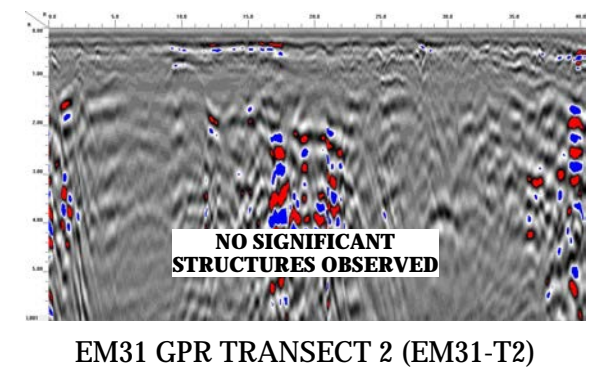
CLIENT
NCDOT
FIGURE 7

EM31 GROUND CONDUCTIVITY RESULTS AND RADAR IMAGES

The EM31 and GPR results obtained for this project may delineate the approximate perimeters of buried waste at the suspected disposal area. However, some of the buried waste may not be detected by the geophysical investigation. Furthermore, some EM31 apparent conductivity anomalies may be in response to changes in soil character and not due to buried waste.
