GEOENVIRONMENTAL PHASE II INVESTIGATION

PARCEL 008 - V. L DEHART 403 STOKESBURGE ROAD WALNUT COVE, STOKES COUNTY, NORTH CAROLINA **STATE PROJECT: R-5768 WBS ELEMENT: 44670.1.1** APRIL 30, 2019

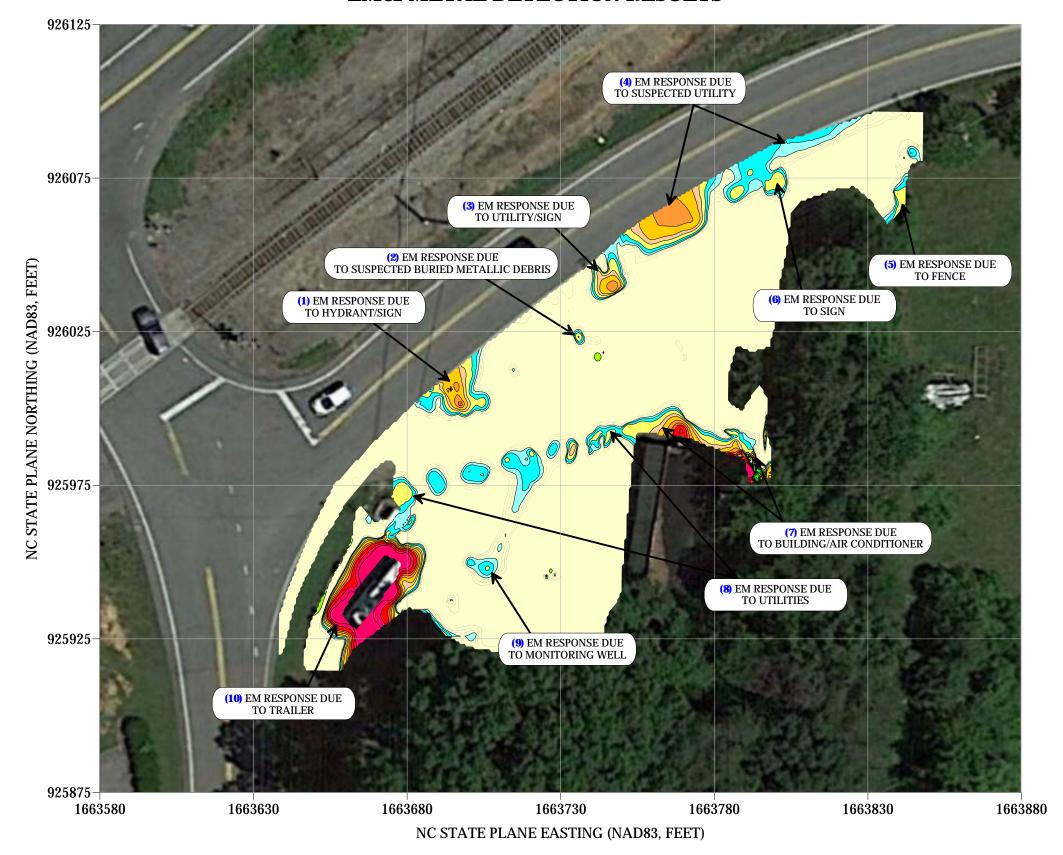
EM61 METAL DETECTION RESULTS

NO EVIDENCE OF METALLIC USTs WAS OBSERVED.

The contour plot shows the differential results of the EM61 instrument in millivolts (mV). The differential results focus on larger metallic objects such as USTs and drums. The EM61 data were collected on April 3, using a Geonics EM61 instrument. Verification GPR data were collected using a GSSI UtilityScan DF instrument with a dual frequency 300/800 MHz antenna on April 3, 2019.
