**STIP Project No. R-5768
US 311/NC 65/SR 1928 (Stokesburg Rd.)
Walnut Cove, Stokes County, North Carolina**

GEOENVIRONMENTAL PLANNING REPORT

October 2017

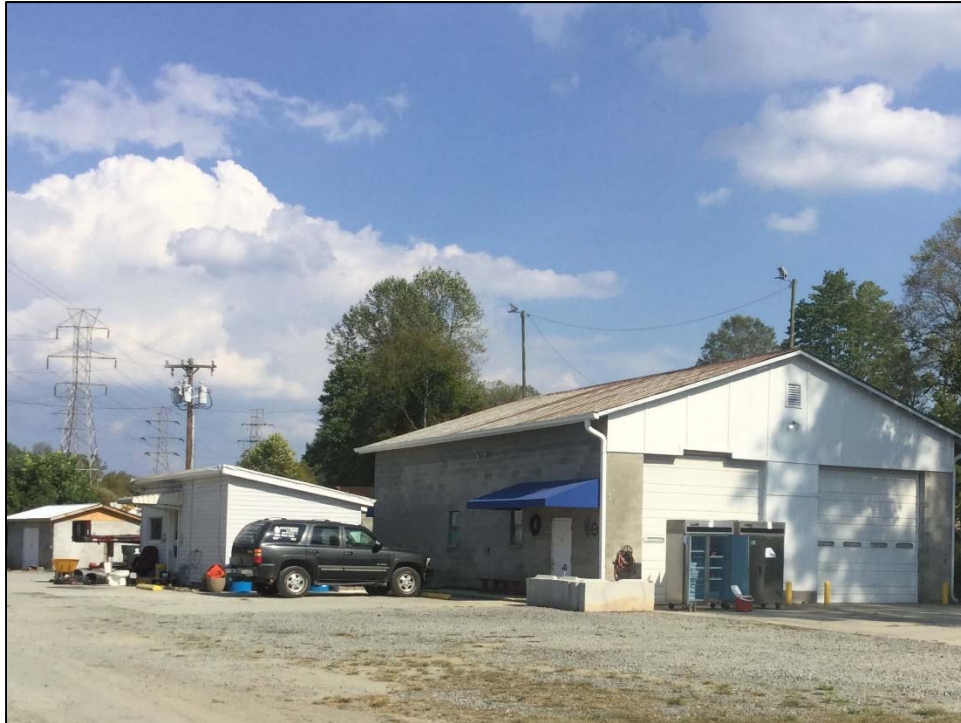
Looking east from S. Main Street at the building front and entrance.

This facility currently is a cement vehicle maintenance area. The facility is not listed in the reviewed public records. This site was not previously identified as a potential project concern.

The site inspection of September 28, 2017, showed that the site is used for truck maintenance and parking for tractor trailers and construction vehicles. Two small sheds serve as an office and supply building, and a larger building with two bays is a maintenance garage. The exterior of the buildings show no evidence of USTs, AST or discharges out of the buildings into the soil. All maintenance activities occur within the building.

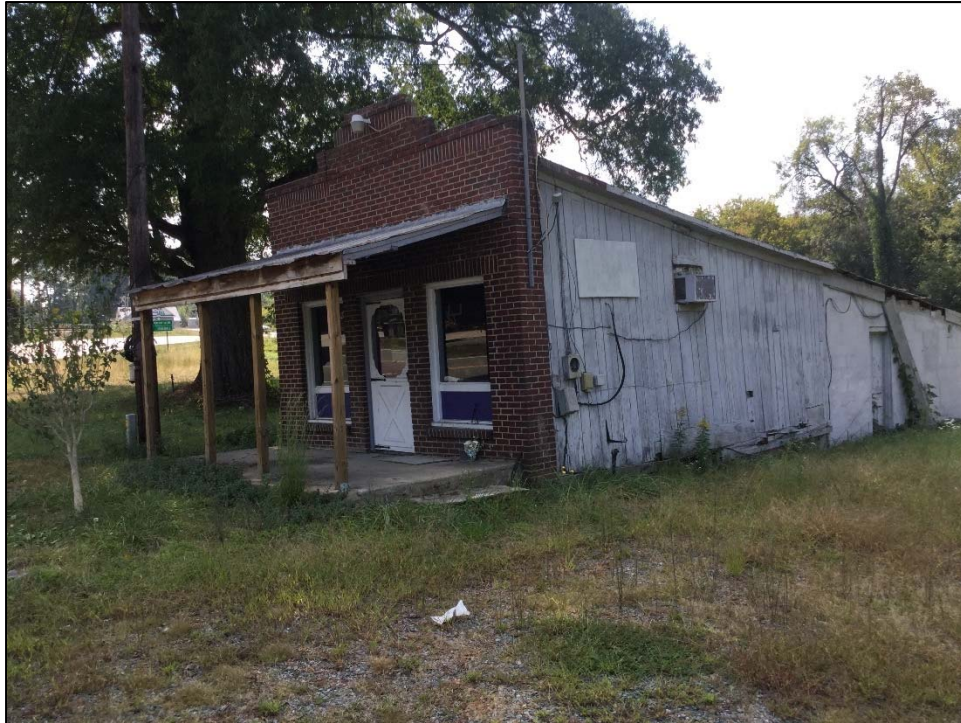
Building front and entrance, facing south.

This facility currently is unoccupied and appears abandoned. The site is listed in the reviewed public records in the historical auto database, for records as an automotive supply and parts facility listed to, Grindstaff Joe, between 1992 to 1999.

The site inspection of September 28, 2017, showed that the property contains a single structure that has been abandoned and is in a state of disuse. The remainder of the property is covered in grass or gravel, with a single tree adjacent to the building. The vegetation is sparse and stressed, but no visible signs of areas of affected growth is present. No ASTs or surface signs of USTs are present.

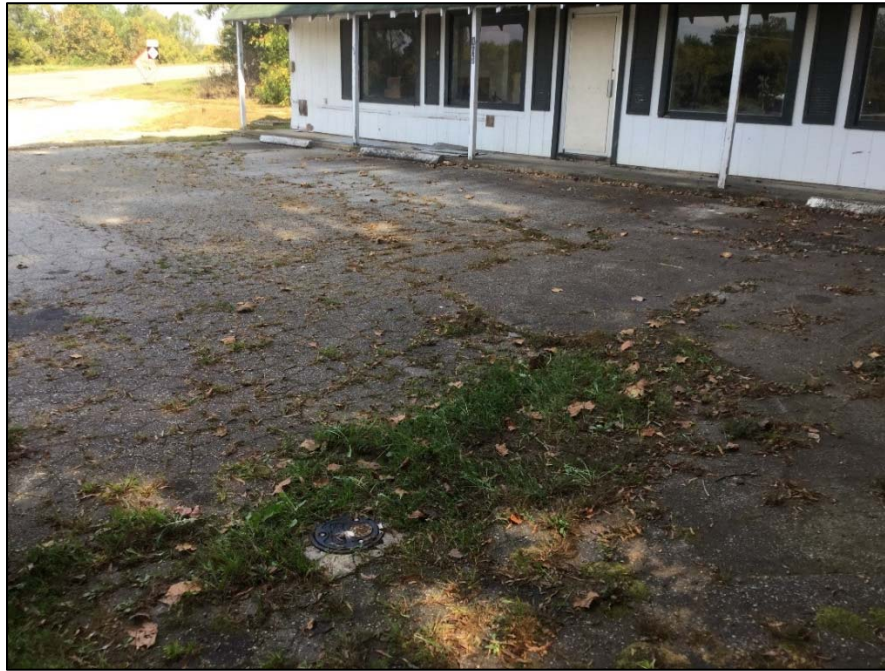
Looking SE at the front of facility, with groundwater monitoring well in foreground

This facility currently is abandoned. The facility is listed in the reviewed public records in the UST database, for three 4,000-gallon gasoline tanks, all removed – and LUST and LUST TRUST databases for an open case of petroleum release with gross benzene contamination of groundwater in February 2000, with clean-up completed in September 2001.

Public records reviewed on October 5, 2017, designate the site as a former gasoline facility containing three 4,000-gallon gasoline USTs with unknown installation dates. The tanks were excavated on June 2, 1998, and removed for off-site disposal. Analytical laboratory results of soils excavated from beneath the USTs indicated the presence of petroleum concentrations below NC standards. Contaminated soils were identified near the dispenser island and the product lines with limited excavation removing impacted soils. High BTEX concentrations were detected in groundwater adjacent to NC 65.

The site inspection on September 28, 2017, identified an abandoned building and small parking lot. No indication of USTs were identified, but a cover plate indicating the presence of four groundwater monitoring wells were noted. **This site is anticipated to present moderate geo-environmental impacts to the project.**

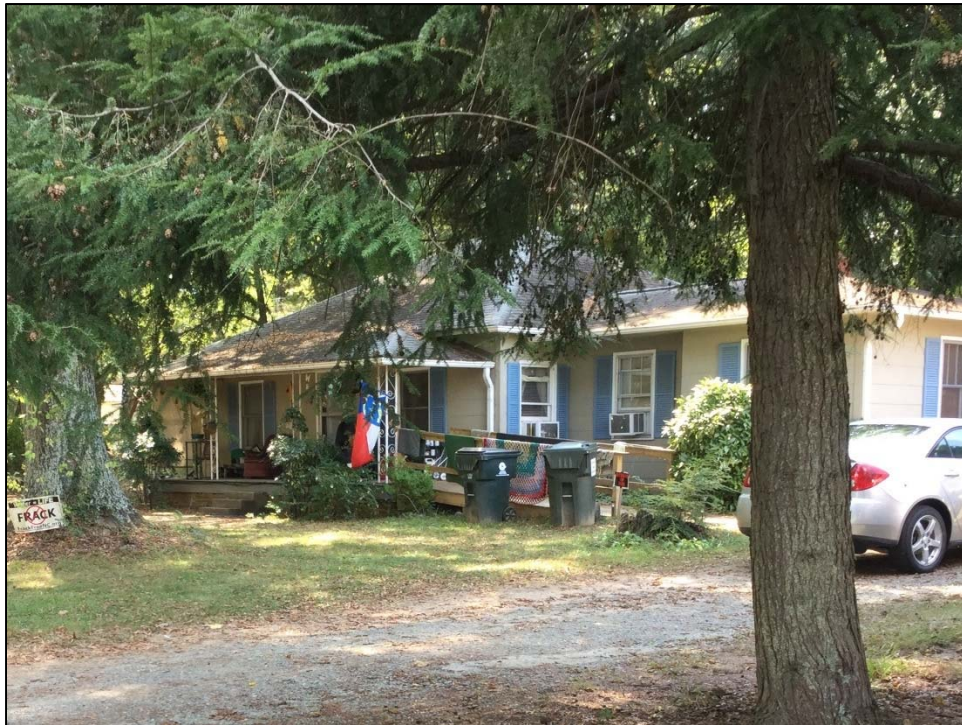
Front of residence

This facility currently operates as a private residence. The facility is listed in the reviewed public records in the LAST and the IMD databases, for a case of 200 gallons of petroleum release from an AST in March 2004, with soil contamination. Closure and cleanup were not reported, but contaminated soil was noted as being removed. This site was not previously identified as a potential project concern.

The site inspection of September 28, 2017, showed that the property is a private residence. No signs of a UST or AST were present. The ground surface is lawn, with a bare-earth driveway. No business or commercial activity was apparent.

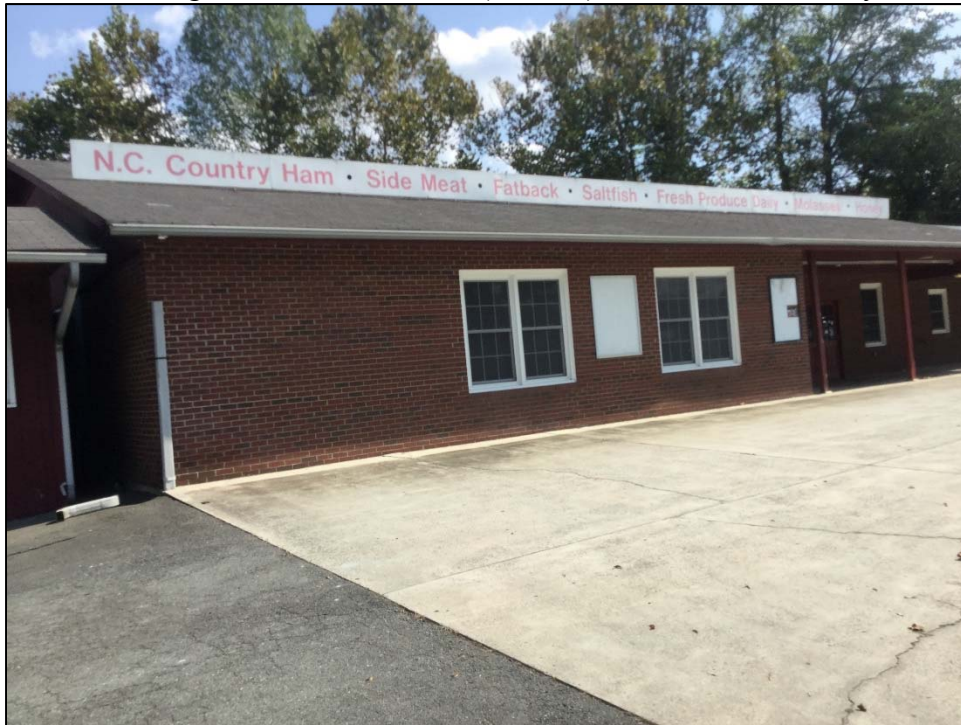
Looking SE from S. Main St. (US 311) at the front of facility

This facility is a small strip mall of small businesses. The facility is not listed in the reviewed public records.

The site inspection of September 28, 2017, showed that the site is used as a fresh produce and meat market on designated days. The market was not open at the time of assessment. A hair salon is also present in the strip mall. There are no signs of discharges, spills or hazardous material use on-site. There were no indications of USTs or ASTs, or other hazardous material storage on-site.

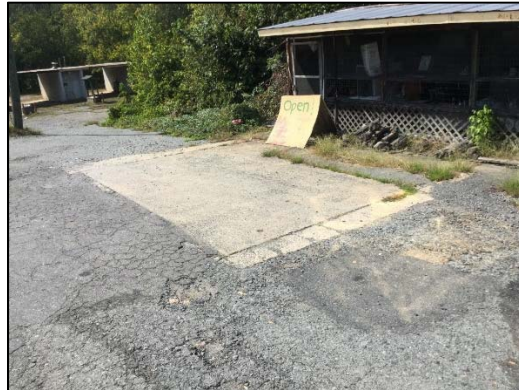
Concrete pad, former location of fuel USTs

The September 28, 2017, inspection of this property that fronts S. Main Street (US 311) observed the facility operating as restaurant and storage site. The facility is not listed in the reviewed public records. On the west side of the facility is a concrete patch in the asphalt paving pad. The owner of this property stated that a UST was removed between 1975 to 1980. The owner also operates a fuel delivery business with tanker trucks, but there is no infrastructure at this site. The wash bays located in the western portion of the property are not currently used. The ground surface is mostly asphalt pavement, with patches of gravel.

This site is anticipated to present moderate geo-environmental impacts to the project.

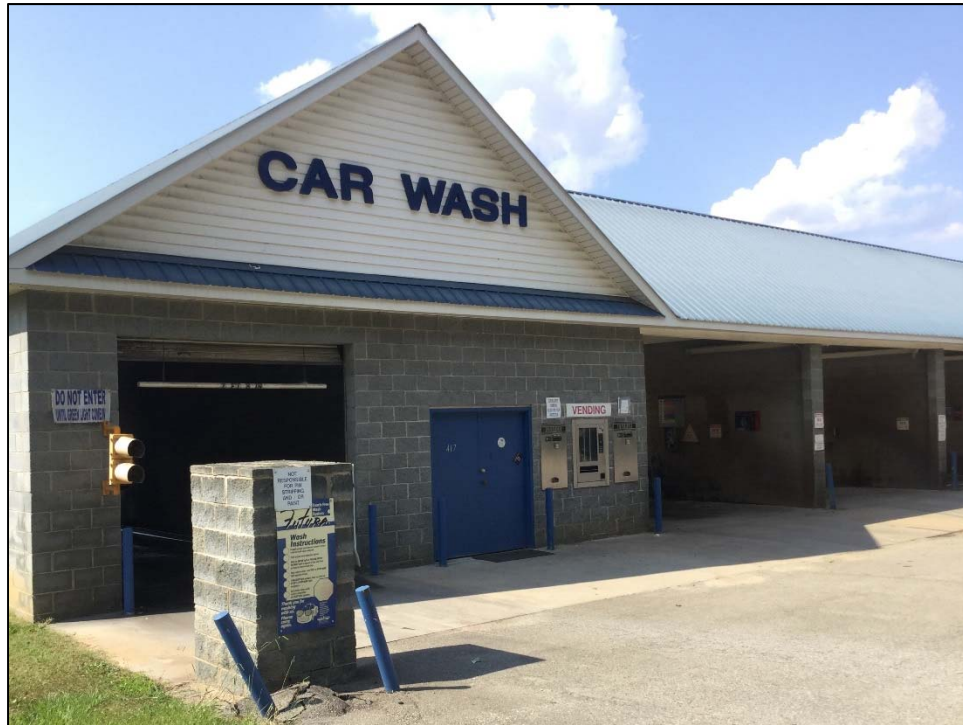
| 7) | Property Name Car Wash 415 Stokesburg Road | Property Owner: Walkertown Lube-N-Wash, LLC |

This facility currently operates as an automated self-serve car wash. The facility is not listed in the reviewed public records.

The site inspection of September 28, 2017 showed that the site is an automatic car wash with 5 bays – one that moves the vehicle through the bay, and four that are stationary with central floor drains for hand washing. Minimal wash water appears to flow out of the bays. There are no indications that there are USTs to receive/recycle the used water. There were no personnel on site. Vacuums are also present in separate setups and an oil/water separator may be in place onsite.

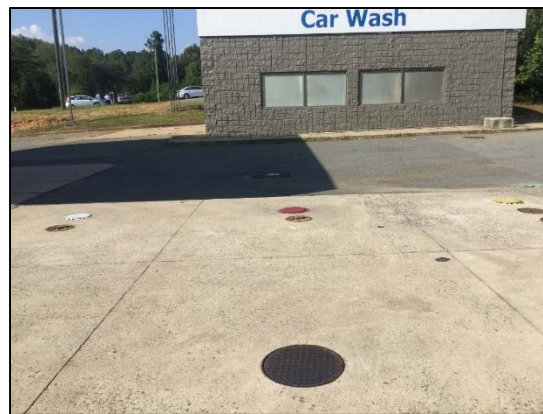
Fuel USTs, with car wash

This facility currently operates as a gas station and convenience store. The facility is not listed in the reviewed public records.

The site inspection of September 28, 2017, showed that the site has six dispenser islands, a car wash building, and a convenience store. There are three fuel USTs – premium gasoline, regular gasoline, and diesel fuel. The car wash was not in operation at the time of inspection. Significant sediment from the north side of the property had washed alongside the car wash and north edge of the paved asphalt surface. There was no indication of tanks in use for the car wash. No ASTs were present. No vehicle maintenance or repair is performed.

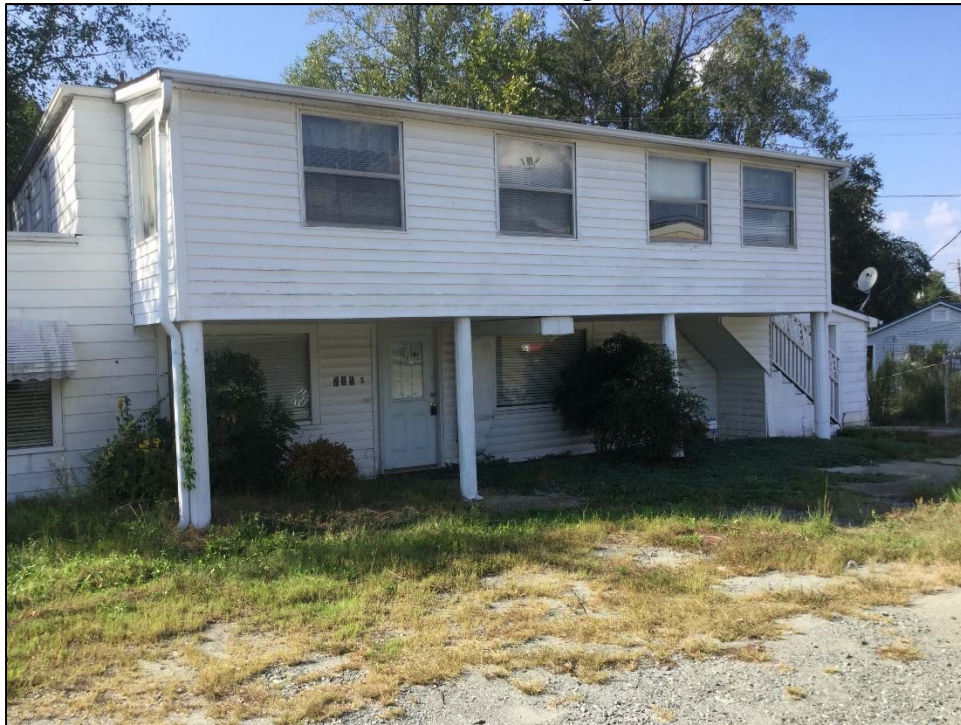
Front of building

This facility currently is abandoned. NCDEQ’s database identified four tanks on the property, with a 3,000-gallon gasoline UST installed in 1986 and a 4,000-gallon and two 3,000-gallon gasoline USTs installed in 1964. Reportedly, one 3,000 gallon UST associated with the former operations was removed and replaced with the same sized UST in 1986. All USTs were removed in 2005 and no groundwater incident number was assigned. A cleanup was reported in 1986 and closed out to residential standards in 2016

The site inspection of September 28, 2017 showed that the site is a single residential building, with no activity. It appeared to be abandoned. The ground surface is a mix of gravel cover and short grass. A single monitoring well is in place in the gravel area, possibly indicating the former location of commercial tanks.
