**GEOENVIRONMENTAL PHASE II INVESTIGATION**  
**PARCEL 004 – JIMMY & DEBBIE KNIGHT**  
**301 MAIN STREET**  
**WALNUT COVE, STOKES COUNTY, NORTH CAROLINA**  
**STATE PROJECT: R-5768**  
**WBS ELEMENT: 44670.1.1**  
**APRIL 30, 2019**

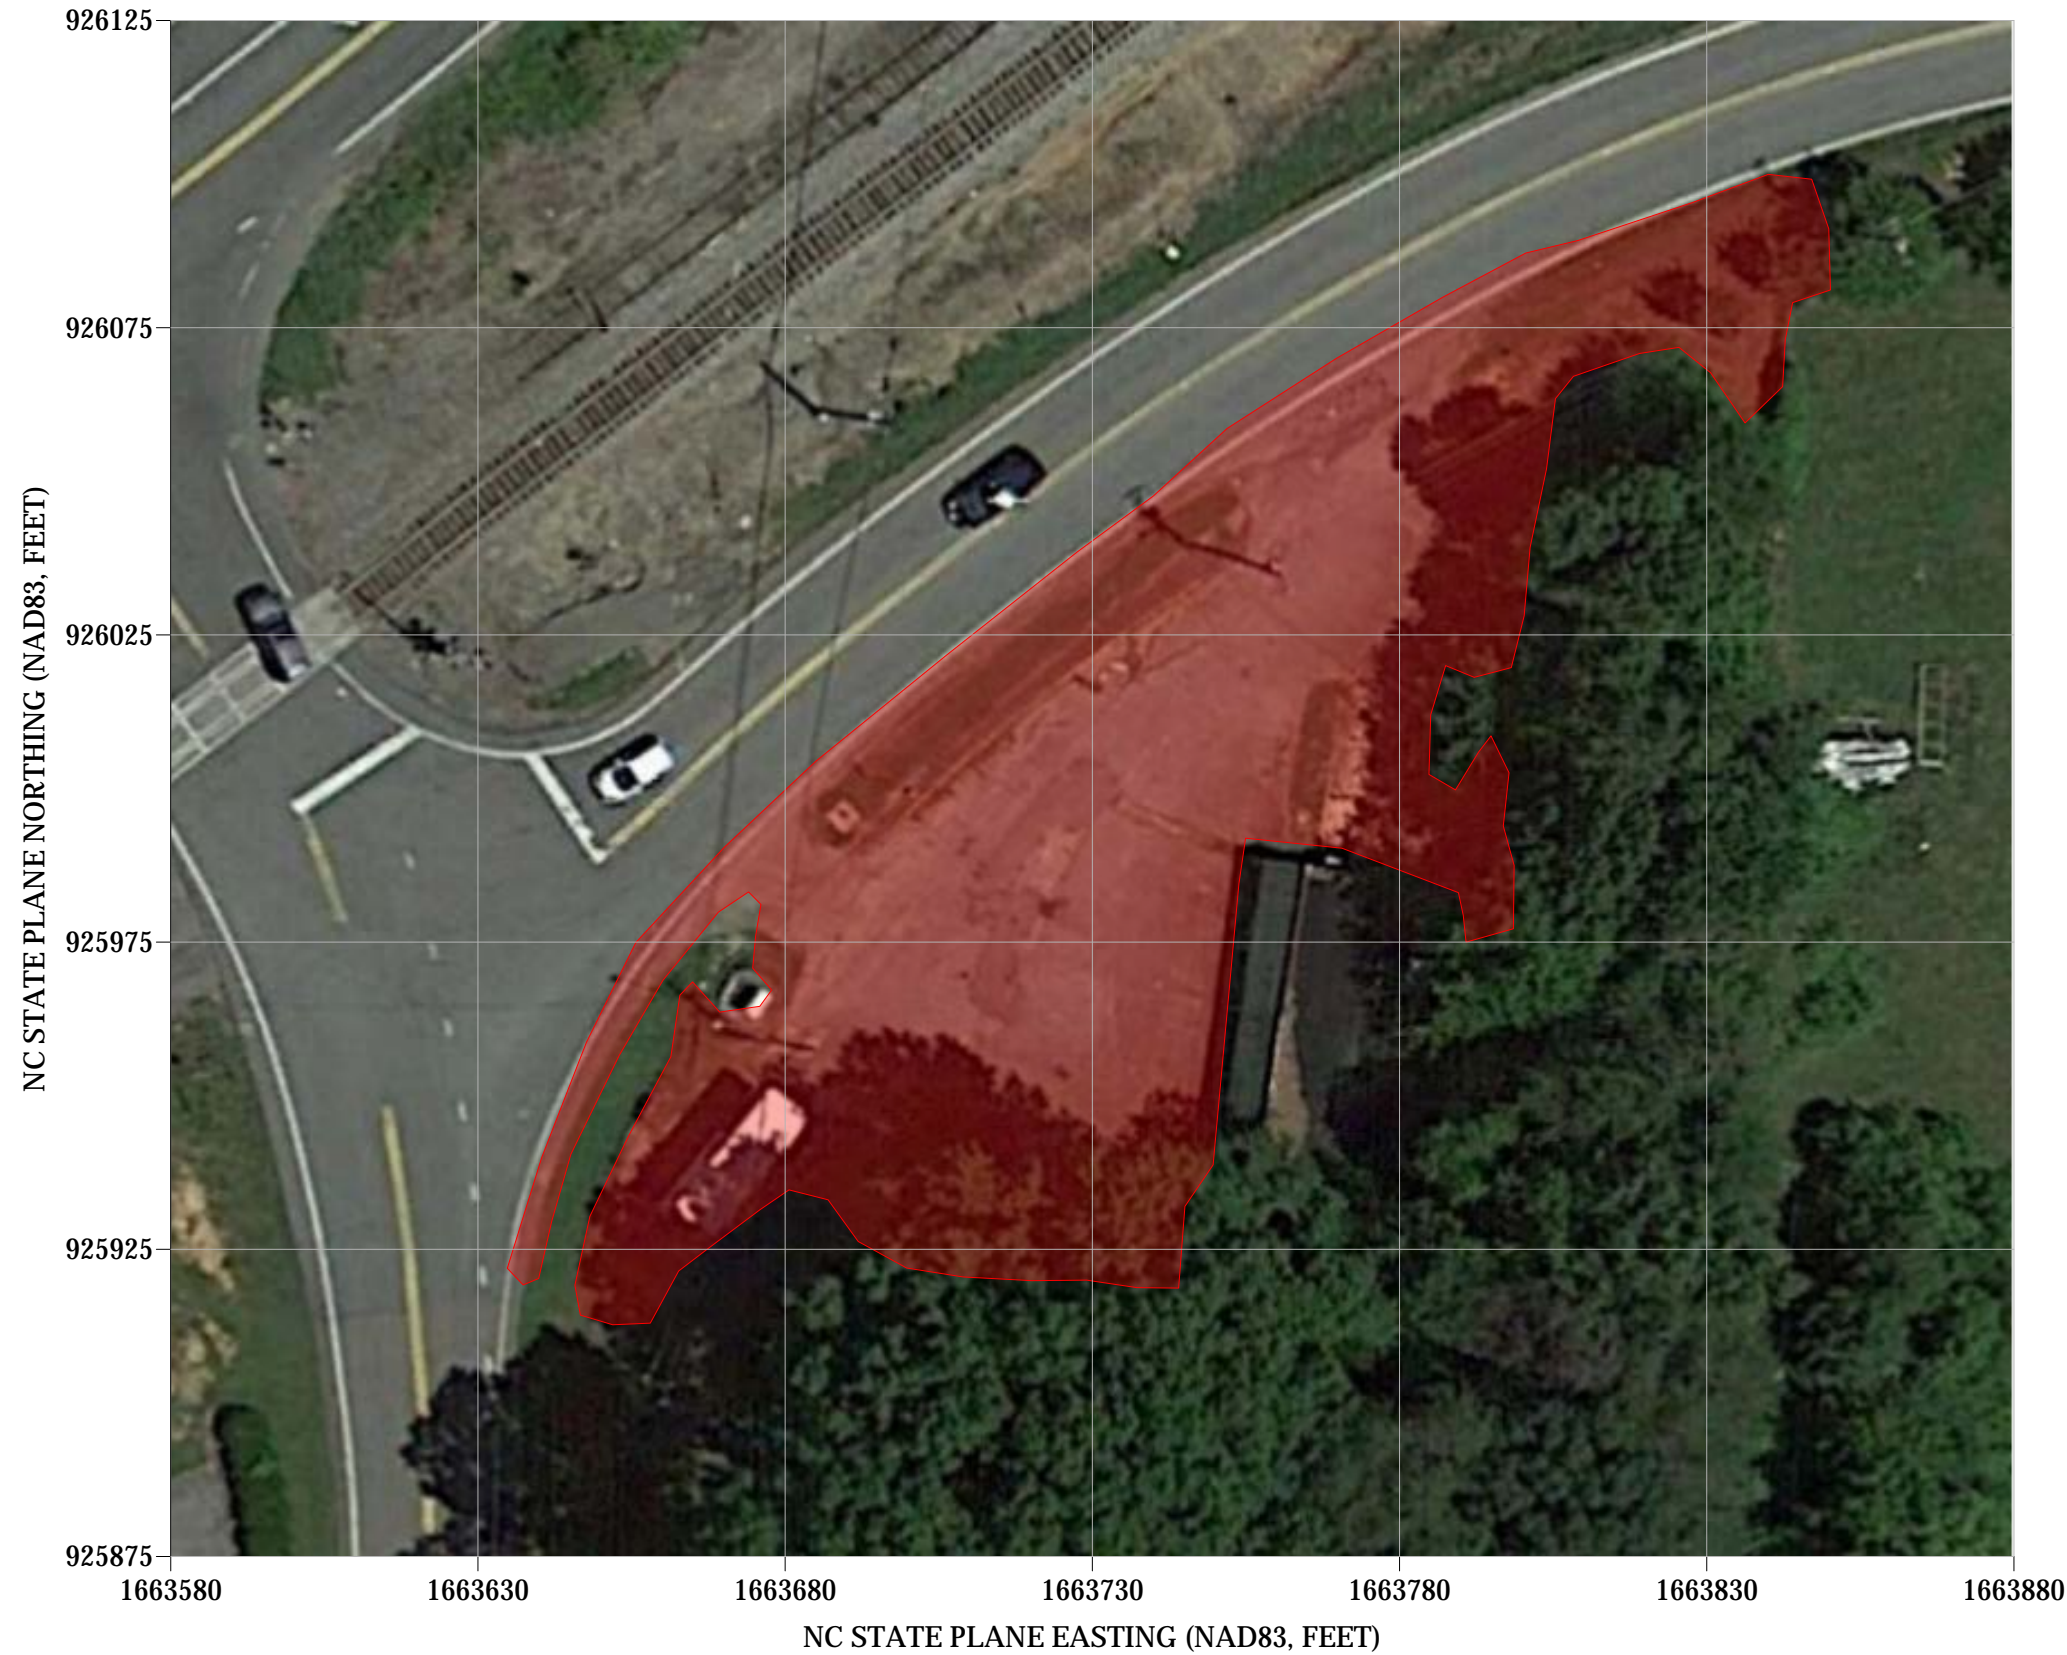
## APPROXIMATE BOUNDARIES OF GEOPHYSICAL SURVEY AREA

View of Survey Area  
(Facing Approximately East)

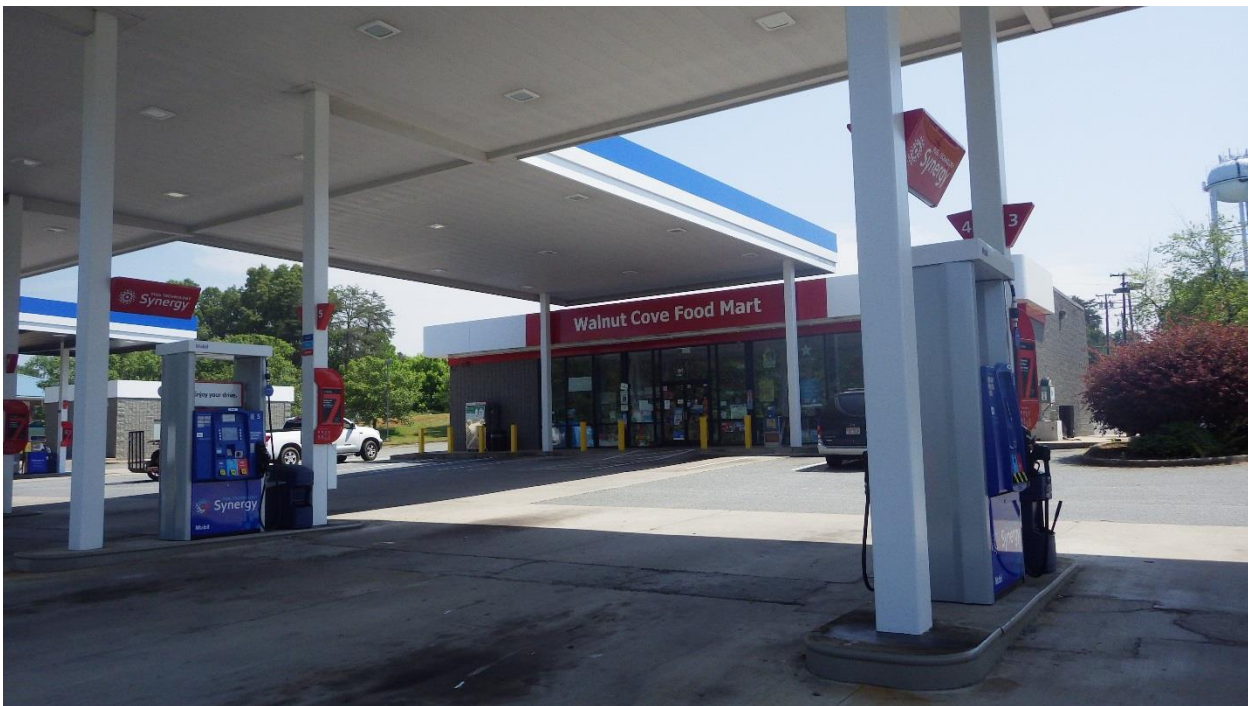
This is an active Mobil Gas Station. Based on NCDEQ's database, there are 4 USTs currently active on site. No monitoring wells are observed to be present at the time of this site visit. **This site is anticipated to present low geoenvironmental impacts to the project.**

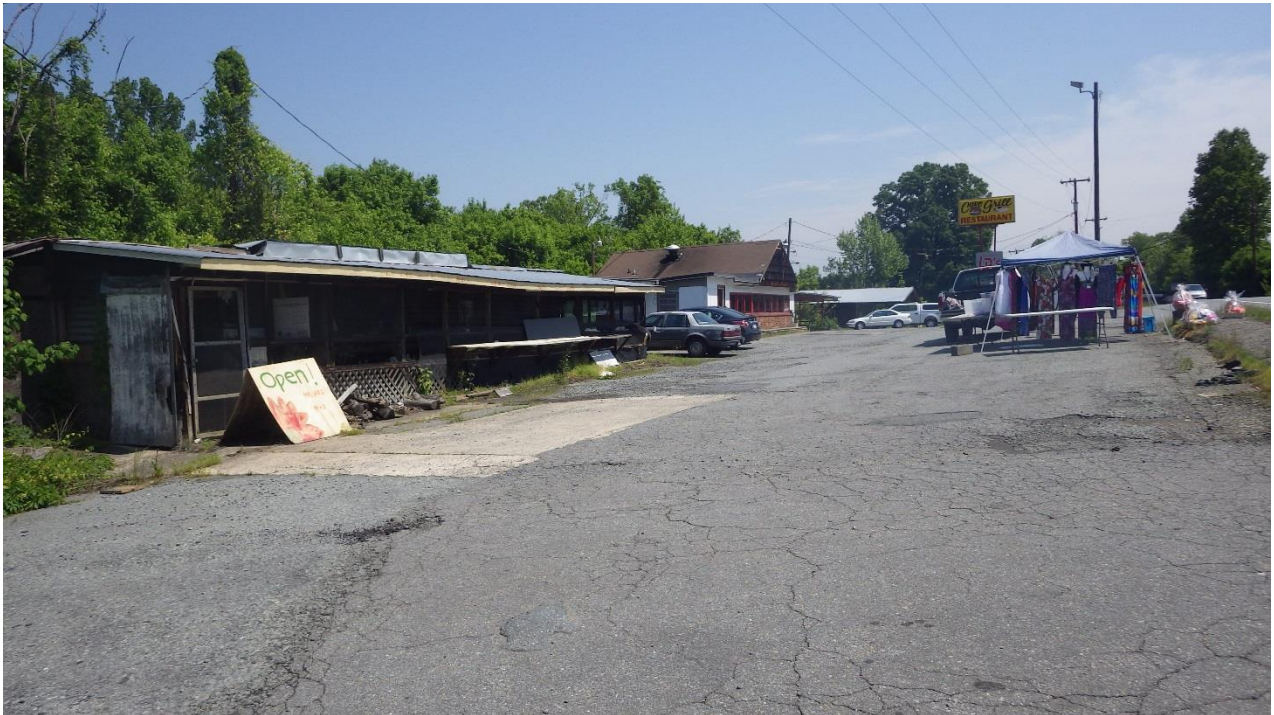
This is a large lot with a restaurant (the Cover Grill) and some storage business currently in operations. There are evidence of USTs and associated features on site. This was an old country store, USTs are probably still in the property. There are no record can be located from NCDEQ database. No monitoring wells are observed to be present on site. **This site is anticipated to present medium geoenvironmental impacts to the project.**

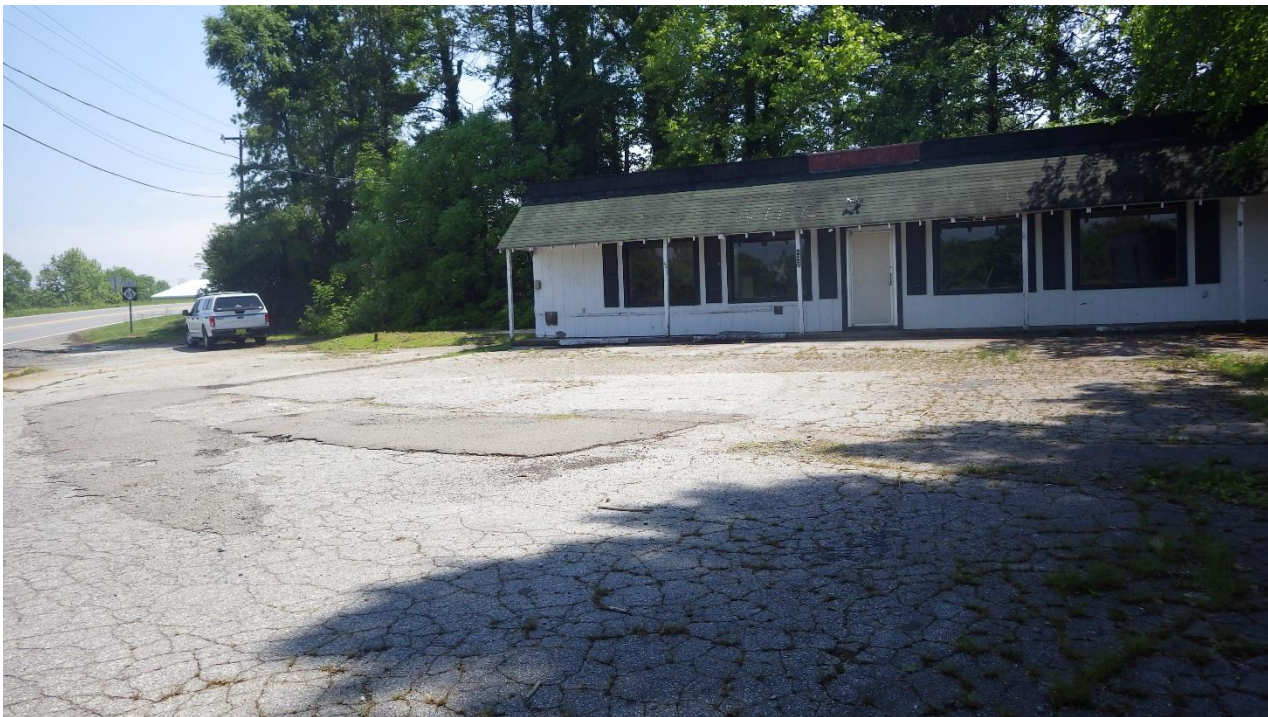
This is the vacant building, the Former FRIENDLY FOOD MART #6 convenience Store was located at the corner of NC 65 and STOKESBURG RD. Based on NCDEQ's database, there were three 4000 gallons tanks installed in 1975 reportedly removed in 1998. Four (4) monitoring wells were observed to be present on site. The tank closure report could not be located in DEQ's files. **This site is anticipated to present medium geoenvironmental impacts to the project.**

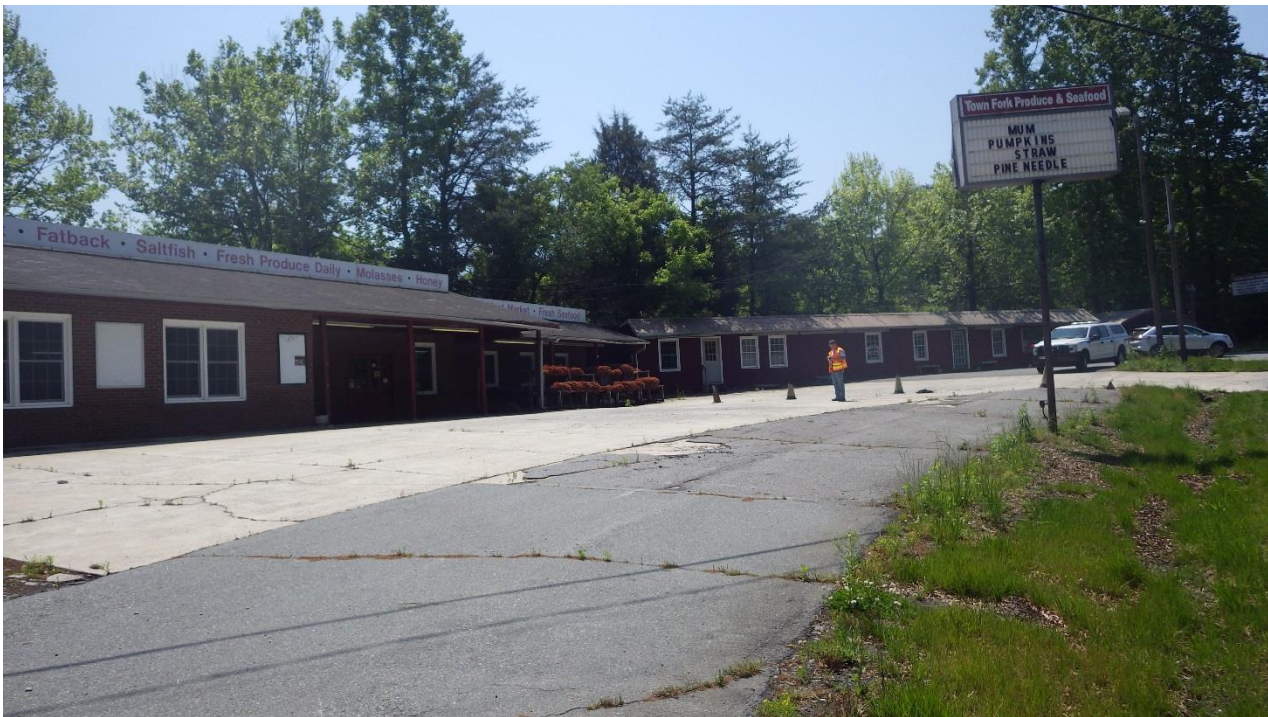
This is the former GENE MILLER convenience store later converted to a multi business center. Based on NCDEQ's database, there were four tanks on the property, one was installed in 1986, and the others in 1964. No new USTs were installed since 2005. There are evidence of sewer line installed in the area of former USTs. No monitoring wells were observed to be present at the time of this site visit. Reportedly, one 3000 gallon UST associated with the former operations was removed and was replaced with the same sized UST in 1986. All USTs were removed in 2005 and no groundwater incident number was assigned. **This site is anticipated to present medium geoenvironmental impacts to the project.**

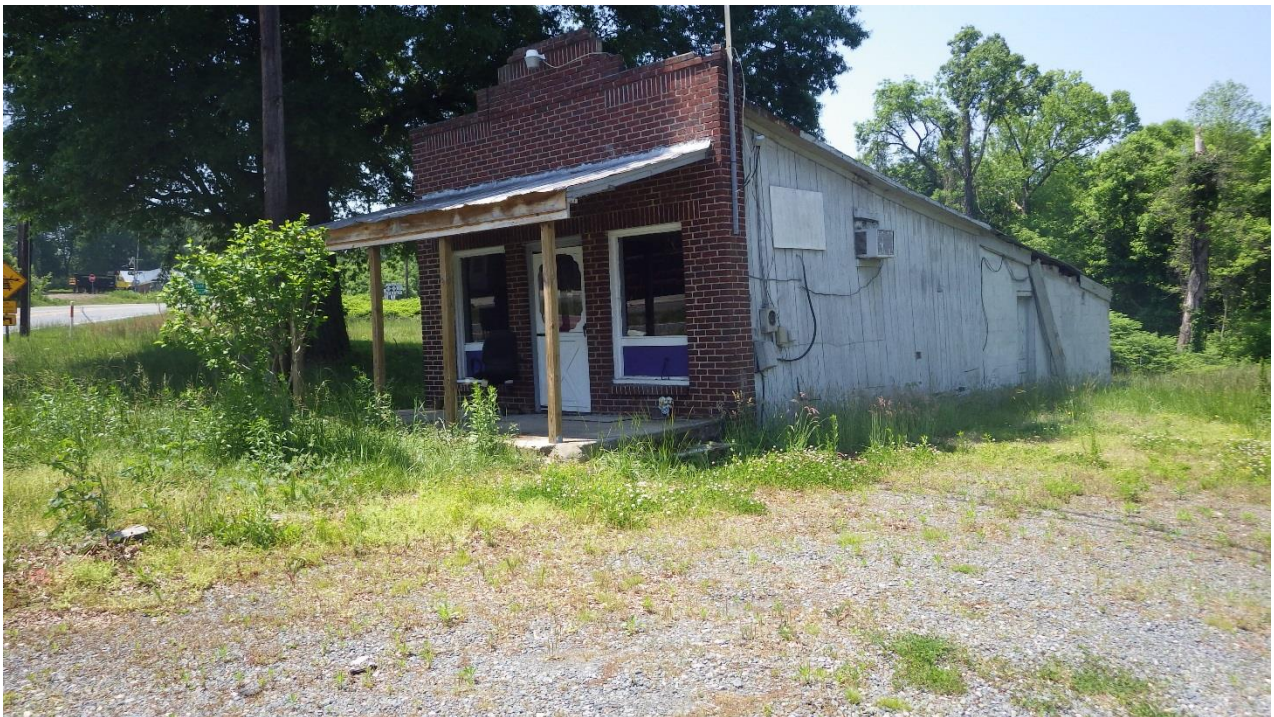
This is a vacant building. Based on the location and the style of the structure, the site is probably a former convenience store. However, USTs and associated features are not observed to be present at the time of this site visit. No monitoring wells are observed to be present on site. No record was located from NCDEQ's database. **This site is anticipated to present medium goenvironmental impacts to the project.**
