TIP NO: B-5808
WBS: 45762.1.1
COUNTY: Cabarrus
DIVISION 10

DESCRIPTION: Replace Bridge No. 57 & 59 on US 29 & US 601 over Irish Buffalo Creek

SUBJECT: GeoEnvironmental Report for Planning

Hazardous Materials Report

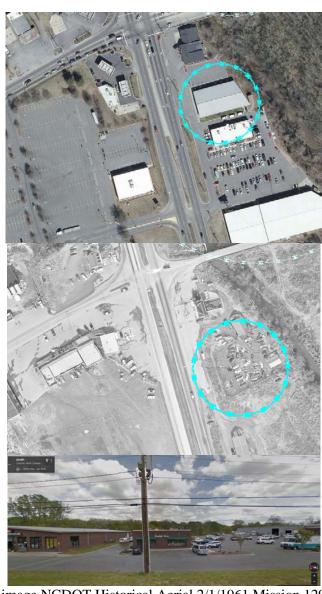
Historical Automotive Service and/or Automotive Recycling 570 – 530 Concord Pkwy N Concord, NC

First Image c. 2015; second image NCDOT Historical Aerial 2/1/1961 Mission 129, exposure 13 (top of page is northward); Third Image Google Streetview c. 2016 (view northeastward)

This parcel is located south of the intersection of US 29 & US 601 and Poplar Tent Rd. This single parcel contains Dan'elle Clothing Warehouse, Punchy's Diner, and Punchy Whitaker's Wheel and Tire Pros. This parcel does not appear on the UST Section Registry nor are any NCDEQ incidents associated. There is no evidence of USTs or UST removals. Hydraulic lifts were not observed at the modern Punchy Whitakers Wheel and Tire Pros. In a NCDOT Historical Aerial, several cars and pre-existing buildings were observed that suggest that auto service and/or auto recycling was performed, thus hydraulic lifts or spills from auto recycling may be present. This site is anticipated to present low geoenvironmental impacts to the project.

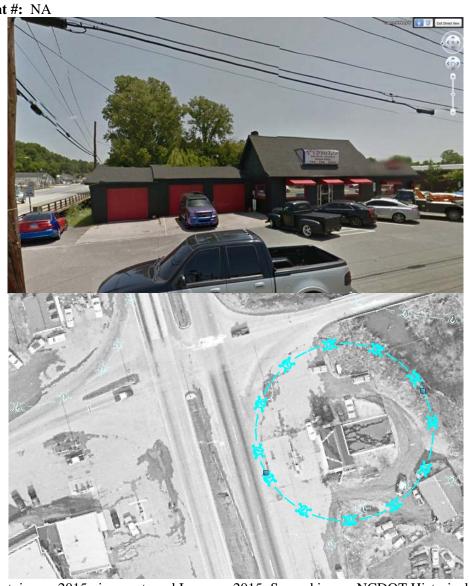
> Premier Auto Sound Security Concord Ink Tattoo/Piercing 590 Concord Pkwy N Concord, NC

First Image Streetview c. 2015 view eastward Image c. 2015; Second image NCDOT Historical Aerial 2/1/1961 Mission 129, exposure 13 (top of page is northward)

This apparent former gas station is located on southeastern quadrant of the intersection of US 29 & US 601 and Poplar Tent Rd. The architectural style, age, location and NCDOT Historical Aerial suggest that it operated as a gas station c. 1961. This site is anticipated to present low geoenvironmental impacts to the project.

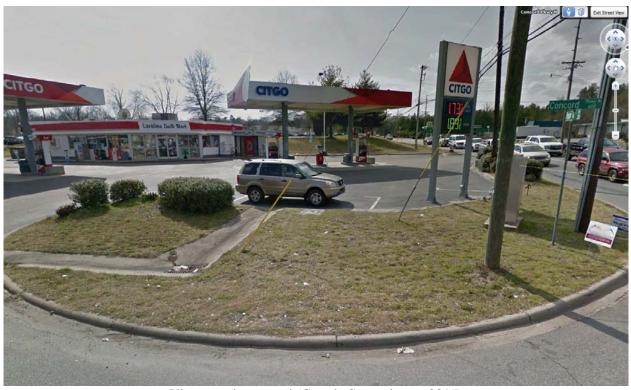
Citgo AKA Carolina Quick Lube 589 Concord Pkwy N Concord, NC

View southeastward (Google Streetview c. 2015)

This active gas station is located on south-southwestern quadrant of the intersection of US 29 & US 601 and Poplar Tent Rd. A groundwater monitoring well was observed near the store building. **This site is anticipated to present low geoenvironmental impacts to the project.**

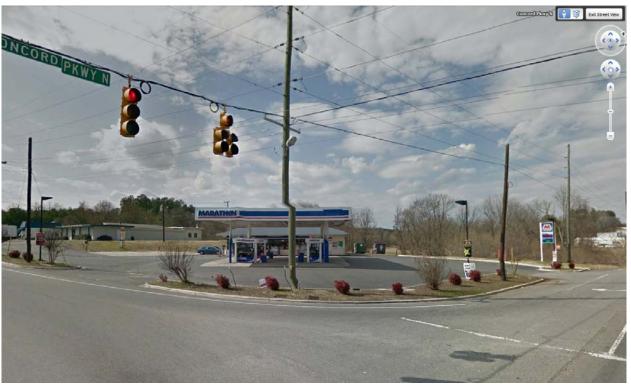
Marathon Mid-State Oil Company/ Sun Oil 603 Concord Pkwy Concord, NC

View northwestward (Google Streetview c. 2015)

This active gas station is located on the western quadrant of the intersection of US 29 & US 601 and Poplar Tent Rd. An Incident was assigned by NCDEQ. This site is anticipated to present low geoenvironmental impacts to the project.

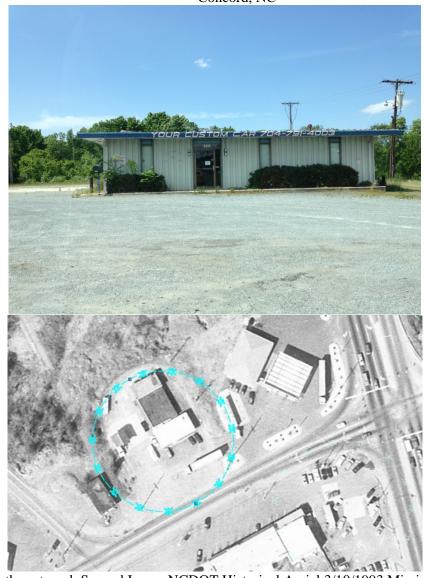
Your Custom Car AKA Twice the Ice AKA Security Oil Company 2242 Poplar Tent Rd. Kannapolis, NC

First image view northwestward; Second Image NCDOT Historical Aerial 3/10/1993 Mission 3092, exposure 60 (top of page is northward);

This former gas station and/or oil company facility is located approximately 300 feet west of the intersection of US 29 & US 601 and Poplar Tent Rd. According to the UST Section Registry USTs were registered and an Incident recorded. Four USTs are evident west of the building. **This site is anticipated to present low geoenvironmental impacts to the project.**

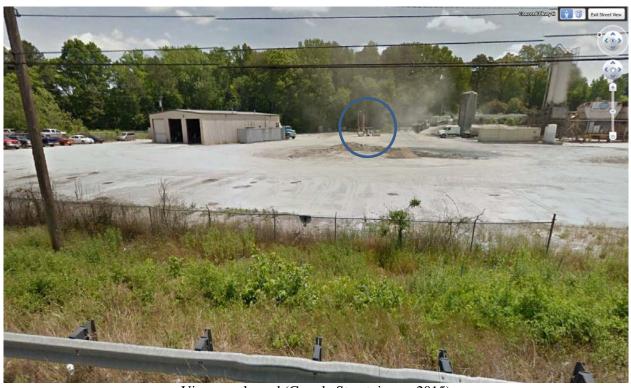
Cement Plant 470 McGill Ave. PO Box 508 Concord, NC

View northward (Google Streetview c. 2015)

This cement plant is located on northeastern quadrant of the intersection of US 29 & US 601 and Poplar Tent Rd. According to the UST Section Registry two USTs were reportedly filled in situ with inert material. An above ground storage tank (AST) is currently on site currently (blue circle). **This site is anticipated to present low geoenvironmental impacts to the project.**

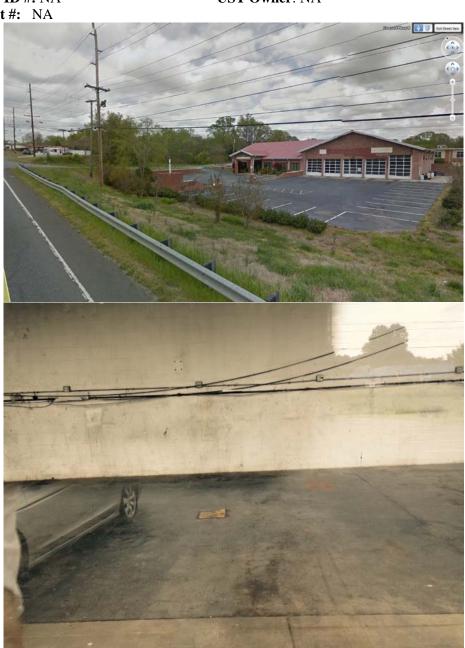
Webster Radiator and A/C 650 Concord Pkwy N. Concord, NC

View north-northeastward (Google Streetview c. 2015)

This former location of Webster Radiator and A/C is located 1000 feet north of the intersection of US 29 & US 601 and Poplar Tent Rd. Hydraulic lifts may be present behind the bay five bay doors. **This site is anticipated to present low geoenvironmental impacts to the project.**

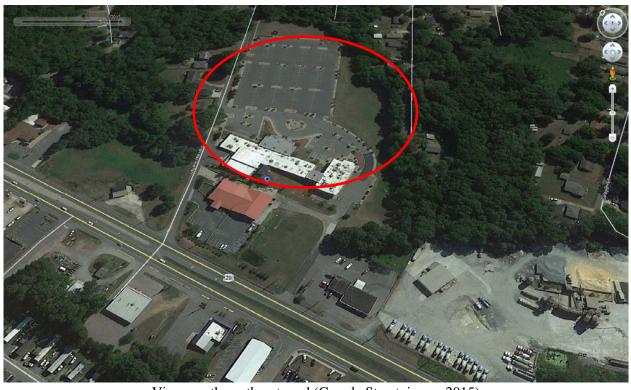
Cabarrus Schools Maintenance Facility 660 Hwy 29 N Concord, NC

View north-northeastward (Google Streetview c. 2015)

This school maintenance facility is located 1000 feet north of the intersection of US 29 & US 601 and Poplar Tent Rd. behind the site of Webster Radiator and A/C. According to the UST Section Registry a UST registered and an Incident recorded, and a No Further Action status was reportedly granted c. 2001. **This site is anticipated to present low geoenvironmental impacts to the project.**

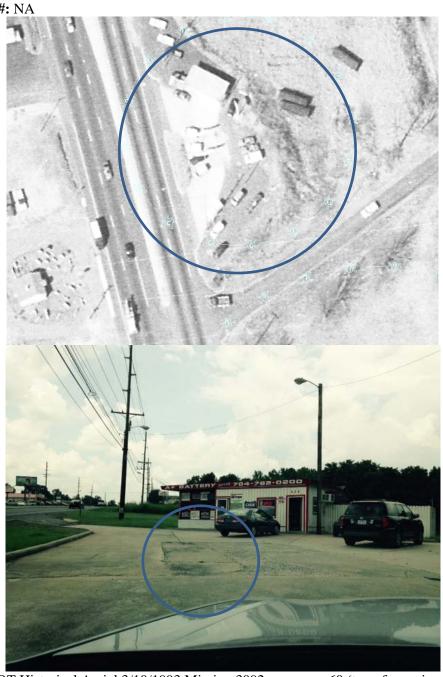
9) **Property Name** Car Battery Sales

First Image NCDOT Historical Aerial 3/10/1993 Mission 3092, exposure 60 (top of page is northward); Second Image view northward

This car battery sales facility and apparent former gas station is located 1000 feet north of the intersection of US 29 & US 601 and Poplar Tent Rd. A NCDOT Historical Aerial suggests it was a gas station (first image, blue circle), and an apparent former pump island is evident in the concrete (second image, blue circle). **This site is anticipated to present low geoenvironmental impacts to the project.**

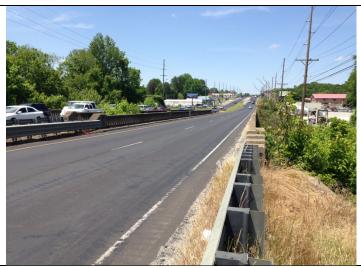
Bridge 57 on US 29 & US 601 over Irish Buffalo Creek. View to the north.

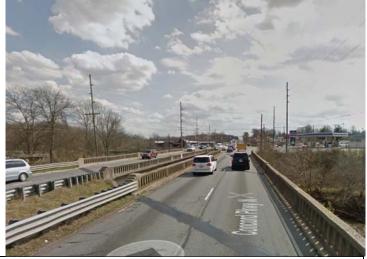
Bridges 57 (left) & 59 (right) on US 29 & US 601 over Irish Buffalo Creek. View to the south. (Google Streetview c. 2015)

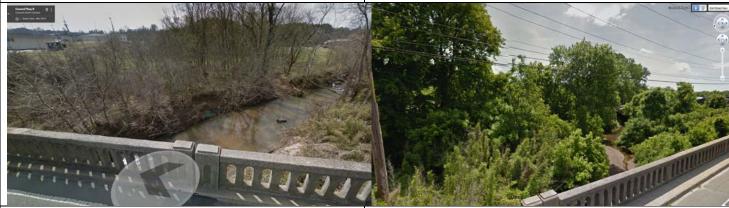
Bridge 57 on US 29 & US 601 view of Irish Buffalo Creek northwestward. (Google Streetview c. 2015)

Bridge 59 on US 29 & US 601 view of Irish Buffalo Creek southeastward. (Google Streetview c. 2015)
